Subject: Fall 2008 Cap Inspection
Keith Middle School
New Bedford, Massachusetts

CAP INSPECTION FORM KEITH MIDDLE SCHOOL

SITE PHOTOGRAPHS
September 2008 Cap Inspection
Keith Middle School
New Bedford, Massachusetts

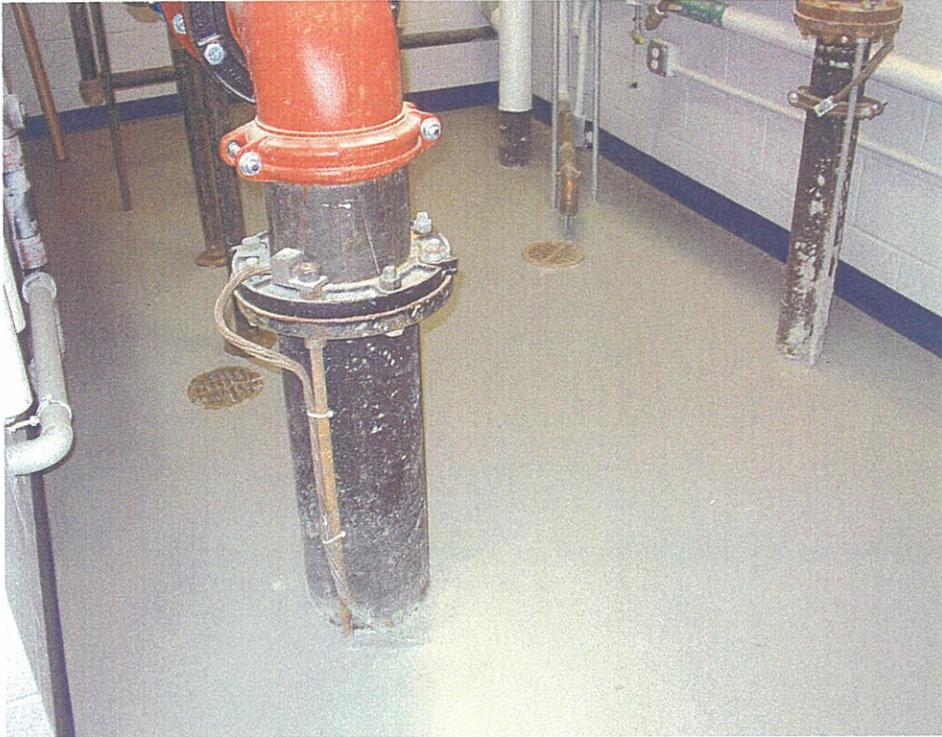
- Rm 049 = ok (Custodial Office)
 - Rm 053 = ok (Generator)
 - Rm 051 = Generally ok, conf. in minor crack previous identified.
- Note minor standing water near one pipe penetration (photos collected)
- Rm. 029 = ok (Cym)
 - Bathrooms = ok throughout
 - Stairs = ok, w/ small tile separation in stair #5 (photo)
 - Entrances = ok throughout
 - Hallways = Generally ok, w/ some minor settling along base. Also note settling cracks in wall near center of bldg (Rm. 145) (photos collected). All minor
 - Courtyard = ok, w/ v. minor cracks in concrete
 - Rm. 046 = ok (engineer office)

1) Pipe penetrations in boiler room.

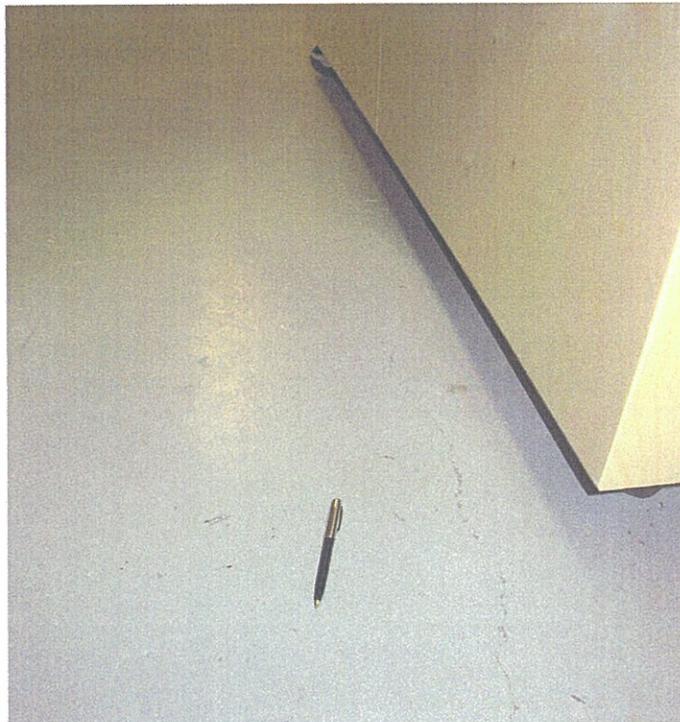
The two cracks in the boiler room floor are still less than ¼-inch wide. The majority of interior concrete floors are covered with tiles or other type of flooring material. Based on visual inspection and conversations with current employees, there are no breaches or other significant damage or deterioration of the interior surficial flooring materials or, where visible, concrete floors. Minor cracking along base of hallway walls and tile separations (e.g., cafeteria and Room 067) appear to be surficial and related to the settling of the building. No construction was occurring within the building at the time of the inspection.

2) Minor crack in boiler room floor.

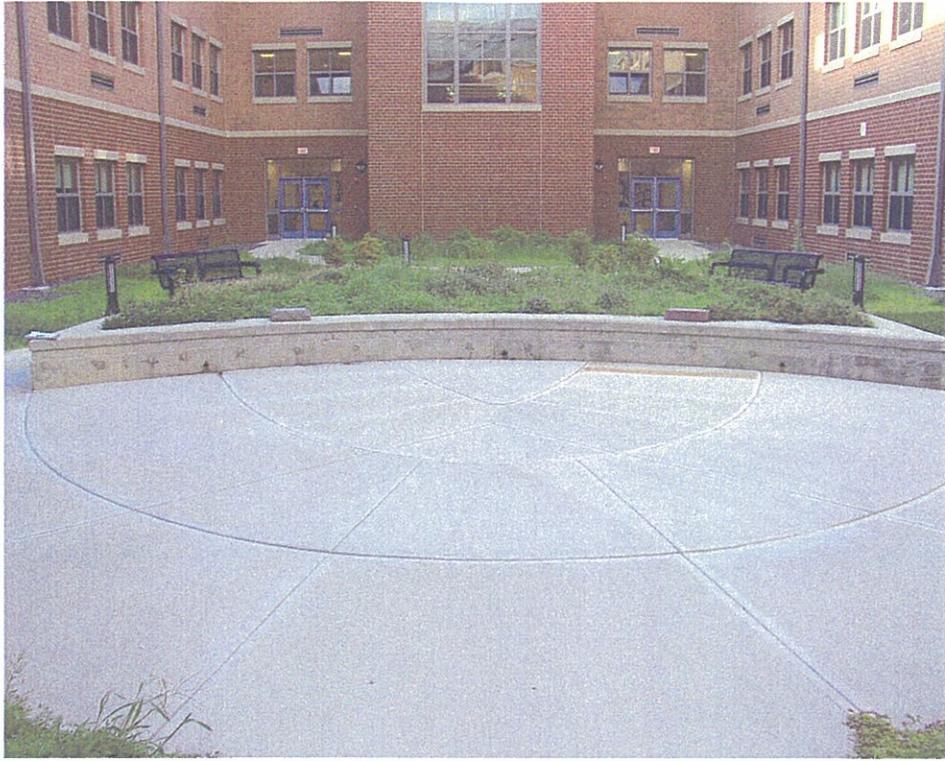
3) Courtyard looking south.

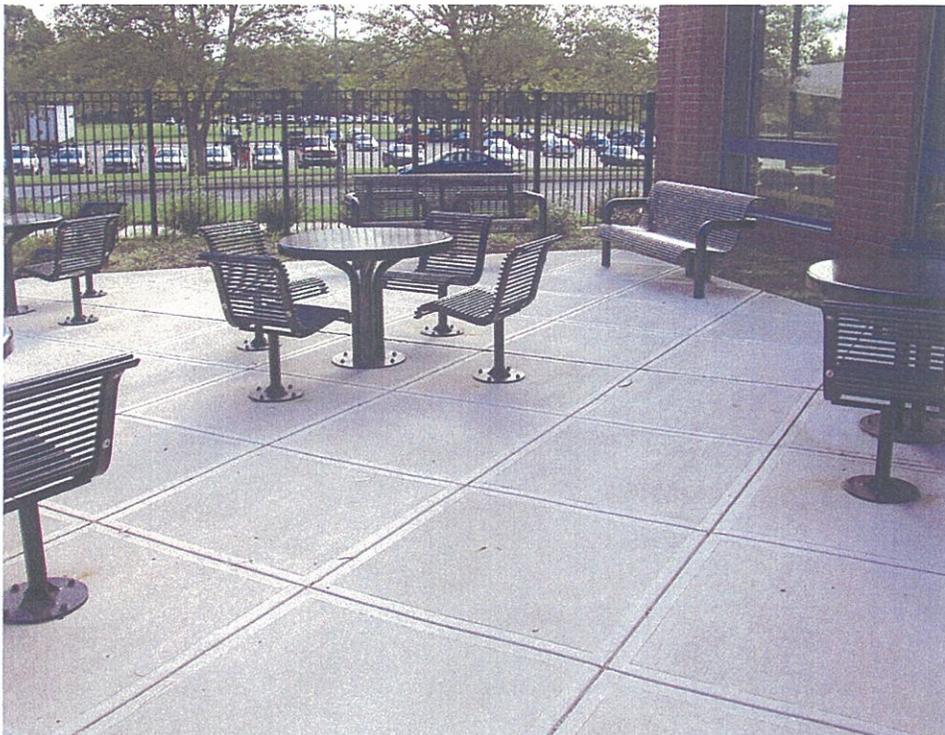
4) Community room courtyard.

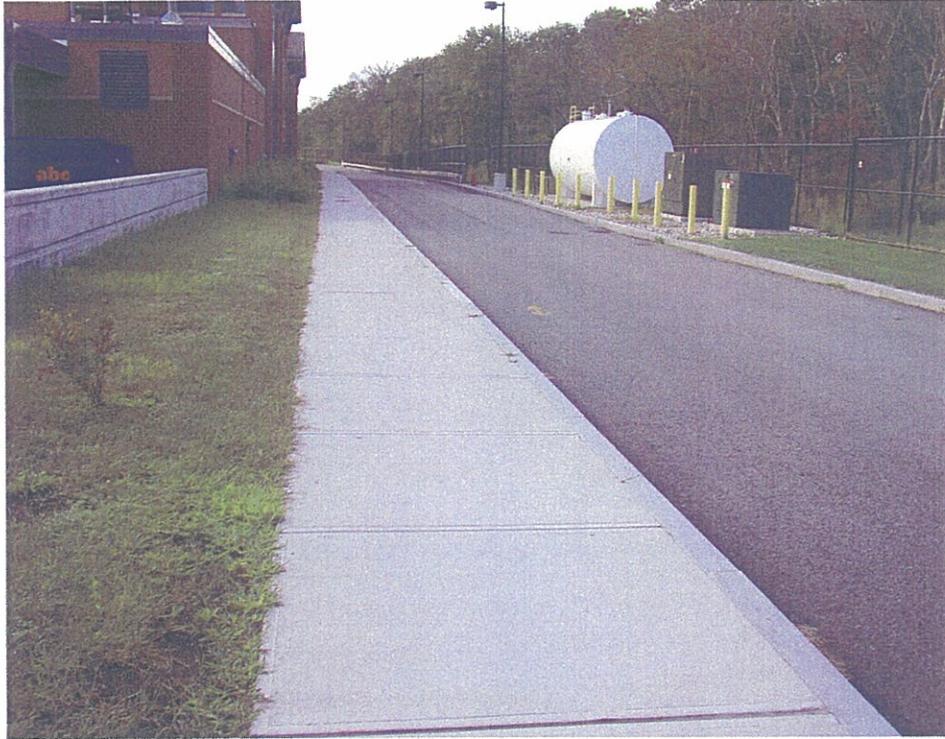
5) West side of school looking south.

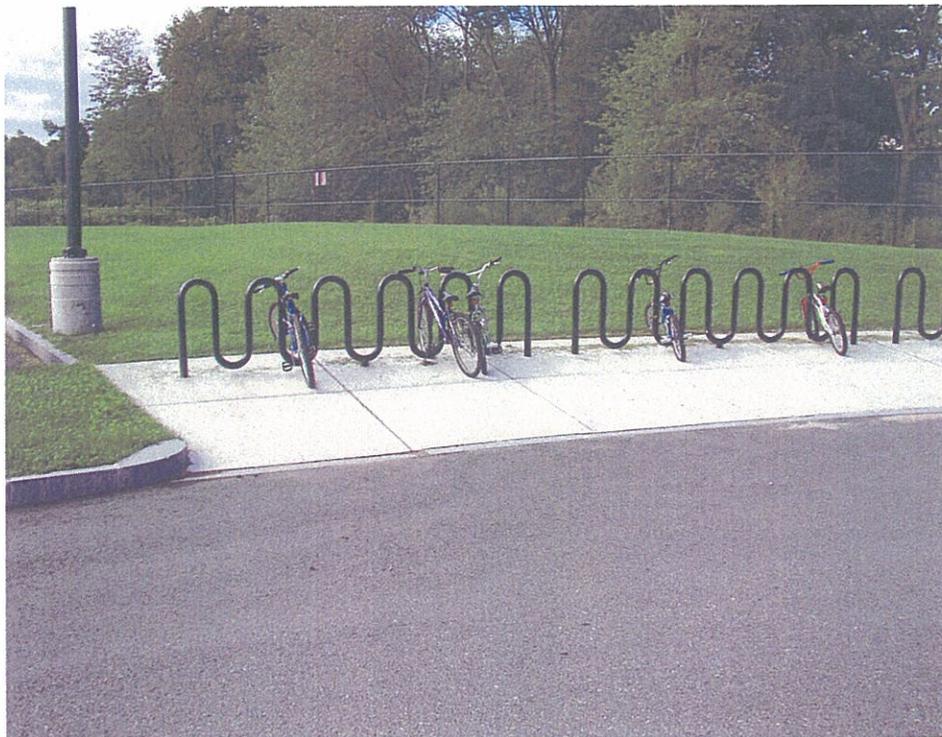
6) Southeastern bike rack looking southeast.

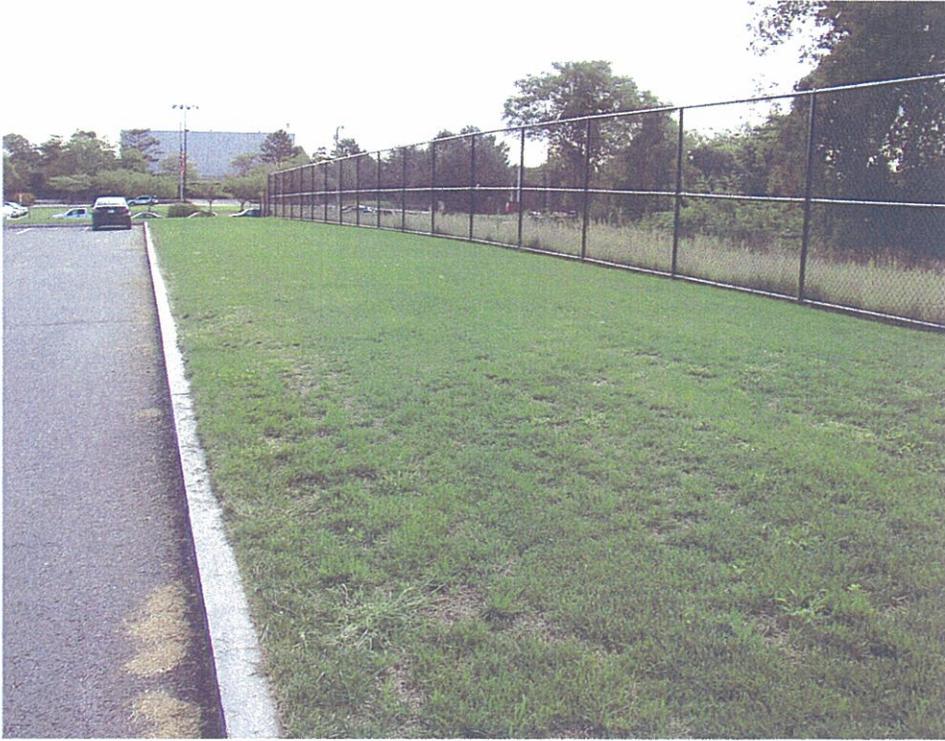
7) Southern fenceline looking west.

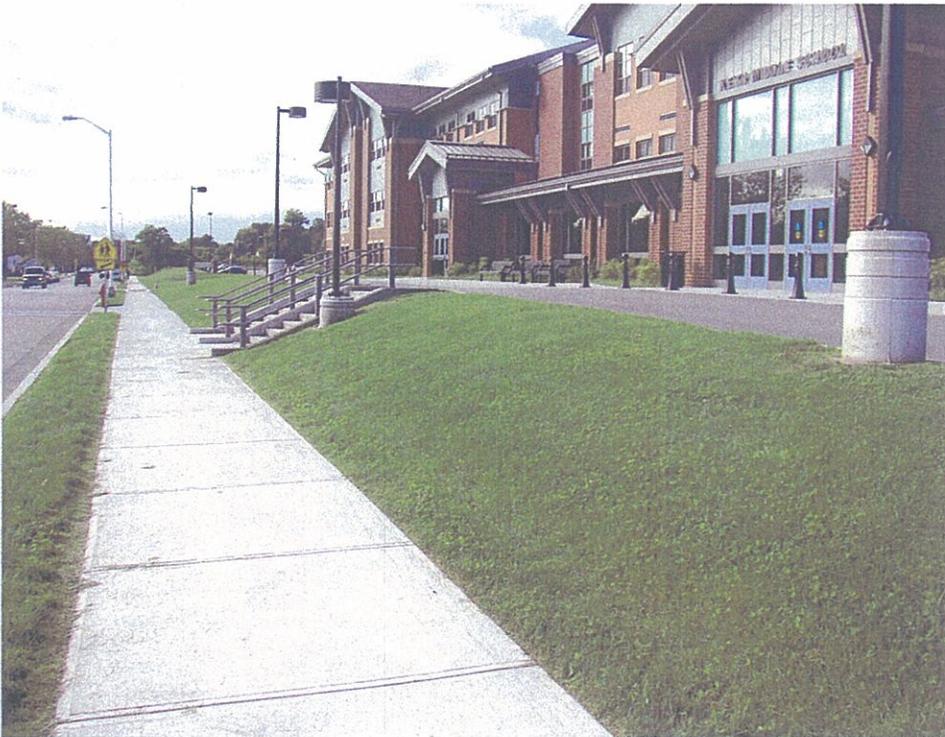
8) East side of school facing south.

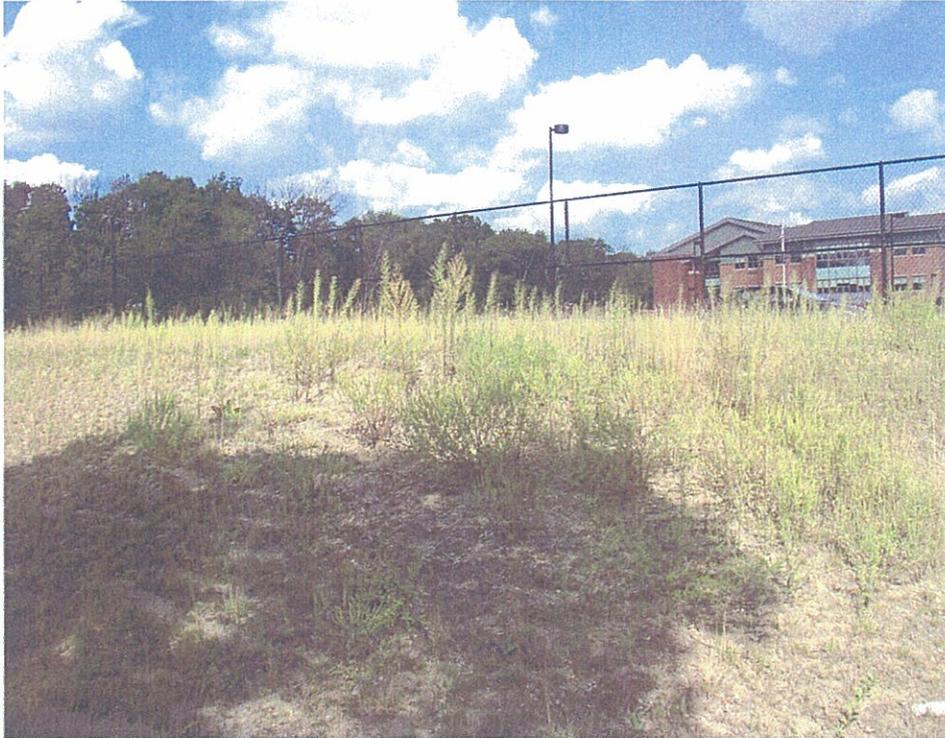
- Sparse vegetation located on the steep slope at the southeastern corner of the Site property. The amount of vegetation has increased since the previous inspection, however, relatively minor erosion rills are still visible, leaving this area at risk for further erosion during significant weather events (i.e., rain, wind).

1. The ground surface at the southeastern corner of the school property, though starting to establish vegetation, is sparsely vegetated. See Photograph #9.

9) Condition of vegetation in southeast corner of property.

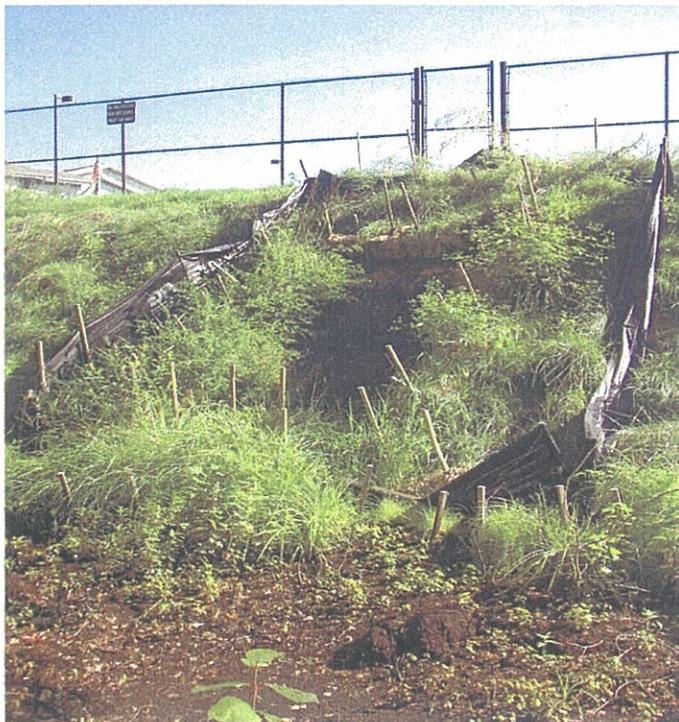
- A shallow slope failure located on the steep slope between the wetland to the west and the southern parking lot to the east. A photograph of the slope failure prior to the temporary repair is presented in Attachment 4. A temporary repair has been implemented and a permanent solution is currently being planned.

2. The slope failure in the steep slope between the wetland to the west and the southern parking lot to the east The hay bales, silt fence and geotextile filter fabric were all in good condition at the time of the inspection and no further slumping was observed. A permanent repair is required and is in the process of being designed. See Photograph #10.

10) Condition of temporary slope failure repair.

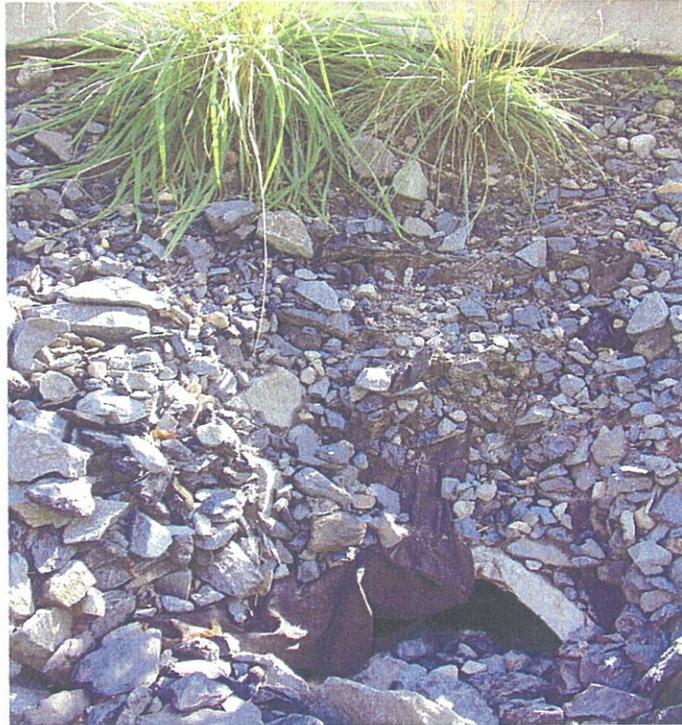
- Sloughing riprap stabilization stone that is undermining the concrete fence support at the top of the slope and filling the outlet of the storm water drainage culvert on the west side of the Site. Design and planning of a permanent solution is currently underway.

3. Riprap stabilization rock placed around the outlet of one of the storm water drainage culverts is falling down the slope and filling the end of the culvert. The outlet in question is the fourth outlet south of the above ground oil storage tank. The falling riprap has undermined the concrete fence support at the top of the slope and the deposited rock is impeding the flow of water from the culvert. The structural integrity of the fence may be compromised if the sloughing of the riprap continues. The cap soils beneath the riprap may also become exposed and susceptible to erosion. A permanent repair is required and is in the process of being designed. See Photograph #11 and #12.

11) Sloughing of rip rap at culvert outlet.

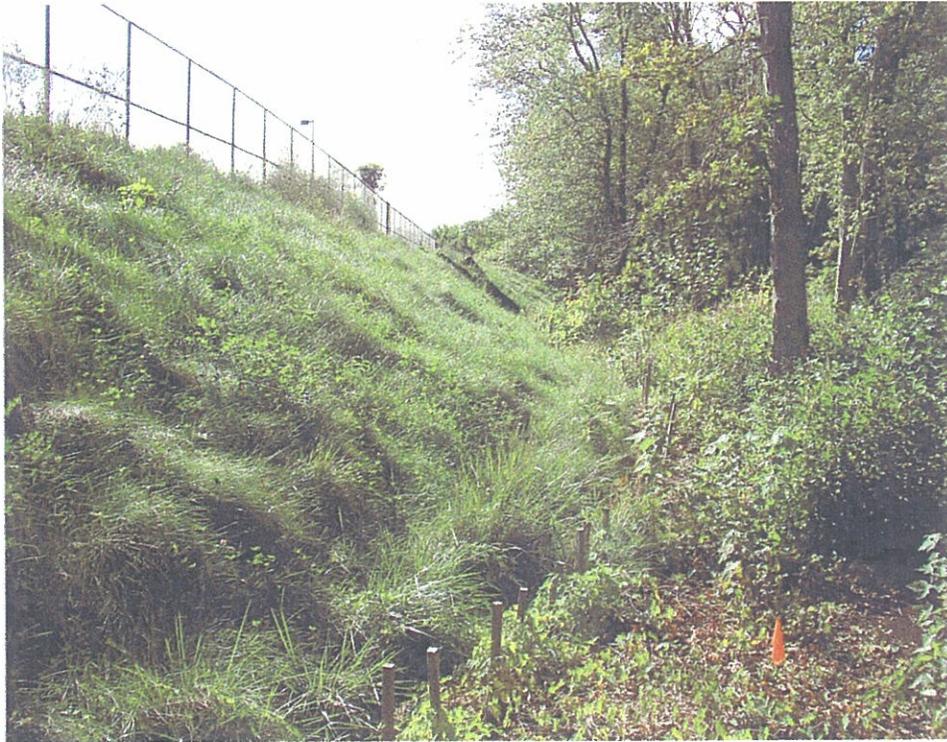
13) Vegetation north of slope failure (eastern cap slope) facing south.

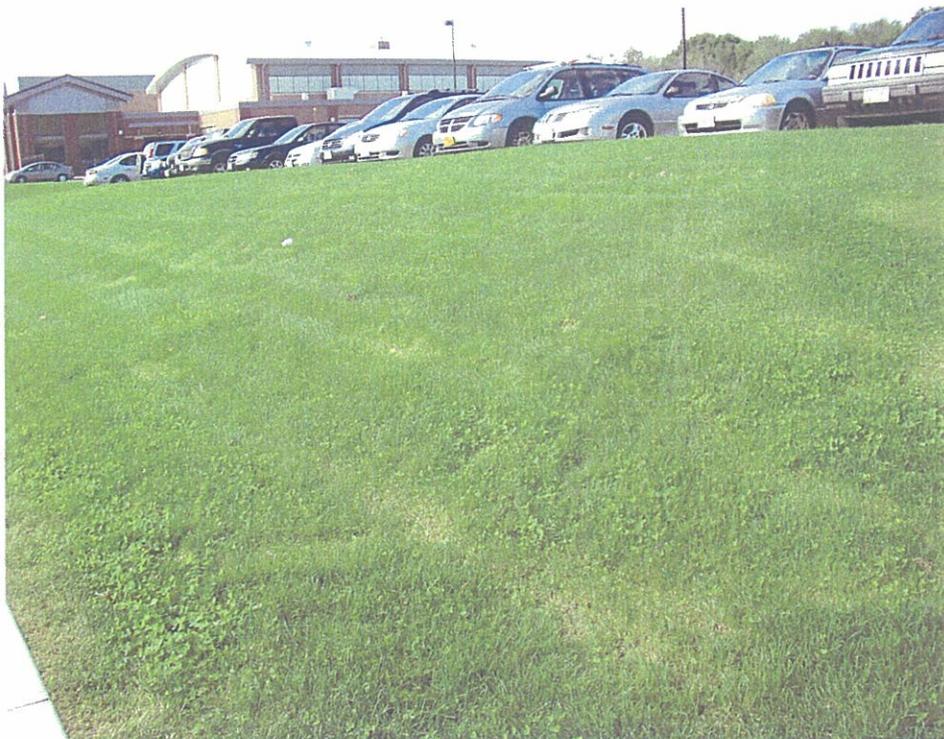
13) Condition of vegetation in northeast corner of property.

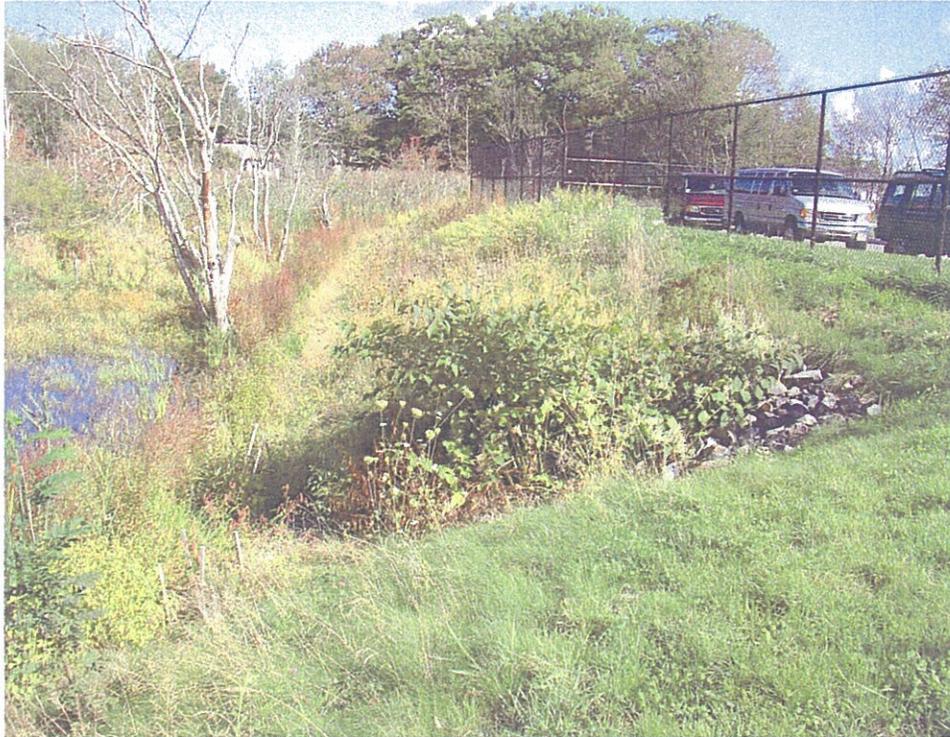
14) Vegetation on northwest corner of property (facing north).

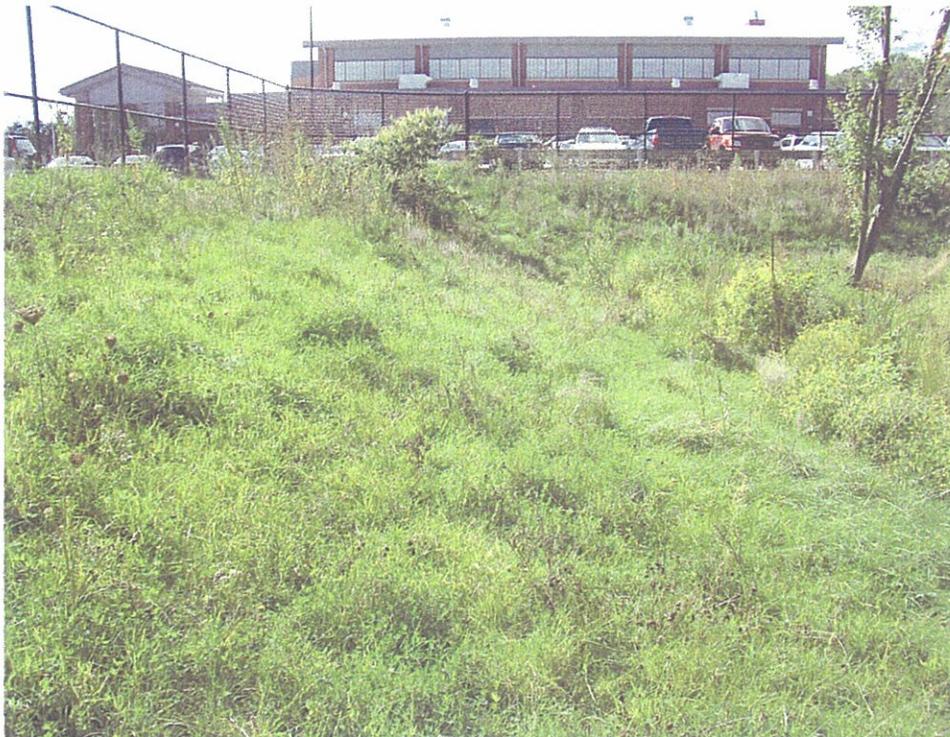
15) Vegetation on north side of property (facing south).
