**Subject:       Fall 2009 Cap Inspection  
                  Keith Middle School  
                  New Bedford, Massachusetts**

**SITE PHOTOGRAPHS**  
**November 2009 Cap Inspection**  
**Keith Middle School**  
**New Bedford, Massachusetts**

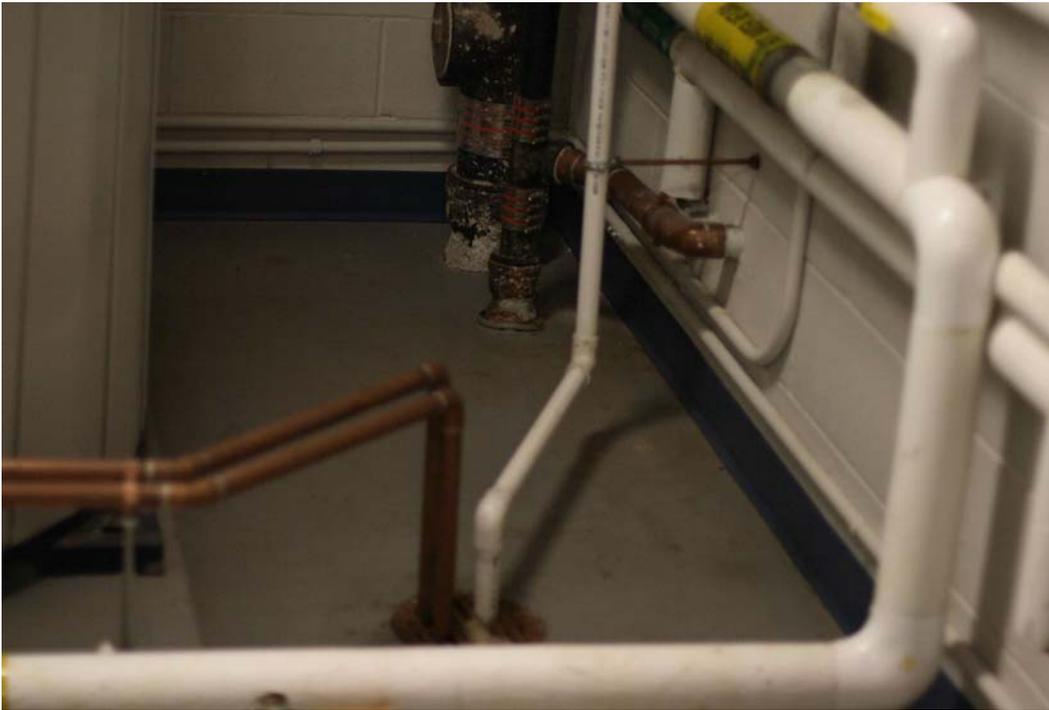
0600 THE PROVIDED ACCESS TO ALL AREAS  
OF THE FIRST FLOOR TO CONDUCT  
INSPECTIONS. SCHOOL IS IN SESSION  
THE CONDUCTED INSPECTIONS; NO AREAS  
OF CRACKING IN CONCRETE GREATER  
THAN 1/4 - INCH IN WIDTH WERE  
PRESENT IN ANY AREA WHERE CONCRETE  
IS VISIBLE, OTHER AREAS OF THE  
FLOOR COVERED W/TILES ARE WELL  
MAINTAINED AND THERE IS NO EVIDENCE  
OF ANY SIGNIFICANT WEAR OR  
SETTLEMENT, PIPE PENETRATIONS  
THROUGH FLOORING WERE INSPECTED  
AND THERE IS NO ~~ANY~~ CHANGE  
IN CONDITIONS.

**1) Pipe penetrations in boiler room.**

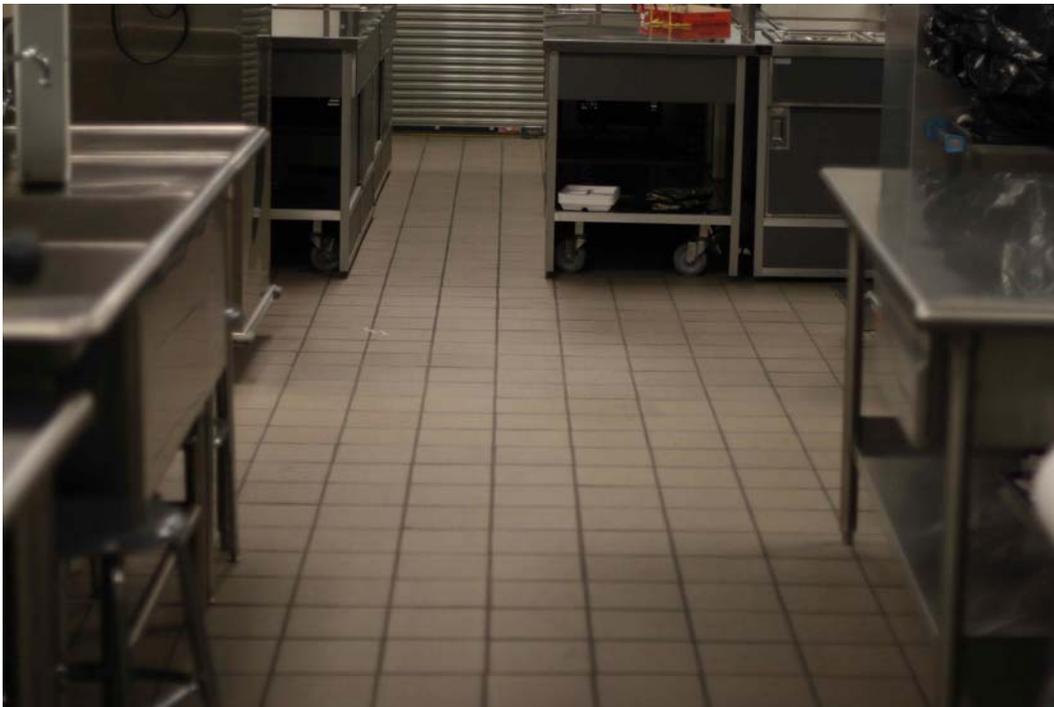
**2) Kitchen.**

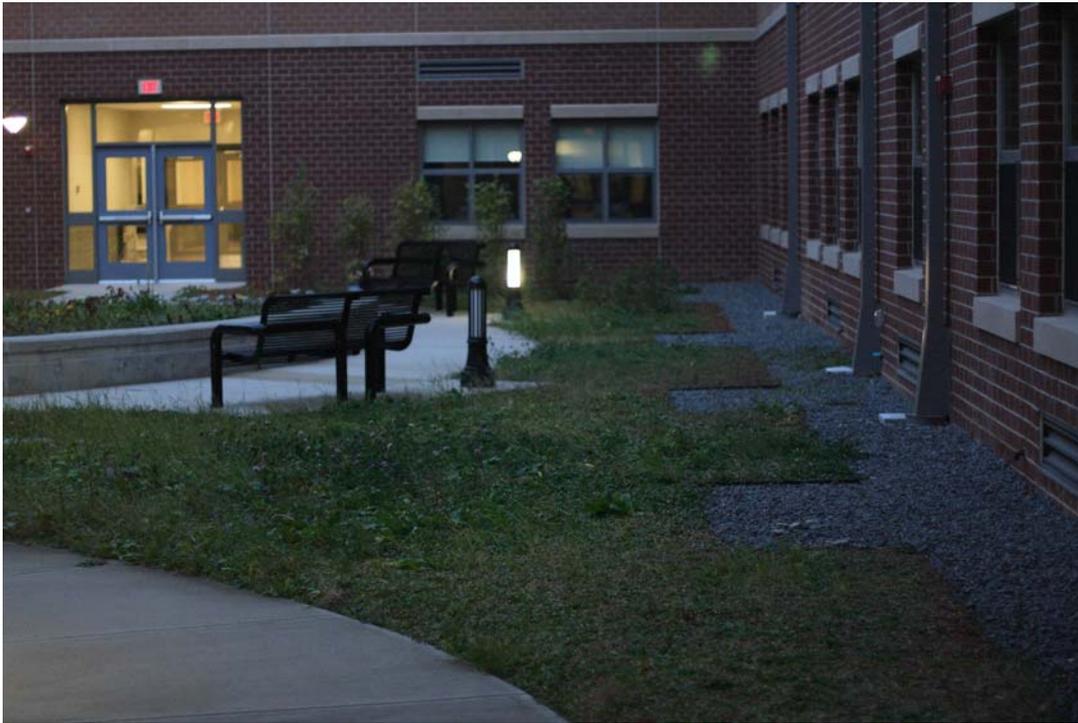
**3) Courtyard looking North.**

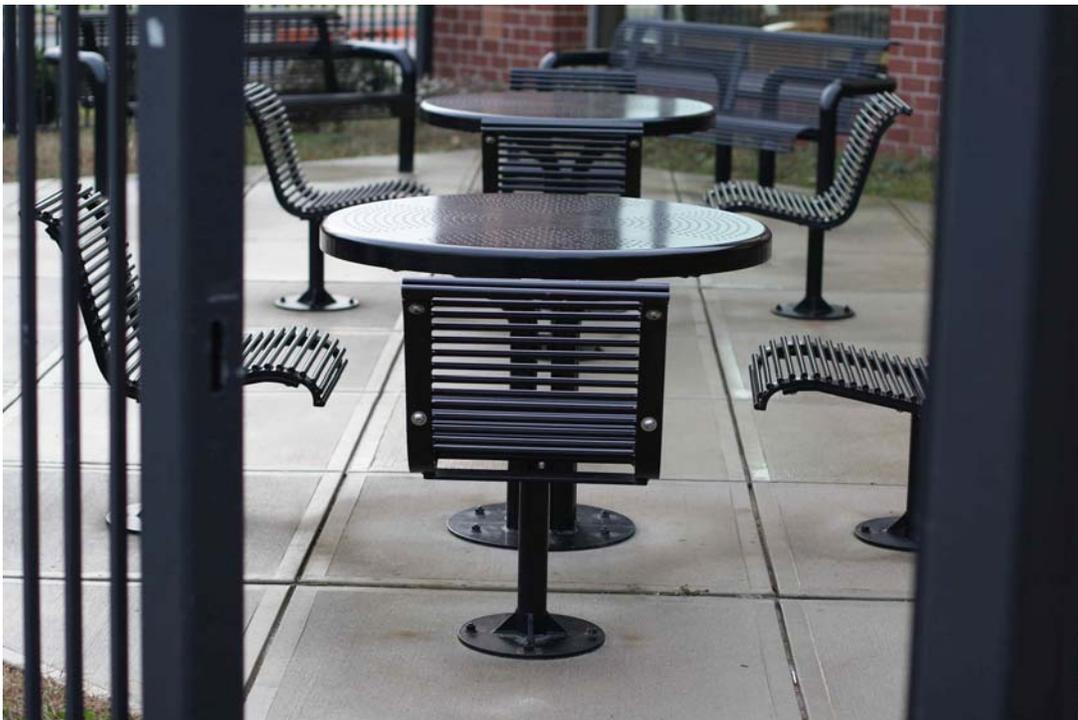
**4) Community room courtyard.**

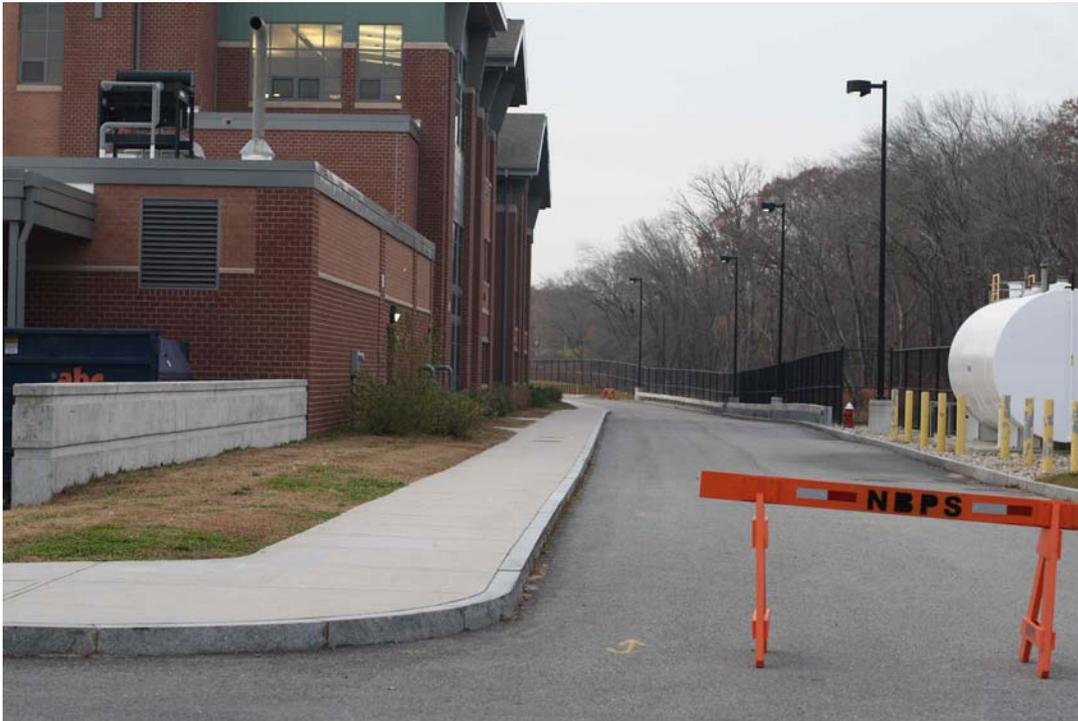
**5) West side of school looking South.**

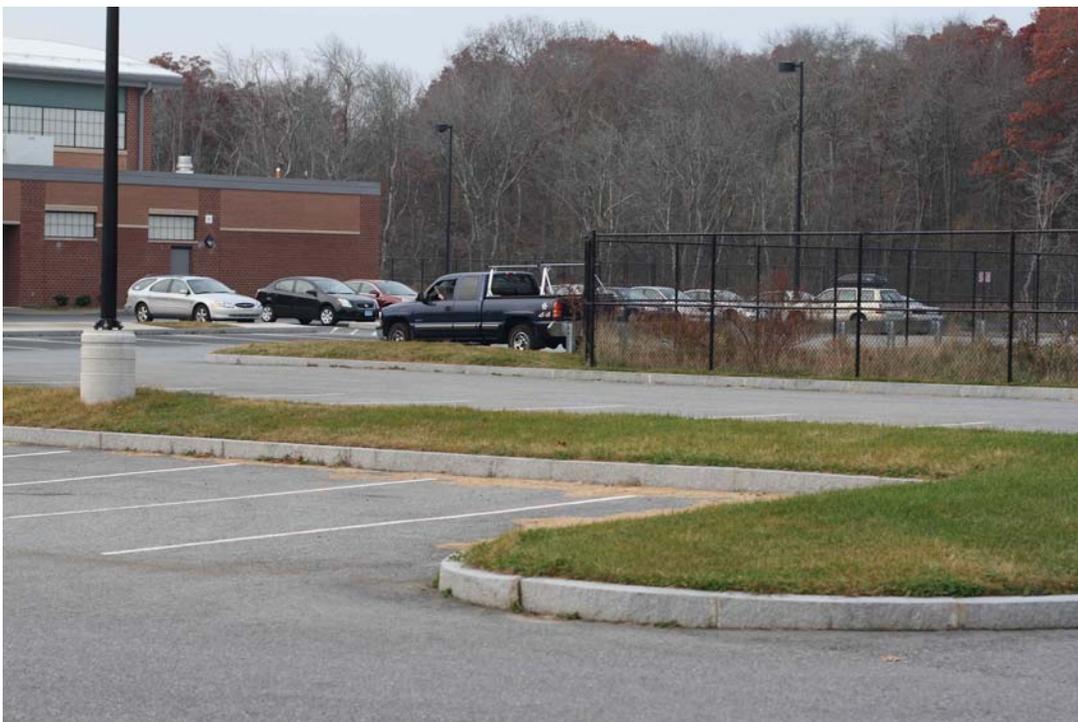
**6) North parking lot facing Southwest.**

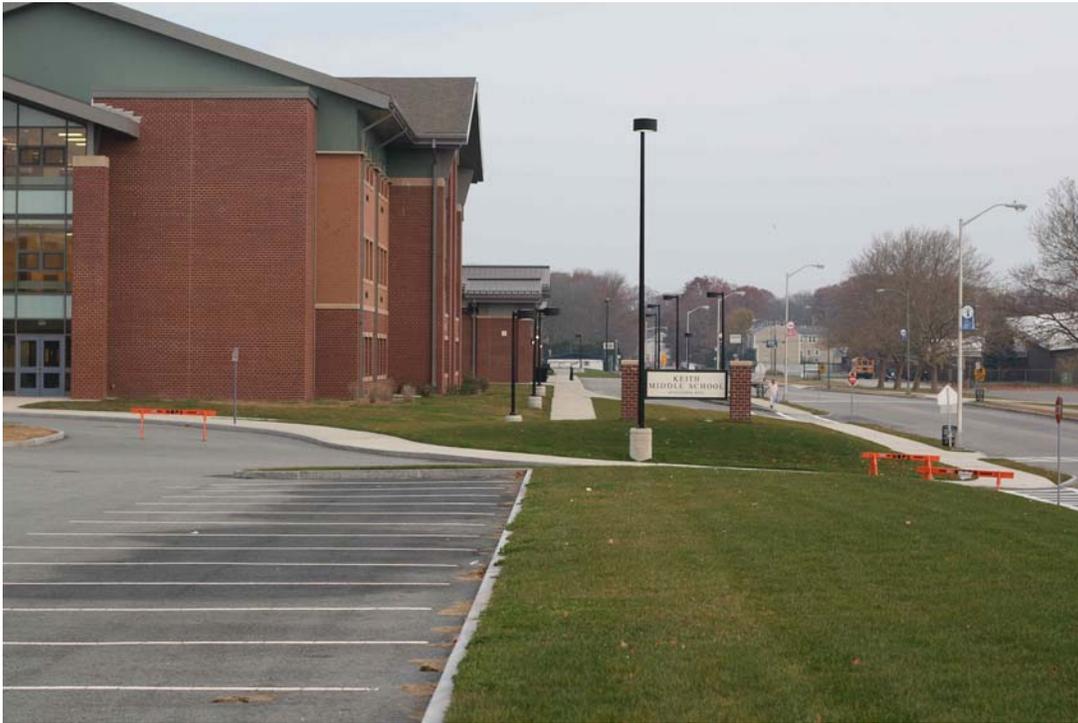
**7) East side of school facing North.**

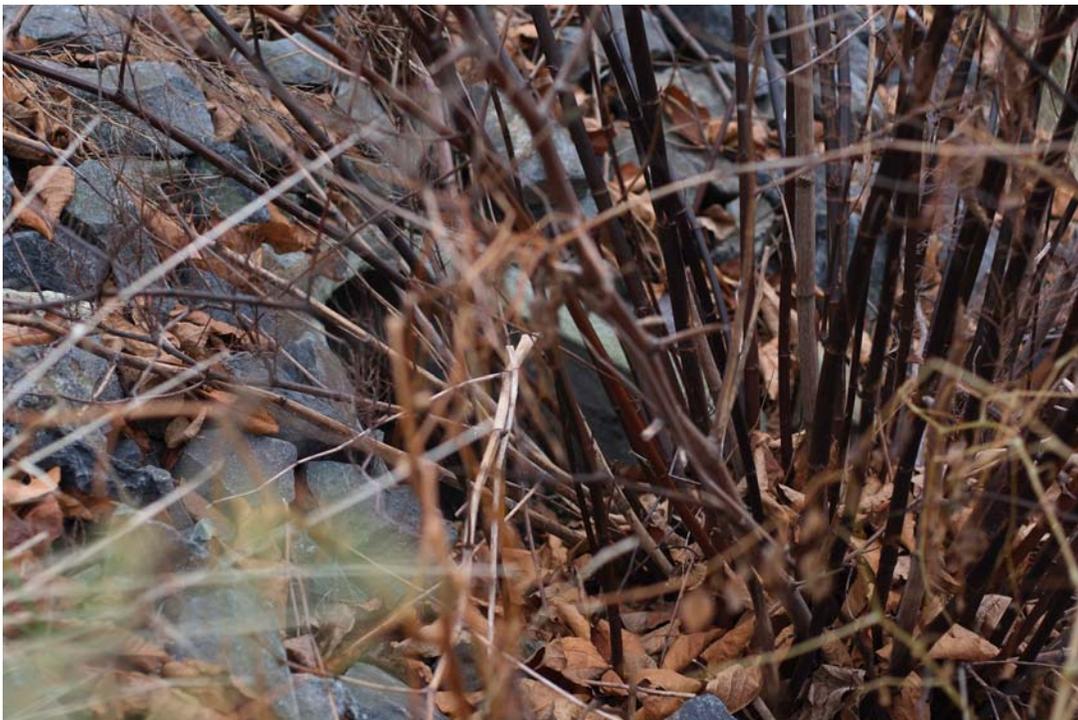
4. Woody vegetation is becoming more established, Photographs #8 and #13. Woody vegetation should be removed from the culvert outlets so unobstructed flow occurs at each discharge.

**8) Woody Vegetation in front of culvert outlet.**

- There is a gopher hole at the northwestern corner of the Site. The hole should be filled in and the area reseeded in the spring to minimize erosion.
- Woody vegetation is established at the culvert outlets and should be removed to allow unobstructed flow from each discharge.

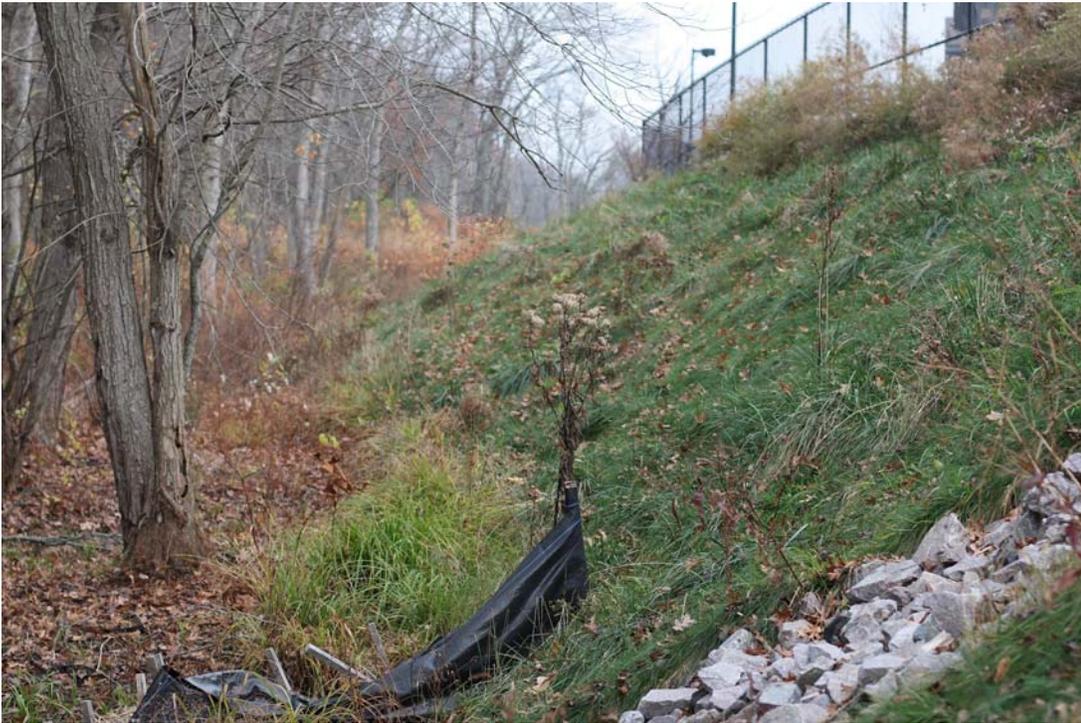
1. The repair to the slope failure between the wetland to the west and the southern parking lot to the east is currently functioning as intended. The hay bales and silt fence are still in place as shown in Photograph #9. The vegetation surrounding the repair is established and the hay bales and silt fence at the base of the repair may be removed.

**9) Temporary slope failure repair and slope facing north.**

- A shallow slope failure located on the steep slope between the wetland to the west and the southern parking lot to the east has been repaired. A photograph of the slope failure prior to the temporary repair is presented in Attachment 4. A permanent repair has been implemented and should not require additional work. Vegetation appears established and the hay bales and silt fence may be removed in the spring should the vegetation fill in adequately following the winter months.

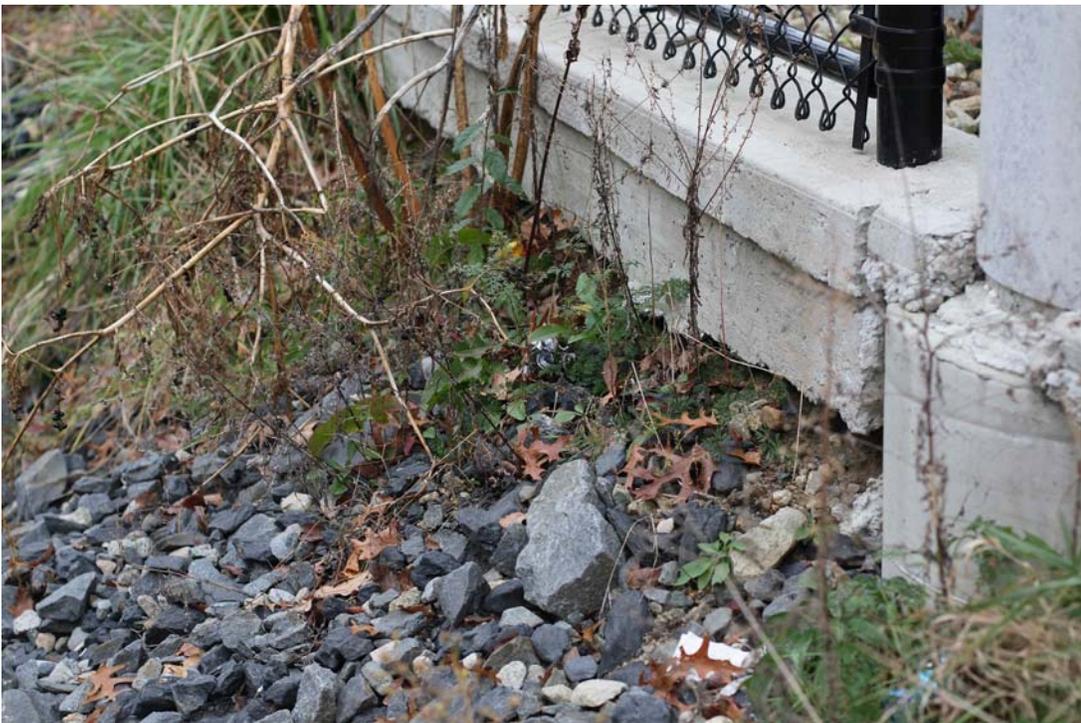
2. Riprap stabilization rock placed around the outlet of one of the storm water drainage culverts is falling down the slope and filling the end of the culvert. The outlet in question is the fourth outlet south of the above ground oil storage tank. The falling riprap undermined the concrete fence support at the top of the slope. See Photographs #10 and #11. Photograph #10 shows a crack in the concrete support of the fence along the top of slope. The structural integrity of the fence may be compromised if the sloughing of the riprap continues. The cap soils beneath the riprap may also become exposed and susceptible to erosion. The area appears stable at the moment. The extent of erosion seems similar to the conditions observed during the previous inspection. See inspection report letter dated May 7, 2009, Attachment 3, Photographs #11 through #13.

**10) Undermining of fence support south of above ground storage tank.**

- Sloughing riprap stabilization stone that is undermining the concrete fence support at the top of the slope and filling the outlet of the storm water drainage culvert on the west side of the Site. Design and planning of a permanent solution is currently underway.

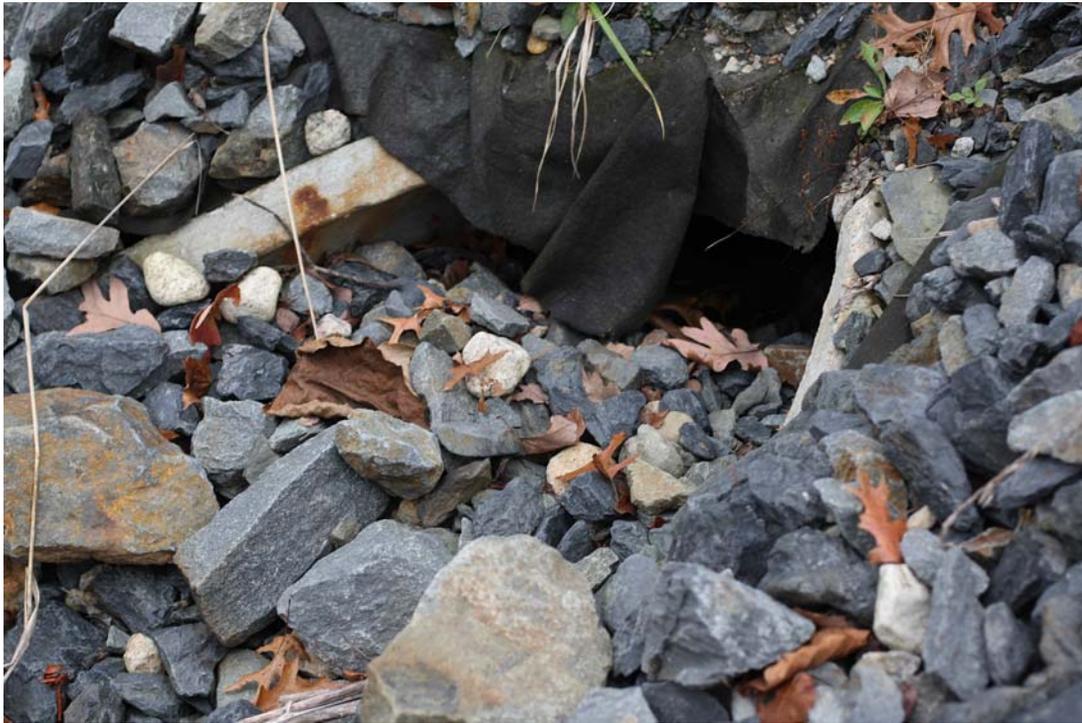
**11) Culvert on steep slope below the fence support. South of above ground storage tank.**

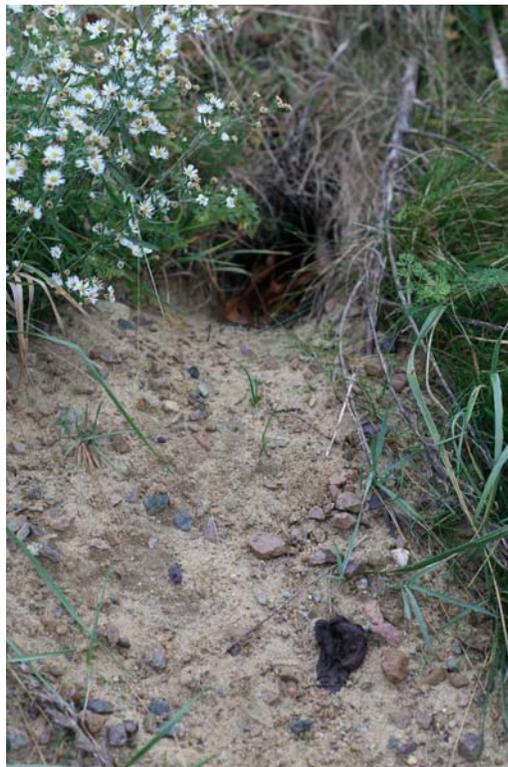
3. There is a gopher hole located at the northwestern corner of the cap, Photograph 12. Measures should be taken to remove the burrowing animal from the area. The hole should be filled in with suitable soil material and reseeded to minimize the chance of erosion.

**12) Gopher hole Northwest corner.**

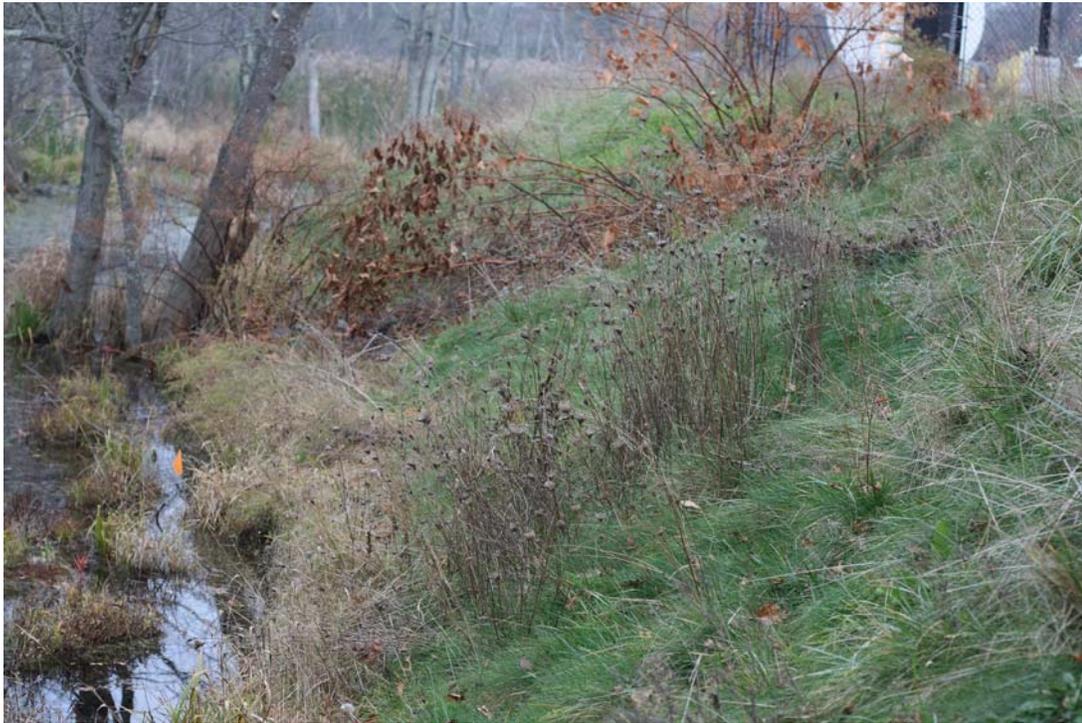
**13) Woody vegetation on Eastern slope facing North.**

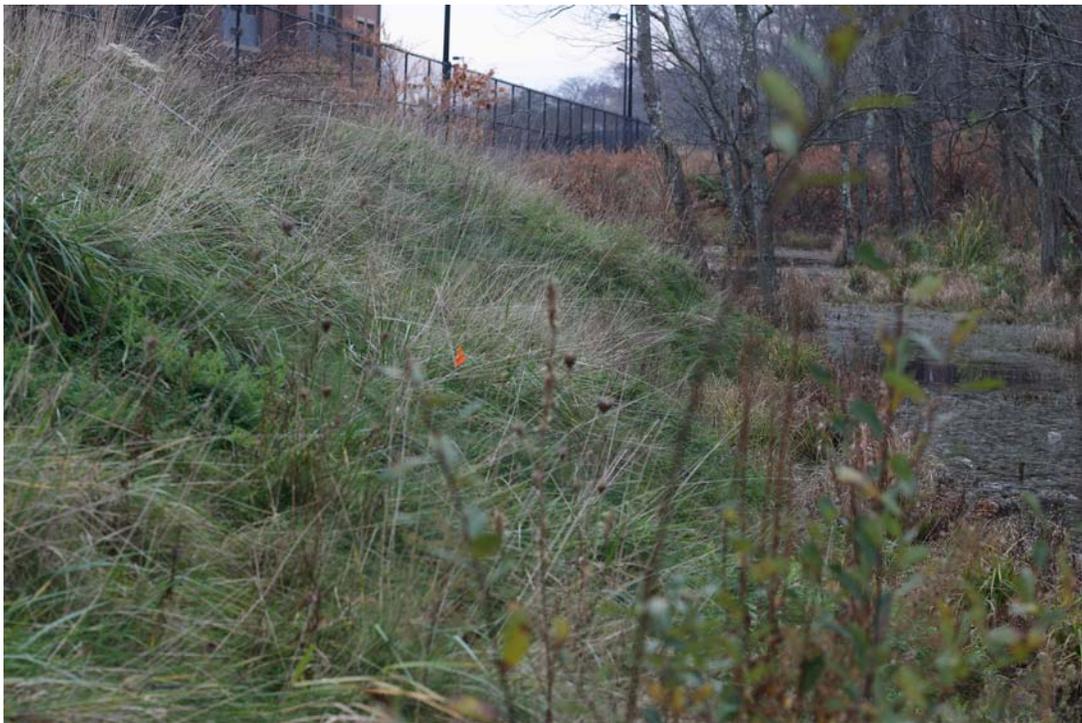
**13) Eastern slope facing South.**
