Subject: November 2008 Cap Inspection
Keith Middle School
New Bedford, Massachusetts

SITE PHOTOGRAPHS
November 2008 Cap Inspection
Keith Middle School
New Bedford, Massachusetts

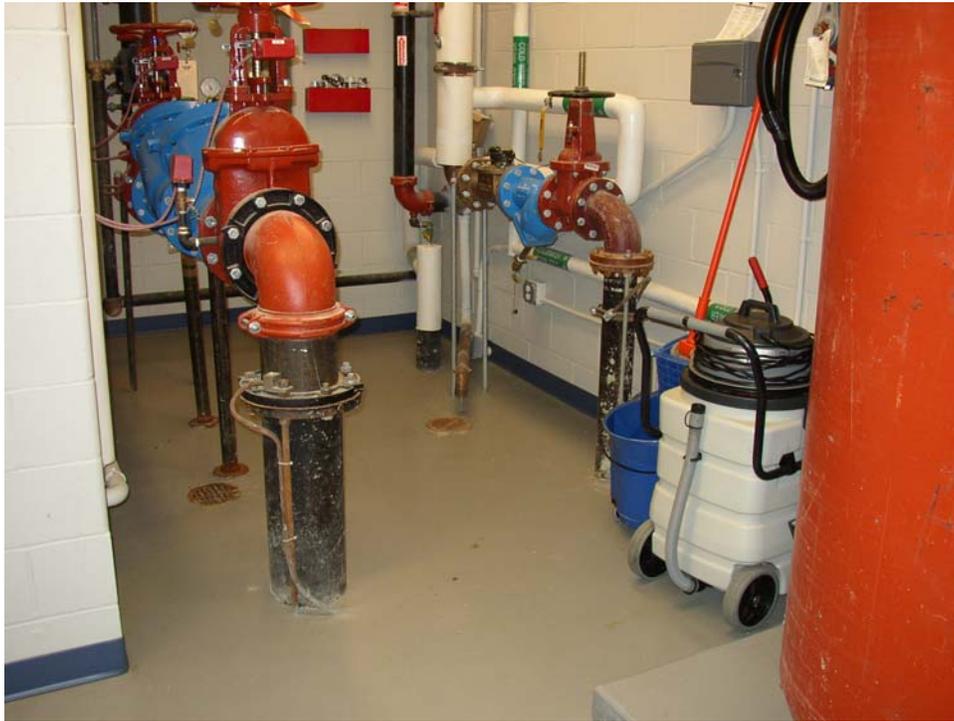
1) Example of pipe penetrations in boiler room.

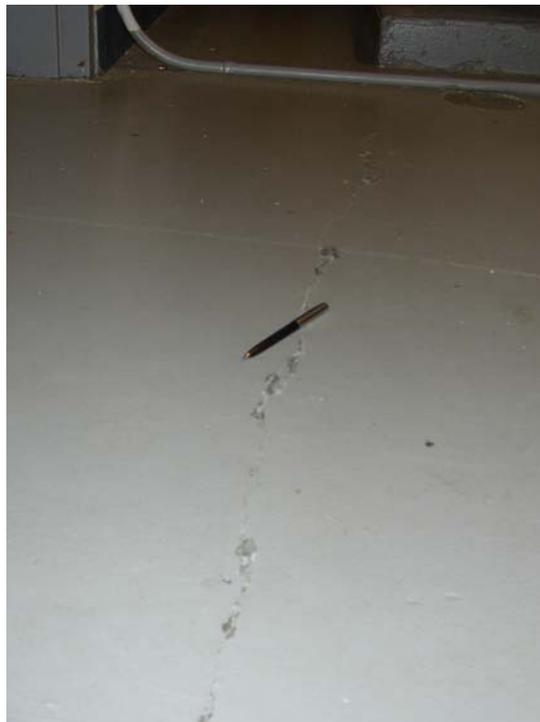
The two cracks in the boiler room floor are still less than ¼-inch wide. The majority of interior concrete floors are covered with tiles or other type of flooring material. Based on visual inspection and conversations with current employees, there are no breaches or other significant damage or deterioration of the interior surficial flooring materials or, where visible, concrete floors. Minor cracking along base of hallway walls and tile separations (e.g., cafeteria, Room 067 (Stagecraft), Stairwell #2 and Stairwell #4) appear to be surficial and related to the settling of the building. No construction was occurring within the building at the time of the inspection and no access limitations were encountered.

2) Minor crack in boiler room (051) floor.

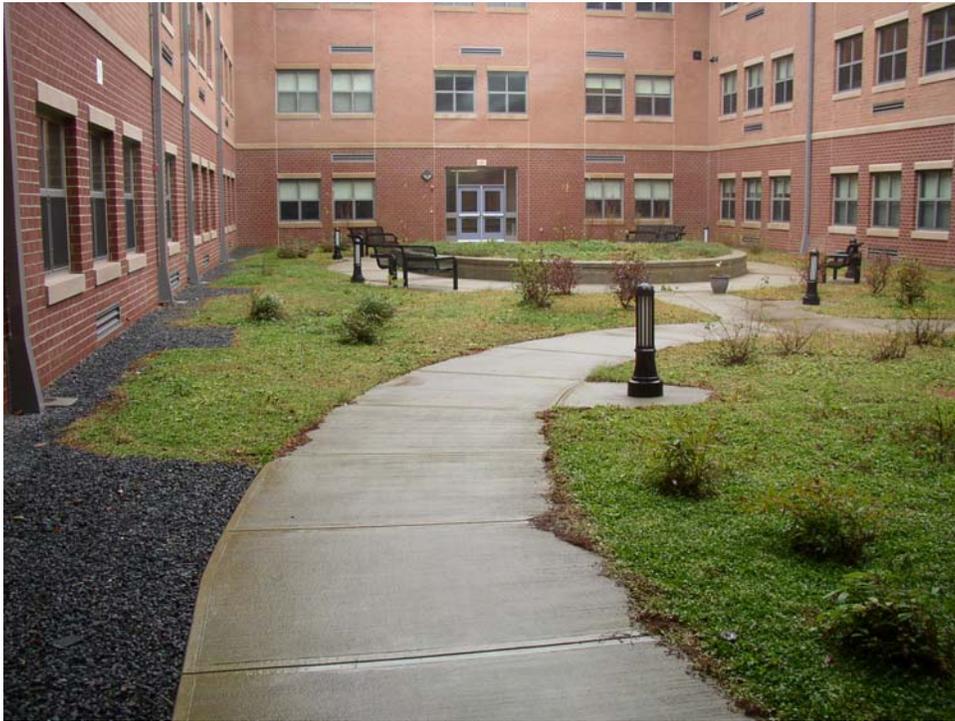
3) Courtyard looking north.

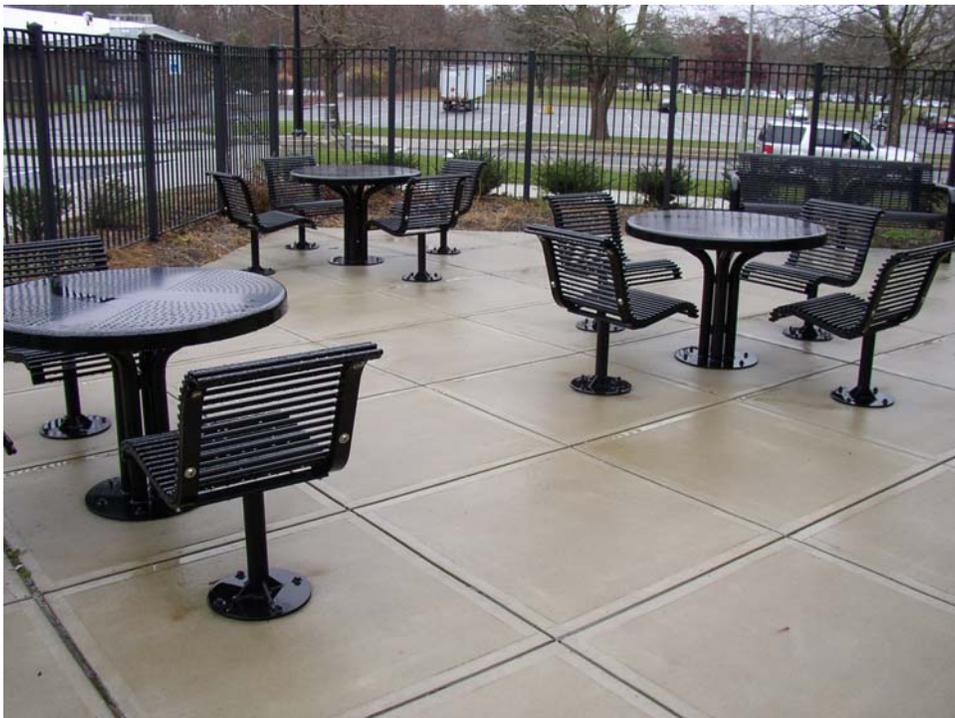
4) Community Room/Faculty Lounge (014) courtyard facing east.

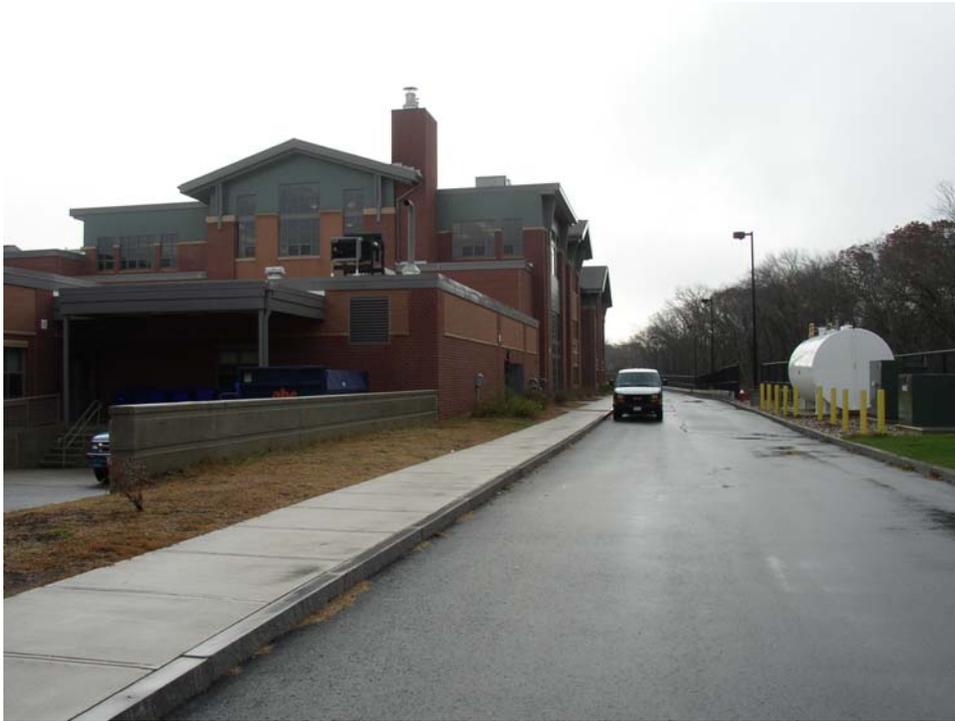
5) West side of school looking south.

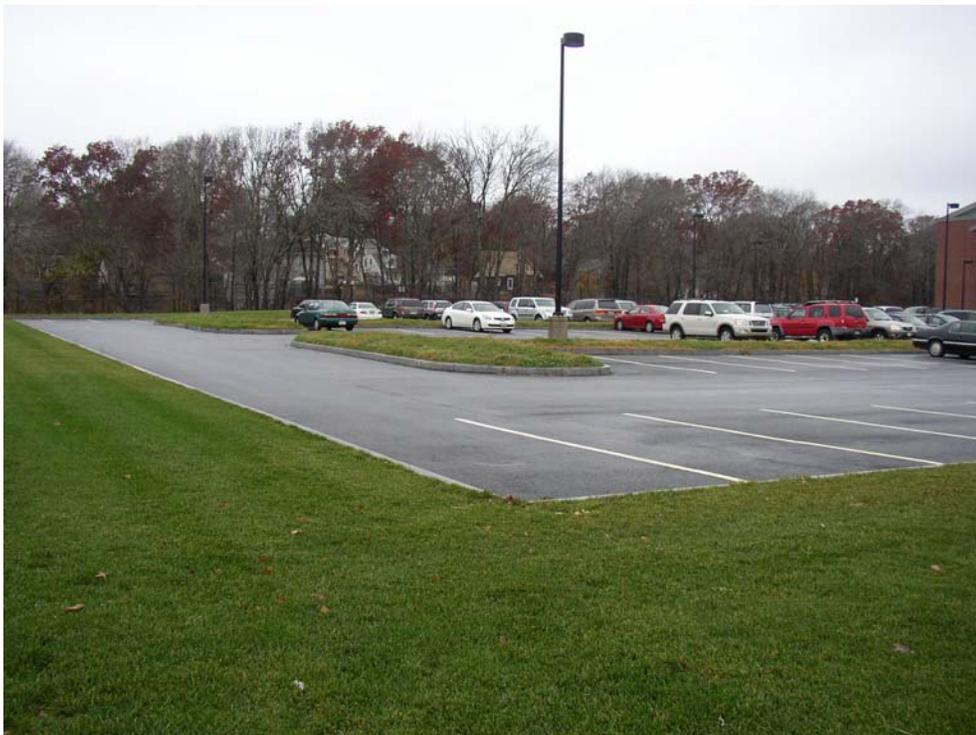
6) Southern parking lot looking northwest.

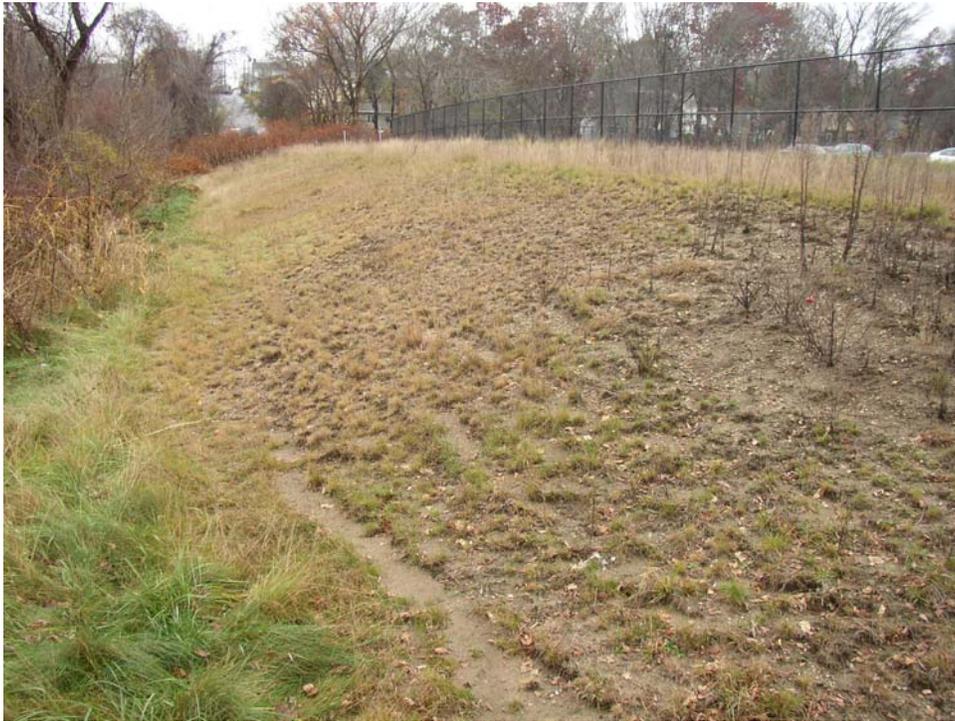
1. The ground surface at the southeastern and southwestern corners of the school property, as well as along the southern cap slope, though starting to establish vegetation is sparsely vegetated. Some larger vegetation has begun to establish in the southwestern corner of the cap as well. See Photograph #7 and #8.

7) Southern slope looking west with minor erosion in southeast corner.

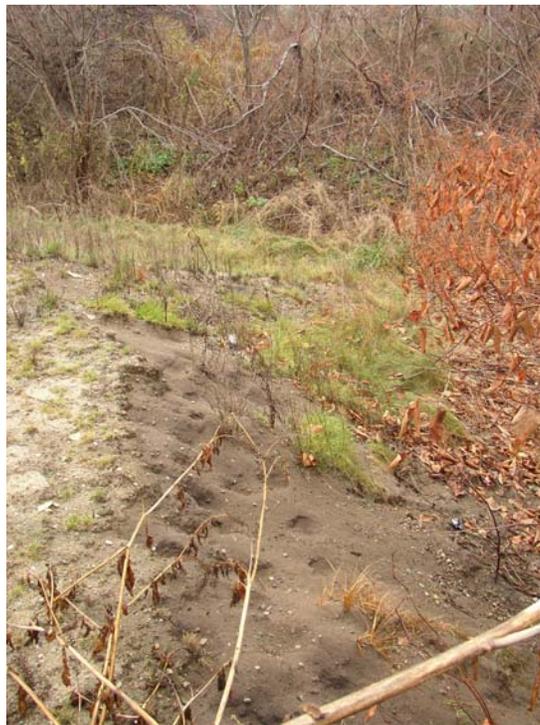
8) Minor erosion in southwest corner of cap slope facing south.

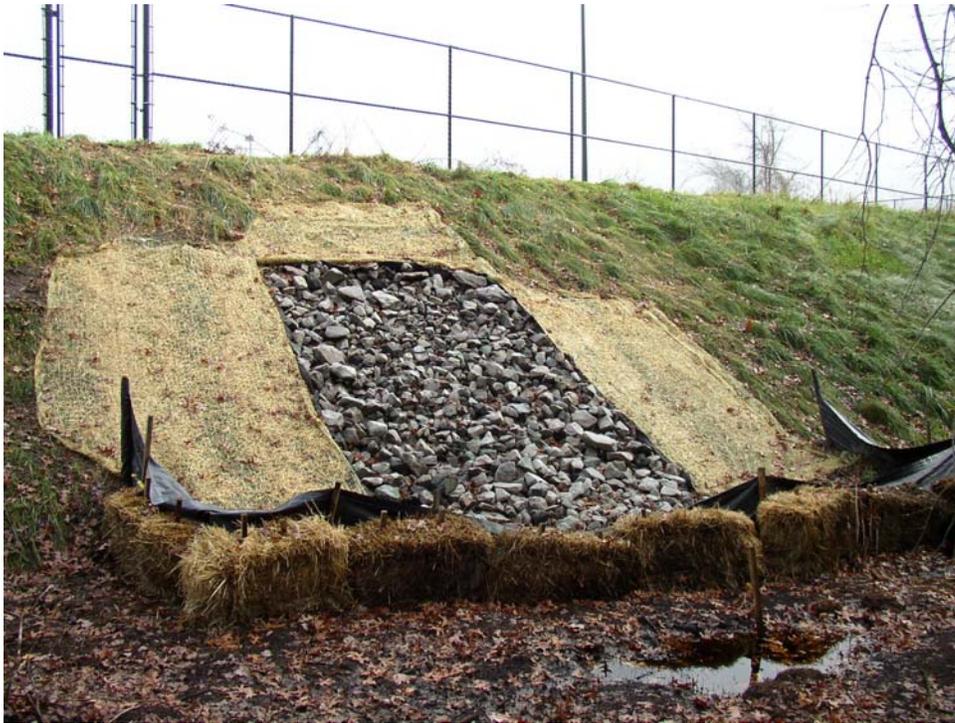
2. The slope failure in the steep slope between the wetland to the west and the southern parking lot to the east has been repaired. New hay bales, silt fence, geotextile filter fabric and rip-rap stone have been installed and were all in good condition at the time of the inspection. No slumping was observed. This should act as a permanent repair pending the establishment of vegetation surrounding the riprap stone. See Photograph #9 and #10.

9) Condition of slope repair in southwest portion of cap facing southeast.

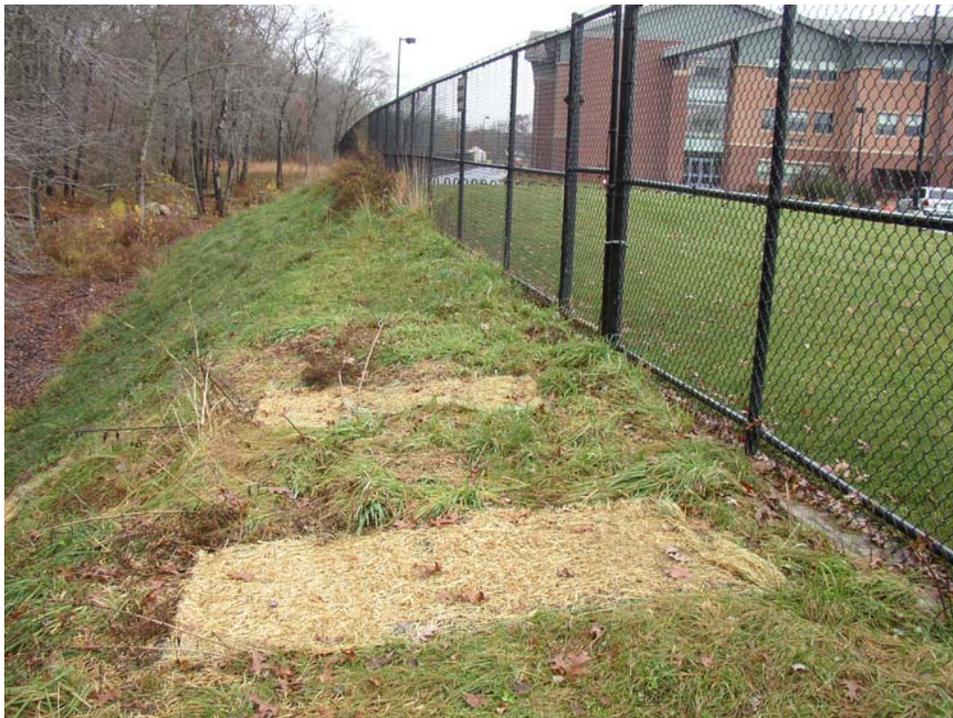
10) Condition of slope repair along western fence facing north.

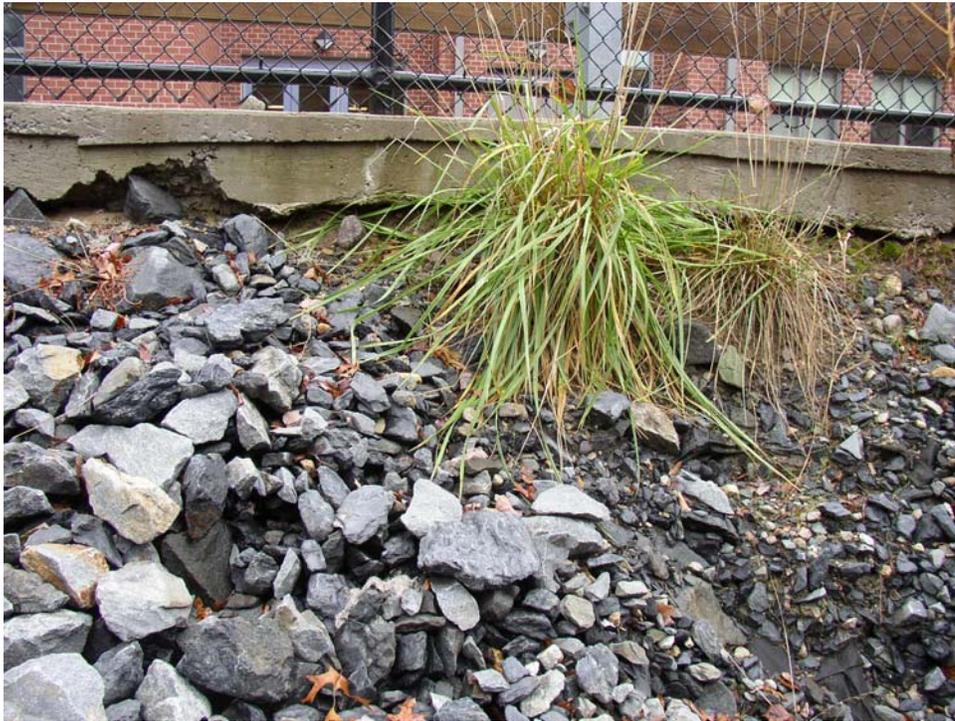
3. Riprap stabilization rock placed around the outlet of one of the storm water drainage culverts is falling down the slope and filling the end of the culvert. The outlet in question is the fourth outlet south of the above ground oil storage tank. The falling riprap has undermined the concrete fence support at the top of the slope and the deposited rock is impeding the flow of water from the culvert. The structural integrity of the fence may be compromised if the sloughing of the riprap continues. The cap soils beneath the riprap may also become exposed and susceptible to erosion. A permanent repair is required and is in the process of being designed. See Photographs #11 and #12.

11) Undercutting of fenceline at culvert outlet facing southeast.

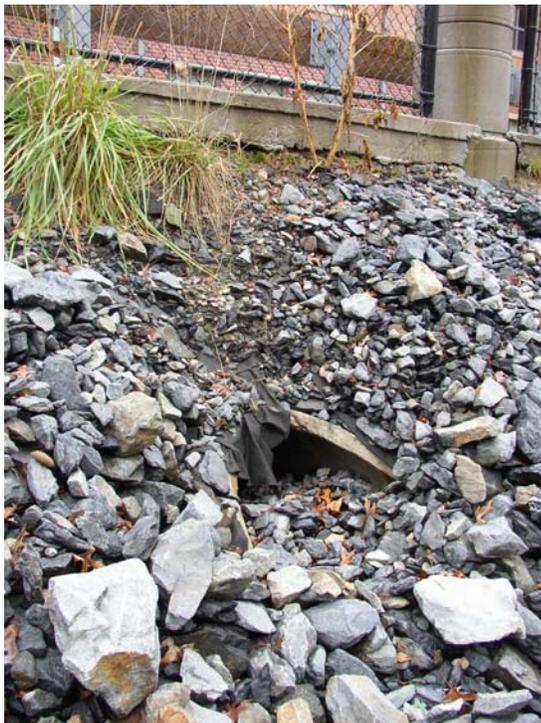
12) Sloughing of riprap at culvert outfall facing southeast.

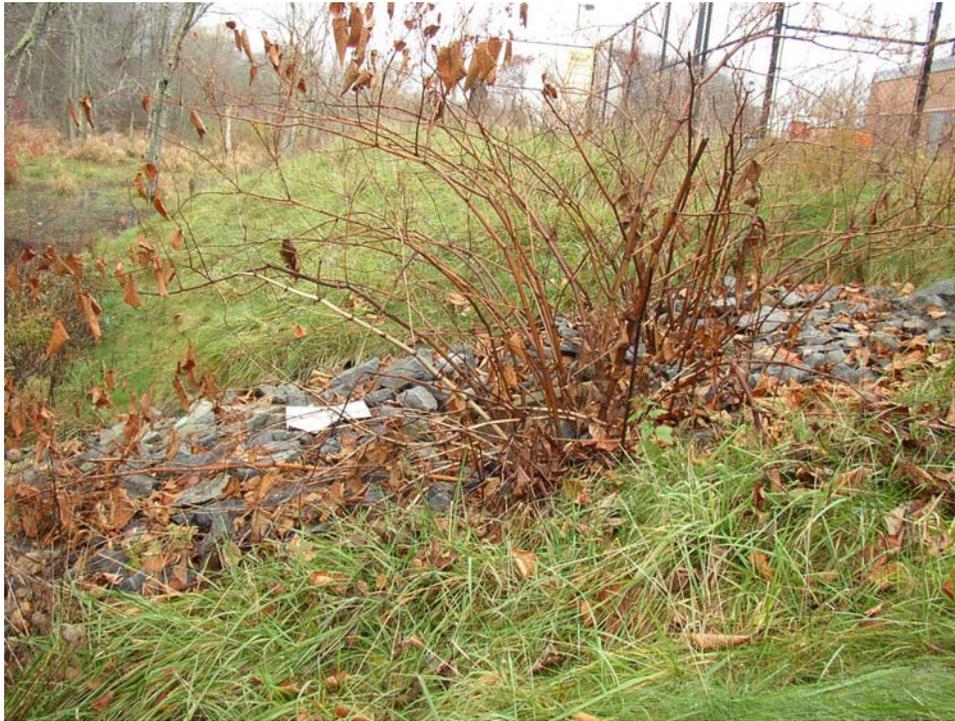
4. The cap slope (outside the perimeter fence) is becoming somewhat overgrown with vegetation. This is not currently causing any issues with the cap integrity, however, the potential for deep rooting vegetation and/or burrowing animals to become established is increased. See Photograph #13.

13) Example of larger vegetation growth near culvert outfall facing north.

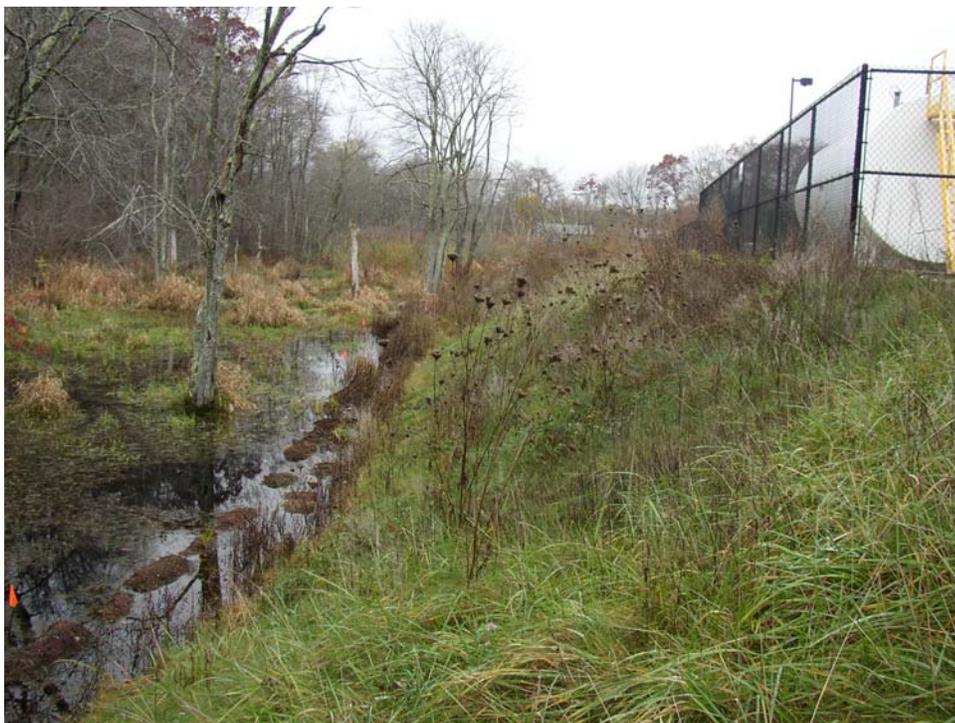
14) Condition of vegetation in northeast portion of cap facing north.

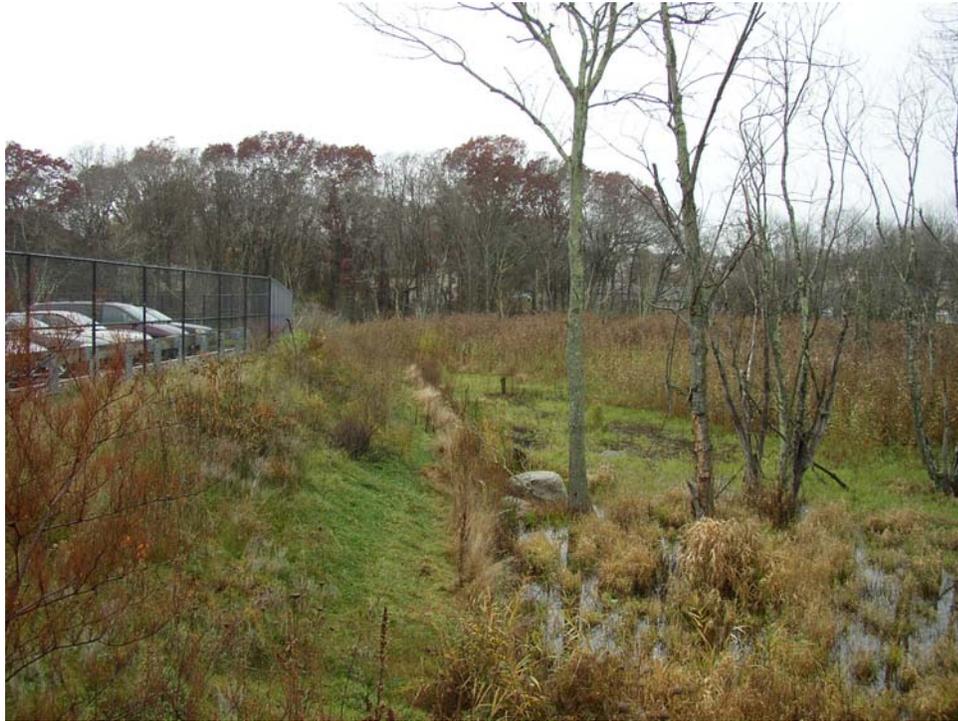
15) Vegetation near northeast corner of cap slope facing west.

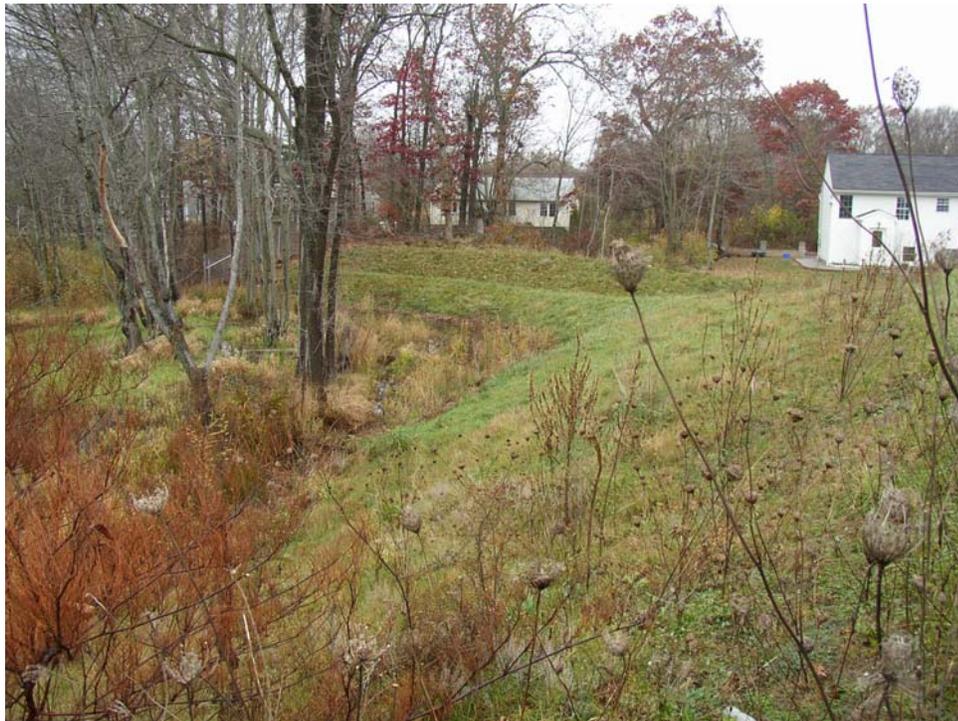
16) Vegetation on northern portion of cap slope facing north.

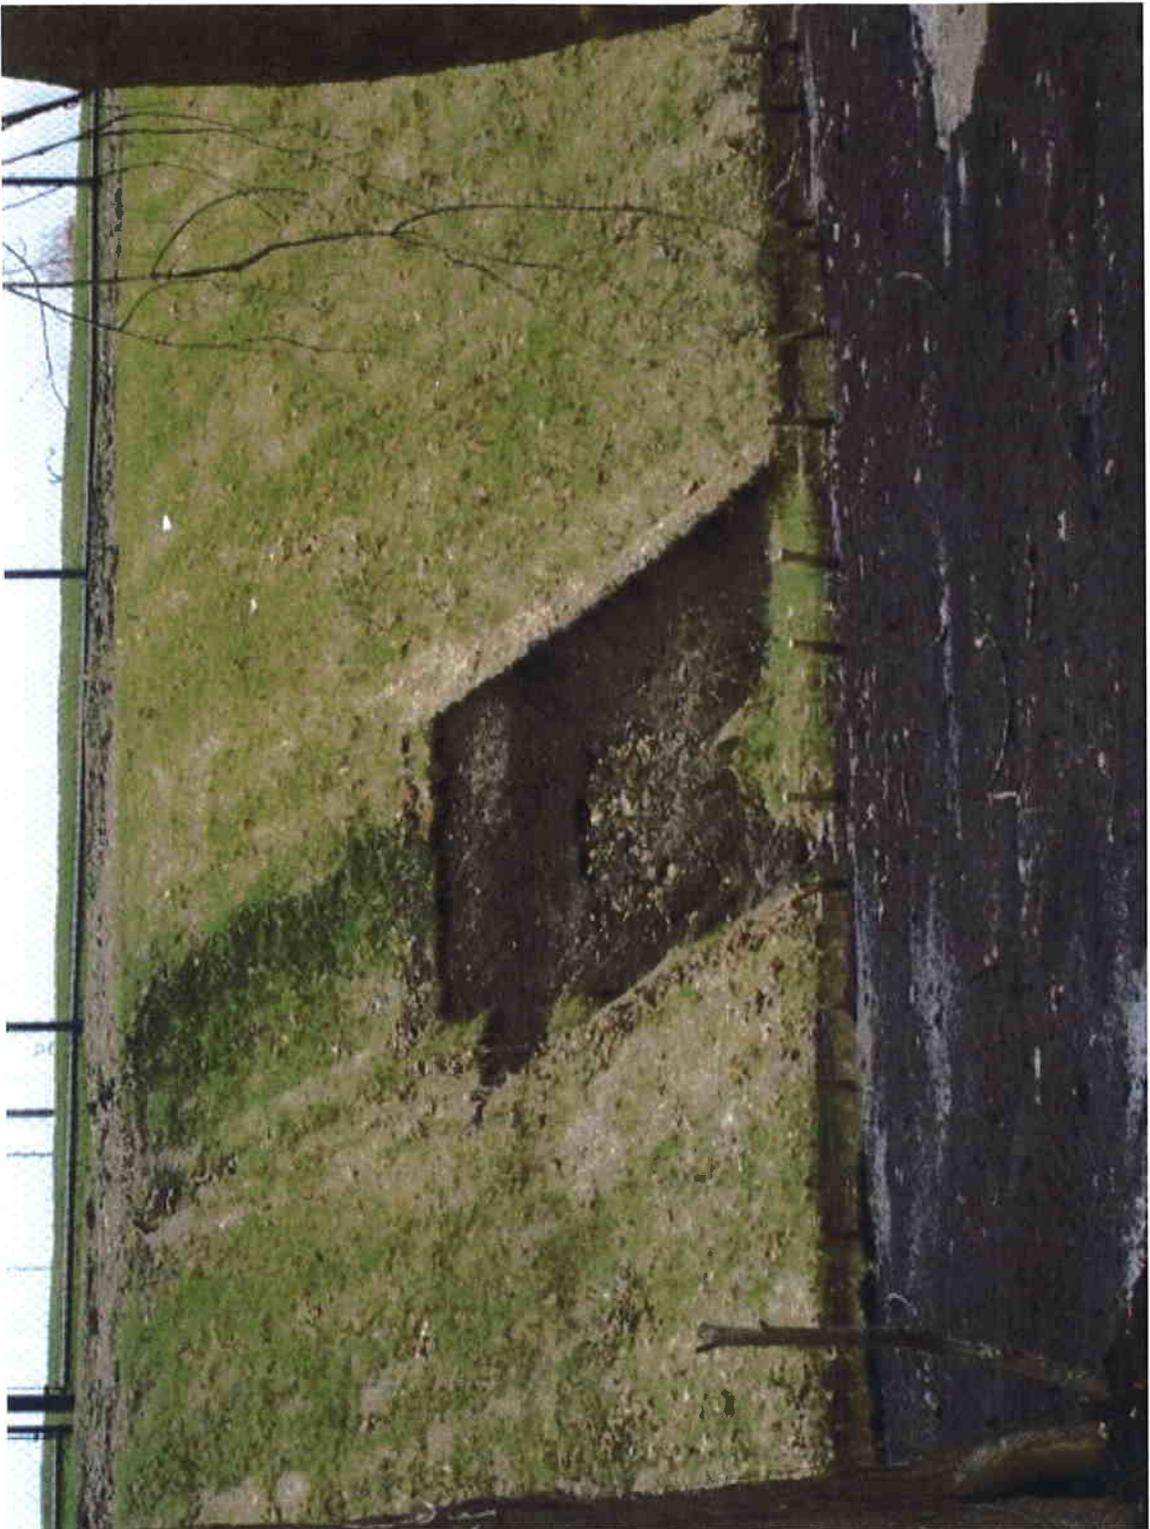
Attachment 4
Slope Failure Photograph

- A shallow slope failure located on the steep slope between the wetland to the west and the southern parking lot to the east has been repaired. A photograph of the slope failure prior to the temporary repair is presented in Attachment 4. A permanent repair has been implemented and should not require additional work pending the reestablishment of vegetation around the repaired area.
