**Subject: Spring 2010 Cap Inspection
Keith Middle School
New Bedford, Massachusetts**

SITE PHOTOGRAPHS
April 2010 Cap Inspection
Keith Middle School
New Bedford, Massachusetts

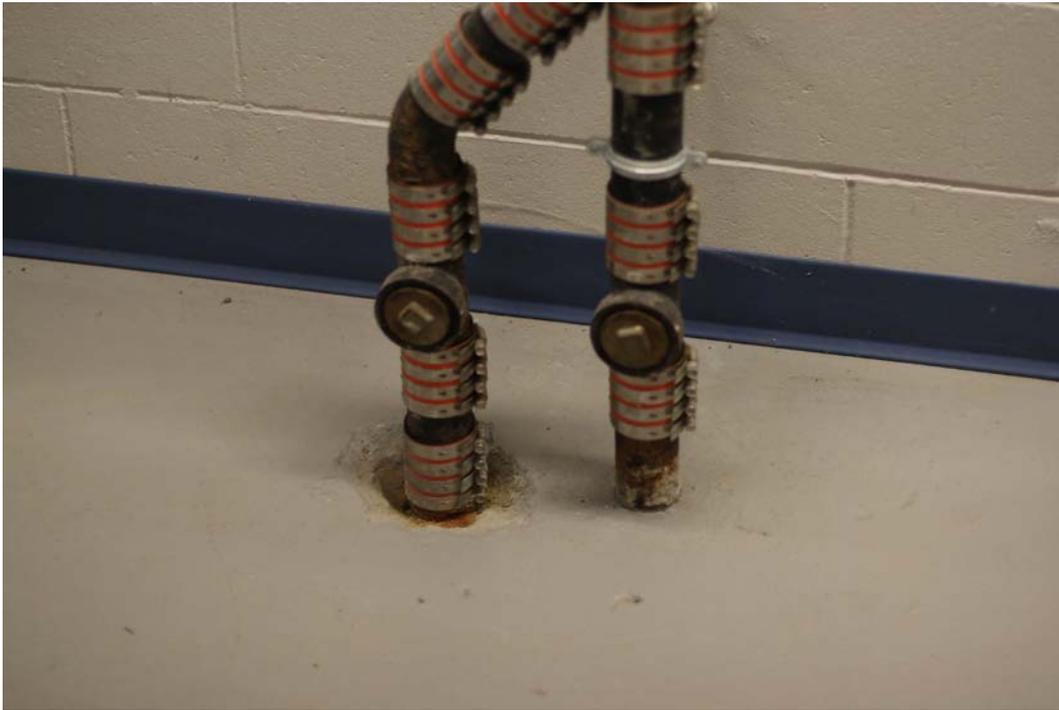
The two cracks in the boiler room floor are still less than ¼-inch wide. The majority of interior concrete floors are covered with tiles or other type of flooring material. Based on visual inspection and conversations with current employees, there are no breaches or other significant damage or deterioration of the interior surficial flooring materials or, where visible, concrete floors. No construction was occurring within the building at the time of the inspection.

1) Pipe penetrations in boiler room.

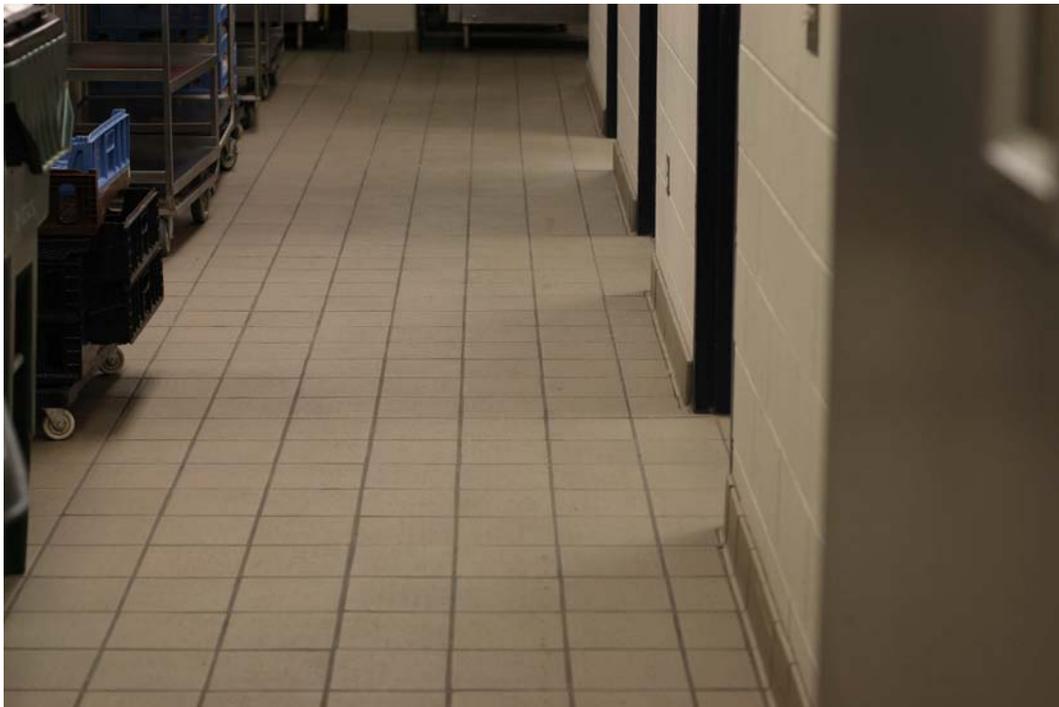
2) Kitchen.

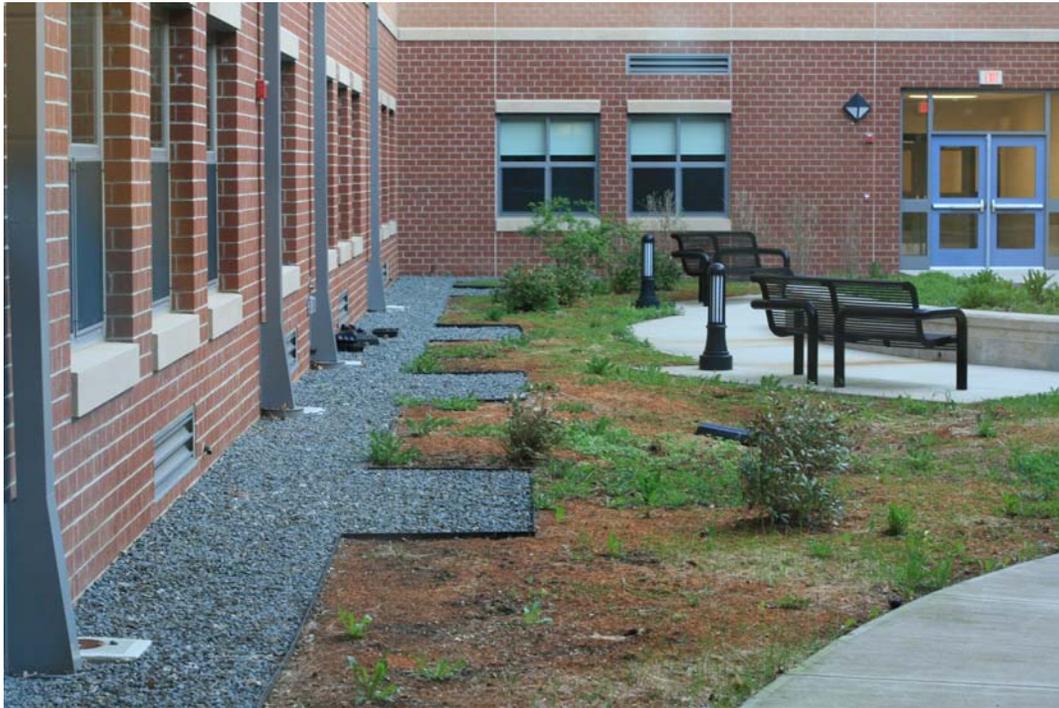
3) Courtyard looking North.

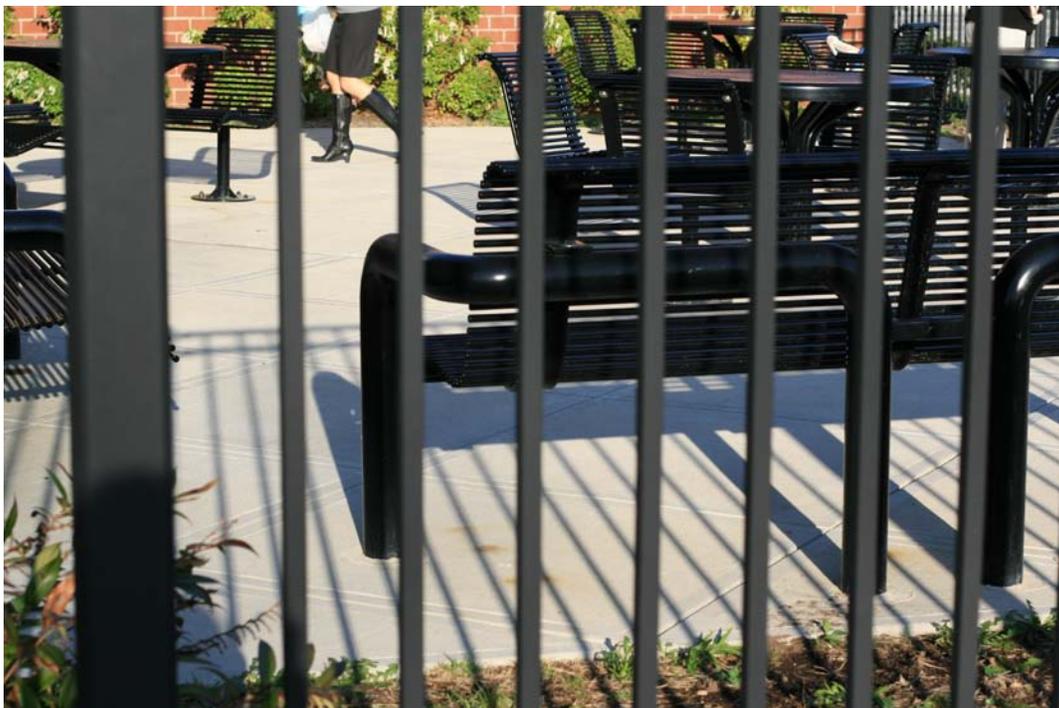
4) Community room courtyard.

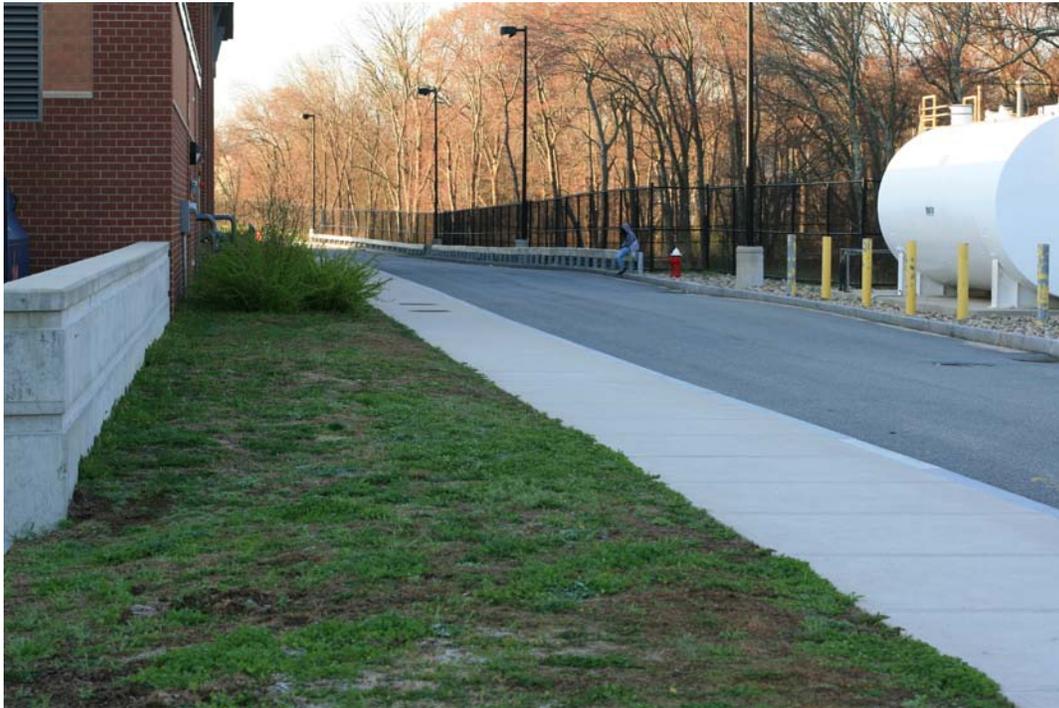
5) West side of school looking South.

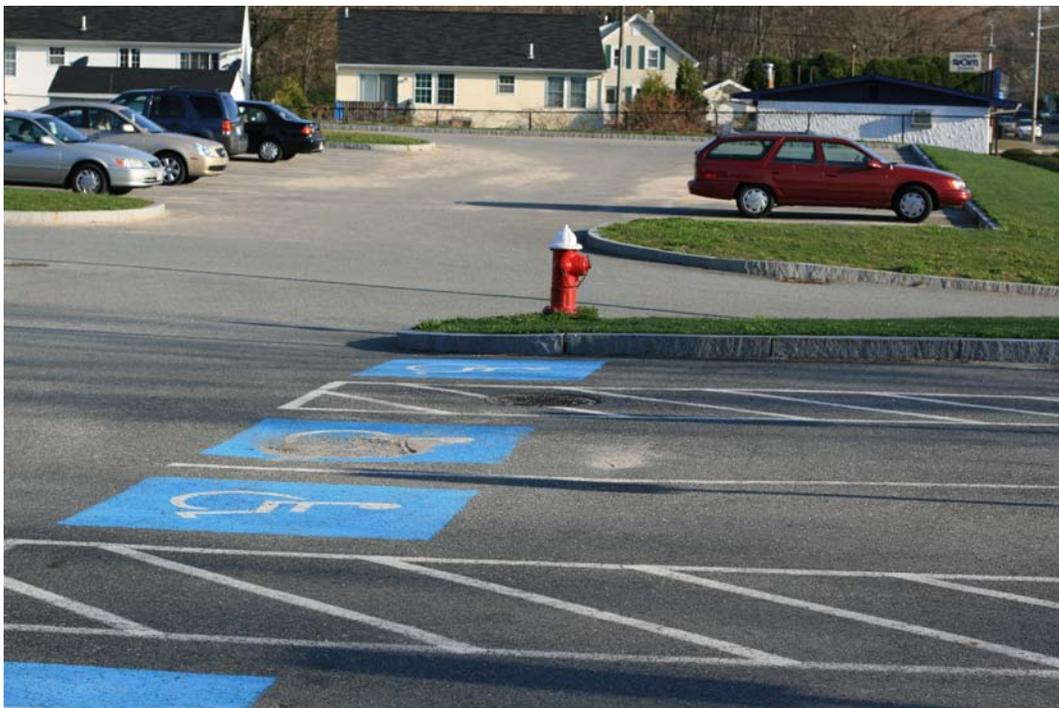
6) North parking lot facing North.

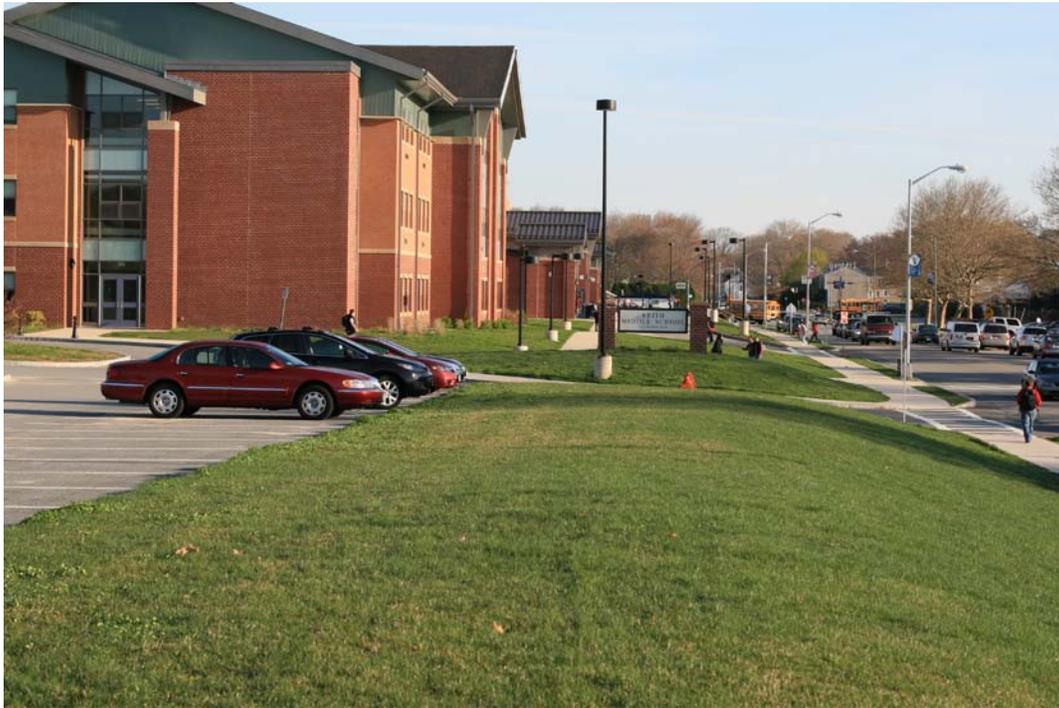
7) East side of school facing North.

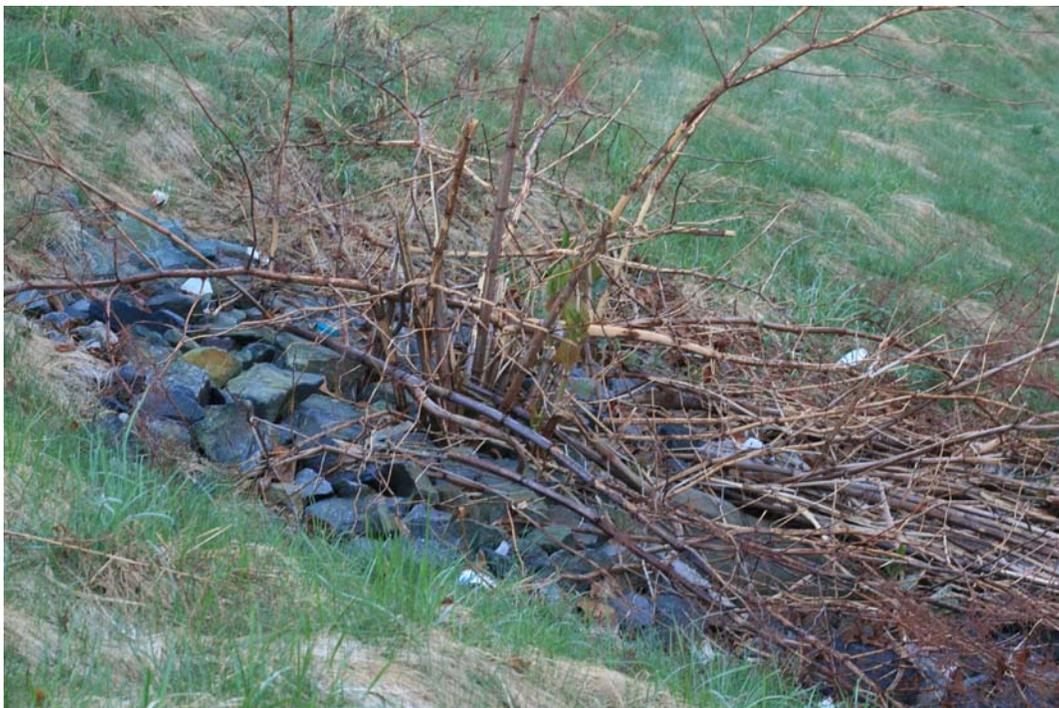
4. Woody vegetation is becoming more established, Photographs #8 and #13. Woody vegetation should be removed from the culvert outlets so unobstructed flow occurs at each discharge.

8) Woody Vegetation in front of culvert outlet.

- Woody vegetation is established at the culvert outlets and should be removed to allow unobstructed flow from each discharge.

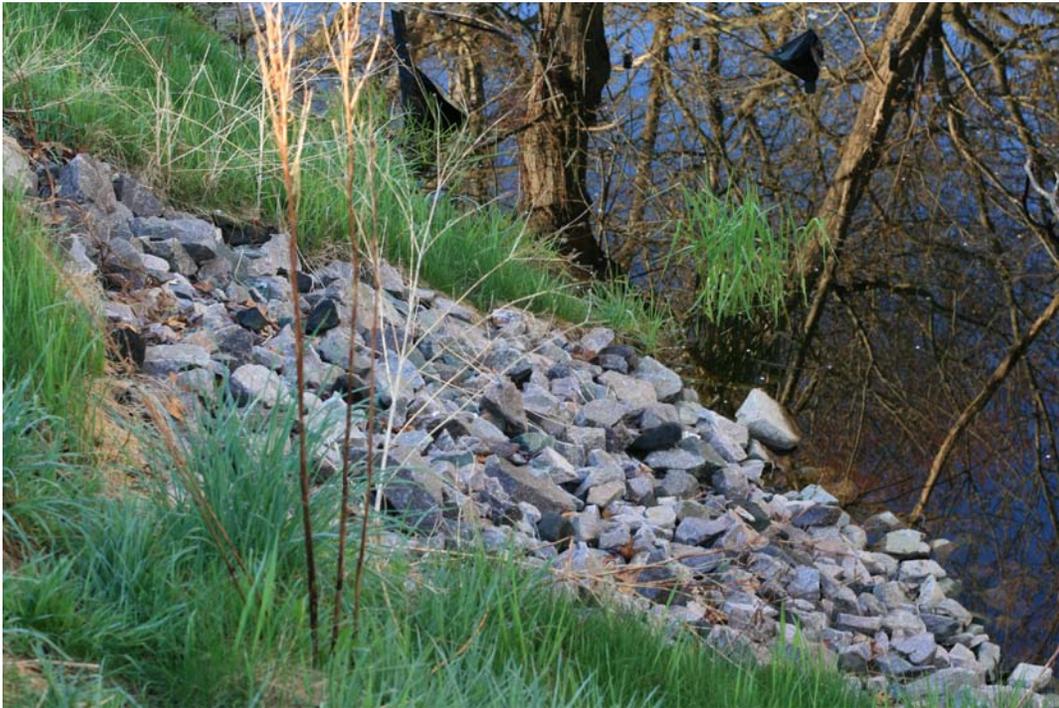
1. The repair to the slope failure between the wetland to the west and the southern parking lot to the east is currently functioning as intended. The hay bales and silt fence are still in place. Photograph #9 shows stakes from the silt fence that is still visible. The vegetation surrounding the repair is established and the hale bales and silt fence at the base of the repair should be removed.

9) Temporary slope failure repair.

- A shallow slope failure located on the steep slope between the wetland to the west and the southern parking lot to the east has been repaired. A photograph of the slope failure prior to the temporary repair is presented in Attachment 4. A permanent repair has been implemented and should not require additional work. Vegetation appears established and the hay bales and silt fence should be removed at this time.

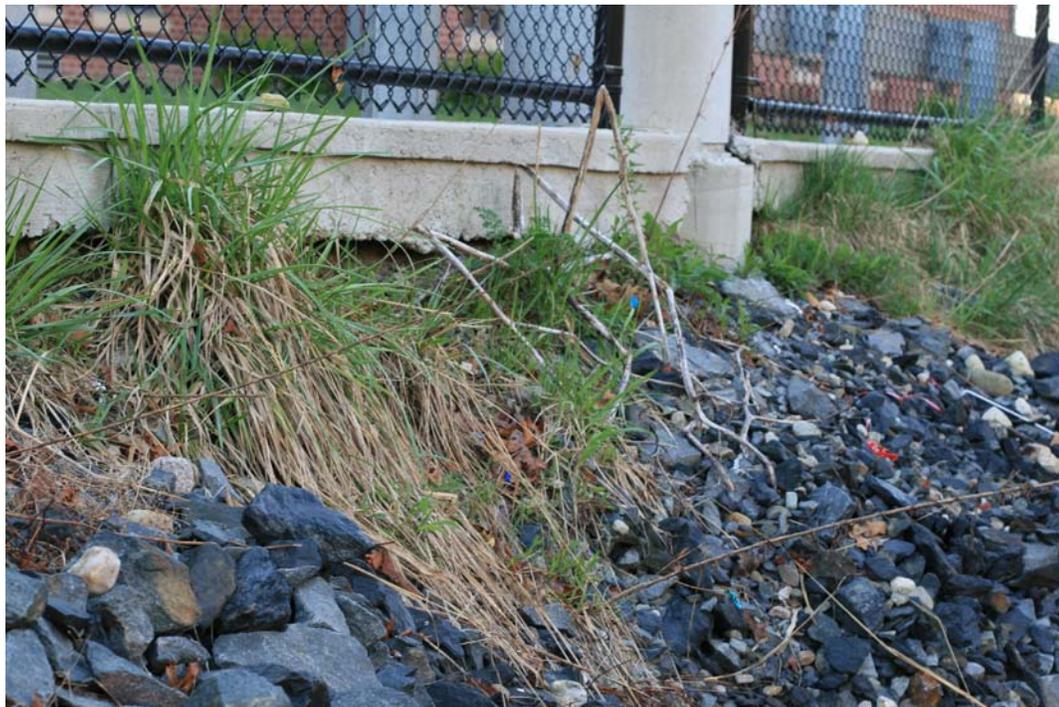
2. Riprap stabilization rock placed around the outlet of one of the storm water drainage culverts is falling down the slope and filling the end of the culvert. The outlet in question is the fourth outlet south of the above ground oil storage tank. The falling riprap undermined the concrete fence support at the top of the slope. See Photographs #10 and #14. Photograph #10 shows a crack in the concrete support of the fence along the top of slope. The structural integrity of the fence may be compromised if the sloughing of the riprap continues. The cap soils beneath the riprap may also become exposed and susceptible to erosion. The area appears stable at the moment. The extent of erosion seems similar to the conditions observed during the previous inspection. See inspection report letter dated December 11, 2009, Attachment 3, Photograph #10.

10) Undermining of fence support south of above ground storage tank.

- Sloughing riprap stabilization stone that is undermining the concrete fence support at the top of the slope and filling the outlet of the storm water drainage culvert on the west side of the Site. Design and planning of a permanent solution is currently underway.

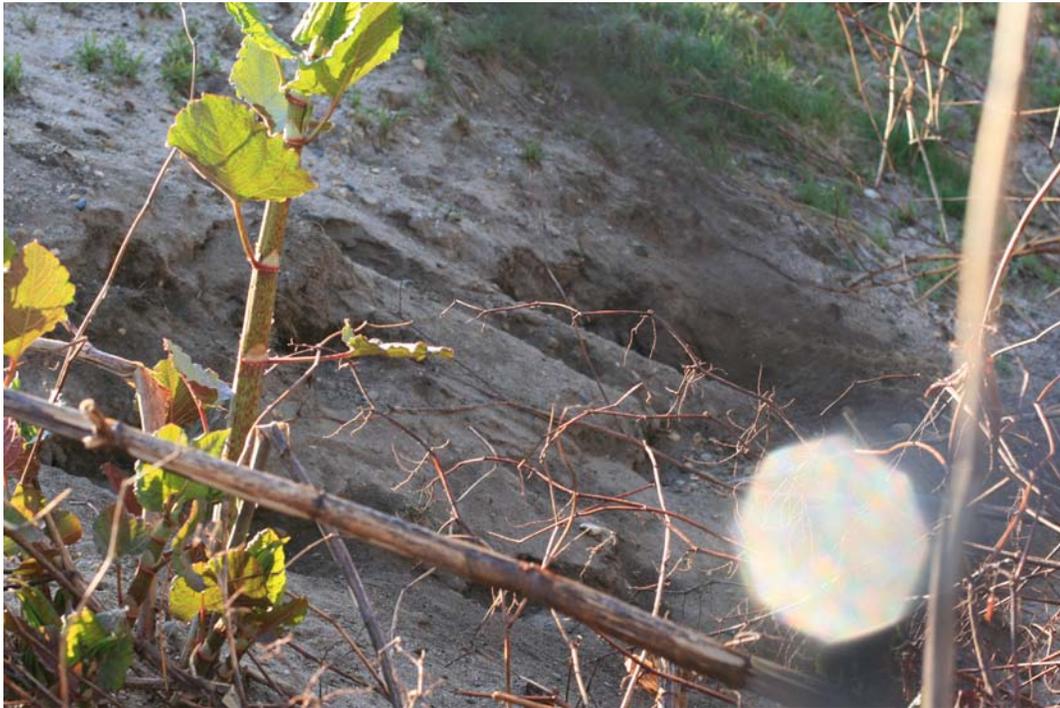
5. Erosion is occurring on the southern end of the cap adjacent to the Bethel A.M.E. property. Access to this area is currently blocked by fencing. The rills in this area should be filled in and efforts should be taken to establish vegetation along this slope.

11) Erosion visible through the fence that blocks access to the southern slope.

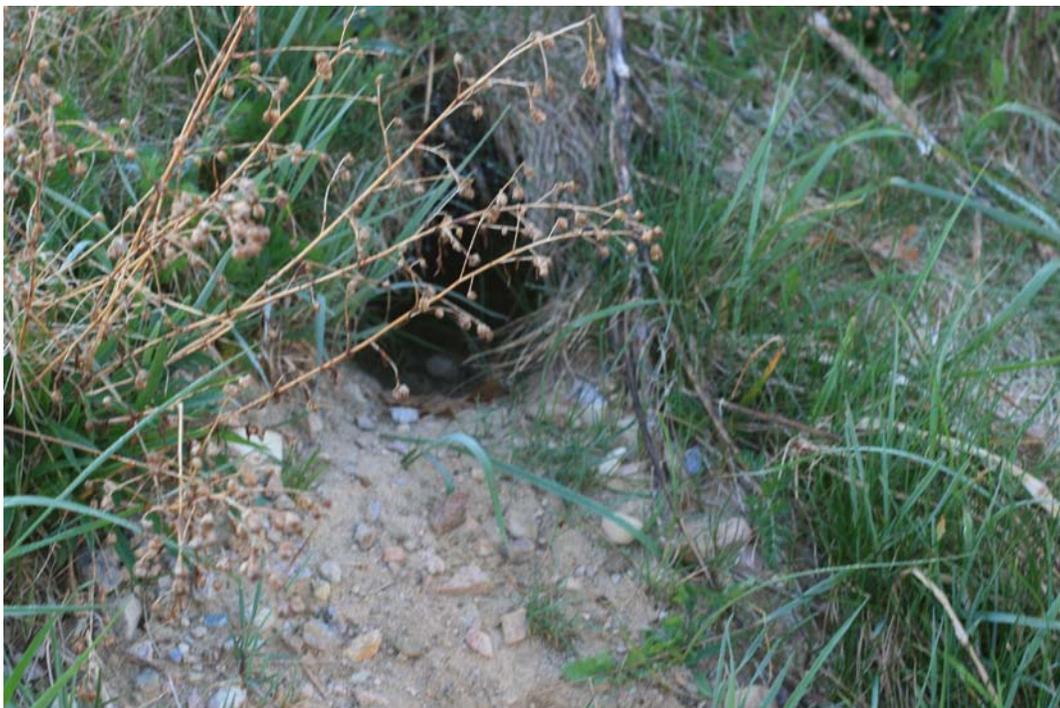
3. There is a gopher hole located at the northwestern corner of the cap, Photograph #12. Measures should be taken to remove the burrowing animal from the area. The hole should be filled in with suitable soil material and reseeded to minimize the chance of erosion.

12) Same gopher hole Northwest corner.

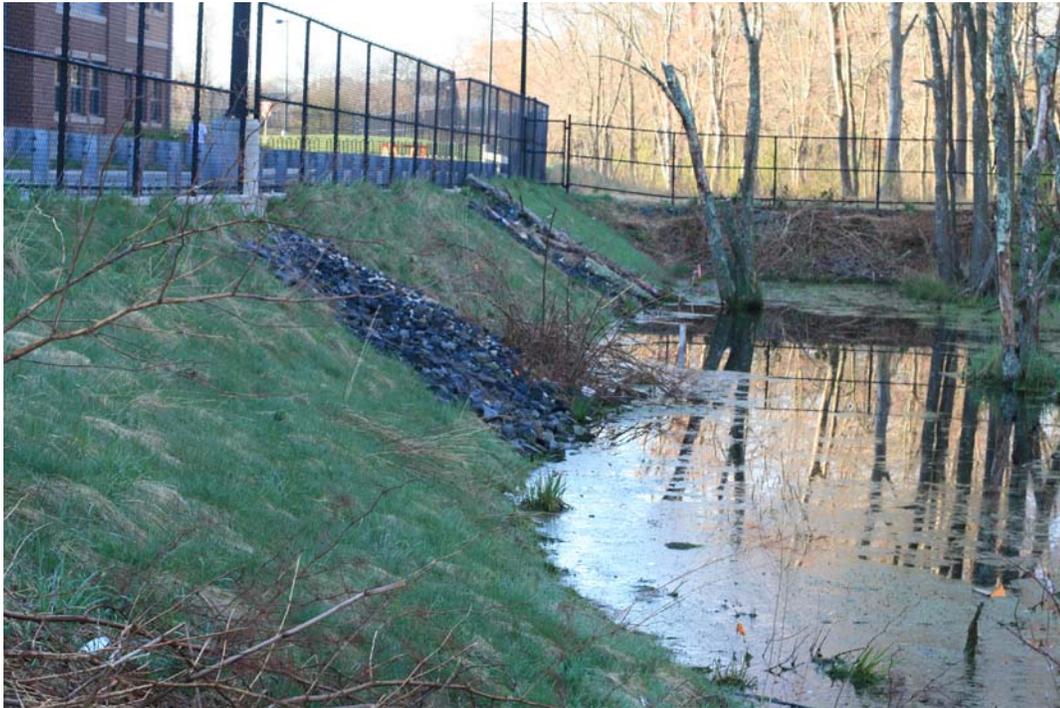
13) Eastern slope facing South.

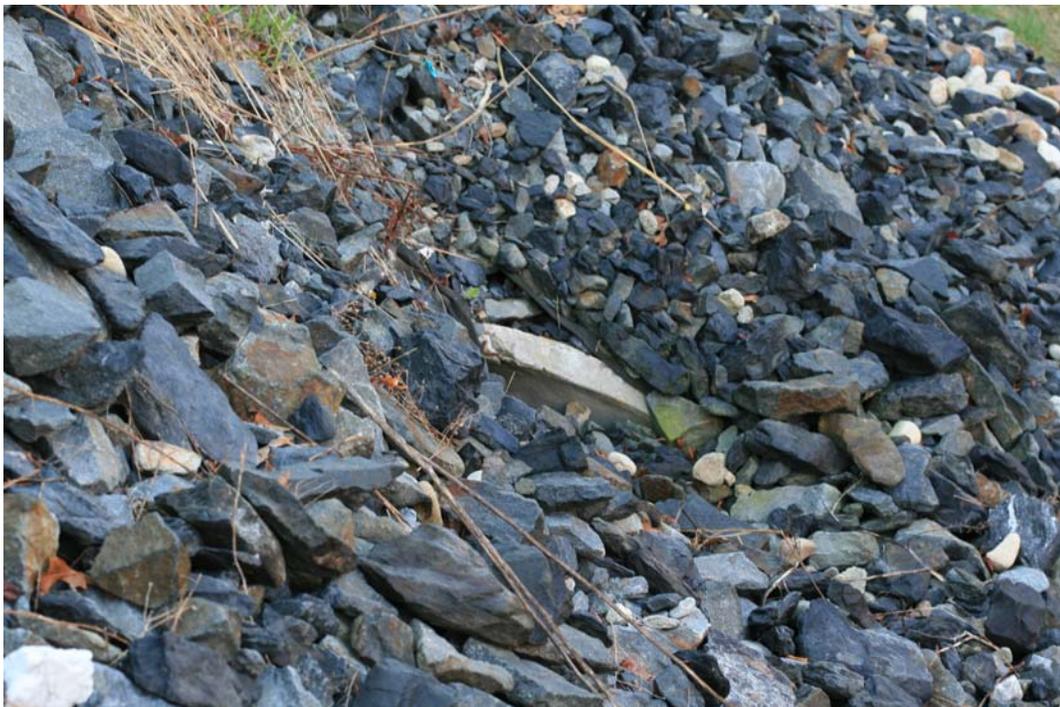
14) Culvert filled in with riprap.
