August 26, 2010

**Subject: Summer 2010 Cap Inspection
Keith Middle School
New Bedford, Massachusetts**

SITE PHOTOGRAPHS
August 2010 Cap Inspection
Keith Middle School
New Bedford, Massachusetts

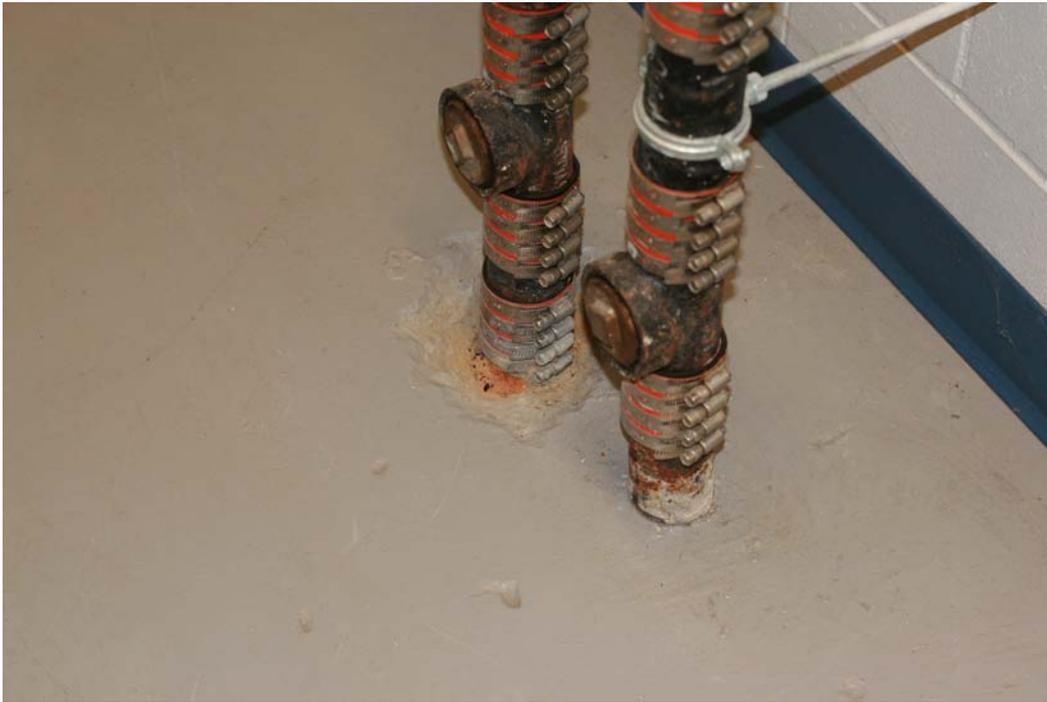
PIPE PENETRATIONS WERE INSPECTED AND THERE ARE NO CHANGES

1) Pipe penetrations in boiler room.

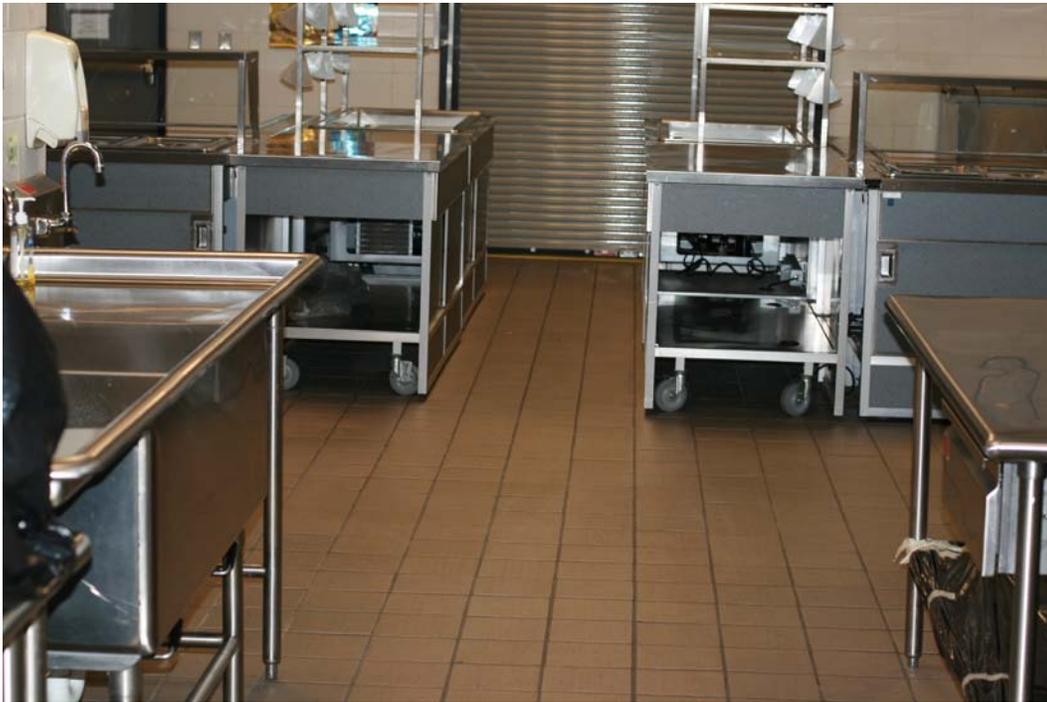
2) Kitchen.

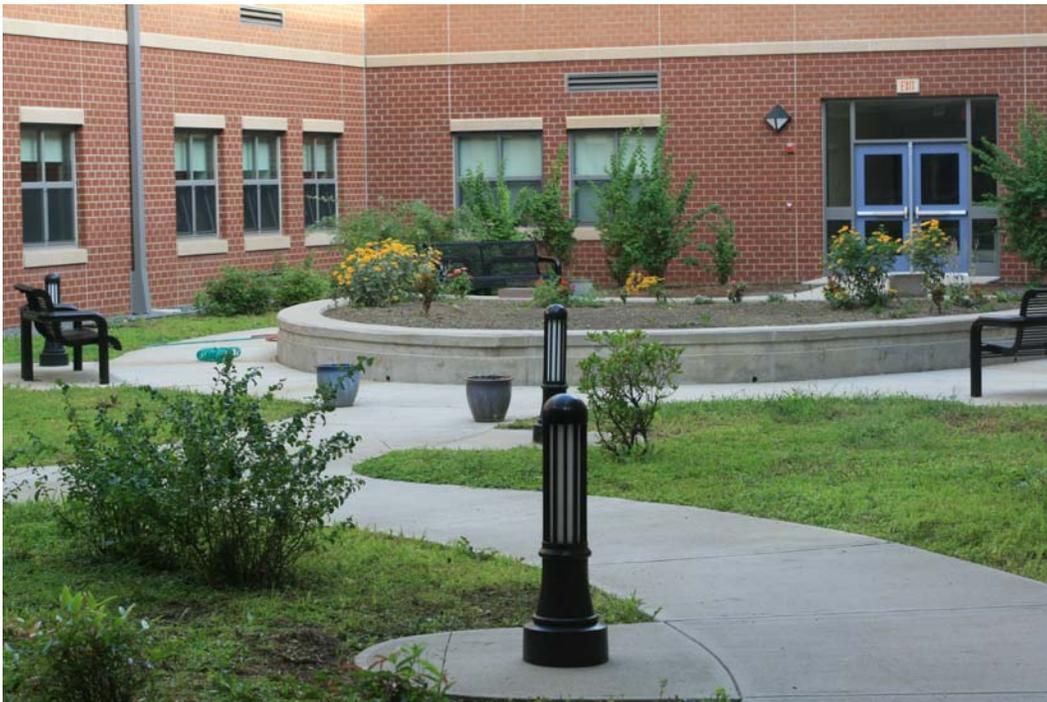
3) Courtyard looking North.

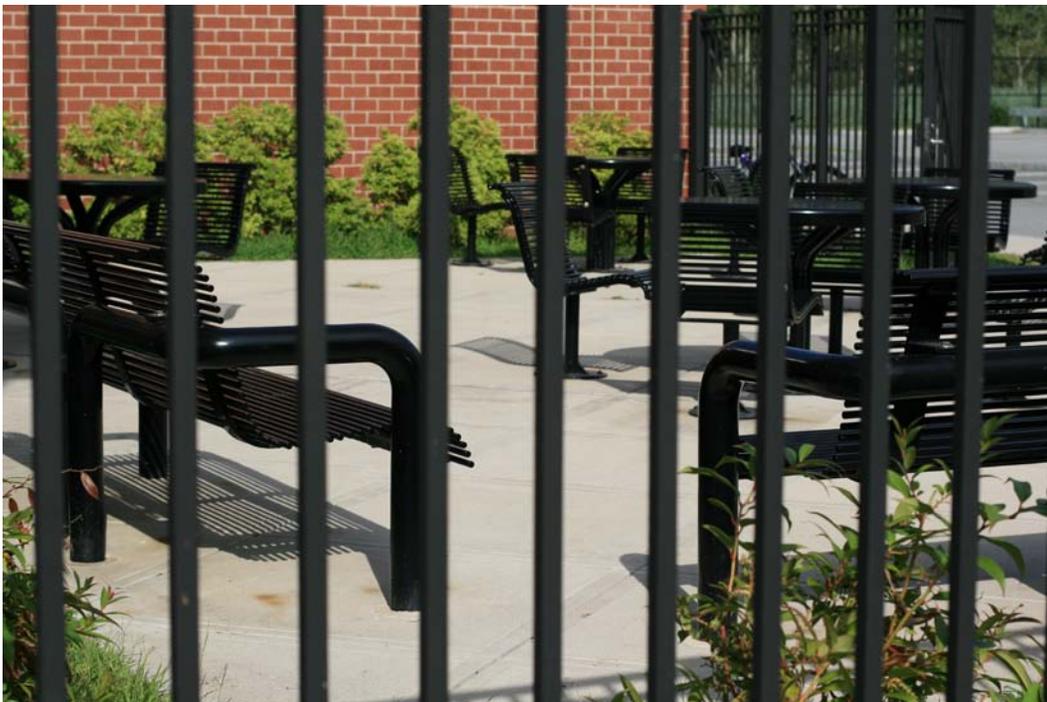
4) Community room courtyard.

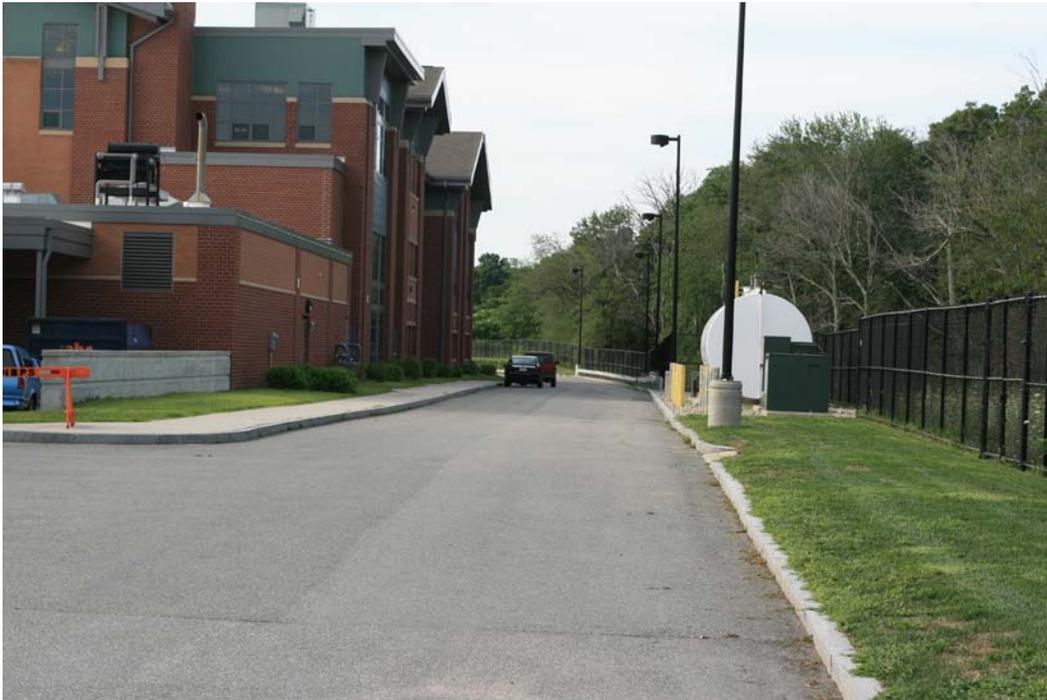
5) West side of school looking South.

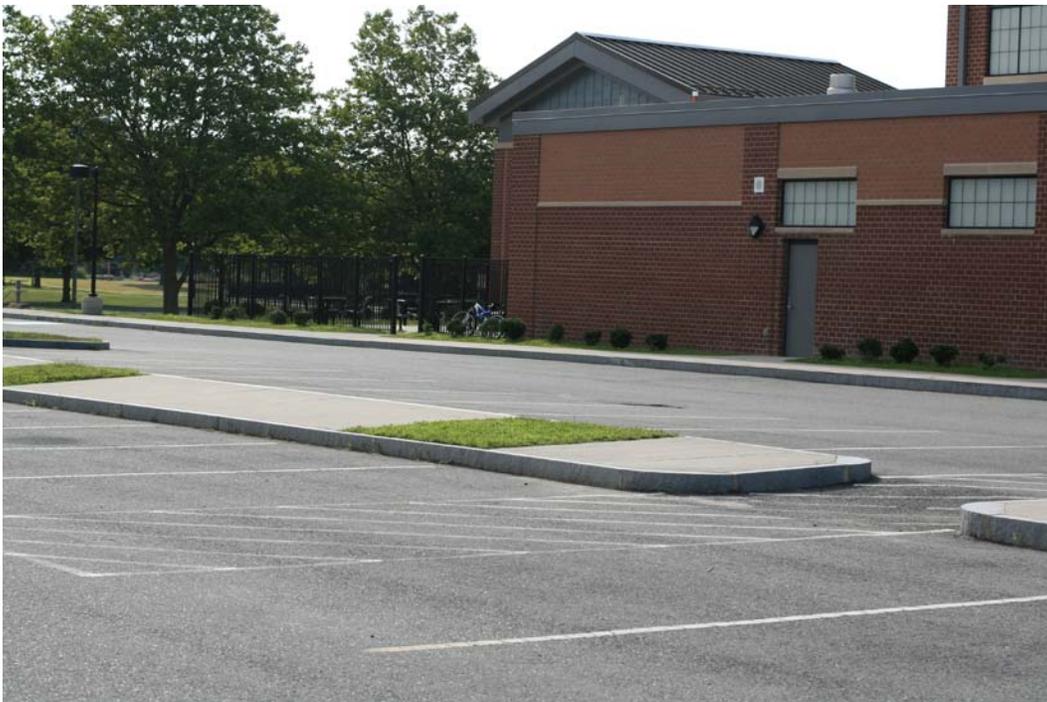
6) North parking lot facing Southeast.

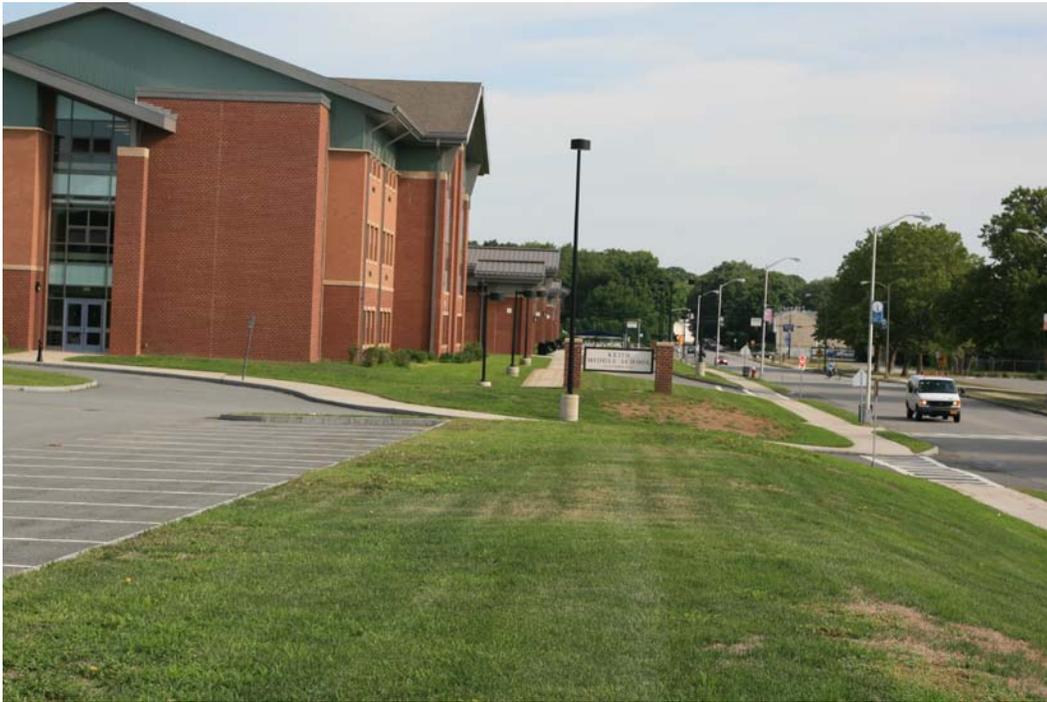
7) East side of school facing North.

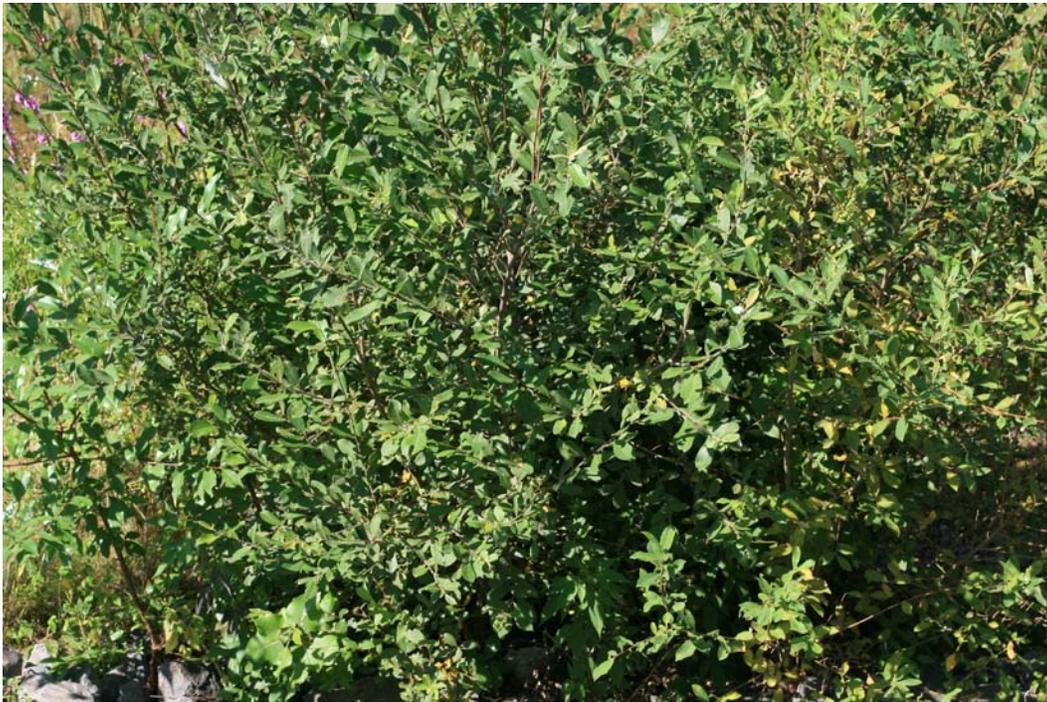
2. Woody vegetation is becoming more established, Photographs #8 and #10. Woody vegetation should be removed from the culvert outlets so unobstructed flow occurs at each discharge.

8) Woody Vegetation in front of culvert outlet.

- Woody vegetation is established at the culvert outlets and should be removed to allow unobstructed flow from each discharge.

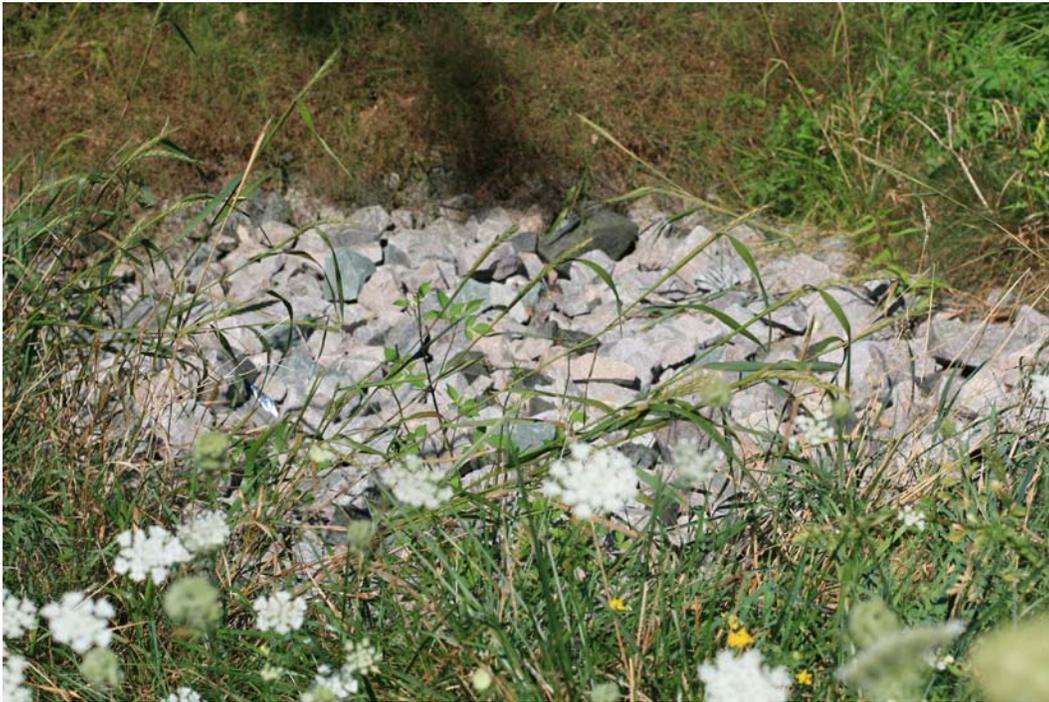
UNABLE TO SEE EROSION RILLS IN SW CORNER DUE TO THICK VEG. RIPRAP REPAIR TO SLOPE IS STABLE. HAY BALES / SILT FENCE REMOVED.

9) Temporary slope failure repair.

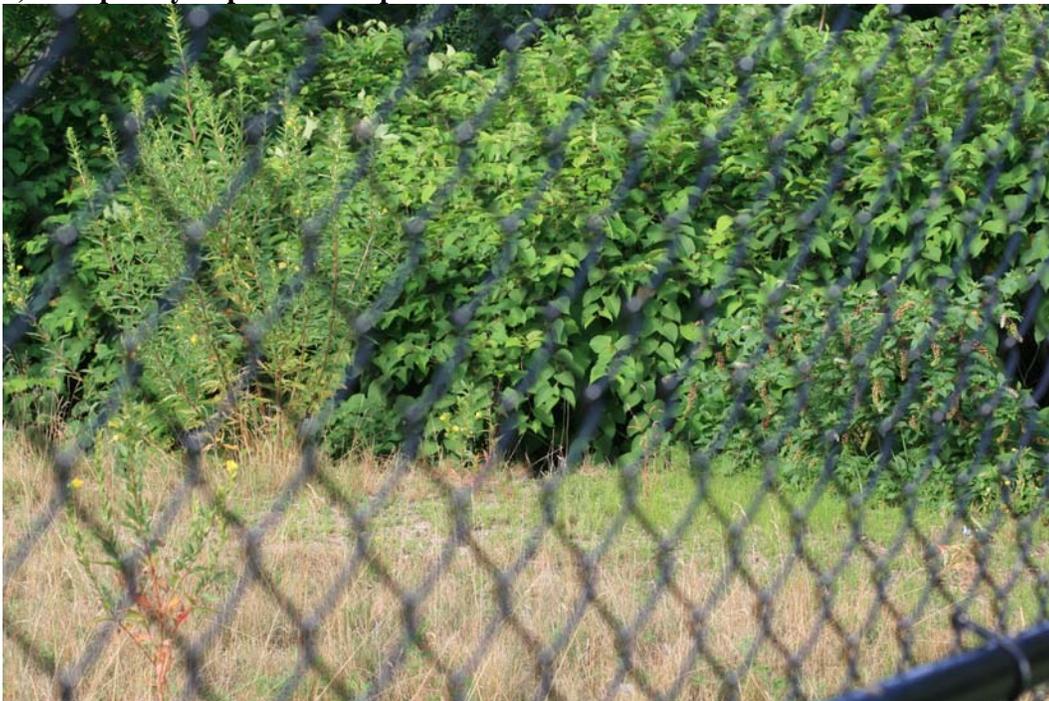
- The southern slope, adjacent to the Bethel A.M.E., has erosion rills and grassed areas are sparse. The slope is currently inaccessible for full inspection and repair due perimeter fencing.

10) Vegetation on Southern slope.

3. Erosion is occurring on the southern end of the cap adjacent to the Bethel A.M.E. property. Access to this area is currently blocked by fencing. The rills in this area should be filled in and efforts should be taken to establish vegetation along this slope.

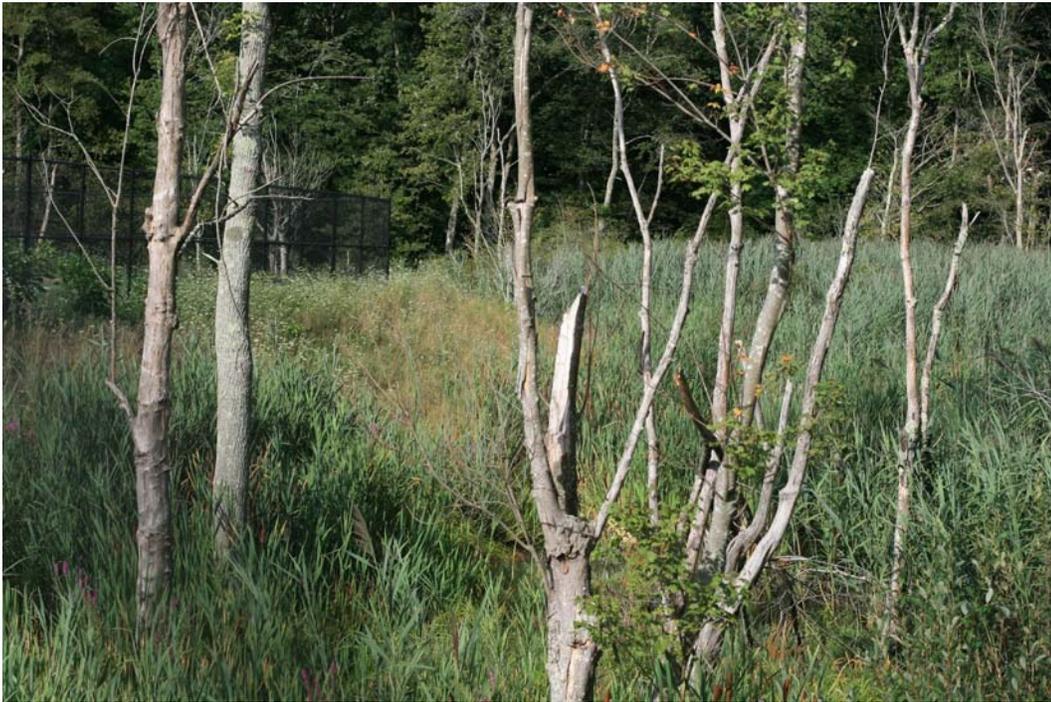
11) Northern slope facing Southwest.

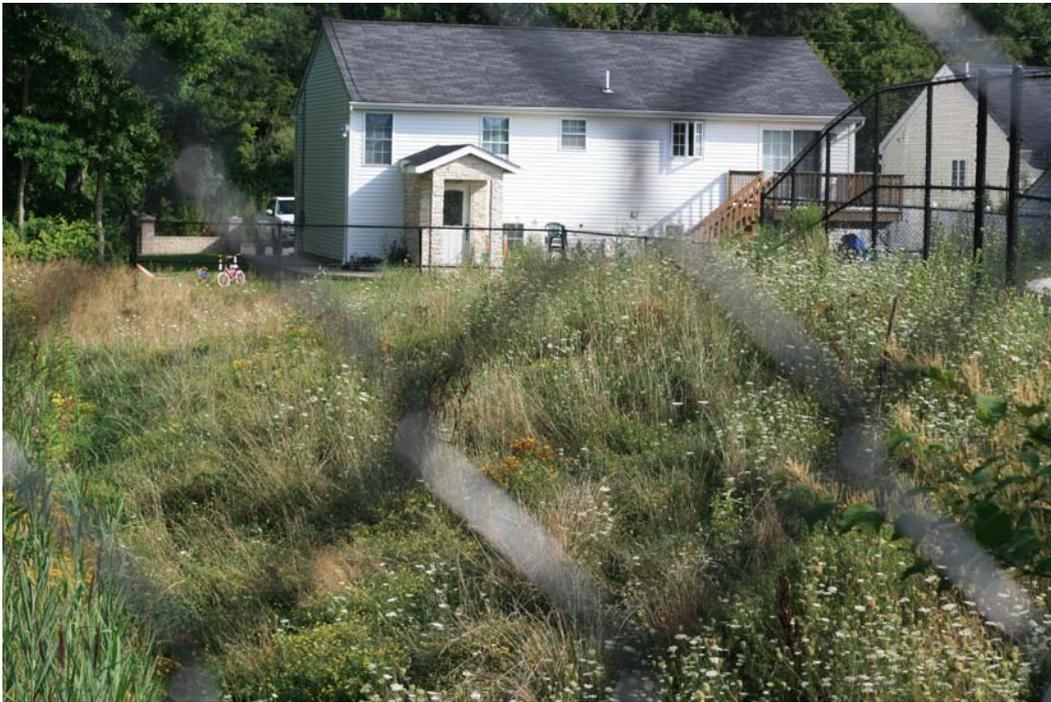
12) Northern slope facing North.

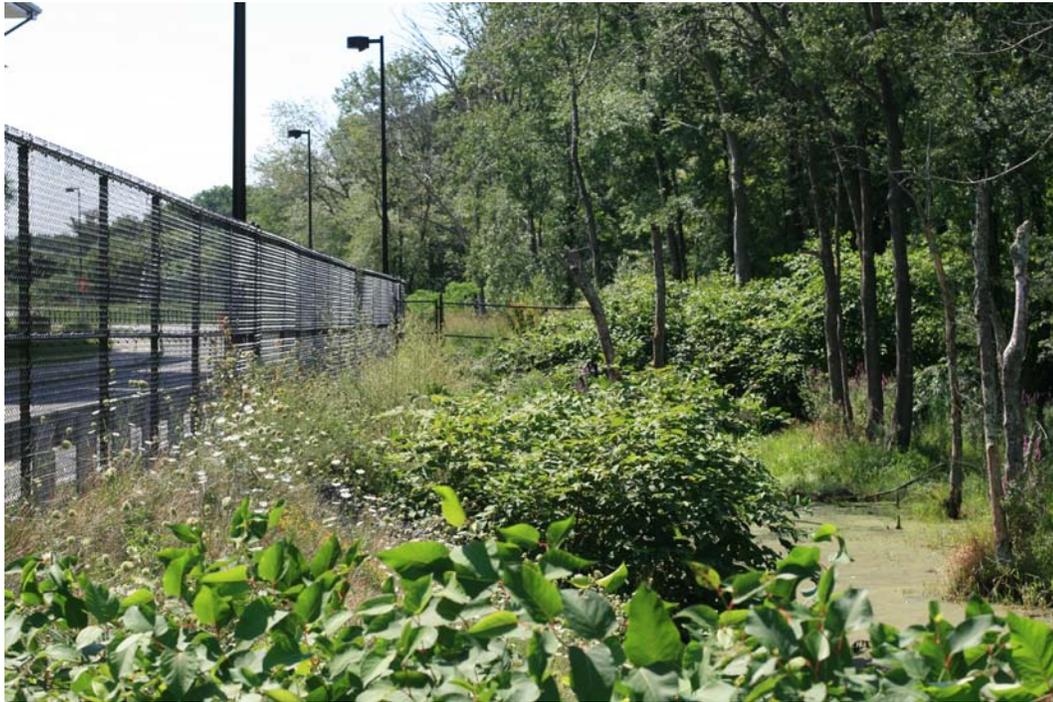
13) Eastern slope facing South.

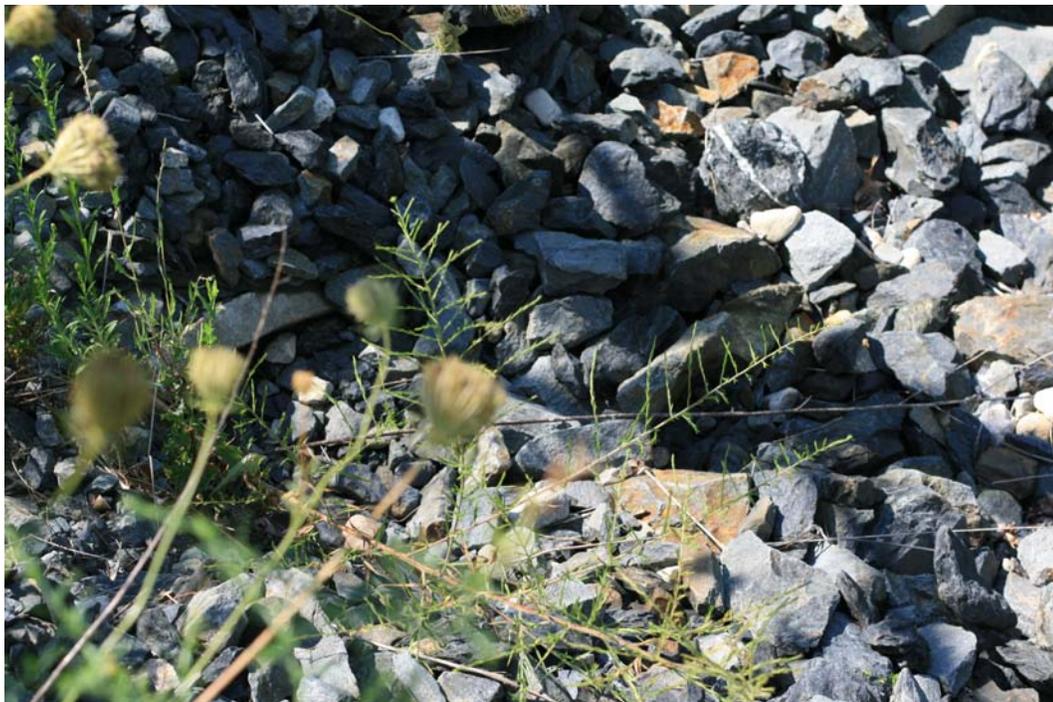
- Sloughing riprap stabilization stone that is undermining the concrete fence support at the top of the slope and filling the outlet of the storm water drainage culvert on the west side of the Site. Design and planning of a permanent solution is currently underway. The area is stable at this time.

1. Riprap stabilization rock placed around the outlet of one of the storm water drainage culverts is falling down the slope and filling the end of the culvert. The outlet in question is the fourth outlet south of the above ground oil storage tank. The falling riprap undermined the concrete fence support at the top of the slope. See Photograph #14. The structural integrity of the fence may be compromised if the sloughing of the riprap continues. The cap soils beneath the riprap may also become exposed and susceptible to erosion. The area appears stable at the moment. The extent of erosion seems similar to the conditions observed during the previous inspection. See inspection report letter dated May 11, 2010, Attachment 3, Photograph #10.

14) Culvert filled in with riprap.
