January 24, 2013

**Subject: Fall 2012 Cap Inspection  
Keith Middle School  
New Bedford, Massachusetts**

**SITE PHOTOGRAPHS**  
**November 2012 Cap Inspection**  
**Keith Middle School**  
**New Bedford, Massachusetts**

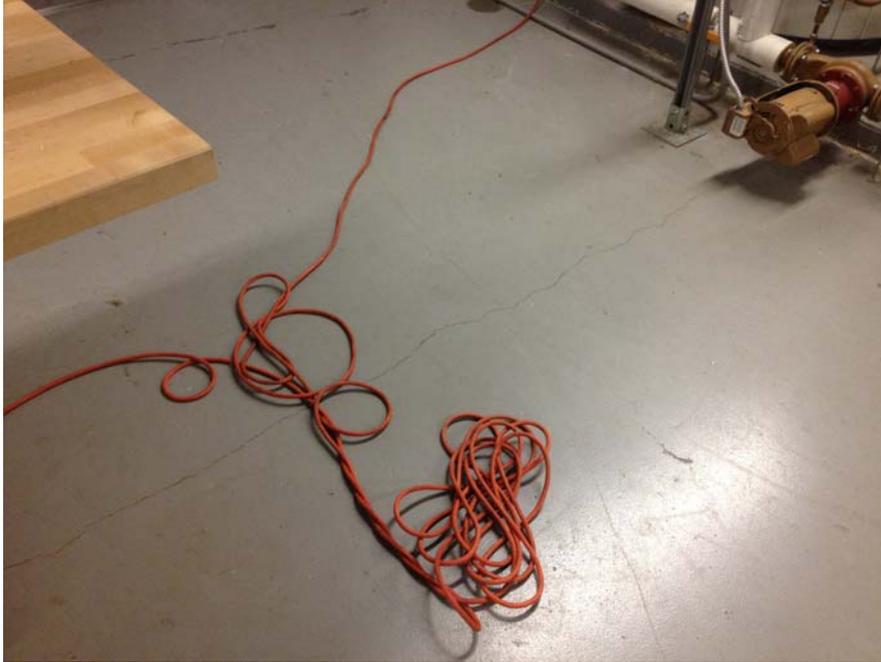
Four cracks in the boiler room floor are less than 1/4-inch wide, see Photographs #1 and #2. Three minor cracks in storage room 44 are also less than 1/4-inch wide, see Photograph #3. The majority of interior concrete floors are covered with tiles or other type of flooring material. Based on visual inspection and conversations with current employees, there are no breaches or other significant damage or deterioration of the interior surficial flooring materials or, where visible, concrete floors. No construction was occurring within the building at the time of the inspection.

**1) Minor crack in boiler room floor.**

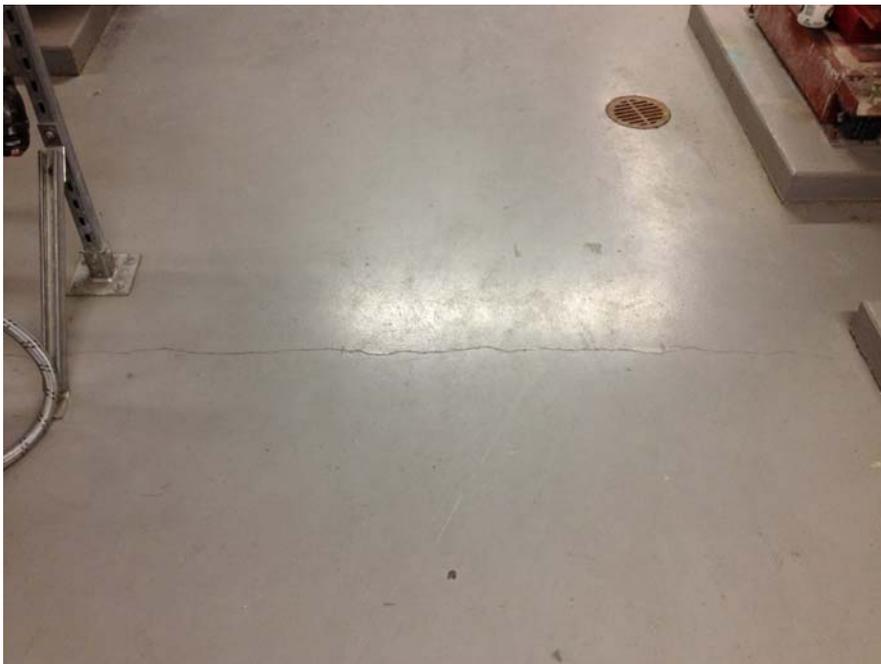
**2) Minor crack in boiler room floor.**

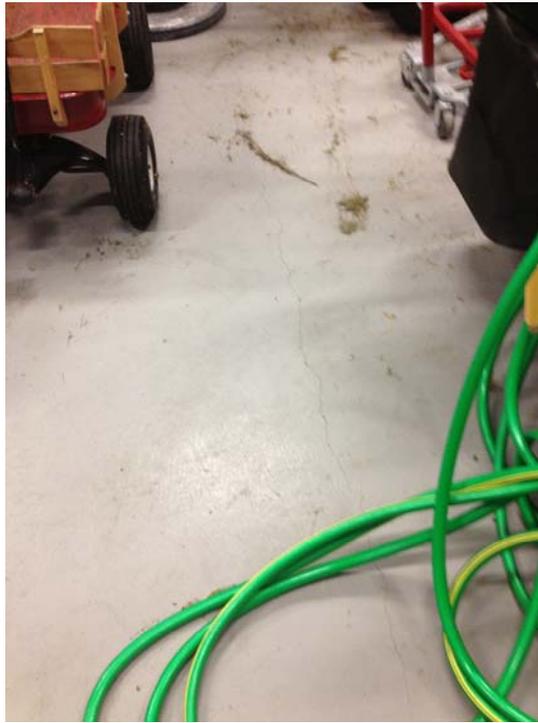
**3) Minor crack in storage room 44 floor.**

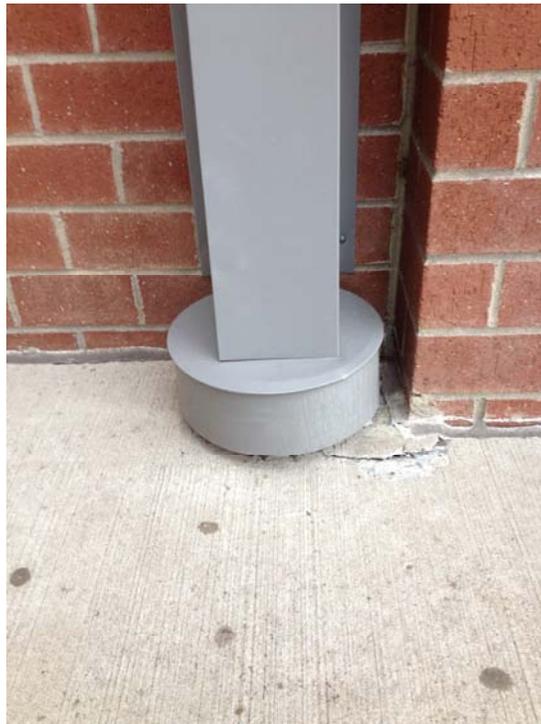
**4) Minor cracking of concrete next to downspout.**

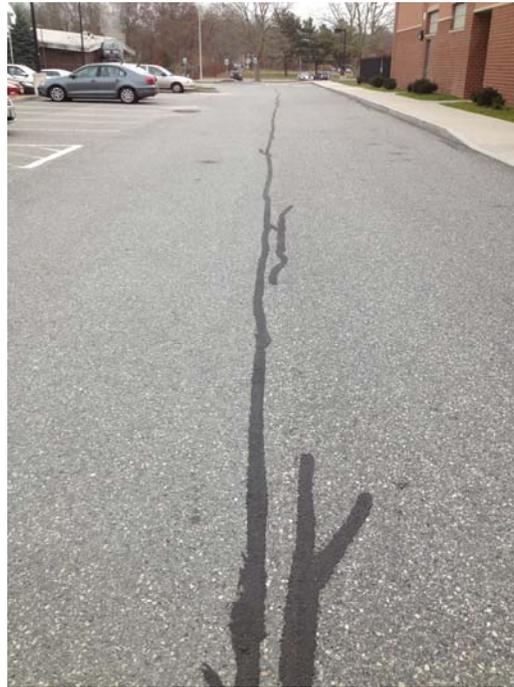
All asphalt cracks in the parking lots and entrance were repaired during the summer, see Photographs #5 and #6.

**5) Parking lot crack repairs.**

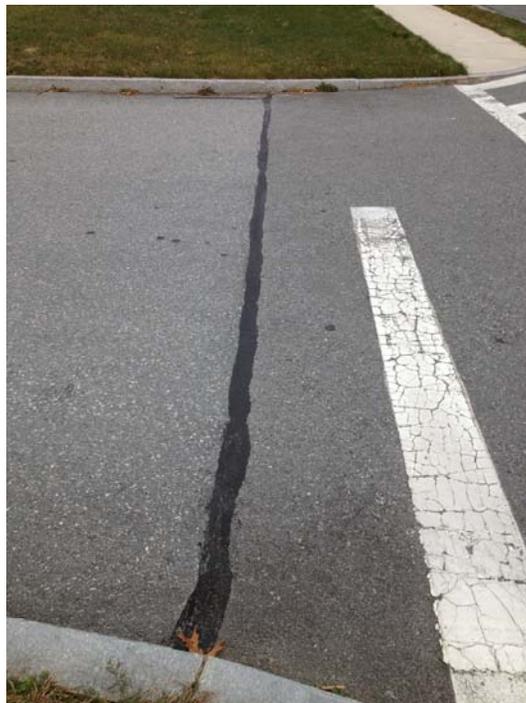
**6) Parking lot seam repairs.**

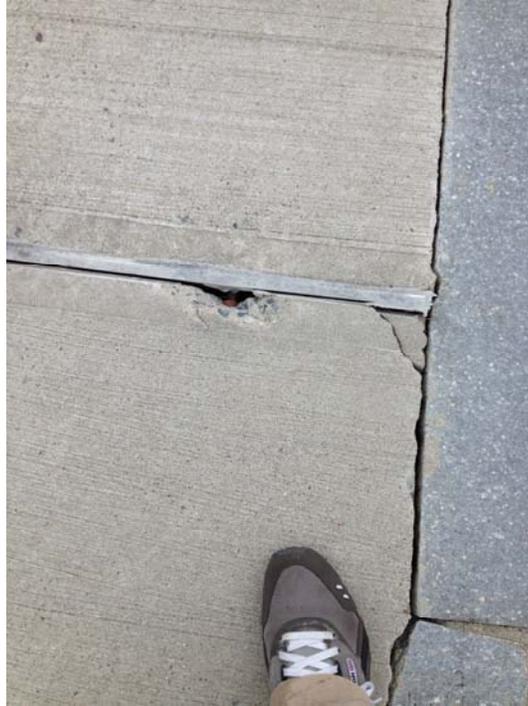
- 1) There is a chunk missing from the sidewalk and a cracked corner that should be repaired or filled, see Photograph #7. (*This repair was made in December 2012, see Photograph #17.*)
- 2) Caulking in joints between brick walls and concrete walkways is deteriorating, see Photograph #8.
- 3) Minor cracks were observed next to a downspout along the concrete walkways, see Photograph #4. These cracks appear ok at the present time, but may require repair in the near future. (*This repair was made in December 2012, see Photograph #18.*)

**7) Sidewalk crack and missing chunk located southeast of school.**

- A crack in the sidewalk was observed near the southern parking lot entrance and should be filled or repaired. *(This repair was made in December 2012.)*

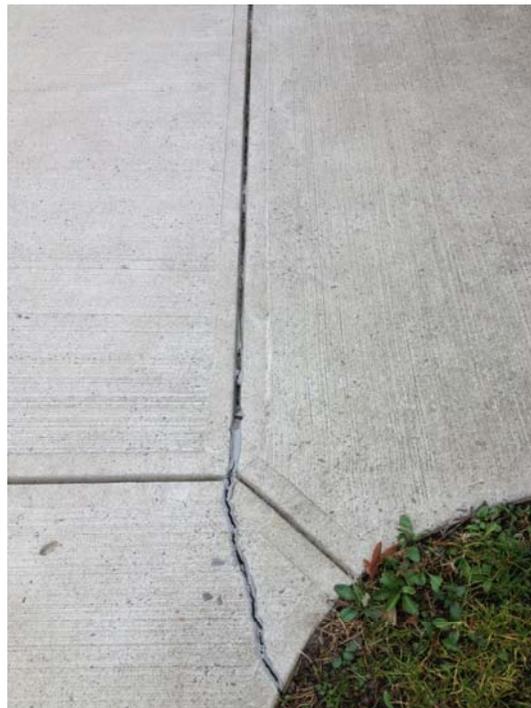
**8) Sidewalk repair deteriorating at northern side of school.**

caulking. Continued infiltration of weather elements into the joint could eventually separate and deteriorate the walkway.

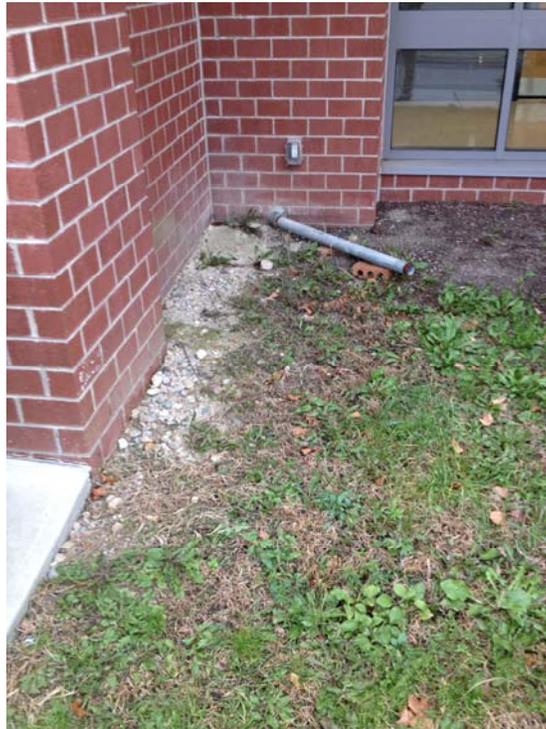
**9) Repair to prevent undermining of concrete walkway by eastern entrance.**

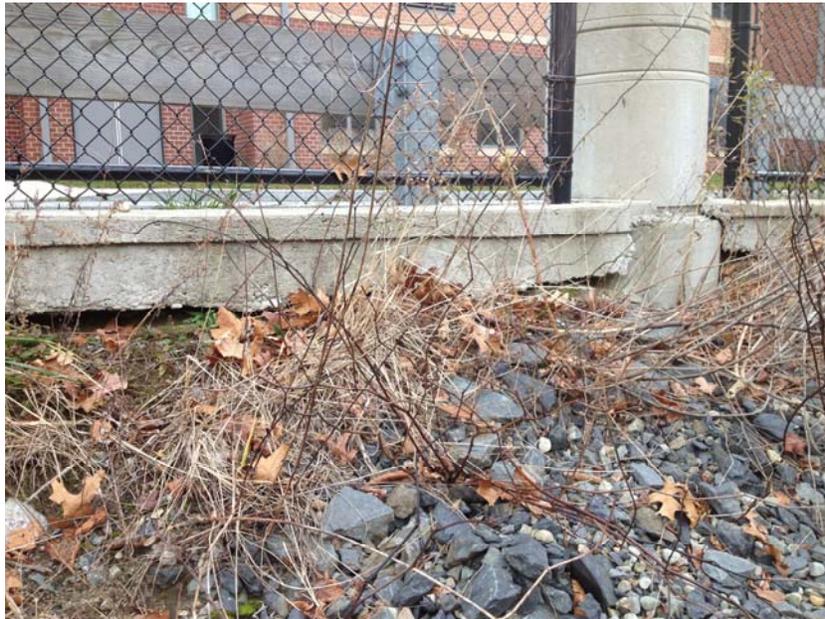
- Sloughing riprap is undermining the concrete fence support at the top of the slope, and filling the outlet of the storm water drainage culvert on the west side of the Site. Areas of soil erosion were observed along the upper slope, as well as a crack in the concrete fence support. The area appears relatively stable at this time, but the condition is likely due to an increase in steepness. The crack in the concrete fence support is not identified as a cap integrity issue, nor is the riprap accumulating in the culvert outlet, but these issues should be addressed to maintain the integrity of the fence and the function of the culvert.

- 1) The structural integrity of the fence may be compromised if the sloughing and erosion continues, see Photograph #10. The cap soils beneath the riprap may also become exposed and susceptible to erosion. The area appears stable at the moment, but the condition is likely due to an increase in steepness beyond the cap design slope. The extent of erosion seems similar to the conditions observed during several previous inspections. See inspection report letters dated May 4, 2012 and August 31, 2011.

**10) Undermining of concrete structure for fence west of school.**

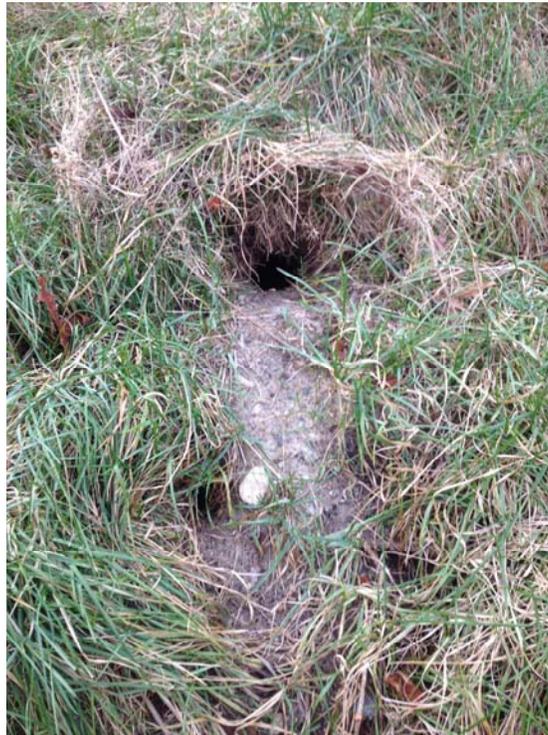
- 2) Animal burrow holes were observed on the slopes to the north, south and southwest of the school, see Photographs #11, #12 and #13. Potentially deep rooted vegetation was observed on the slope to the south and west of the school and should be cut down, see Photographs #14 and #15.

**11) Animal burrow at northern slope of cap.**

- New animal burrows were observed on the north, south, and southwest slopes. The burrows appeared to be inactive, but should be filled in or investigated in the spring.
- Potentially deep rooted vegetation was observed on the ridge of the southern and southwestern slope and should be cut down.

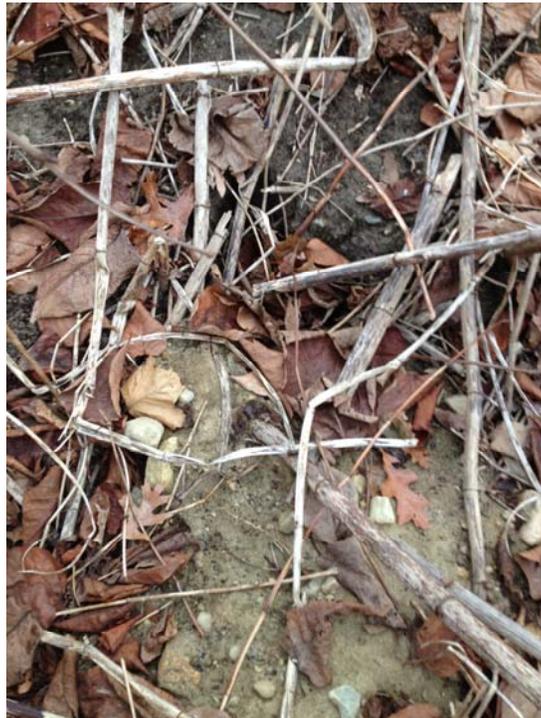
**12) Animal burrow at southwest corner of cap. Knotweed has been cut back.**

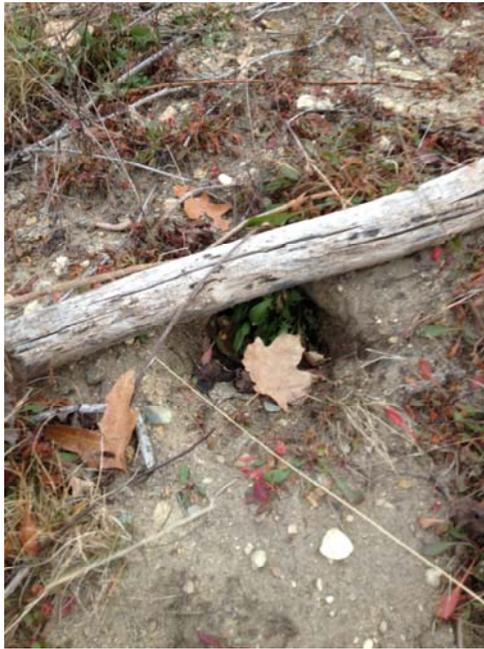
**13) Animal burrow at southern slope of cap.**

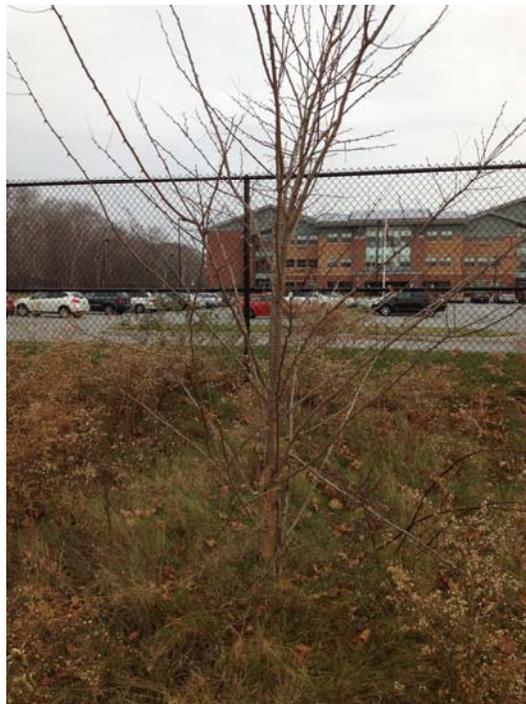
**14) Potentially deep-rooted vegetation at southern slope of cap.**

- Potentially deep rooted vegetation was observed on the slope south and west of the school and should be cut down.
- The orange warning layer is visible by the base of a section of riprap, at the transition from the school slope area to the wetland remediation area. The area appears very stable, is covered in large-diameter riprap, and does not show any signs of erosion. Black separation fabric was also visible at the southwest corner of the slope, but was determined to be beyond the limits of the cap.

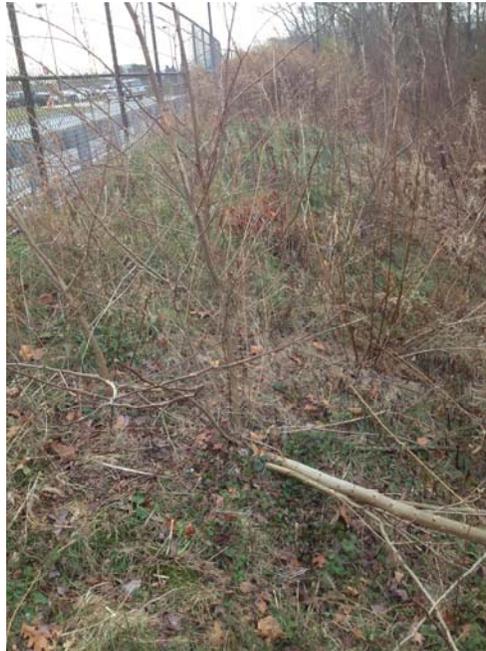
**15) Potentially deep-rooted vegetation at western slope of cap.**

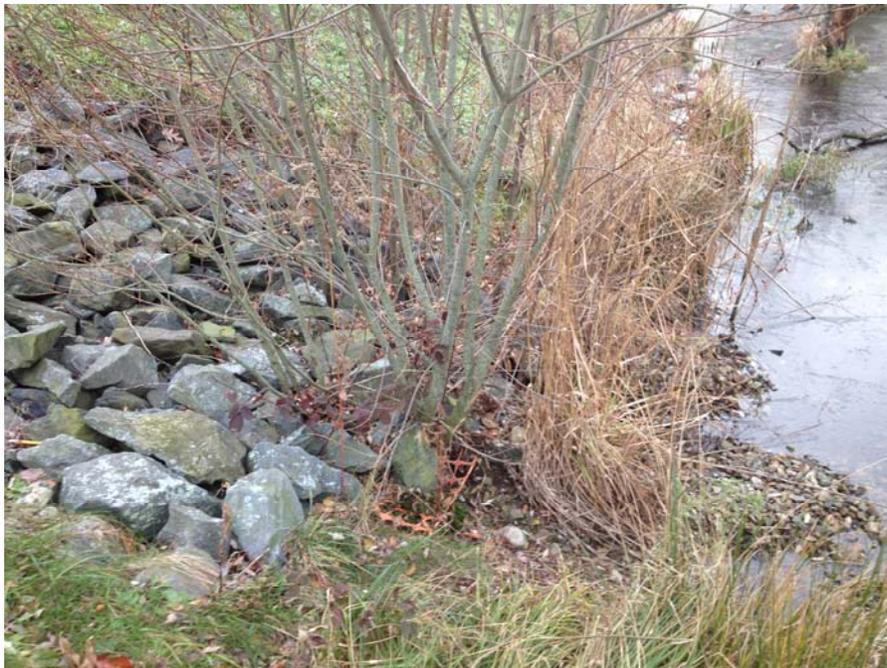
- 3) Potentially deep rooted vegetation was observed by riprap at the base of the slope to the west of the school, see Photograph #16. The orange snow fence protruding in this location appears to be located at the transition from the school slope area to the wetland remediation area. The area appears very stable, is covered in large-diameter riprap, and does not show any signs of erosion. The deep rooted vegetation in this area should be cut down to ground level.

**16) Potentially deep-rooted vegetation at western slope of cap by rip rap.**

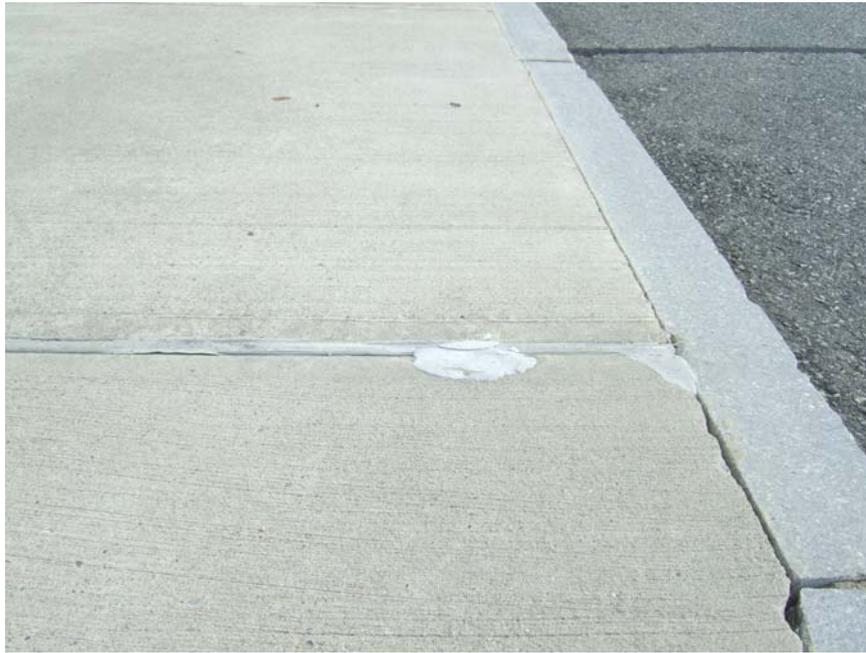
**17) Sidewalk repaired near southern parking lot entrance.**

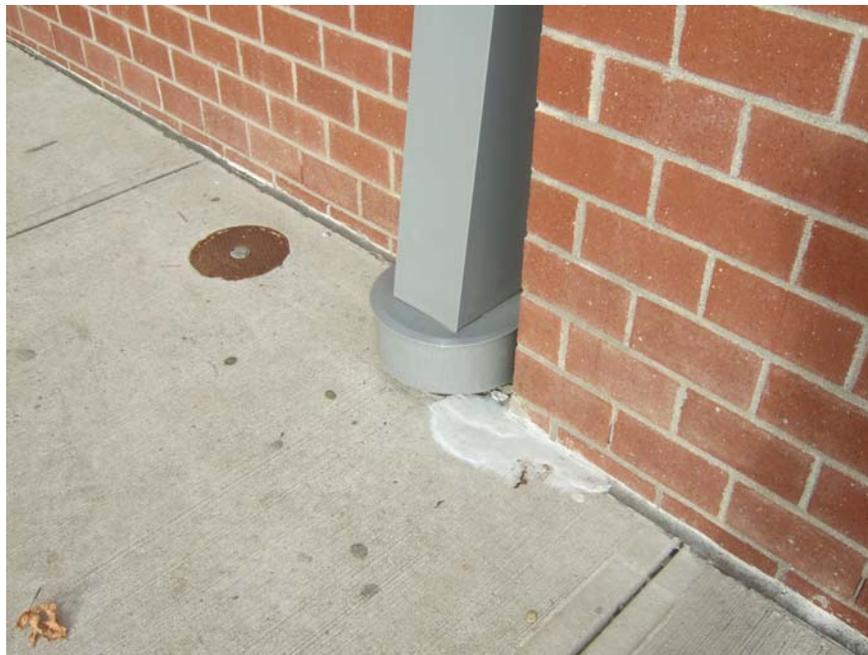
**18) Concrete repaired next to downspout.**
