December 27, 2011

**Subject: Winter 2011 Cap Inspection  
Keith Middle School  
New Bedford, Massachusetts**

**SITE PHOTOGRAPHS**  
**December 2011 Cap Inspection**  
**Keith Middle School**  
**New Bedford, Massachusetts**

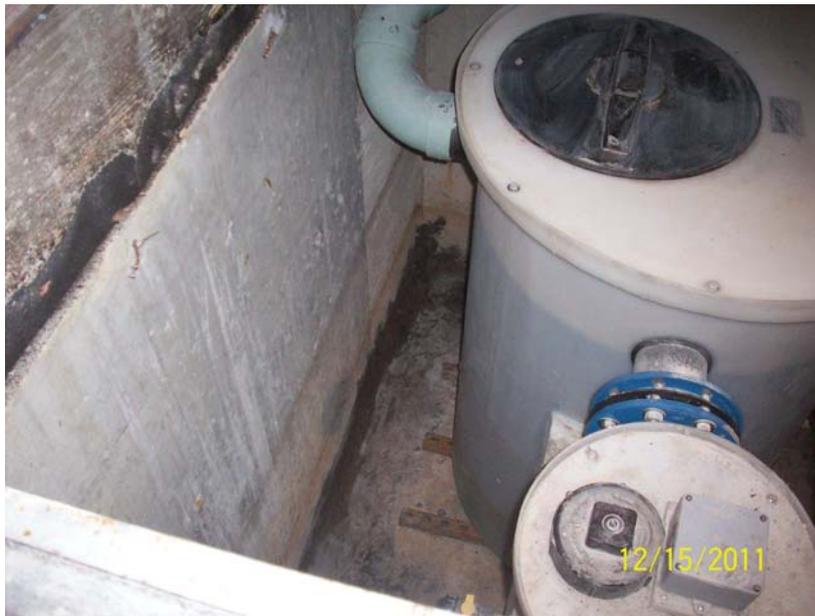
The standing water that was observed in the sub-slab vault adjacent to the western science classroom during the previous two inspections was dry during this inspection, and there was no sign that standing water had occurred in recent months. Following the August 2011 inspection,

**1) Dry science room vault.**

Standing water was pumped out of the sub-slab concrete vault located adjacent to the western science classrooms. Evidence of a breach was reportedly not observed by City personnel during the pump-out event, but the joints were re-sealed with hydraulic cement. No standing water has been observed in recent months; see Photographs #1 and #2.

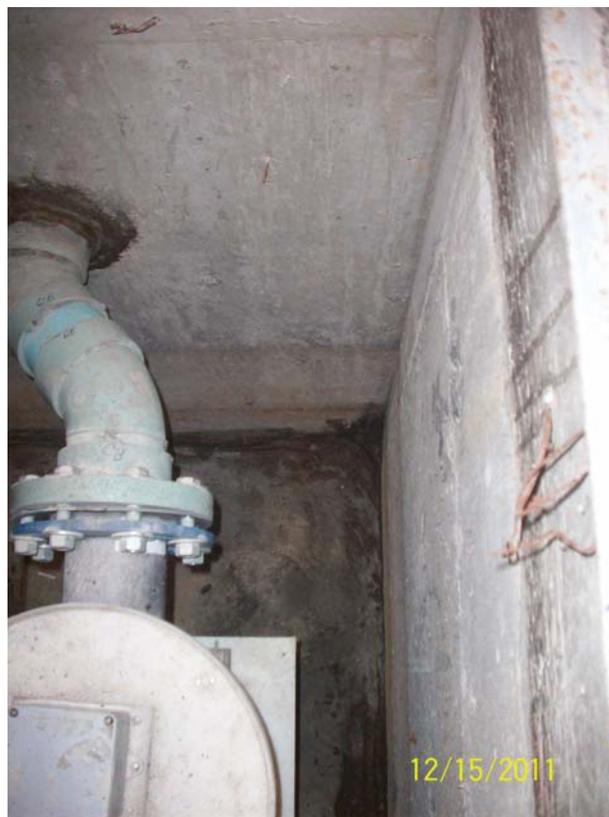
**2) Dry science room vault.**

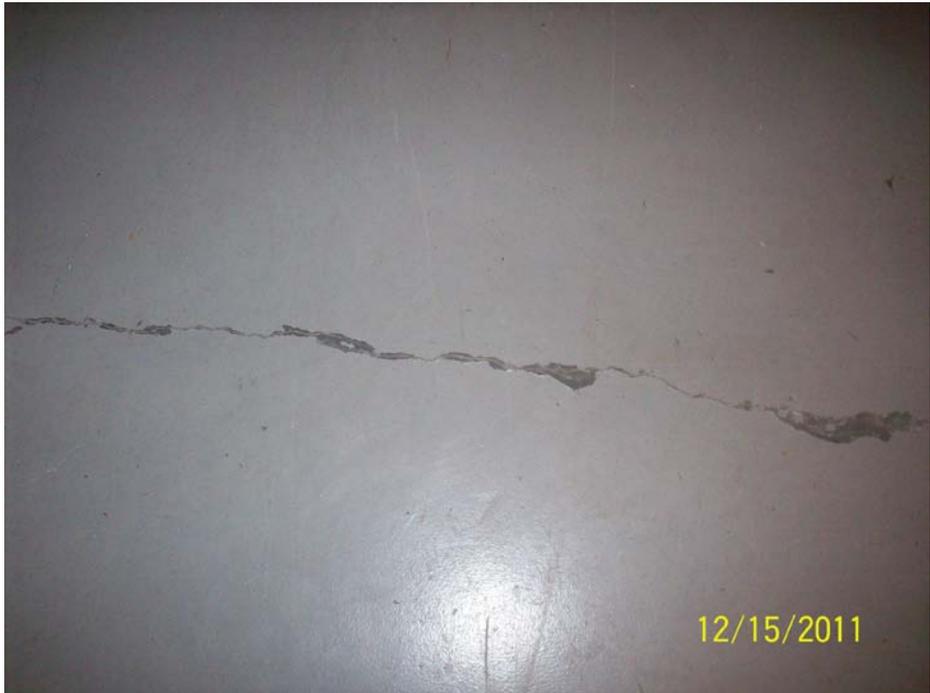
Four cracks in the boiler room floor are less than ¼-inch wide, see Photograph #3. Pipe penetrations appeared intact, see Photograph #4. Three minor cracks in storage room 44 are also less than ¼-inch wide, see Photograph #5. The majority of interior concrete floors are covered with tiles or other type of flooring material. Based on visual inspection and conversations with current employees, there are no breaches or other significant damage or deterioration of the interior surficial flooring materials or, where visible, concrete floors. No construction was occurring within the building at the time of the inspection.

**3) Minor crack in boiler room floor.**

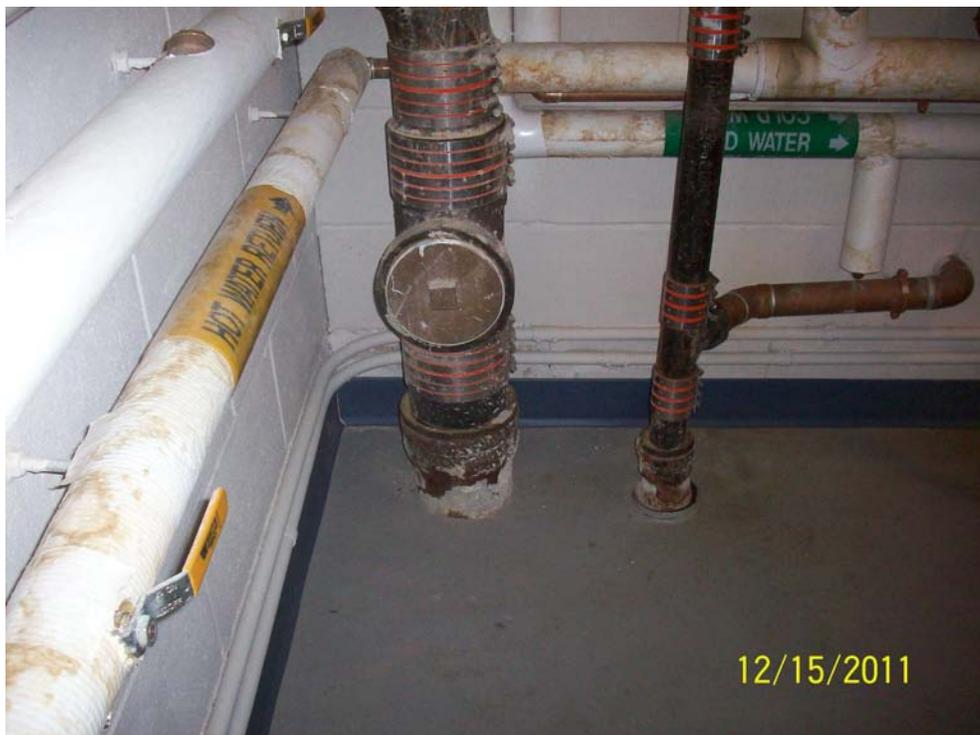
**4) Pipe penetrations in the boiler room.**

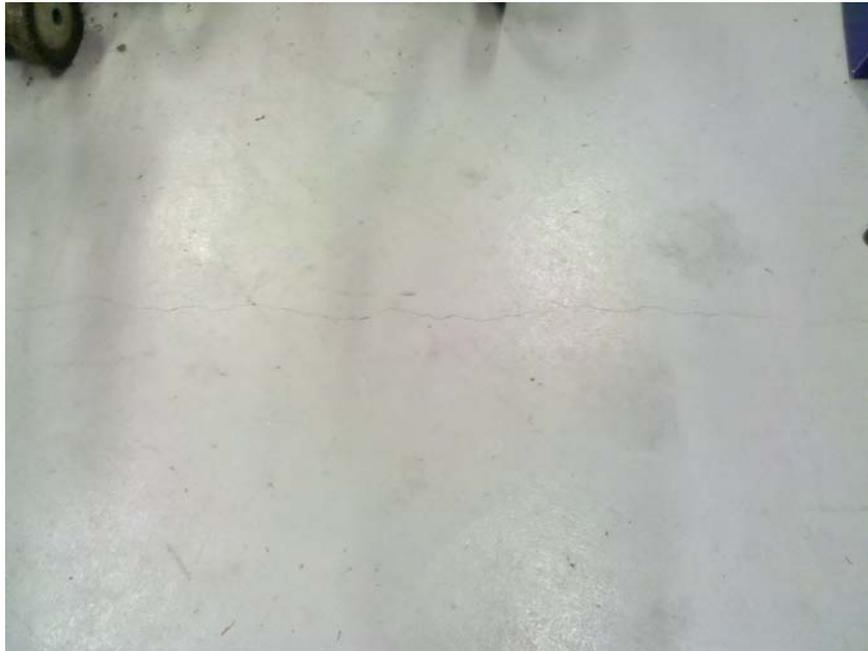
**5) Minor crack in storage room 44 floor.**

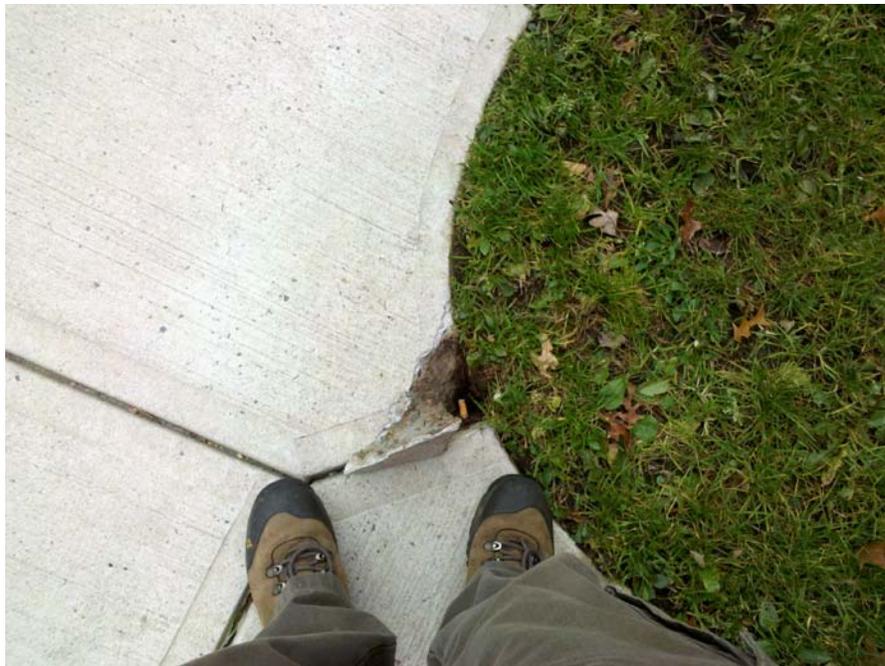
The courtyard area within the building was acceptable. The concrete walkway leading to the western-most entrance at the north of the building exhibited a significant crack, and a piece of the concrete walkway had become dislodged. This crack will need to be repaired. The concrete walkways at the north of the school exhibited several other minor cracks that appeared less than 1/4-inch wide, and will be monitored in future inspections.

- 1) Significant crack and loose piece of concrete walkway, see Photograph #6. This section of the concrete walkway should be replaced or repaired.
- 2) Caulking in joints between brick walls and concrete walkways is deteriorating.
- 3) Separation of the seams of the asphalt parking lot entrances and cracks greater than ¼-inch in parking lots, see Photographs #13 and #14.
- 4) Minor cracks were observed at several locations along the concrete walkways, see Photographs #7 and #8. These cracks appear ok at the present time, but may require repair in the near future.

**6) Significant crack and loose piece of concrete in walkway leading to western-most entrance at north end of school.**

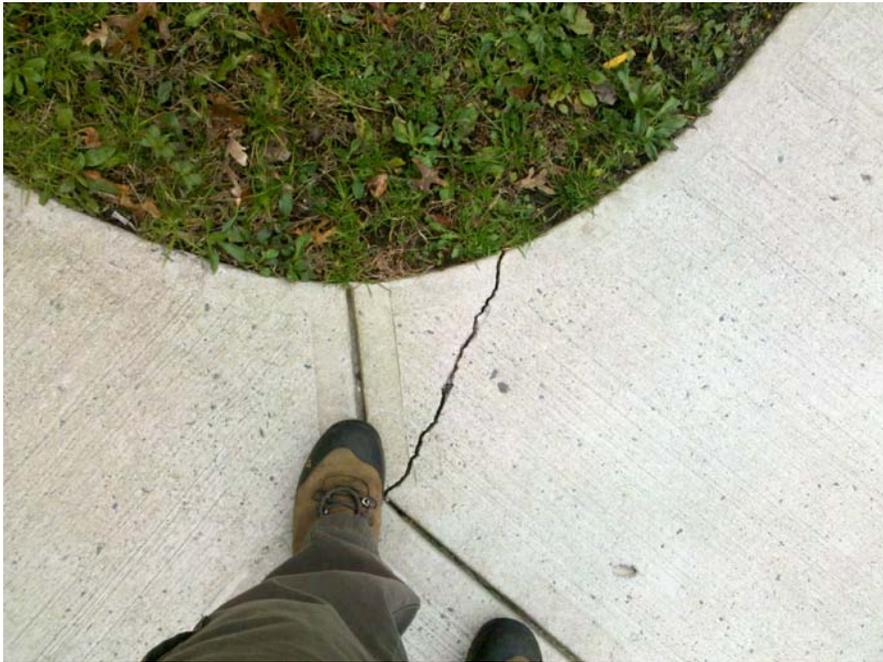
**7) Minor crack in concrete walkway.**

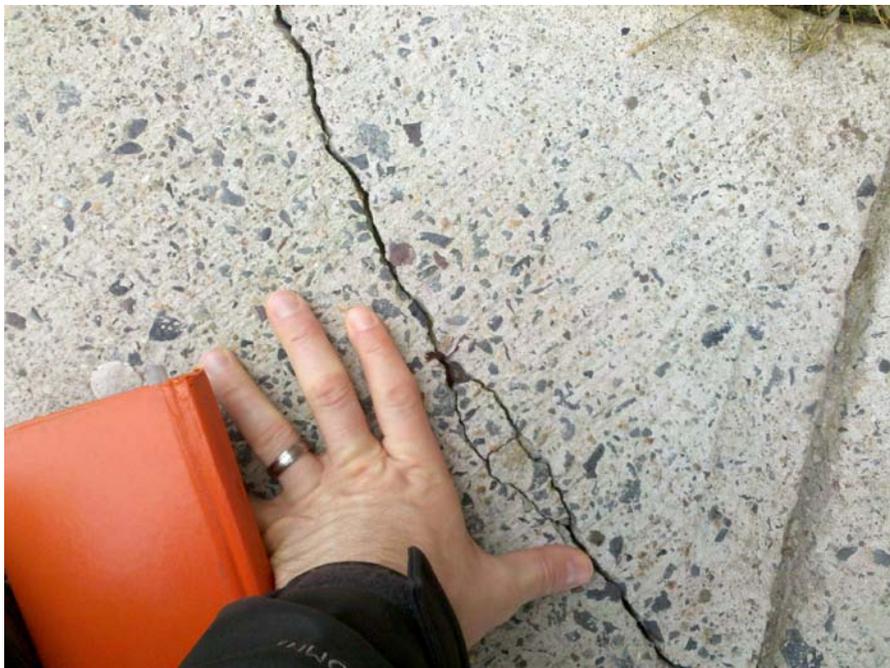
**8) Minor crack in concrete walkway.**

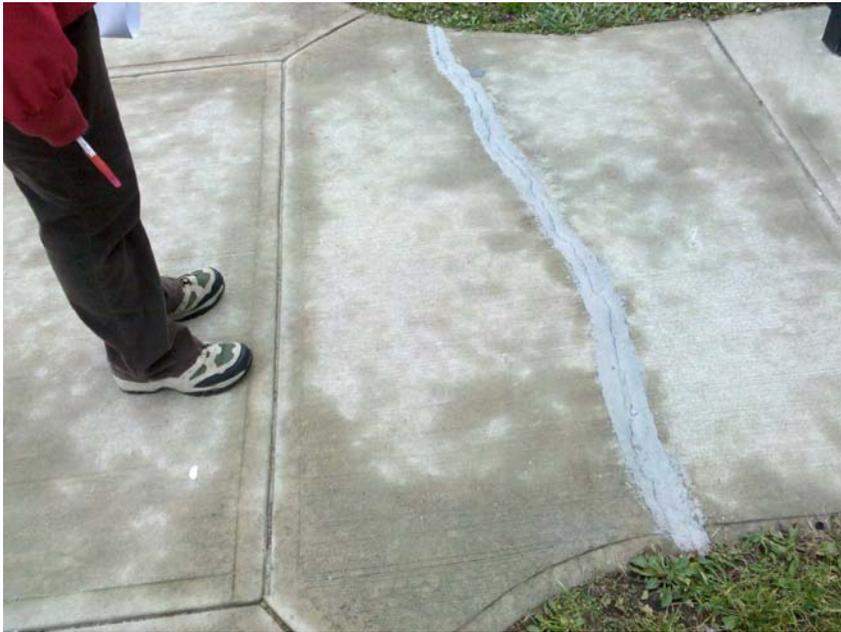
**9) Significant crack repair in walkway leading to community room area.**

A significant crack in the concrete walkway was successfully repaired, see Photograph #9.

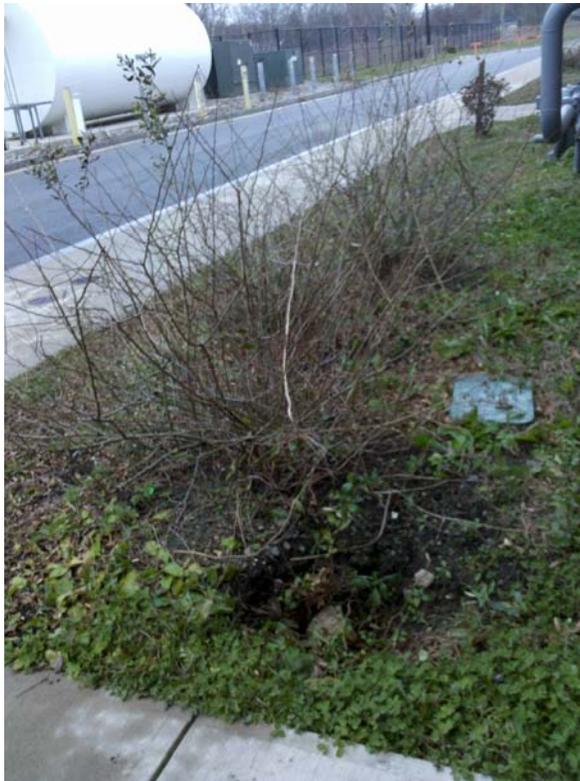
2) A shrub was removed causing a loss of soil in the landscaped area near the western entrance to the school, see Photograph #10. This location needs to be filled with soil in order to maintain the integrity of the cap at this location.

**10) Soil loss due to shrub removal.**

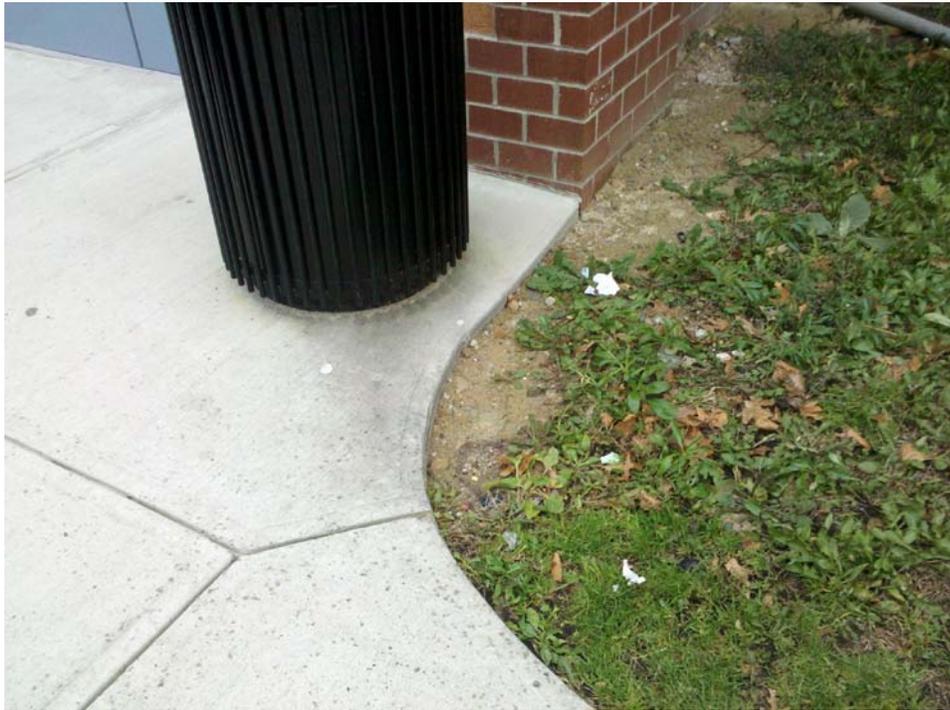
**11) Repair to prevent undermining of concrete walkway.**

Landscaped areas adjacent to the concrete walkway entering the school building at the northern entrance from Hathaway Boulevard were repaired with soil to prevent erosion, see Photographs #11 and #12. Animal burrows identified during previous inspections appeared to be vacated and were backfilled with clean soil. See Photograph #19.

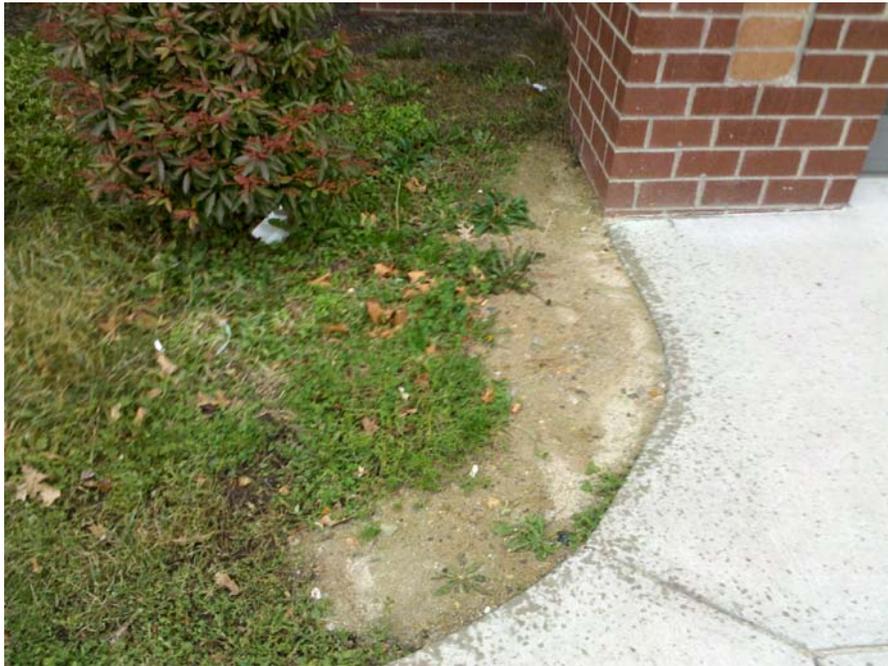
**12) Repair to prevent undermining of concrete walkway.**

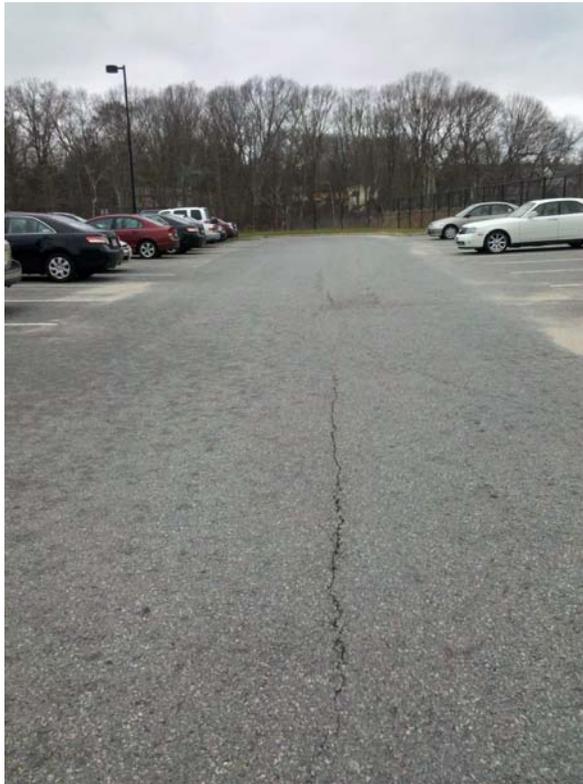
**13) Crack in asphalt parking lot north of school.**

Cracks greater than 1/4-inch were also observed in the asphalt parking lots and should be scheduled for repair. The asphalt seams at the entrances to the school parking lots have become greater than 1/4-inch and should be repaired. Repair of the asphalt cracks and seams could be completed with an elastic asphalt filler/sealer or similar product.

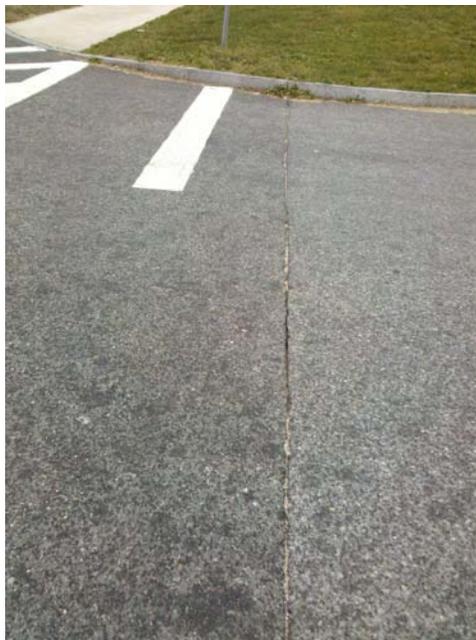
**14) Seam in asphalt pavement at school entrance.**

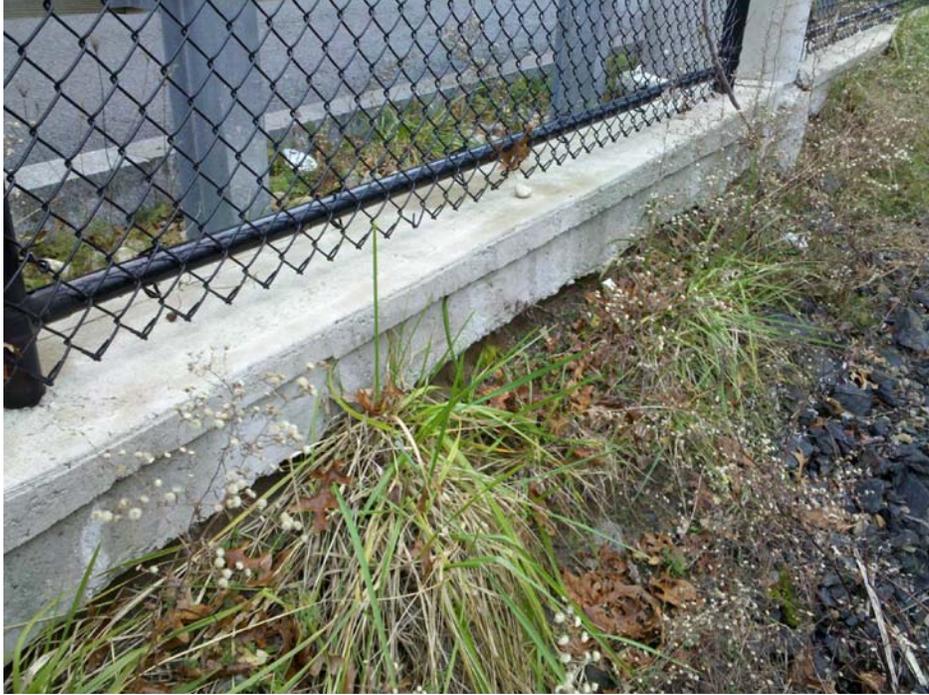
1) The structural integrity of the fence may be compromised if the sloughing and erosion continues, see Photograph #15. A crack in the concrete fence support was also observed, see Photograph #16. The cap soils beneath the riprap may also become exposed and susceptible to erosion. The area appears stable at the moment, but the condition is likely due to an increase in steepness beyond the cap design slope. The extent of erosion seems similar to the conditions observed during several previous inspections. See inspection report letters dated August 31, 2011 and May 4, 2011.

**15) Undermining of concrete structure for fence west of school.**

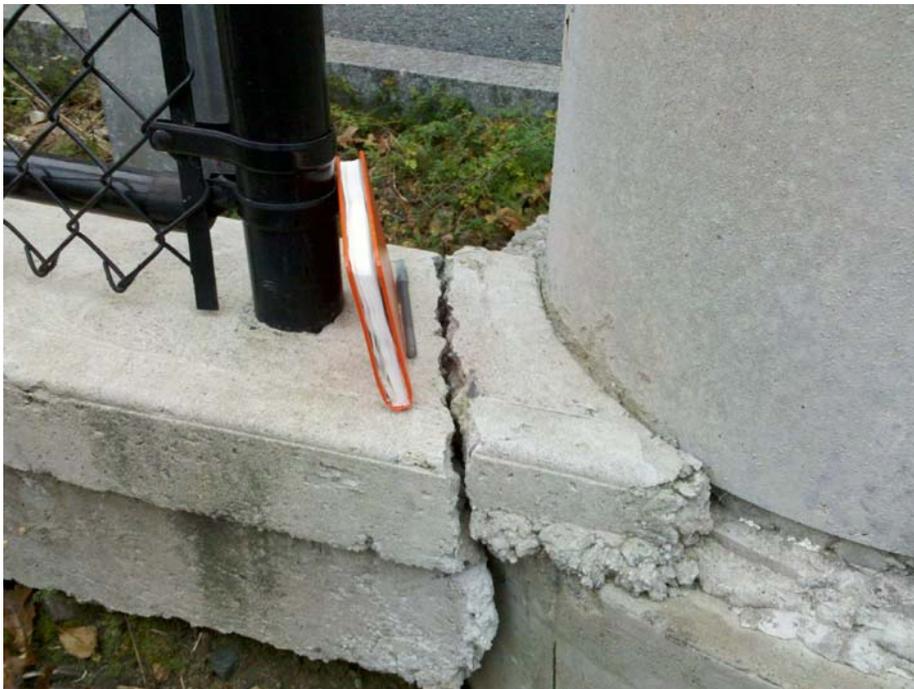
**16) Crack in concrete fence support.**

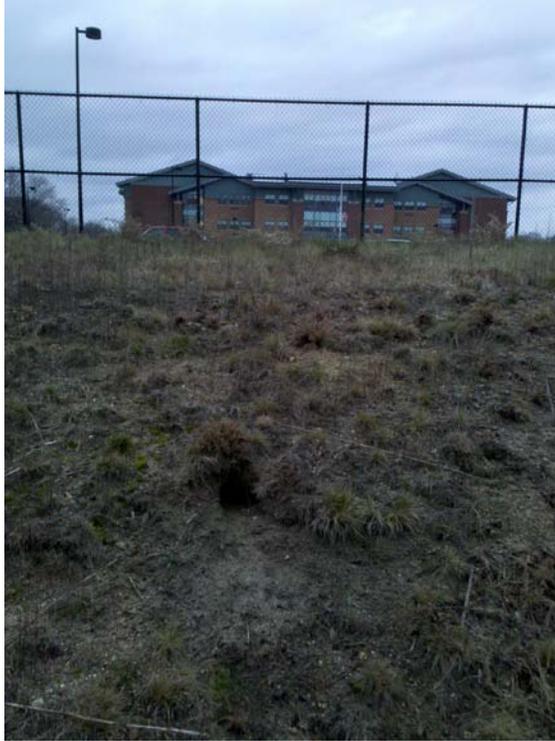
3) New animal burrow holes were observed on the slopes to the north, south, and southwest of the school, see Photograph #17.

**17) Animal burrow south of school.**

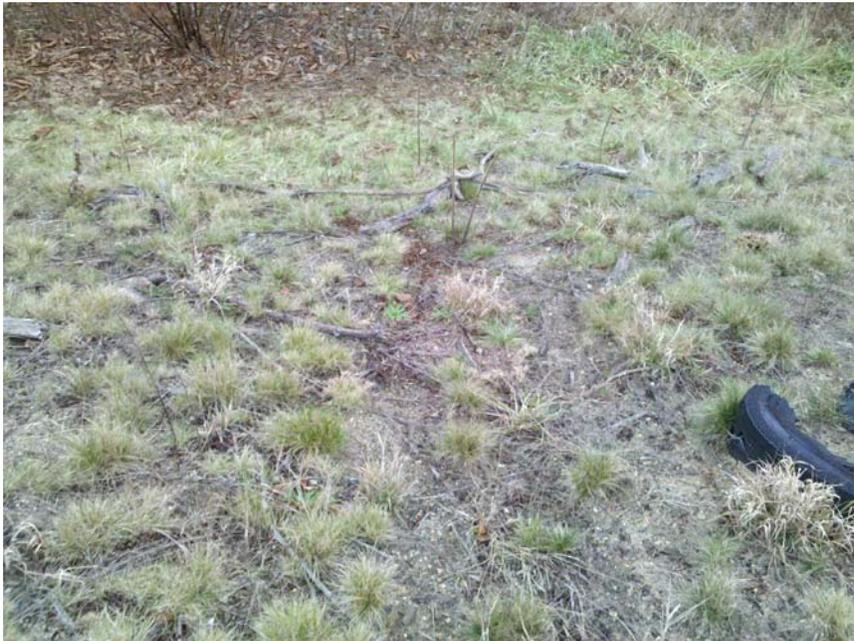
**18) Sparse vegetation on portion of cap south of school.**

1. Some minor erosion had occurred in the past on the southern slope of the cap, as noted in the prior inspection report (dated August 31, 2011). Vegetation is present, although sparse in some areas, see Photograph #18. It is recommended that additional topsoil and shallow-rooted vegetation be added to limit future erosion.

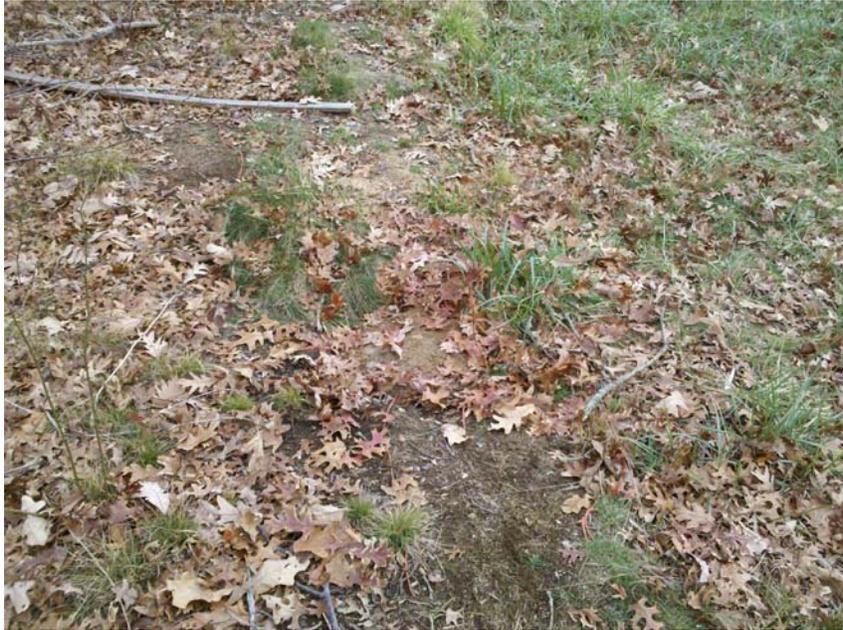
**19) Repaired animal burrow on slope north of school.**
