December 8, 2014

**Subject: Fall 2014 Cap Inspection
Keith Middle School
New Bedford, Massachusetts**

CAP INSPECTION FORM KEITH MIDDLE SCHOOL

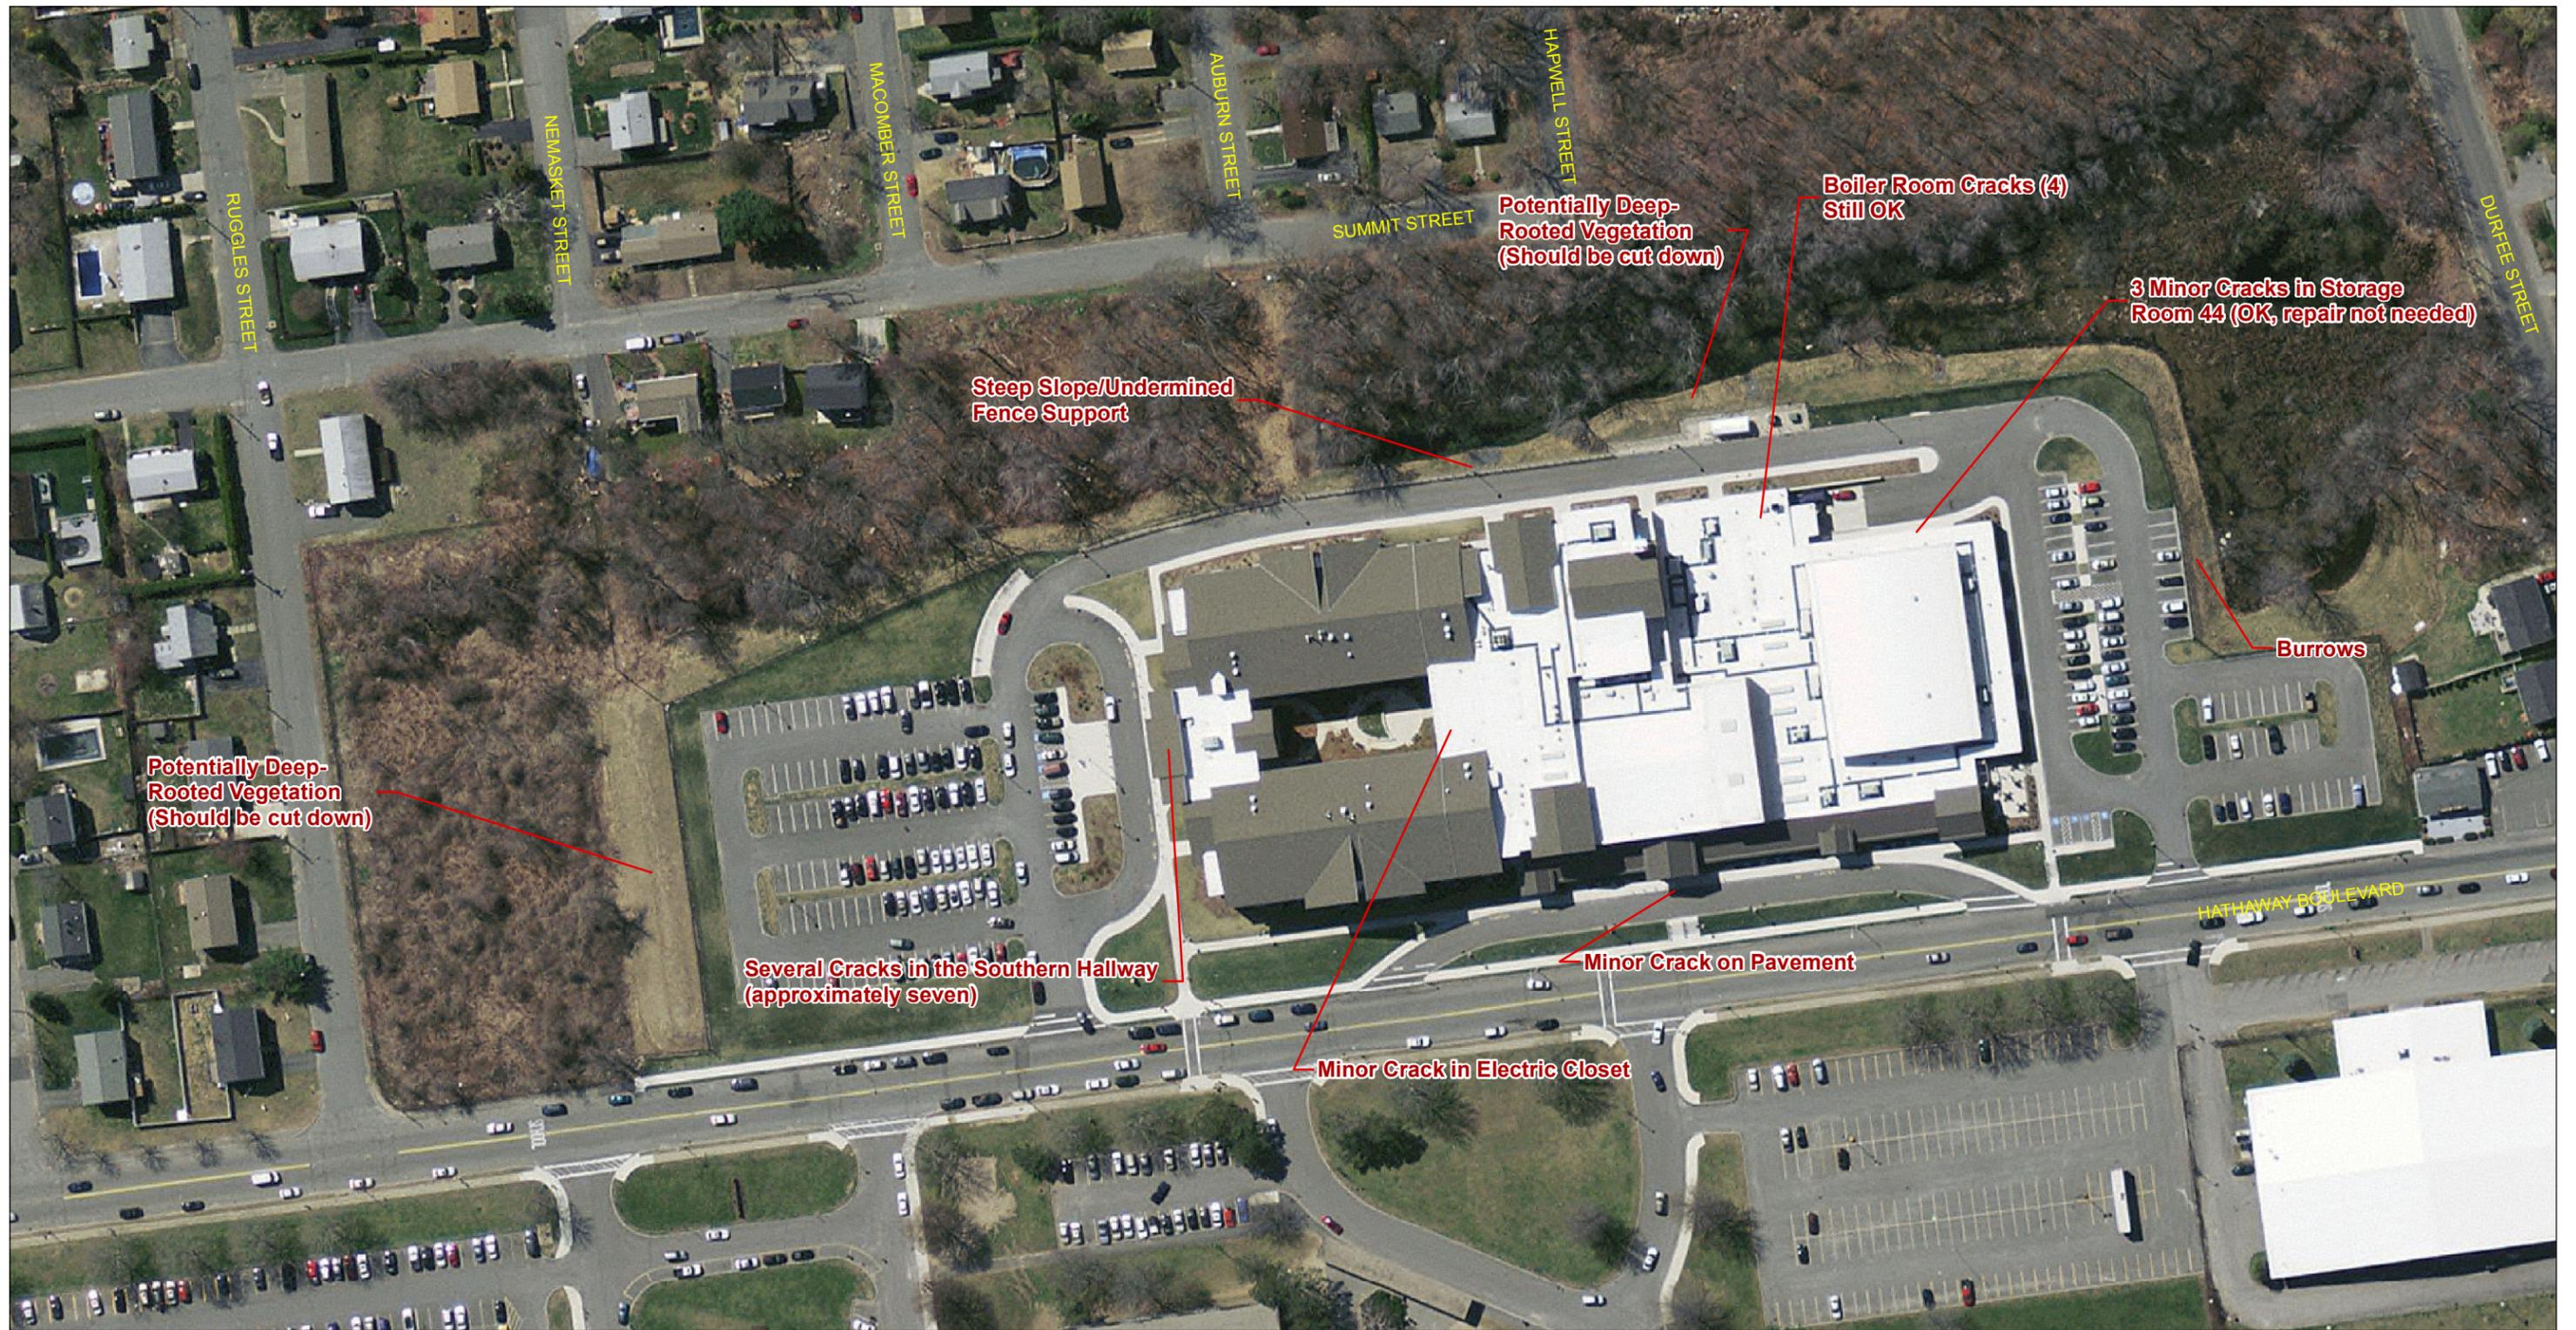
Figure 1

Potentially Deep-Rooted Vegetation (Should be cut down)

Steep Slope/Undermined Fence Support

Several Cracks in the Southern Hallway (approximately seven)

Minor Crack in Electric Closet

Boiler Room Cracks (4) Still OK

3 Minor Cracks in Storage Room 44 (OK, repair not needed)

Burrows

Minor Crack on Pavement

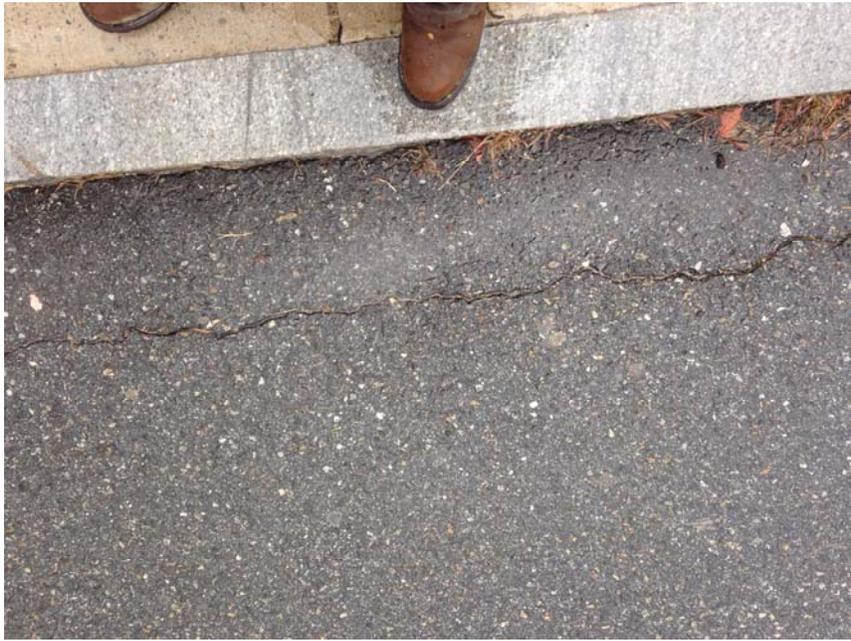
- A minor crack was observed in the eastern driveway pavement. Although less than ¼-inch at this time, this area should continue to be monitored and/or repaired to prevent potential further deterioration.

All asphalt areas look in good condition except for a minor crack observed in the eastern parking lot, which was less than ¼-inch, please view Photograph 1. The two major cracks greater than ¼-inch discovered in the April 2014 inspection was not observed during this inspection. Small tufts of grass were observed penetrating up through the curbed sidewalk in various areas but are less than ¼-inch and deemed acceptable. These areas should be addressed to prevent potential cap issues in the future.

1) Crack in the asphalt less than ¼ -inch, located in eastern driveway

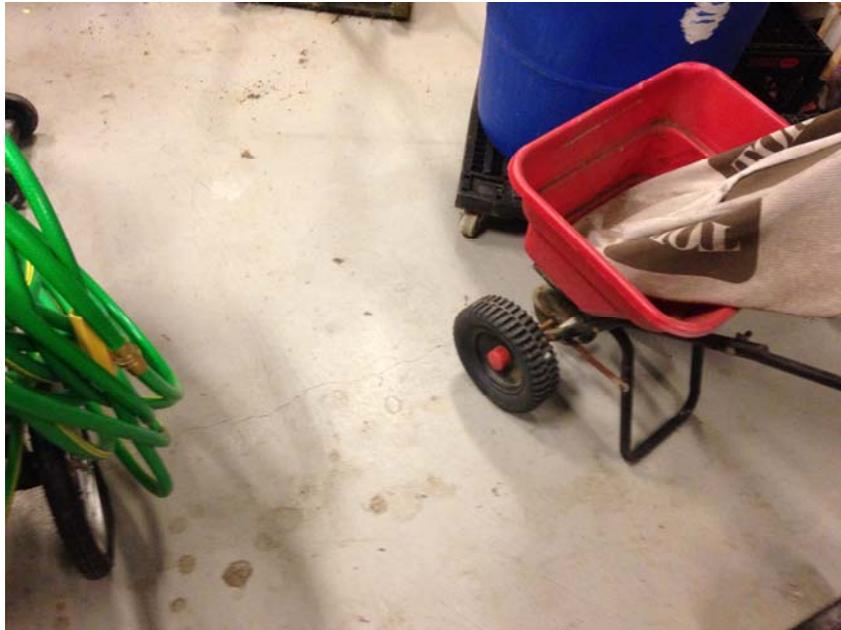
Four cracks in the boiler room floor are less than ¼-inch wide and have not increased in size, see Photograph 2. Three minor cracks in storage room 44 are also less than ¼-inch wide and have not increased in size, see Photograph 2 and Photograph 3. The clean out drain in the boiler room has become badly deteriorated but no cracks greater than ¼-inch was observed. The majority of interior concrete floors are covered with tiles or other type of flooring material. No cracks were observed in the vaults in the science rooms, see Photograph 4 and 5. Approximately 7 minor cracks were observed along the southern hallway, see Photograph 6. Based on visual inspection and conversations with current employees, there are no breaches or other significant damage or deterioration of the interior surficial flooring materials or, where visible, concrete floors. No construction was occurring within the building at the time of the inspection.

2) Crack in the asphalt less than ¼ - inch in storage room 44.

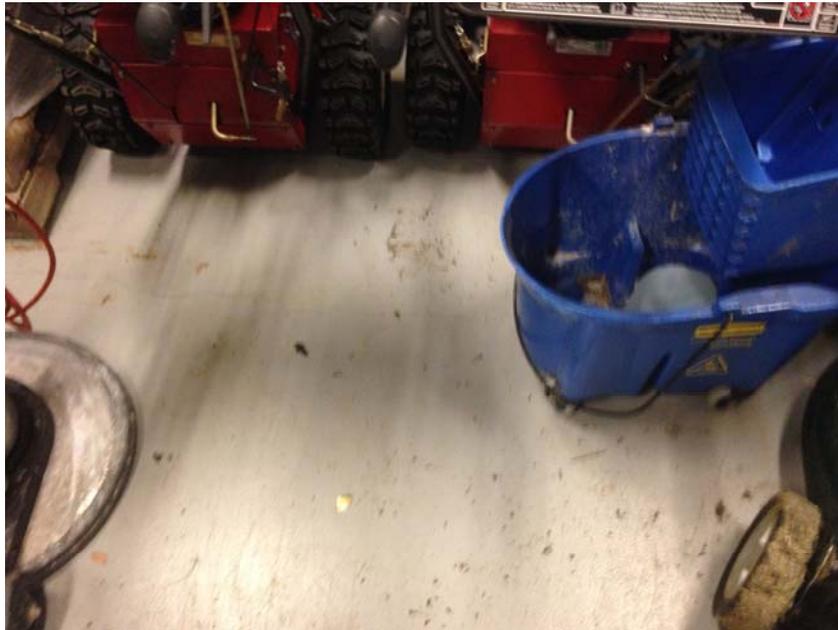
3) Crack in the asphalt less than ¼ - inch in storage room 44.

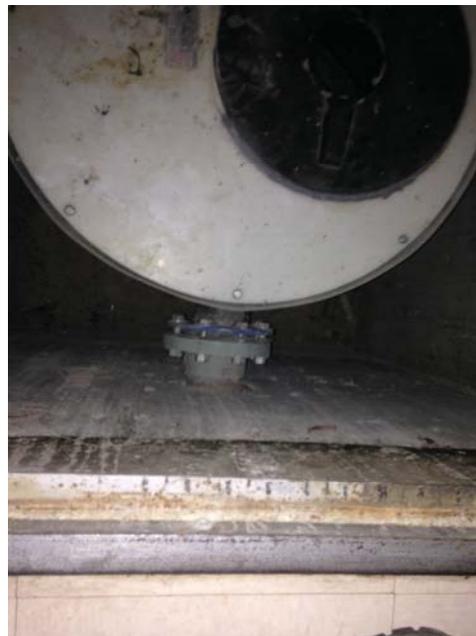
4) Vault in Science room 127

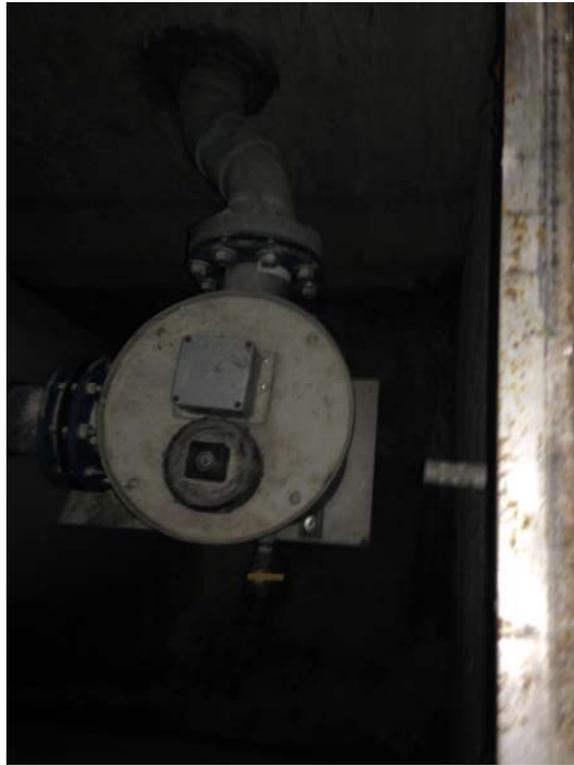
5) Vault in Science room 171

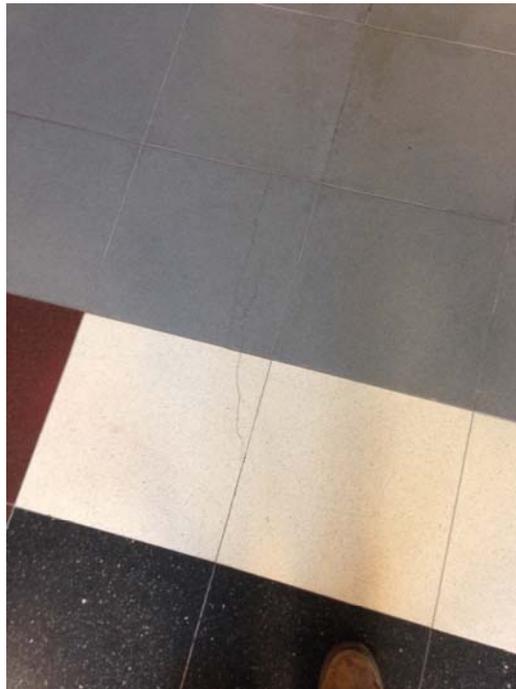
6) Cracks along the southern hallway

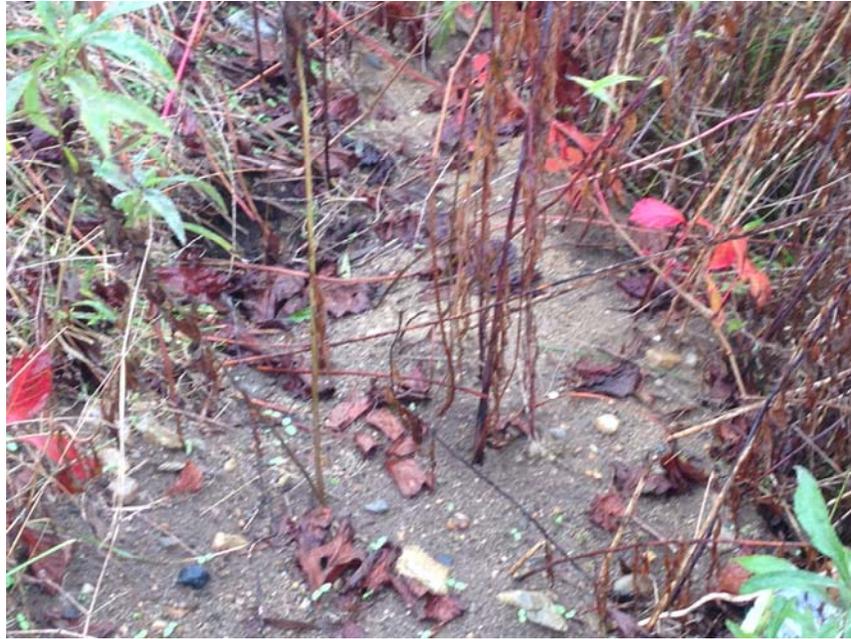
- Several small holes were observed along the northern edges of the cap, which may have been burrowed by small animals. As previously stated in this report, six gophers were previously removed. It was recommended in that in April 2014 inspection that these borrows be filled prior to the next cap inspection, currently these holes remain unfilled.

Landscaping was inspected by Rishabh Iyer to observe unacceptable conditions. Animal borrows were observed along the northern slopes, please see Photograph 7. During the April 2014 inspection, borrows were observed in western portion however due to the thickly vegetated brush, the southern portion of western slope was inaccessible. Deep rooted vegetation was observed on the western and southern slope, please see picture 8 and 9. All vegetation should be mowed in the near future. Sloughing and erosion under the fence to the west of the school appears to be stable and the extent of erosion similar to conditions observed during past inspections.

7) Animal borrows on the northern slope

- Animal burrows were observed in the northern slopes. Reportedly, six gophers were captured during 2013, but the burrows need to be filled in.
- Potentially deep-rooted vegetation was observed on the western and southern slopes and should be cut down.

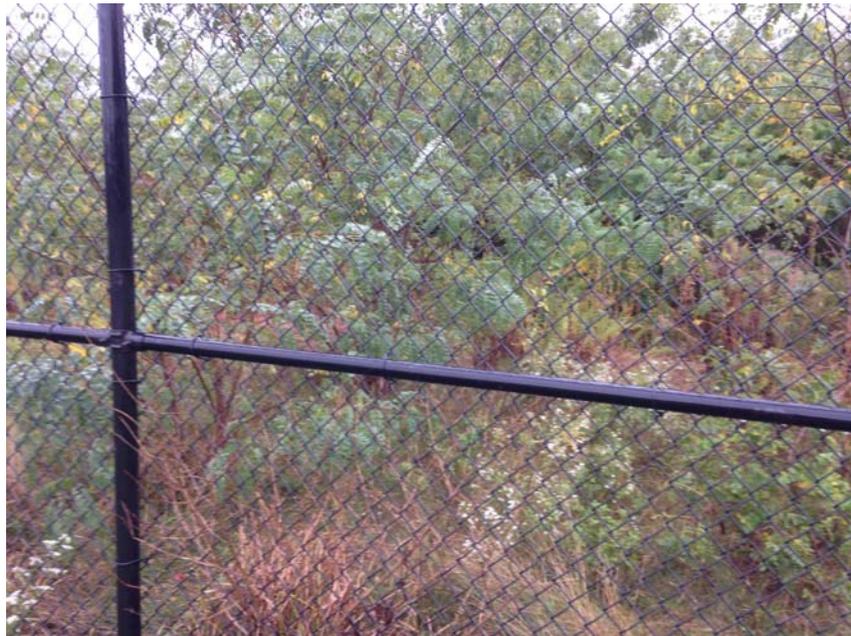
- Potentially deep-rooted vegetation observed on the slopes south and west of the school and should be cut down.

8) Potentially deep rooted vegetation on the southern slope

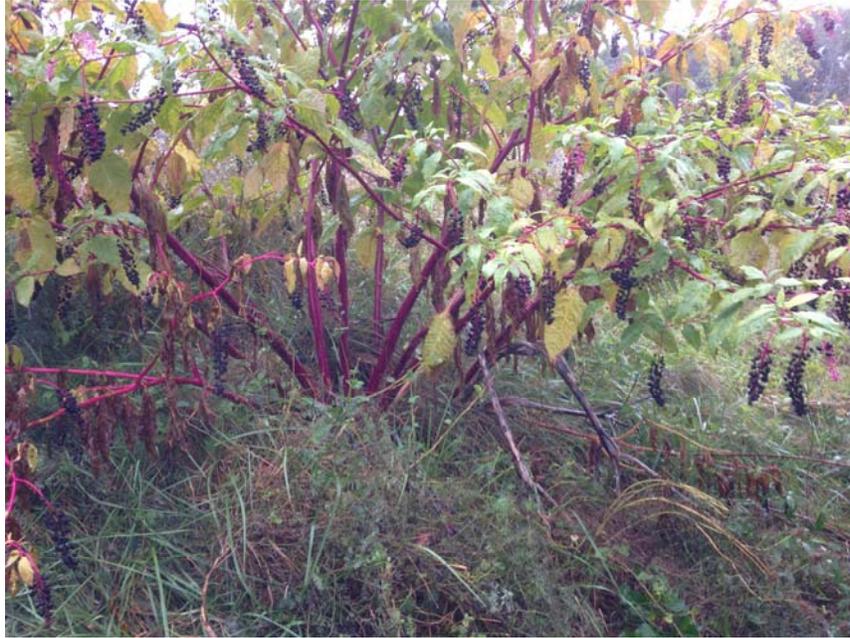
9) Potentially deep rooted vegetation on the western slope

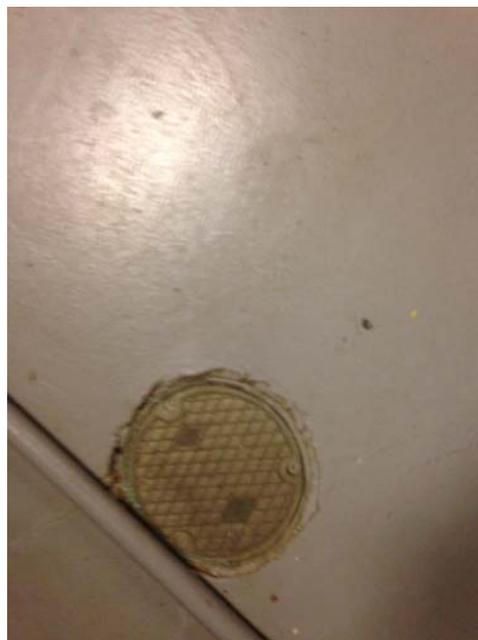
- Two clean-out drains located in the bathroom near room 148, the school store and the boiler room appeared to be deteriorating, please see photograph 10, though no cracks greater than ¼-inch were observed at this time. These areas should be monitored and/or repaired to prevent future deterioration.

10) Deteriorated clean out drain in boiler room.
