New Bedford High School Environmental Investigation Univent Dust Issue

Wednesday – January 25, 2012

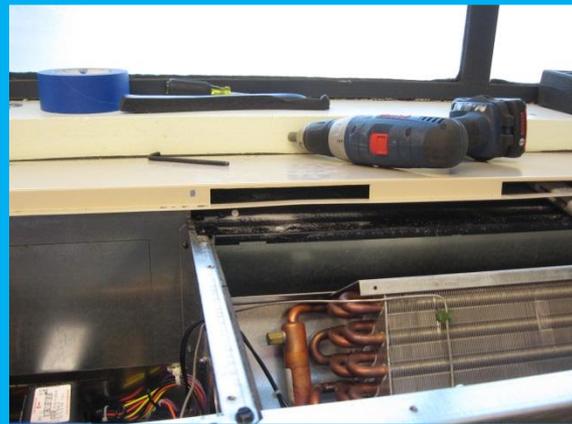
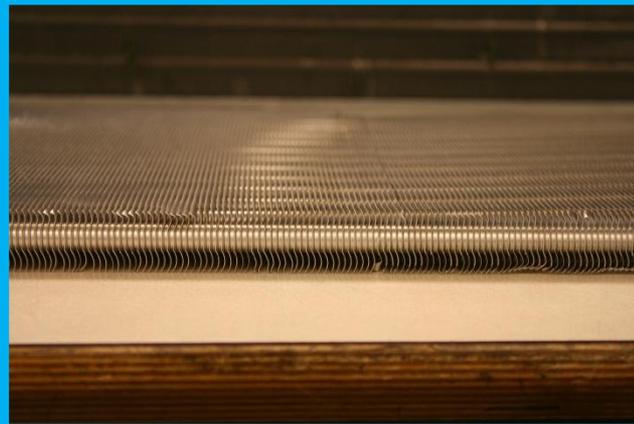
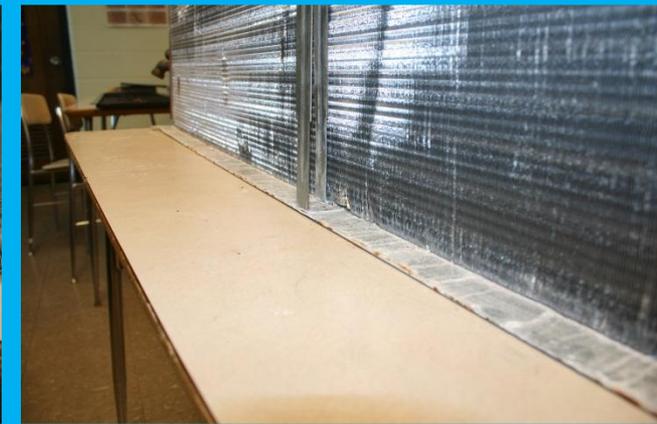
White dust

- **Observed near certain unit ventilators (univents) in some B-Block classrooms.**
- **Prevalent in third floor univents with heating & cooling capabilities.**
- **Also observed to lesser degrees in 2nd and 1st floor units.**

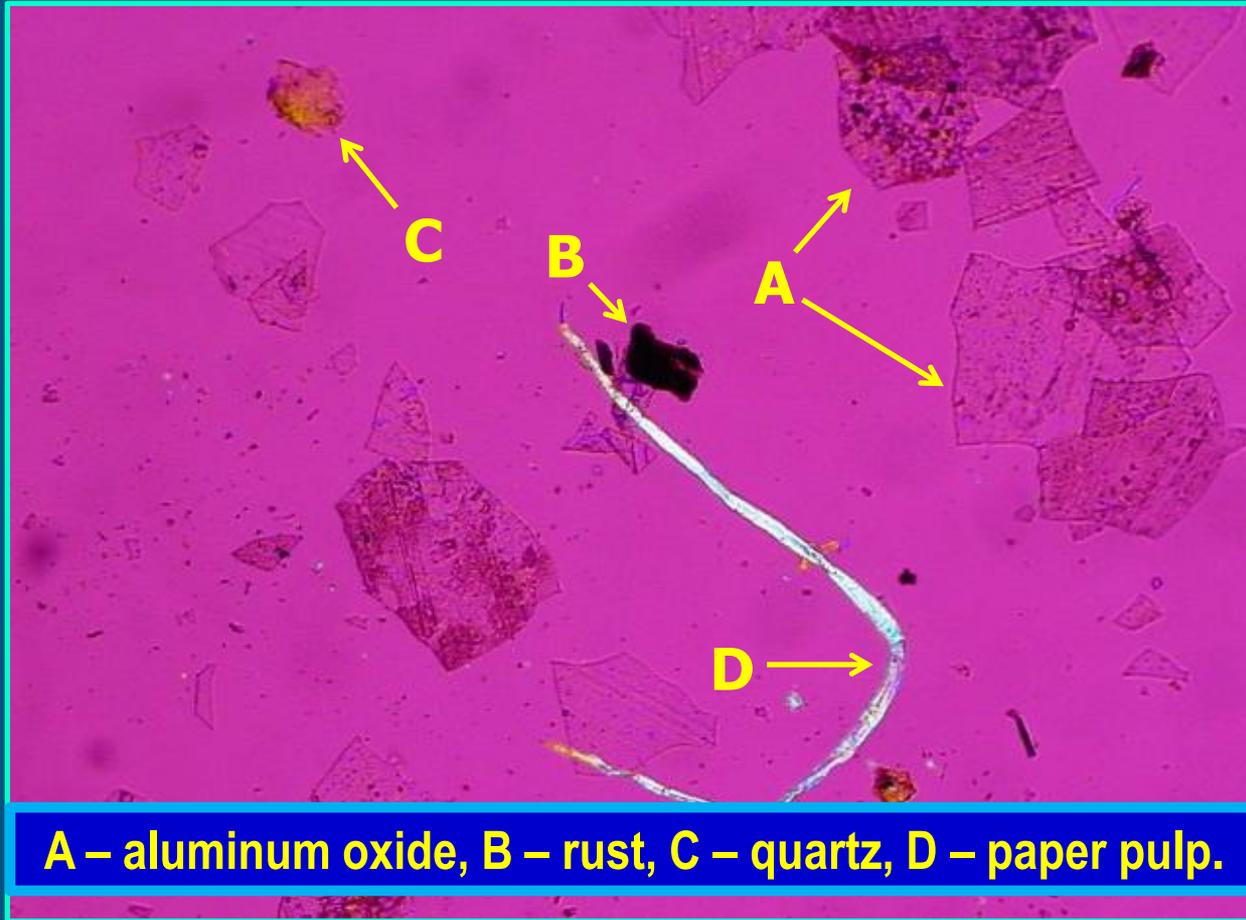
Polarized Light Microscopy (PLM)

A – aluminum oxide, B – rust, C – quartz, D – paper pulp.

- **Aluminum oxide** – 85 percent
- **Rust** – 5 percent
- **Cellulosic material** – Less than 3 percent
- **Glass** – Less than 2 percent
- **Quartz** – 1 percent
- **Calcite/Dolomite** – 1 percent
- **Unidentified inert organics** – 1 percent
- **Unidentified inorganics** – 1 percent
- **Gypsum/anhydrite** – Less than 1 percent
