Subject: Spring 2013 Wetland Inspection
Keith Middle School, New Bedford, Massachusetts

SITE PHOTOGRAPHS
May 2013 Wetland Inspection
Keith Middle School
New Bedford, Massachusetts

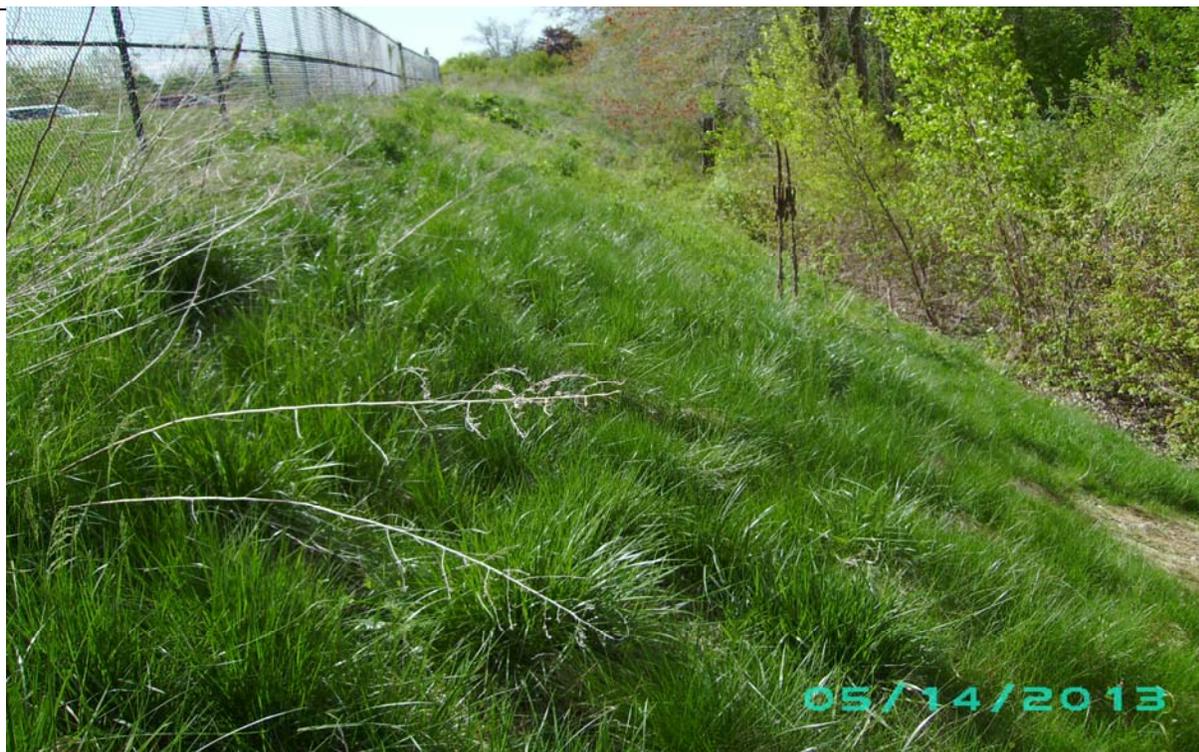
1) Slope in southern portion of wetland/cap edge looking south. Vegetation is well established.

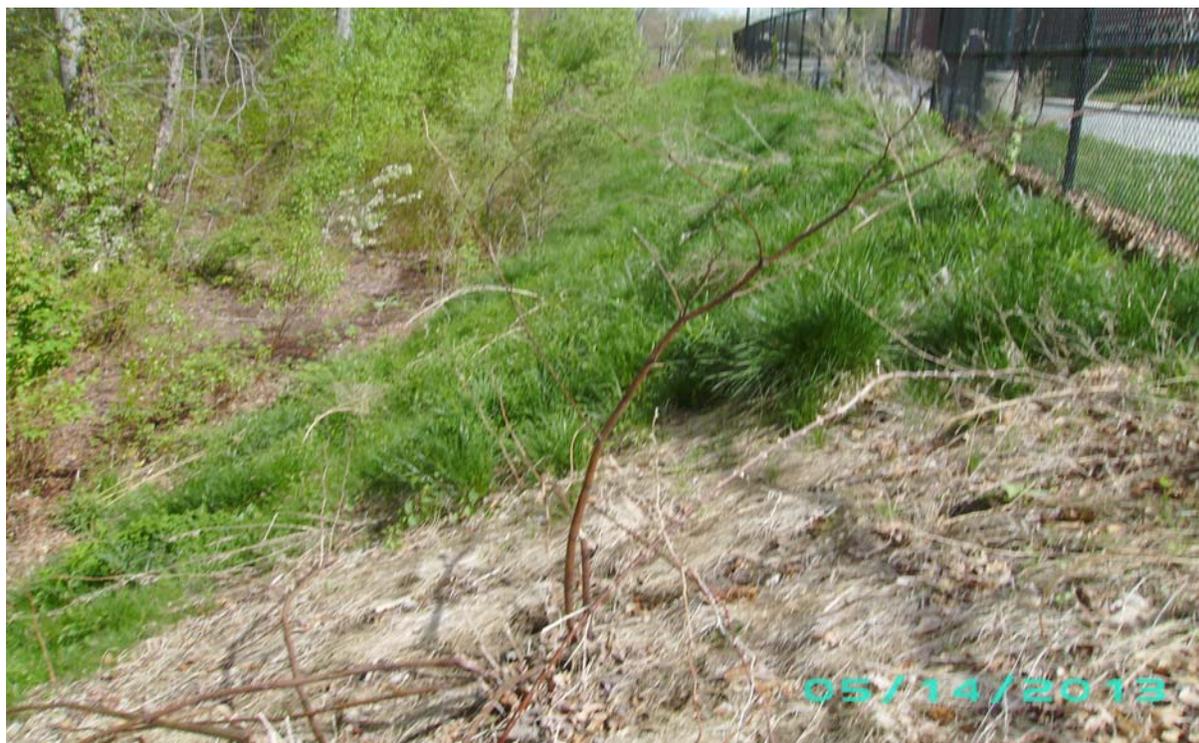
Several small stands of the invasive plant Japanese knotweed (*Polygonum cuspidatum*) that were formerly present in the vicinity of stormwater outfalls and in the central portion of the wetland/cap slope have been treated with herbicides since the 2012 inspection. In addition, small tree saplings comprised primarily of black locust (*Robinia pseudoacacia*) have also been recently treated with an herbicide. It appears that these applications were effective in greatly reducing knotweed abundance along the landfill cap slope. Tree saplings appear to also have been adversely affected although the herbicide had recently been applied so the effectiveness of the herbicides on these plants cannot yet be ascertained.

2) Slope in southern portion of wetland/cap edge looking north. Japanese knotweed stand treated with herbicide in foreground.

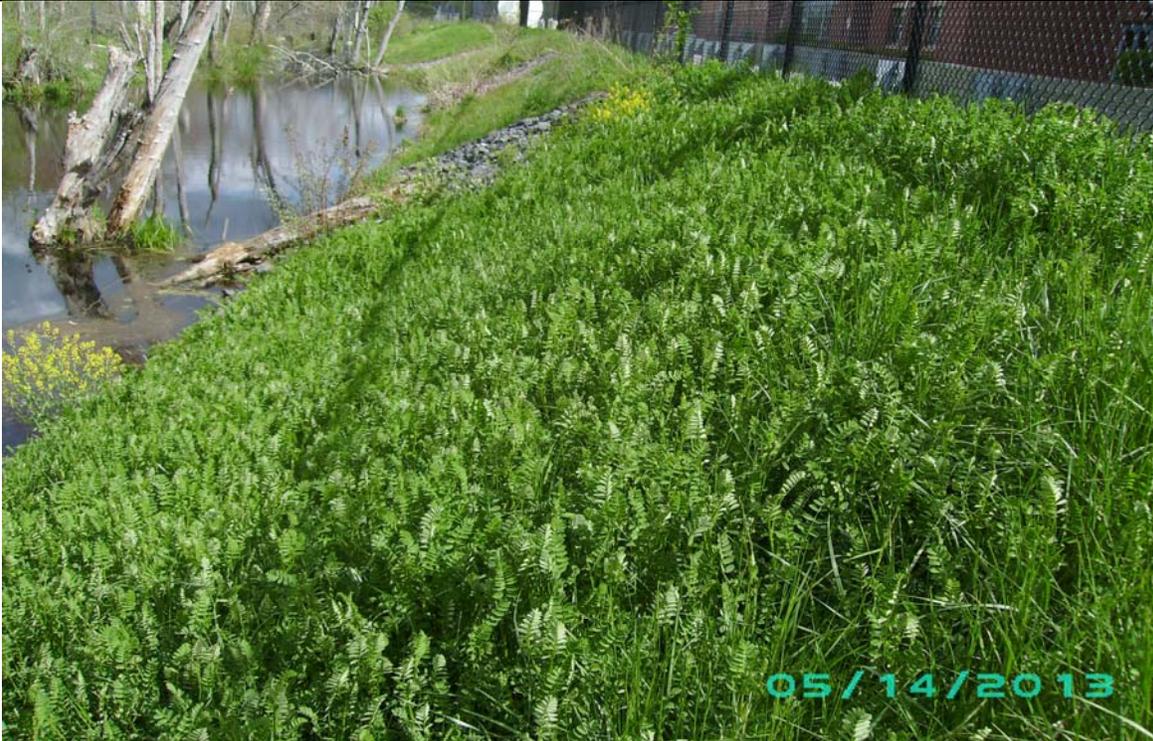
3) Central portion of slope looking north.

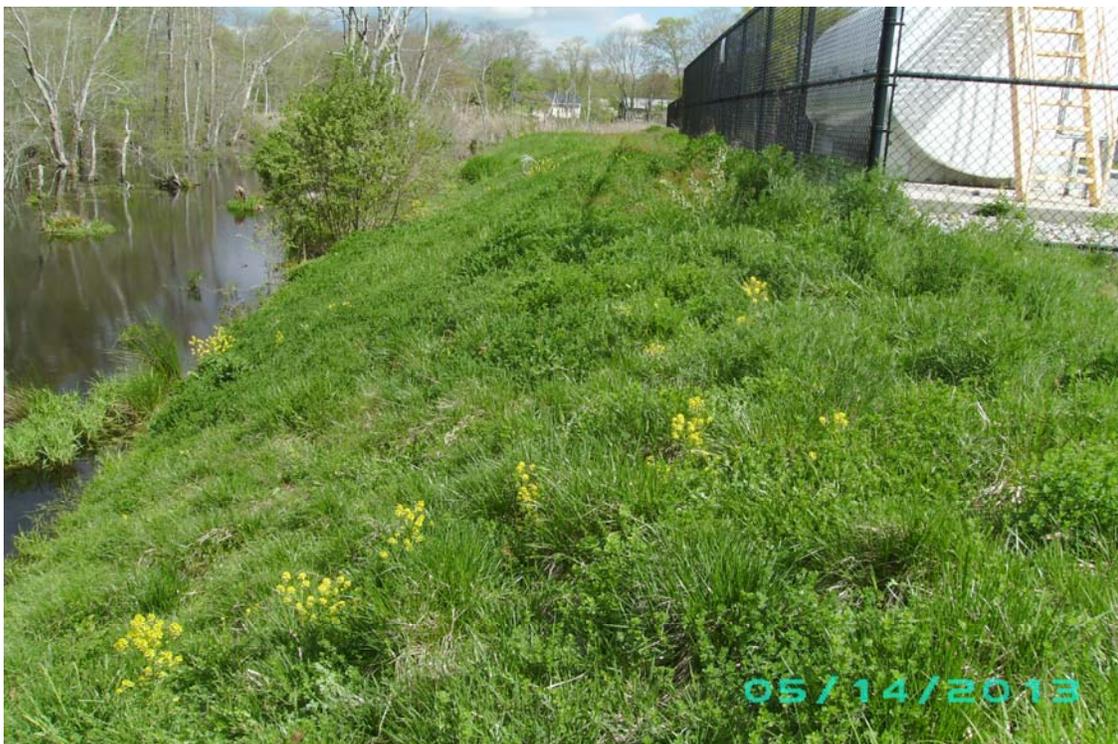
4) Northwestern portion of wetland/cap.

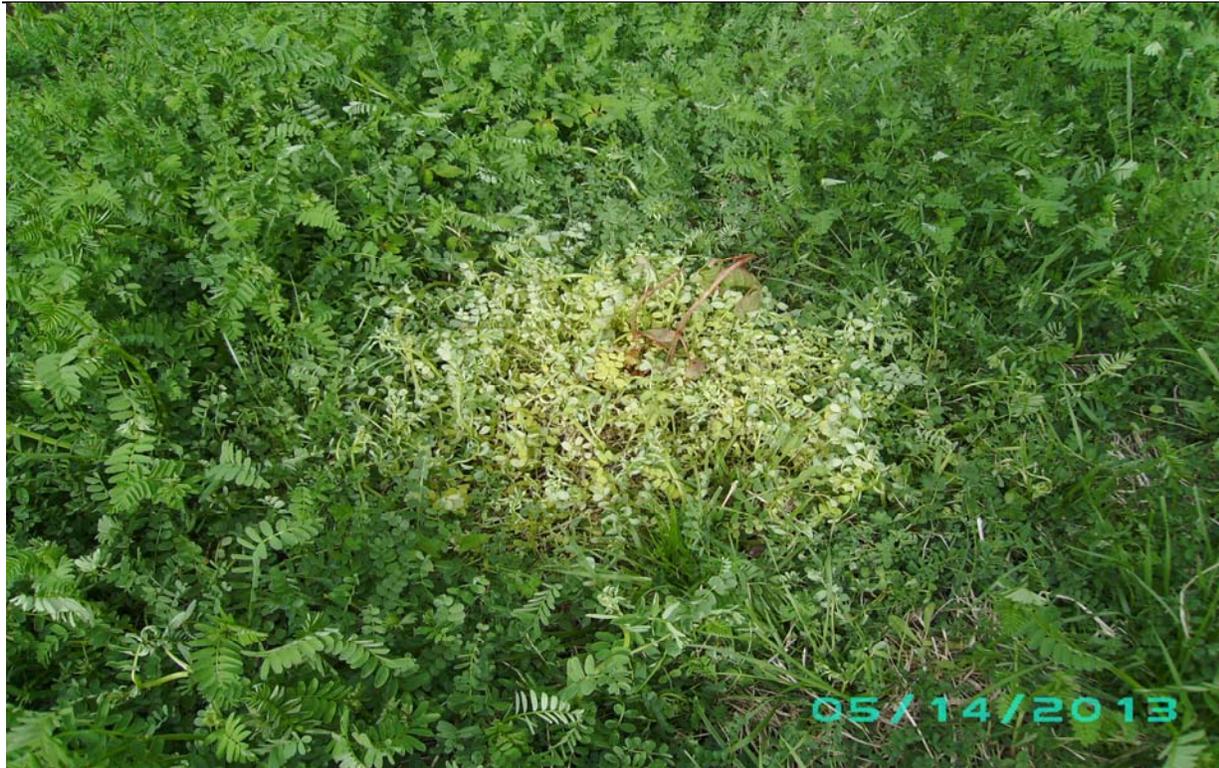
5) Recent evidence of herbicide application for lone Japanese knotweed plant .

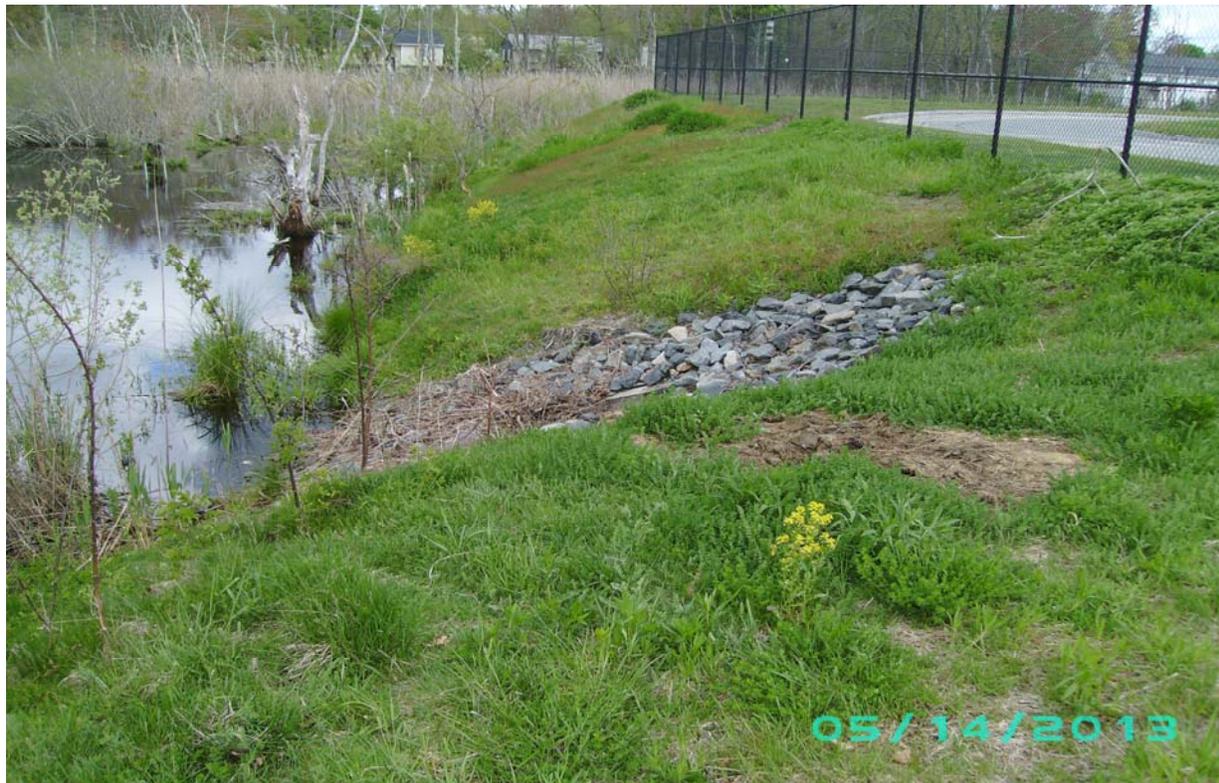
6) Stabilized slope along northwestern cap looking north.

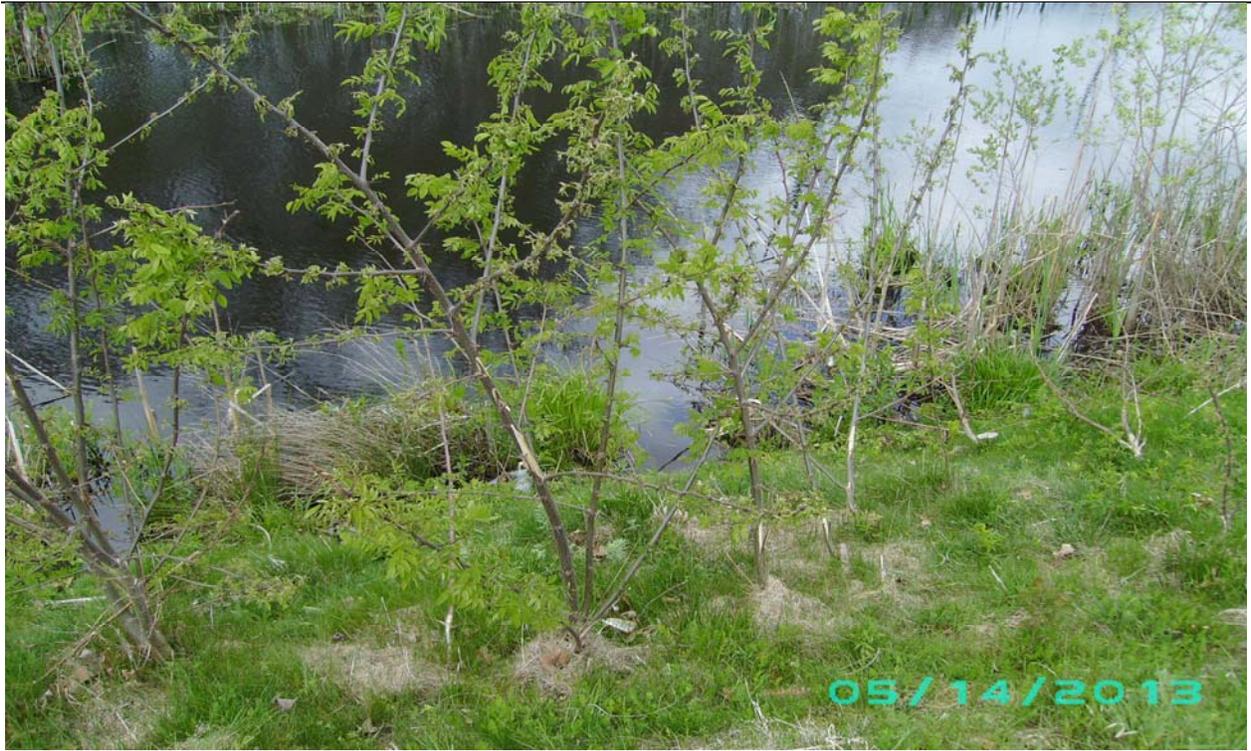
7) Black locust saplings along toe of slope. Note wounds in saplings indicating recent herbicide application.

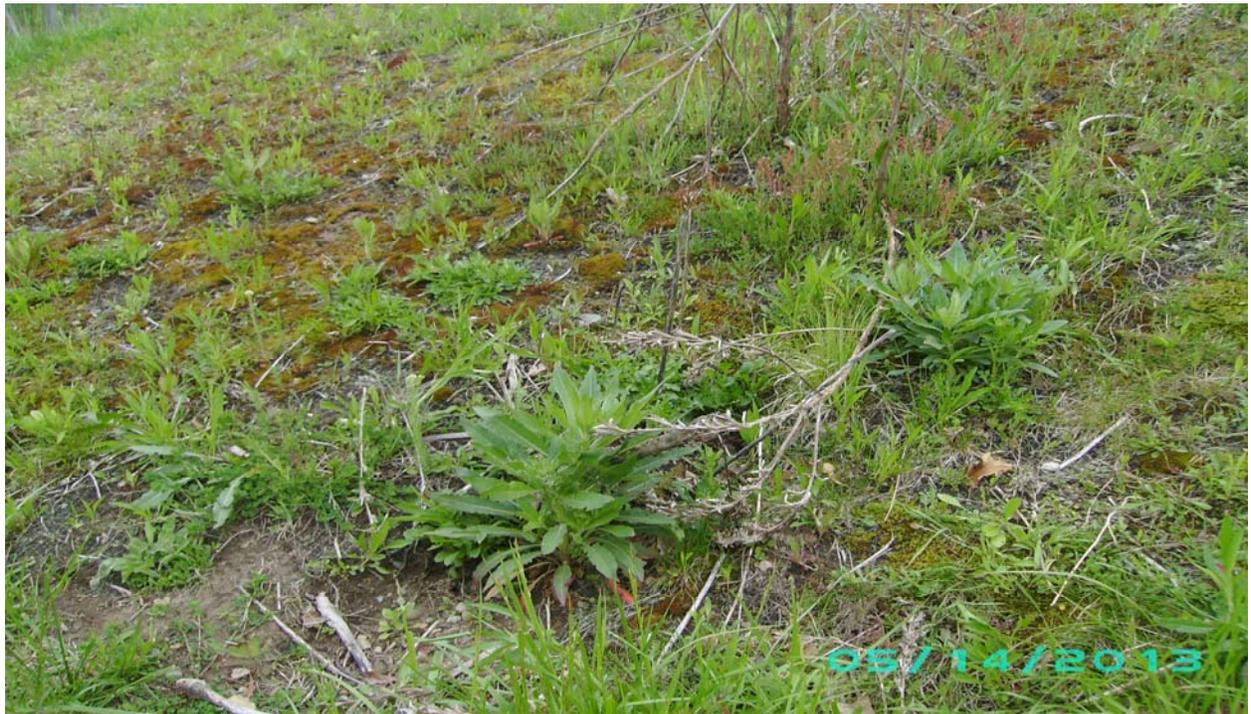
8) Sparsely vegetated northwestern portion of cap. Area is stabilized.

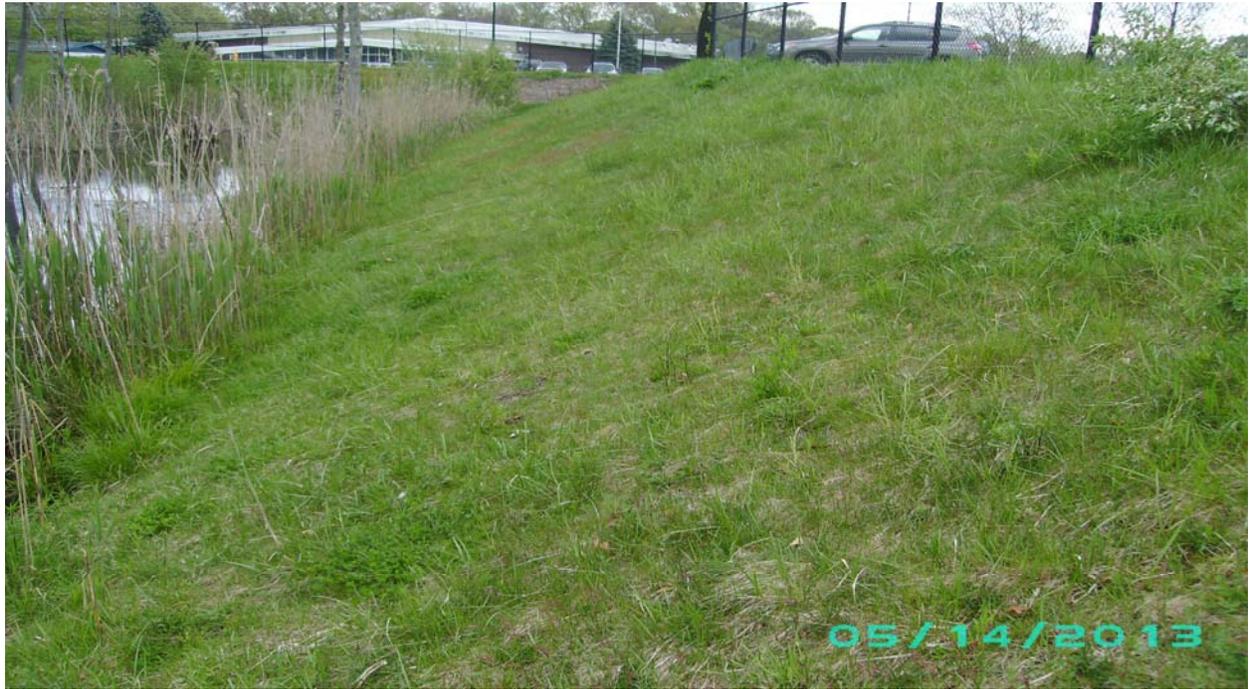
9) Northern portion of wetland/cap slope.

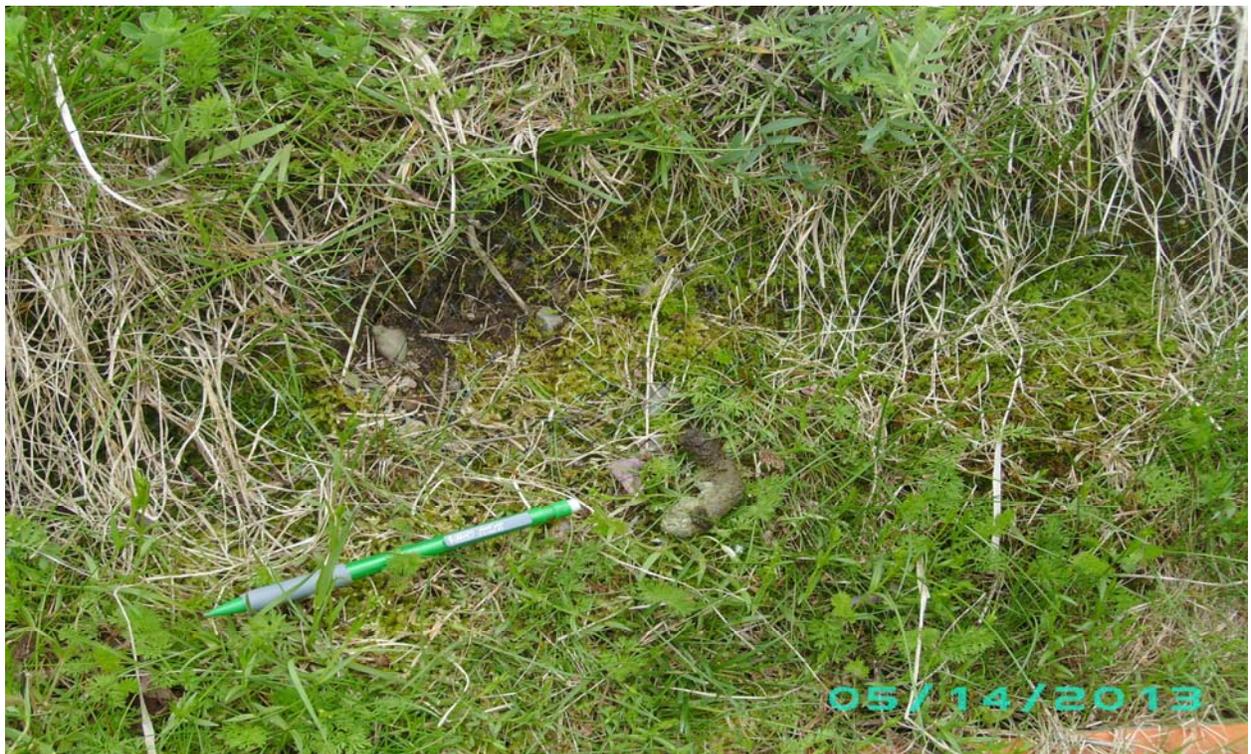
An apparent area of slight slumping (i.e., approximately one to two inches in height) was noted in the northern portion of the cap slope during the inspection. Although corrective actions do not appear warranted at this time, this area should continue to be monitored in subsequent inspections to verify that slumping is not increasing.

10) Close-up of slight slumping area along northwestern portion of slope. Canada goose dropping in center of photograph.
