Subject: Spring 2011 Wetland Inspection
Keith Middle School, New Bedford, Massachusetts

SITE PHOTOGRAPHS
May 2011 Wetland Inspection
Keith Middle School
New Bedford, Massachusetts

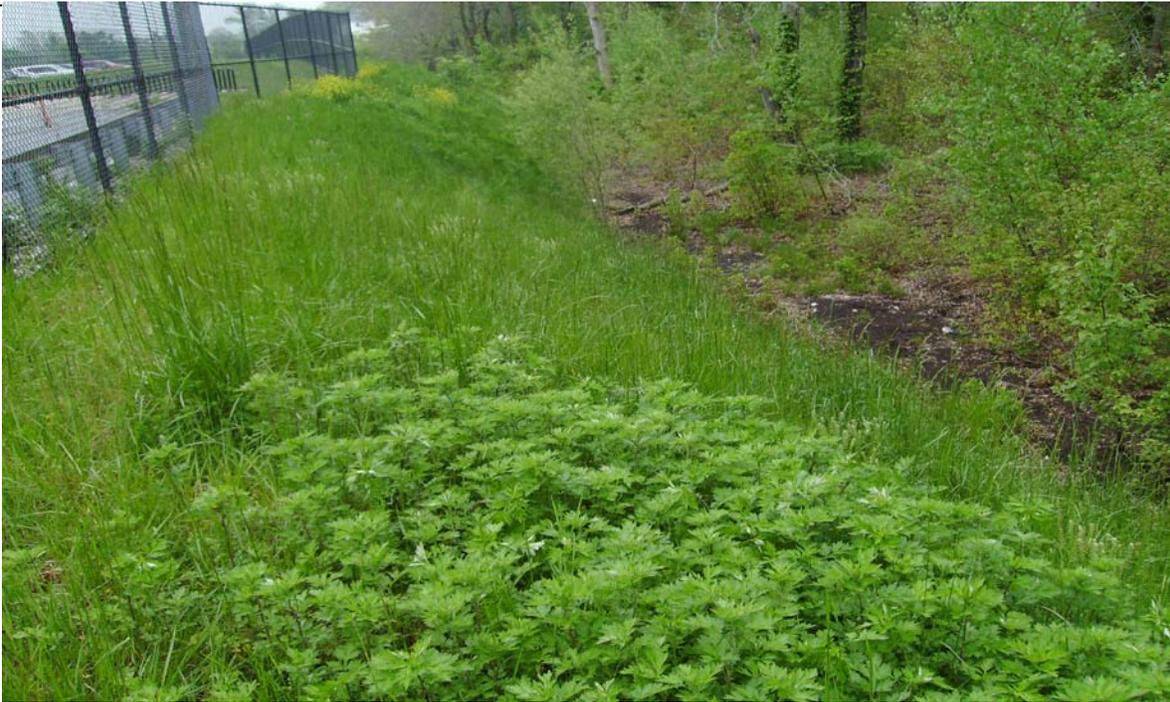
1) Slope in southern portion of wetland/cap edge looking south. Vegetation is well established.

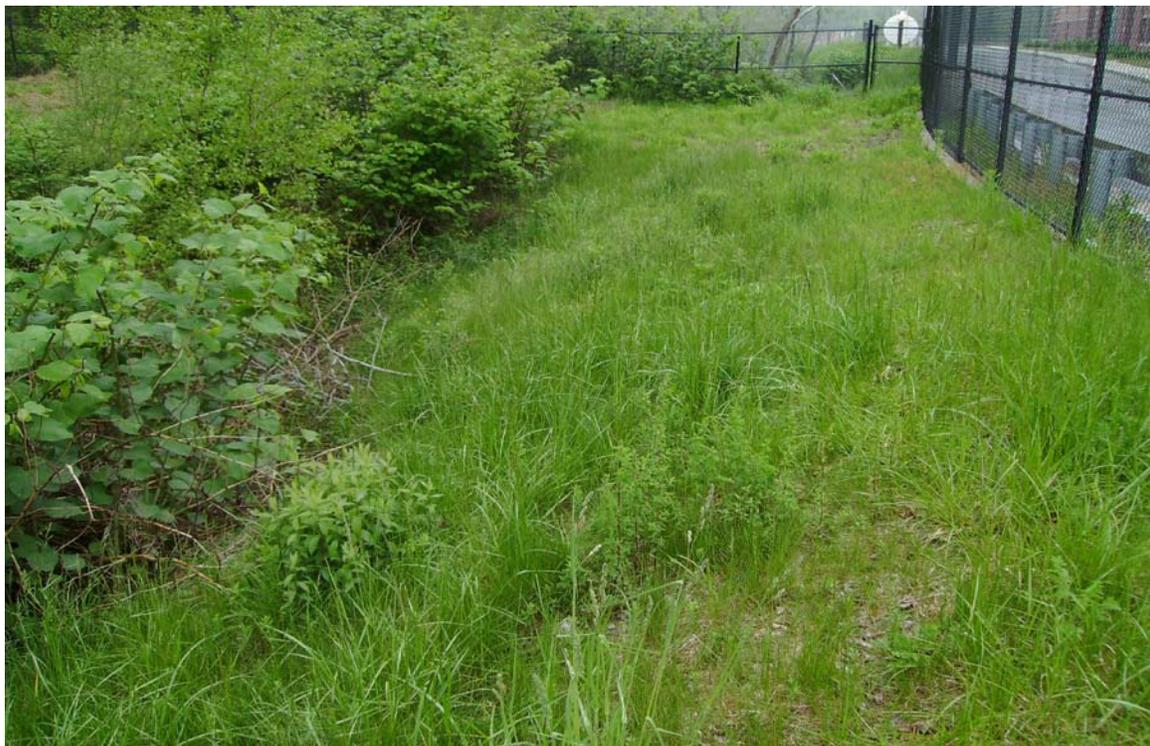
2) Slope in southern portion of wetland/cap edge looking north.

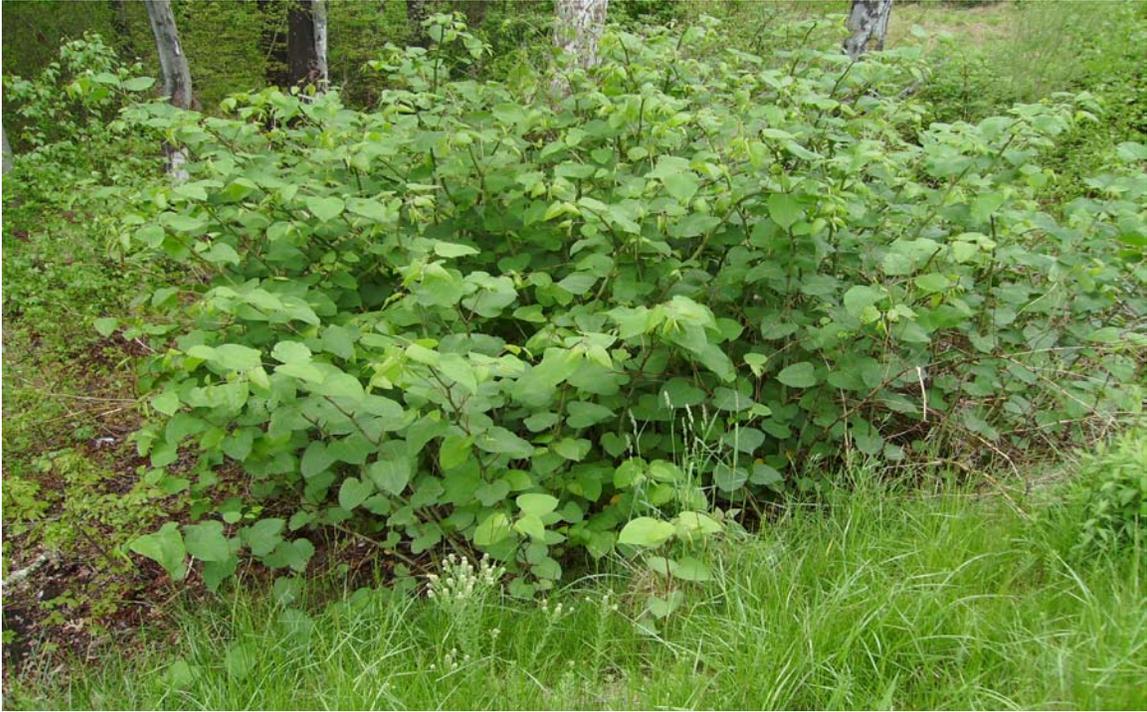
Seven to eight stands of the invasive plant Japanese knotweed (*Polygonum cuspidatum*) are present in the vicinity of stormwater outfalls and in the southern portion of the wetland/cap slope. These plants form a dense overstory that precludes understory vegetation from becoming established due to the heavy shading. Erosion is more likely to occur beneath the Japanese knotweed stands due to the absence of the ground vegetation. It is recommended that the knotweed stands be eliminated from the slope and vicinity of the wetland through one or two cuttings during the growing season with a subsequent herbicide application in the late summer/early fall. The initial cutting of the knotweed should proceed shortly. Currently, the height of the knotweed ranges from 5 to 8 feet. One or two cuttings of the knotweed over the summer will result in lower stem heights in the late summer/early fall so herbicide application can be minimized. In addition, a late summer/early fall herbicide application has been shown to be more effective in controlling knotweed as the plants are translocating nutrients from their leaves to their underground rhizomes at this time of the year. Glyphosate has been shown to be an effective herbicide for controlling Japanese knotweed. The herbicide needs to be applied carefully to the knotweed vegetation as overspray that contacts other vegetation will cause damage to non-target plants. Due to the presence of standing water immediately adjacent to several of the knotweed stands, it is recommended that an glyphosate herbicide be applied that is safe for water contact. Rodeo™ is a glyphosate-based herbicide that is much safer to use near surface waters than Round-Up™ which is also a glyphosate-based herbicide. The knotweed foliage should be sprayed (leaves should be wet but not dripping) with an active ingredient glyphosate concentration of only 2% so the Rodeo™ herbicide will require diluting with water to obtain the correct concentration. It should be noted that subsequent treatments may be required to completely eliminate stands of knotweed at the site.

3) Stand of Japanese knotweed along southern portion of wetland/cap slope.

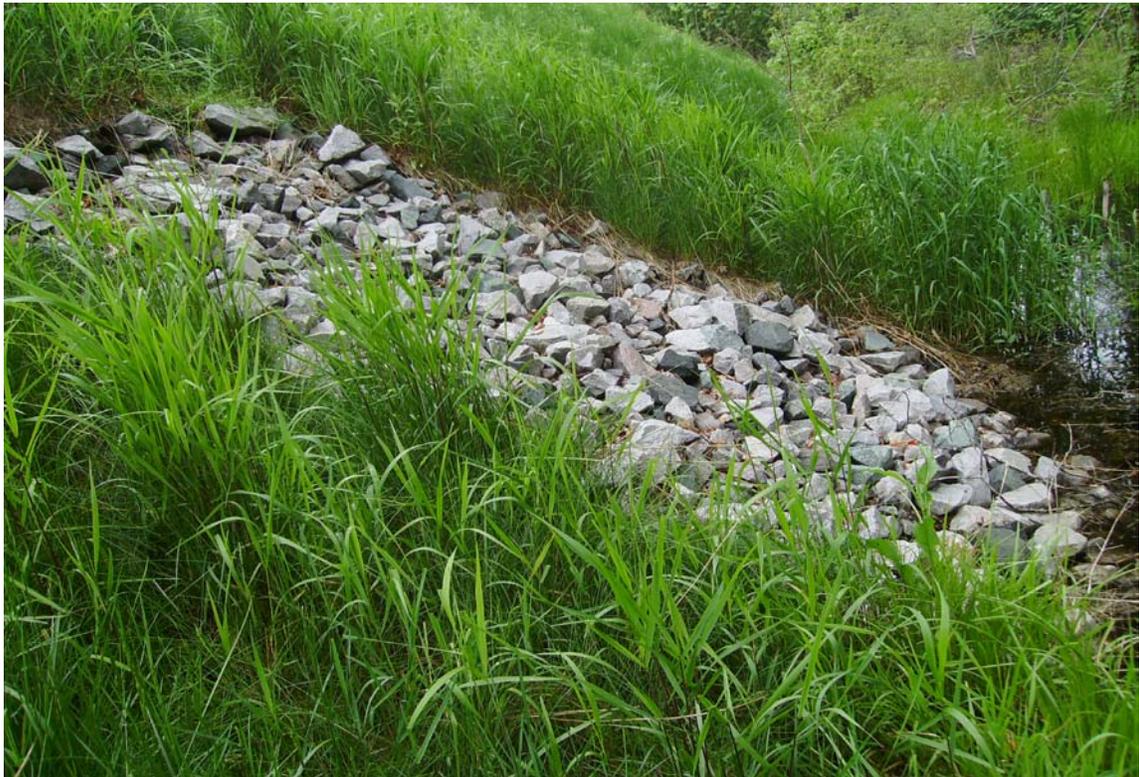
4) Previously repaired portion of cap slope in southern portion of wetland/cap edge.

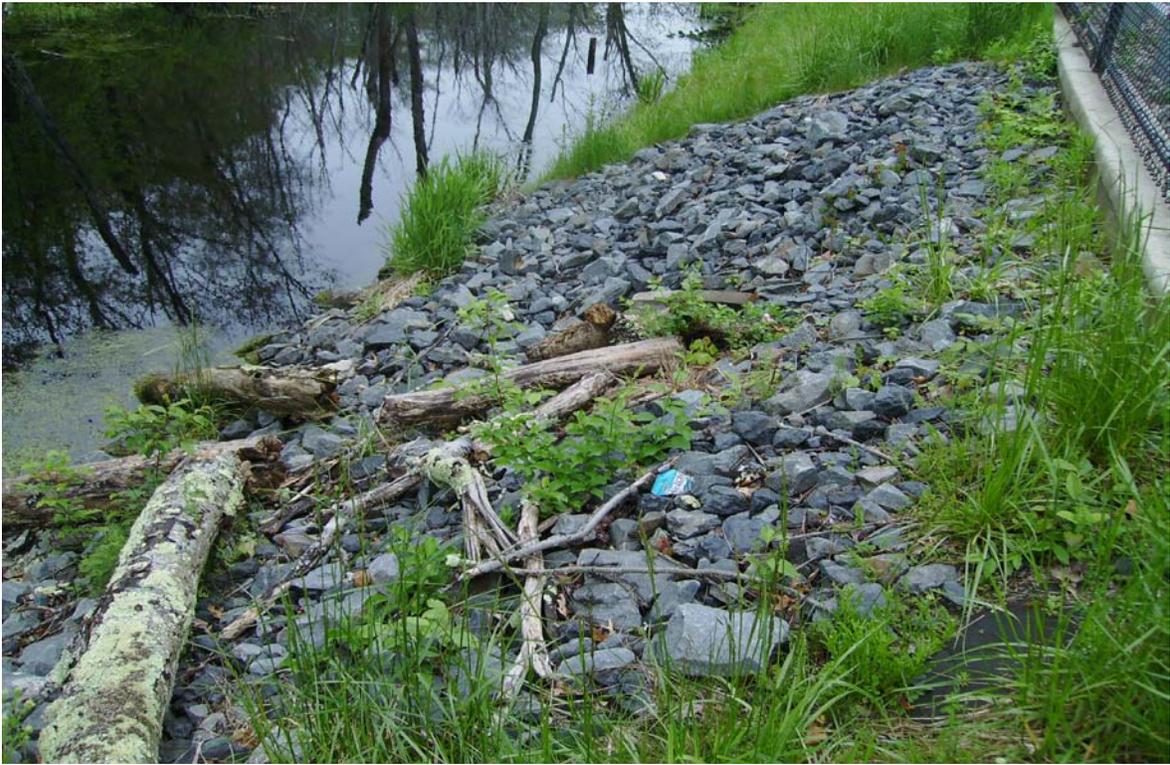
5) Rip rap slope in central portion of site.

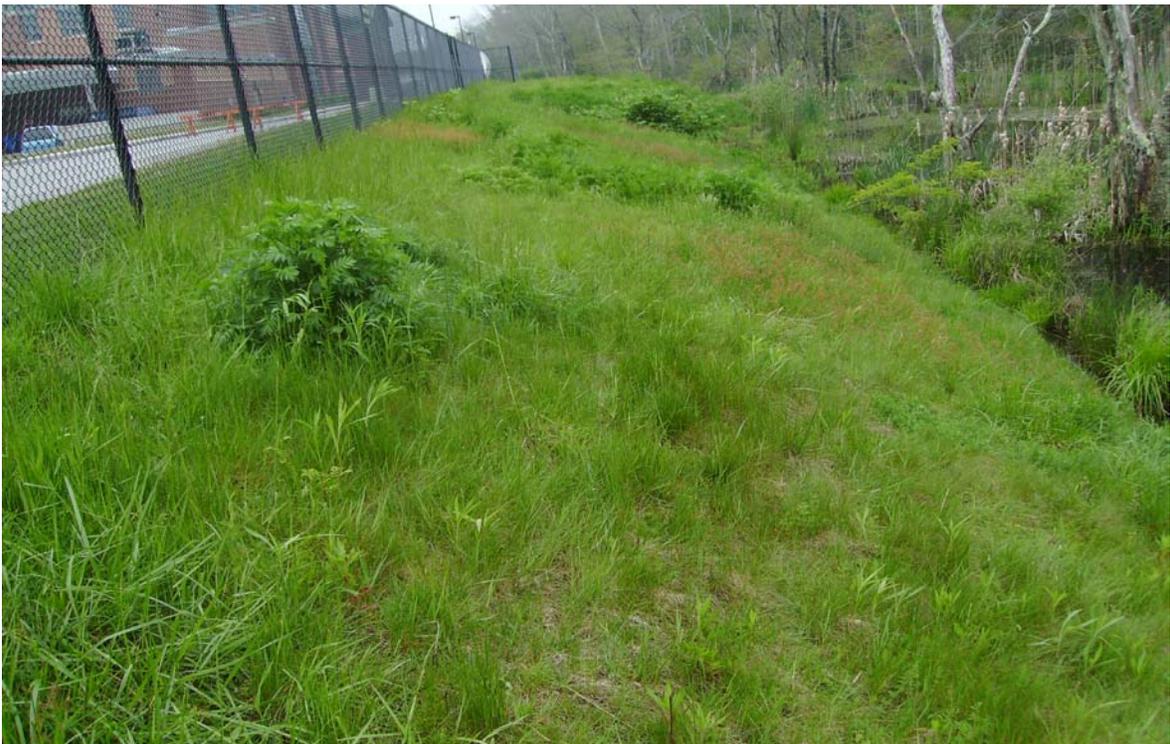
6) Stabilized slope along northern cap looking south.

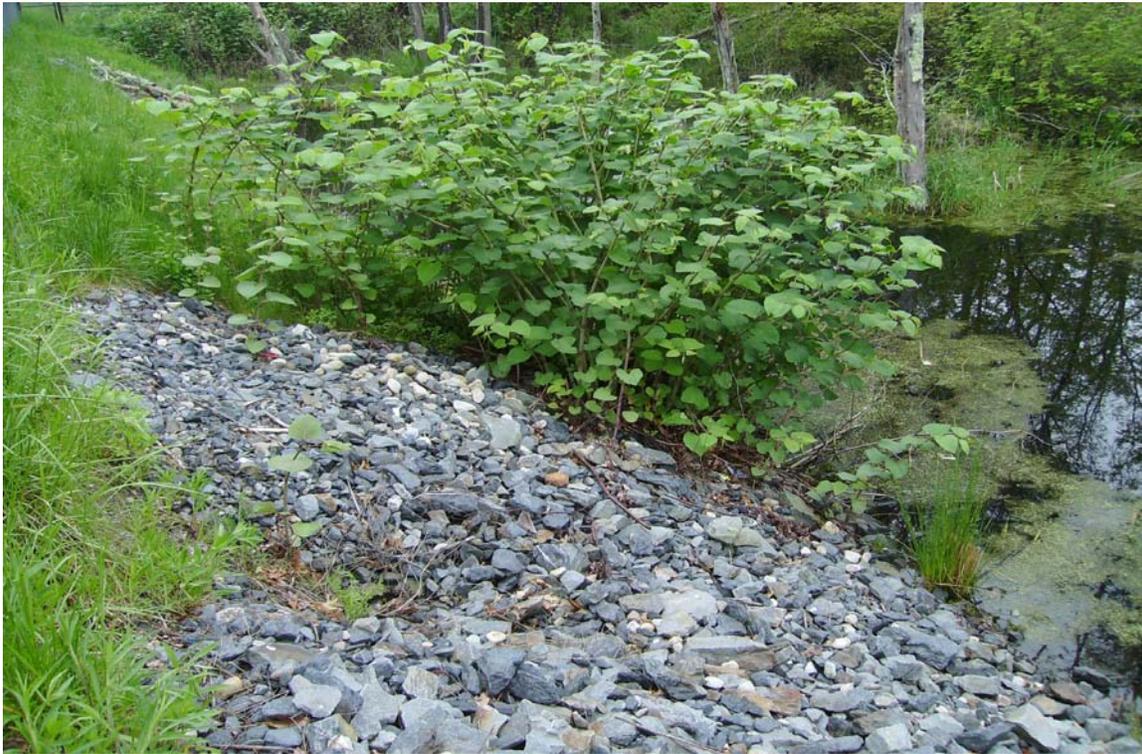
7) Rip rap slope in central portion of cap slope. Note small stand of Japanese knotweed in center of photograph adjacent to standing water.

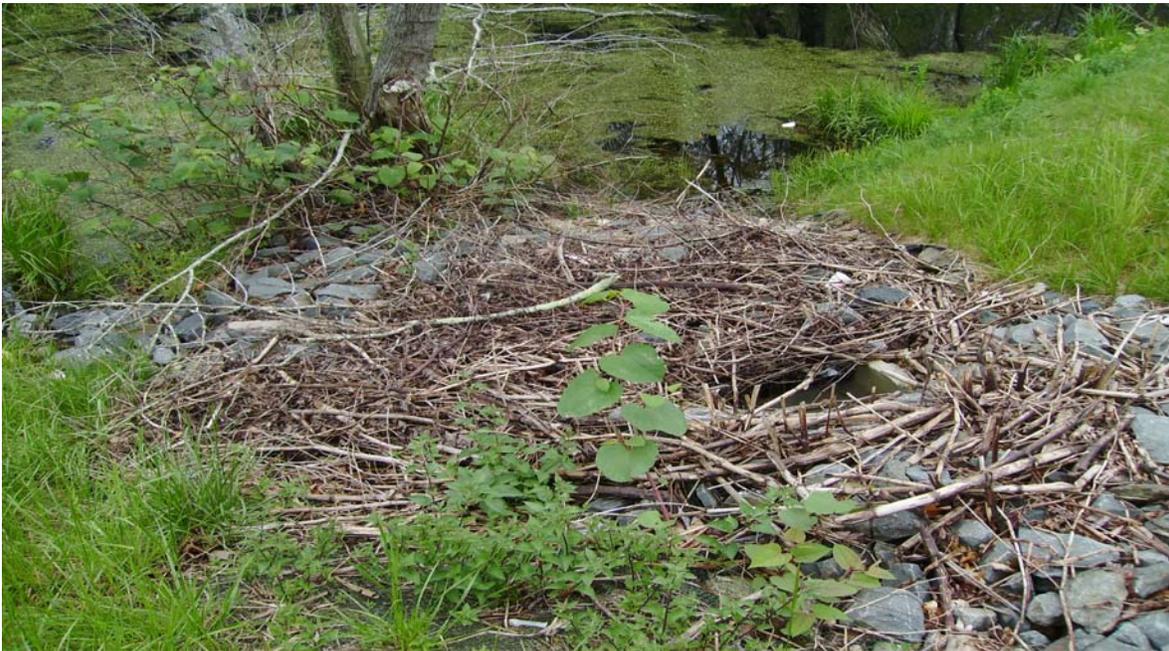
8) Rip rap at outfall in central portion of cap slope. Note mostly dead Japanese knotweed stand except for center foreground and left center rear of photograph.

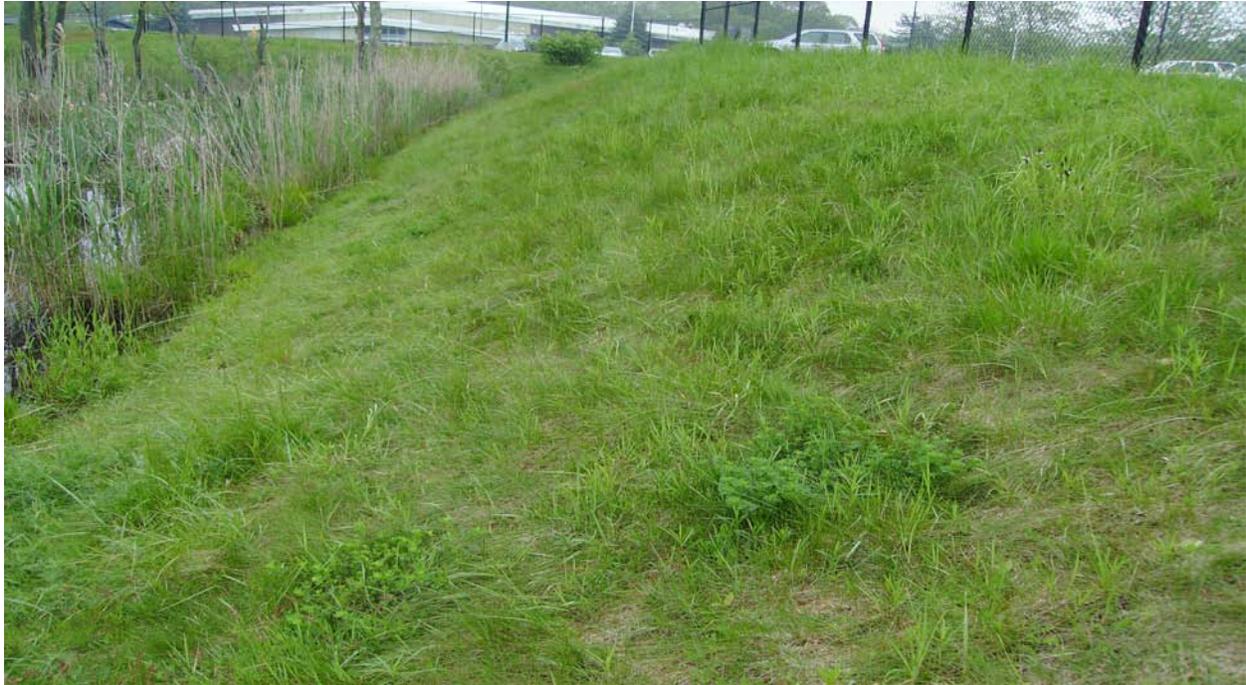
9) Northern portion of wetland/cap slope. Vegetation is well established.

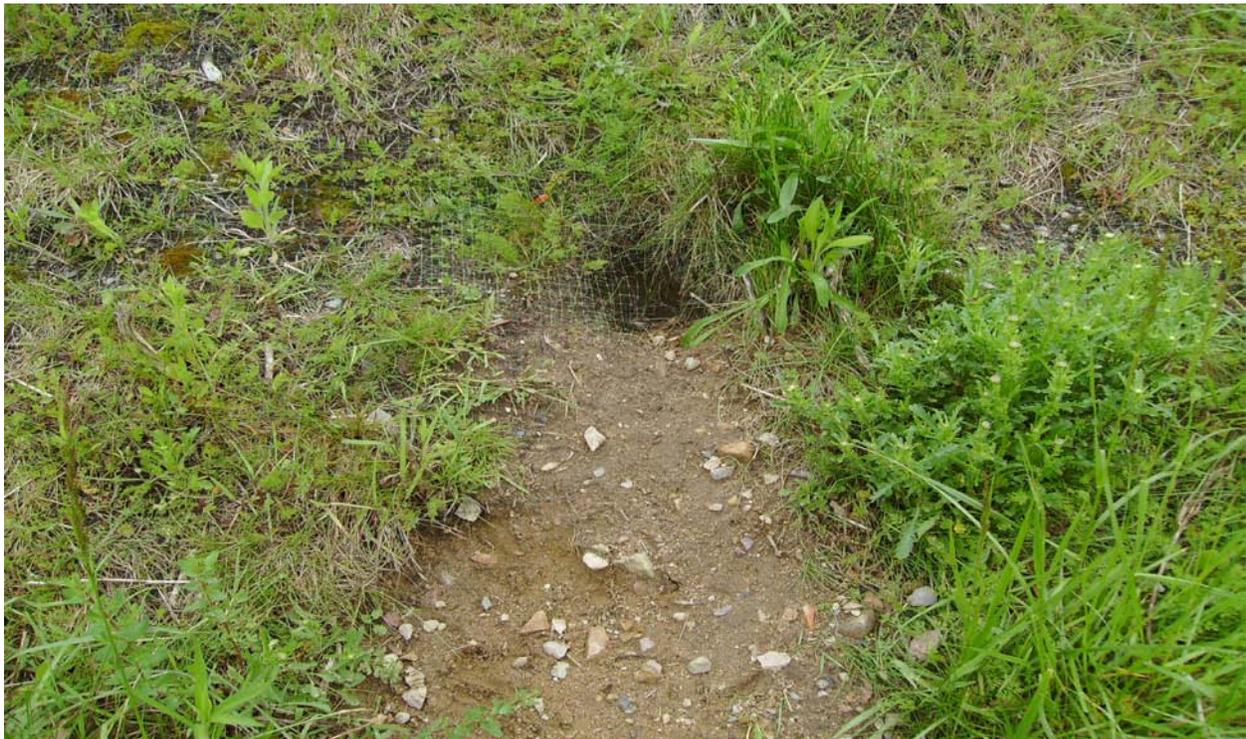
Condition Partially excavated burrow present in NW portion of cap slope. Appears abandoned - no recent activity noted.

10) Partially excavated burrow along northwestern portion of slope.
