June 25, 2009

TRC Project Number: 115058

Subject: Spring 2009 Wetland Sediment Inspection Keith Middle School, New Bedford,  
Massachusetts

**SITE PHOTOGRAPHS**  
**May 2009 Wetland Inspection**  
**Keith Middle School**  
**New Bedford, Massachusetts**

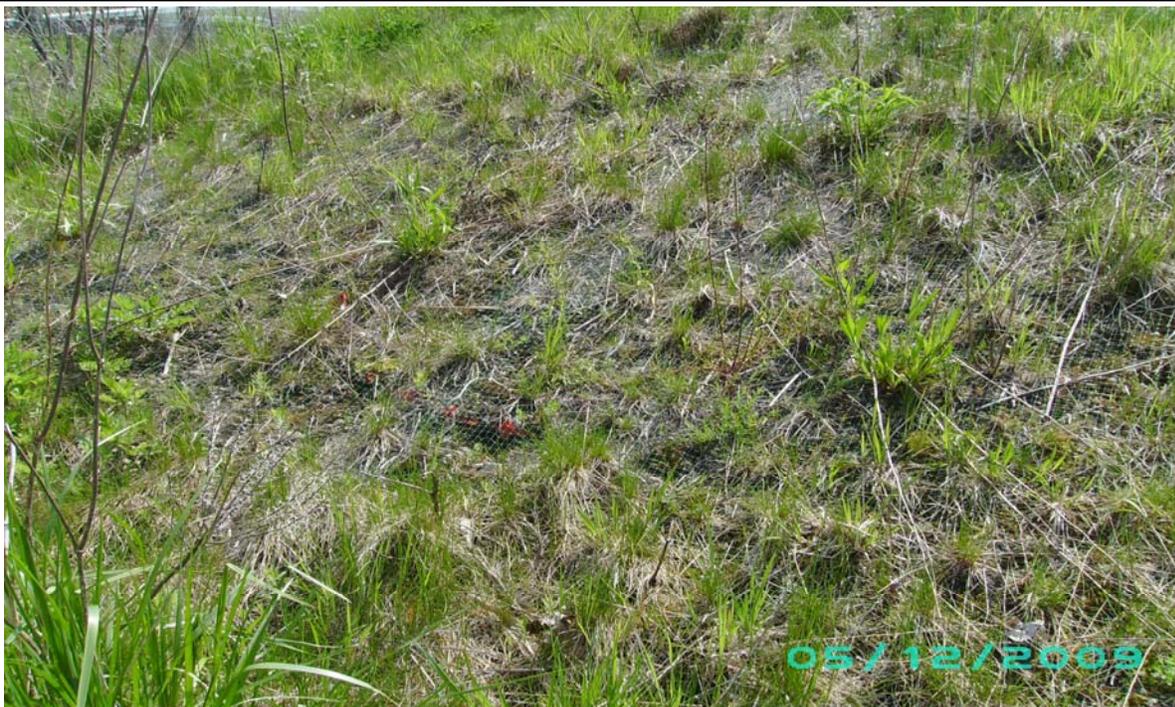
In general, the slope extending down to the wetland from the parking lots and rear school access drive is well vegetated with grasses and herbaceous plants. One small area of thin vegetative cover remains within the northwestern portion of the slope. The thin cover revealed the slope stabilization netting used during construction of the slopes. However,

this area appears to be currently stabilized with no erosion evident with increased vegetation present since the previous site inspection. Overall, no evidence of erosion or sedimentation into the adjacent wetland was noted during the site inspection.

Condition Thin vegetative cover present along NW corner of slope. No erosion noted but need to monitor in future.

**1) Thin/spotty vegetation on slope in northwestern part of site looking up.**

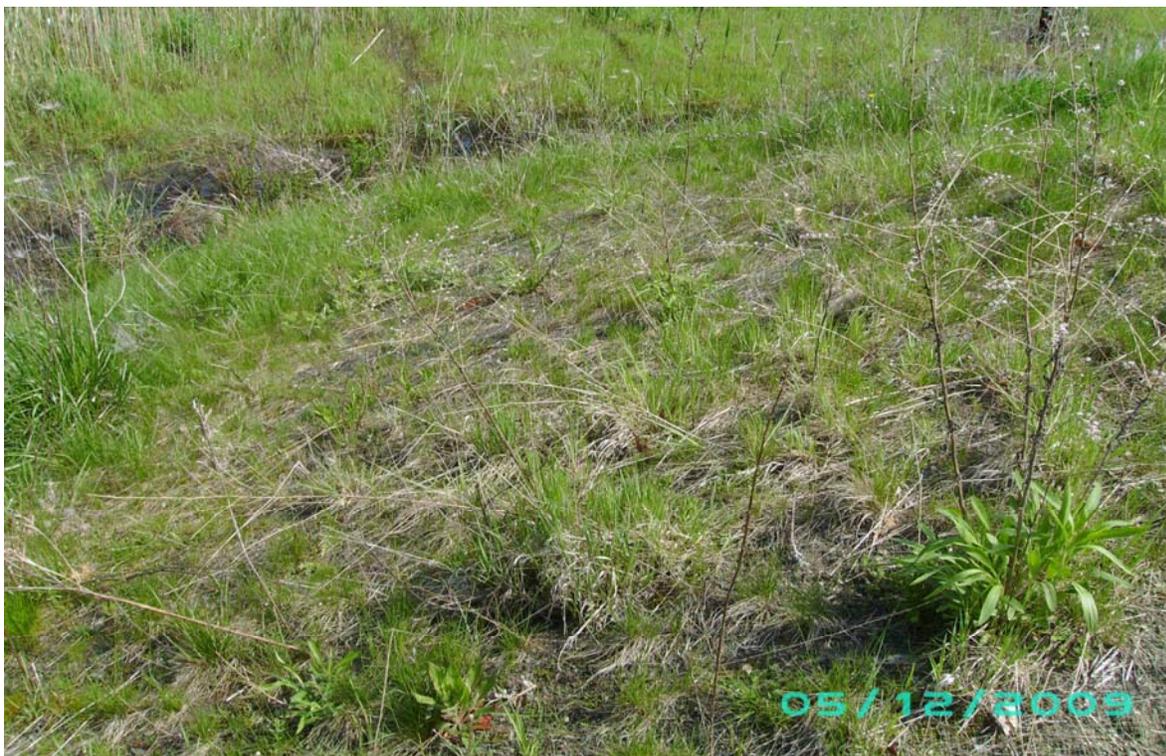
**2) Thin/spotty vegetation on slope in northwestern part of site looking down.**

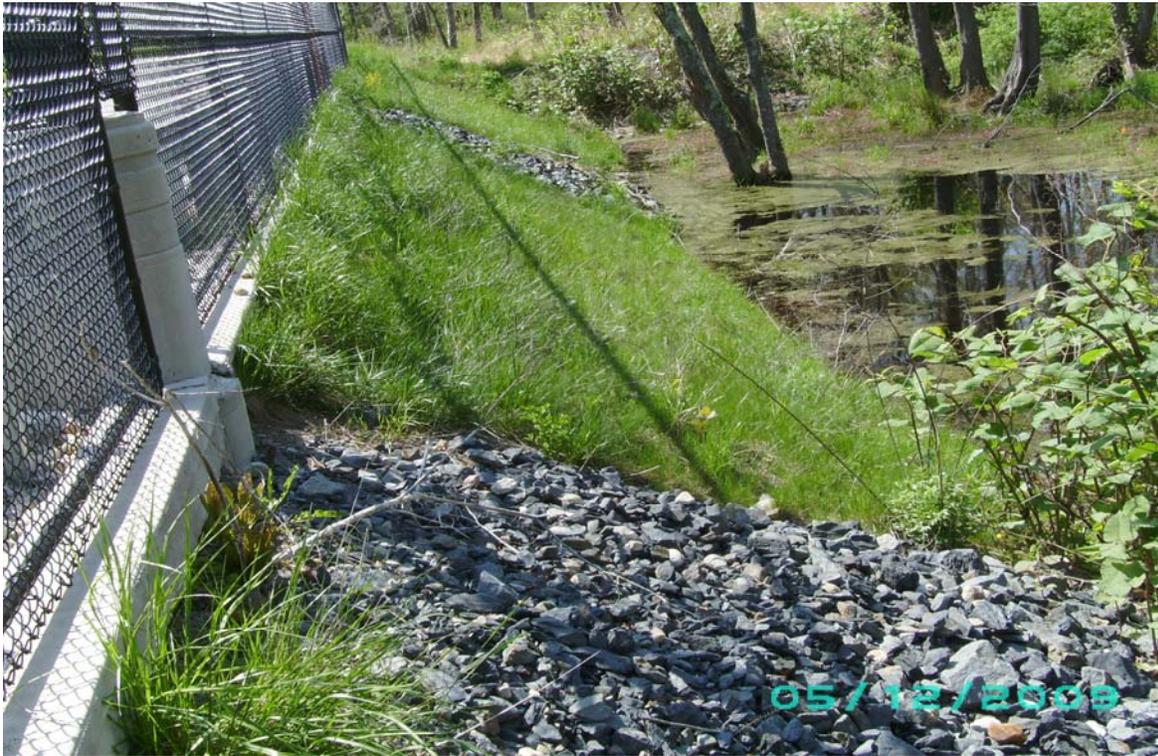
**3) Top of slope along parking lot in northern part of site, facing west.**

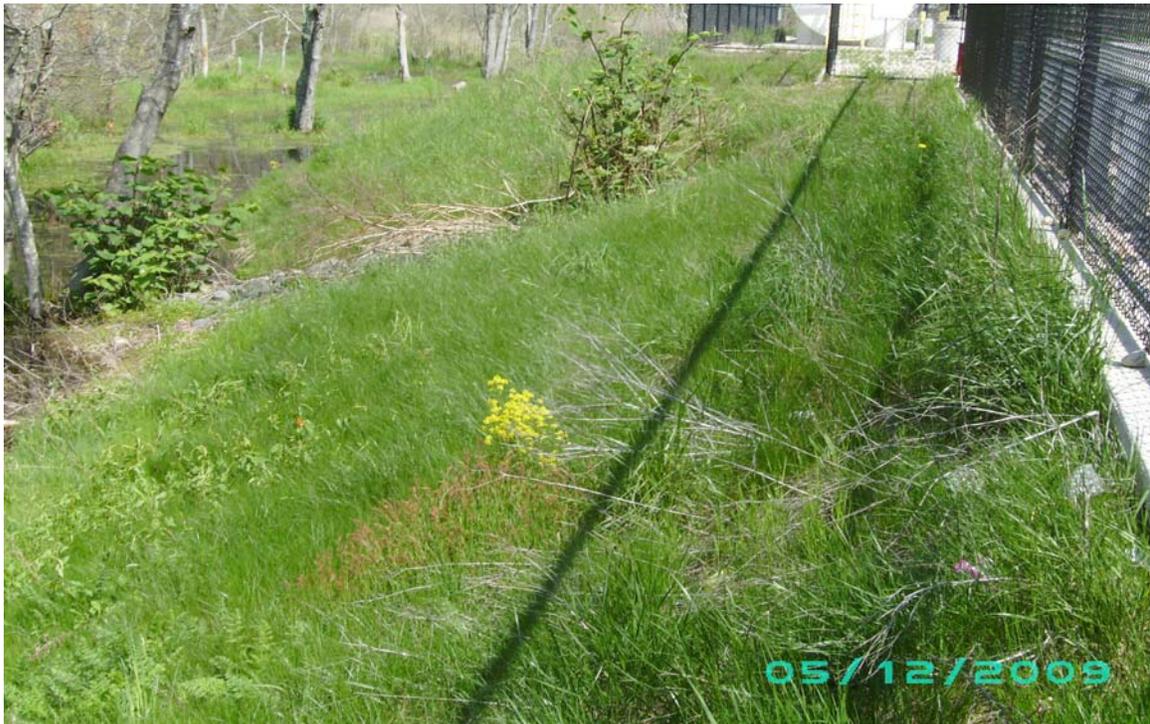
**4) Slope along northern portion of slope, facing west.**

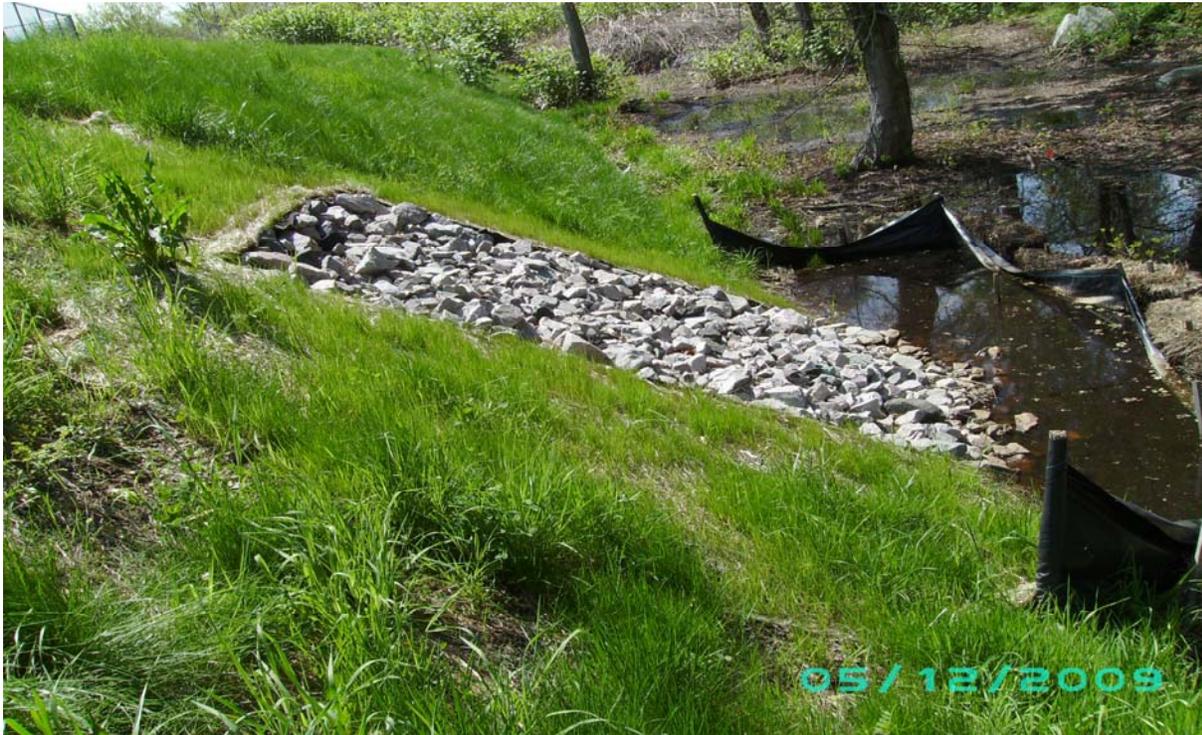
The area of slope failure previously noted during the 2008 inspection has been stabilized with riprap and appears to be stable although this area should be monitored closely at the time of the next site inspection. The silt fence and haybales previously installed downgradient of the repaired area can be removed.

Slope failure area has been stabilized with riprap

**5) Area of former slope failure repair, facing southeast.**

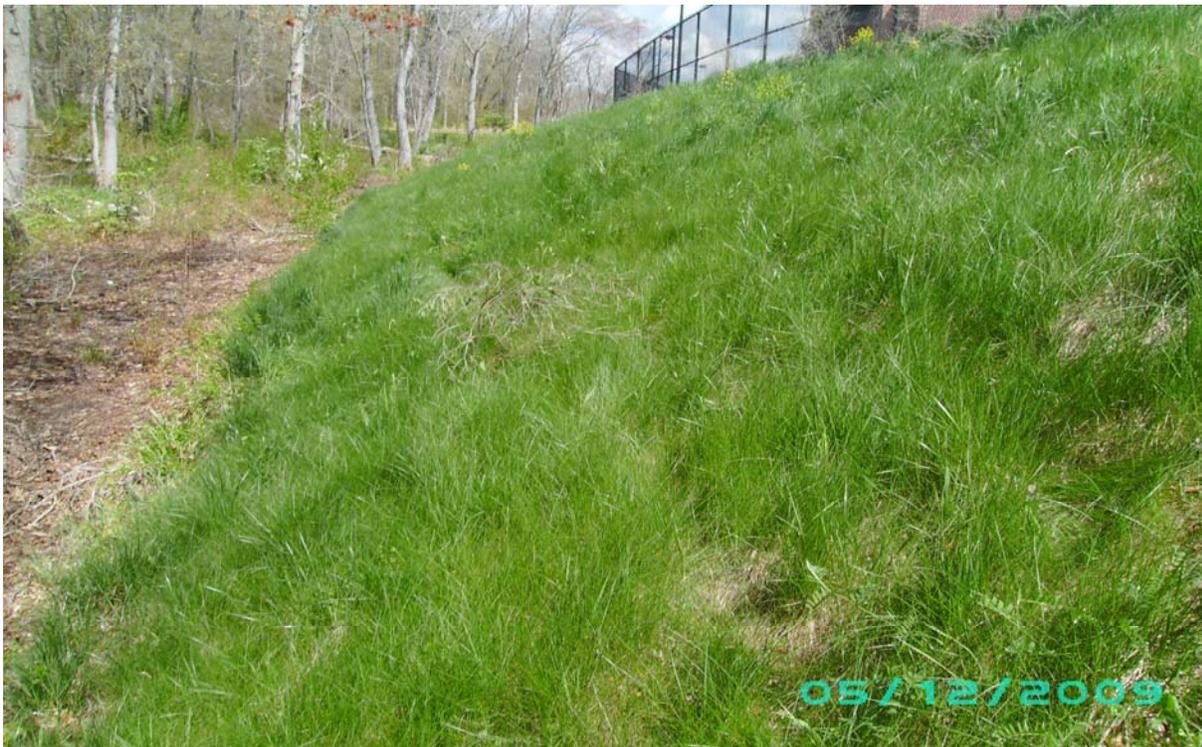
**6) Southern portion of slope where vegetation is well established and stabilizing slope.**
