Wannalancit Mills
650 Suffolk Street
Lowell, MA 01854

April 24, 2015

**Subject: Spring 2015 Cap Inspection
Keith Middle School
New Bedford, Massachusetts**

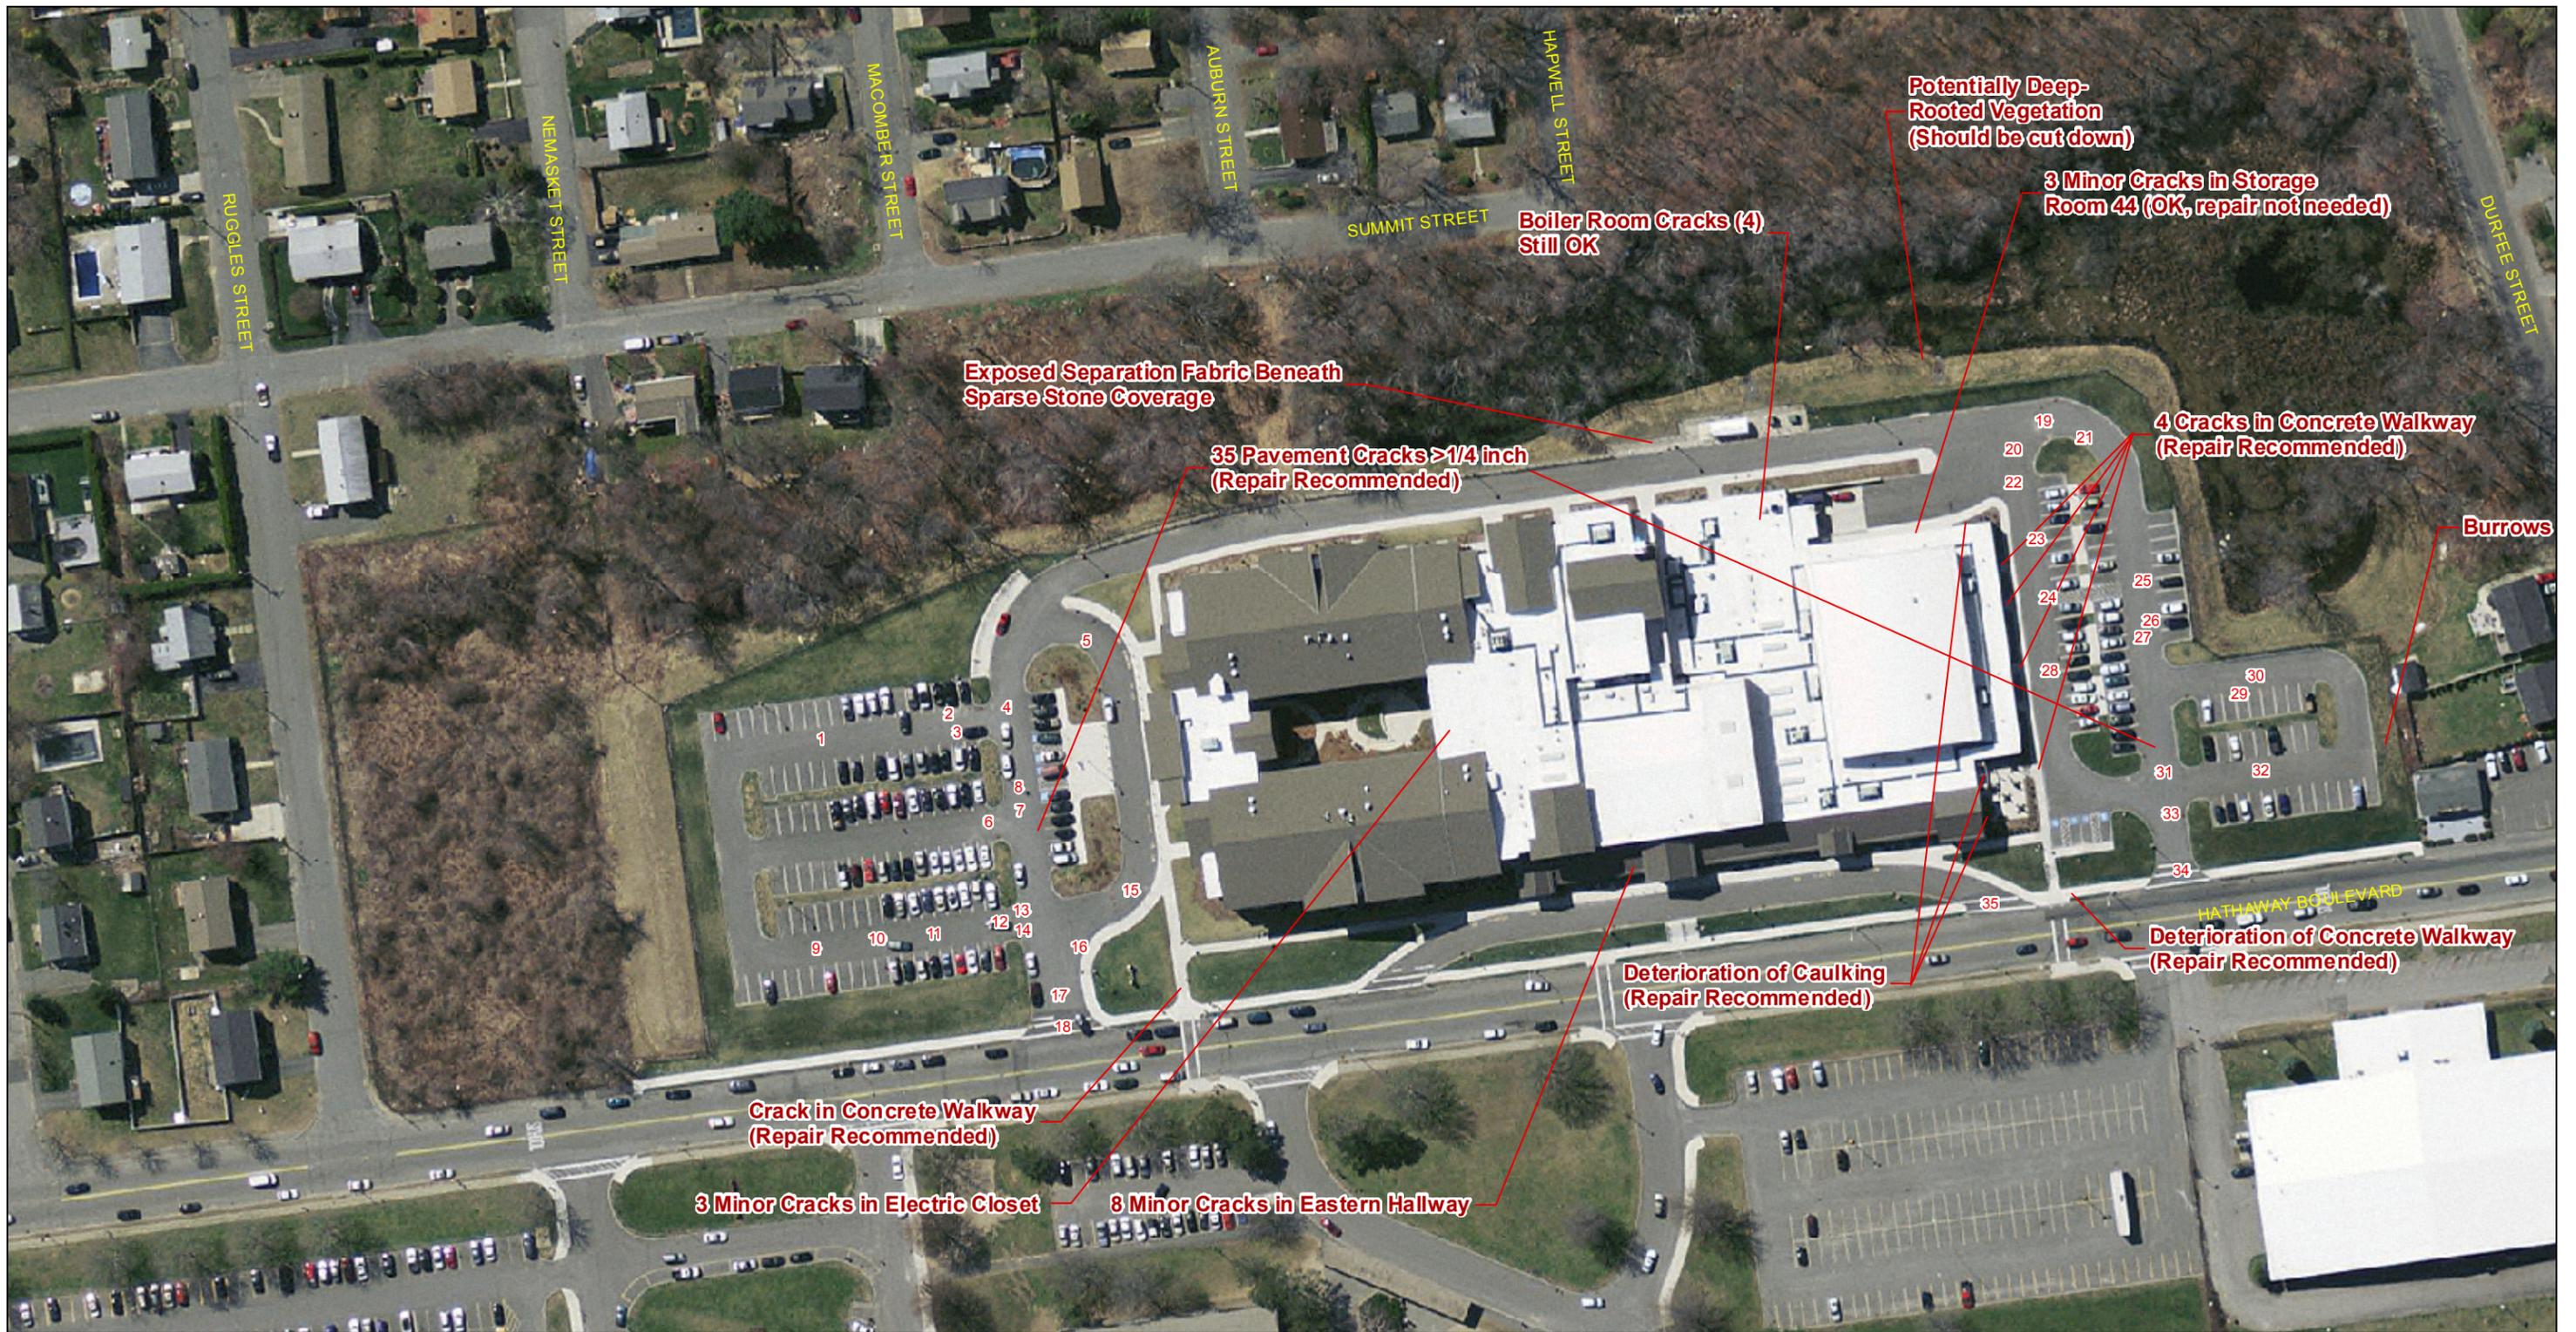
FIGURE 1

The paved parking lots and driveways surrounding the school have developed a total of 35 cracks greater than ¼-inch, which pose a threat to the integrity of the cap and require repair prior to the next scheduled inspection in accordance with the LTMMIP. Their locations are depicted on Figure 1.

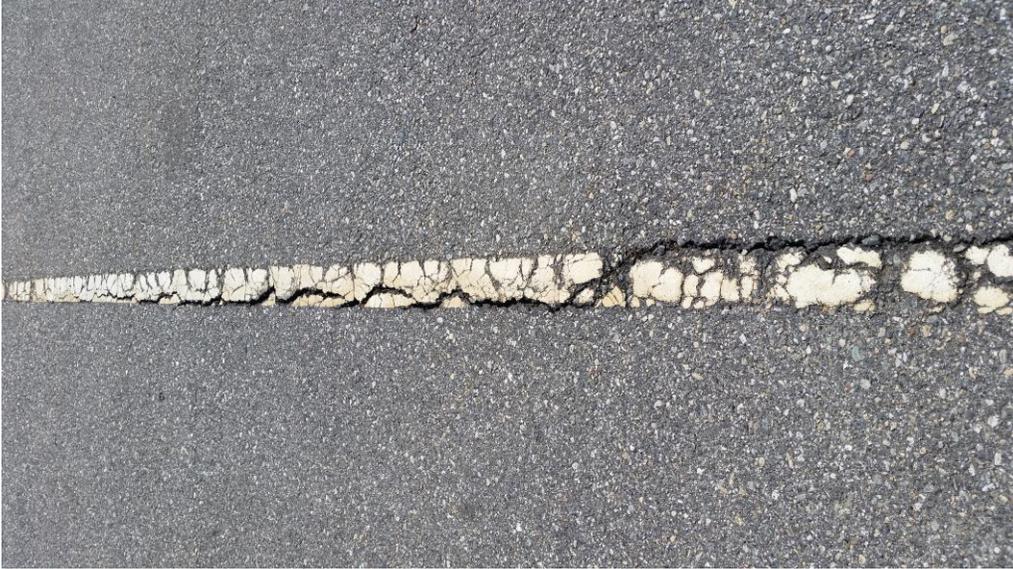
11:25 16 CRACKS NOTED IN ASPHALT IN NORTH
PARKING LOT

1) Crack in pavement greater than 1/4-inch, located in northern parking lot.

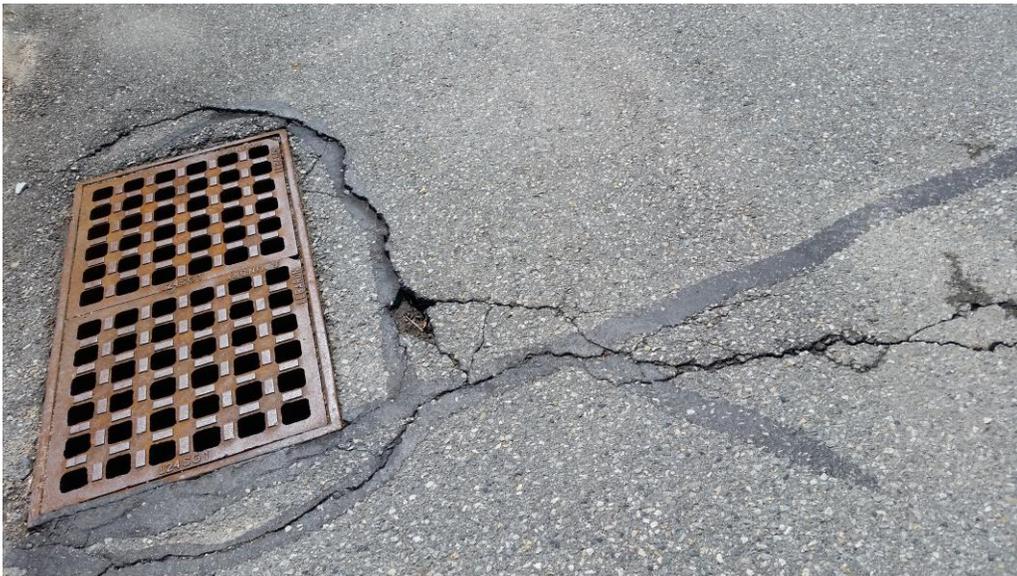
12:40 17 CRACKS NOTED IN ASPHALT IN SOUTHERN
PARKING LOT.

2) Crack in pavement greater than 1/4-inch, located in southern parking lot.

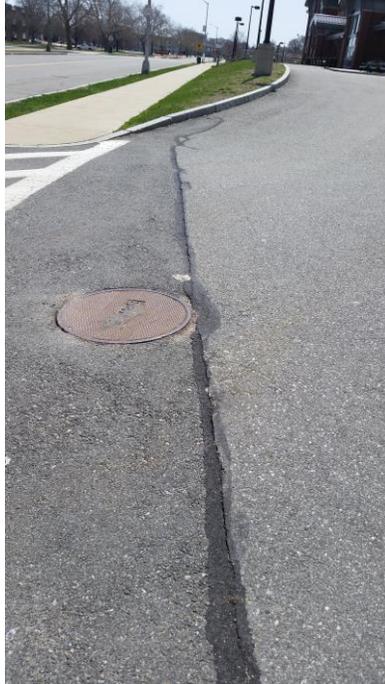
3) Crack in pavement greater than 1/4-inch, located on northern side of eastern driveway.

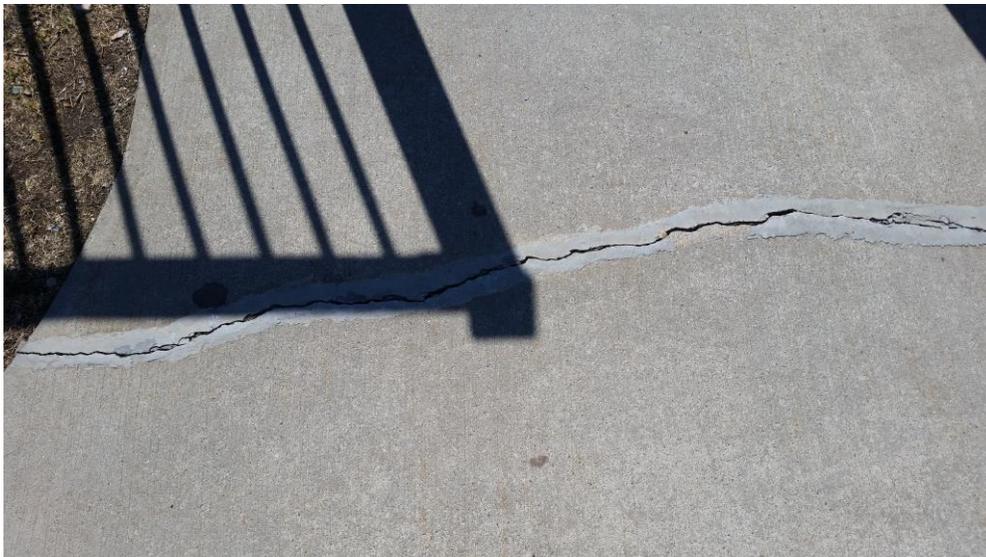
4) Crack in concrete walkway greater than 1/4-inch, located on northern side of building.

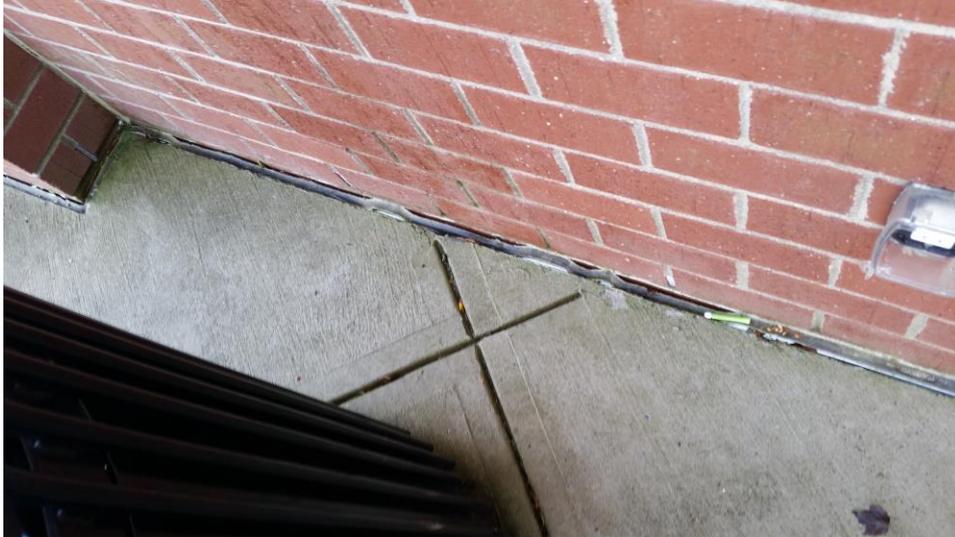
In several areas around the exterior of the school building, a bead of caulking has been installed in the joint between the foot of the brick building walls and the concrete walkways. The caulking prevents weather elements (i.e., rain, snow, and ice) from entering the joint space. As noted in previous reports, the caulking appeared deteriorated in several areas. The caulking used to repair cracks in the walkways also appears to be deteriorating. Although conditions were not indicative of a potential for soil exposures, TRC recommends continuous observation and repair/replacement of the caulking, as necessary. Continued infiltration of weather elements into the joint could eventually separate and deteriorate the walkway.

- 5) **Deteriorated caulking in joint between brick wall and concrete walkway, located on northern side of building.**

- Areas of caulking between the building walls and exterior walkways are continuing to deteriorate. These areas will likely need to be repaired in the future.

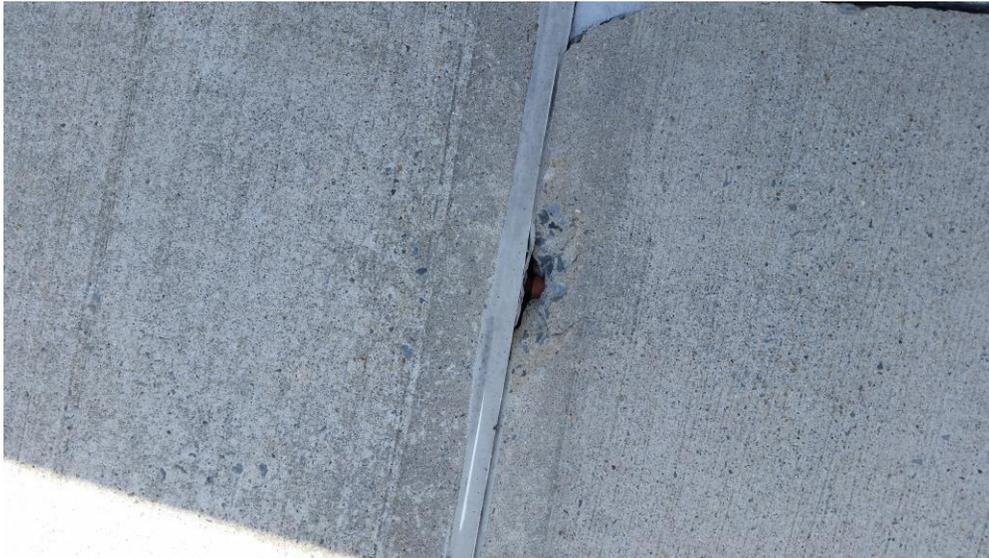
- 6) **Crack in concrete walkway greater than ¼-inch, located on southeastern side of building.**

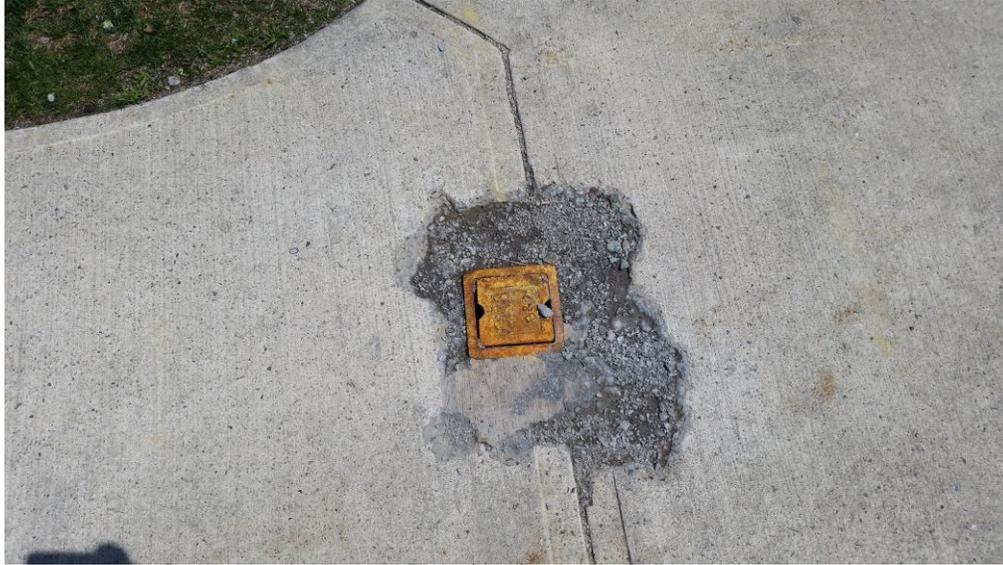
7) Deterioration of concrete walkway, located on northeastern side of building.

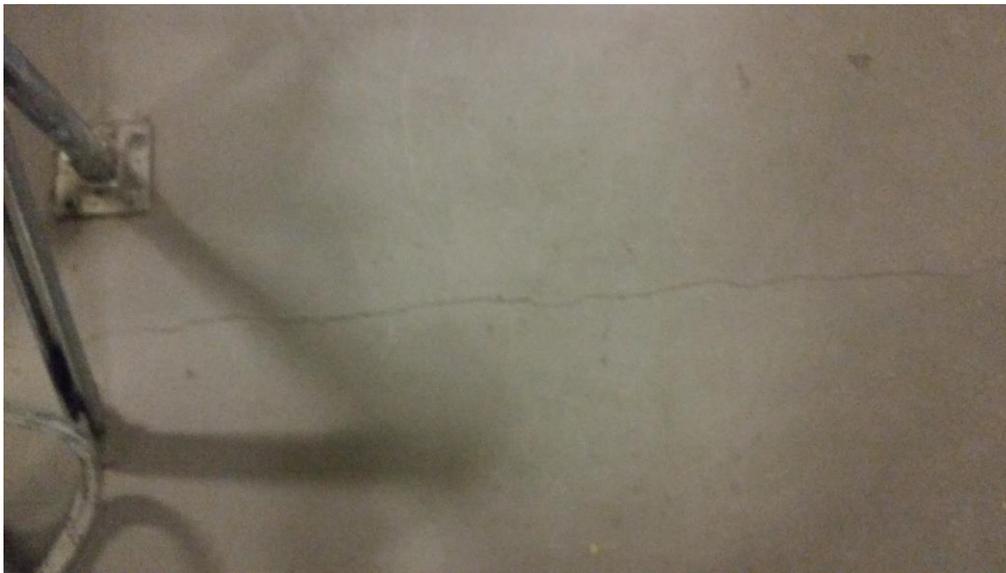
Based on TRC's inspection, the concrete floor within the footprint of the building is currently acting to prevent exposure to the impacted fill beneath. Four minor cracks were previously noted in the boiler room floor and still do not present a cap integrity issue at this time. Three very minor cracks were also observed in storage room 44, and also do not require repairs at this time. Several hair line cracks were observed in the eastern hallway (approximately eight) and one hair line crack was observed in the electric closet. Each of the cracks noted above appears in a general east-to-west orientation. Six cracks in the tile flooring of the boys' locker room and an additional crack in the tile flooring of the girls' locker room were observed, but there was no evidence of damage to the concrete floor underneath.

8) Crack in concrete floor less than ¼-inch, located in boiler room.

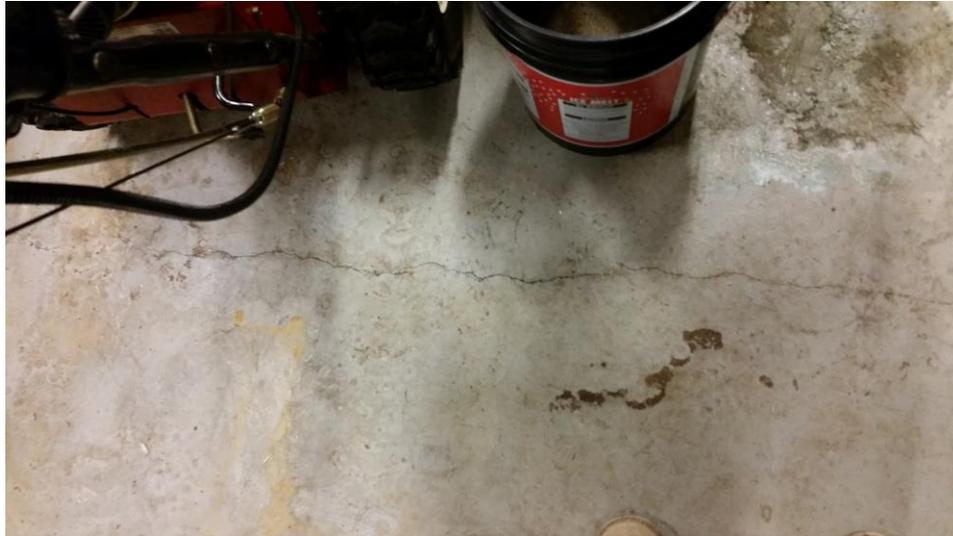
9) Crack in concrete floor less than ¼-inch, located in storage room 44.

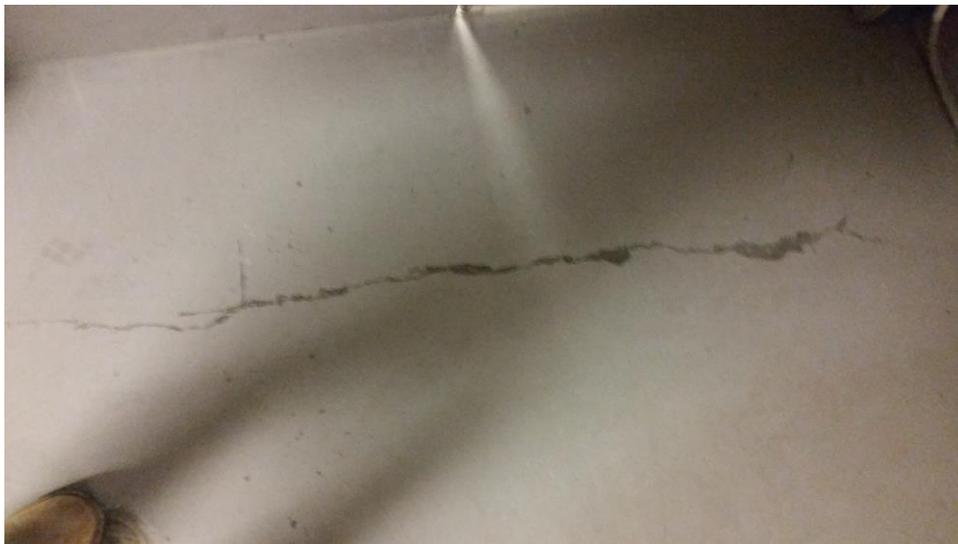
10) Crack in concrete floor less than ¼-inch, located in electric closet.

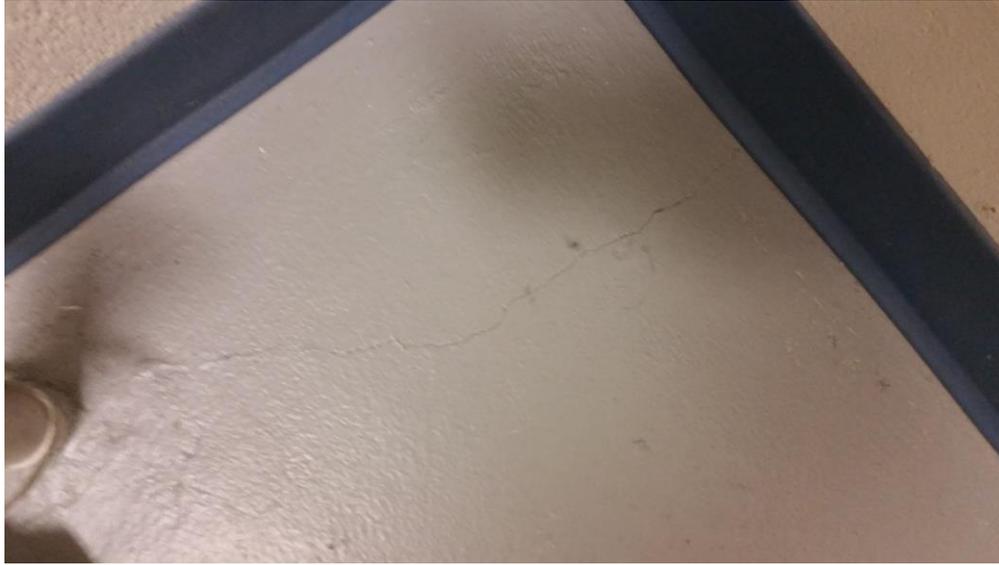
11) Crack in pavement greater than 1/4-inch, located in main electrical room.

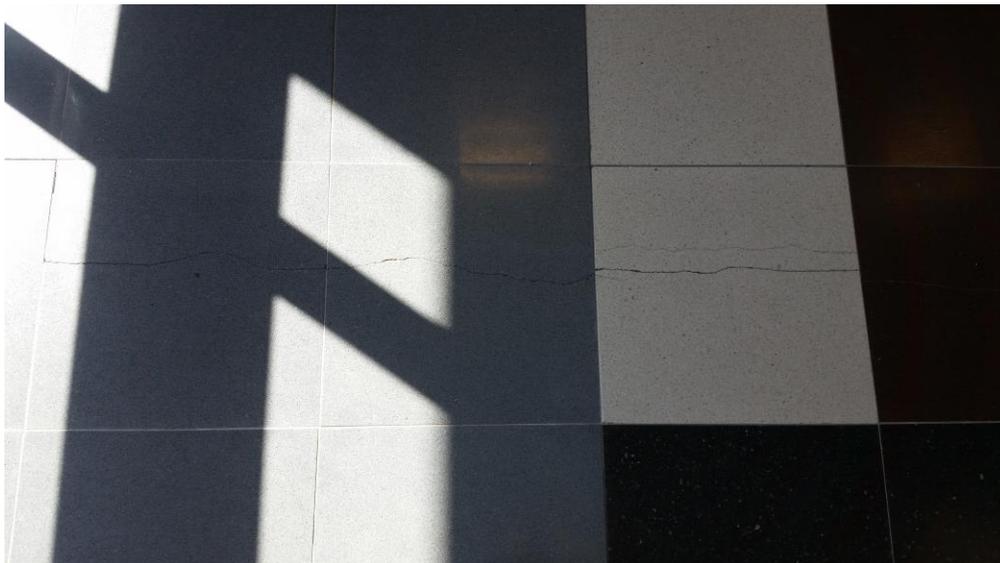
12) Crack in tile flooring less than 1/4-inch, located in eastern hallway.

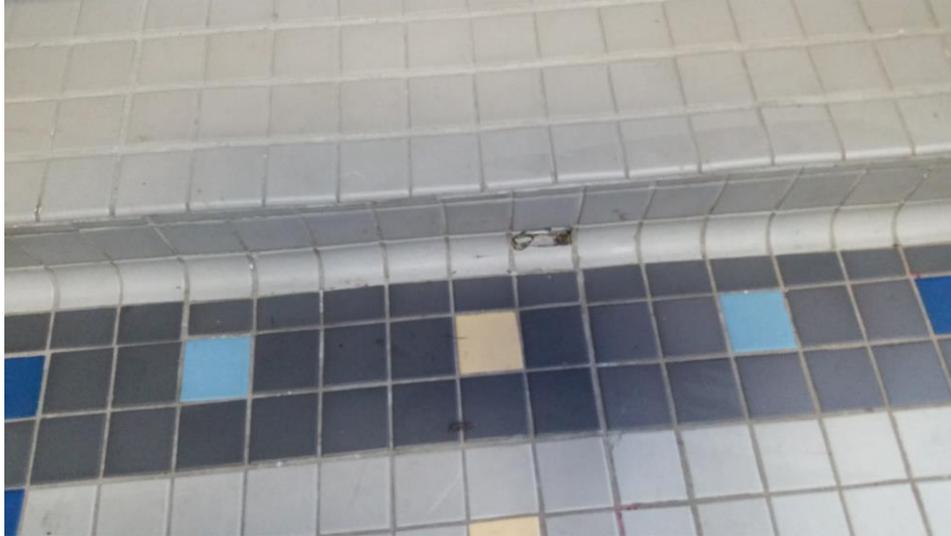
13) Crack in tile flooring of boys' locker room.

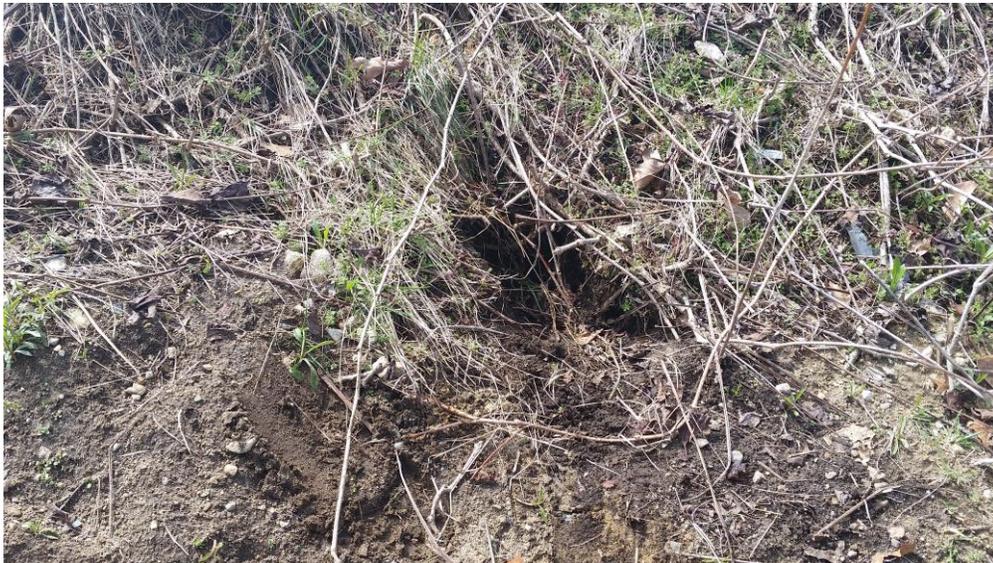
- Several small holes were observed along the northern edge of the cap, which may be the result of animal burrowing. TRC pointed out the locations of the holes to the City on the day of the inspection and they were filled in immediately.

14) Animal burrow hole in slope on northern edge of property.

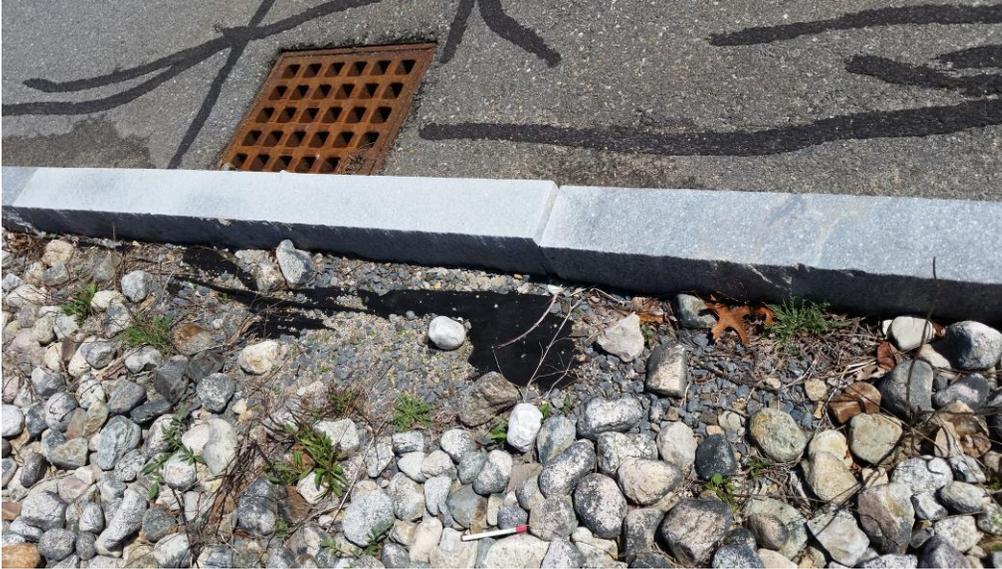
15) Exposed separation fabric beneath sparse stone coverage along perimeter of driveway, located on western side of building.

- The black separation fabric that demarcates the underlying contaminated fill from the clean imported fill is visible beneath sparse stone coverage on the perimeter of the driveway running along the western side of the building. The stone should be augmented or adjusted to ensure that exposure to the impacted fill beneath the cap is prevented.

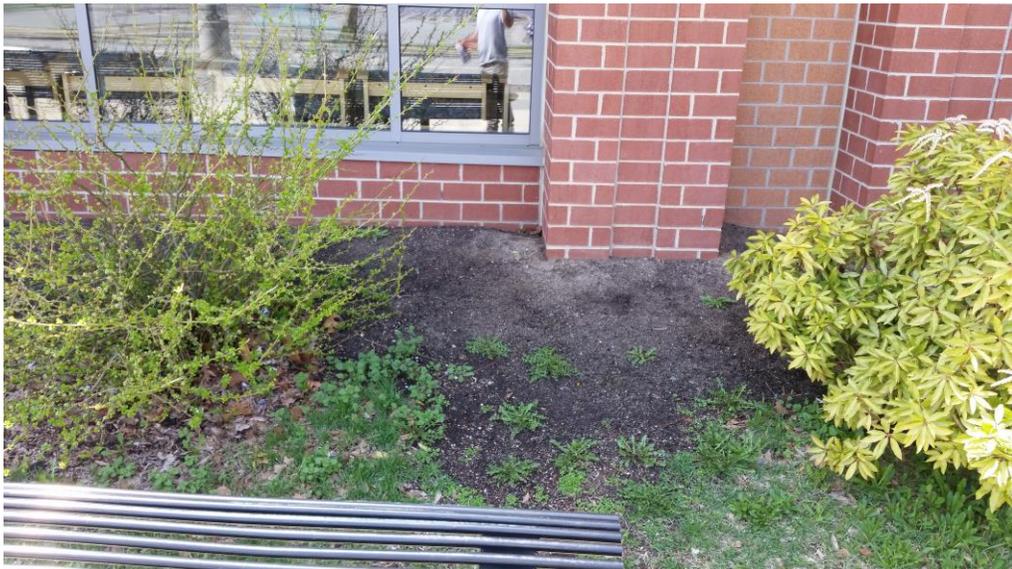
16) Poor vegetative cover over soil inside building footprint, located on eastern side of school.

- Poor vegetative cover exists over cap soils on the eastern side of the building, making the soils susceptible to erosion. This area should be monitored and/or repaired to prevent future damage to the integrity of the cap.
