November 4, 2015

**Subject: Fall 2015 Cap Inspection
Keith Middle School
New Bedford, Massachusetts**

SITE PHOTOGRAPHS
October 2015 Cap Inspection
Keith Middle School
New Bedford, Massachusetts

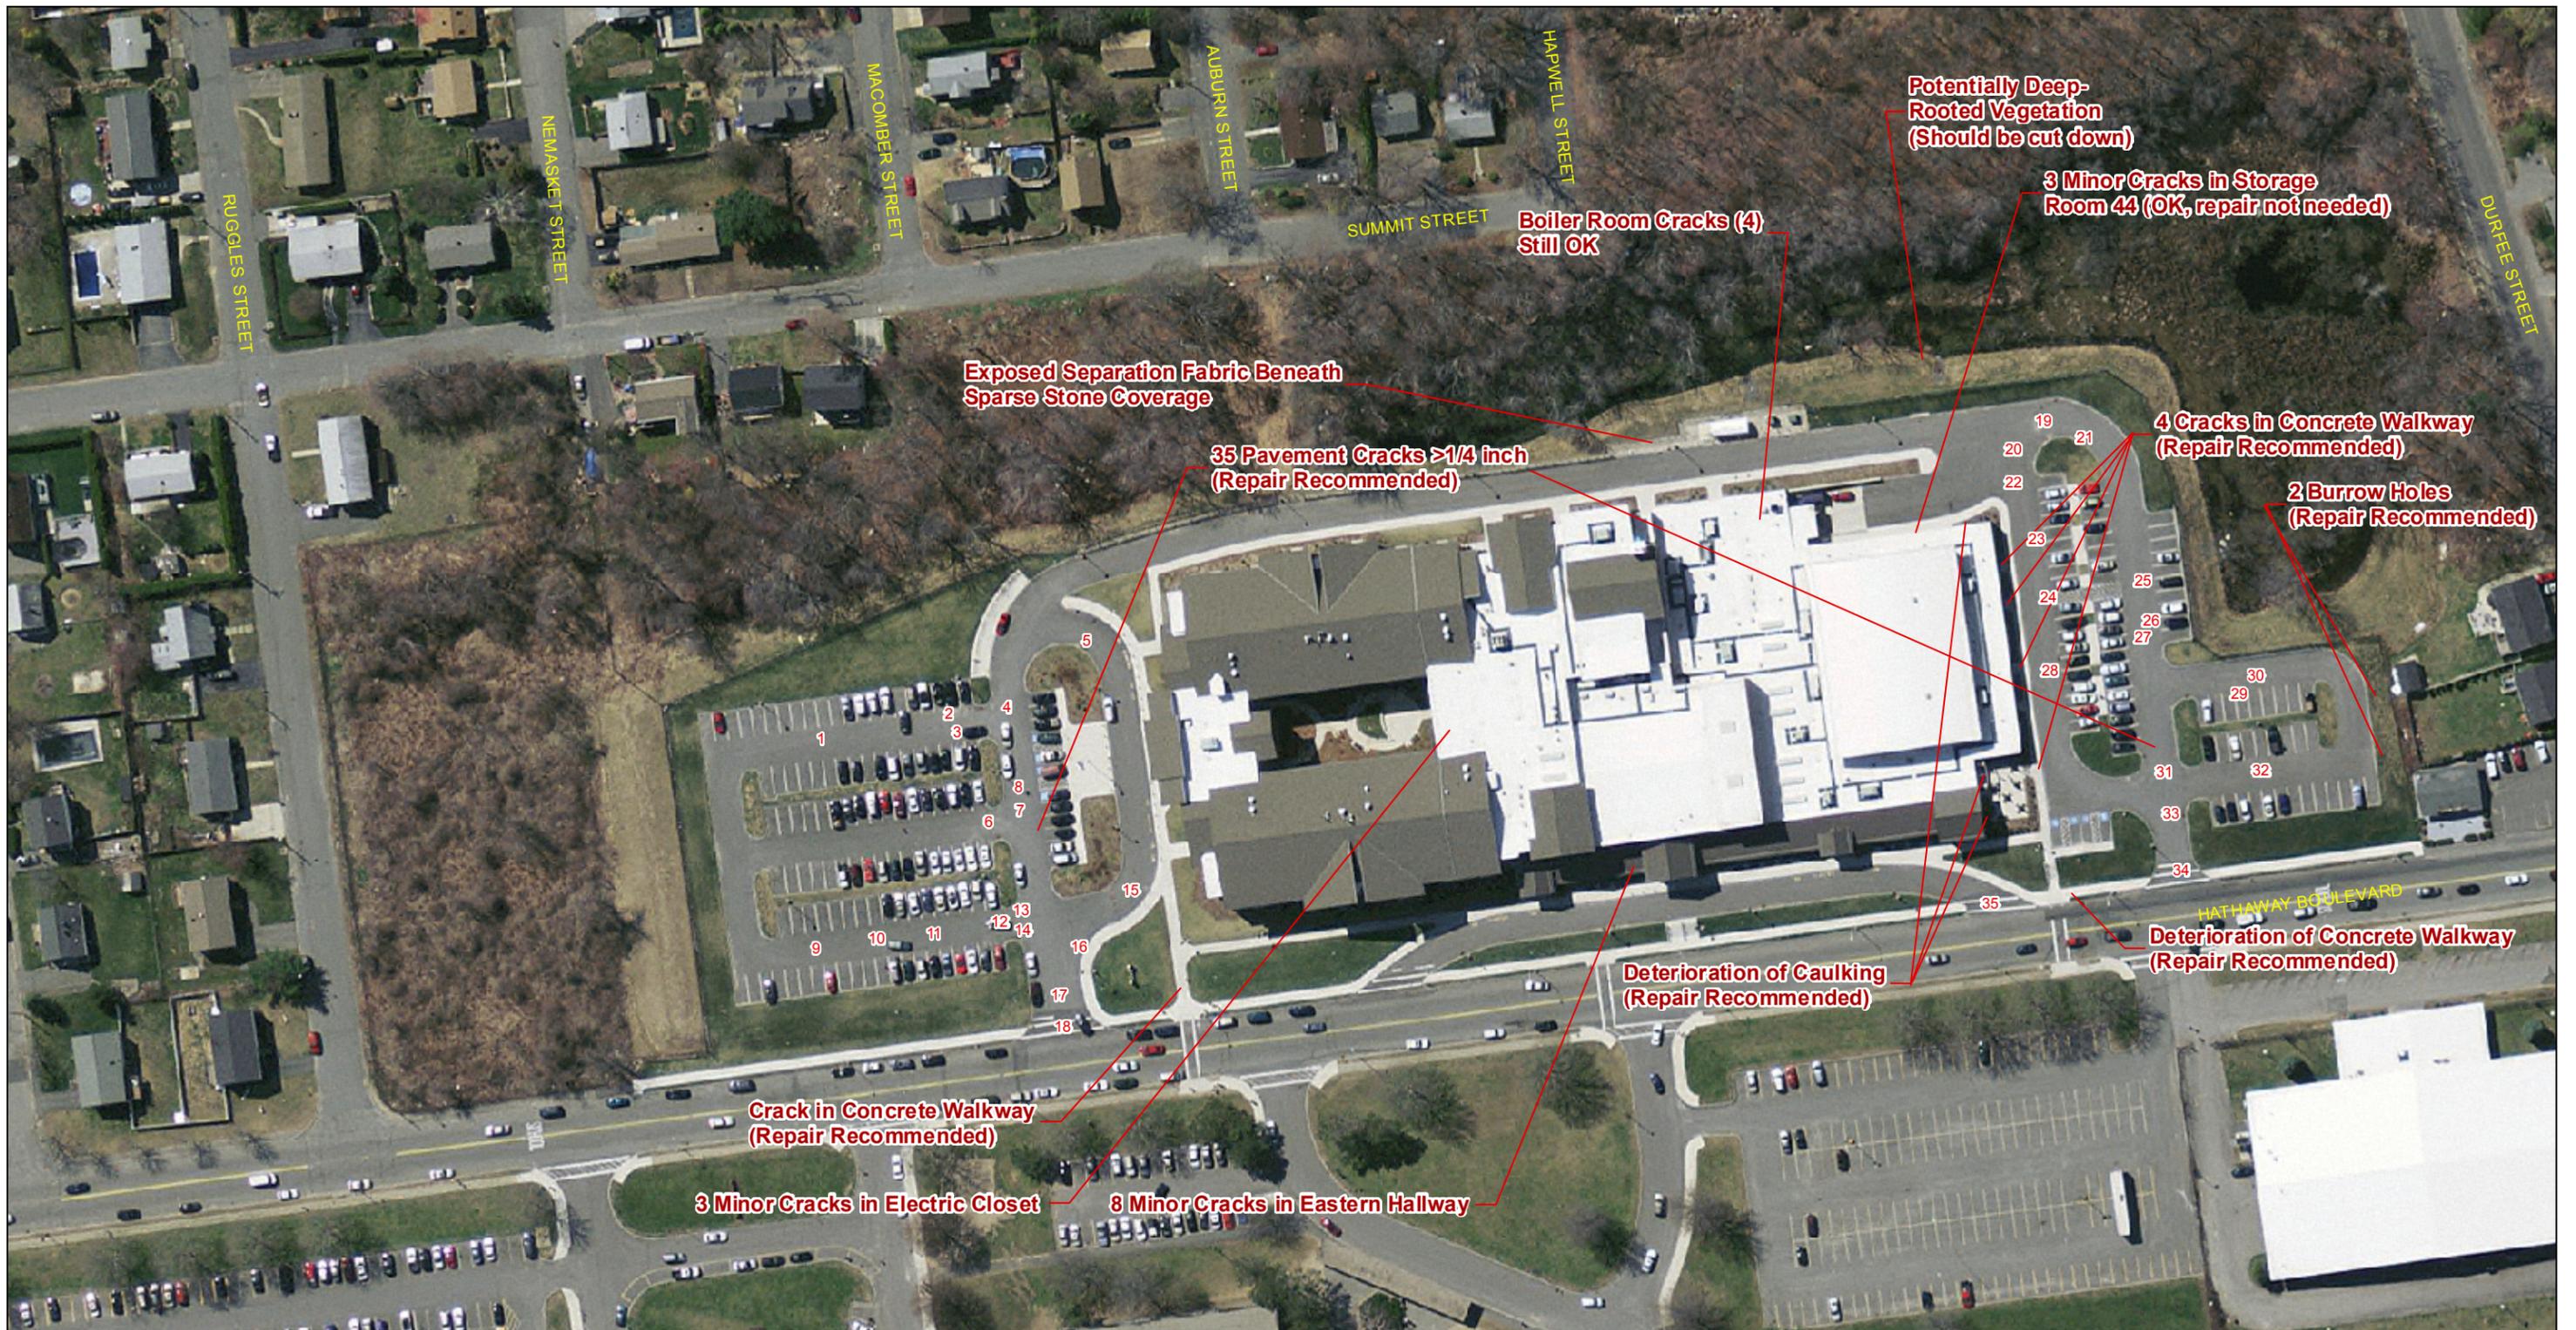
FIGURE 1

The paved parking lots and driveways surrounding the school have developed a total of 35 cracks greater than ¼-inch, which pose a threat to the integrity of the cap and require repair prior to the next scheduled inspection in accordance with the LTMMIP. Their locations are depicted on Figure 1.

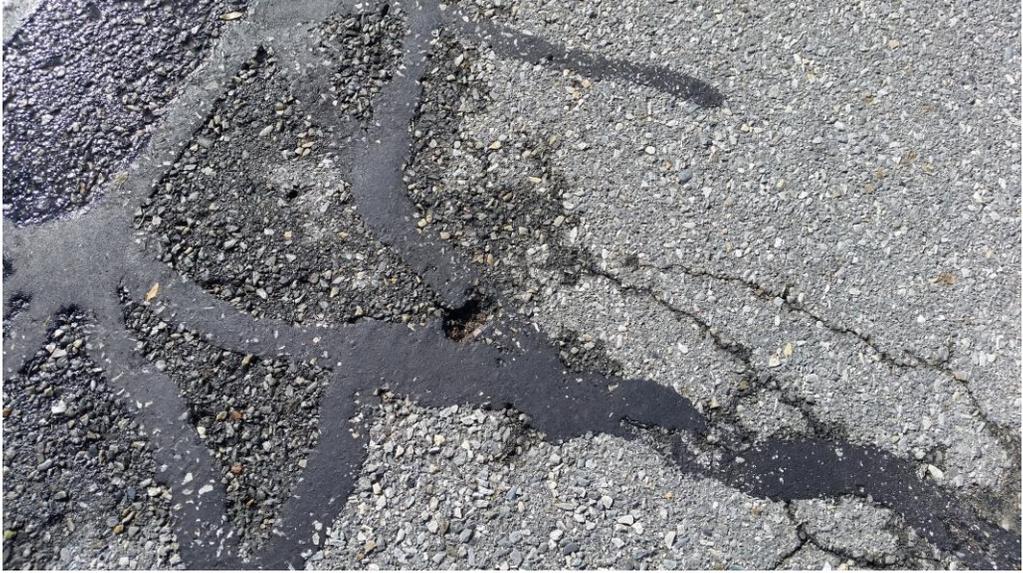
- 1) 16 cracks in asphalt paving greater than ¼-inch in width, see Photograph 1 for example and Figure 1 for individual locations.
- 2) 18 cracks in asphalt paving greater than ¼-inch in width, see Photograph 2 for example and Figure 1 for locations.
- 3) Crack in asphalt paving greater than ¼-inch in width, see Photograph 3.
- 4) 4 cracks in concrete walkway greater than ¼-inch in width, see Photograph 4. Deterioration of caulking in joints between brick walls and concrete walkways. See Photograph 5.
- 5) Crack in concrete walkway greater than ¼-inch in width, see Photograph 6.

1) Crack in pavement greater than 1/4-inch, located in northern parking lot.

No repairs to asphalt and concrete paving since last inspection were observed. TRC maintains its recommendation that the issues noted above be repaired before the next inspection in the spring of 2016.

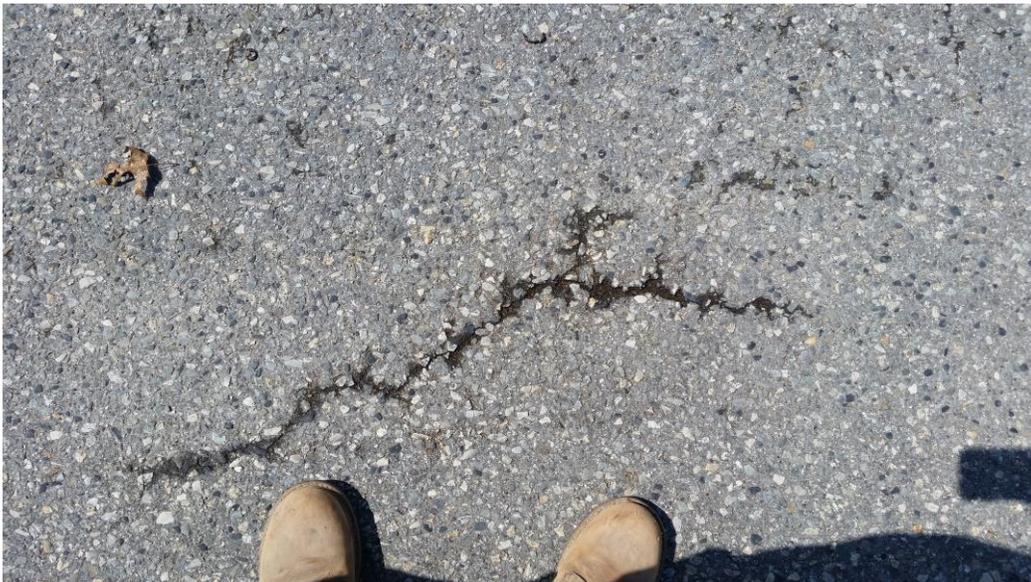
2) Crack in pavement greater than 1/4-inch, located in southern parking lot.

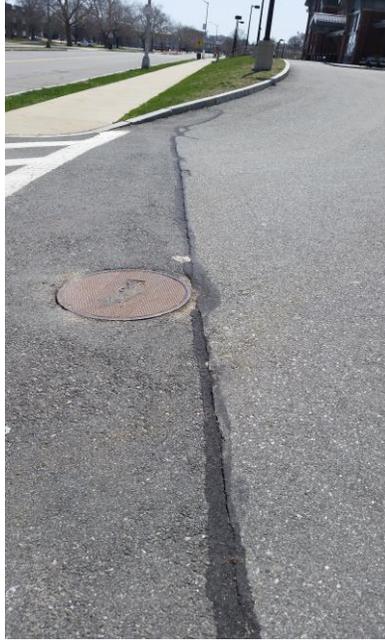
3) Crack in pavement greater than ¼-inch, located on northern side of eastern driveway.

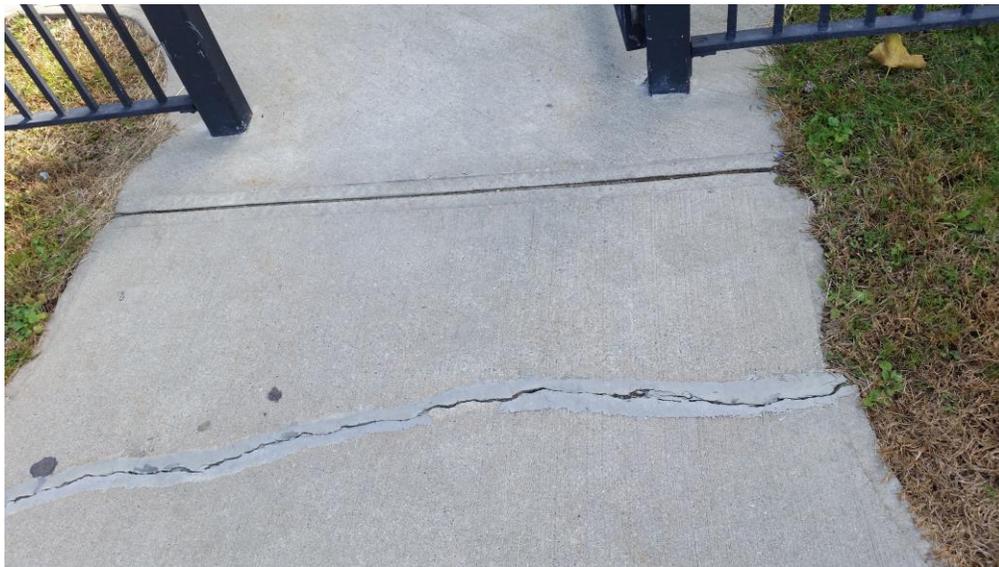
4) Crack in concrete walkway greater than ¼-inch, located on northern side of building.

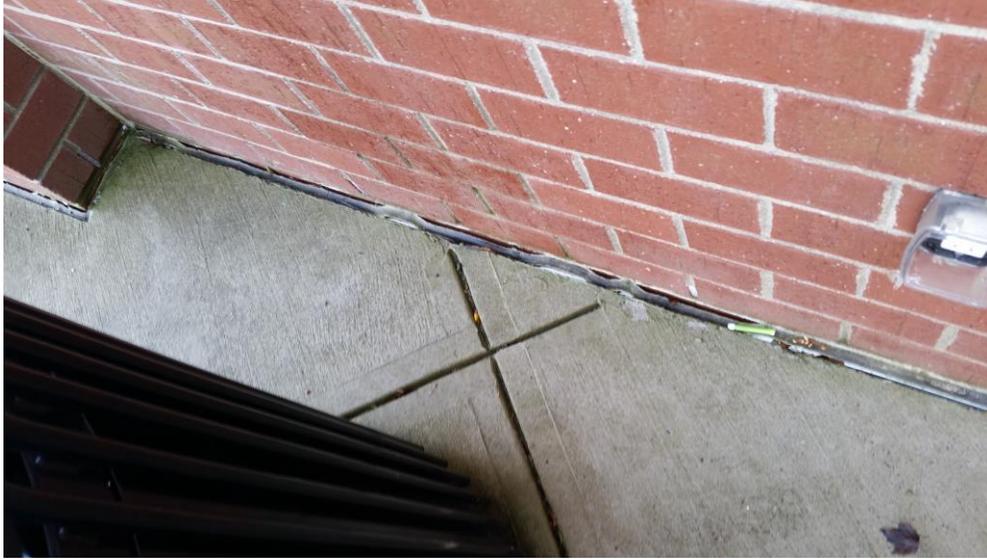
In several areas around the exterior of the school building, a bead of caulking has been installed in the joint between the foot of the brick building walls and the concrete walkways. The caulking prevents weather elements (i.e., rain, snow, and ice) from entering the joint space. As noted in previous reports, the caulking appeared deteriorated in several areas. The caulking used to repair cracks in the walkways also appears to be deteriorating. Although conditions were not indicative of a potential for soil exposures, TRC recommends continuous observation and repair/replacement of the caulking, as necessary. Continued infiltration of weather elements into the joint could eventually separate and deteriorate the walkway.

- 5) **Deteriorated caulking in joint between brick wall and concrete walkway, located on northern side of building.**

- Areas of caulking between the building walls and exterior walkways are continuing to deteriorate. These areas will likely need to be repaired in the future.

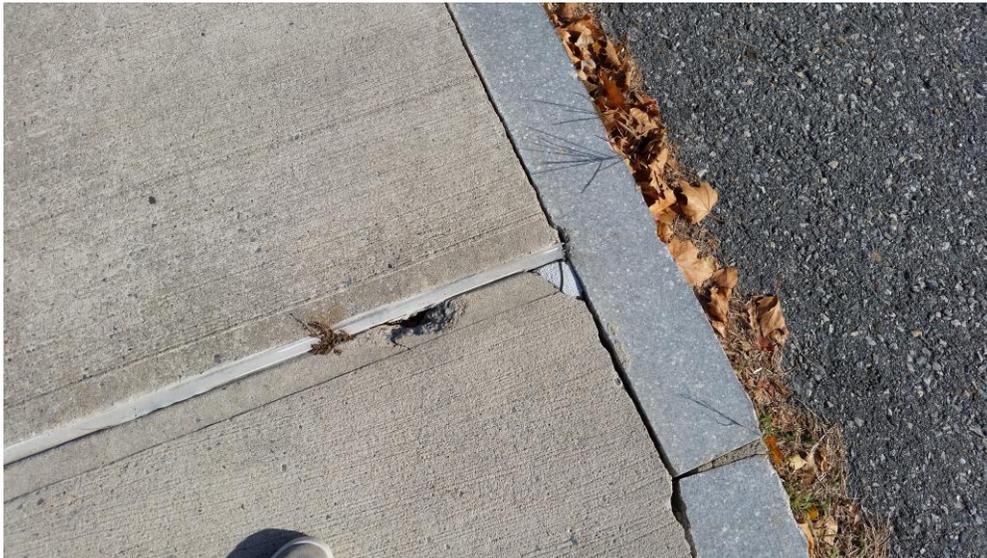
- 6) **Crack in concrete walkway greater than 1/4-inch, located on southeastern side of building.**

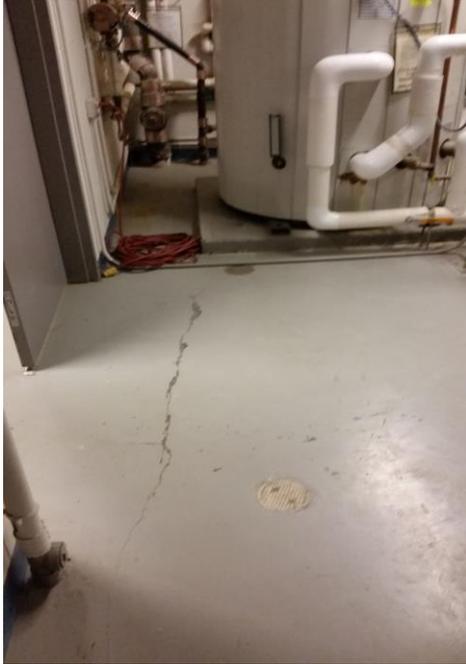
Four cracks in the boiler room floor are less than ¼-inch wide and have not increased in size, see Photograph 7. Three minor cracks in storage room 44 are also less than ¼-inch wide and have not increased in size, see Photograph 8. Three minor cracks in the electrical closet are less than ¼-inch wide, see Photograph 9. Two minor cracks in the main electrical room are also less than ¼-inch wide, see Photograph 10. Approximately eight minor cracks were observed along the eastern hallway, see Photograph 11. The majority of interior concrete floors are covered with tiles or other type of flooring material. Approximately six cracks in the tile in the boys' locker room and one crack in the tile in the girls' locker room were observed, but there was no evidence of damage to the concrete floor underneath, see Photograph 12. Based on visual inspection and conversations with current employees, there are no breaches or other significant damage or deterioration of the interior surficial flooring materials or, where visible, concrete floors. No construction was occurring within the building at the time of the inspection.

7) Crack in concrete floor less than 1/4-inch, located in boiler room.

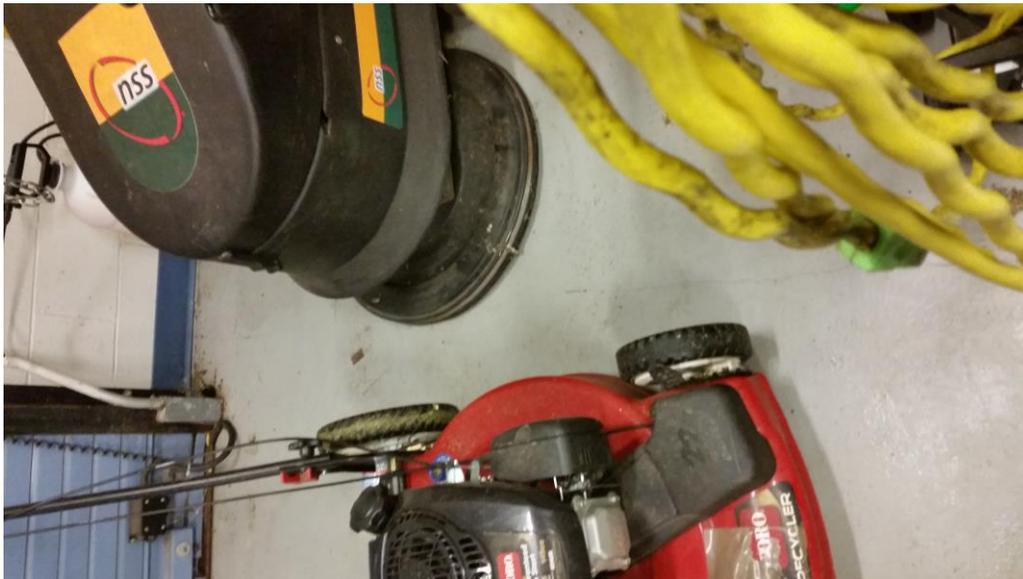
8) Crack in concrete floor less than 1/4-inch, located in storage room 44.

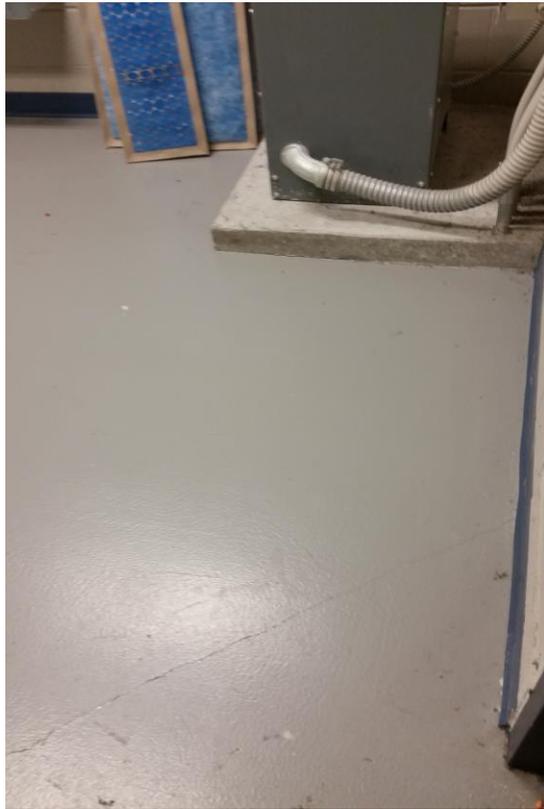
9) Crack in concrete floor less than 1/4-inch, located in electric closet.

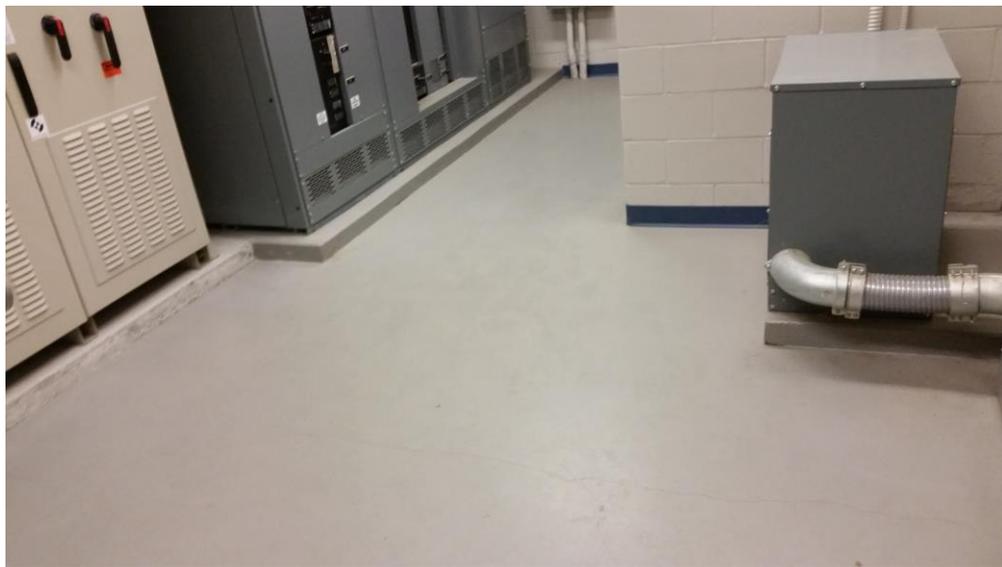
10) Crack in concrete floor less than 1/4-inch, located in main electrical room.

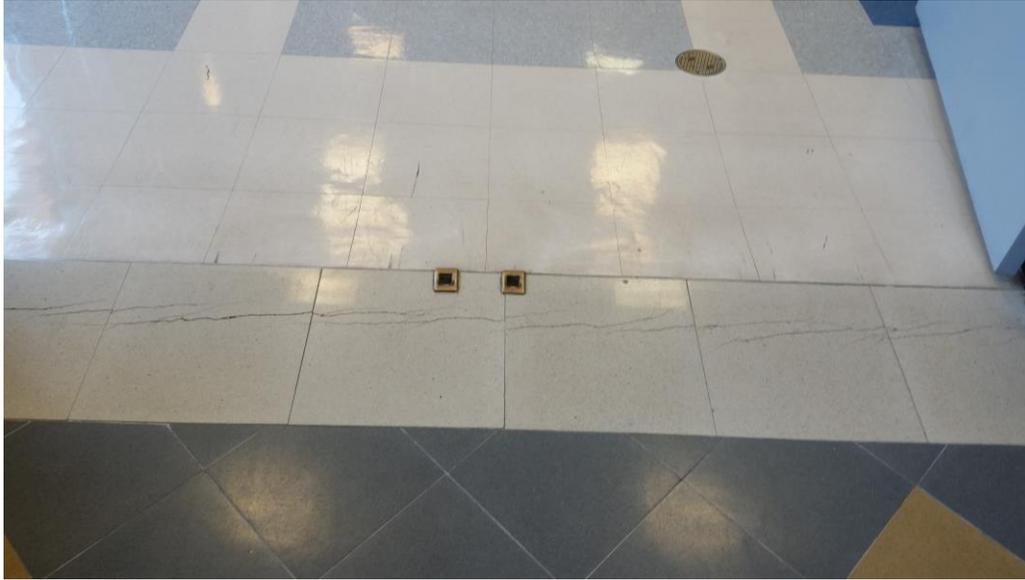
11) Cracks in tile flooring less than ¼-inch, located in eastern hallway.

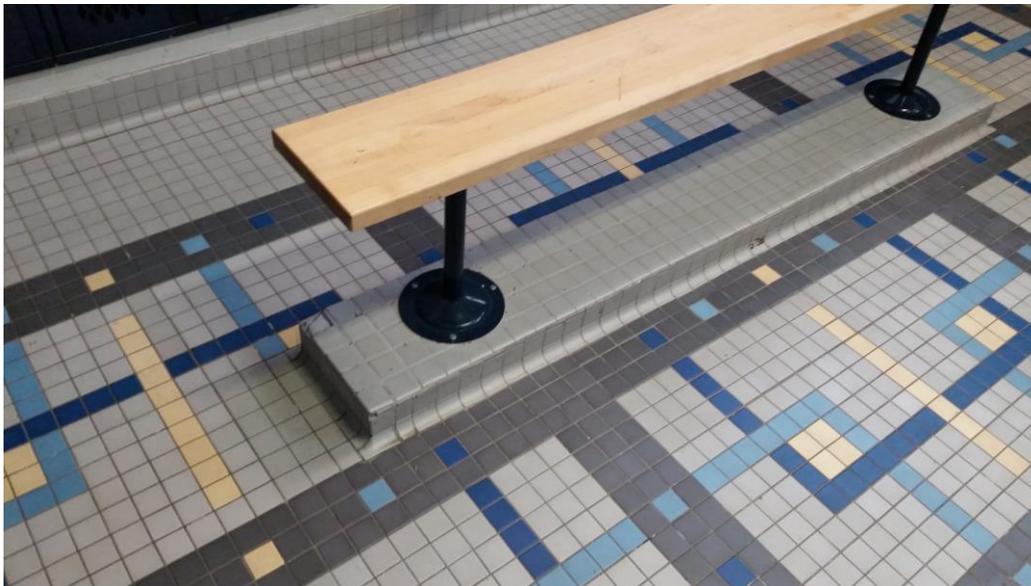
12) Cracks in tile flooring of boys' locker room.

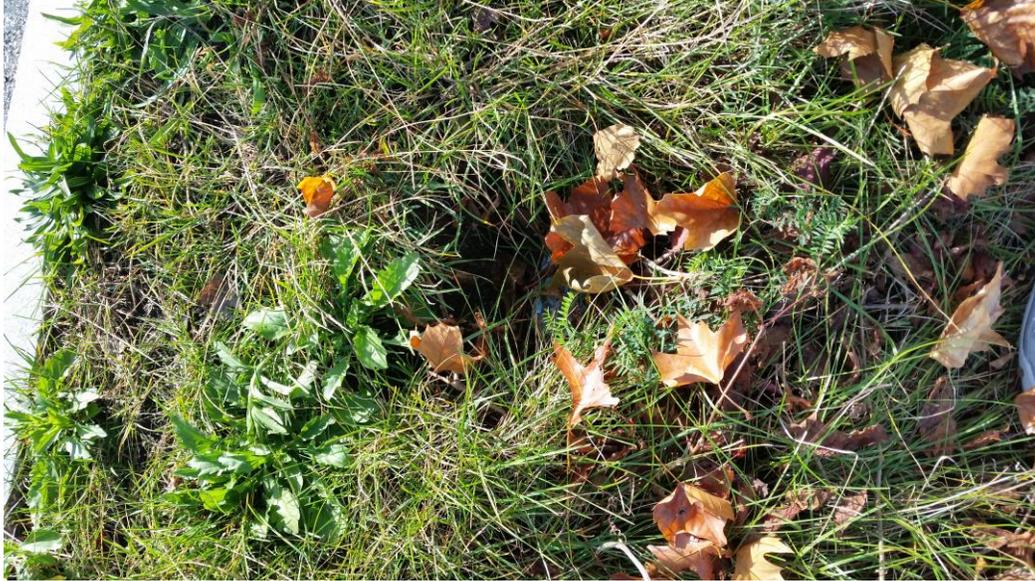
- 1) Two animal burrow holes were observed on the slope to the north of the school near the Corner Sports building, see Photograph 13.
- 2) Potentially deep-rooted vegetation was observed on the slope to the west of the school and should be cut down.
- 3) Exposed separation fabric was observed beneath sparse stone coverage along the western edge of the property, see Photograph 14.

13) Animal burrow hole in slope on northern edge of property.

Repairs to the animal burrow holes on the northern slope near the Corner Sports building were adequate. The two holes TRC observed during this inspection are in new locations and indicate more recent animal activity. No repairs were made to the deep-rooted vegetation and exposed separation fabric on the western side of the property. TRC maintains its recommendation that the issues noted above be repaired before the next inspection in the spring of 2016.

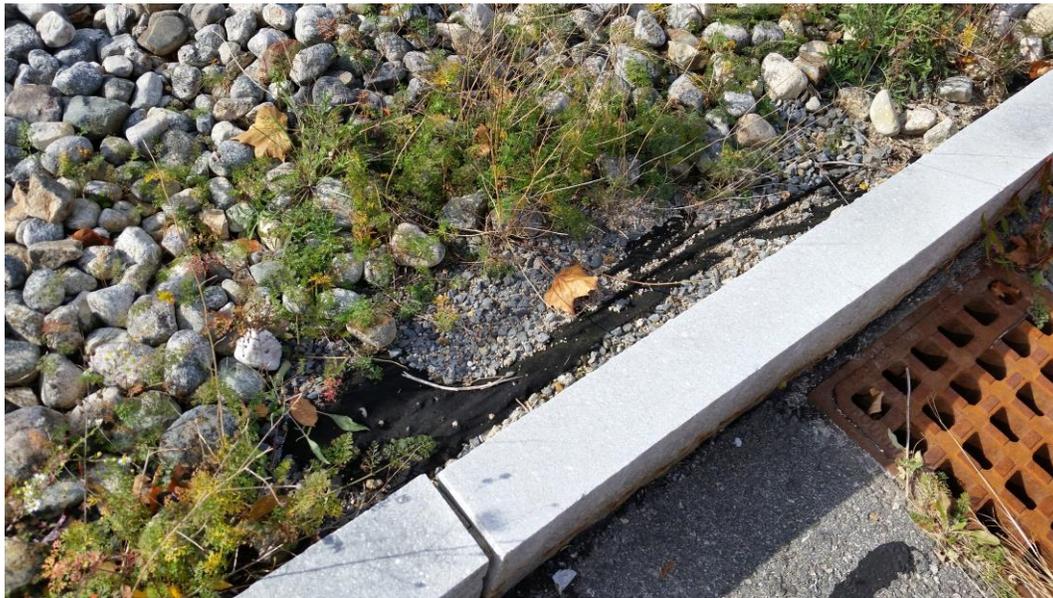
14) Exposed separation fabric beneath sparse stone coverage along perimeter of driveway, located on western side of building.

- Exposed separation fabric was observed beneath sparse stone coverage along the western edge of the property and should be covered to prevent exposure of the contaminated soils below.
- Animal burrow holes were observed on the northern slope and should be filled to restore the integrity of the cap in that area.

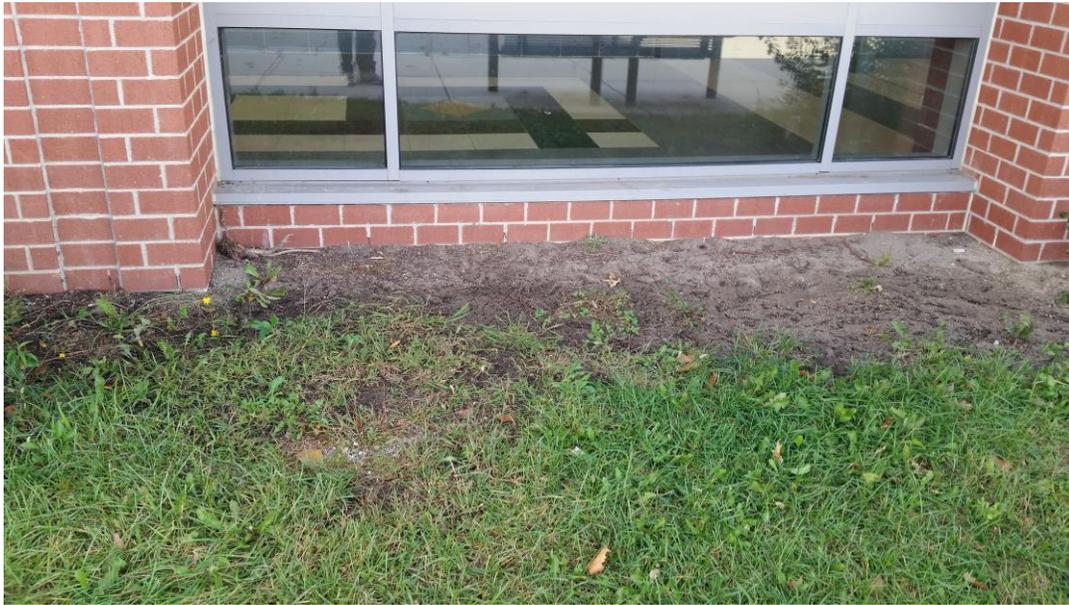
15) Poor vegetative cover over soil inside building footprint, located on eastern side of school.

- Poor vegetative cover exists over cap soils on the eastern side of the building, making the soils susceptible to erosion. This area should be monitored and/or repaired to prevent future damage to the integrity of the cap.
