Subject: Spring 2014 Wetland Inspection
Keith Middle School, New Bedford, Massachusetts

WETLAND SEDIMENT INSPECTION FORM
KEITH MIDDLE SCHOOL

SITE PHOTOGRAPHS
May 2014 Wetland Inspection
Keith Middle School
New Bedford, Massachusetts

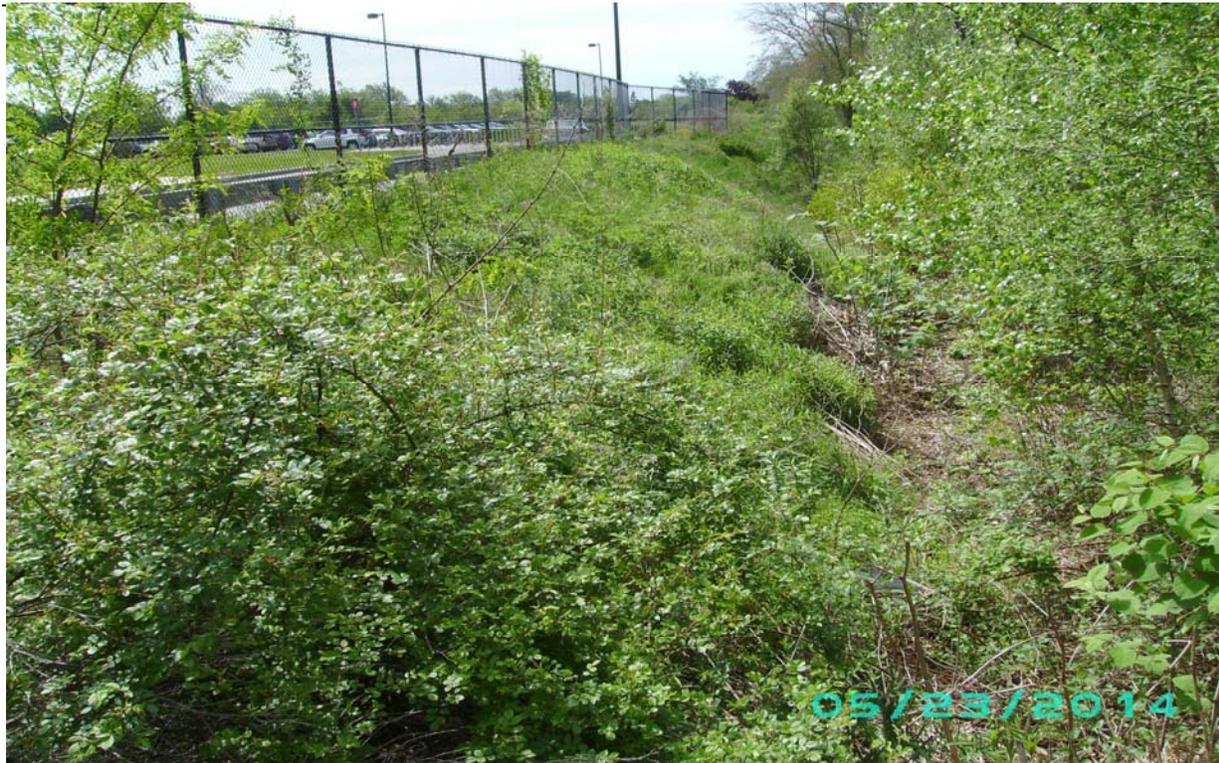
1) Slope in southern portion of wetland/cap edge looking south. Vegetation is well established on the slope.

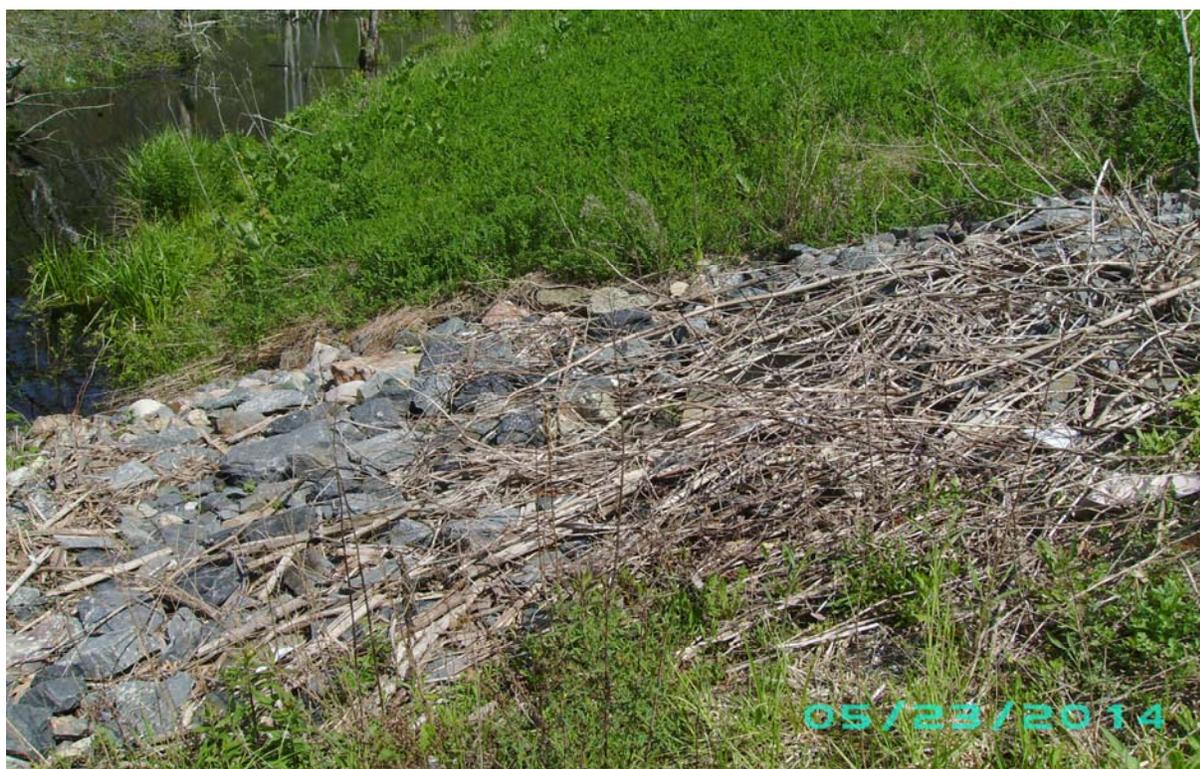
Several small stands of the invasive plant Japanese knotweed (*Polygonum cuspidatum*) that were formerly present in the vicinity of stormwater outfalls and in the central portion of the wetland/cap slope have been previously treated with herbicides. In addition, small tree saplings comprised primarily of black locust (*Robinia pseudoacacia*) have also been treated with an herbicide. It appears that these applications were effective in greatly reducing knotweed abundance along the cap slope. Currently, stands of Japanese knotweed that require herbicide treatment are not present. Tree saplings appear to also have been adversely affected although one black locust tree sapling remains near the toe of the northwestern landfill slope.

4) Past evidence of herbicide application for Japanese knotweed stand at outfall location.

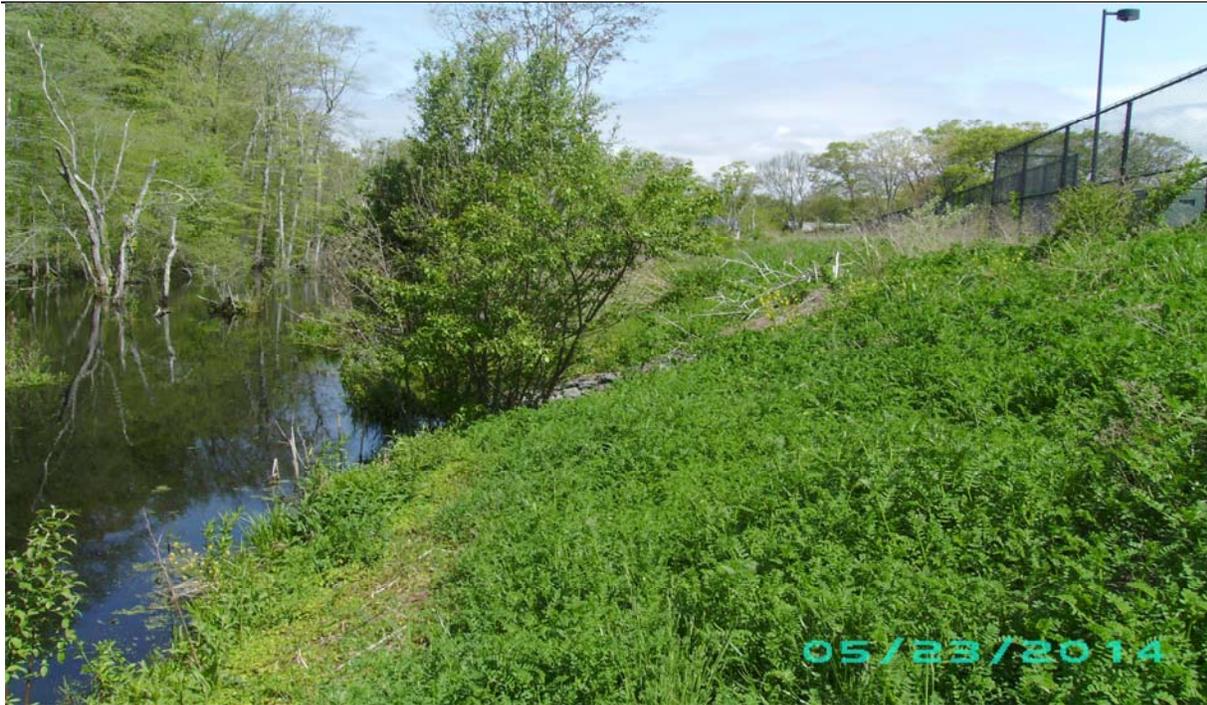
5) Stabilized slope along northwestern cap looking north. Note willow saplings along pond edge.

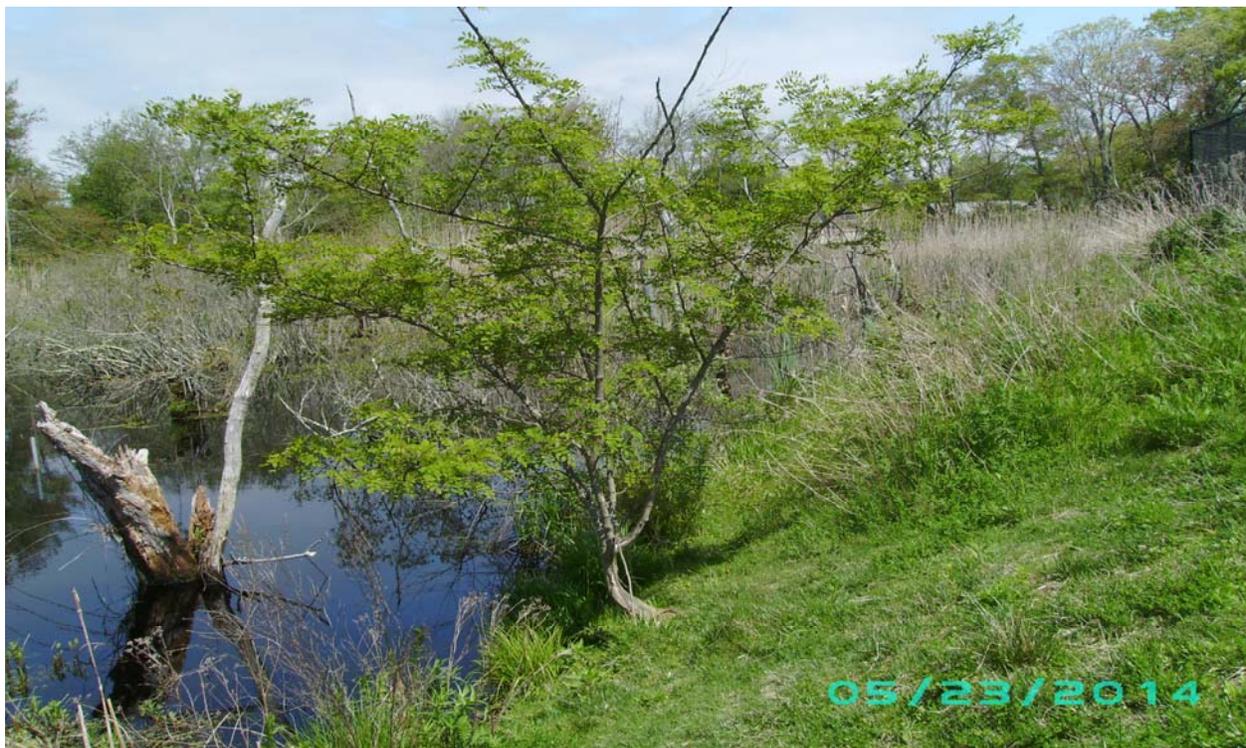
6) Black locust sapling along toe of slope. Tree is stressed but surviving despite 2013 herbicide application.

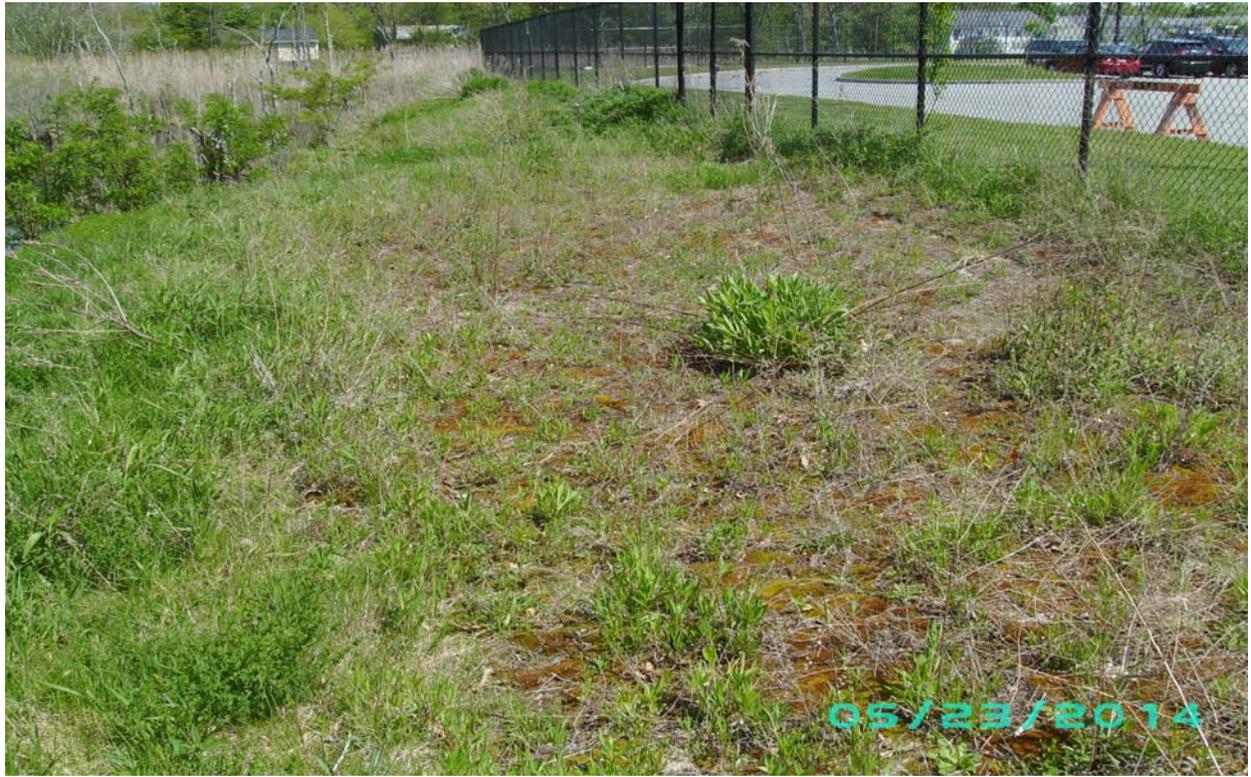
In general, the slope extending down to the wetland from the parking lots and rear school access drive is well vegetated with grasses and herbaceous plants. The predominant vegetation noted on the slope of the landfill cap include grasses, vetch, sheep sorrel, birdsfoot trefoil, mugwort and black swallowwort. Overall, no evidence of erosion or sedimentation into the adjacent wetland was noted during the site inspection. Slopes previously noted as having thin vegetative cover were evaluated and, although plant cover remains thin, these slopes were stabilized.

7) Sparsely vegetated northwestern portion of cap. Area is stabilized.

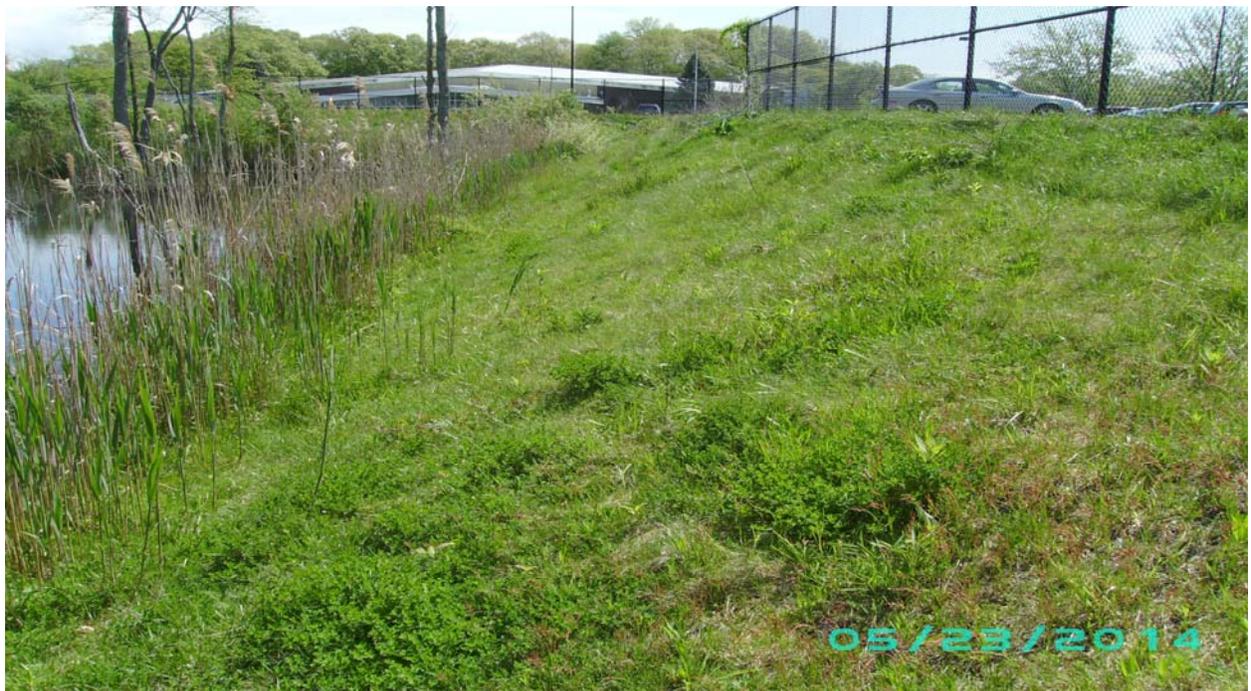
8) Northern portion of wetland/cap slope.

An apparent area of slight slumping (i.e., approximately one to two inches in height) was previously noted in the northern portion of the cap slope during the 2012 and 2013 inspections. However, this area was not apparent during the latest inspection and appears to be obscured by dense vegetation.

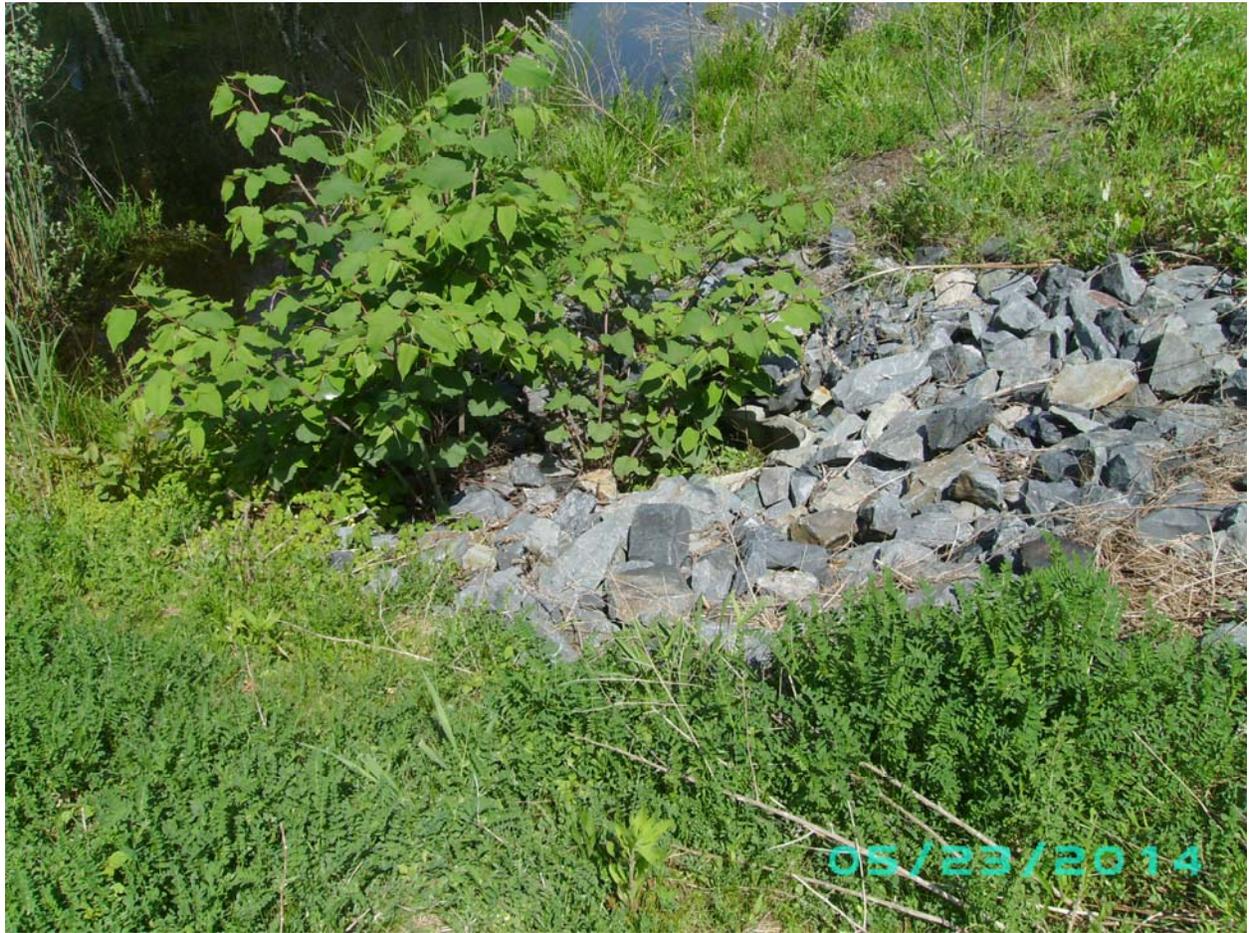
9) Small stunted stand of Japanese knotweed associated with outfall in central portion of slope.
