CLE BUILDING INSPECTION REPORT

Project: Alma Del Mar Charter School

Exterior Building Envelope Condition Survey

Report No.: ADM-01.10.24.2014
Inspection Date(s): 10.14.2014
10.15.2014
1.016.2014
Report Date: 10.24.2014

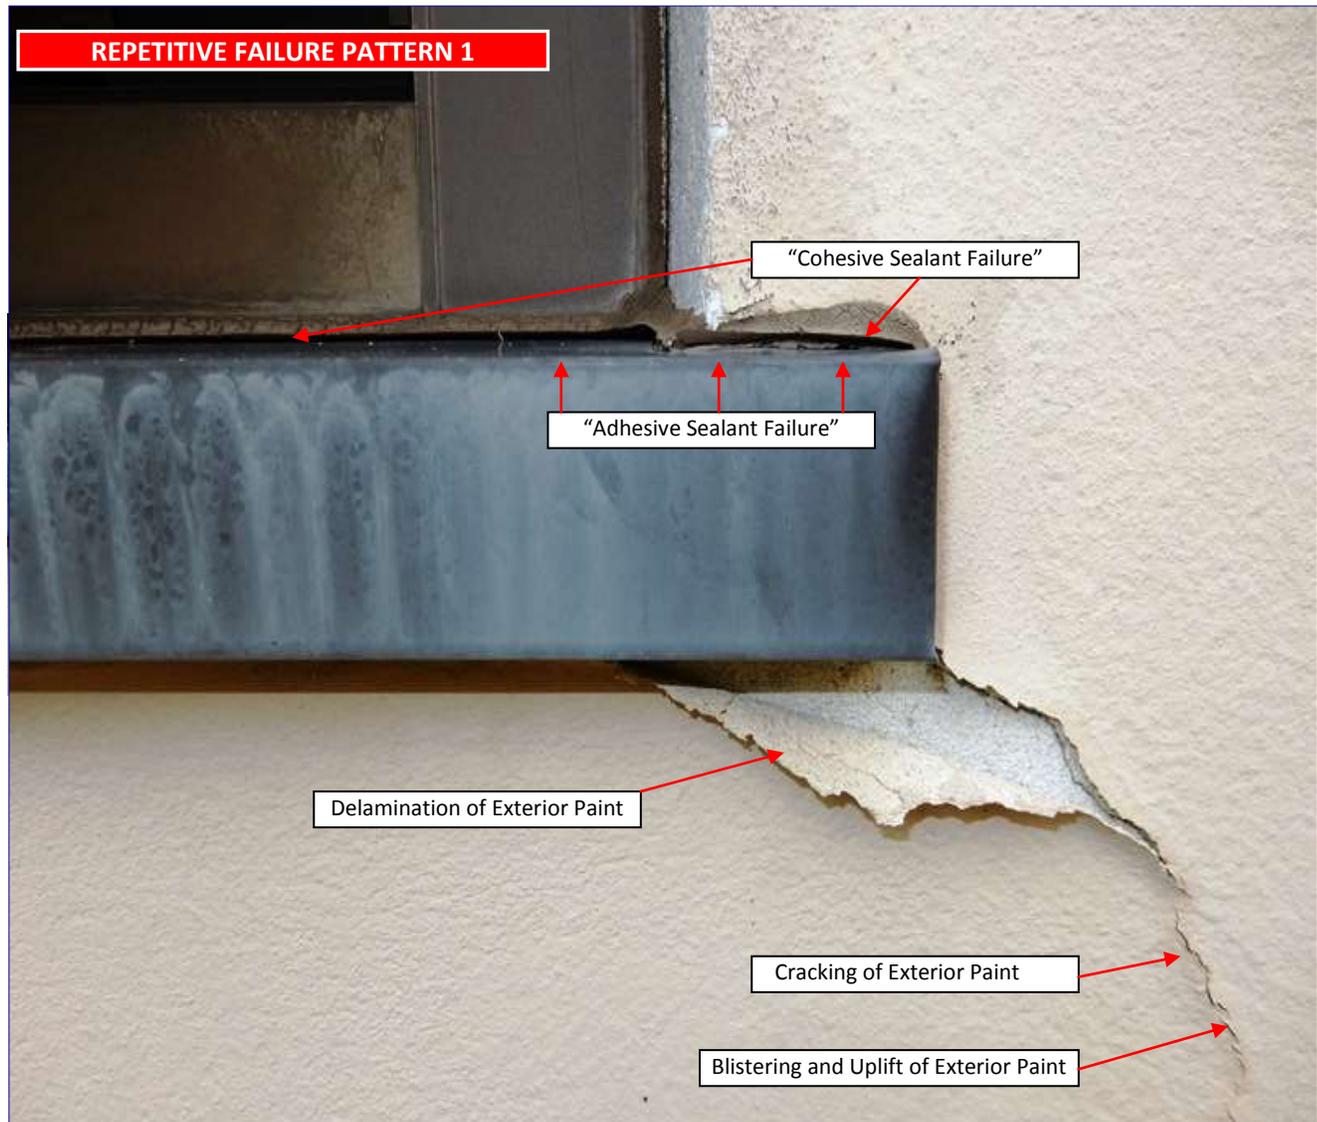
The above photo demonstrates a primary repetitive failure pattern found at the Alma Del Mar project site. The pattern contains:

1. Radial cracking of stucco at the corners of punched openings.
2. Adhesive Bond-Line Sealant Failure.
3. Cohesive Sealant Failure.
4. Flaking, Peeling, Blistering, & Delaminating Paint.

All of these conditions will continue to occur, and water intrusion exacerbated, without timely repair and maintenance.

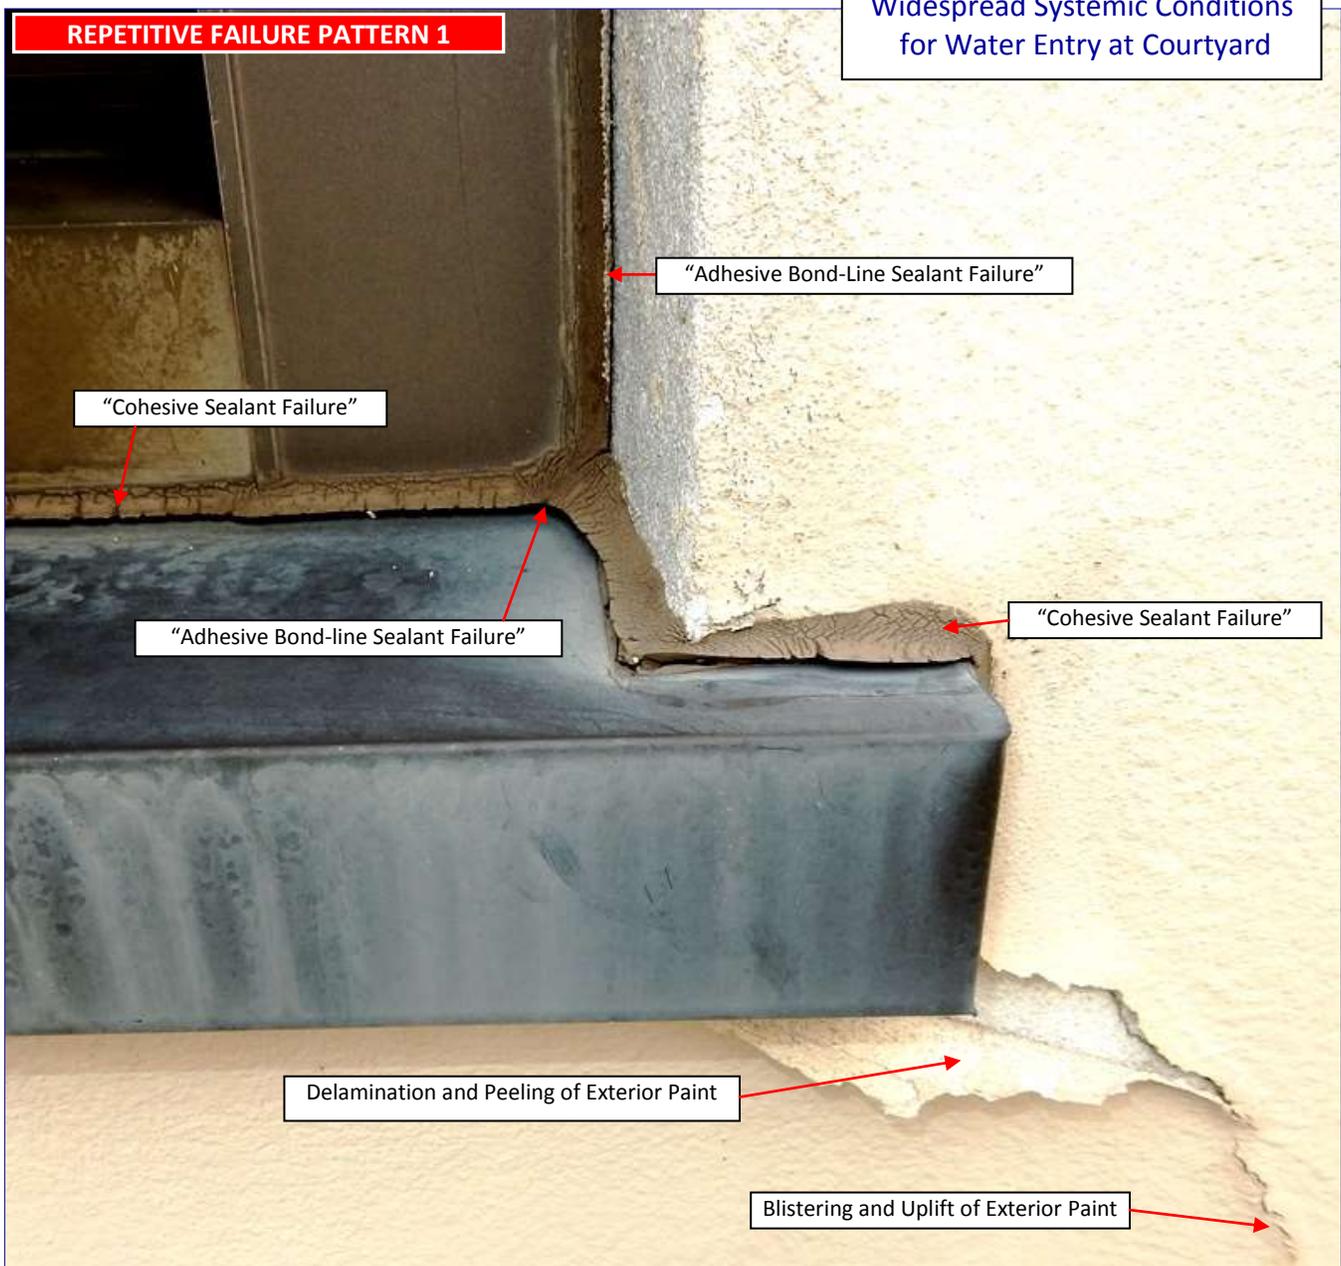
Widespread Systemic Conditions for Water Entry at Courtyard

The above photo shows the same repetitive failure conditions, all of which stem from interface failure of dissimilar materials – caused by direct material failure and moisture uptake. These conditions are widespread and clearly evident, and they create an exterior envelope condition which is highly susceptible to water penetration.

Maintenance must be undertaken to ensure that the exterior building skin maintains continuity between dissimilar materials. Materials must be correctly selected for each application, and they must be installed in the proper manner to achieve functional service life. Although relatively new aluminum retrofit windows have been installed, the perimeter sealant conditions documented above are capable of allowing water migration into interior wall regions.

Left unmitigated, these conditions will continue to accelerate breakdown of an already aged and failed envelope system.

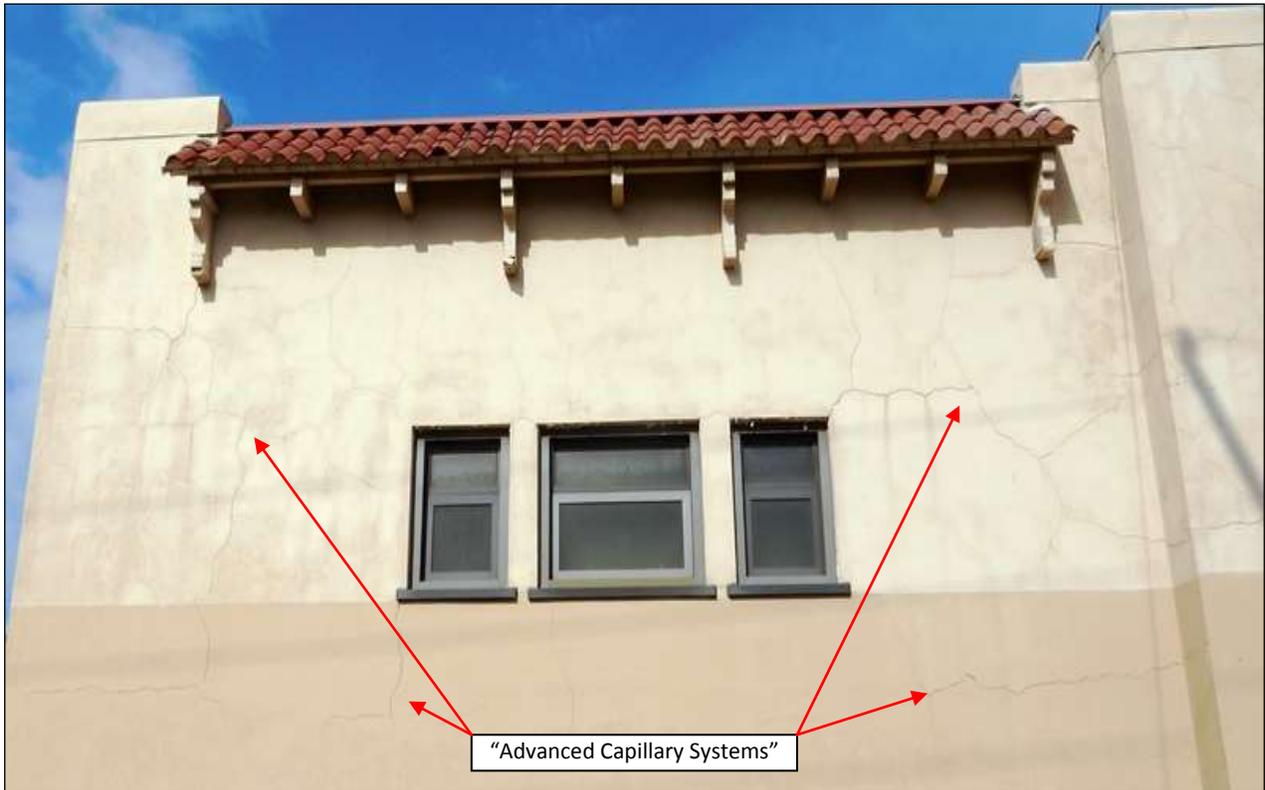
Rilem Tube Testing indicated immediate uptake and transport of water to the interior side of stucco system. Sounding of the stucco system indicates multiple pockets of delamination at interior layers. If ongoing water intrusion remains unchecked, these regions will remain vulnerable to further breakdown and experience increased susceptibility to collapse and separation from the interior structural wall assembly.

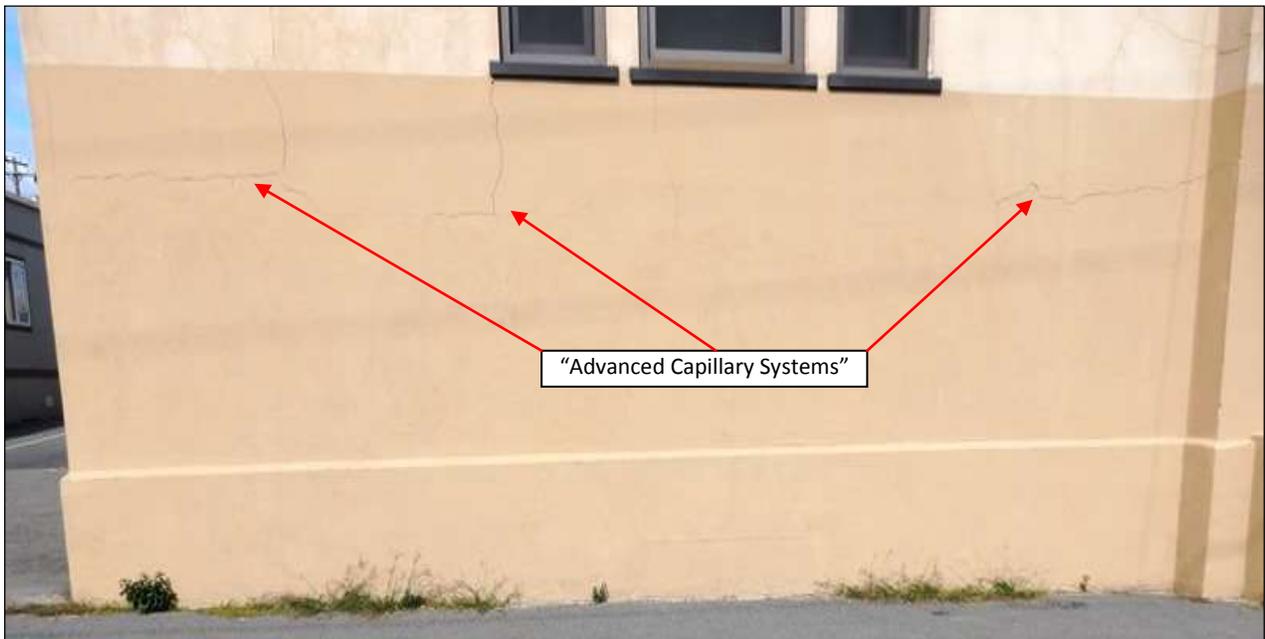
Examples of compounding surface conditions from moisture uptake and water penetration past surface layers.

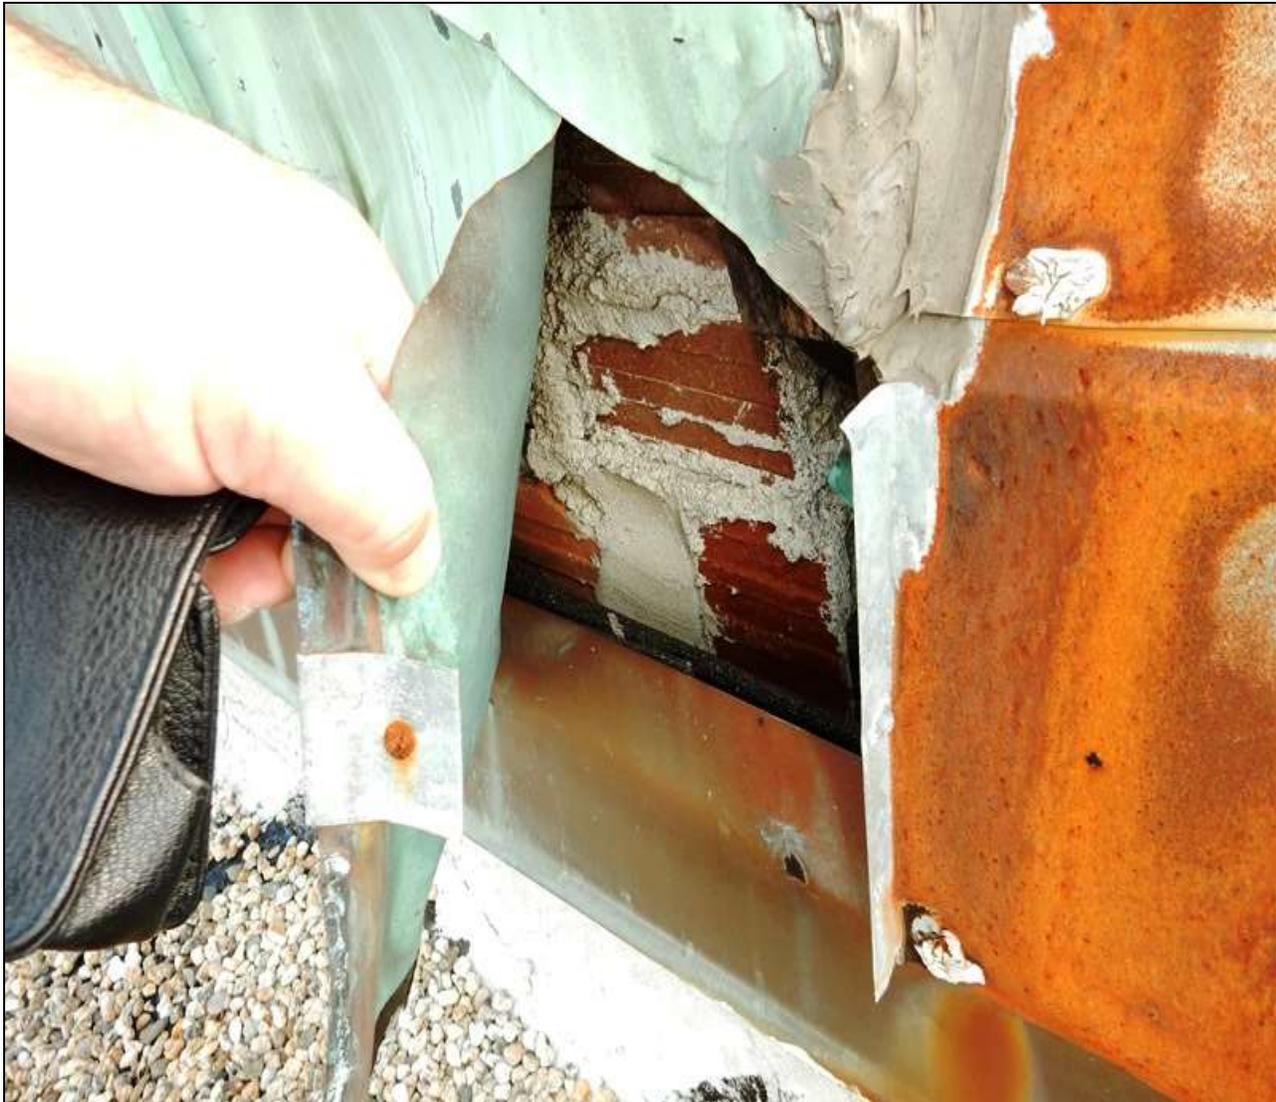
Multiple Areas of Missing and/or Damaged Interior Parapet Skin

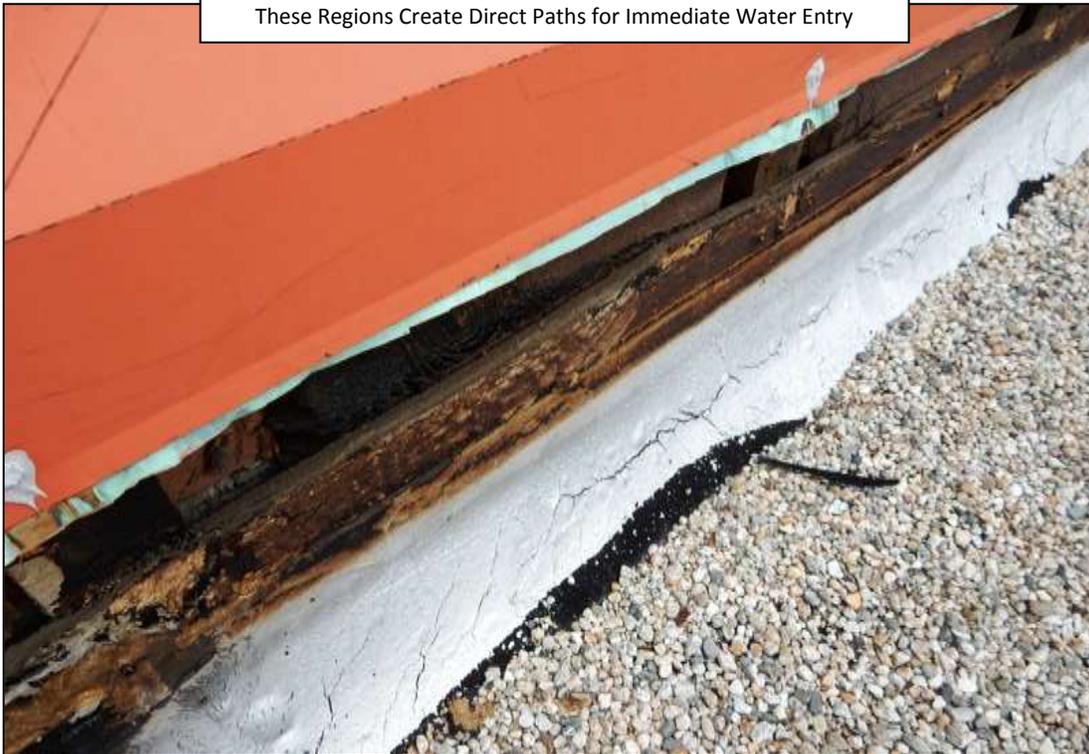
Multiple Areas of Missing and/or Damaged Interior Parapet Skin.
These Regions Create Direct Paths for Immediate Water Entry

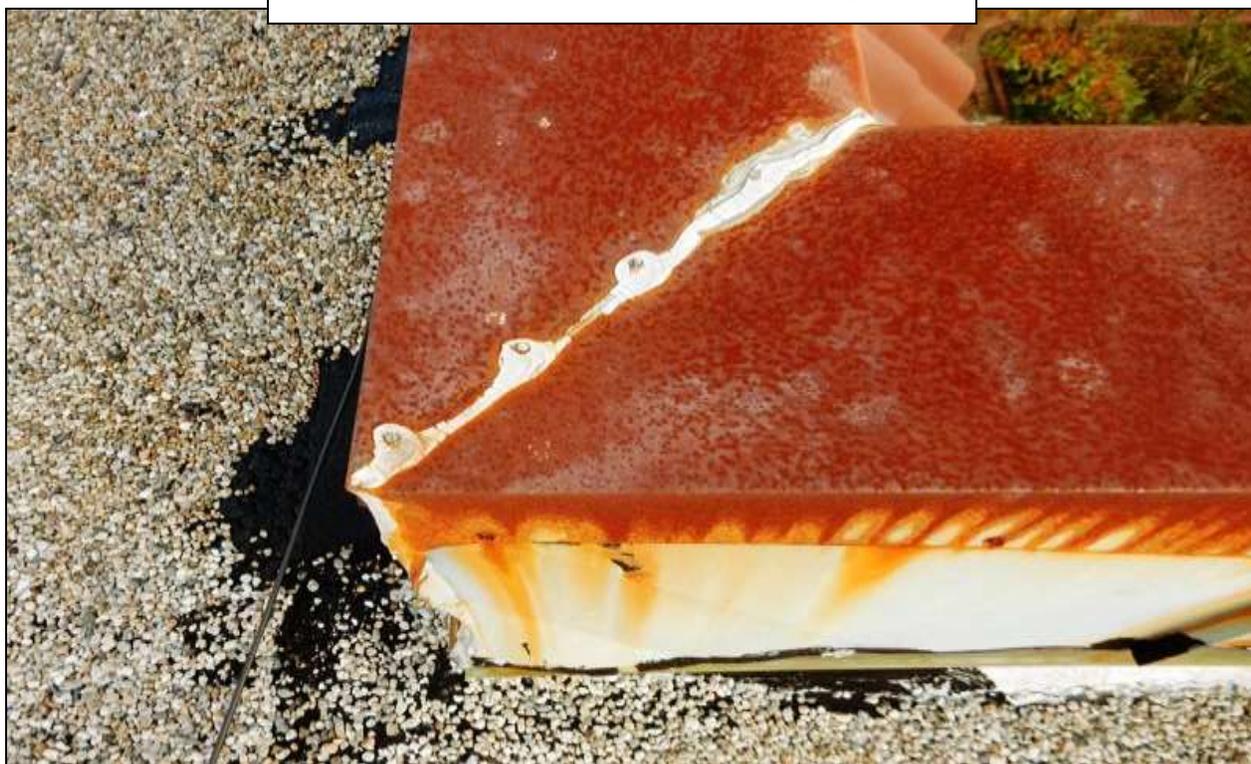
Parapet Metal System in Advanced State of Material Degradation

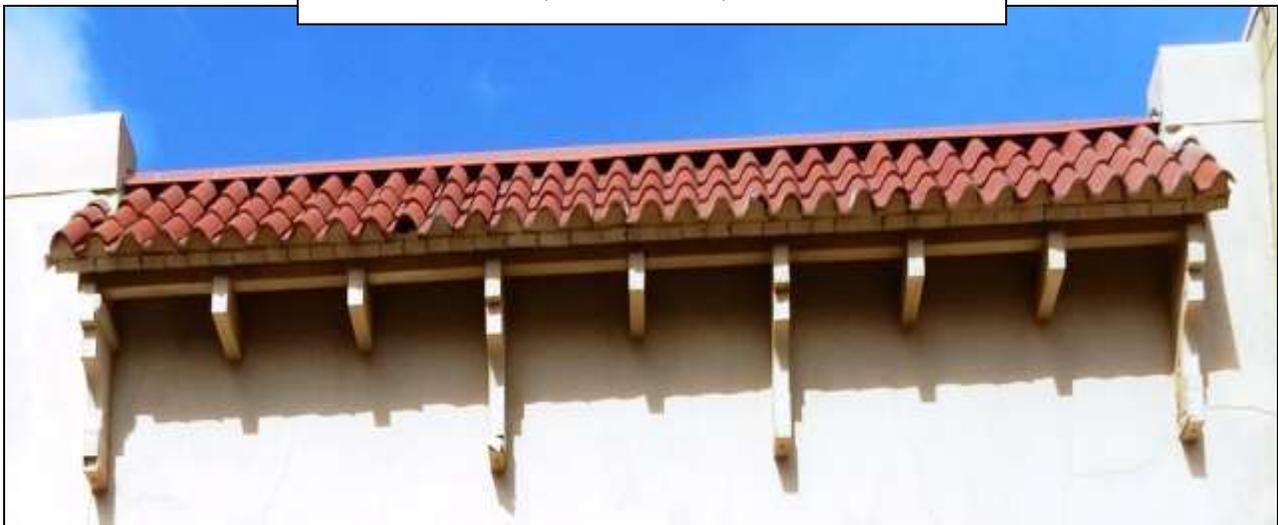
Broken Tiles and Exposed WRB Tar Paper Exist in Some Areas

There are areas where the tiles are damaged and the WRB’s tar paper is torn and the underlying plywood substrates are exposed. Some surface decay of the plywood and decking are evident.

Repairs will be needed to mend the WRB and maintain water resistivity.

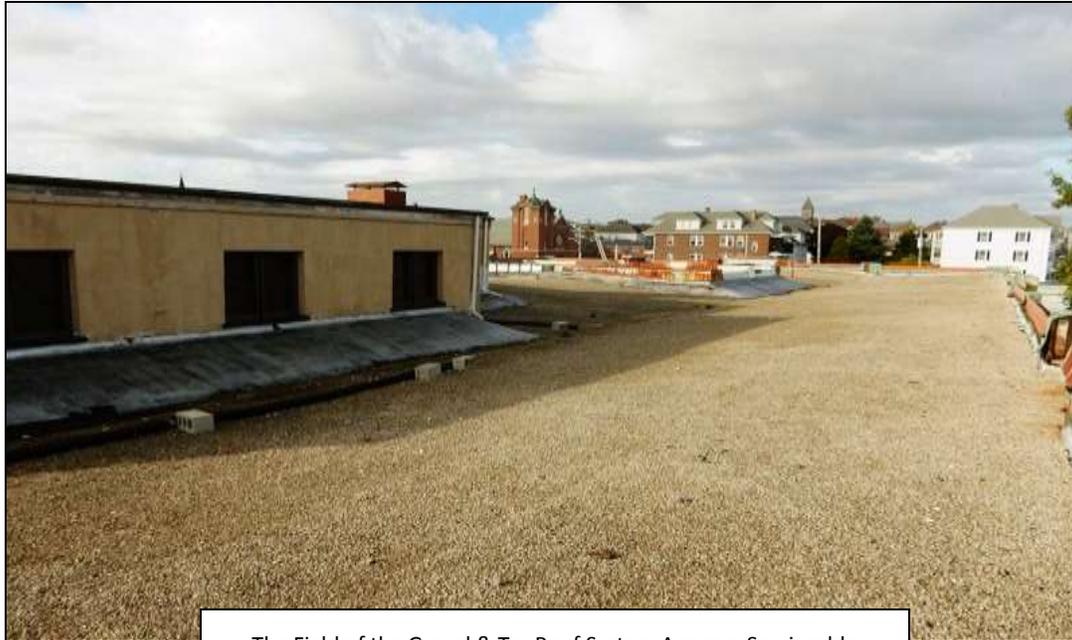
The Field of the Gravel & Tar Roof System Appears Serviceable

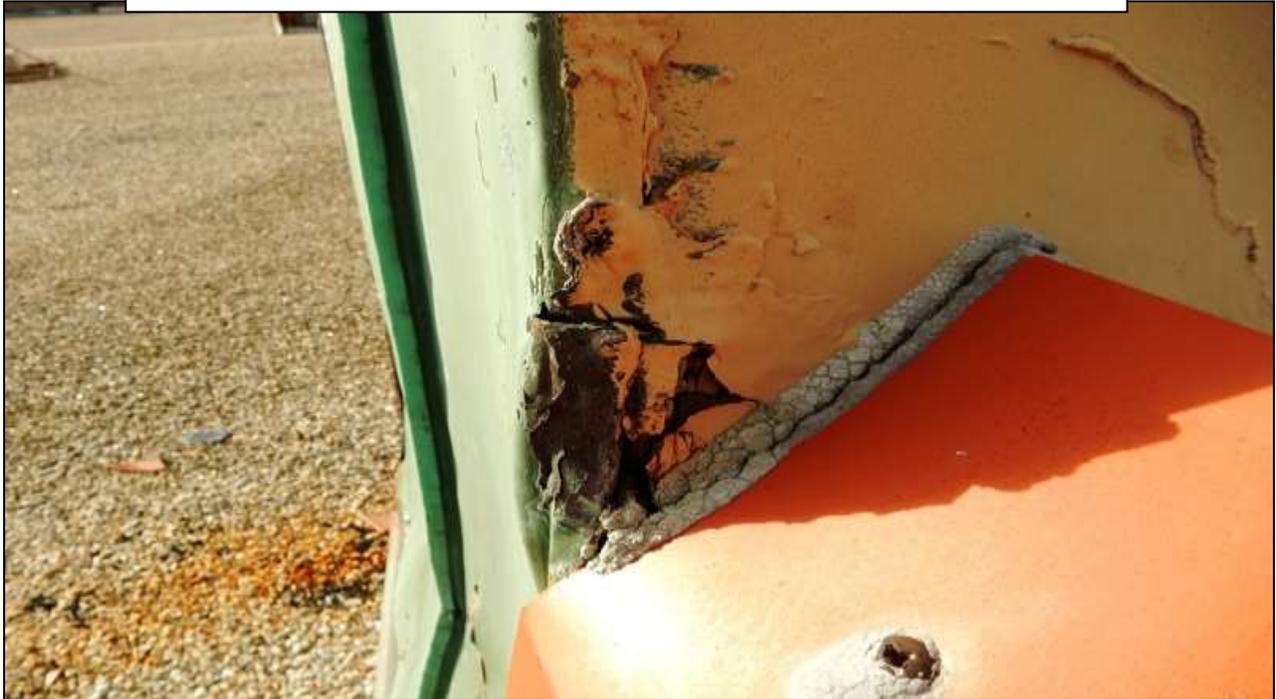
Transition Areas Are Vulnerable Due to Breakdown and May Provide Pathways for Water Entry

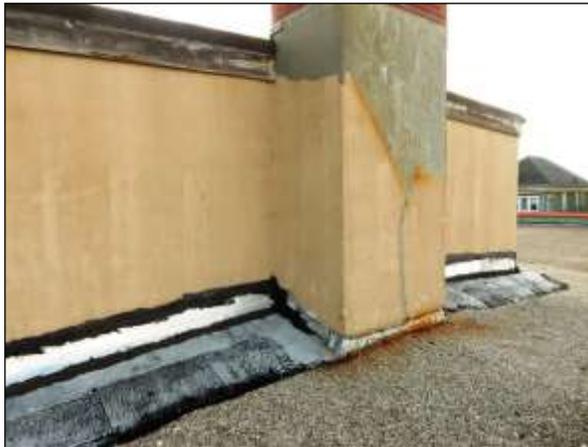
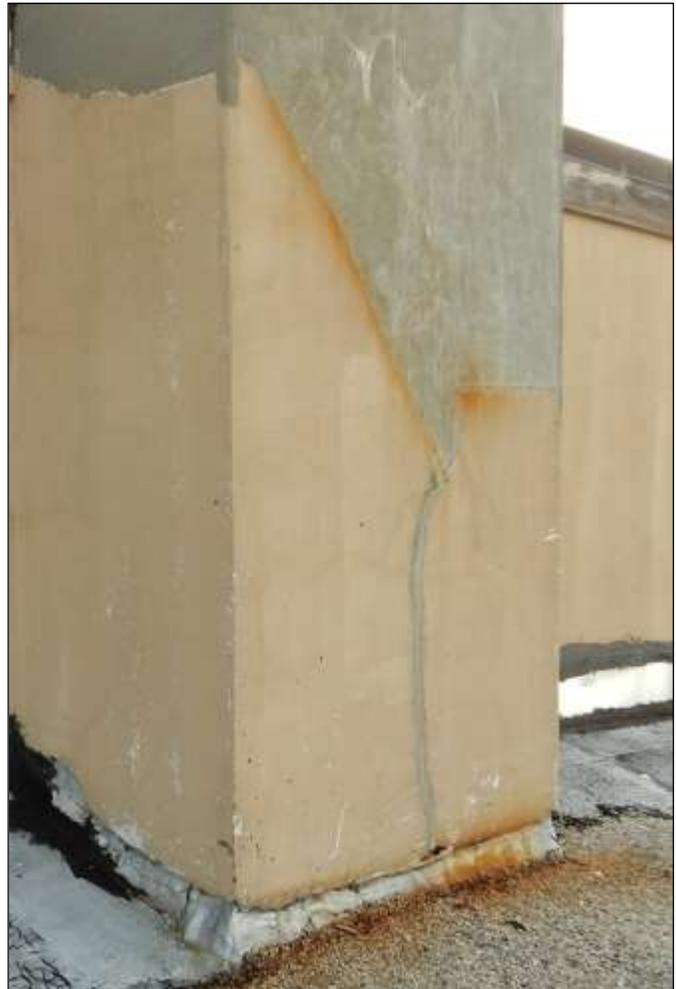
The stucco system at the roof has capillary systems which have allowed water and moisture uptake. Rust and corrosion of interior components is evident in the form of surface discoloration.

Water gaining access to the interior side of the stucco system may be migrating underneath the roofing membrane system as well.

These areas require attention to ensure that no further damage occurs and that vulnerability to water penetration is eliminated.

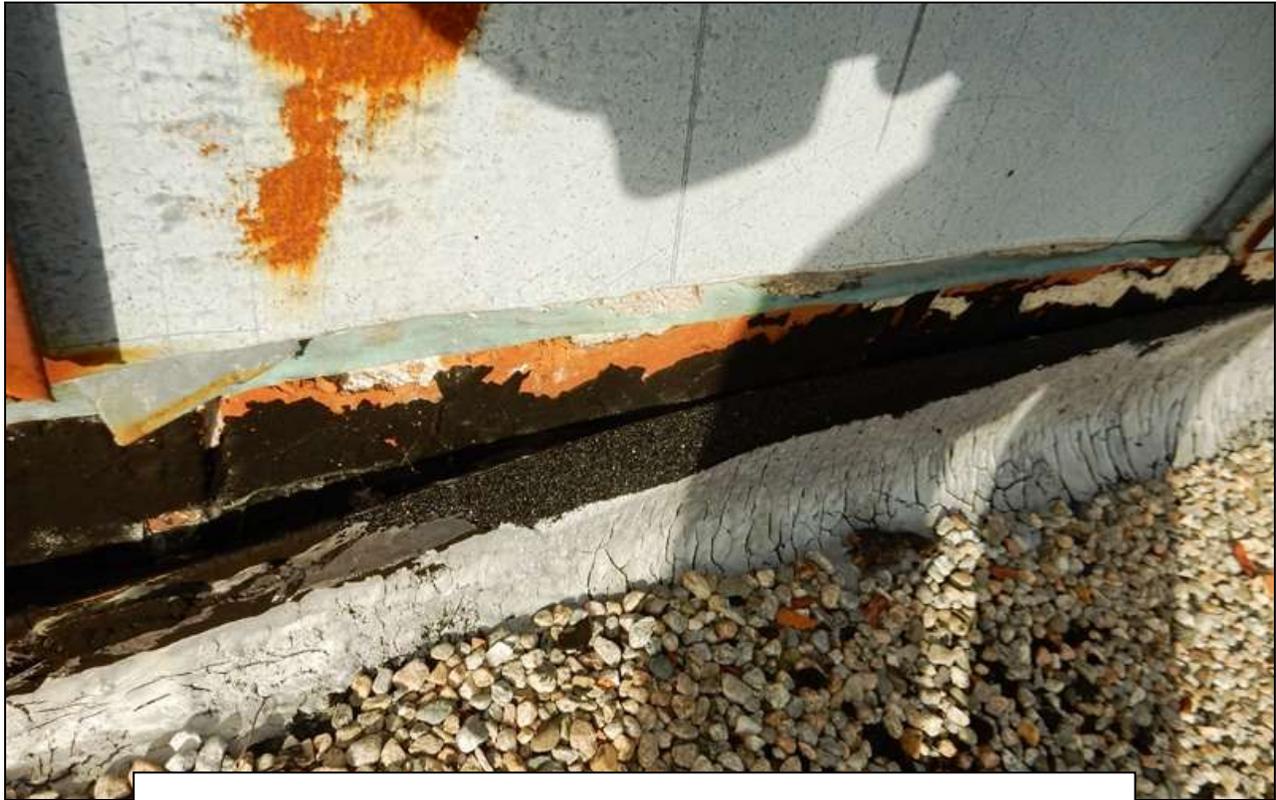
Transition Areas Are Vulnerable Due to Breakdown and May Provide Pathways for Water Entry

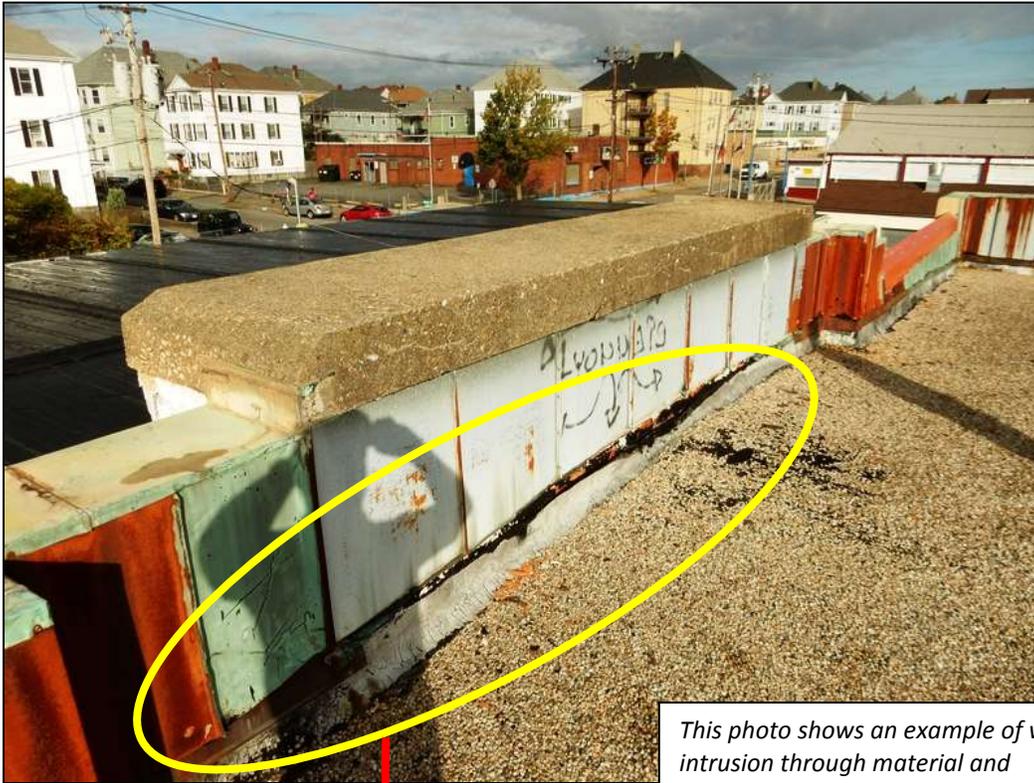
This photo shows an example of water intrusion through material and transitional interface failure. The photo below shows a moisture meter reading detecting elevated moisture content in the structural framing members located below the leak area.

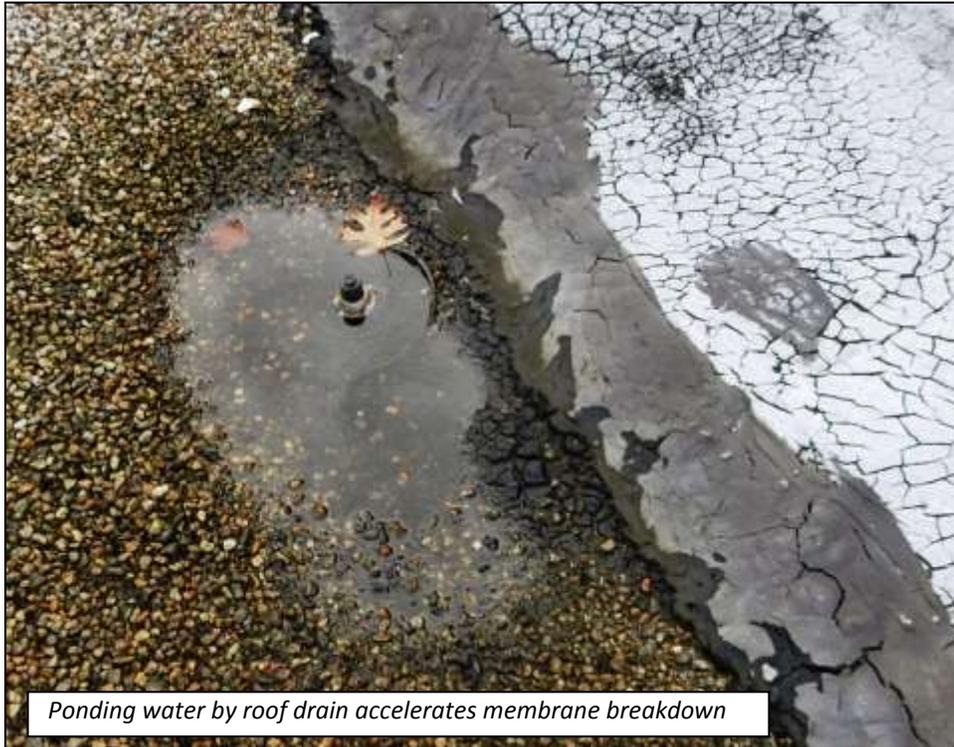
Ponding water by roof drain accelerates membrane breakdown

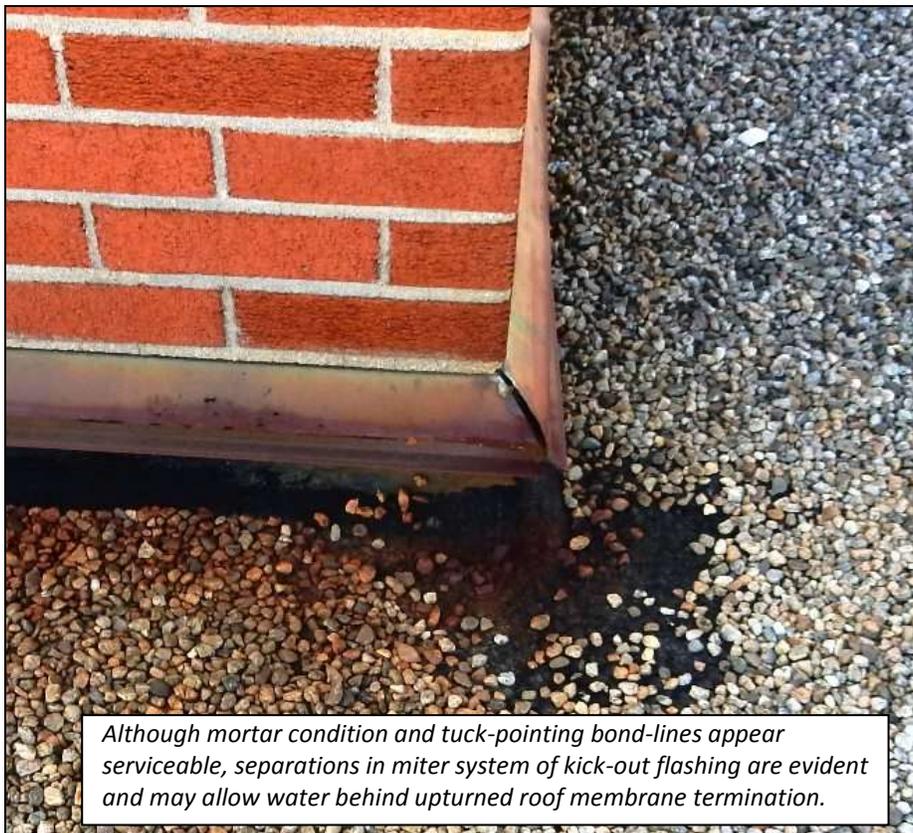
Although mortar condition and tuck-pointing bond-lines appear serviceable, separations in miter system of kick-out flashing are evident and may allow water behind upturned roof membrane termination.

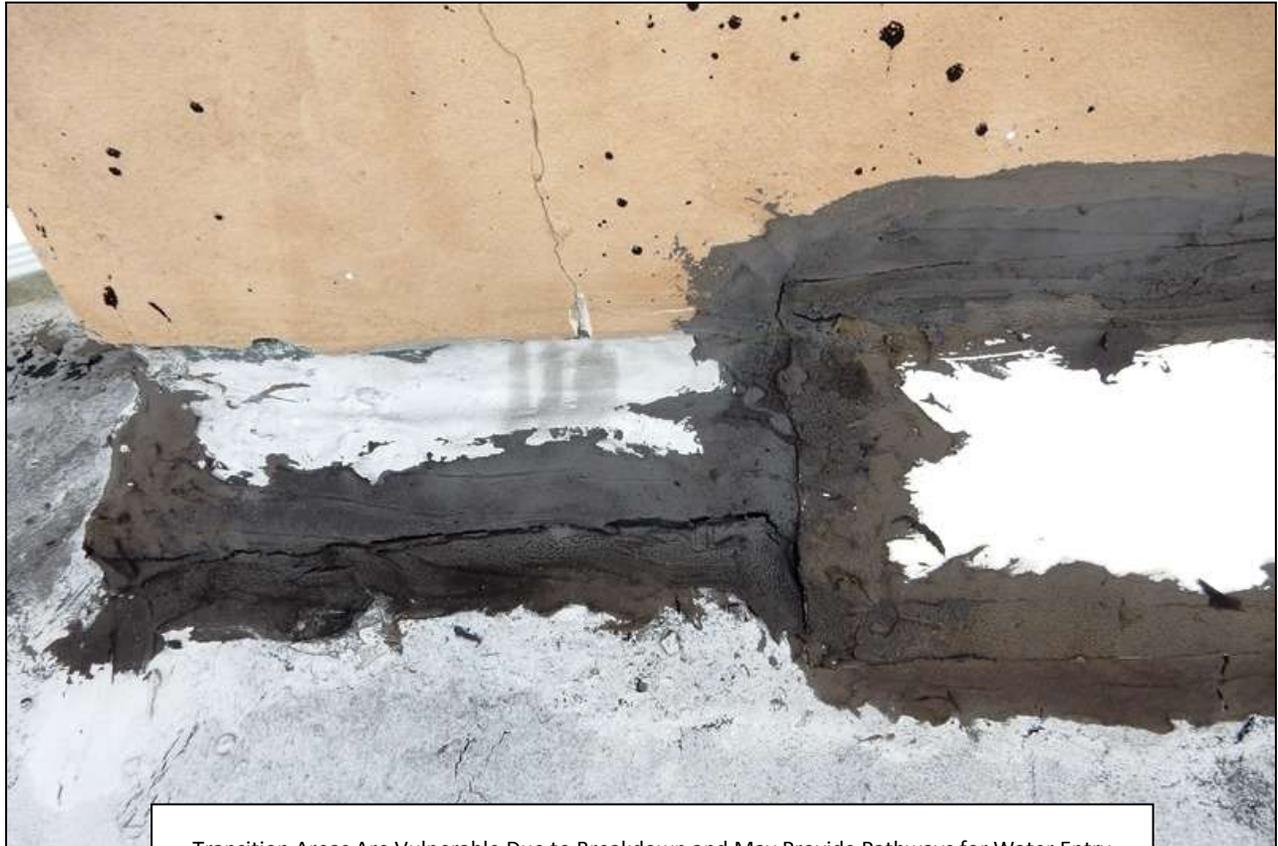
Transition Areas Are Vulnerable Due to Breakdown and May Provide Pathways for Water Entry

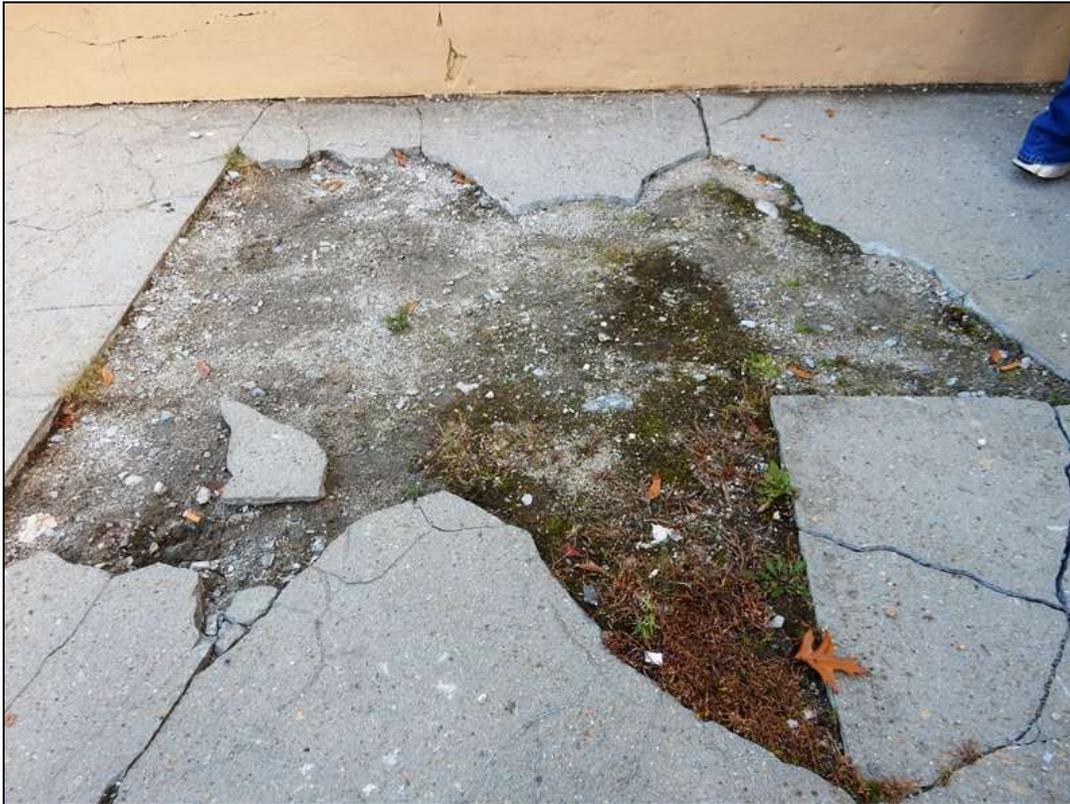
The concrete sidewalk system also manifests damage and breakdown, and the above photo shows an area that poses a trip-hazard and potential life-safety issue.

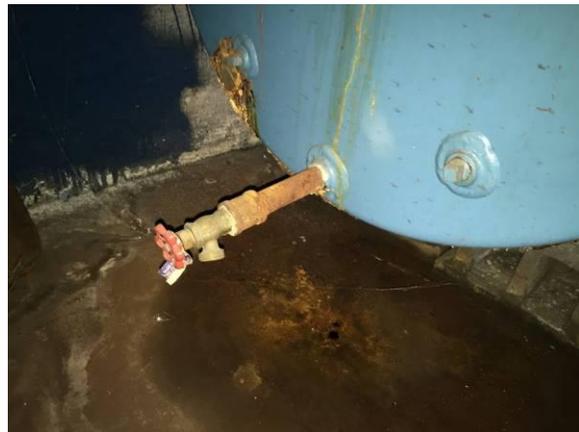
Boiler Feedwater Tank with Repaired Leak

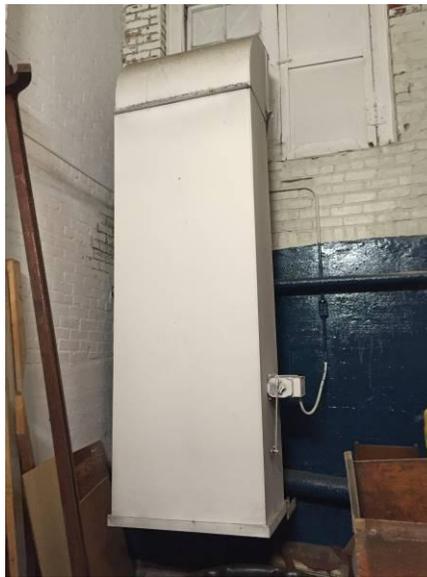
Boiler Combustion Air Ductwork

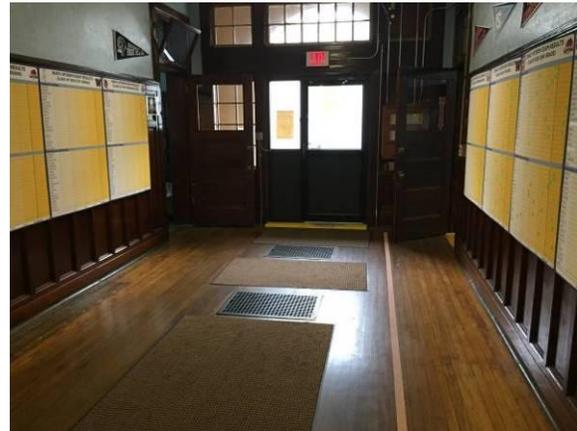
Abandoned Ventilation Floor Grilles

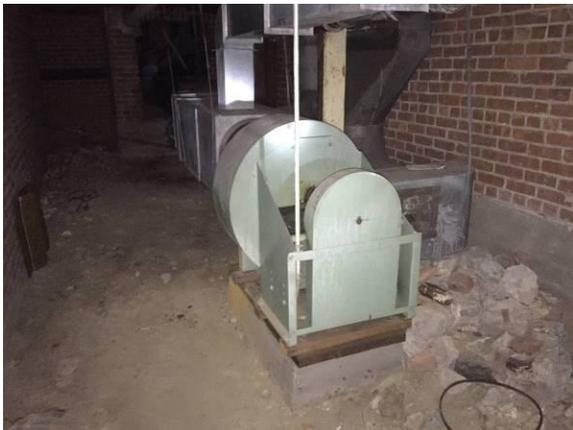
There is an inoperable exhaust air fan that is located in one of the tunnels located below the building. It is our understanding that the fan has not been used for several years. The associated exhaust air ductwork appears to be in fair condition.

Exhaust Fan in Tunnel (Abandoned)

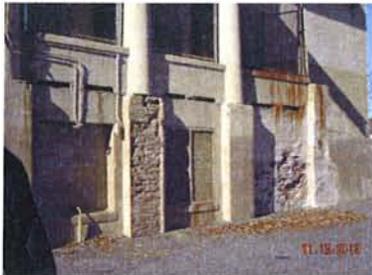
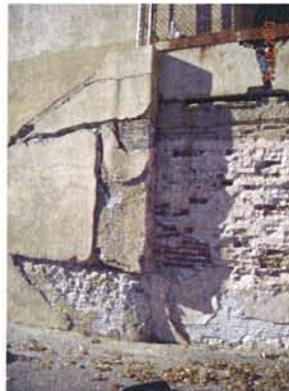
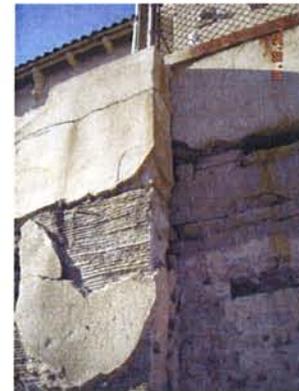
2. The stucco finish at the eastern porch/colonnade has severely deteriorated as well, as shown in the photos below.

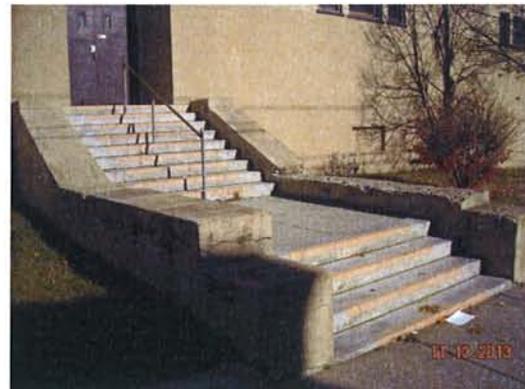
3. Concrete entry stair walls and landings along the north and south sides of the building are in poor condition and are in need of repair/replacement (photo right). The damage observed appears to be moisture and age related. These conditions will deteriorate at an increasing rate as moisture continues to infiltrate the construction, and freeze-thaw action occurs.
