Fort Taber / Fort Rodman
New Bedford, Massachusetts

**Architectural / Structural Assessment
& Feasibility Study for Universal Accessibility**

Final Report

Bargmann Hendrie + Archetype, Inc.
Boston, Massachusetts

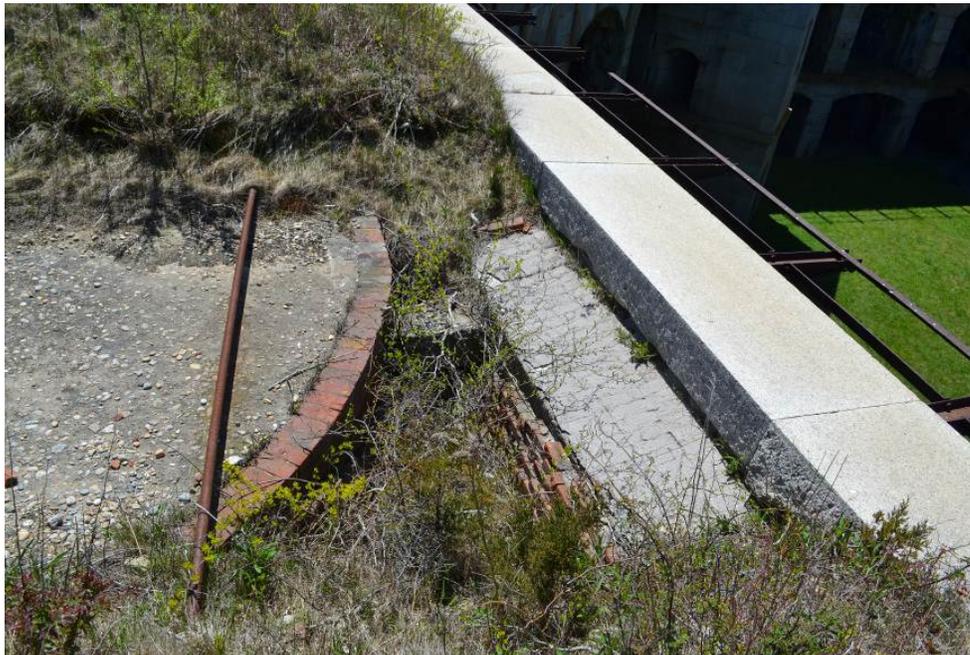
Figure 20. Excavated area of roof reveals concrete foundation for gun emplacements.

Extensive water is seeping through the terreplein and draining down to the masonry ceiling vaults, walls, and arches below. To prevent further water deterioration, it is recommended to remove the earth fill above the casemates and barracks and stockpile suitable material for reinstallation. Introducing a waterproof membrane roofing system and flashings could prevent the water from further deteriorating the masonry below.

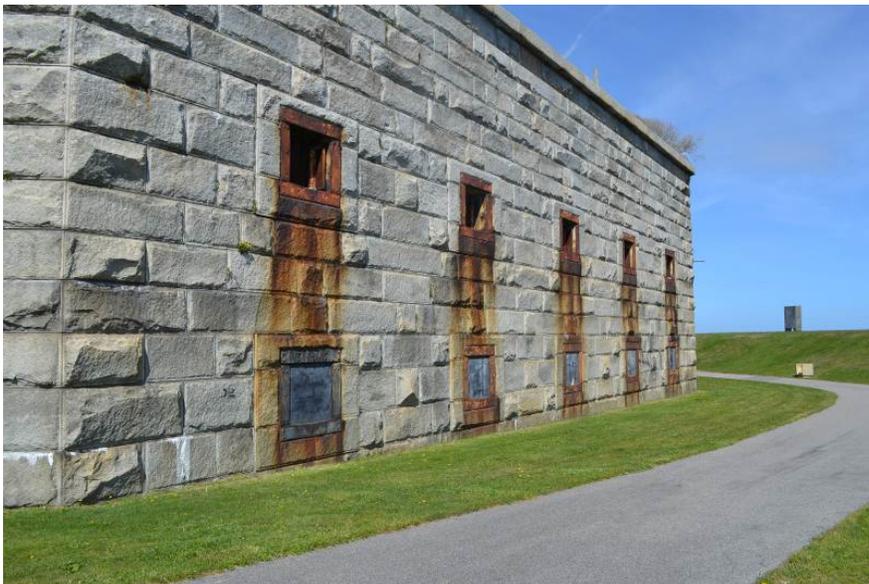
The exterior rough-cut granite block walls are about 36'-0" tall and about 7'-6" thick. A granite pediment and pilasters mark the main and only entrance on the northwest elevation. Most of the mortar joints at the exterior walls have eroded and some granite blocks have cracked. Algae growth can be found on the north and northwest elevations along with vegetation growth in the mortar joints. The rusted iron trim embrasure openings have caused staining on large areas of the masonry directly under the openings. Efflorescence is also visible on the exterior elevations due to water infiltration.

Figure 21. South elevation of exterior walls.

Cut and repoint mortar joints on all elevations. Reset dislocated stones and repair cracks in stones with an epoxy injection to prevent water infiltration. Repoint via grout injecting open mortar joints between the exterior wall and the brick vaulted ceilings. Bowing cornice stones should be anchored to the stone walls below. Lead weather caps could be installed at sky-facing joints to prevent water infiltration and mortar deterioration.

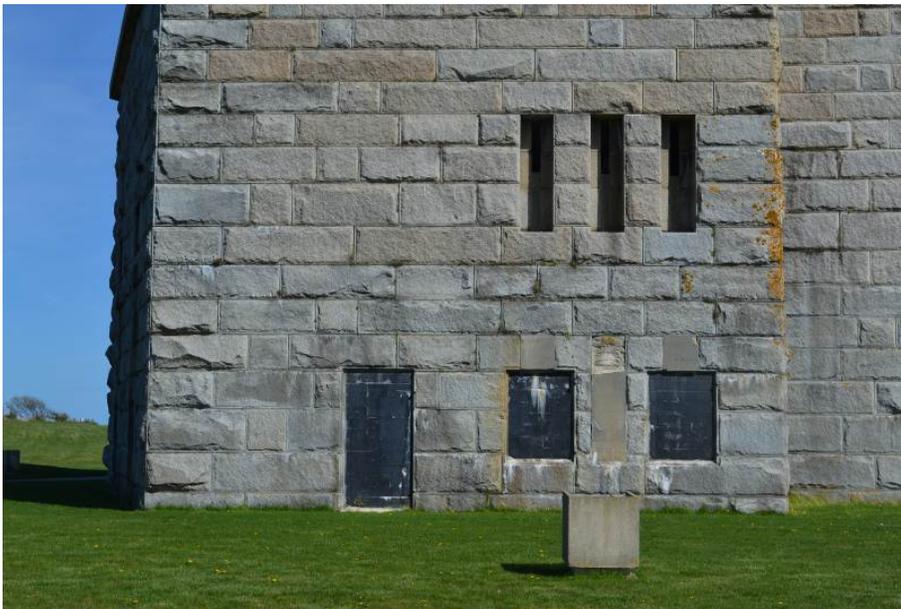
Figure 22. Northwest elevation of exterior walls. Note concrete-filled door and window openings.

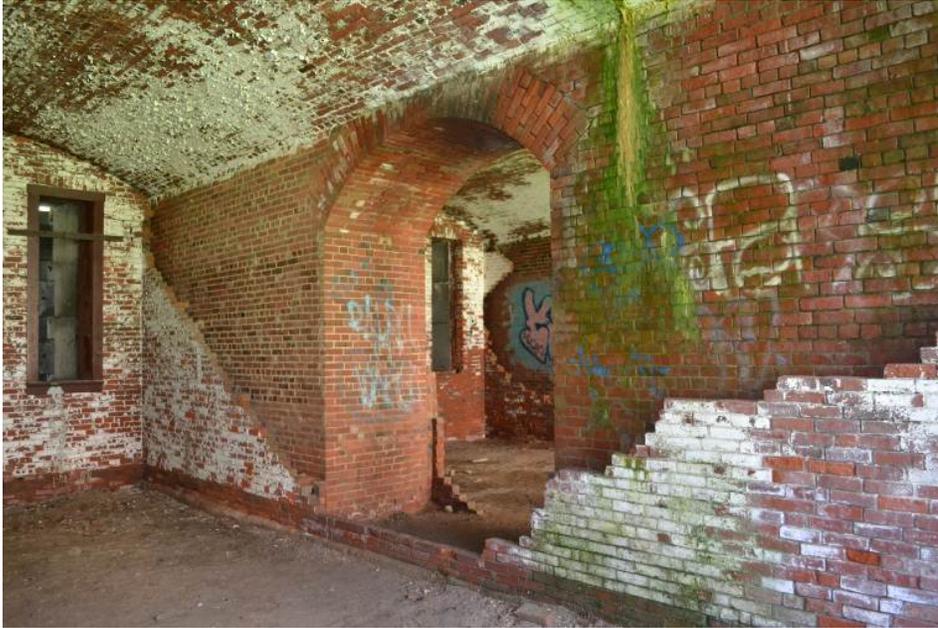
Figure 25. Living quarter brick structural walls and furring walls with graffiti, efflorescence and mineral deposits.

Remove inappropriate concrete patches at the brick walls and infill with brick. Dismantle or reconstruct brick furring walls at quarters for aesthetic or historical reasons. Remove vegetation from mortar joints and algae from granite. Remove graffiti and treat rust stains with a chemical cleaner. Remove efflorescence from masonry surfaces. Dismantle and reconstruct all shifted masonry at buckled walls. Pin-repair cracked granite lintels over doorways and use an epoxy injection at cracks in the granite. Epoxy-inject cracked granite stones and cut and repoint all granite and brick masonry. Removed and replace spalled brick where the masonry is to be reconstructed or repaired. Only remove the most damaged spalled brick where no other masonry repairs are needed.

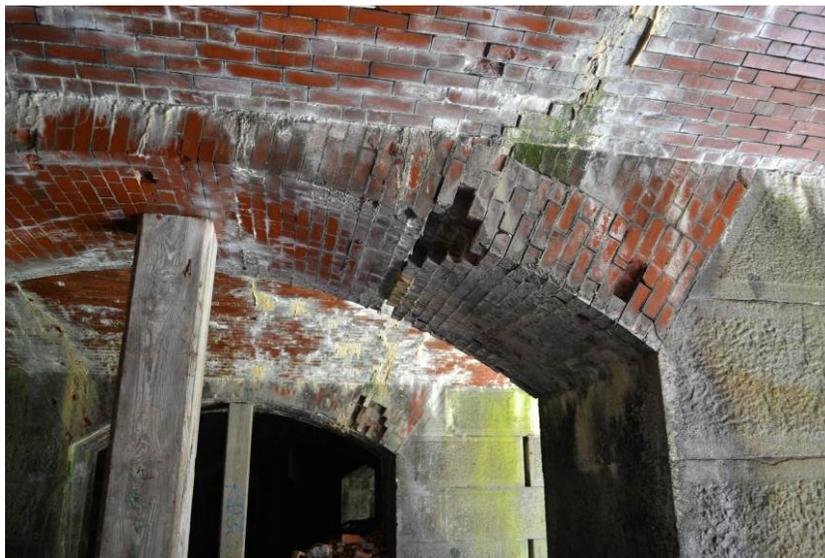
Some of the bricks at the vaults and arches have spalled and dropped from the ceiling (Figure 26). The interior granite casemate walls and barracks walls have brick archways that are badly deteriorated. Large sections of these arches have jacked out of place and spalled and crumbled the brick (Figure 28). The arches have cracked, slipped and widened. The mortar joints in the arches and vaults on both tiers have eroded. Wood support columns have been placed under most of the casemate arches to provide some temporary stabilization. The deterioration in the arches and vaults are compromising the structure of the fort as well as creating a safety hazard to visitors.

Figure 26. Brick arch at interior granite wall. Note large crack in vault, missing brick at arch, efflorescence, and wood support column as a typical condition throughout the fort.

If only minor work is to be completed in the first phase of construction, adjust, repair or supplement temporary wood column shoring, as well as install plywood forms at the loose brick masonry with in the vaults and arched openings to protect the public from falling debris. At failed facings of arches between casemates, remove and stockpile loose face brick to prevent falling debris.

Approximately 1/3 of the brick arches will need to be significantly repaired and partially reconstructed, while most of them will require resetting portions of the missing brick. Once the brick back-up walls are exposed, additional reconstruction may be required. Dismantle and partially reconstruct select brick vaults and injection-grout all cracks at arches and vaults. Repoint all brick masonry. At vaults where surrounding brick is stable, cracks should be jet cleaned, pointed, and injected with a compatible grout. Once arches are stable, it will be possible to remove all wood support columns.

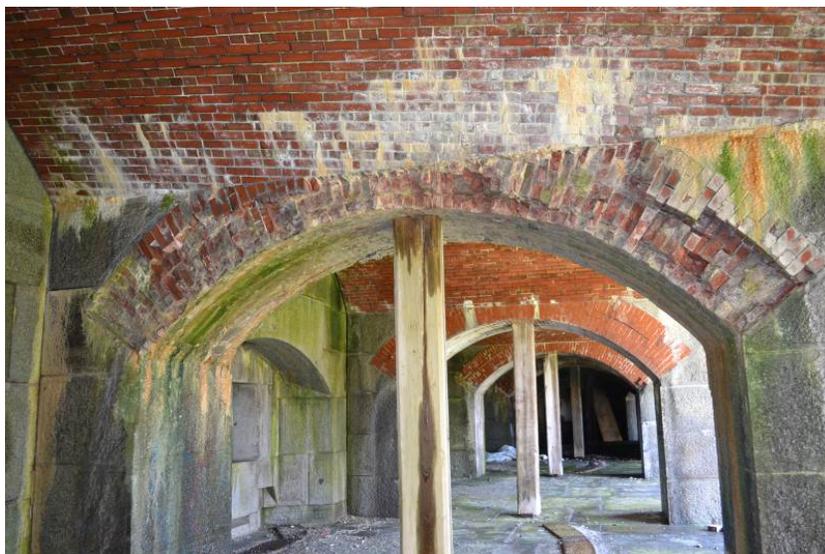
Figure 27. Large portions of the brick in the arches have been displaced and fallen to the ground.

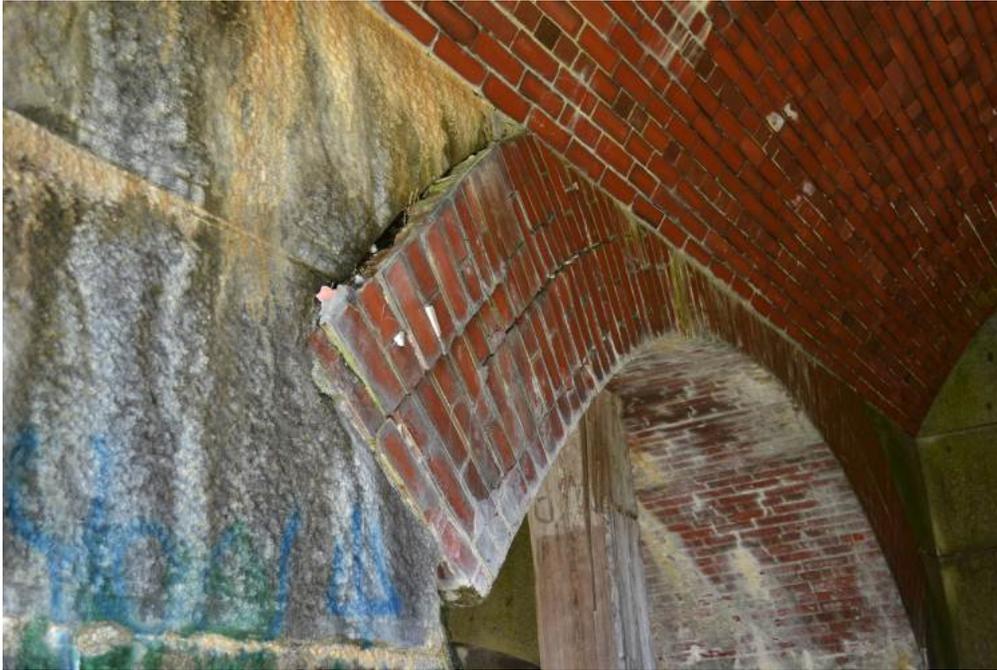
The ceilings in all of the casemates and barracks are structural brick barrel vaults. Water infiltration has caused the vaults to elongate and create large cracks in the masonry. Masonry cracking occurs when water is absorbed in the brick and then undergoes freezing and thawing cycles. Generally, these cracks run transversally across each vault between the granite support walls. A few of the arch spans at the vault ceilings have shifted laterally. The vault cracking is minor on the 2nd-tier casemate vaults but more significant on the 1st-tier casemate vaults. The amount of cracks at the vaults in the barracks is relatively equal between the 1st and 2nd-tier vaults.

Figure 28. The outer wythe of brick has jacked out of place due to water infiltration and expansion of the brick in the arches and ceiling vaults.

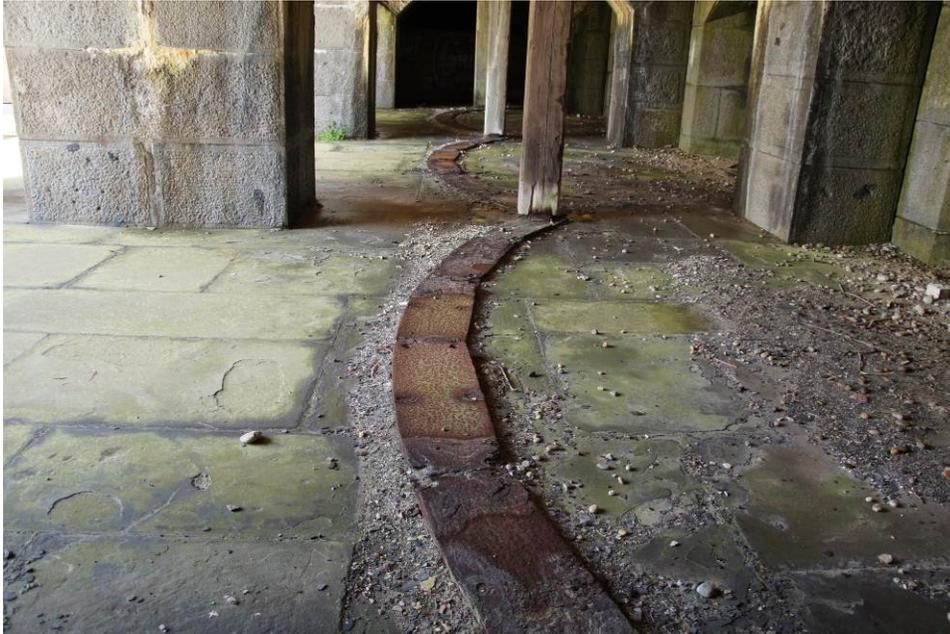
The 1st and 2nd-tier casemate floors are made of bluestone pavers set into grout. For the most part, these stones are in good condition. Some of the floor surfaces are covered in debris and it is difficult to see the condition of the stone. Some stones have collapsed over drainage channels at the 1st-tier floor (Figure 30). Some stones have shattered or disintegrated and now pose tripping hazards (Figure 31). Green algae has formed on the stones that do not get sunlight during the day.

The condition of the iron tracks for the Rodman guns vary from casemate to casemate. Some tracks are almost completely intact while others have been removed or are barely visible due to deterioration.

Figure 29. Bluestone walking surfaces and iron canon tracks at 1st-tier.

At bluestone slabs that have caved-in or collapsed over drainage channels, provide new, removable bluestone slabs to match originals. Remove vegetation and biological growth throughout. Remove shattered and disintegrated stones and other paving deemed a tripping hazard and replace with salvaged and/or new bluestone slabs. Stabilize and epoxy-repair delaminated and cracked pavers otherwise in fair to good condition.

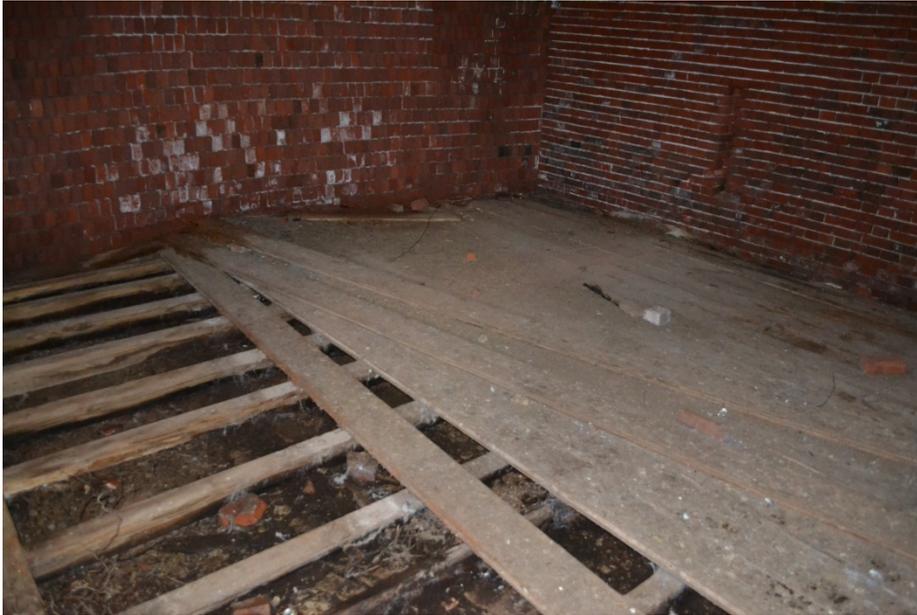
The 1st-tier magazine floors are depressed about 1'-6" and have stepped concrete around the perimeter walls (Figure 33). The 2nd-tier floors are dirt with remnants of wood framing members and wood floor boards. The boards are now deteriorated, but the southwest magazine floor is a good representation of what the floor used to look like (Figure 34).

Figure 34. Wood framing and floor boards in southwest magazine on 2nd tier.

At the 1st and 2nd-tier magazines and 1st-tier barracks with depressed or sunken floor levels, document existing conditions, remove debris and provide new compacted fill at floor. Align finish grade with existing door thresholds and walking surfaces to make accessible. At the 2nd-tier barracks, provide a wood boardwalk over a portion of the existing floor but leave a portion of the floor exposed to show the top of the brick vault and concrete construction. See Accessibility Option A for proposed area of boardwalk.

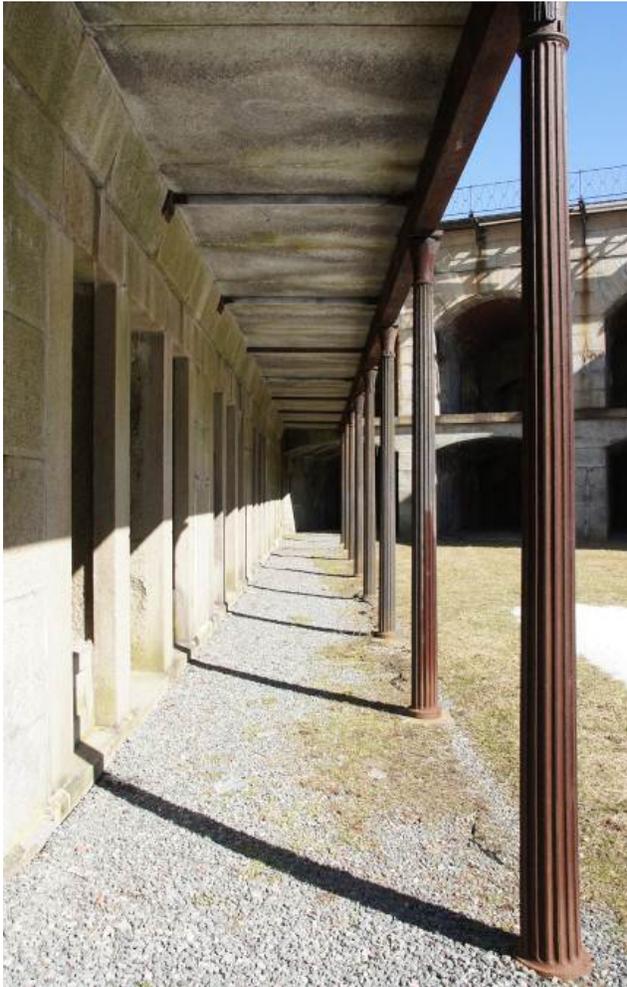
Directly after exiting the sally port and entering the interior of the fort, soldiers would have been protected by a covered gallery running the whole length of the northwest parade elevation. The two-tier gallery is located off of the living barracks and provided a walkway between the casemates and the barracks. The existing cast iron fluted columns are in fair to poor condition. Most of the acanthus leaves are missing and the columns and soffits are rusted. The first column directly to the south of the sally port has cracked and shifted. There is rust exfoliation on most of the iron beam soffits near the center of their span between the columns.

Figure 35. Gallery with cast iron columns.

Remove rust in situ and apply a zinc-rich primer to all ironwork. Repair and reinforce or replace the cracked column south of the sally port. Restore the acanthus leaf features by casting replicas in aluminum or fiberglass and finish the restored assembly with an appropriate primer and finish coats.

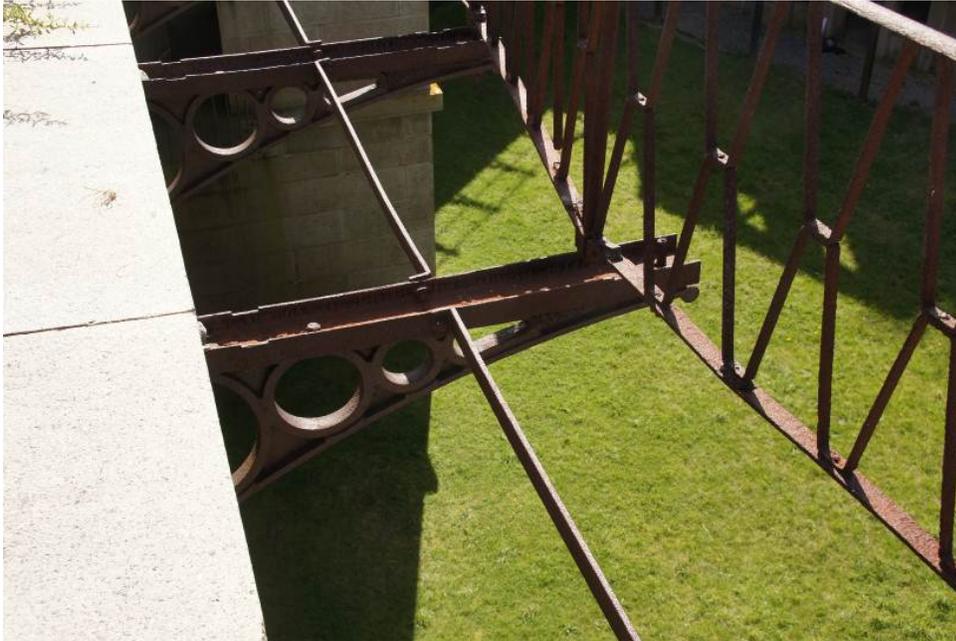
Figure 38. Cast iron brackets, support rails, and guardrails at roof galleries.

Remove the deteriorated wood plank decking at upper gallery. Remove rust from the metal components in situ and apply zinc-rich primer and apply 2-3 epoxy finish coats to metalwork. Remove one intact bracket for documentation and replication and reinstall original bracket. Replicate a bracket and install it at the missing location on east corner. Repair the support rails throughout the gallery. Analyze the structural capacity of the gallery to carry loads. Reconstruct the wood gallery decking and guardrails at the north section and lighthouse entrance as a basic scope and reconstruct the wood gallery decking and guardrails throughout as an optimal scope.

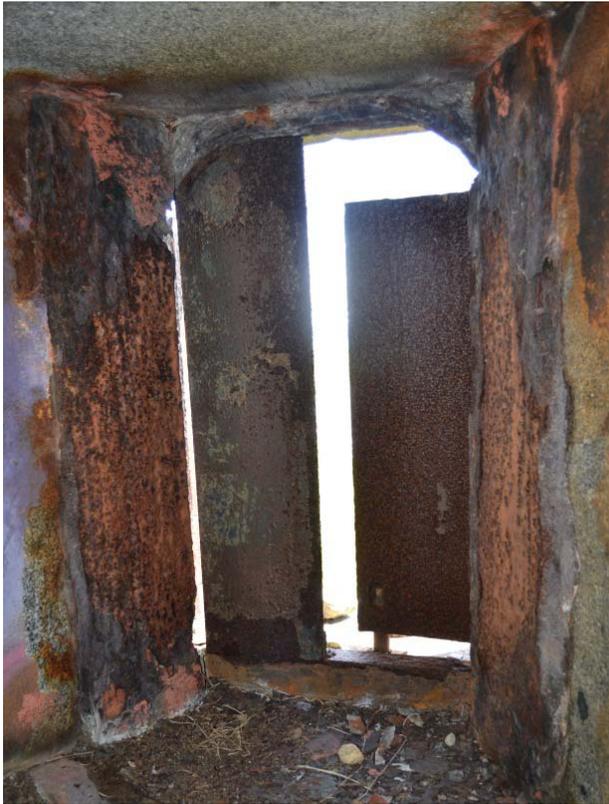
Figure 50. Rusted trim in foreground, with Totten shutter on right and modern barrier on left.

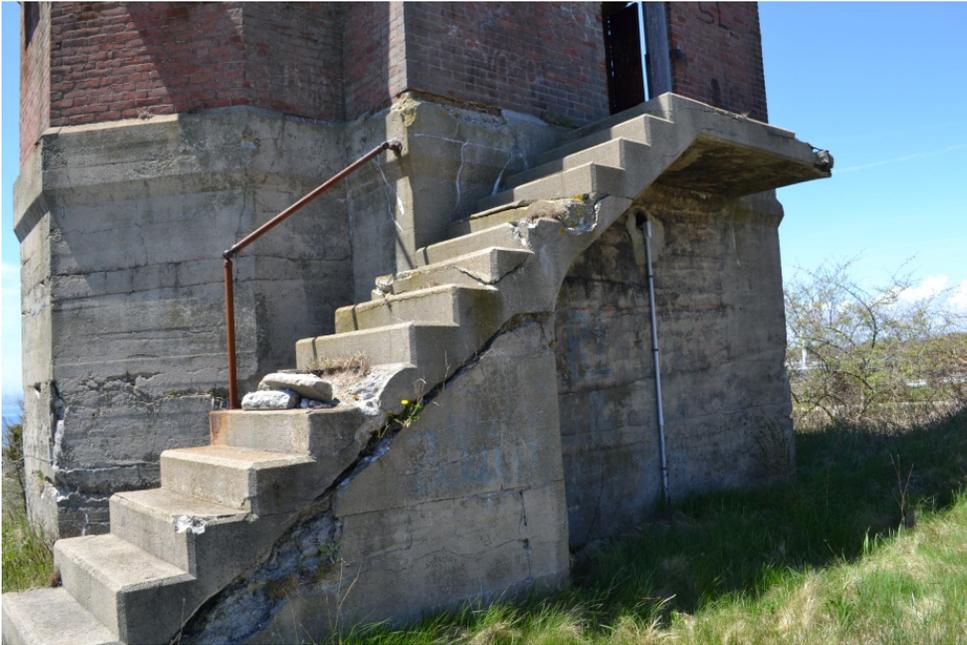
Figure 70. Deteriorated concrete stairs.

Provide shoring beneath the reinforced concrete stair, as required. Reset loose masonry and provide epoxy injection repairs at major cracks. The cracked brick masonry at the south elevation should be dismantled and re-set. The backup masonry should be reviewed and repaired as needed. All embedded metal to remain should be cleaned and painted. Prep and refinish exposed metalwork (e.g. railings, shutters and associated hardware). Treat exposed rebar and repair/patch concrete at access stairs. Repair the existing concrete roof structure and walls. At the roof, epoxy repair broken glass lenses and provide custom-fabricated purple glass replacements.

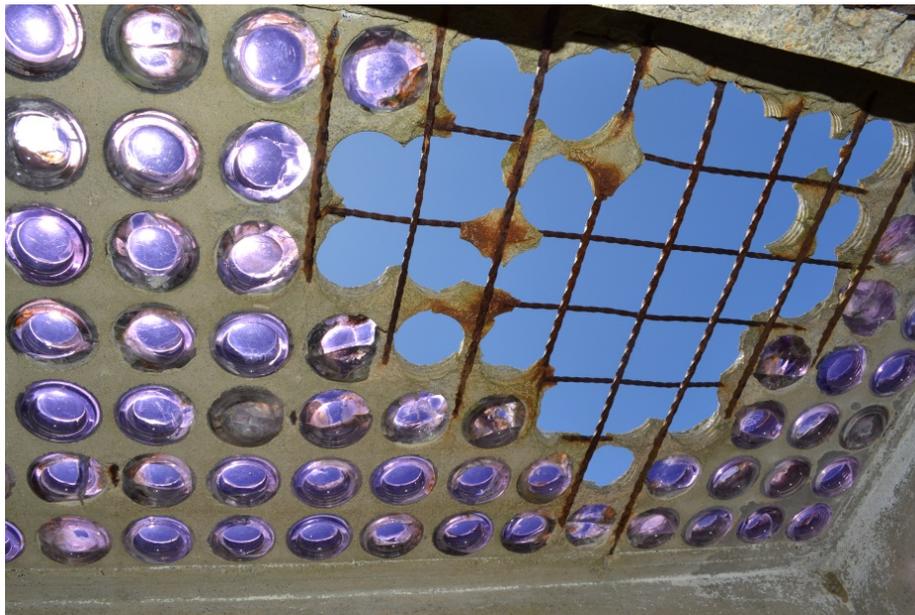
Figure 72. Deteriorating concrete exposes the rebar and breaks the glass disks.

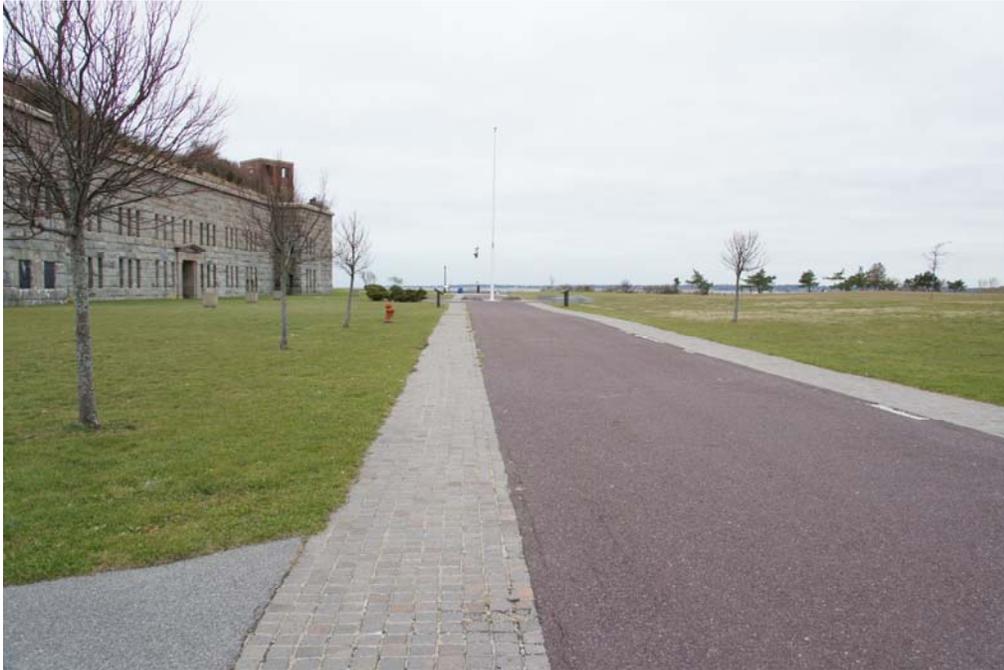
Figure 88. View of walkway from parking lot to fort.

The ramp and curb at the parking lot should be repaired. Some minor repair of the walkways from the parking lot to the fort is recommended. Alternate materials such as stonedust, chip-and-seal asphalt, bluestone, or granite walkways should be considered to replace the loose gravel at the sally port and gallery walkway inside the fort. Repair existing site lighting around fort.

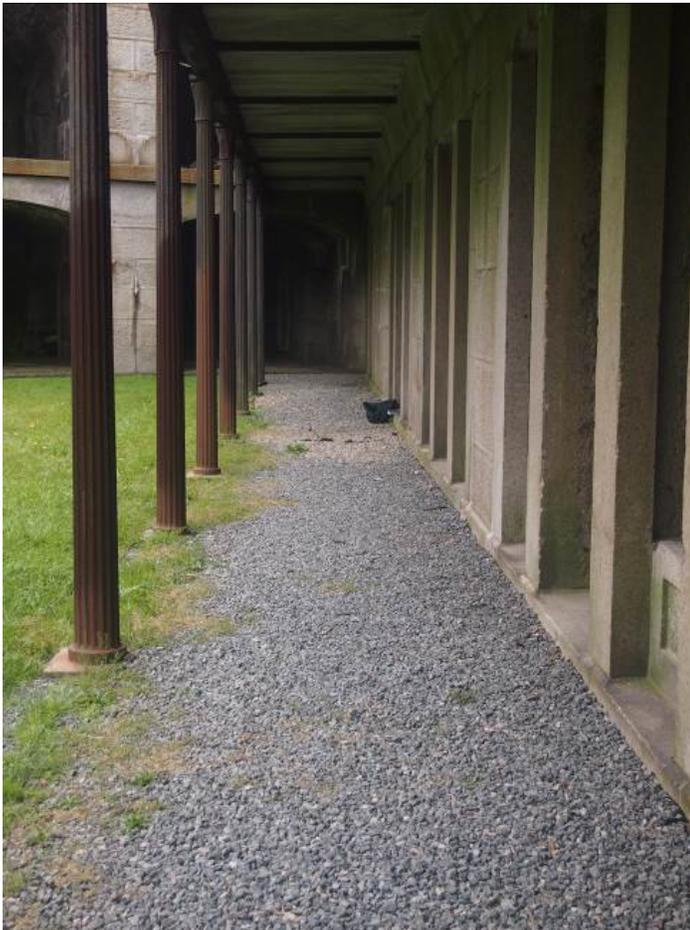
Figure 4. Loose gravel walkway at gallery on northwest parade elevation.

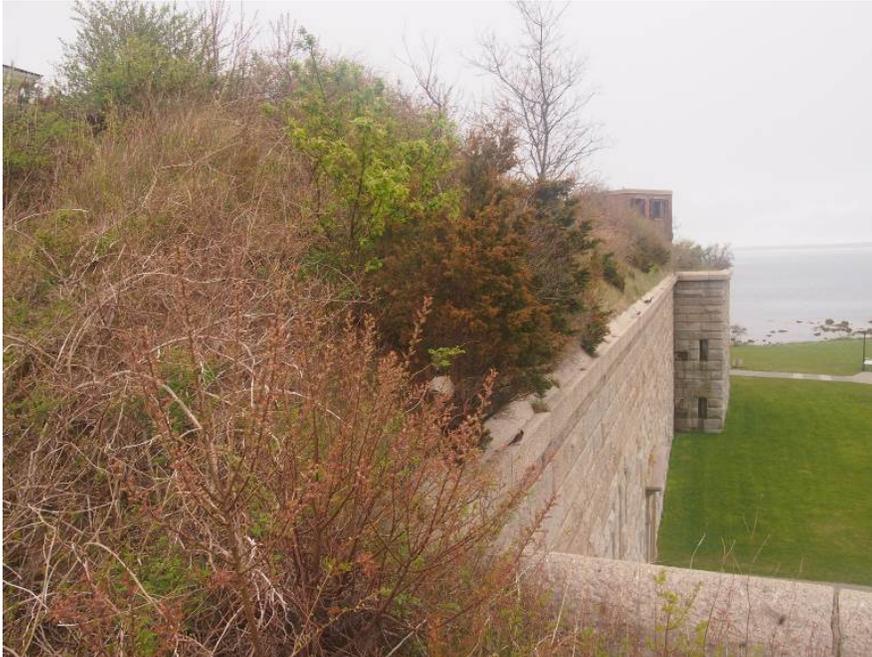
Figure 6. Overgrown brush at terreplein.

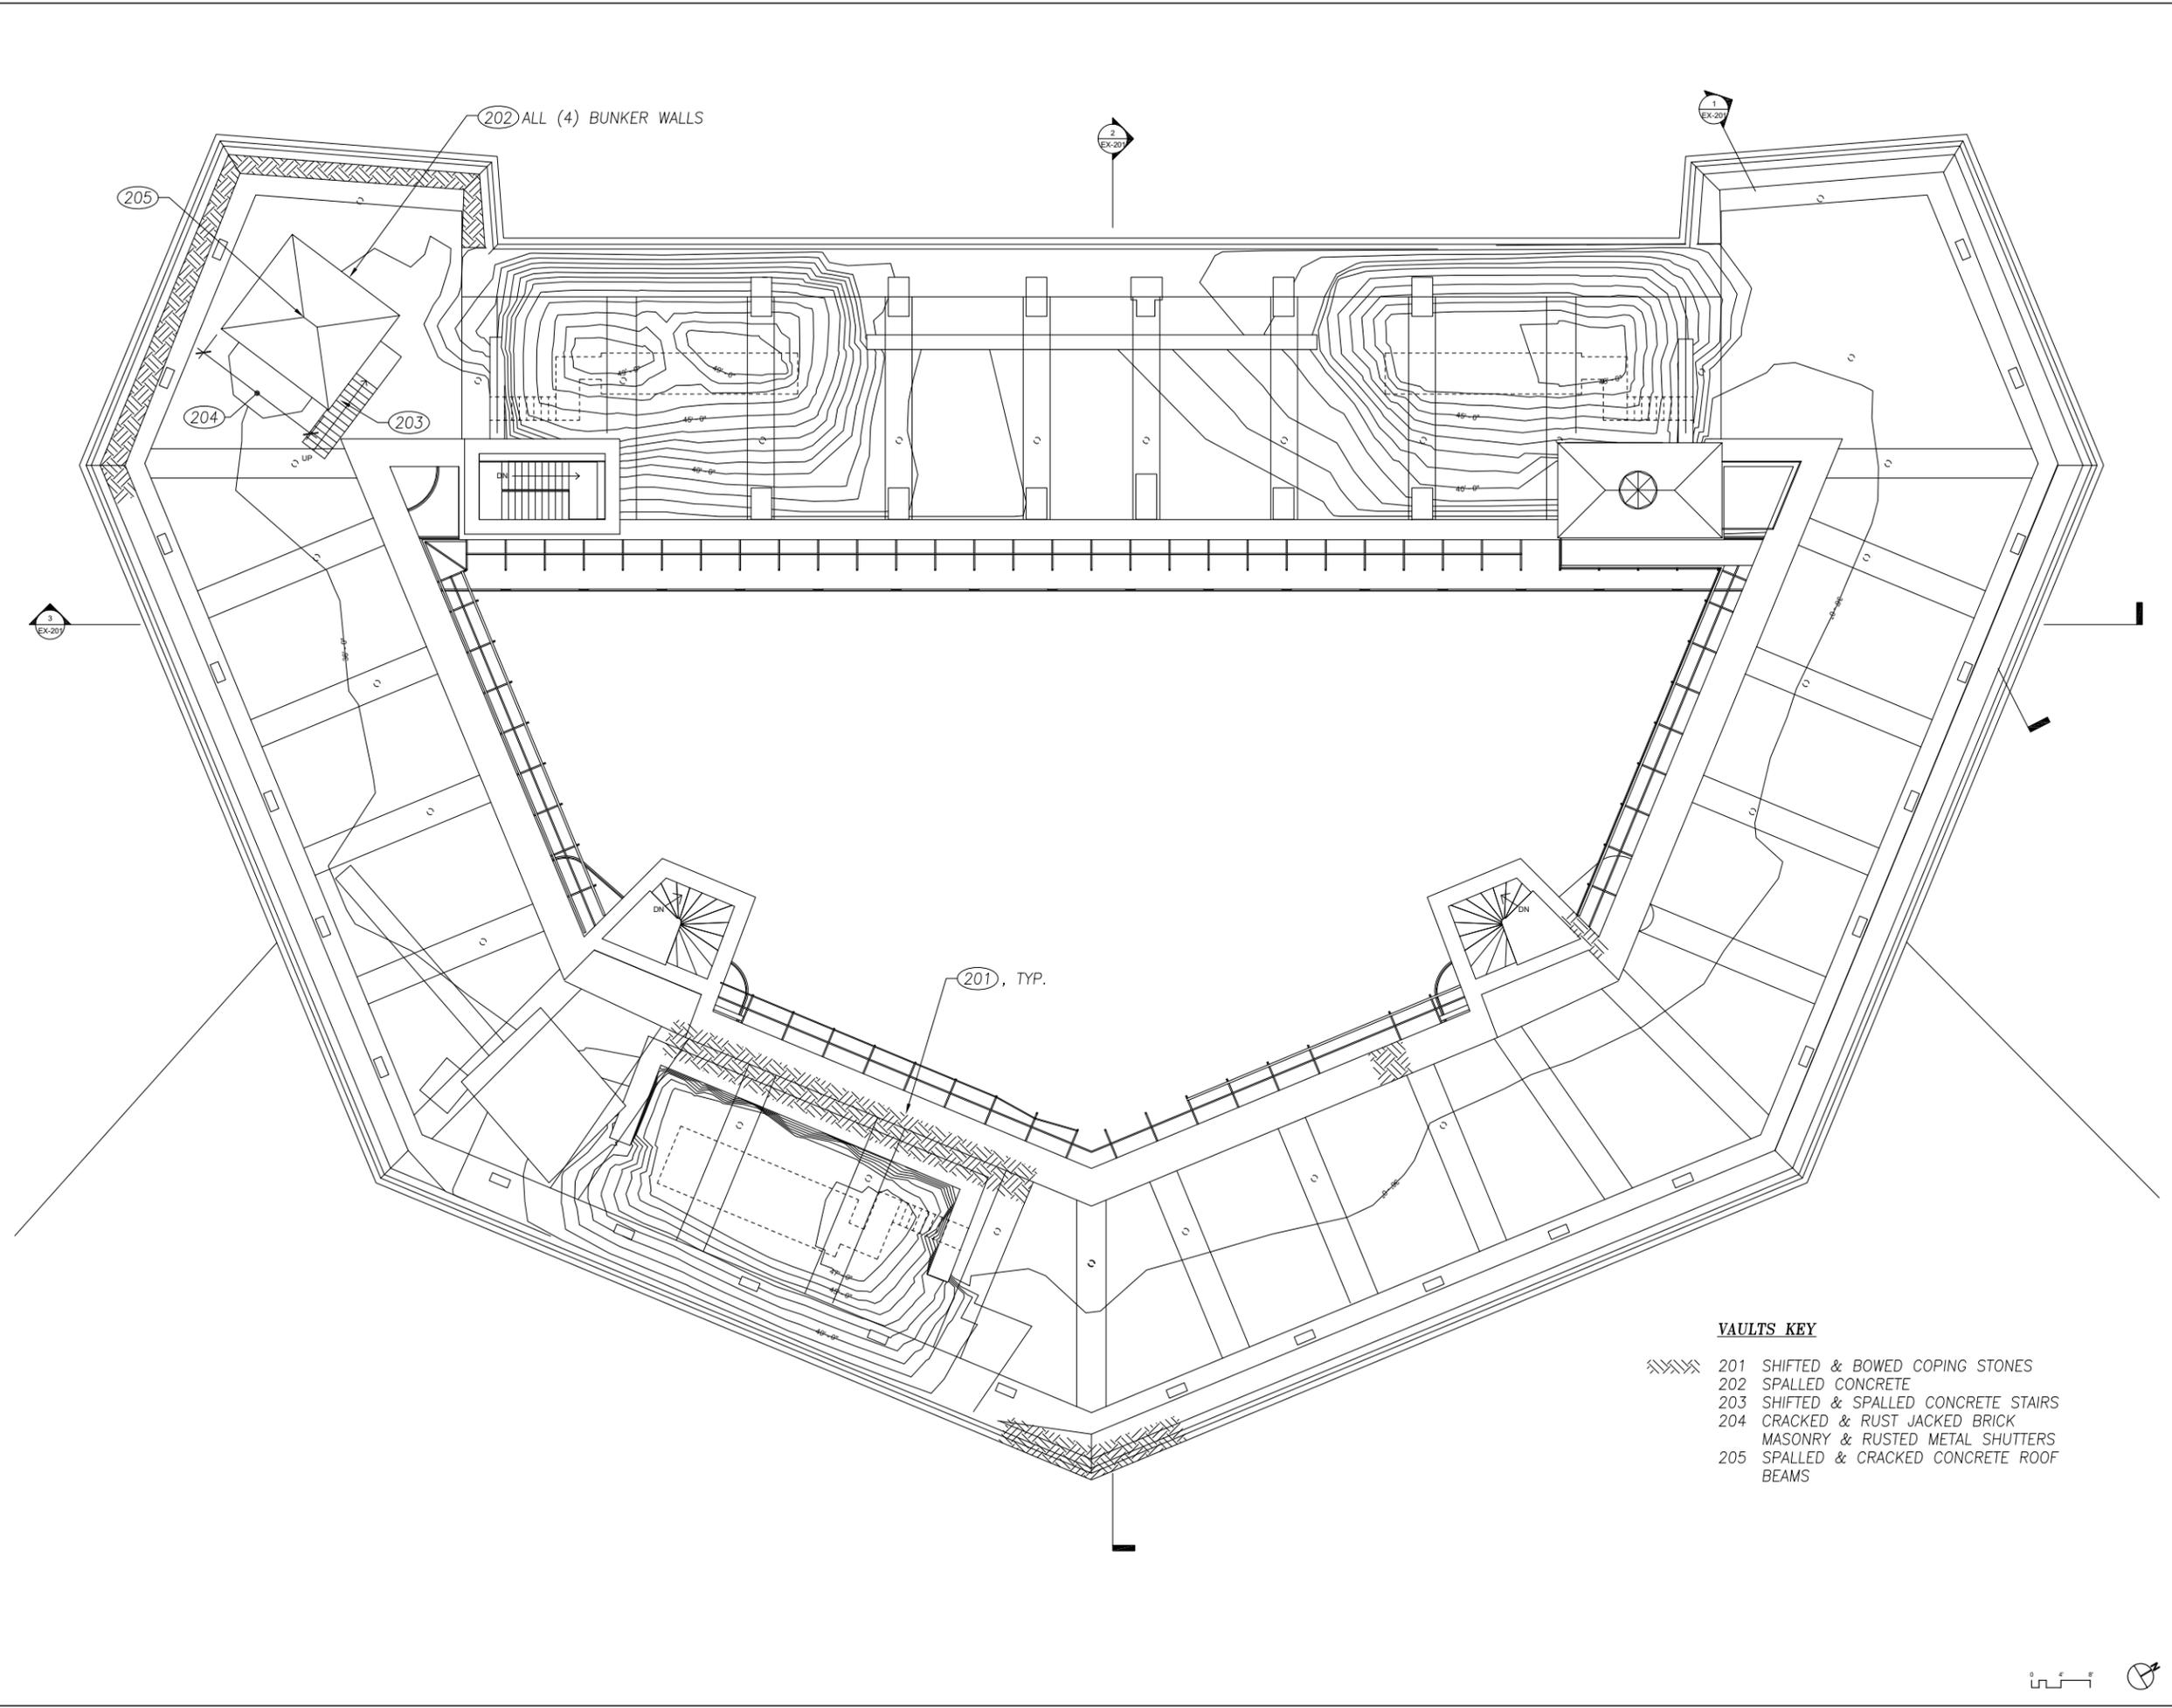
EX-103

- VAULTS KEY**
- 201 SHIFTED & BOWED COPING STONES
 - 202 SPALLED CONCRETE
 - 203 SHIFTED & SPALLED CONCRETE STAIRS
 - 204 CRACKED & RUST JACKED BRICK MASONRY & RUSTED METAL SHUTTERS
 - 205 SPALLED & CRACKED CONCRETE ROOF BEAMS

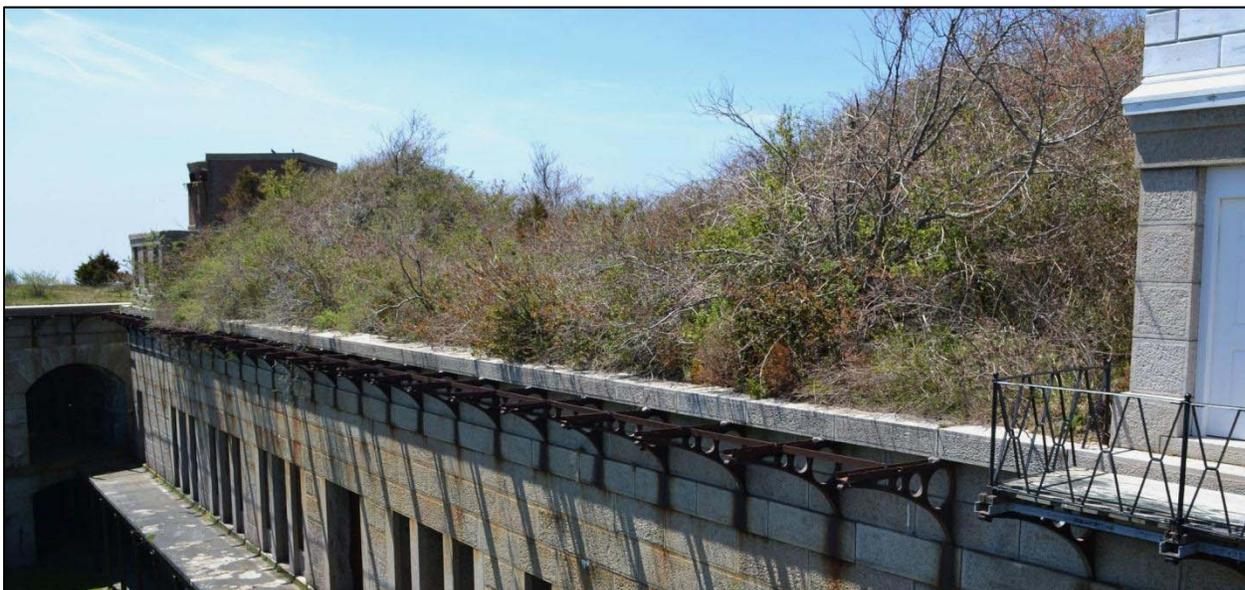
View of northwest ramparts from the edge of the parade walls. A comprehensive drainage system flashed to "daylight" over the existing coping would prevent further water infiltration down into the casemates below.

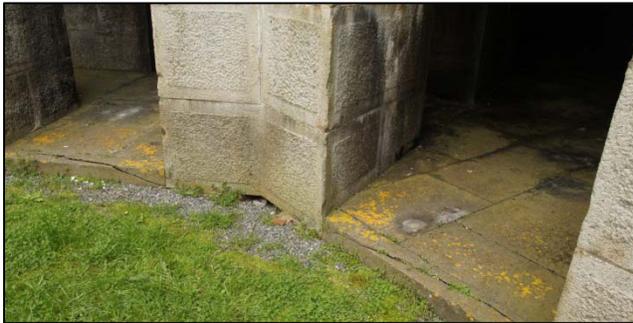
This existing underground drainage channel fed by vertical drains deep in the heart of the granite casemate piers has become undermined by flooding and/or scour.
