STATEMENT OF REASON FOR PROPOSED DEMOLITION
And
NARRATIVE OF PROPOSED DEVELOPMENT

**Re: NOTICE OF CLASSIFICATION DETERMINATION FOR DEMOLITION REQUEST
33 Emery Street...demolition circa 1920 two-story brick masonry school building**

REPRESENTATIVE PHOTOS OF EXISTING BUILDING

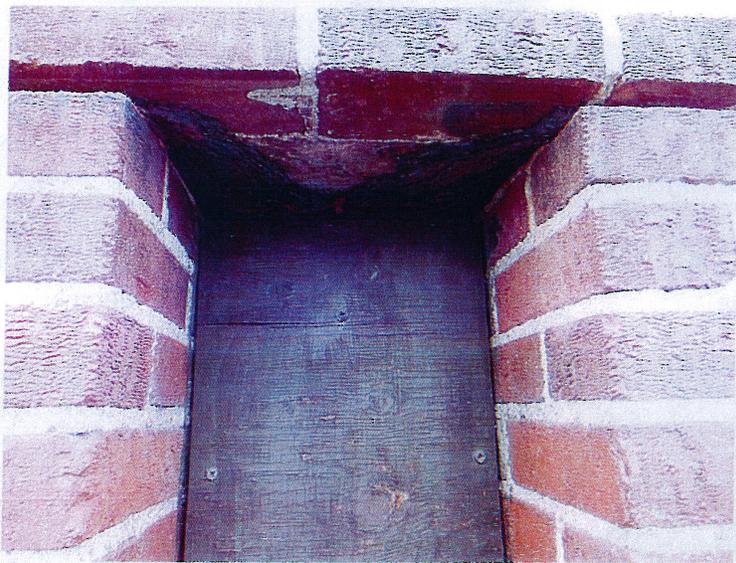
The exterior of the building is showing significant deterioration to the brick and stone masonry walls particularly at window and door openings where the brick is supported by steel lintels that have extensive damage from exposure. Repair and/or replacement of both the steel lintel along with much of the surrounding brickwork on either side of the opening will be required. In several areas the cracking of the horizontal mortar joints continues along a pathway spanning multiple window/door openings in succession. There is further evidence of deterioration to much of the decorative/structural masonry stonework above entrances and along the roof line from exposure to moisture as well as decay over nearly a century of service.

Deteriorated Steel Lintel at Brick Opening

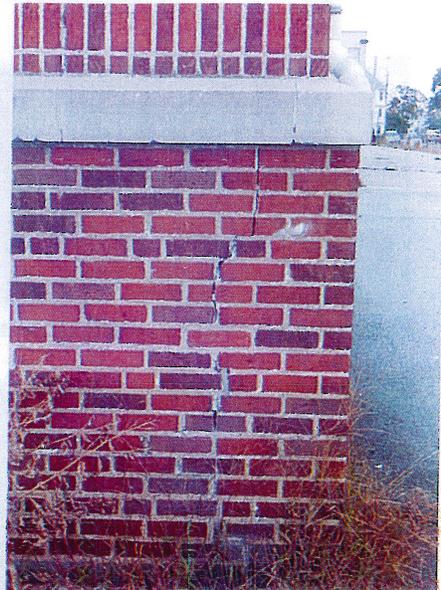
Masonry Settlement Cracks

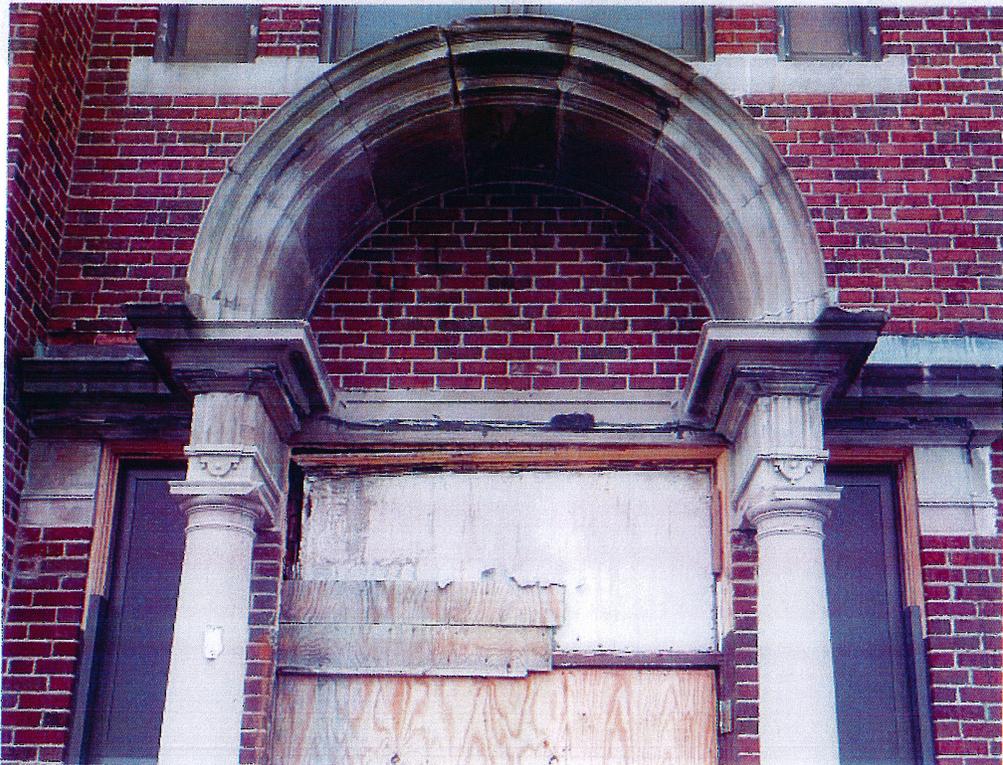
Stone Masonry Deterioration

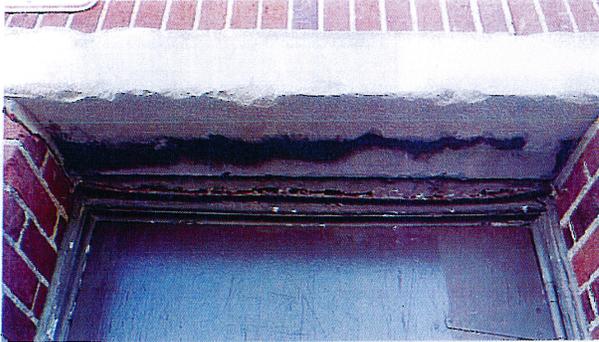
Deteriorated Lintel at Brick Opening

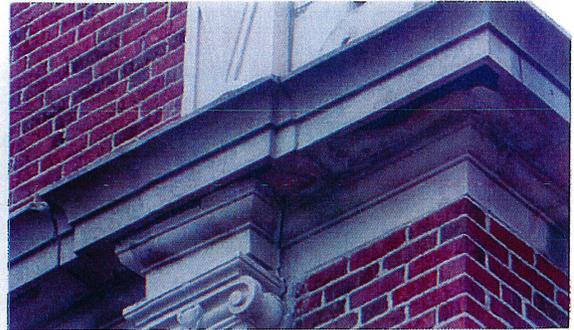
Stone Masonry Cracking and Settlement

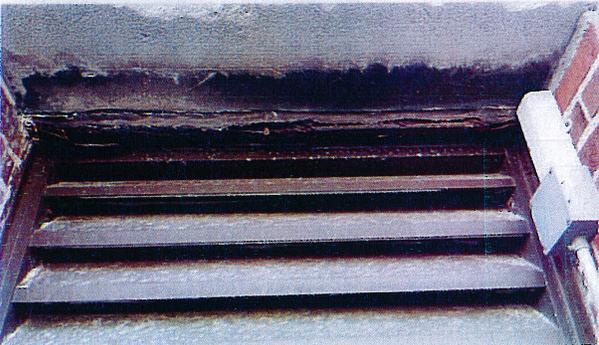
Deteriorated Lintel at Brick Opening

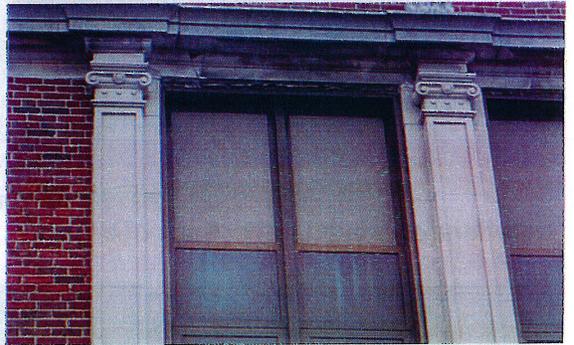
Stone Masonry Cracking and Settlement

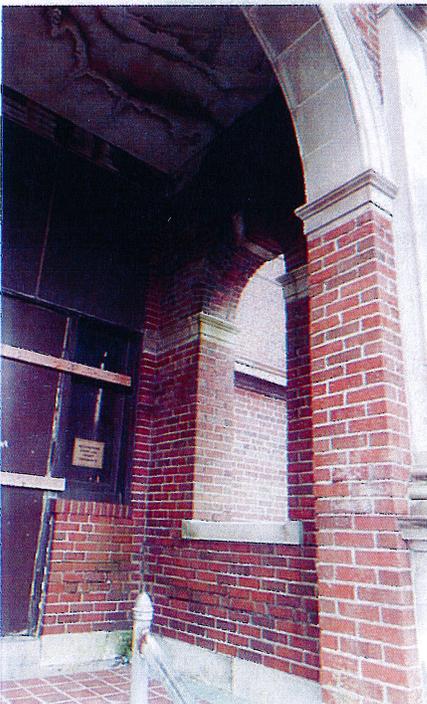
Stone Masonry Deterioration

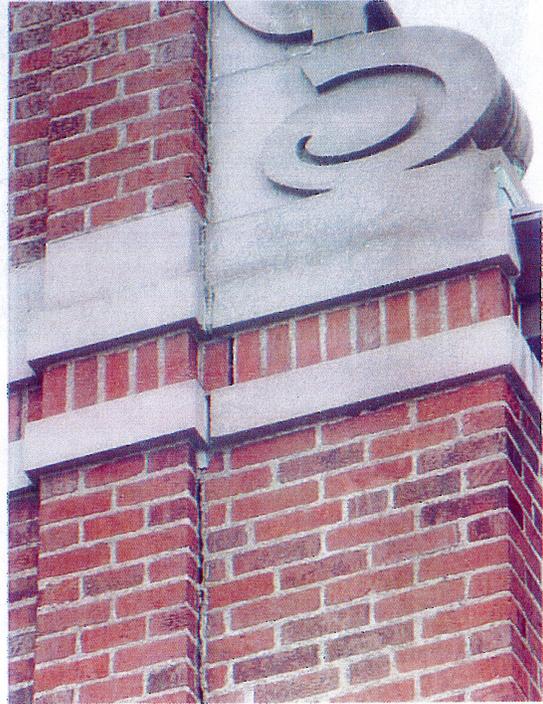
Masonry Cracking

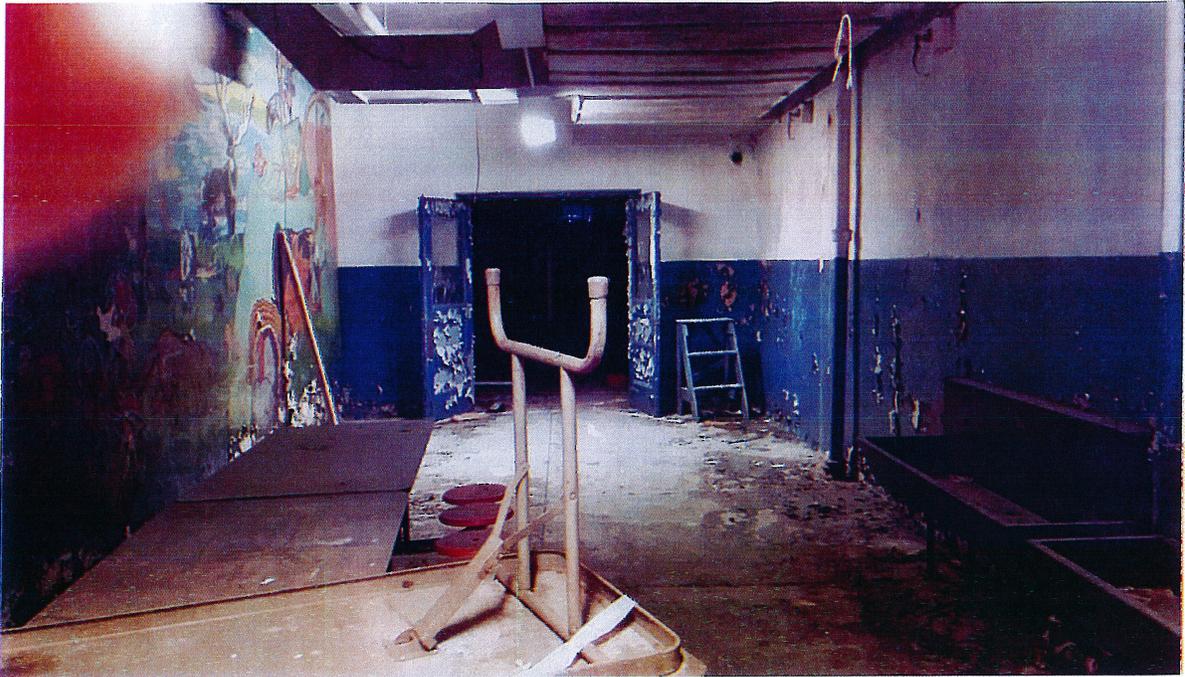
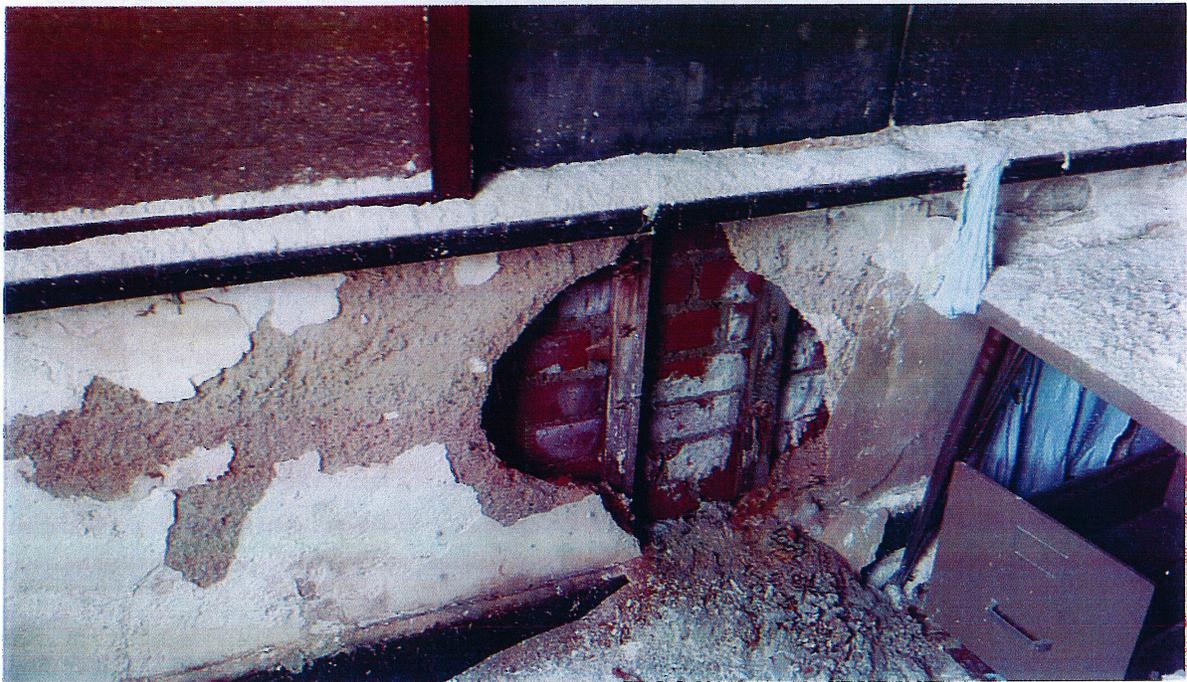
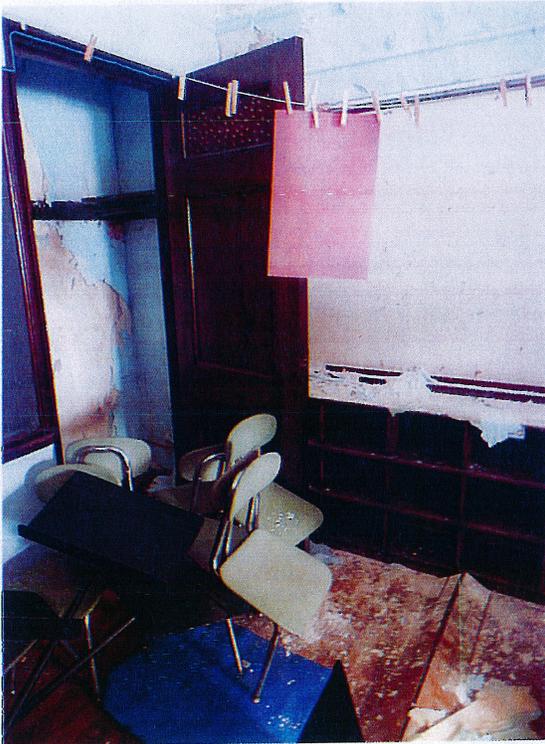
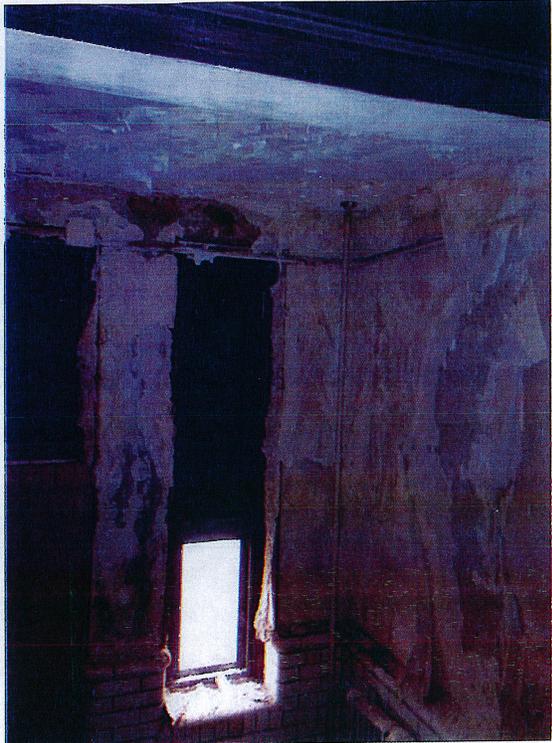
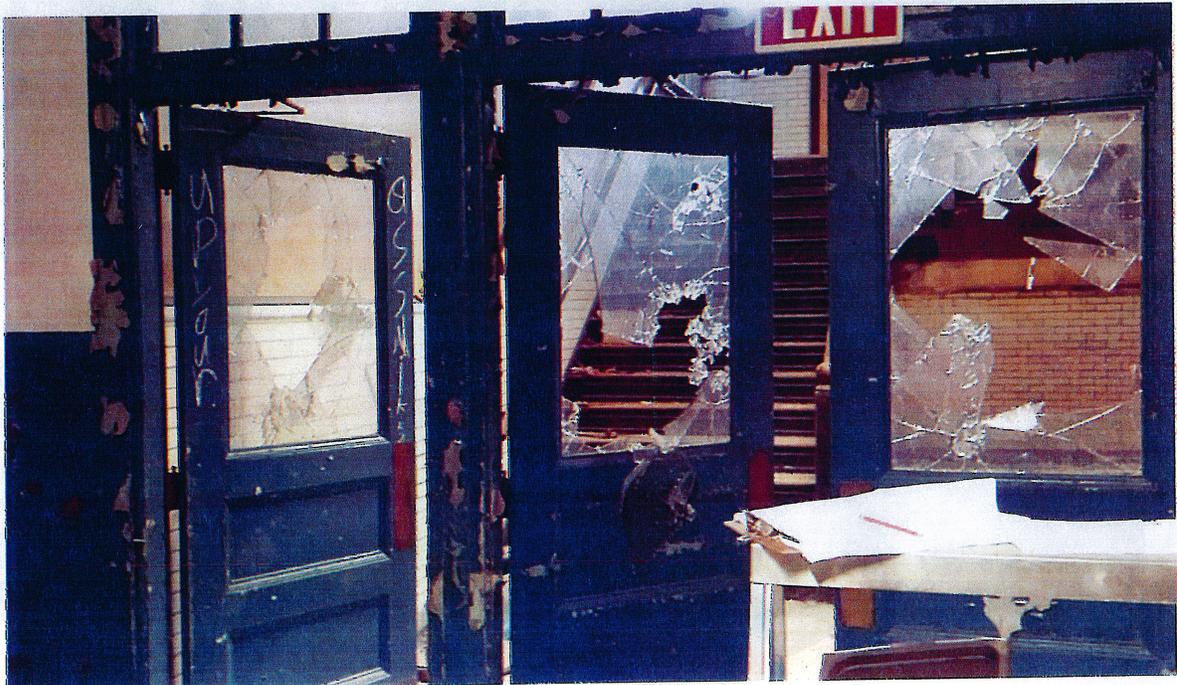
The interior of the building suffers from a lack of heat and use, vandalism and moisture. This is most pronounced at the gym/cafeteria ceiling that had collapsed requiring total replacement. All other second floor ceilings may also be at risk for collapse due to exposure to similar conditions. As is consistent for a building of this age, all interior mechanical, plumbing, electrical, fire protection, communication and food service systems will require full replacement as the original systems are obsolete or missing. The building did not have a sprinkler system, and much of the original plumbing has been stripped out by vandals.
