STAFF REPORT

NEW BEDFORD HISTORICAL COMMISSION MEETING

LOCATION: 141 William Street, First Baptist Church (Map 52, Lot 209)

Your Theatre – First Baptist Church Restoration/Renovation

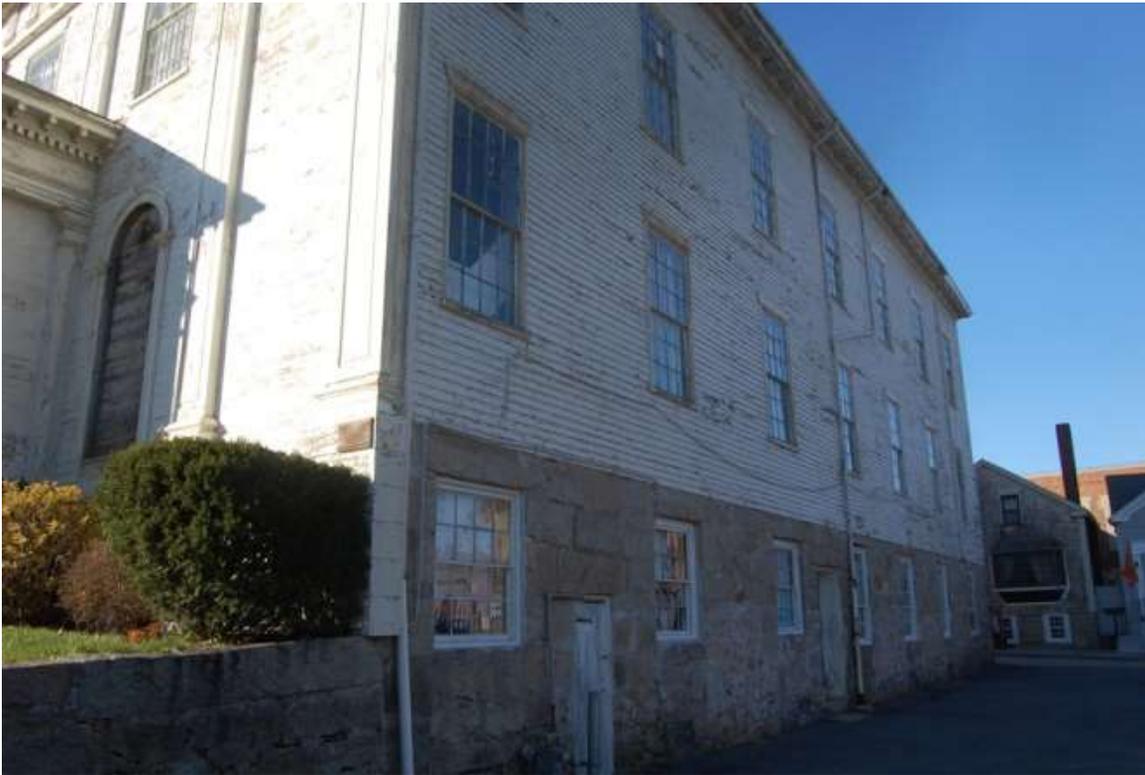
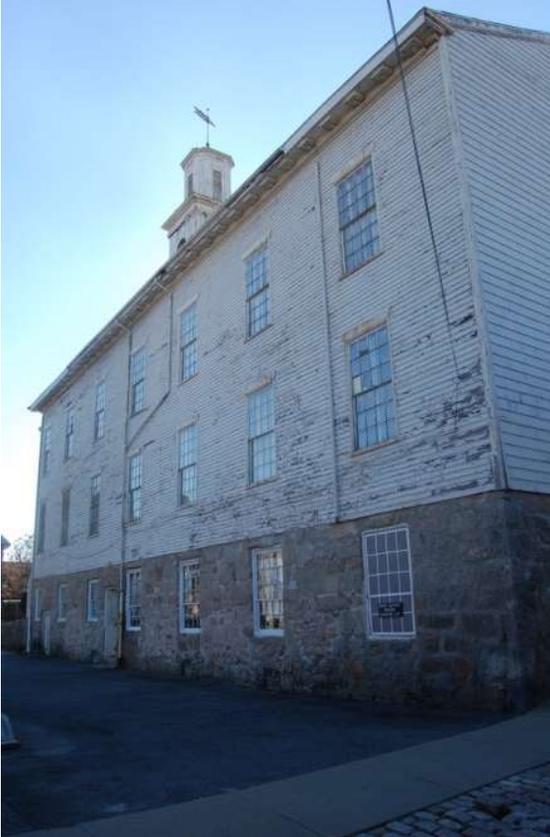
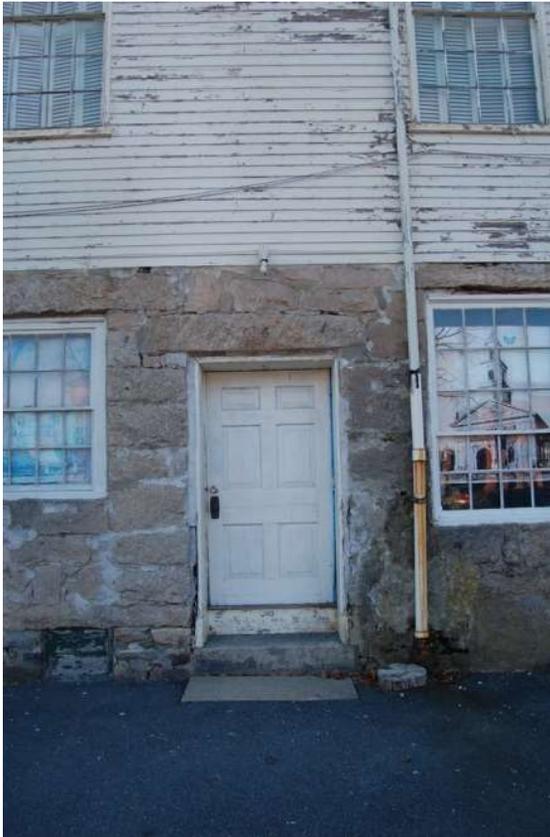
The basement level of the Church is constructed on field stone masonry supporting the wood two story structure above. This stone foundation on the East Elevation is missing mortar in a number of locations and the masonry retaining wall tying into the basement level has been pushed out of plumb over time by the soil that it retains.

The existing clapboard siding is in good condition with some areas that need repair or replacement. The exterior trim for the original structure is painted wood using various profiles for window/door casings, soffit and fascia trim, corner boards and pilasters. The condition of

the trim is good in most locations but there are areas where the trim is severely deteriorated due to constant exposure to water or missing.

3. East Elevation, First Baptist Church.

Describe work and impact on existing feature: The proposed work is to preserve the existing wood siding and trim and replace “in kind” only those portions that are missing or cannot be repaired with epoxy using the same materials and profiles of the existing feature. New work will be sanded, caulked and blended to smoothly blend with the existing trim. All east elevation clapboard siding and trim will be prepped and painted.

The side entry door and trim will be restored and refinished and weather stripped. A cast concrete entry ramp and stair will be constructed at the side door to provide accessibility to Fellowship Hall. The stone foundation will receive a gentle power-washing to remove dirt and mildew from its surface. Loose mortar will be removed and open joints cleaned prior to repointing with masonry mortar to match the color, texture, tooling and hardness of the original mortar. Intact existing mortar will be left in place. Joints between the masonry and window/door frames shall be caulked and painted as required.

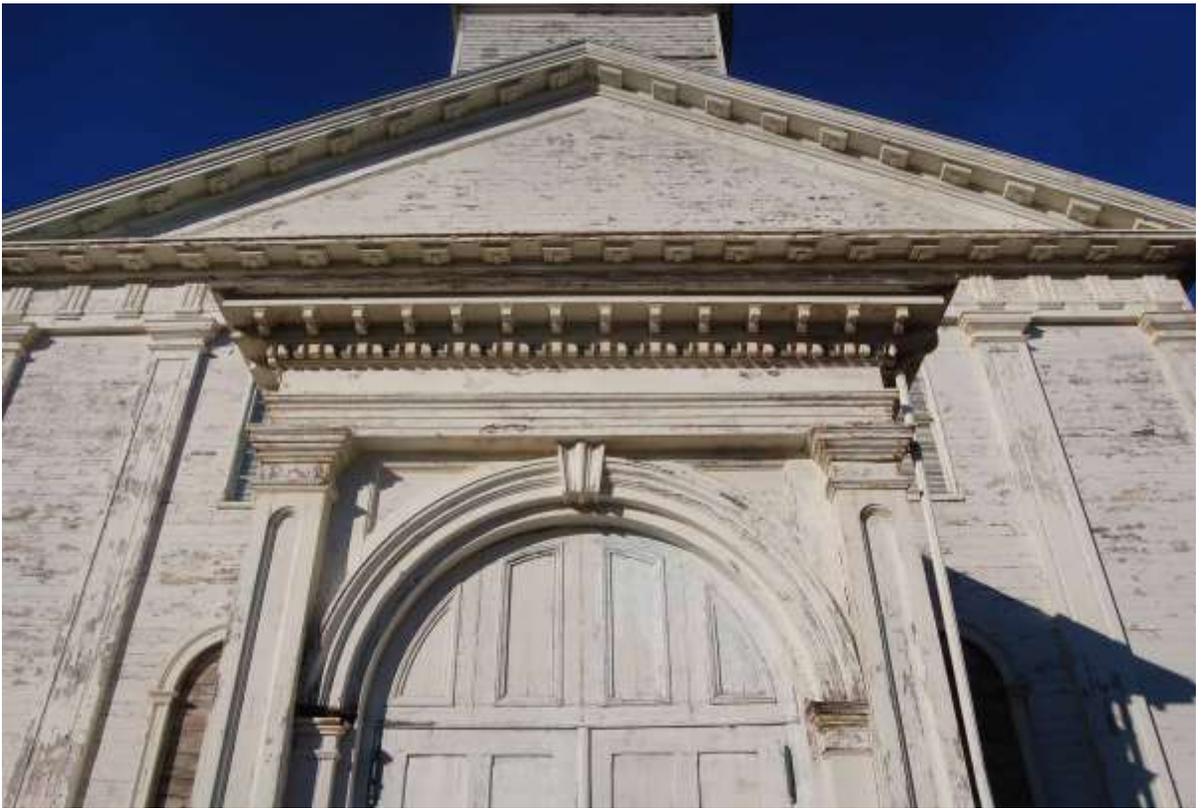
The front façade has flush wood vertical siding. Paint failure is evident on the front elevation. The existing windows are primarily single glazed wood double hung units with sash weights that appear to be original to the structure. The windows in the older Church portion of the building are in poor condition due to loss of paint, broken/missing window panes, loss of glazing compound and broken sash cords. Window glazing is deteriorated and missing, trim is missing or badly decayed in several locations and the front entry doors are decayed along the bottom rail. Because the building has not been painted in nearly 40 years, much of the siding and trim is bare of any paint and exposed to the elements.

The existing exterior doors are painted wood stile and rail construction and they are in poor condition and not weathertight. Among the deficiencies are that the paint is peeling and gaps within the paneled doors are opening up. Door hardware does not meet accessibility requirements or egress requirements.

6. South Elevation, First Baptist Church.

Describe work and impact on existing feature: All front elevation clapboard siding and trim will be prepped and painted. Broken or impaired clapboards and trim will be replaced to match existing. All shutters will be removed, and the wood frames, blades, trim and hardware will be repaired and rebuilt to original working condition. The shutters will be prepped and painted per specifications and rehung on existing hardware.

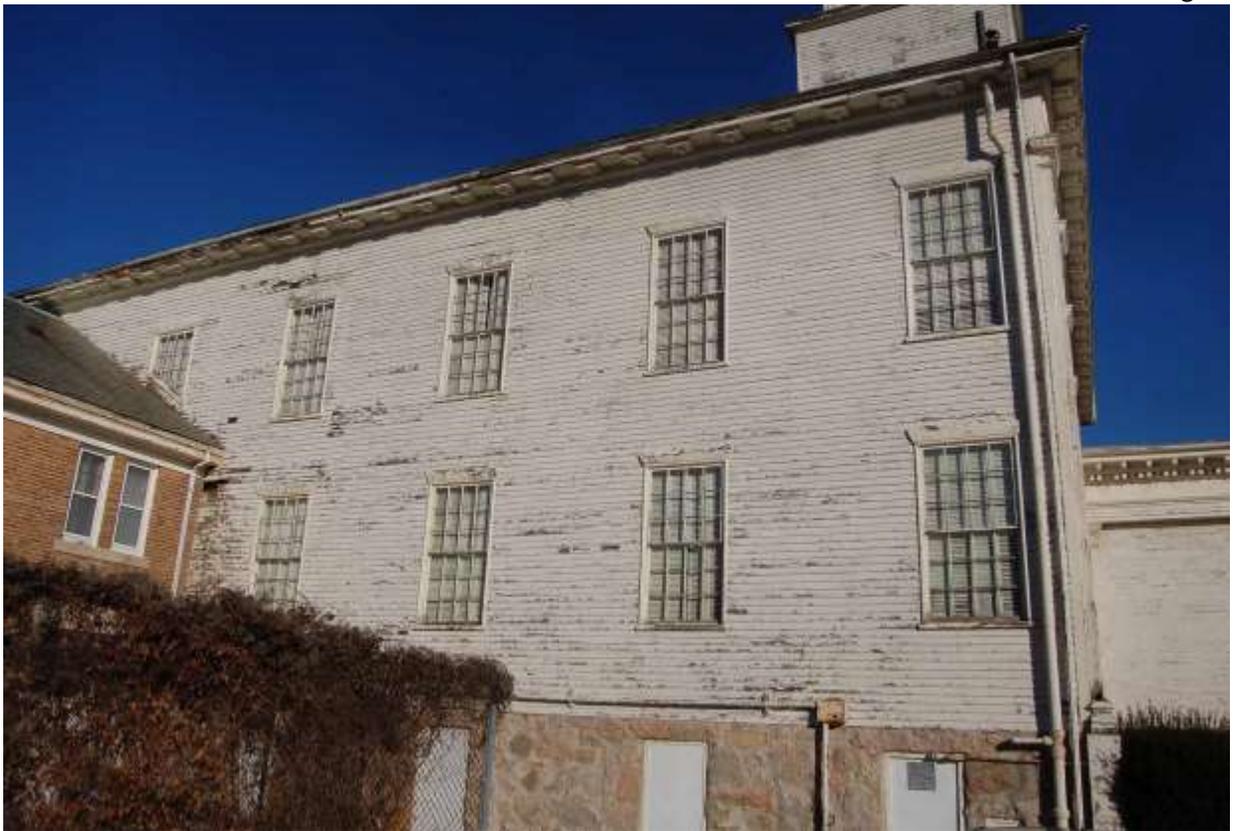
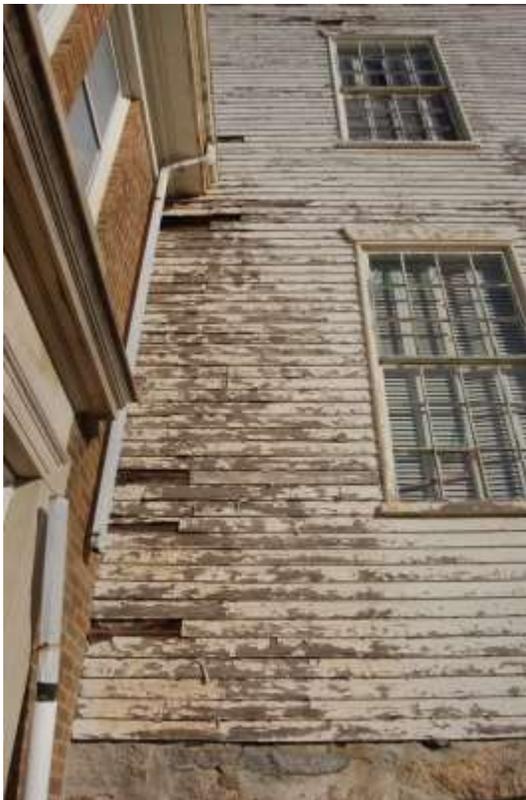
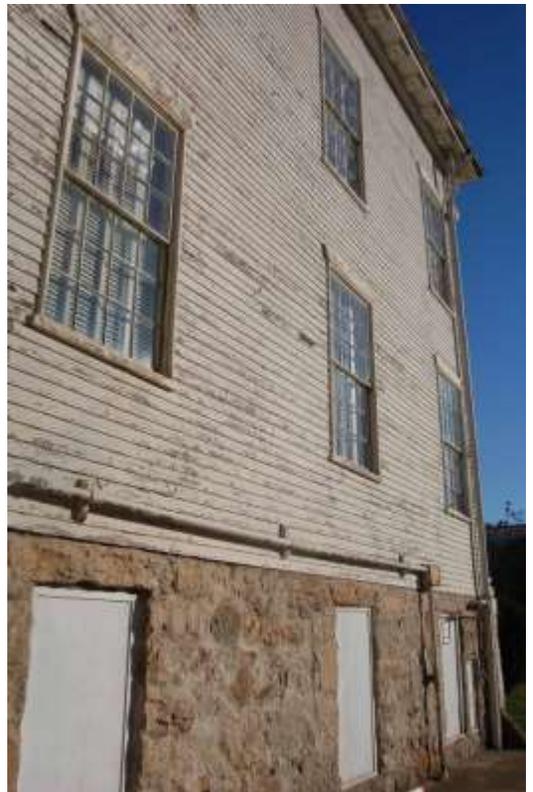
Describe Existing Feature and its Condition: The west elevation adjoins the newer Education Wing built in 1928 which covers approximately 40% of the rear half of the façade. There are four two over two double hung windows at the basement level set in the field stone foundation, one of which is boarded up. There is also a short door at the basement level. The second and third levels have four twelve over twelve double hung original windows and two partial windows, covered by the addition. The clapboard and trim is in fair condition and the paint is severely peeling.

9. West Elevation, First Baptist Church.

Describe work and impact on existing feature: The proposed work is to preserve the existing wood siding and trim and replace “in kind” only those portions that are missing or cannot be repaired with epoxy using the same materials and profiles of the existing feature. New work will be sanded, caulked and blended to smoothly blend with the existing trim. All east elevation clapboard siding and trim will be prepped and painted.

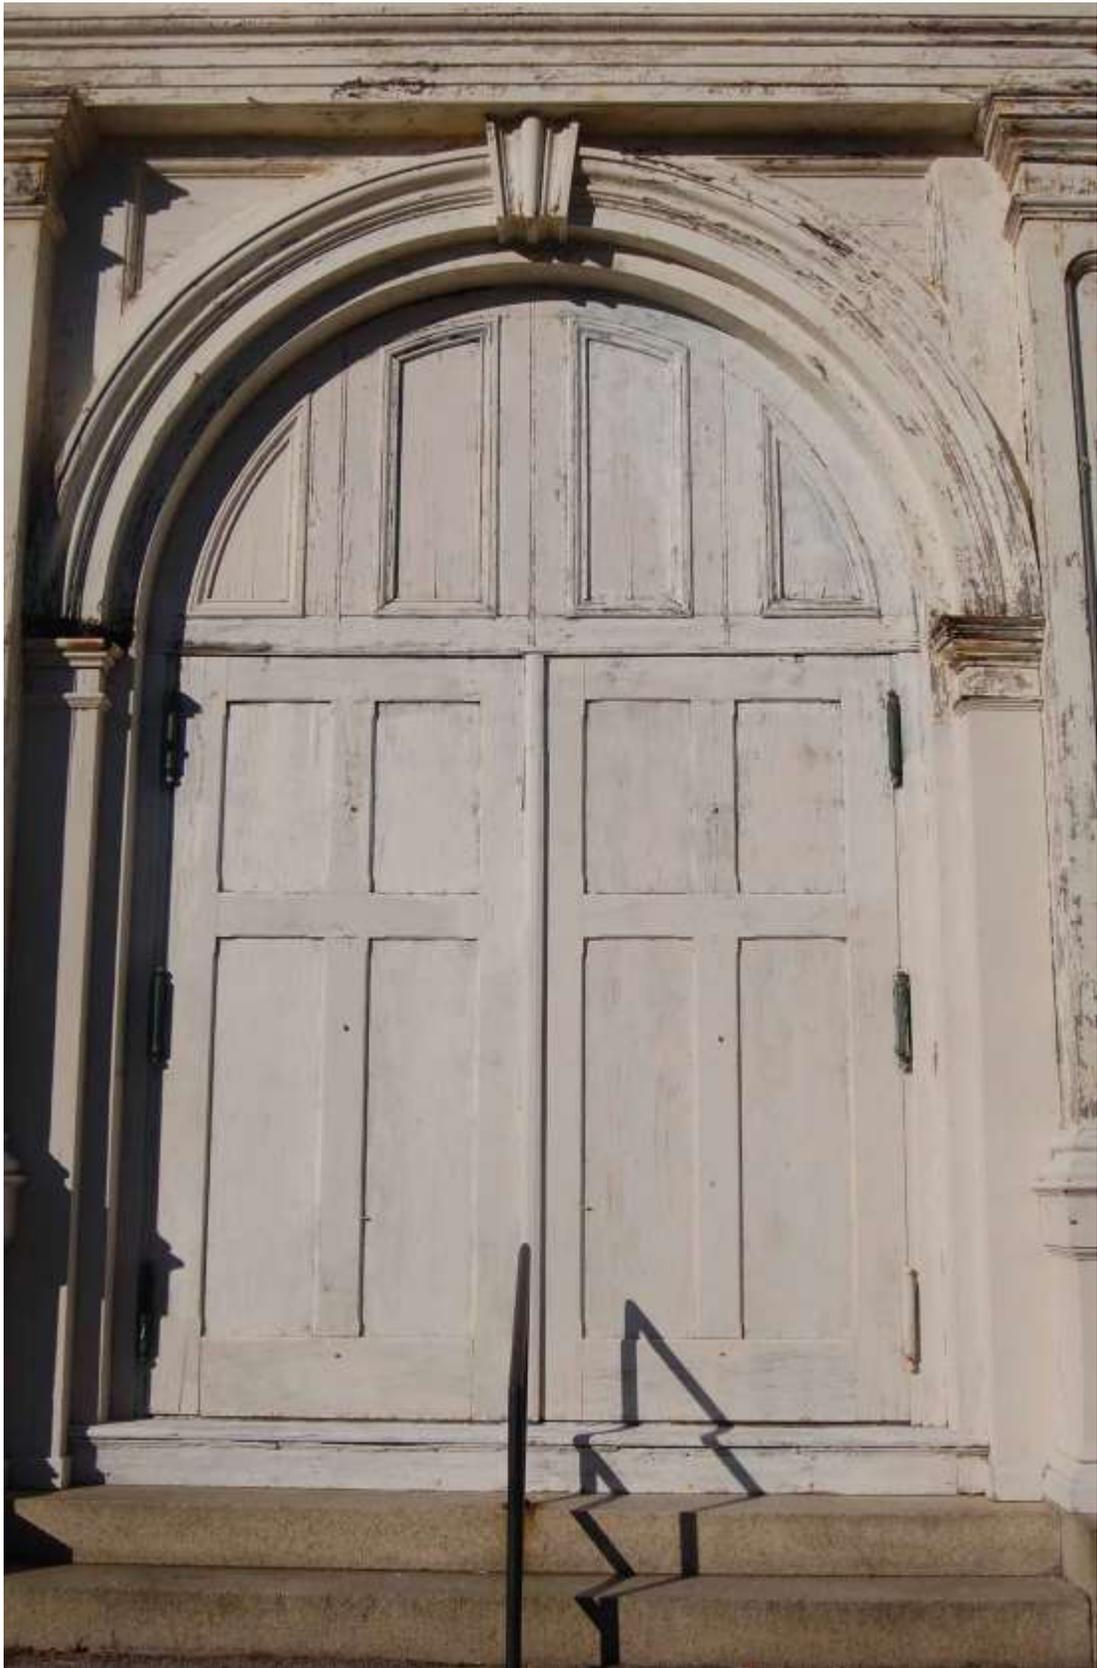
Describe Existing Feature and its Condition: The main exterior entry to the First Baptist Church has two thick paneled wood doors in poor condition which sit in a large columned and arched portico. There are two shallow concrete steps with central iron handrail at the entrance.

15. Main Exterior Entry Door and Stair.

Describe work and impact on existing feature: The proposed scope of work is to completely restore the existing double wood doors. The doors will be dipped and scraped to remove any existing lead paint. Panels will be squared and tightened to fit appropriately within the existing wood frames. Any damaged or decayed wood found within the doors will be repaired to match original appearance. Missing trim will be replaced with in-kind materials and profiles. Doors shall be primed with a penetrating oil primer and receive two coats of latex enamel paint with a semi-gloss finish. Doors will be rehung on existing hardware and calibrated to operate correctly. Where required, accessible hardware shall be provided to meet State Accessibility Regulations. Where required, egress hardware shall be provided to meet code requirements for

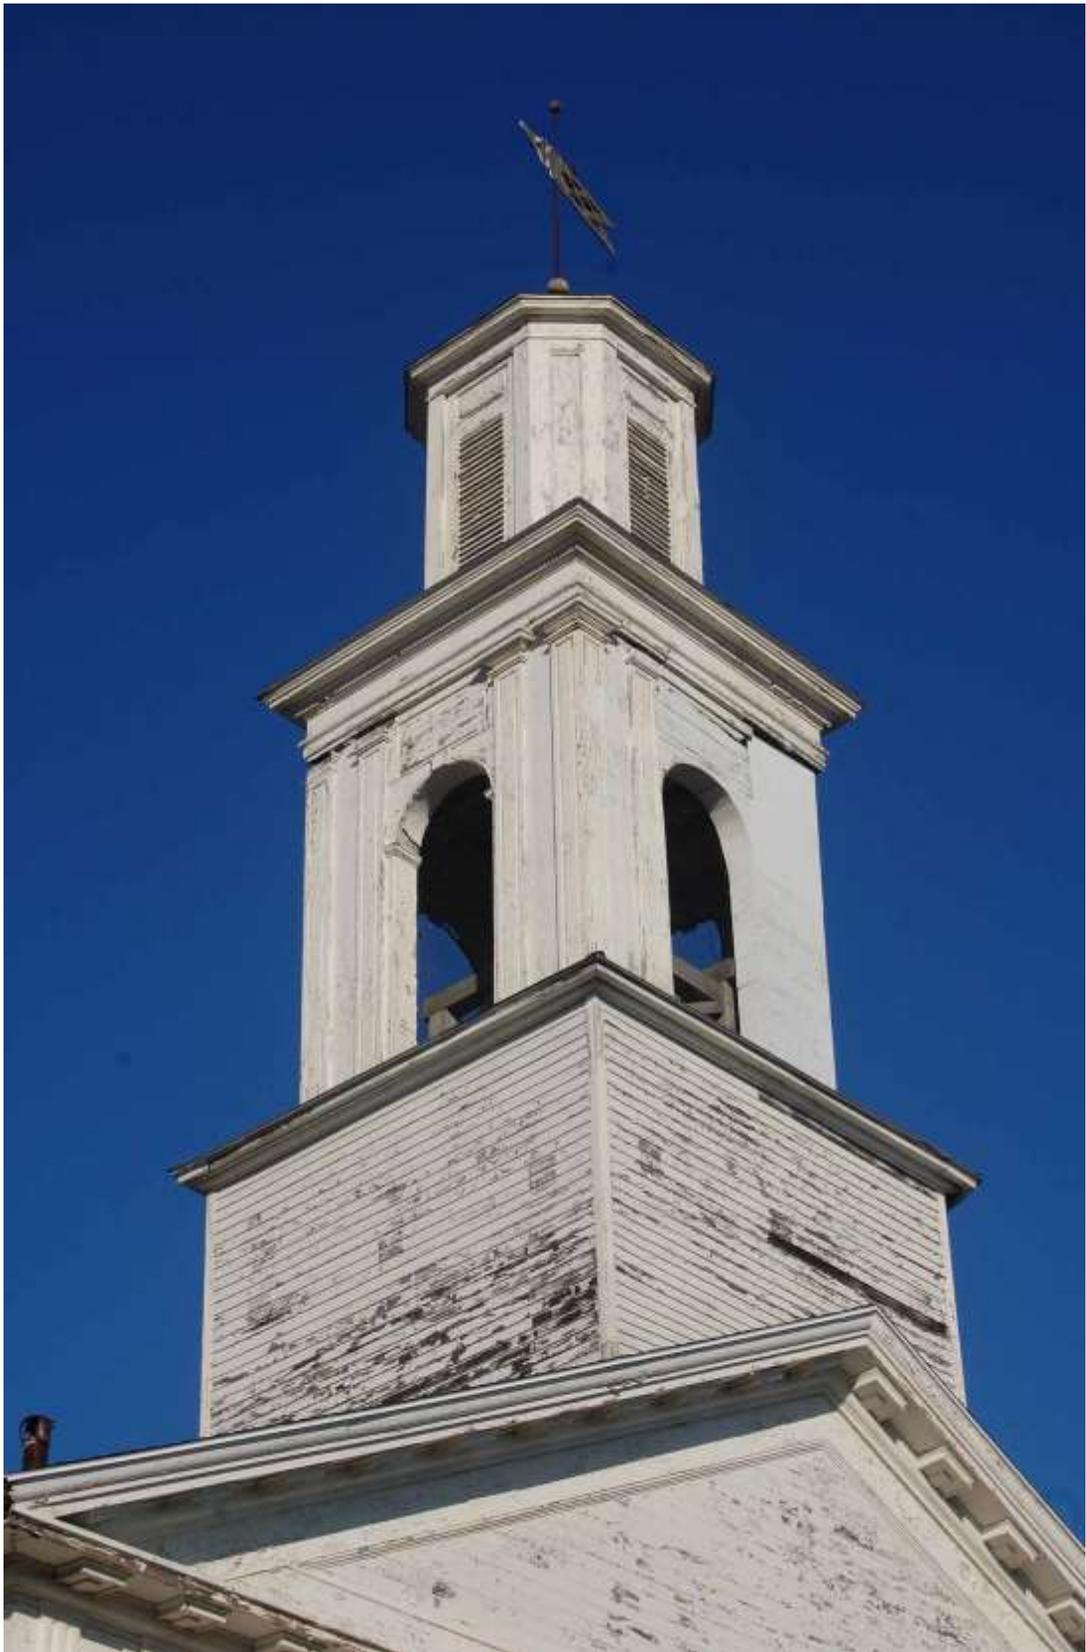
Describe Existing Feature and its Condition: The existing steeple has been replaced at least once in the past after suffering hurricane damage, most recently in 1960, as documented by historic photographs. The same photographs indicate that a number of architectural features on the original steeple have been lost over the years including balustrades and finials. The existing steeple is in poor condition and the extent of its deterioration is not possible to determine without further investigation requiring a lift or crane for access. The steeple has a discernable tilt to the north, which a structural engineer determined previously was the result of structural deflection, since stabilized. In 2012 a portion of the steeple cladding on the southeast corner was lost during a storm after its nailing failed due to the rotting of the timber frame beneath it to which it was attached. This episode suggests that water infiltration has damaged not only the trim and siding of the steeple but its braced timber frame as well. The condition of the flashings and roof over the uppermost section of the steeple appear to be in poor condition which has contributed to the water infiltration.

16. Steeple, First Baptist Church.

Describe work and impact on existing feature: The steeple is intended to be fully restored. The existing structural framing and trusses will be repaired and improved as required to straighten the steeple into its proper position. Any existing structural members showing signs of rot or structural deterioration will be replaced with new solid wood timber framing members. Damaged or missing flashing will be repaired or replaced with in-kind flashing materials. Existing cladding and trim will be secured to the repaired structural frame. Damaged or missing cladding and trim will be repaired to maintain original profiles or replaced with in-kind materials. The steeple will be prepped and painted according to exterior painting requirements.

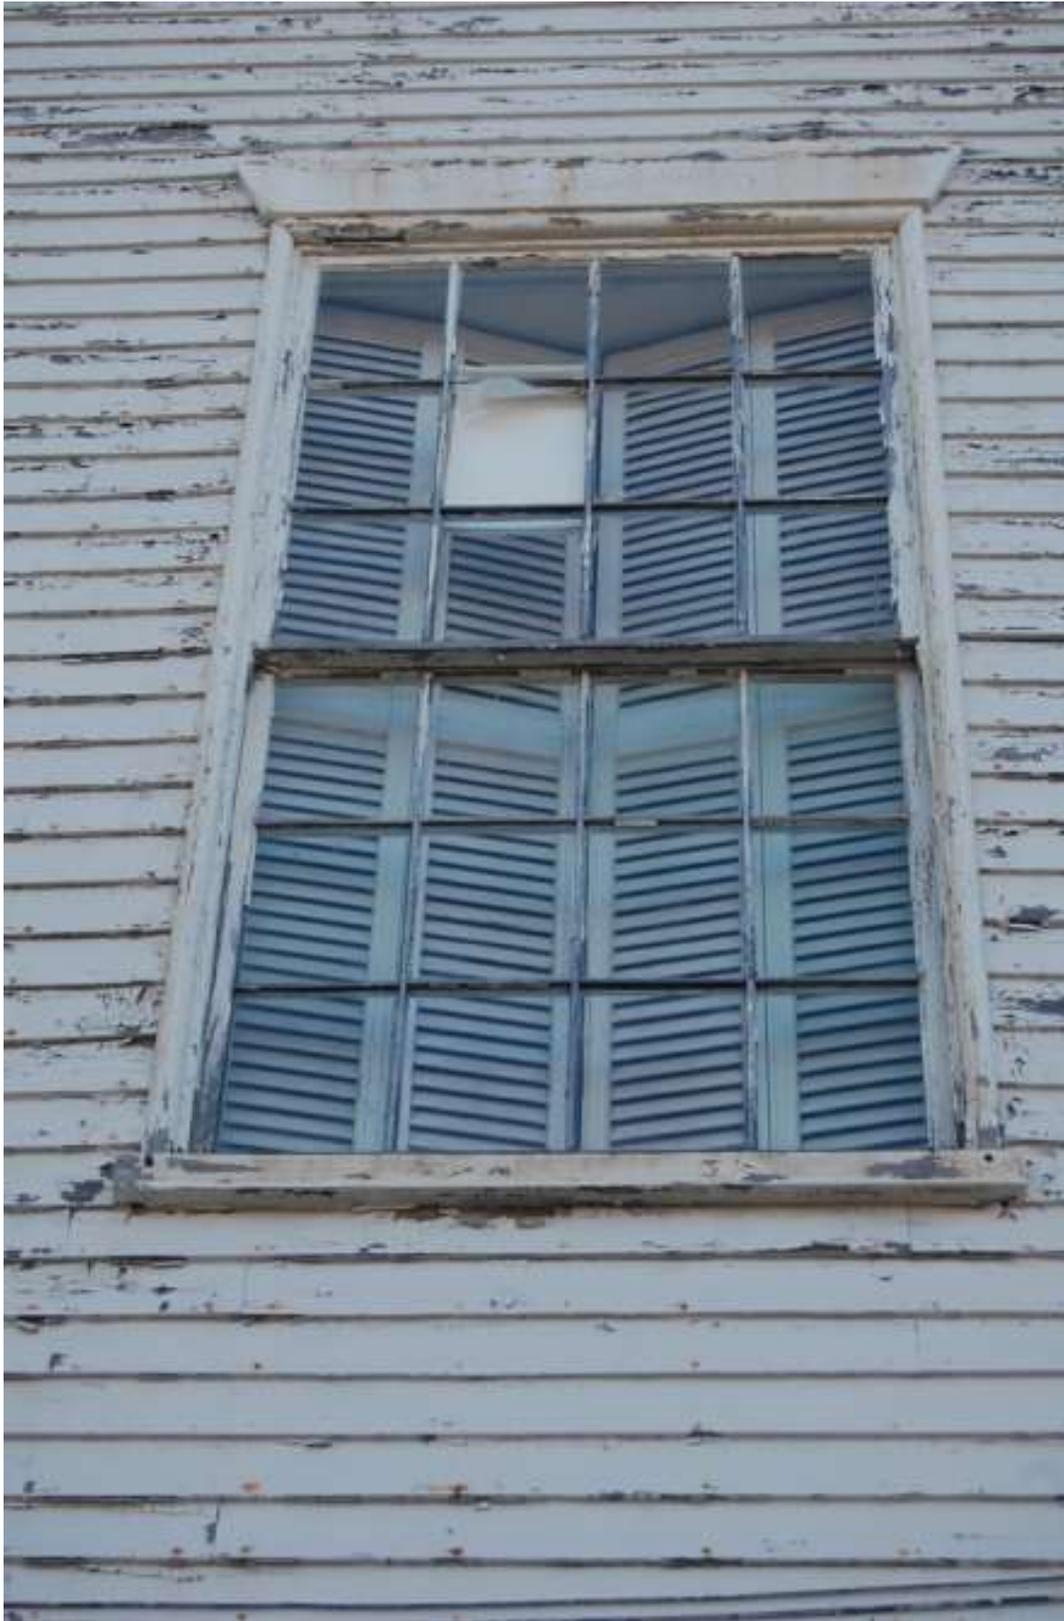
Describe Existing Feature and its Condition: The windows in the building exterior are original to the buildings. The existing windows are primarily single glazed wood double hung units with sash weights that appear to be original to the structure. The windows in the older Church portion of the building are in poor condition due to loss of paint, broken/missing window panes, loss of glazing compound and broken sash cords. Many of the basement level windows have been boarded up with plywood due to their condition and concern about building security. The windows in the 1928 Education Wing are in better condition and provided with exterior storm windows which has protected them from deterioration despite their neglect. The wood elements in the windows appear to be sound in most cases making them worthy of restoration.

21. Exterior Windows, Sill and Flashing, First Baptist Church.

Describe work and impact on existing feature: The proposed scope of work is to completely restore the existing wood windows to their original condition and to furnish them with interior storm window units so as to improve their thermal performance without altering their exterior appearance. The windows will be dipped and scraped to remove any existing paint and glazing compound. Window glass will be removed and salvaged for reinstallation during restoration. Any damage or decay found on the wood sashes will be repaired to match the original appearance and then the sashes shall be treated with a penetrating oil primer. Once primed, the units will be reglazed with the original glass, or new where required to match the original, using glazing points and compound. The reglazed units will receive two coats of latex enamel paint with a satin finish and will be weatherstripped and rehung in the restored frames with new sash cords and weights. Each window will receive an interior double hung storm window with a narrow aluminum frame set close to the existing sash.

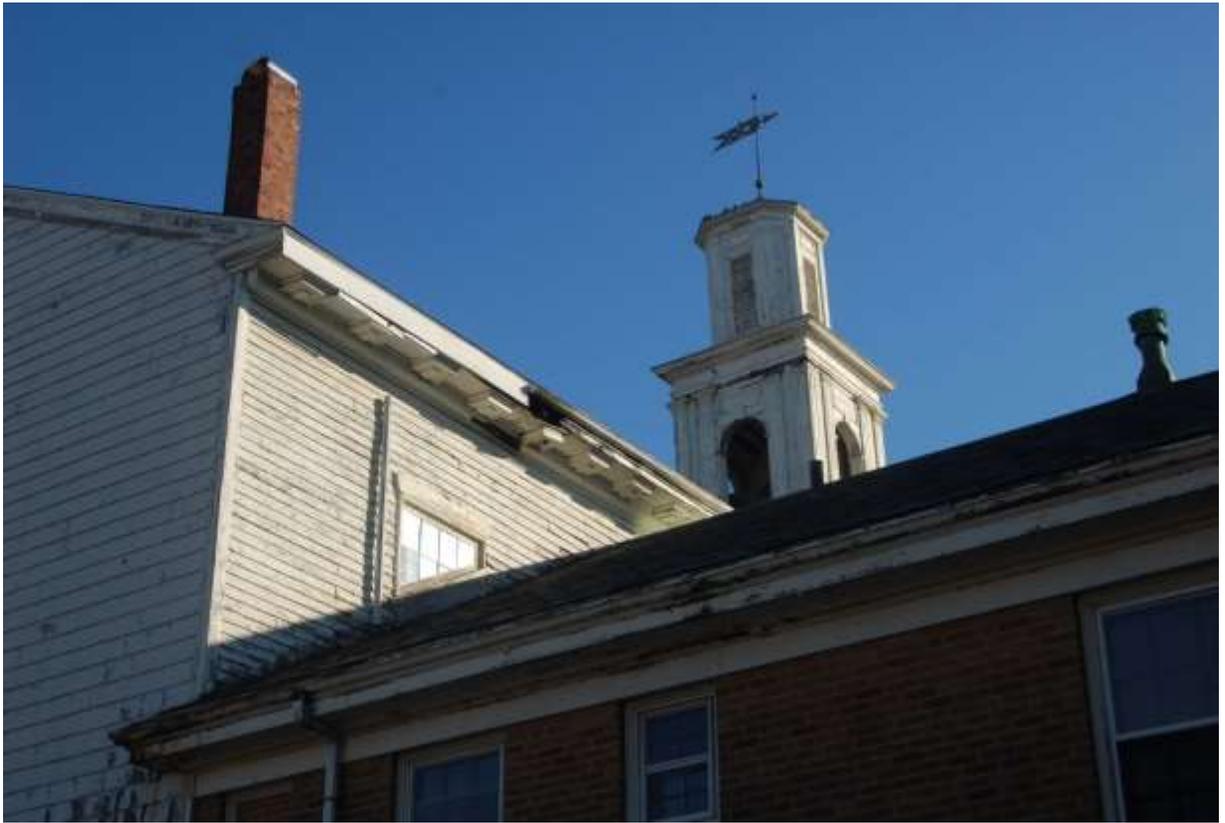
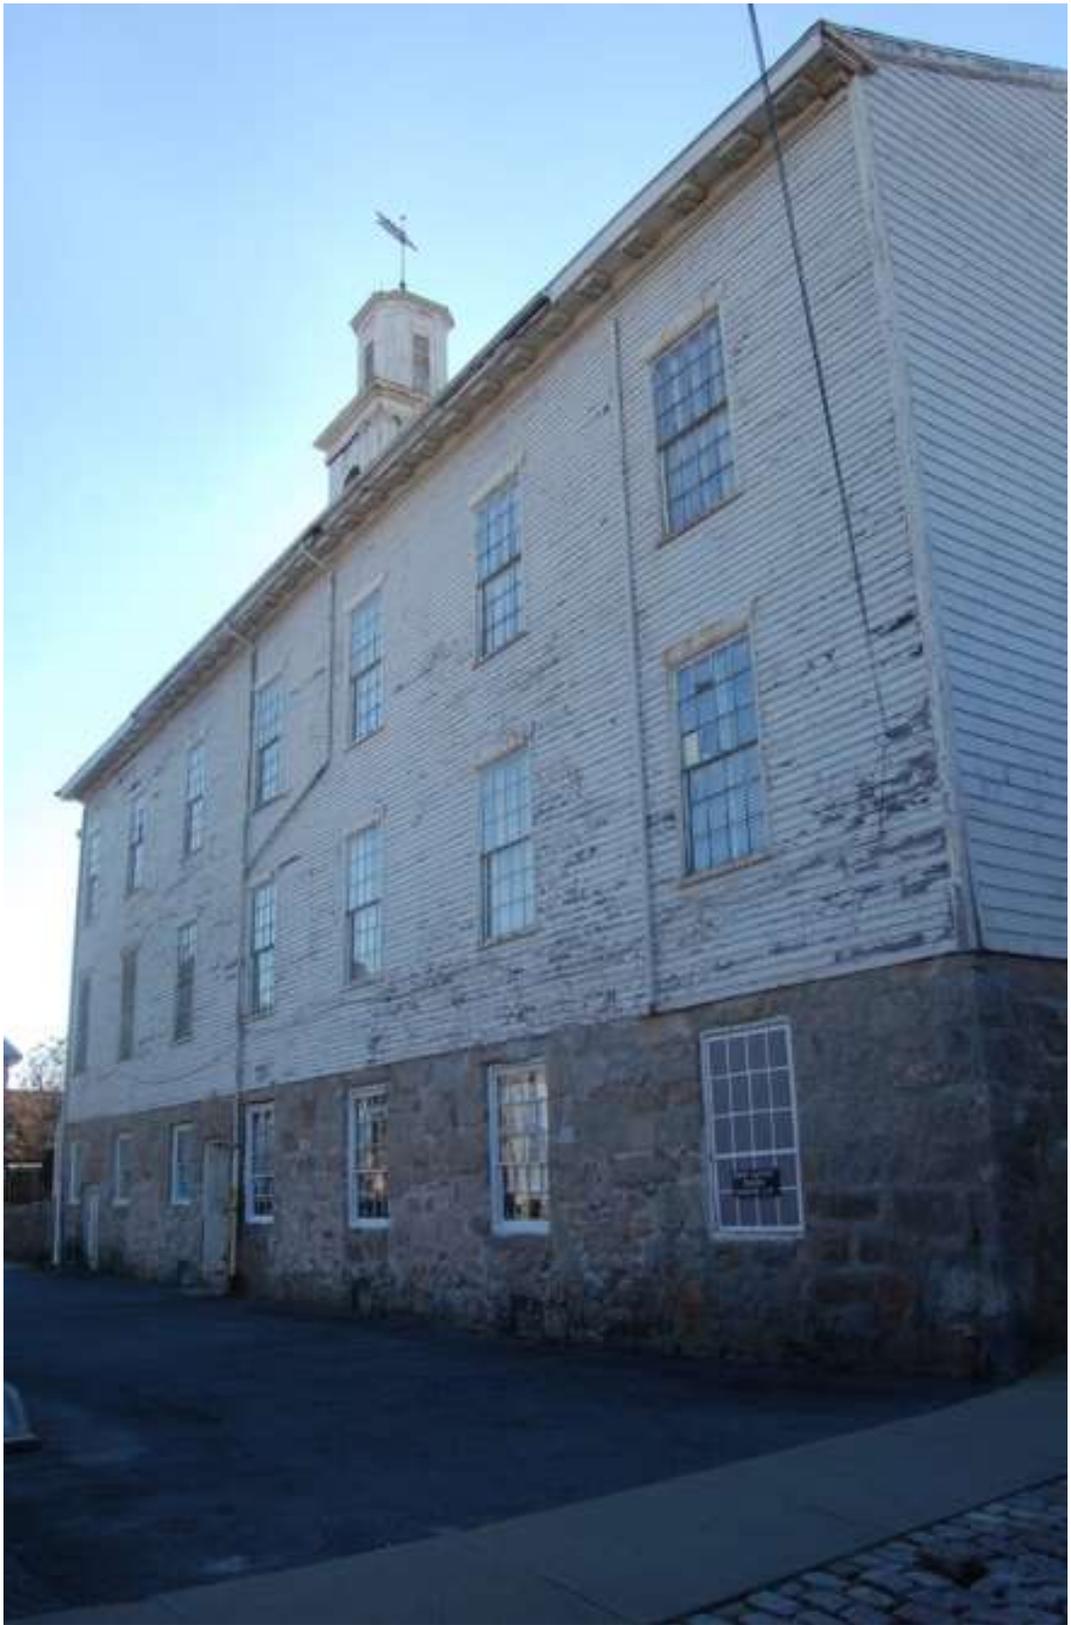
Describe Existing Feature and its Condition: The Church has a three tab asphalt shingle roof which was replaced in 2012 and the Education Wing a slate shingle roof which appears to be original. While both are in reasonably good repair there is evidence of roof leaks at a number of locations on the Meeting House that require additional investigation and suggest that flashing may need to be replaced at the steeple, chimneys and sidewalls. There are a number of missing and broken slate shingles that require attention on the Education Wing. The original wood gutters and steel downspouts are missing in most locations or in very poor condition.

22. Roof, First Baptist Church.

23. Building Gutters, First Baptist Church.

Describe work and impact on existing feature: The proposed roofing work will be limited to inspection and replacement of existing flashings at the steeple, chimneys, and sidewalls to match the original materials and profiles where visible. The missing gutters on the Church will be replaced with painted seamless aluminum gutters with a ogee profile and concealed fasteners as discussed and approved previously by the Massachusetts Historic Commission in 2006. Downspouts will be replaced with painted galvanized steel round gutters to match the appearance of the original gutters. The slate shingle roof will be inspected and missing/broken slates replaced in kind.

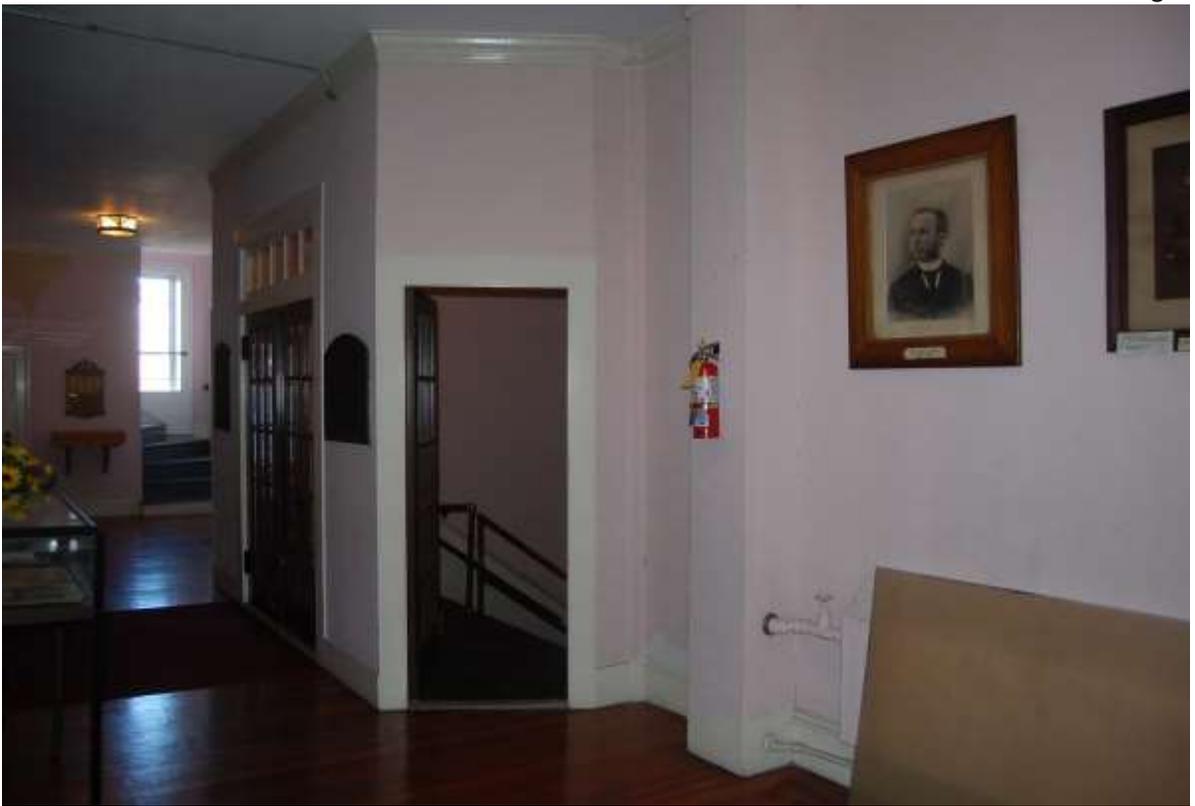
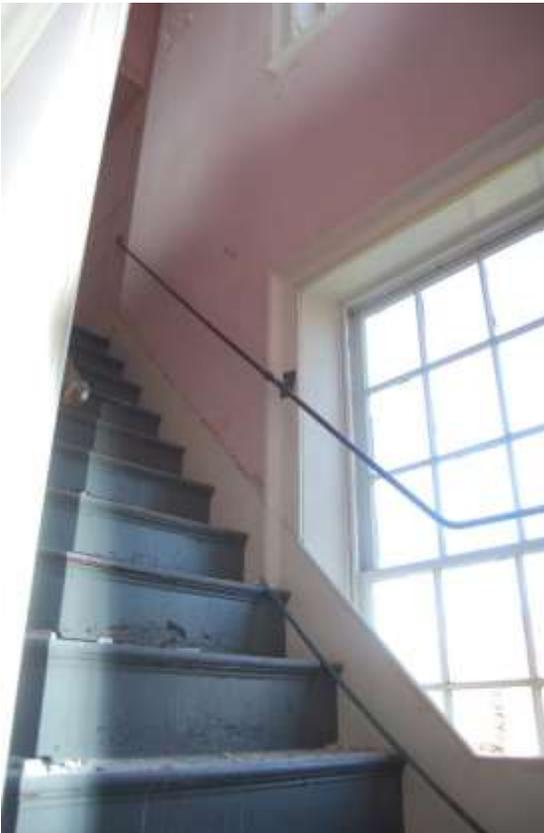
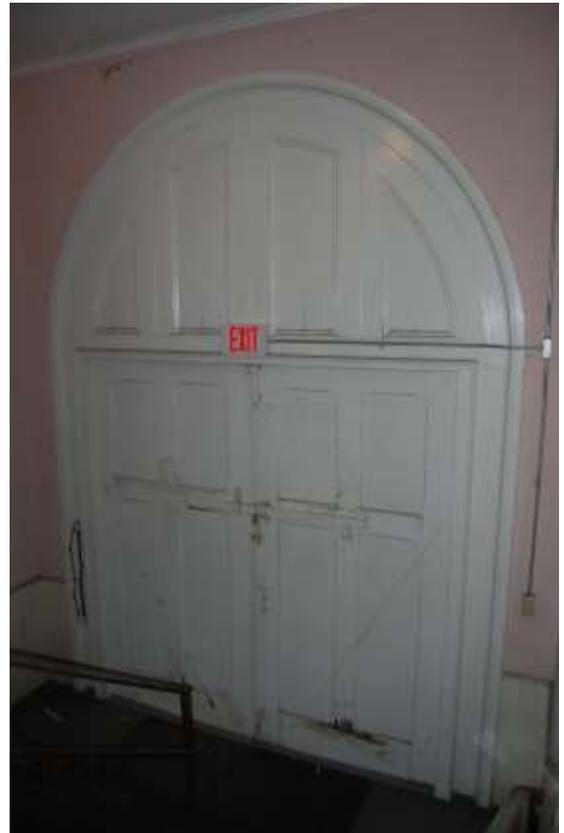
The plaster walls in this area are in fair condition, with multiple cracks. The wood trim is in fair to good condition. The dark wood floors are in good condition.

25. Entry Vestibule and Balcony Stairs, First Baptist Church.

All interior finishes in the entry space are proposed to be restored. Plaster walls and ceilings will be repaired with in-kind materials. Painted surfaces will receive one coat of primer with two coats of final satin finish latex paint. Wood floors will be cleaned and varnished to provide new-like appearance. Interior wood trim will be restored.

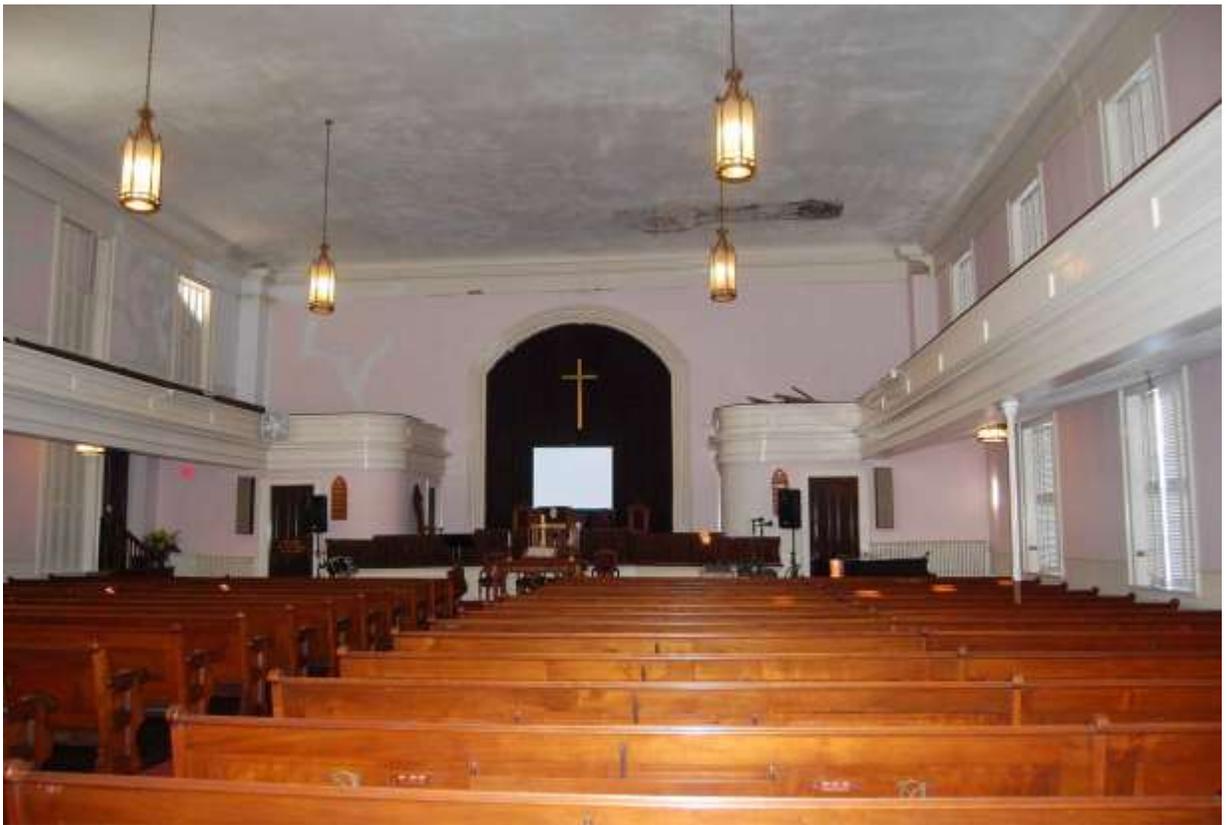
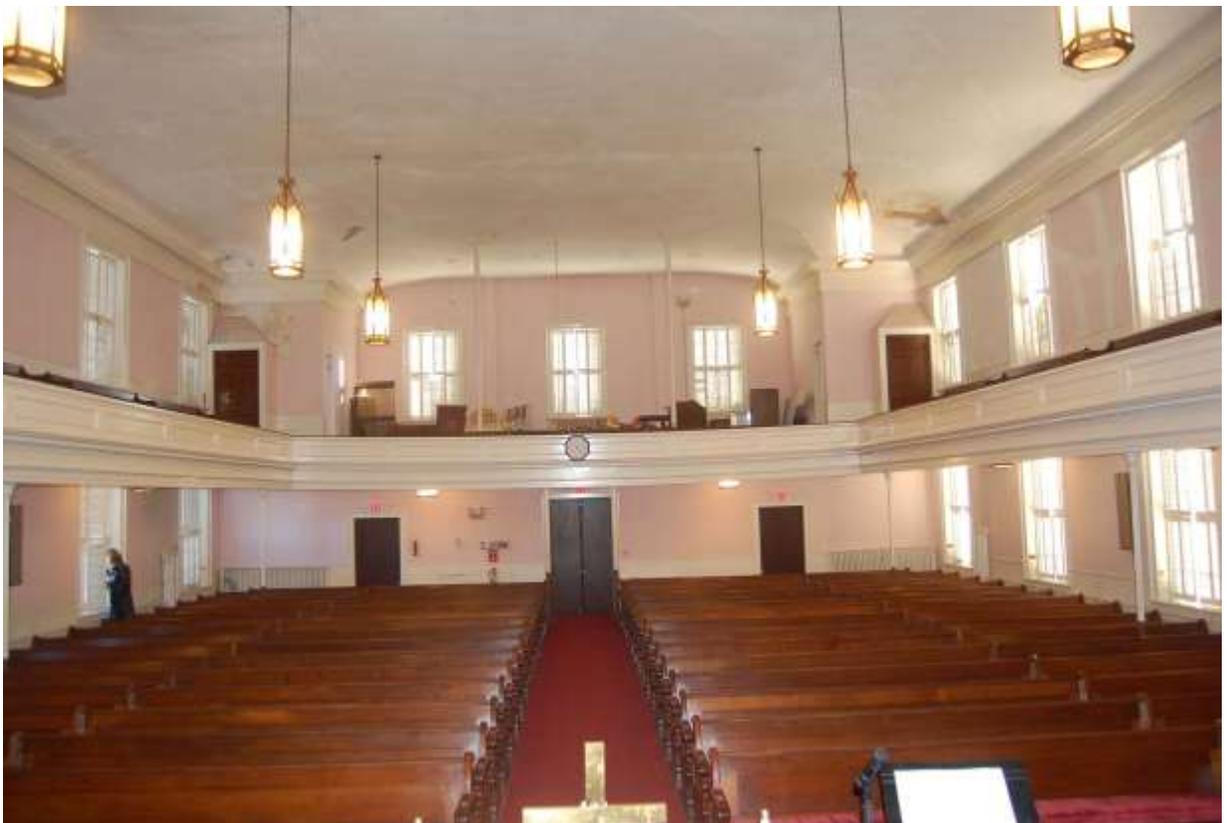
Interior finishes in the Sanctuary have received little maintenance or attention throughout recent years and have fallen into significant disrepair. Interior walls show significant damage from water intrusion. Paint is peeling off from walls and ceilings. Portions of existing plaster walls and ceilings have fallen down. Interior wood trim is damaged or missing. The wood pews appear to be in good sound condition.

28. Sanctuary, First Baptist Church.

Describe work and impact on existing feature: All interior finishes in the Sanctuary are proposed to be restored. Rotten wood lath will be replaced to provide a sound substrate for new plaster finishes. Plaster walls and ceilings will be repaired with in-kind materials. Painted surfaces will receive one coat of primer with two coats of final satin finish latex paint. Painted floors will be cleaned and repainted to provide new-like appearance. Interior wood trim will be restored. Damaged trim will receive epoxy repairs to maintain original profiles. Missing trim will be replaced with in-kind materials to match the original trim work. The majority of Pews are to remain and be used for theatre seating, while some rows require removal to allow for the stage area and new handicapped bathrooms.

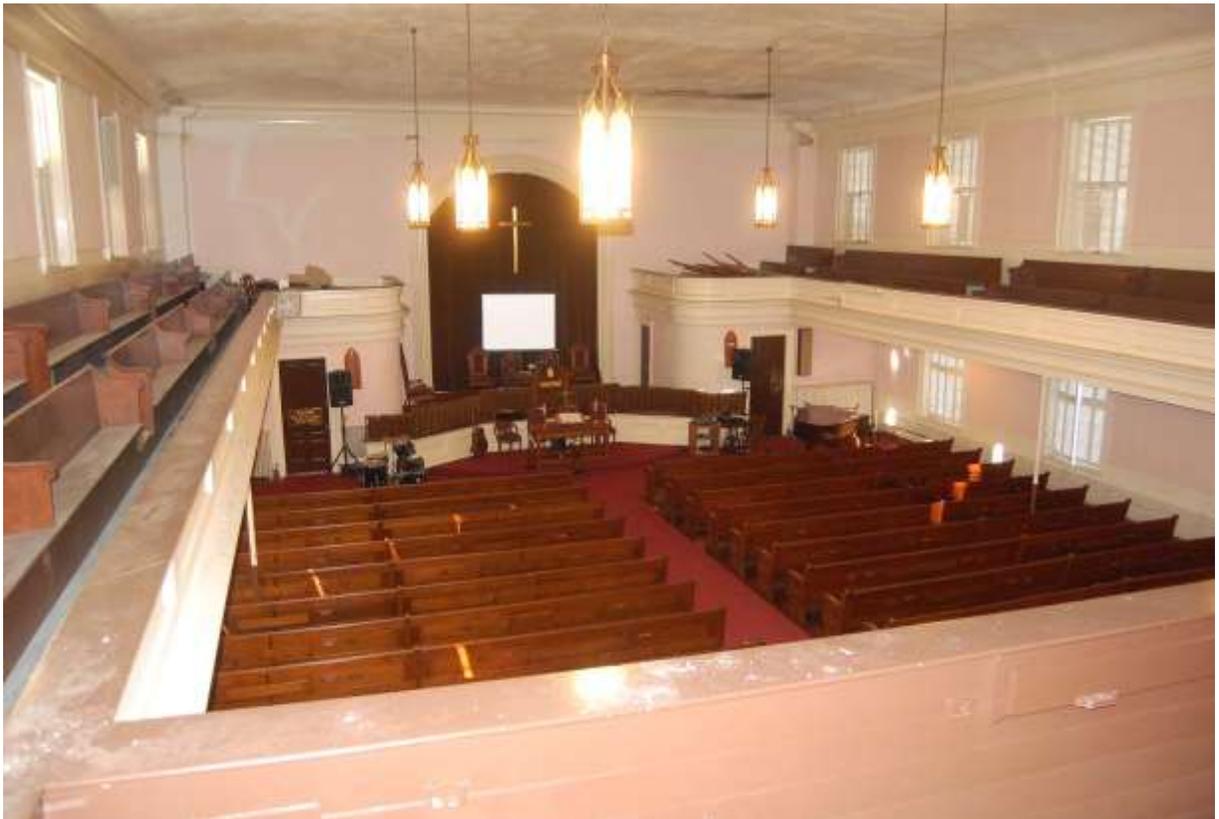
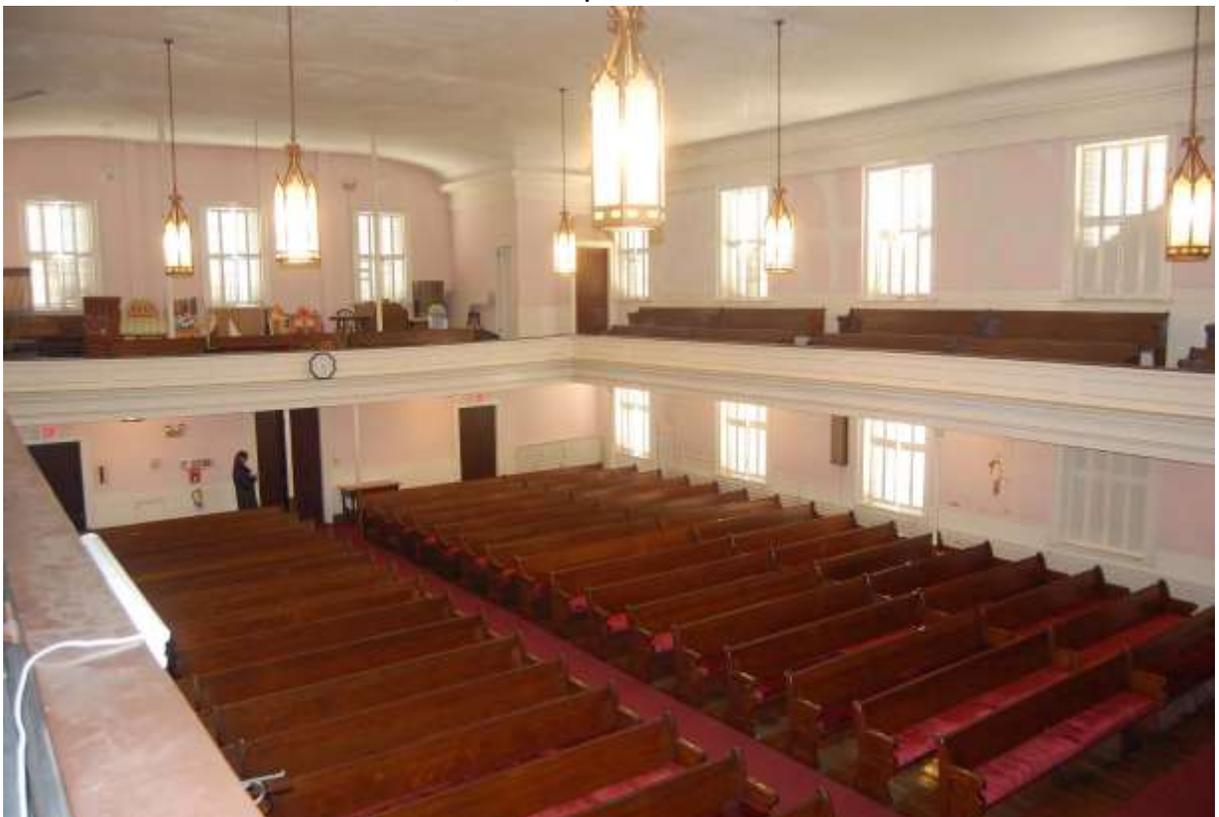
Describe Existing Feature and its Condition: The architecturally significant balconies that wrap around the Sanctuary create a second level of seating. They are accessed by two side stairs from the entry vestibule. The balconies are in good condition and are stable.

51. Choir Loft and Balconies, First Baptist Church.

Describe work and impact on existing feature: Minimal work will be done to the balconies. Wood will be primed and painted and walls will undergo plaster repair, primed and painted per the Scope of Work. The Eastern side access stair will need to be removed to accommodate installation of the chair lift.
