STAFF REPORT

NEW BEDFORD HISTORICAL COMMISSION MEETING

LOCATION: 141 William Street, First Baptist Church (Map 52, Lot 209)

Your Theatre – First Baptist Church Restoration/Renovation

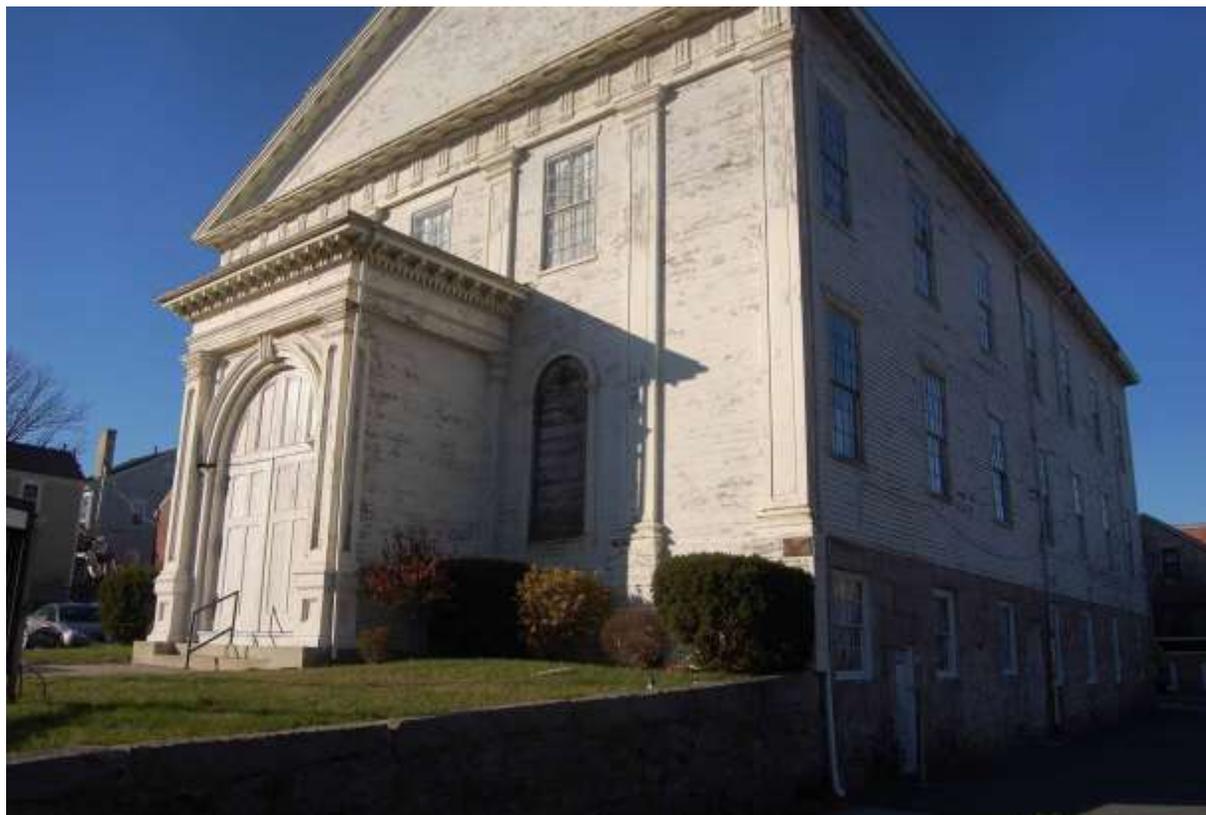
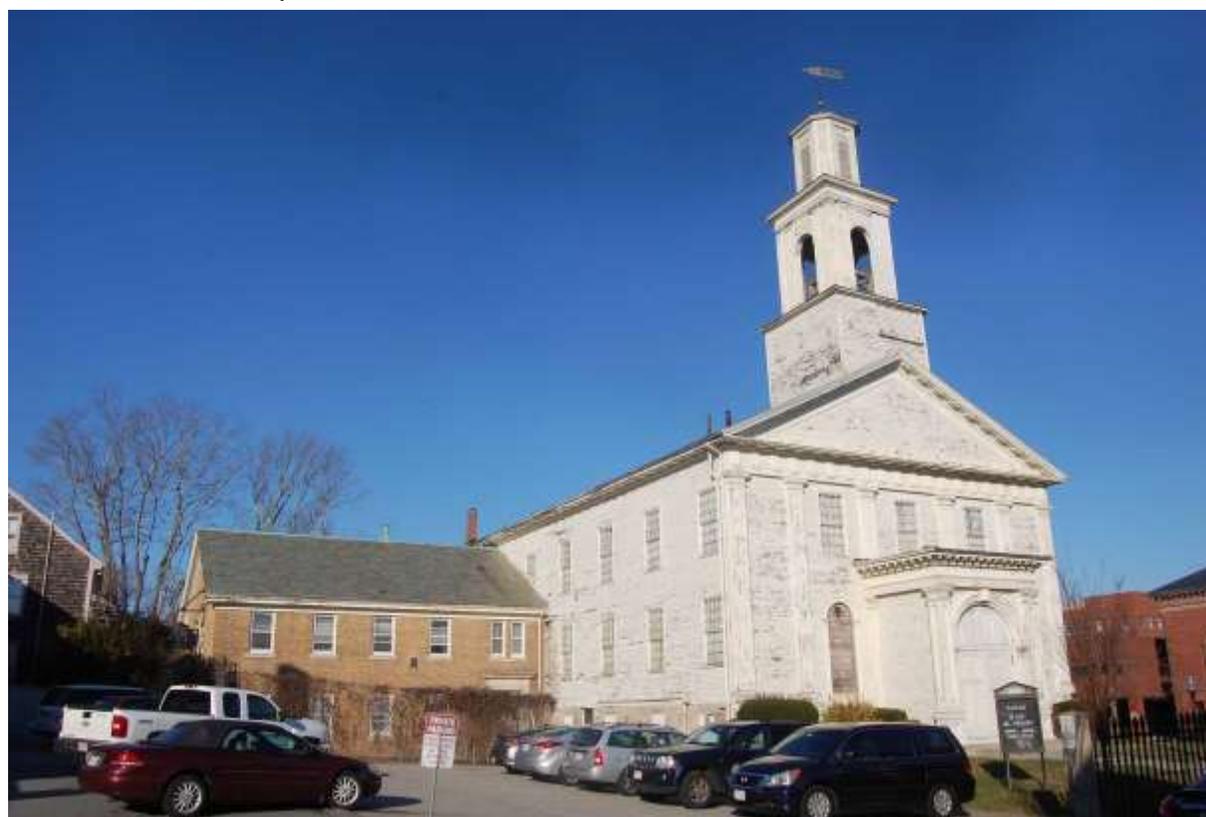
Describe Existing Feature and its Condition: The First Baptist Church abuts a parking lot for the historic City Hall, and the historic New Bedford Public Library. The lot is 16, 080 SF with a grassed front lawn and cement walkway leading to the front entrance of the church. A side walkway leads to the entrance of the Education Wing. There is a small parking lot for the building abutting the west side of the site. There is a retaining wall separating the city-owned parking lot from the Church property in poor condition.

55. Site, First Baptist Church.

The portion of the stone retaining wall that has failed structurally shall be disassembled and the original masonry salvaged for reuse. The wall will be rebuilt with a new reinforced and waterproofed concrete unit masonry wall set behind and hidden beneath the restored masonry that will be installed over it in its original location. The restored masonry will be laid in the same manner using matching mortar, joints, and tooling as the original wall.
