AS-BUILT
OCTOBER 3, 2016

CITY OF NEW BEDFORD
DEPARTMENT OF PUBLIC INFRASTRUCTURE
Bellville Avenue Pump Station Map 111 Lot 99
618 Bellville Avenue, New Bedford MA 02745

DESIGNED BY : DJF
CHECKED BY :
SCALE: NTS
DATE : April 8_16
SHEET 8

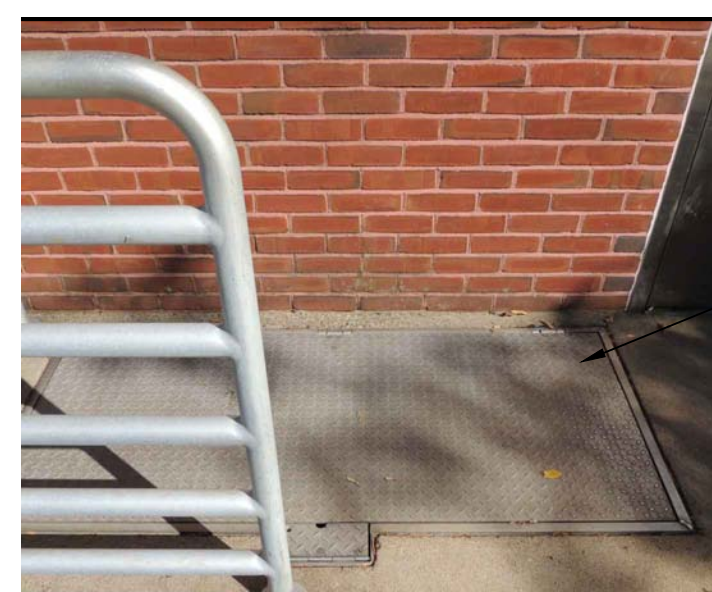
MAXIMUM FLOOD ELEVATION 17.73 W/ 4 FT SEA LEVEL RISE

REFURBISH EXISTING HATCH WITH FLOOD-PROOFING GASKET & HARDWARE. (PENDING)

REPLACE DOOR WITH NEW STAINLESS STEEL FLOOD-PROOF DOOR. (PENDING)

REFURBISH HOSE BIBB WITH FLOOD-PROOF GASKET AS NEEDED. (PENDING)

REMOVE DOOR AND HARDWARE & REPLACE WITH REINFORCED BLOCK AND BRICK MASONRY. (PENDING)

REFURBISH DOOR AND FLOOD-PROOF WITH NEW FRAME AND HARDWARE. (PENDING)

INSTALL STOP LOG CHANNELS EACH SIDE OF OPENING TO ELEVATION 18.00 AND PROVIDE STOP LOGS ON SITE. (PENDING)

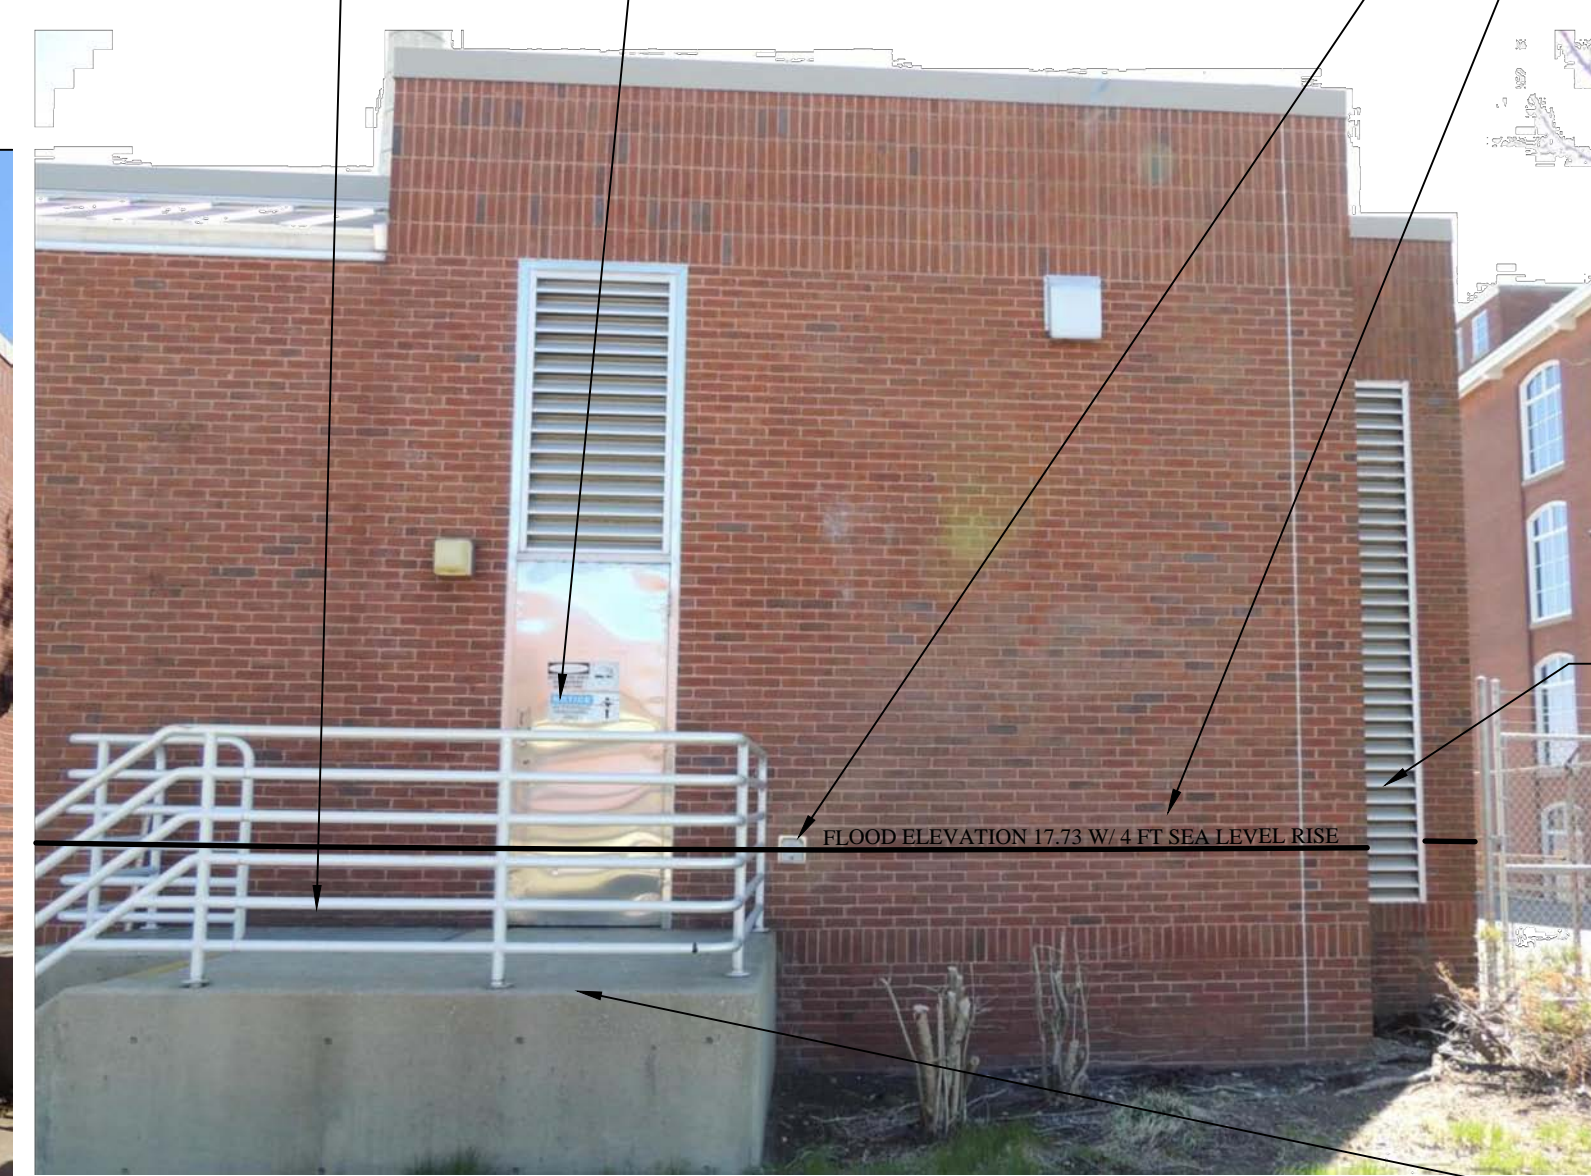
WEST ELEVATION

FLOOD ELEVATION 13.07 W/ 2 FT SEA LEVEL RISE

BENCHMARK ON CONCRETE LANDING AT SW CORNER CHISEL BOX MARK ELEVATION 16.13

REPLACE DOOR WITH NEW STAINLESS STEEL FLOOD-PROOF DOOR. (PENDING)

INSTALL STOP LOG CHANNELS TO ELEVATION 18.00 PROVIDE STOP LOGS ON SITE. (PENDING)

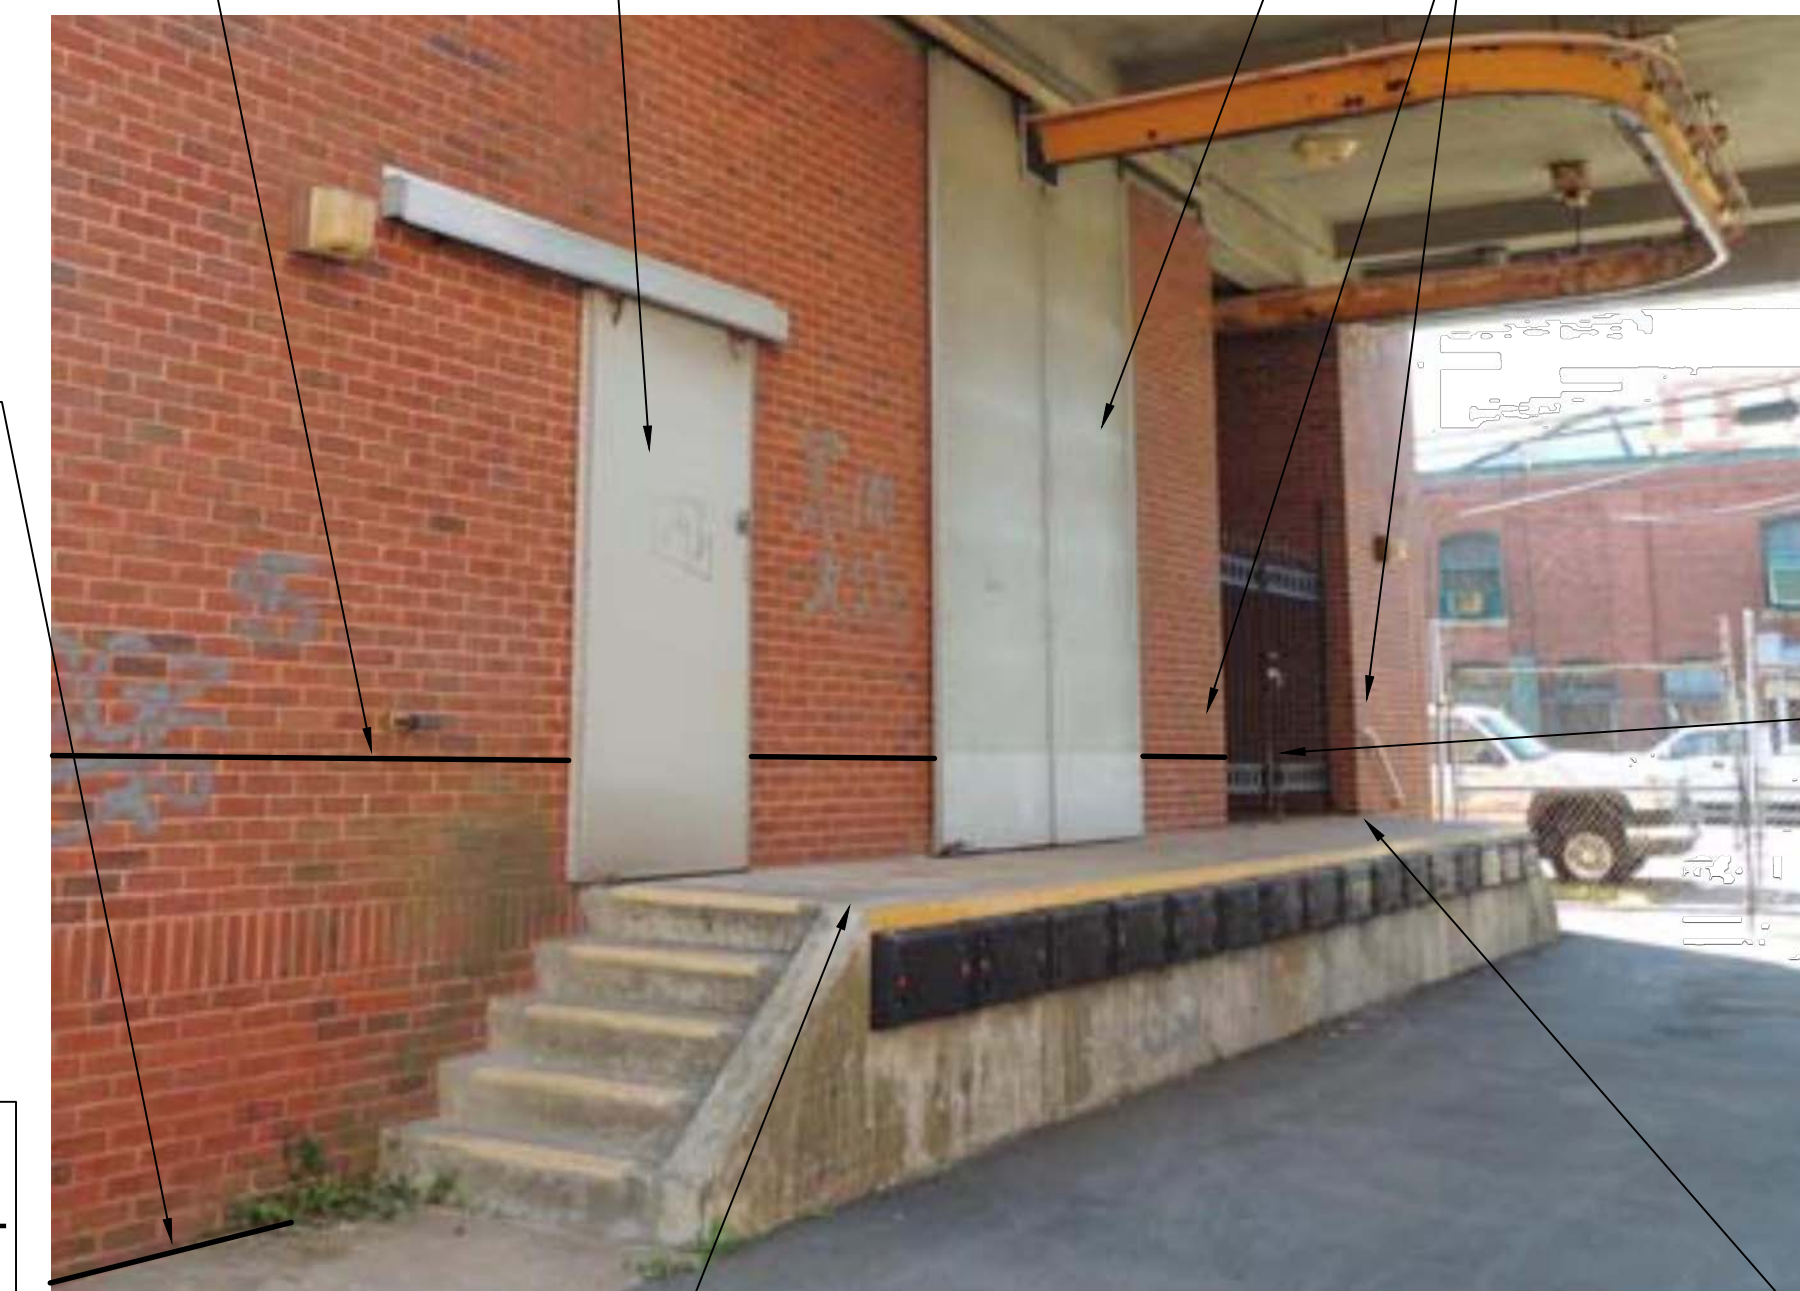
NORTH ELEVATION

BENCHMARK ON CONCRETE DOCK AT NE CORNER CHISEL BOX MARK ELEVATION 16.12

BENCHMARK ON CONCRETE DOCK NEAR BLDG CORNER CHISELED SQUARE ELEVATION 16.18

BENCHMARK ON CONCRETE WALK AT NW BUILDING CORNER CHISEL BOX MARK ELEVATION 13.295

STORY POLE MOUNTED TO BUILDING WALL. (PENDING)

INSTALL STOP LOG CHANNELS TO AT LEAST ELEVATION 17.80 PROVIDE STOP LOGS ON SITE. (PENDING)

REPLACE DOOR WITH NEW STAINLESS STEEL FLOOD-PROOF DOOR. (PENDING)

REFURBISH EXISTING HATCH WITH FLOOD-PROOFING GASKET & HARDWARE. (PENDING)

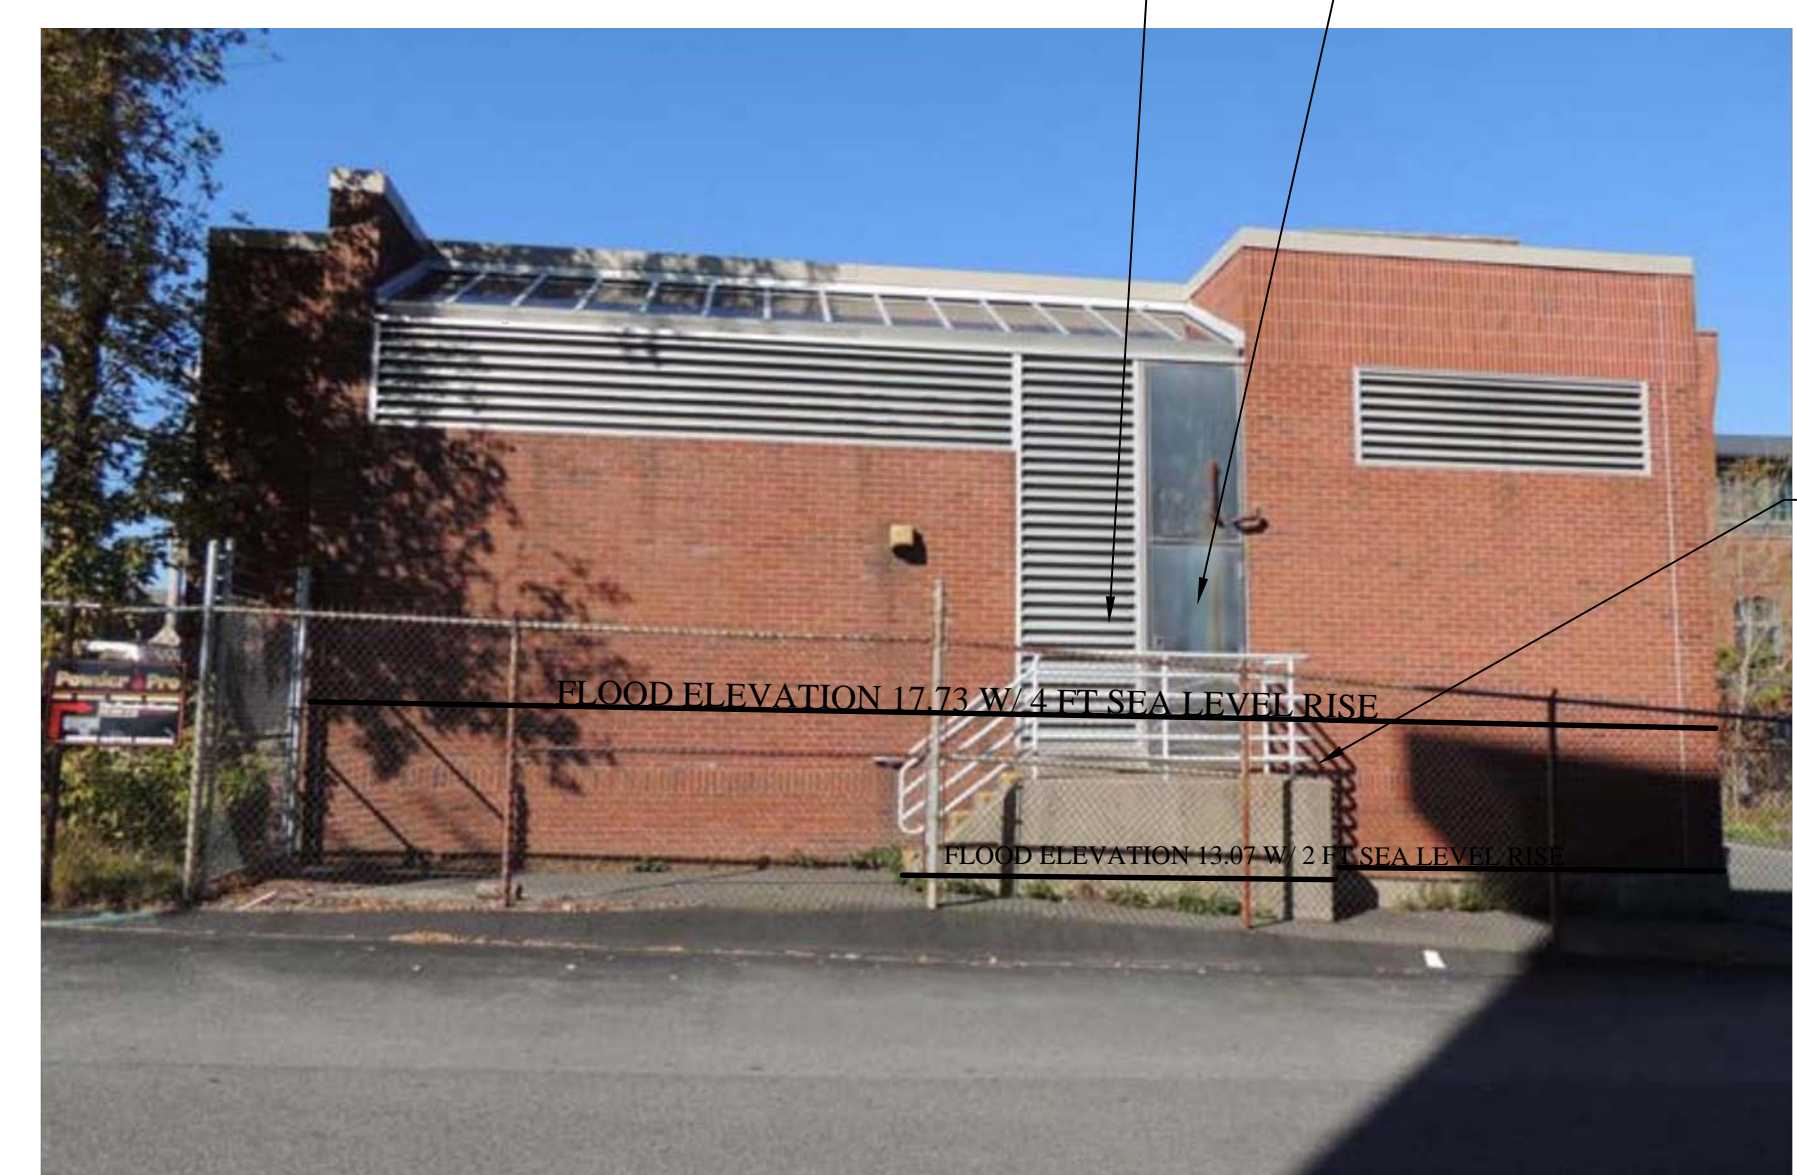
SOUTH ELEVATION

BENCHMARK ON CONCRETE LANDING AT SE CORNER CHISEL BOX MARK ELEVATION 16.09
