Environmental Monitor Report
New Bedford Regional Airport
Runway Safety Improvements Project
MassDEP File No. SE 049-0635

Subject: **Environmental Monitor Report - New Bedford Regional Airport Runway Safety Improvement Project Phases 2 and 3; Variance Order of Conditions and Water Quality Certificate; DEP File No. SE 049-0635.**

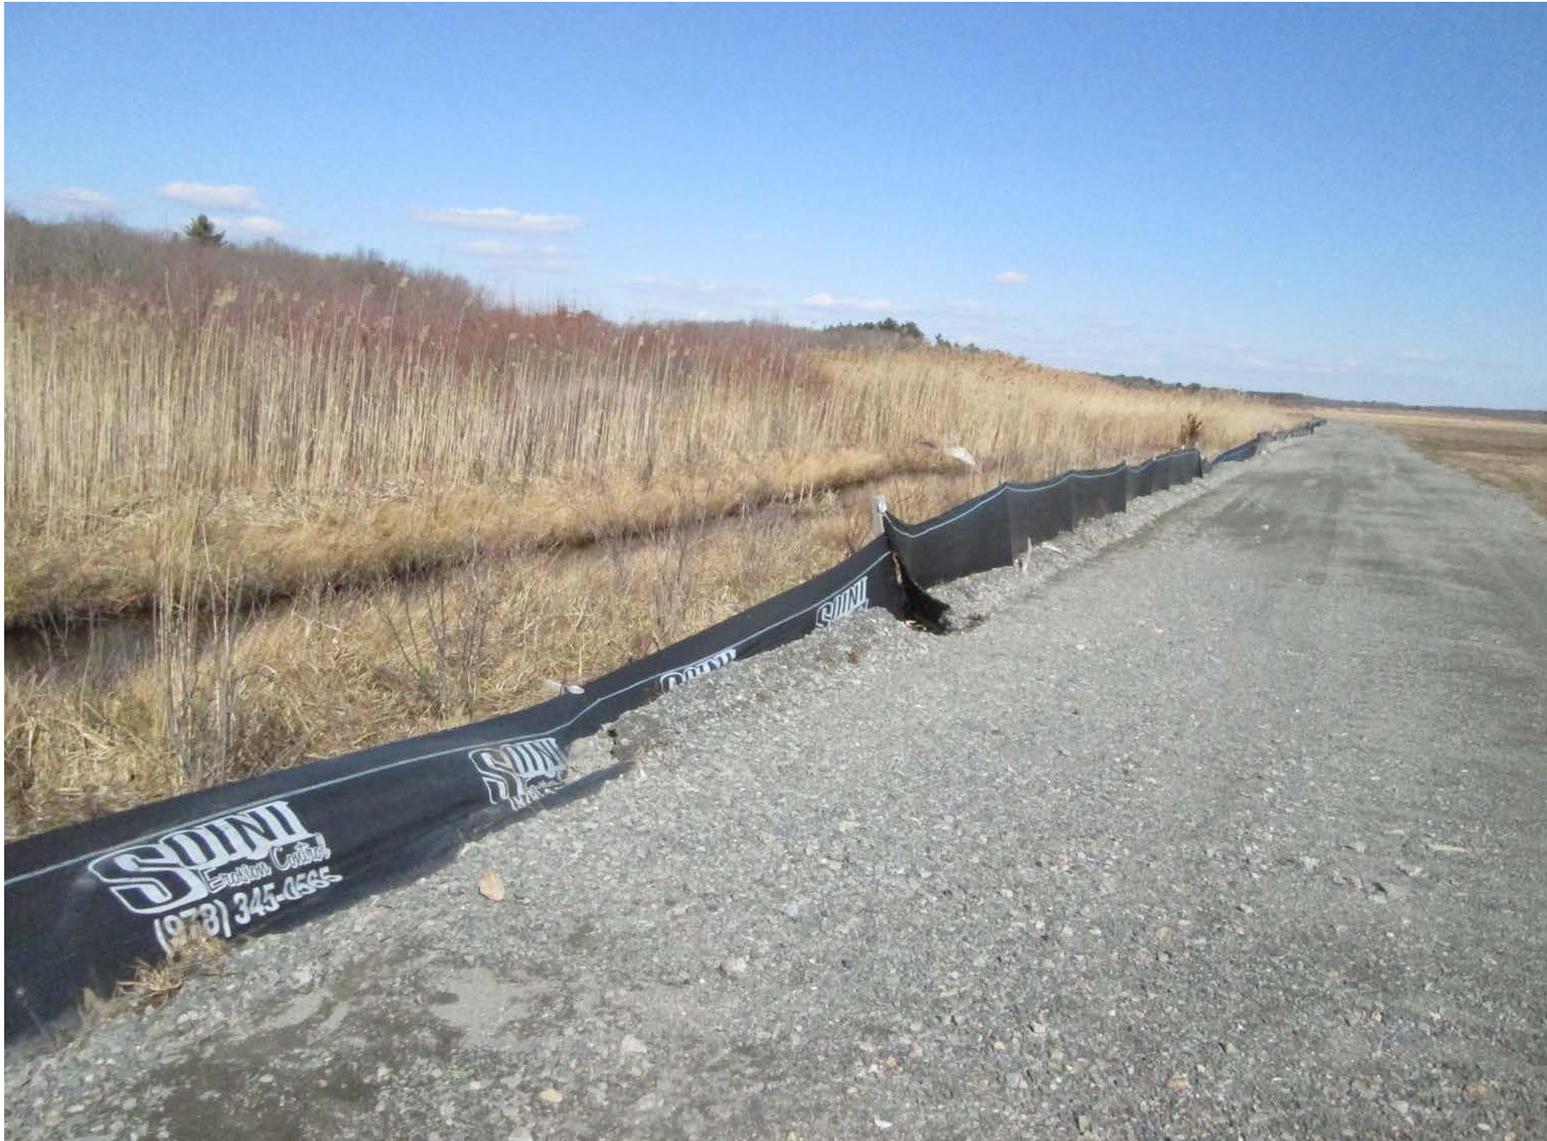
Erosion controls along the RW 5 RSA gravel road are in fair to good condition. A small volume of gravel has washed through the silt fence and has collected in the area between the silt fence and the West Ditch. A very small volume of gravel has also settled in the West Ditch (no more than one "shovel-full"). The gravel may have washed into the resource area from "wave" action after vehicles drove through the ponded water during frozen ground conditions. See attached photos. There is no other evidence of sedimentation within the West Ditch. The existing silt fence may in fact be doing more harm than good at this point in the project as it appears to be acting as a dam and is causing water to pond in the gravel road. We would ordinarily recommend removing it and smoothing out the gravel berm because the fence is no longer necessary given the stability of the road - but with Phase 4 construction starting this spring the fence would only need to be reinstalled in advance of construction traffic using the road. We therefore recommend leaving it alone for now until the Phase 4 contractor mobilizes (April timeframe). There is very little gravel entering the resource area and we would propose to continue monitoring the area should conditions change such that corrective actions are needed in the short term.

View of silt fence along RSA road after snow melt. The silt fence may be doing more harm than good at this point in the project as it appears to be acting as a dam and is causing water to pond in the gravel road. We would ordinarily recommend removing it and smoothing out the gravel berm because the fence is no longer necessary given the stability of the road - but with Phase 4 construction starting this spring the fence would only need to be reinstalled in advance of construction traffic using the road. We therefore recommend leaving it as is until the Phase 4 contractor moves in to repair and upgrade it before commencing work later this spring. There is very little gravel entering the resource area and we would propose to continue monitoring the area should conditions change such that corrective actions are needed in the short term.

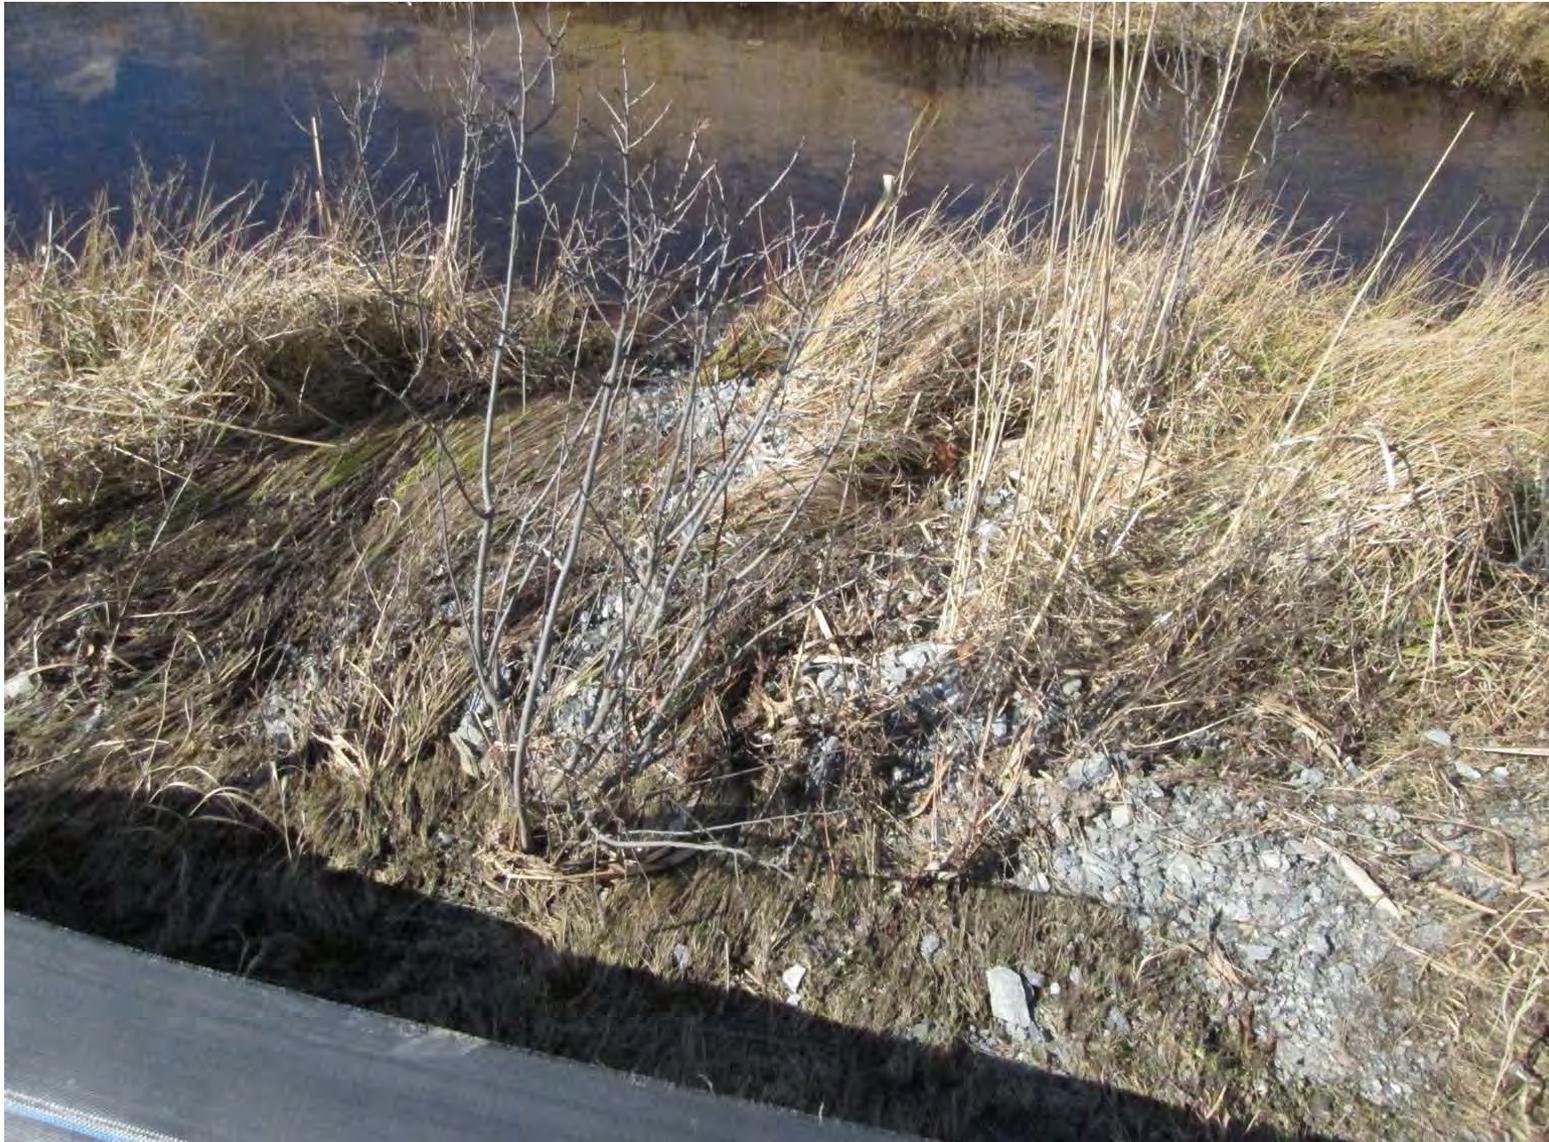
View of discrete area of silt fence along RSA road where the fence was bent back and a small amount of gravel (one “shovel-full”) washed through.

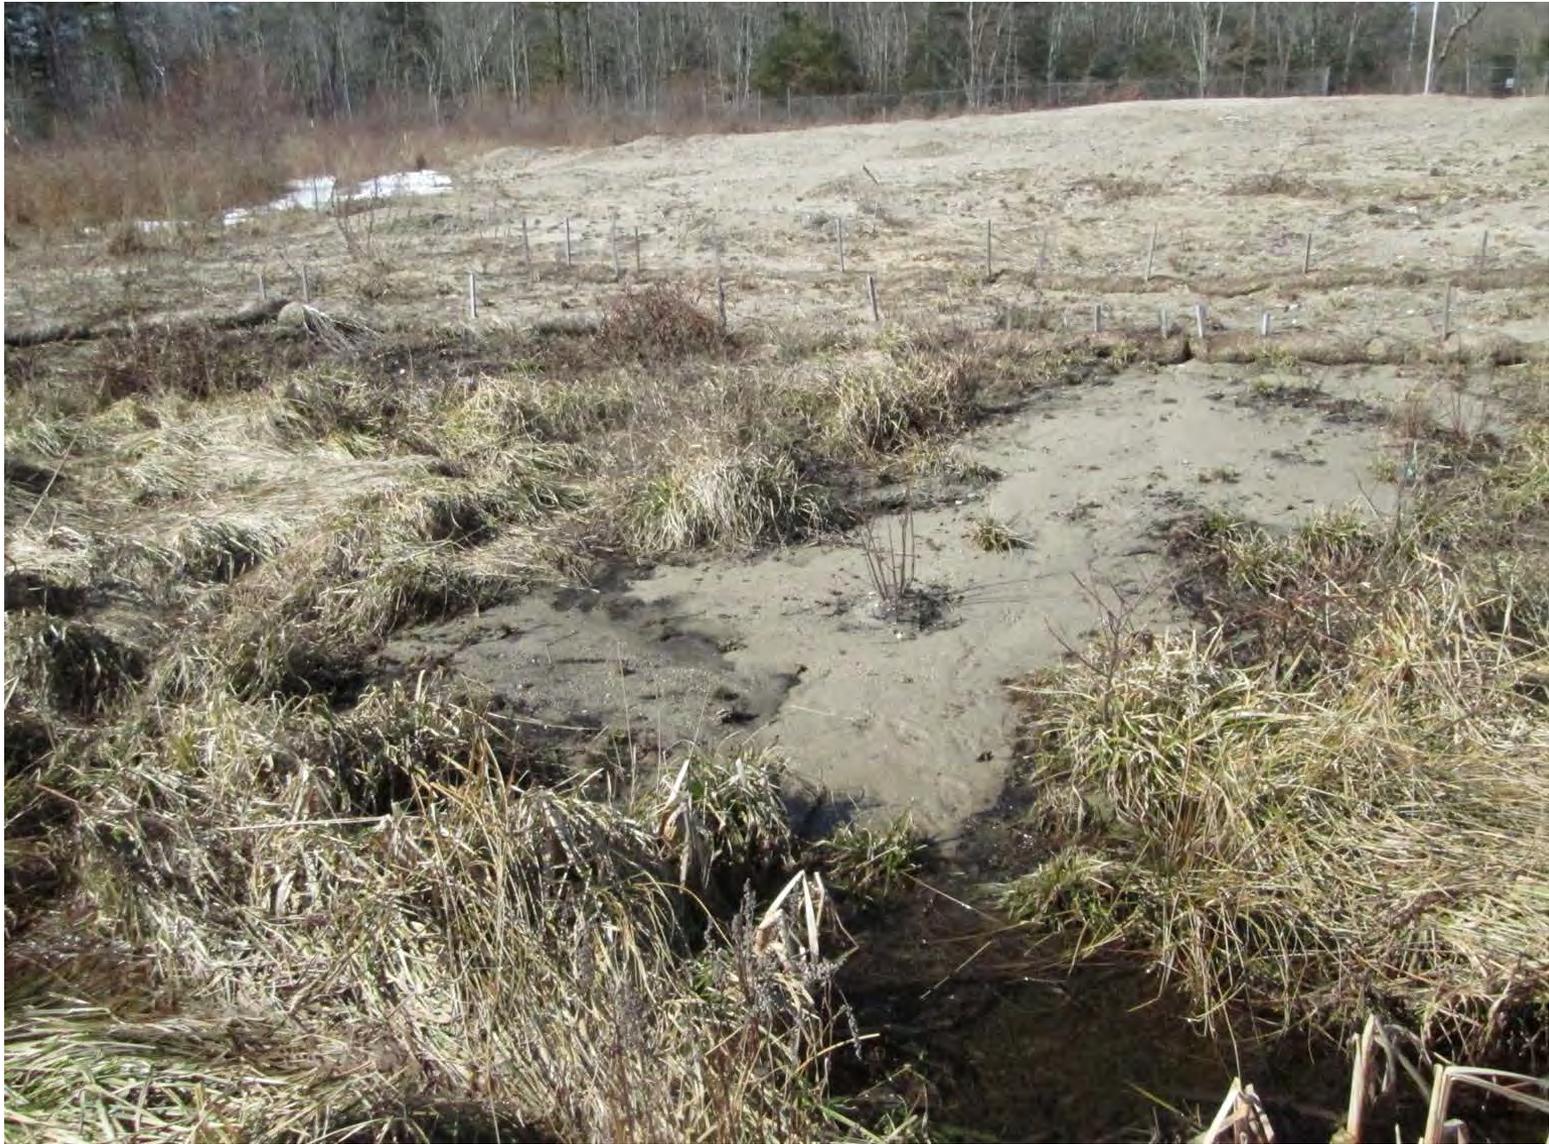
As noted in previous EM reports, sand migrating from turtle nesting area 3 into Wetland Mitigation Site 6 has been an ongoing challenge. By design, the turtle nesting area is supposed to be comprised primarily of an exposed and semi-vegetated sandy substrate. The site contractor (Manafort) has on at least 2 occasions pulled back a small amount of sand that eroded along a slope into Wetland Mitigation Site 6 and re-set the straw wattles. Unfortunately the wattles do not appear

View of turtle area 3/ wetland mitigation site 6 interface after snowmelt. This is a natural low point between these two areas where sand continues to migrate into the construct wetland. We recommend that the sand be raked out, the area re-seeded with a wetland seed mix and additional erosion controls (silt fence) be installed to diffuse the runoff. We will work with the Airport to identify a long term solution to this ongoing challenge including potentially constructing a vegetated natural berm along the interface. The ground is frozen in this location but the Airport staff will make a good faith effort to remove the sand and install the silt fence in the next 2 weeks as conditions allow.

to be mitigating the situation. An approximately 25 ft x 5 ft wide area of sand remains in Site 6 and should be removed by hand; this area has increased since last reported. We recommend that the sand be raked out by hand, the area re-seeded with a wetland seed mix and additional erosion controls (silt fence) be installed to diffuse the runoff. We will work with the Airport to identify a long term solution to this ongoing challenge including potentially constructing a vegetated natural berm along the interface. Once the vegetation is established the sand should be better contained in the turtle area and the controls can be removed. The ground is frozen in this location but the Airport staff will make a good faith effort to remove the sand and install the silt fence in the next 2 weeks as conditions allow.
