Environmental Monitor Report
New Bedford Regional Airport
Runway Safety Improvements Project
MassDEP File No. SE 049-0635

Date: April 1, 2014

Subject: **Environmental Monitor Report - New Bedford Regional Airport Runway Safety Improvement Project Phases 2 and 3; Variance Order of Conditions and Water Quality Certificate; DEP File No. SE 049-0635.**

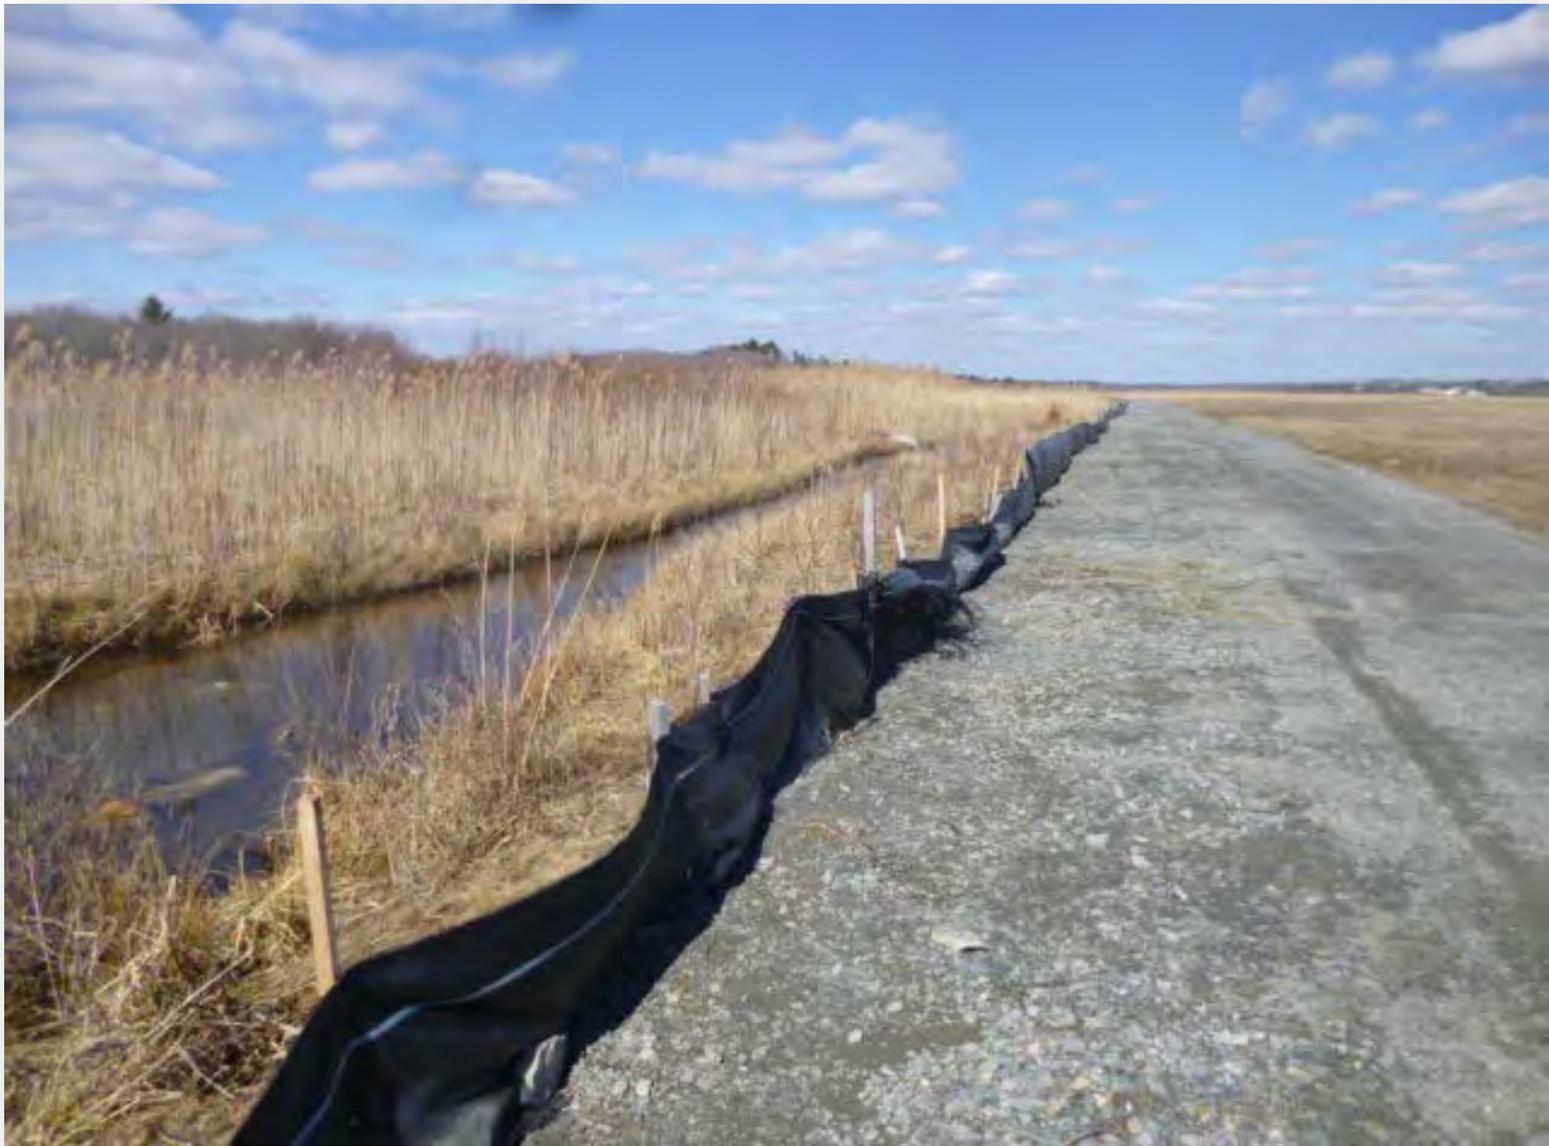
View of recently repaired silt fence by Airport staff. Note that the previous gravel berm located immediately adjacent to the silt fence has been removed and raked back into the access road.

Erosion controls along the RW 5 RSA gravel road are in fair to good condition. The Airport staff repaired the existing fence and raked and tamped the gravel berm that was built up along the edge of the silt fence. The Airport specifically fixed the area where gravel was washing towards the West Ditch. They removed the small volume of gravel that had washed through the silt fence and collected in the area between the silt fence and the West Ditch. The Airport also hand removed the small volume of gravel that settled in the West Ditch. See attached photos. There is no other evidence of sedimentation within the West Ditch. The existing silt fence is in good enough shape to keep silt and sediment from reaching the west ditch and the planted area adjacent to the west ditch. There are some small holes in the silt fence, yet these holes are a few inches of the ground. Phase 4 construction is slated to start in mid-April at that time the silt fence will be reinstalled in advance of construction traffic using the road.

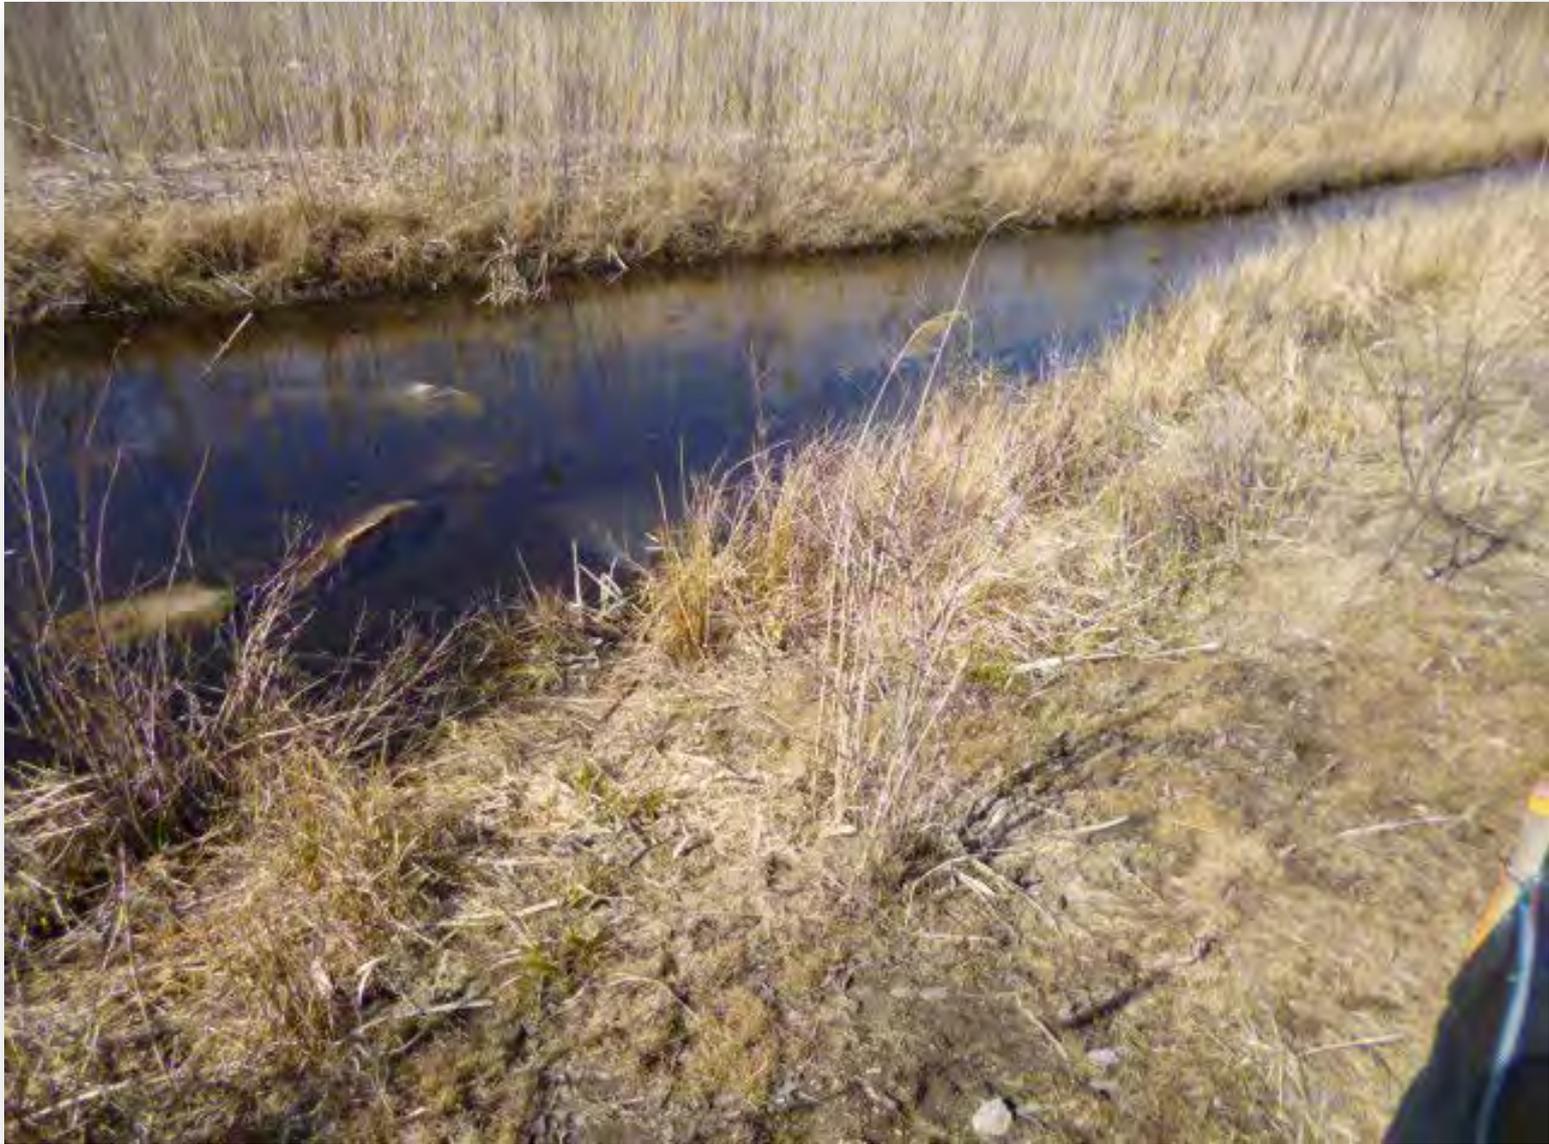
View of area where gravel was removed by hand from the West Ditch and vegetated area adjacent to the West Ditch.

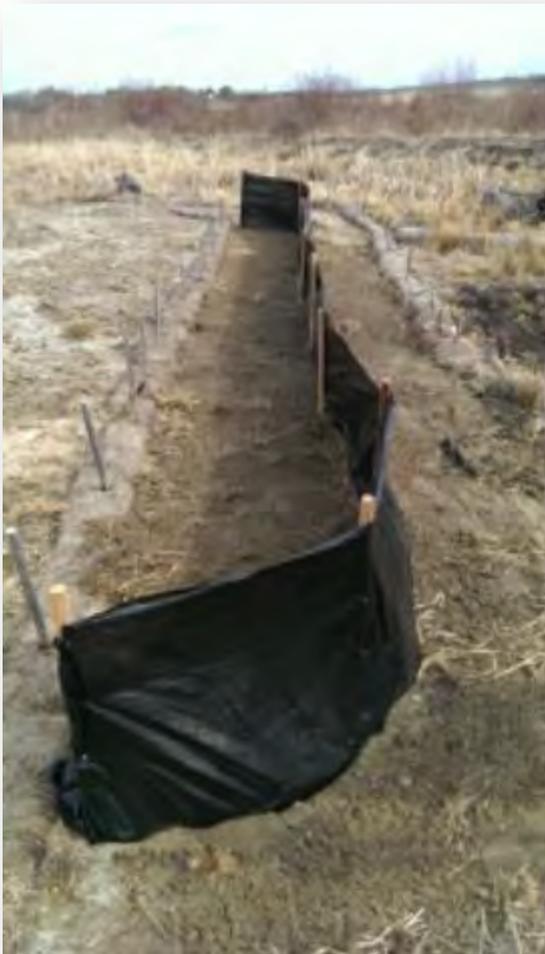
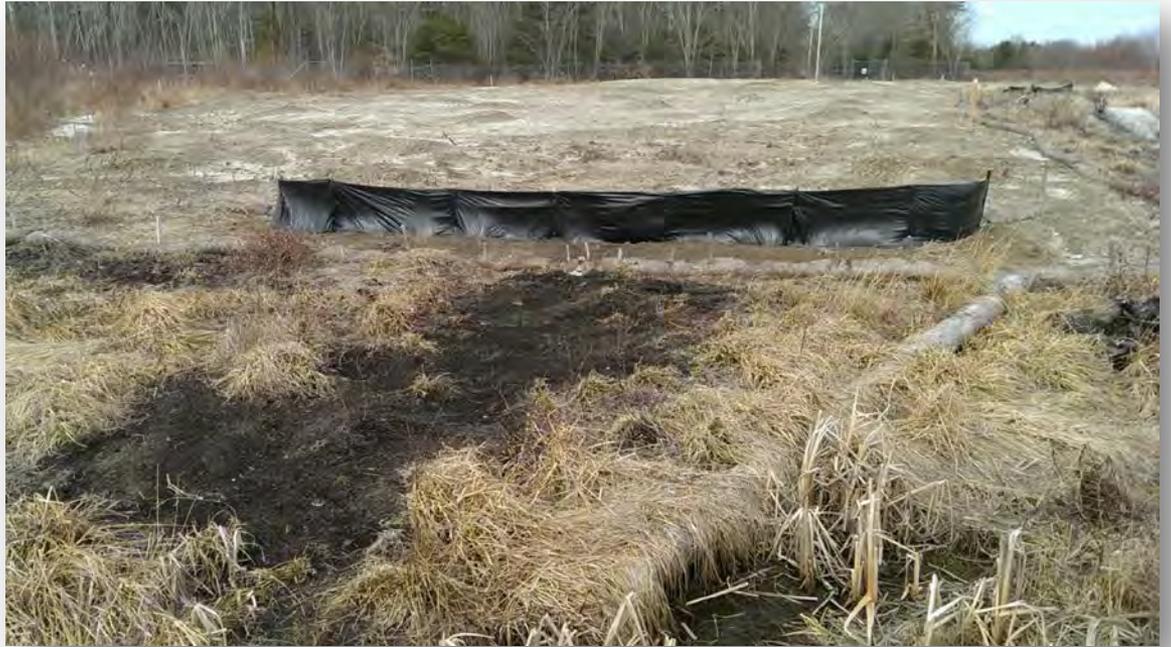
View of silt fence installed at interface between Turtle Area 3 and Wetland Site 6 to keep nesting habitat sand from migrating into the constructed wetland. The second photo on the right depicts the area where Airport staff removed sand that had settled in Wetland 6. If necessary, this area will be seeded with a wetland mix later this spring.

As noted in previous EM reports, sand migrating from turtle nesting area 3 into Wetland Mitigation Site 6 has been an ongoing challenge. In order to keep additional sand from reaching Wetland Mitigation Site 6, Airport staff raked the sand out by hand and a length of silt fence was installed between the two rows of straw wattles previously installed by the site contractor (Manafort). The area will be re-seeded with a wetland seed mix when appropriate. We will work with the Airport to identify a long term solution to this ongoing challenge including potentially constructing a vegetated natural berm or installing less intrusive coir rolls or fiber rolls containing compost along the interface. Once the vegetation is established the sand should be better contained in the turtle area and the controls can be removed.
