NEW BEDFORD REGIONAL AIRPORT  
RUNWAY 5-23 – PHASE 4

Reconstruct, Mark and Grove

Weekly Environmental Report

**NEW BEDFORD REGIONAL AIRPORT  
RUNWAY 5-23 – PHASE 4  
Reconstruct, Mark and Grove  
Report on RSA 5 – ILS Road / West Ditch silt fence failure**

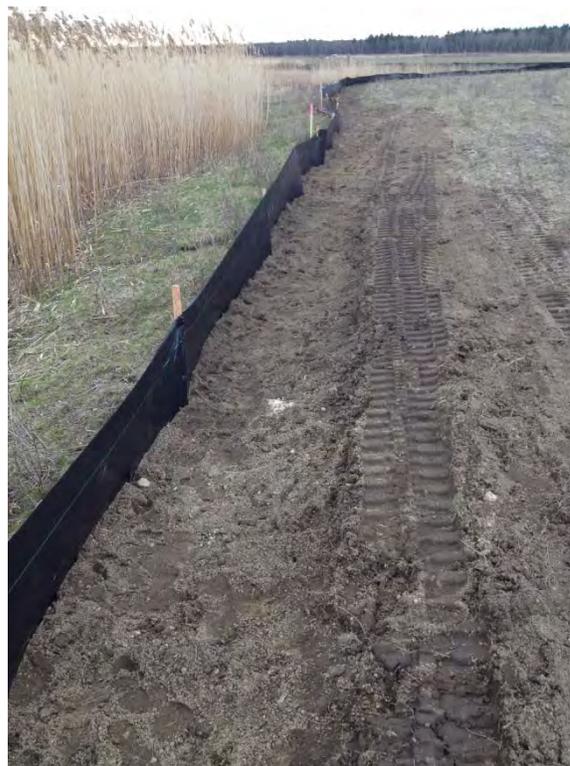
- Installation of silt fence starting at the last bend before the ILS road continued to where the fence comes up to Taxiway A. About half of the area covered today was back filled. Adjustments were made to the silt fence survey line to move it further away from the wetland boundary and closer to the road bed when possible.
- Temporary turtle exclusion barriers were installed at the end of the ILS road.
- A turtle sweep was executed by Oxbow Associates in the area between the end of Runway 5-23 and the ILS road. One long dead turtle skeleton was found. Likely a box turtle, but cause and location of its death were undetermined.

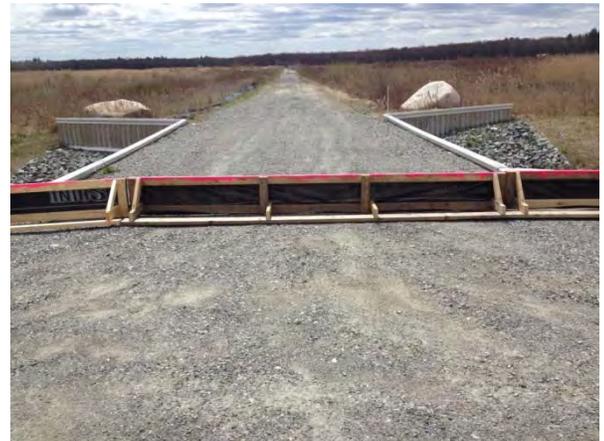
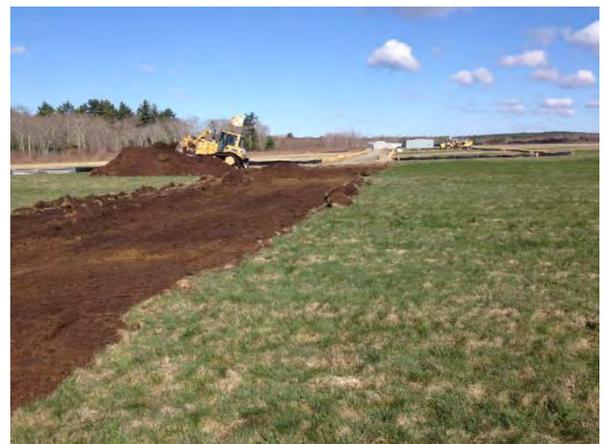
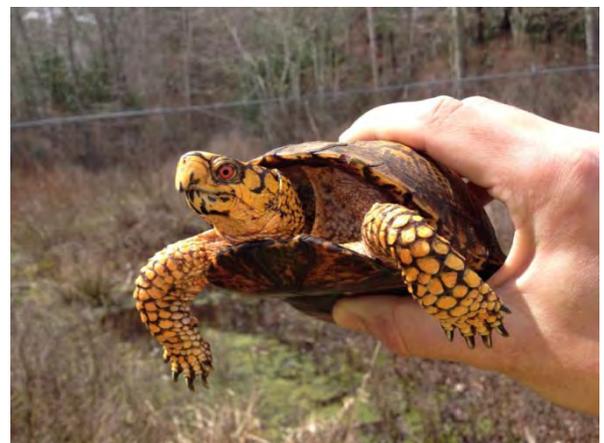
- An access road was excavated between the service road and the runway near the contractor staging area. The material was piled adjacent to the site. The excavator was unable to find a stable substrate because of a large layer of peat. This road cut was then filled back in with the excavated material and a second attempt was made 50 ft further up the road. This cut was successful and they started to lay till down.
- Electricians removed some lighting from the runway and disconnected power.
- Lighted “X” signs were installed at the runway ends.
- Runway barriers were erected at the junctions of Runway 14-32.
- Fill was delivered to the work zone IV access gate and stockpiled at the base of the new access road.
- Four box turtles were found using the radio transmitter in the scrub area adjacent to the contractor staging area.
- Equipment arrived and was delivered to each work site.

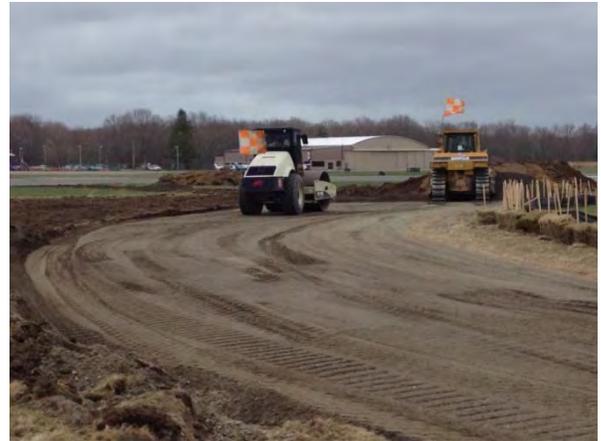
- Work continued on the runway access road connecting the runway to the gravel access road. Fill was added to the road as well as the widened curve in the gravel access road due to the shift in crossing placement.
- A large hay delivery was made and bale were placed starting opposite the contractor staging area and moving toward the ILS road. Bales were placed and staked per plan.
- New end of runway lighting was installed on 5 end of the runway.

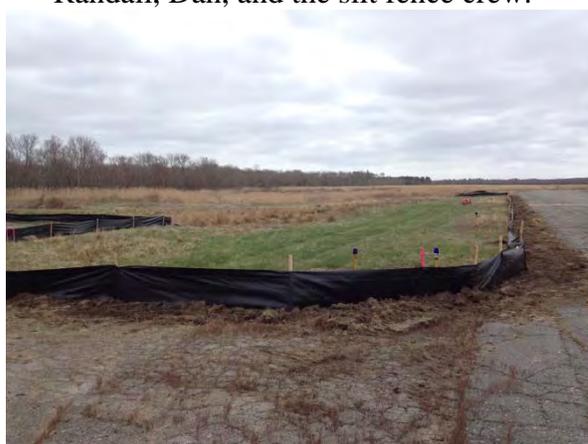
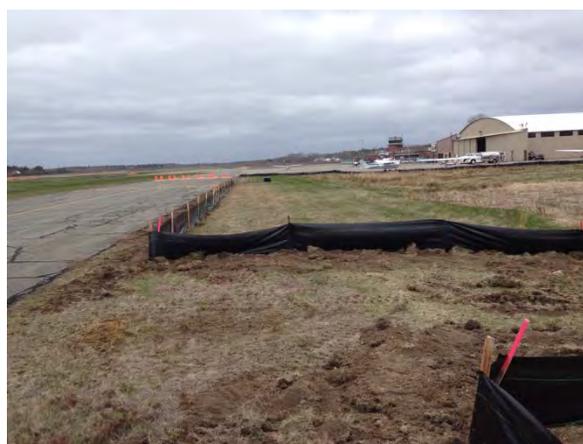
- Unaffiliated contractors arrived to start excavation of an area adjacent to the contractor staging area to build a new airplane hangar. They mostly striped and removed topsoil.
- Resident Engineer ASG (Frank Chase) requested that I look at a section of newly installed silt fence near Taxiway A and the AV Gas hangar. The fence was installed according to plan, but left some lights and associated electrical lines on the wrong side of the fence. He wanted to know if environmentally, it was okay to move the fence back ~10 ft toward the wetland. This seemed possible to me and I relayed the information to Julia, Randall, Dan, and the silt fence crew.

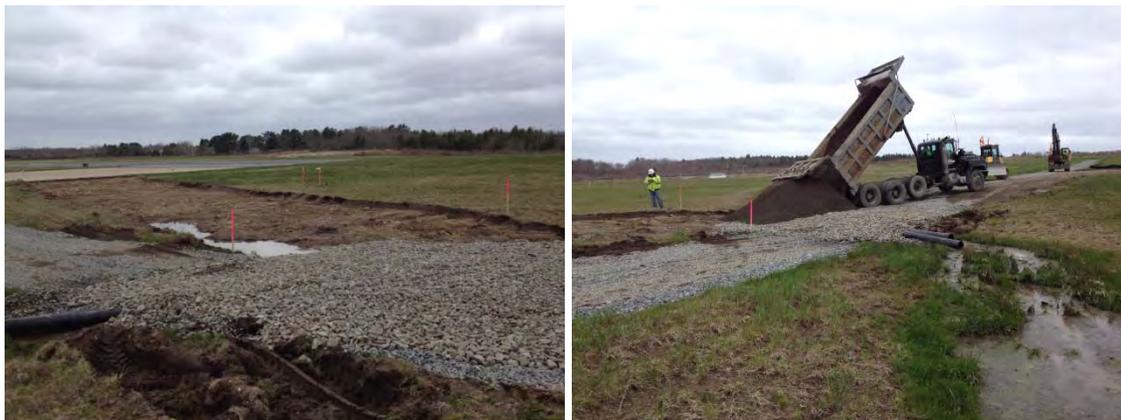
- A connecting road was put in between the Old Plainville Gate access road terminus and the end of Runway 23. Two pipes were laid in gravel through the drainage swale and the covered with 2- 4" rock. Top dressing was added and compressed.

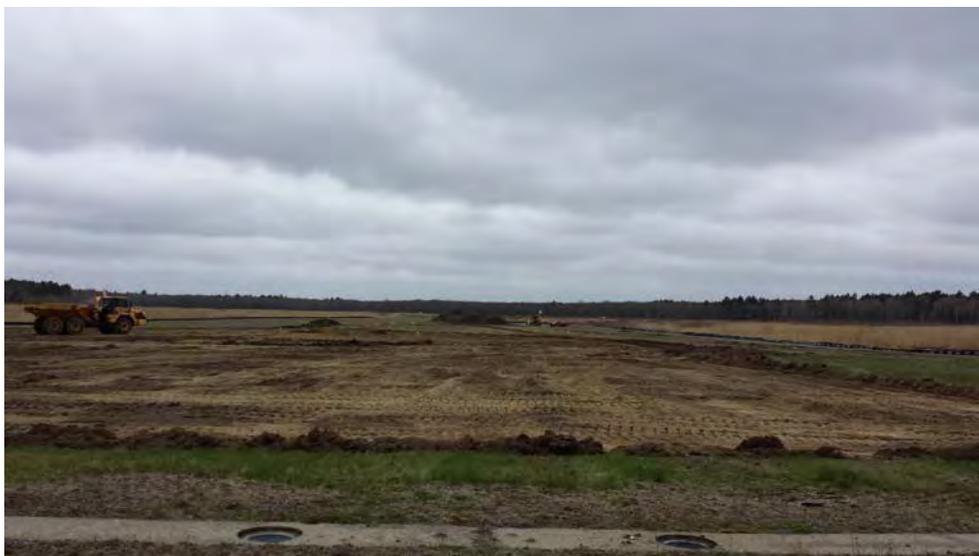
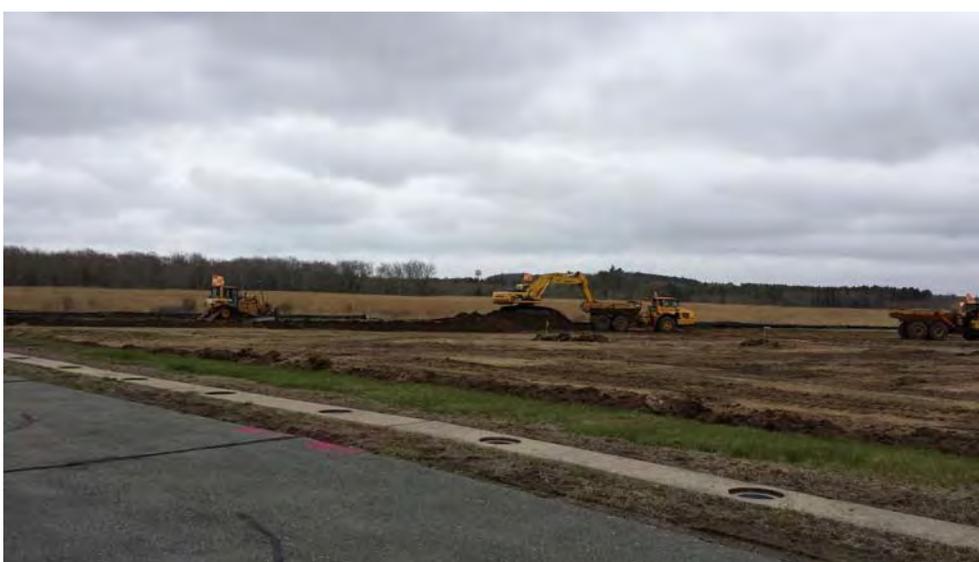
- ET&L stripping loam from 5 end RSA area.
- Stockpiling loam at end of runway in area marked as being 100 ft. plus to any wetland.

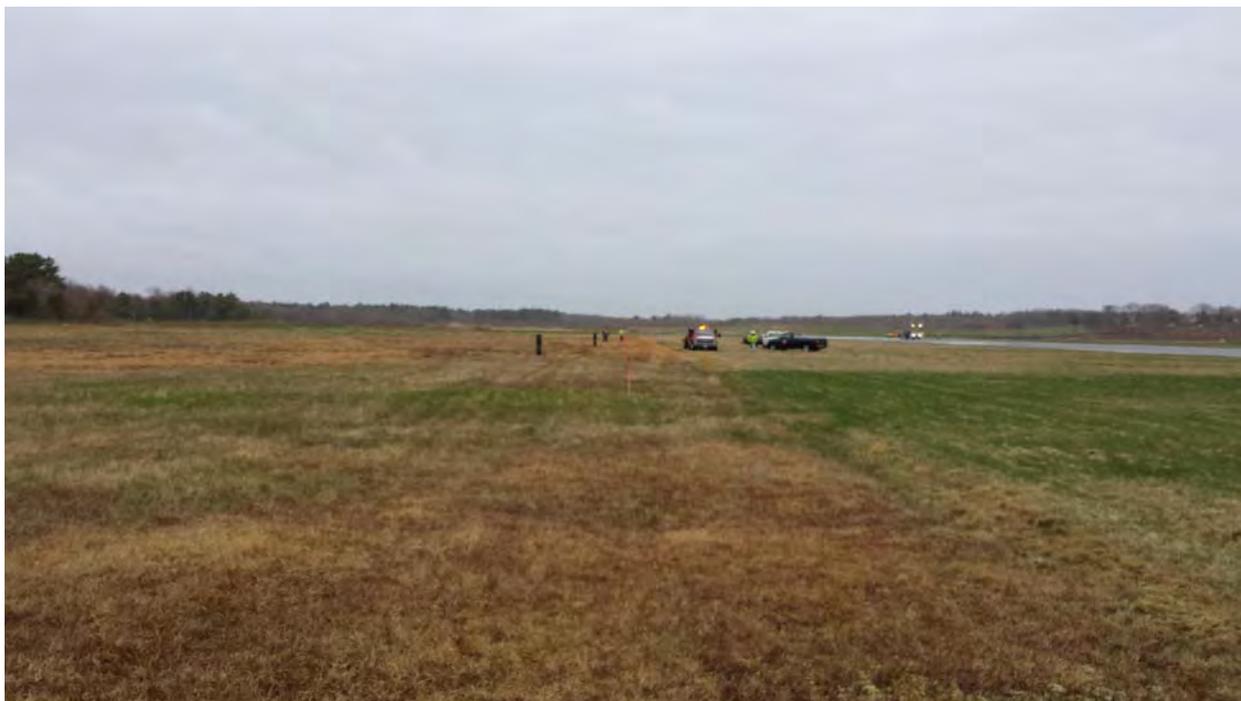
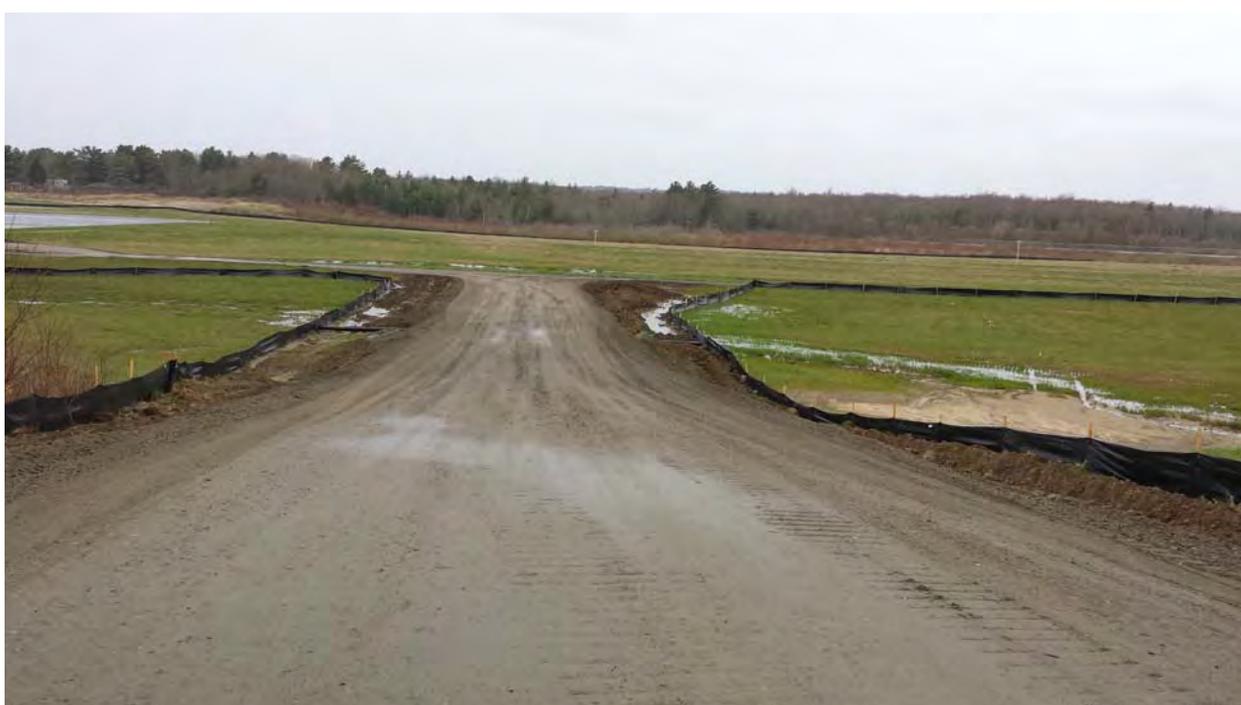
- ET&L laying out silt fence on 23 end of project.
- Ramco installing silt fence on 23 end of runway.

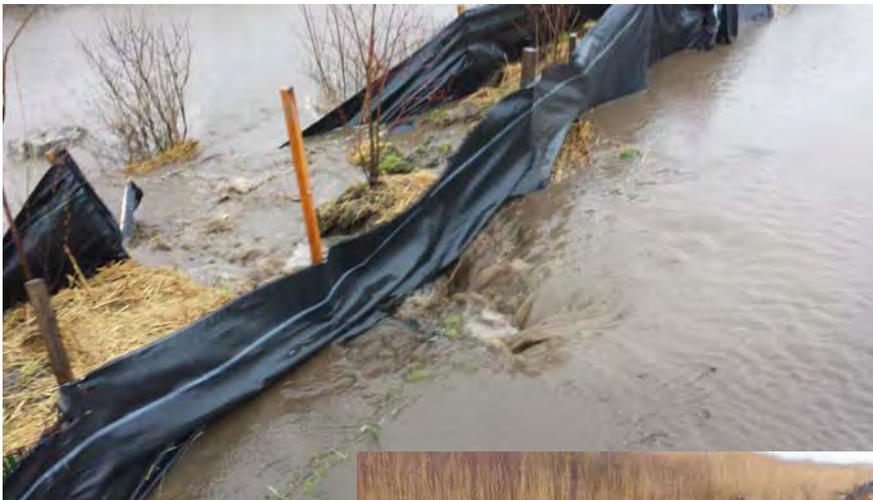
- Conducted a site inspection of RSA 5 end to view conditions during rain storm. Identified a T&L stripping loam from 5 end RSA area. See attached report on issue, resolution and recommendations.

PHOTO – View of active silt fence failure into West Ditch.

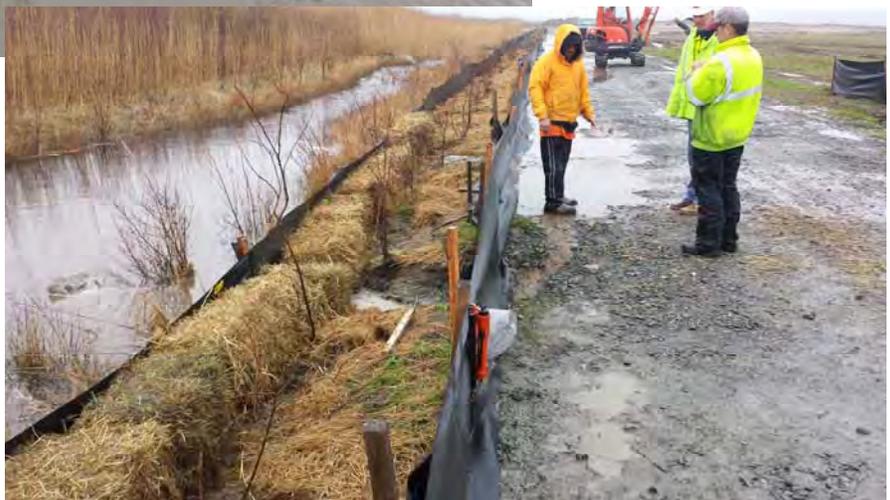
PHOTO (right) – View of same area with hay bales and additional fencing installed.

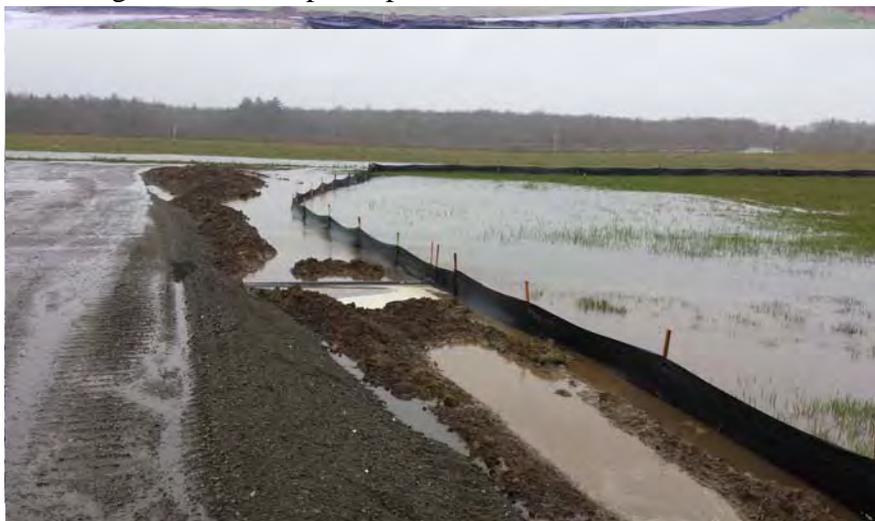
- Grinding of Runway 5 end commenced.
- Stripping of loam along the edge of runway 5. Loam is windrowed and will be moved off site beginning next week.
- Access road off Old Plainville Road inspected. Pipes in low sections working as planned and relieving water build-up on uphill side of road.

Sediment laden water is trapped upslope between silt fence and access road, keeping clean water clean and separating the clean from the dirty water.

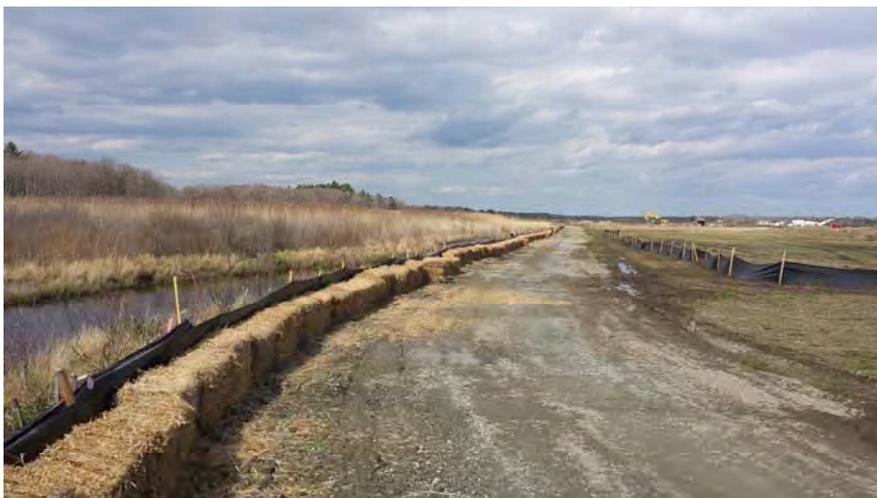
- RAMCO installed a truckload of hay bales along the 5 end OLS road.

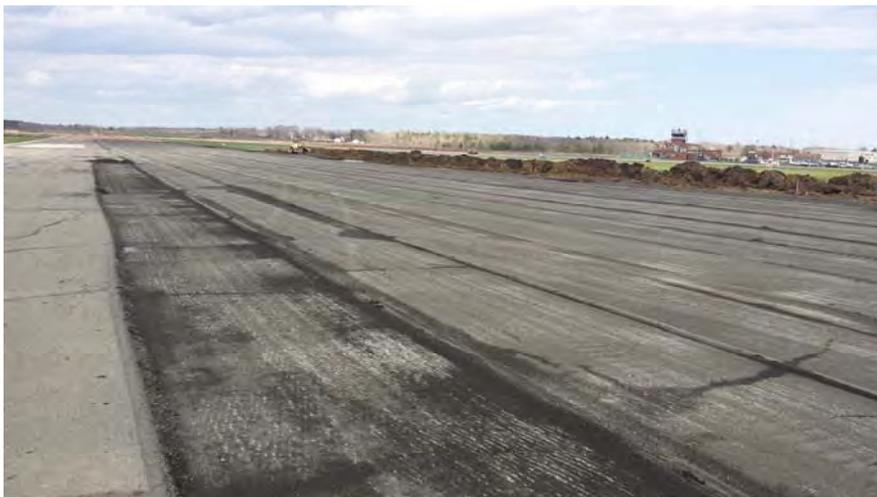
- Grinding of runway 5 occurred from 7:00 to 3:30

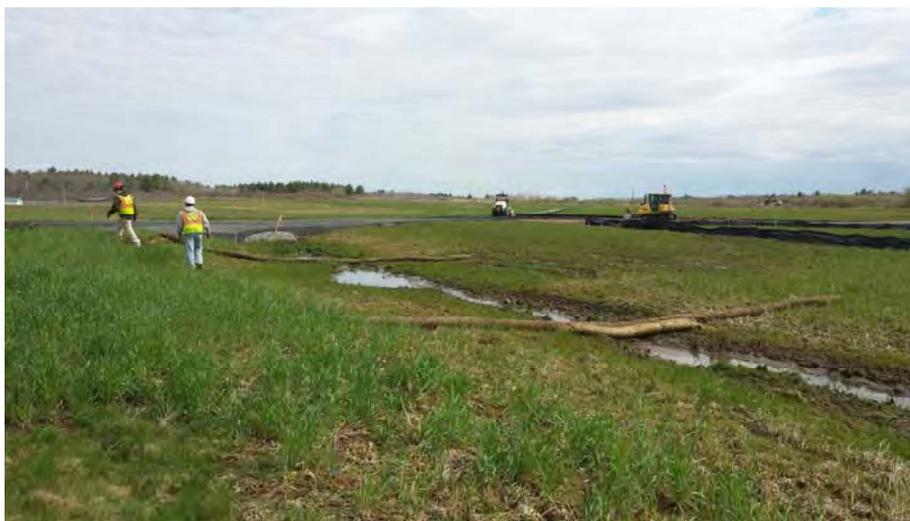
- In conjunction with resident engineer, Ed Clark, revised location of silt fence at bottom of slope so that silt fence does not cross the drainage swale. Added straw wattles across the drainage swale to provide some energy dissipation during higher flows. Will need to add stone to outfall of twin pipe drain in swale.

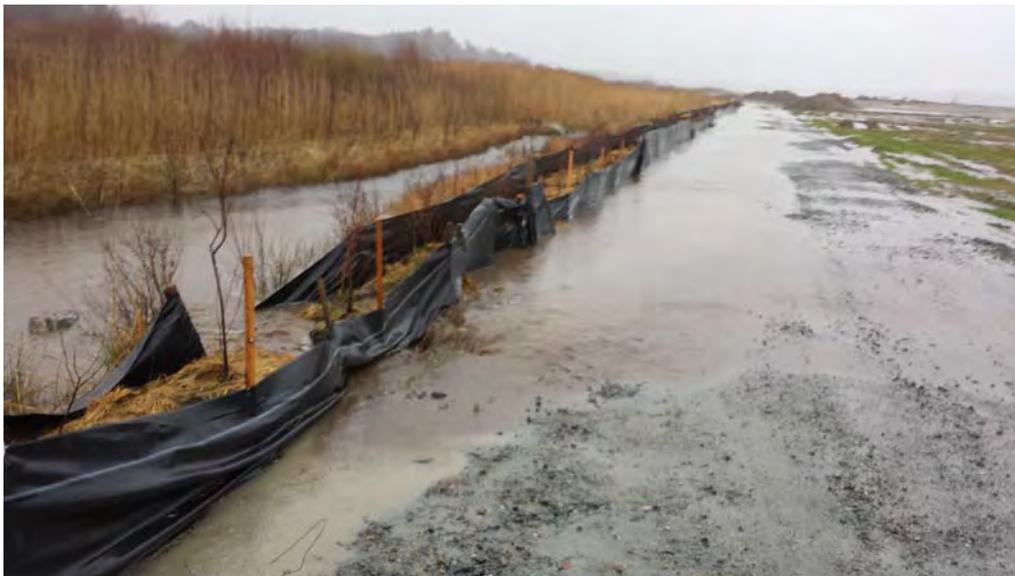
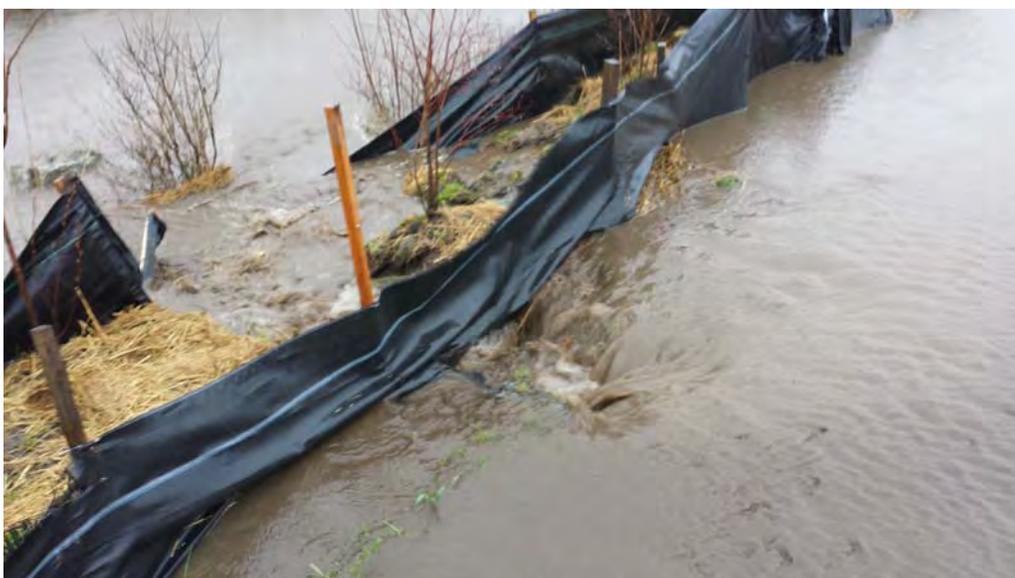
On the morning of May 1 after overnight rain, a site inspection of the 5 end of the runway was conducted. At that time, it was noted that a section silt fence had failed. This fence was located at a low point in the ILS road and collected drainage from approximately 4 acres of area. This failure occurred in the same area as where the banking between the ILS road and the west ditch had been disturbed on April 24.

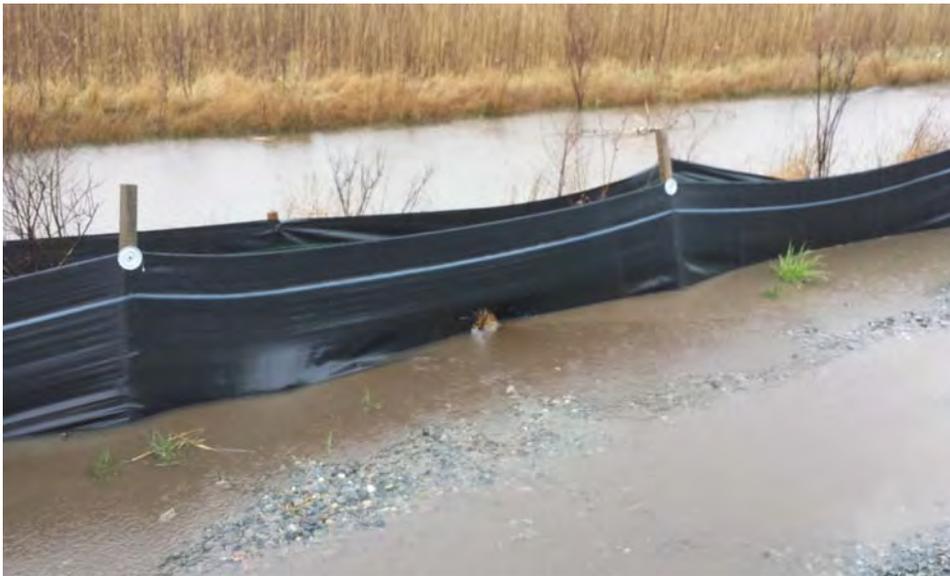
The silt fence along the ILS road in this section was older fencing placed in a previous phase. The bottom of the fence was ripped and may have already had a toe kick hole in it. The volume of water going through the hole in the bottom of the fence undercut the bank and eroded the material around the toe of the fence creating a larger hole. This increased volume the most likely overwhelmed the lower new fence and created a direct discharge to the west ditch mitigation. In addition, another hole was discovered in the bottom of the old fence. While this hole allowed water to get through the fence, the lower new fence protected the bank and did not cause a complete blow out.

The failure was discovered at 7:30 AM and ET&L was immediately contacted. ET&L remobilized their silt fence contractor from the 23 end of the site to the 5 end.

At around 8:30 AM RAMCO began to install a silt fence along the south side of the ILS road to capture some of the storm water and prevent it from reaching the ILS road. In addition, RAMCO re-staked the new silt fence line and added hay bale for support. At this point most of the direct flow into the west ditch was stopped. RAMCO then began to install a new silt fence immediately adjacent to the older fence along the edge of the ILS road.

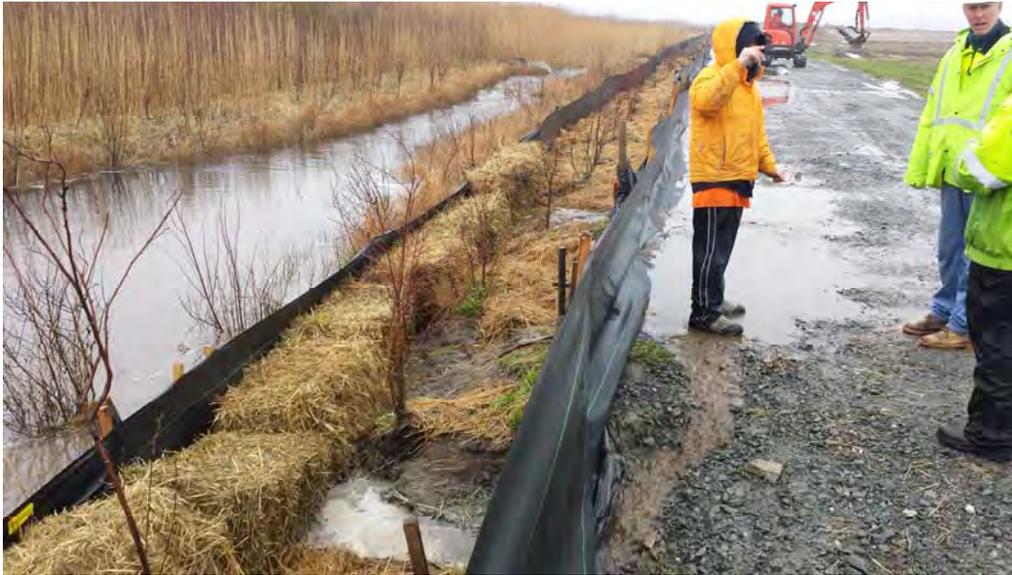
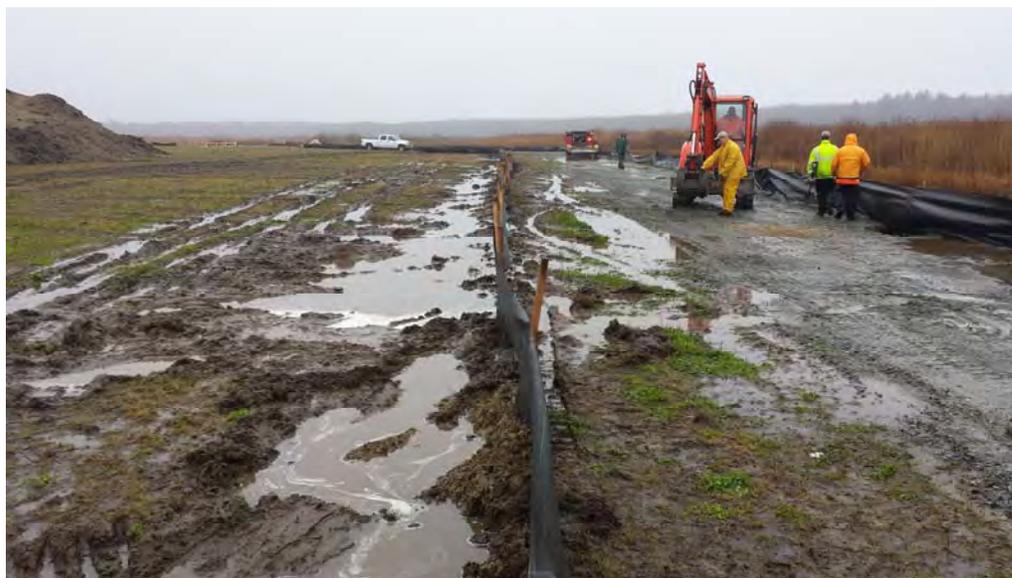
The photo below shows the area of concern after RAMCO installed hay bales along the new silt fence line.

The photo above shows the new silt fence on the south side of the RSA as well as RAMCO installing silt fence adjacent to the old fence.

On May 2, 2014, a truck load of hay bales arrived and the entire length silt fence along the ILS road was backed with the bales.

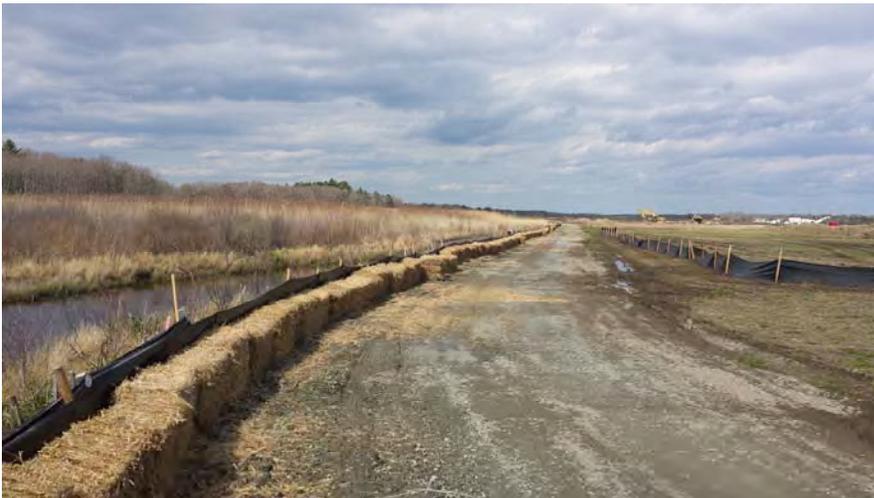
View of repaired silt fence and added hay bales on May 2 2014

To alleviate some of the issues with this, JM Fiske is recommending an additional section of silt fence protection is added to the south side of the ILS road. This section would consist of 200 foot lengths of silt fence with ends turned up slope. This fence would trap some of the water that is currently reaching the ILS road and reduce the amount of ponding and pressure on the ILS road and its existing protection.

In addition, it is recommended that the design team evaluate the long term stability of the buffer slopes. At the end of the project with the entire silt fence removed, there will be concentration of storm water on the ILS road and because the road will not remain level, there will always be discharge points over the short steep buffer banking. Some type of chute should be used for long term discharge of storm water. If a short rock chute is not permitted, the design team may want to consider shallow vegetated swales reinforced with a turf reinforcement mat that will allow vegetation to grow up through it.
