NEW BEDFORD REGIONAL AIRPORT
RUNWAY 5-23 – PHASE 4

Reconstruct, Mark and Grove

Weekly Environmental Report

WEEK 5

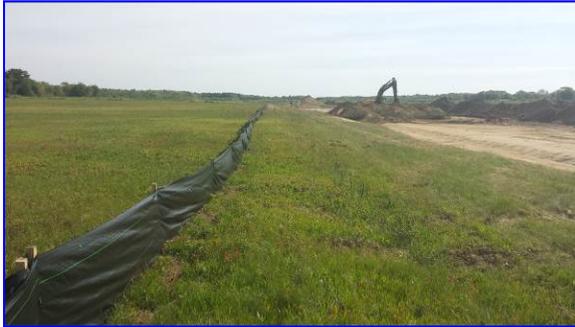
Photo 1 – Inspection of silt fence along north side of 23 end runway.

1. Clean gravel was delivered and stockpiled throughout the day at the end of runway 5.
2. Underdrains being installed at north side of Runway 5.
3. Silt fence inspected.
4. Excavating and transporting off site of excess material from 23 end of runway.
5. Small gap in silt fence on north side of runway 23 repaired.
6. Placement of drainage structure northwest of intersection of Taxiway B and Runway 5.
7. Turtle barriers and movable turtle barriers inspected - intact and secure.
8. Inspected shrubs along West Ditch – 2/55 confirmed dead

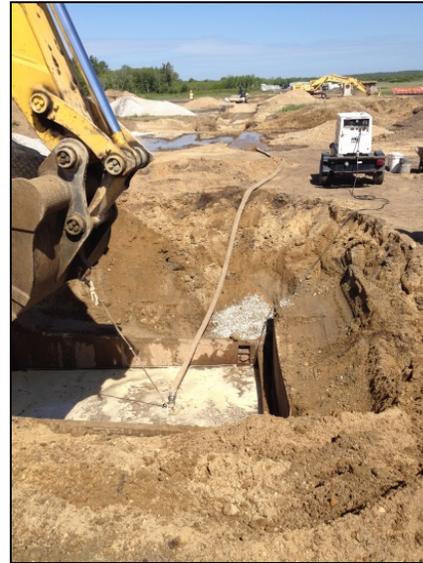
Photo 3: View of excavation for drainage structure installation. Note groundwater in hole.

2. A pit was dug and safety equipment installed for the installation of a drainage junction cistern. The pit quickly filled with water and a sump was used to pump water into a grassy area outside of buffer zone limits. The cistern junction box was installed in the de-watered pit.

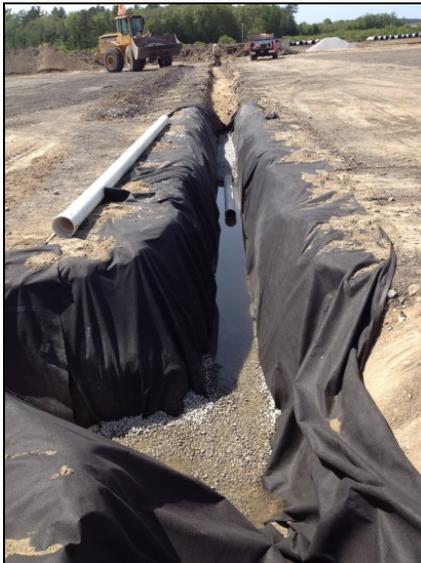
Photo 2: Installation of underdrains on north side of 5 End of Runway

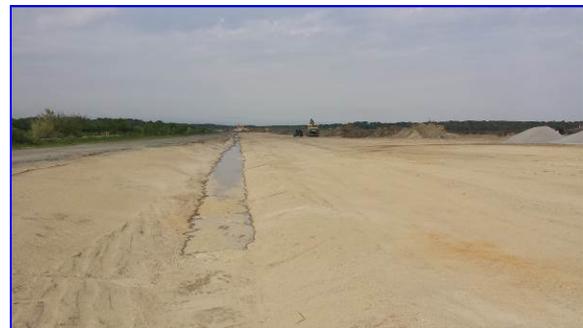
Photo 4: Dewatering of excavation into constructed swales. Water infiltrates in swale and there is no discharge.

4. Installation of drainage pipe northwest of intersection of Taxiway B and Runway 5.
5. Dewatering from drain pipe installation discharged to constructed swales along access road, No discharge to wetlands. All water infiltrated.
6. Walked site with Scot Smyers of Oxbow Associated and marked out location for approximately 30 one-way turtle gates to be placed along perimeter of construction.

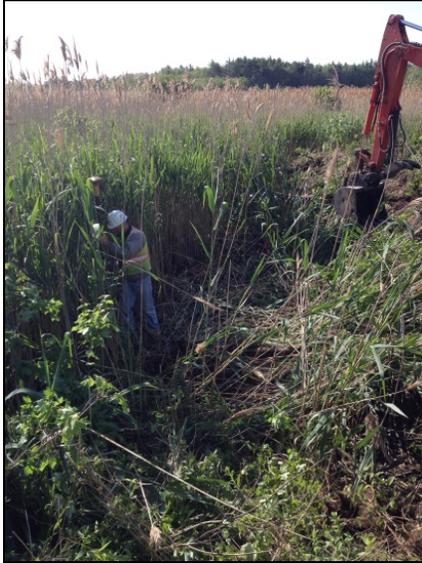
Photo 5: ET&L surveyed silt fence and compost log layout on the ILS Road. Work within wetlands in three authorized locations was monitored.

1. MALS SR gravel pier extensions into wetland areas associated with the project's wetland fill areas were surveyed by ET&L for silt fence layout. Monitoring of this activity took place at the three piers where fill was required.

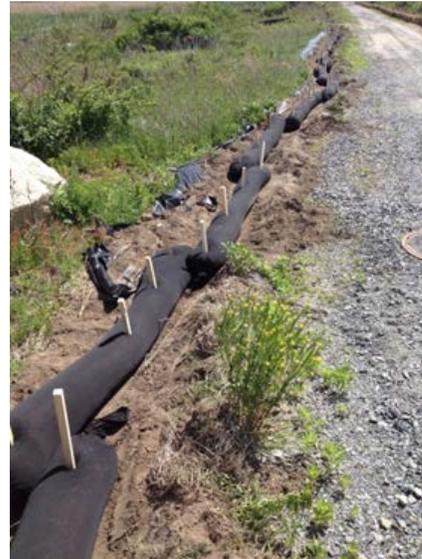
Photo 7: Installation of compost fiber logs started according to plan specifications.

6. Approximately 200' of compost fiber logs were installed along the south side of the ILS road according to specifications.
7. The weekly meeting was attended.

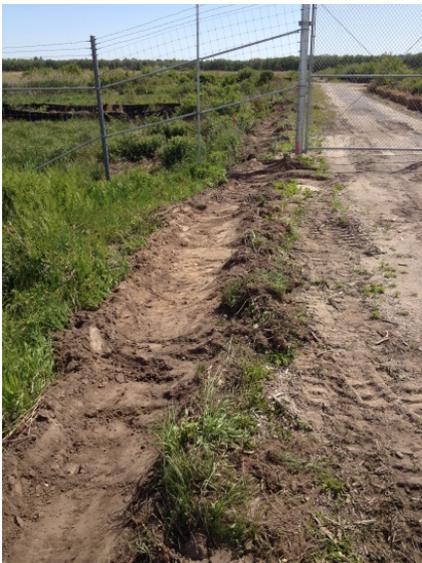
Photo 6: RAMCO created shallow swales to set the compost fiber logs in place along the ILS Road.

3. Drain pipes were installed under Runway 5 near Taxiway D.
4. Additional drainage installations across runway 5 were also ongoing.
5. RAMCO excavated a shallow swale along the ILS road for placement of the compost fiber logs.

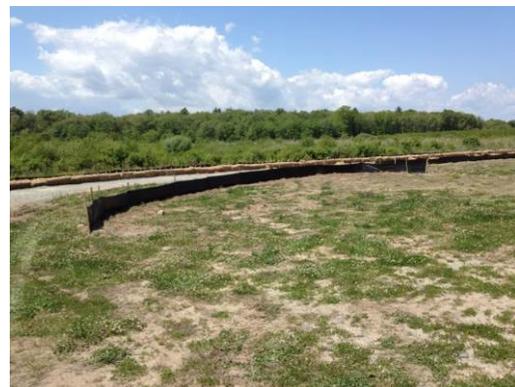
Photo 8: A 75' section of silt fence was installed as a precautionary measure at the end of Runway 'A' in the corner of the haul road near the West Ditch and the ILS Road.

5. Deliveries of fine gravel were made throughout the day and stockpiled at the end of Runway 5.
6. Per an earlier suggestion by the WS, an approximately 75' curving section of silt fence was added to the corner of the gravel haul road near the West Ditch and the bridge to the ILS Road. This fence was installed as a precautionary measure to reduce pressure on the West Ditch fence during heavy rainfall.

1. The WS suggestion to add additional secondary silt fence at the corner of the haul road near the West Ditch and the ILS Road Bridge as a precautionary measure was accepted and installed – COMPLETED.
