JM Fiske Environmental

NEW BEDFORD REGIONAL AIRPORT
RUNWAY 5-23 – PHASE 4
Reconstruct, Mark and Grove
Weekly Environmental Report
WEEK 10
2014 June 28-July 5

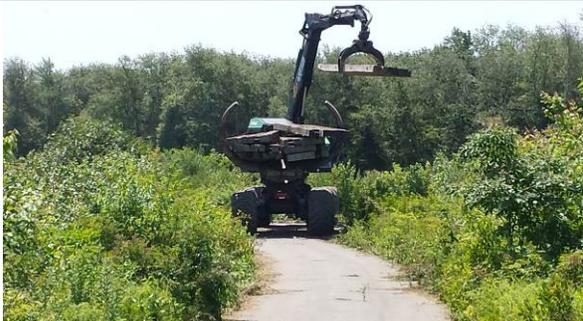
<p>Wagner Wood was on site for Eastern Box Turtle Training. Scott Smyers of oxbow Associates lead the training and Amada Atwell of Epsilon Associates went over permit conditions as the relate to the clearing operation.</p>	
<p>After the training, Oxbow Associates and JM Fiske Associates conducted a turtle sweep of the proposed timber swamp map access road area prior to allowing Wagner Wood to commence work.</p>

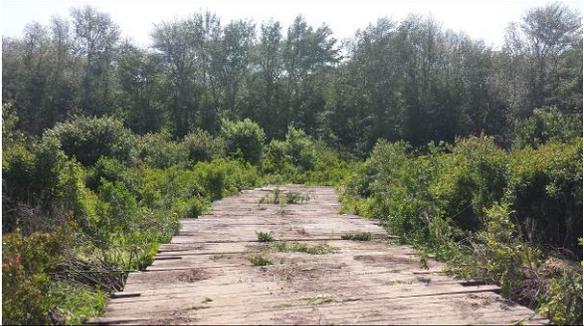
<p>By the end of the day, Wagner Wood had placed the timber swamp mat access road to within 100 feet of the clearing area.</p>

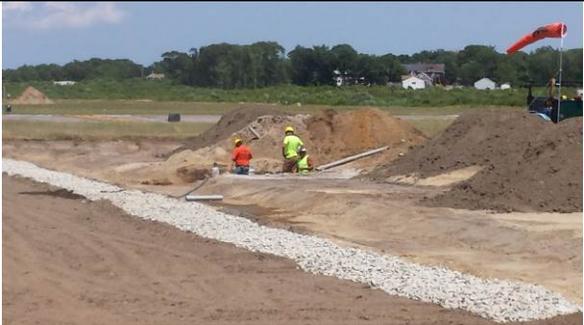
<p>Moulson Electrical was actively working to fishing all work prior to the anticipated re-opening of Taxiway B on Wednesday, July 3.</p>

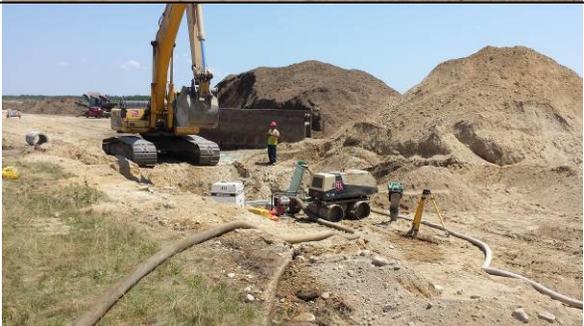
<p>Work continues on the 23 end new drainage installation. Dewatering with multiple pumps could not keep up with the infiltration because of the excessively sandy soils in this area.</p>

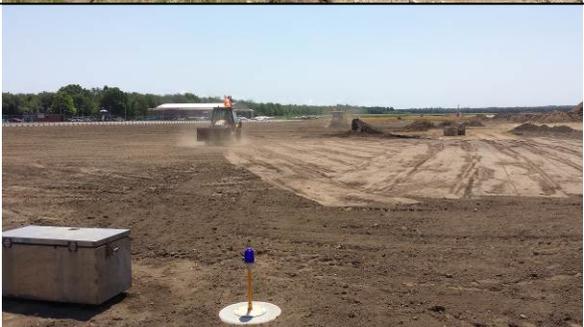
<p>Final loam and grading occurred around taxiway B. MON Landscaping is anticipated to final hydro-seed all exposed soils around taxiway B in preparation for reopening taxiway.</p>

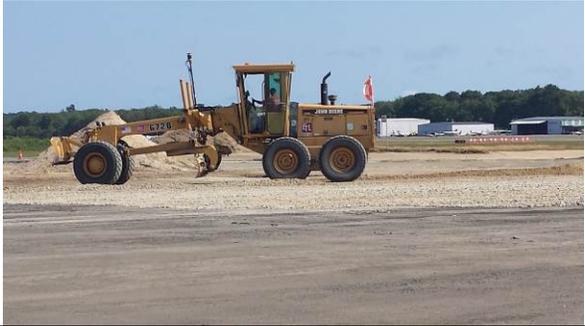
<p>Placement of select gravel and fishing grading of base materials on Runway 23. Area was compacted.</p>

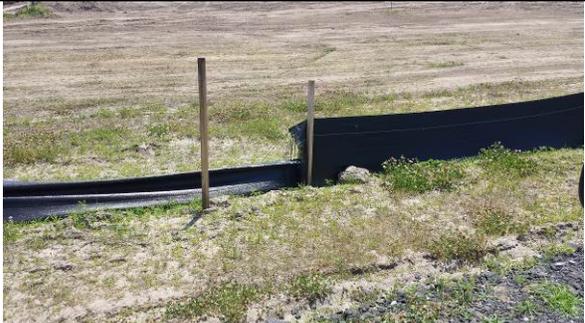
<p>A section of silt fence near the laydown area for the loggers was identified on the 5 End of the runway. ETL was notified and repairs are scheduled.</p>

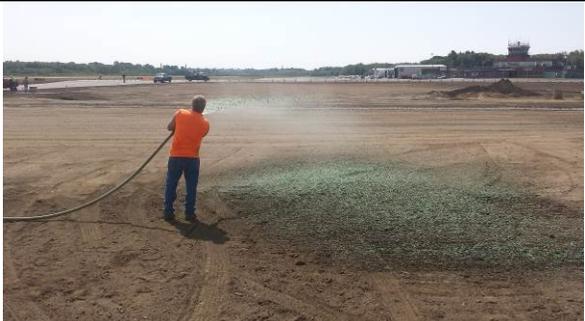
<p>MON Landscaping was on site to provide hydroseeding of prepared areas around Taxiway B</p>

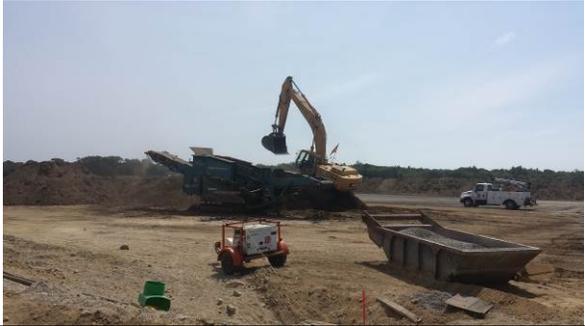
<p>Screening of loam piles on 23 End continues. In addition the loam pile on the 5 end is being moved to make additional room for the Wagner Wood laydown area.</p>

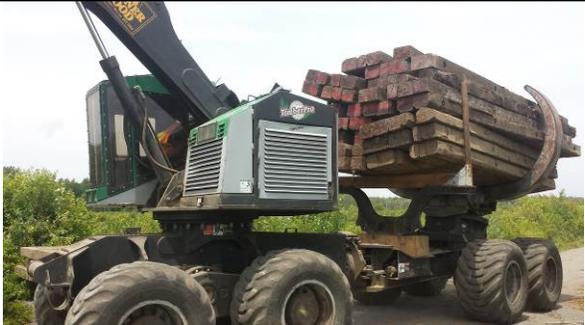
<p>A forwader is being used by Wagner Wood to get the timber swamp mats from the laydown area to the access road and Runway Approach Clearing Area</p>

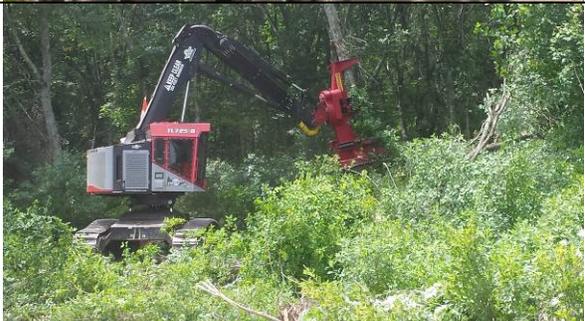
<p>The feller buncher arrived in the afternoon and clearing operation began.</p>

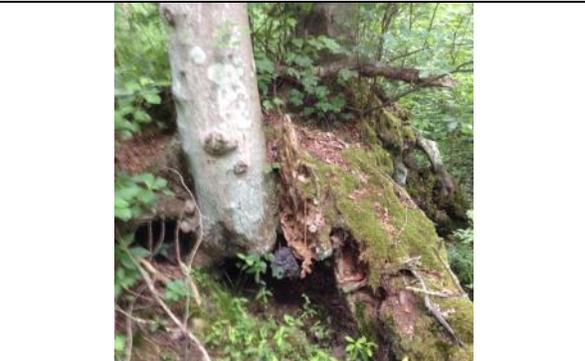
<p>Turtle sweeping took place starting at 7 am. I joined Scott and Ronnie from Oxbow to sweep the foresting cutting area and ILS/swamp mat road for 2.5 hours (7.5 man-hours). Several snakes and frogs were observed and a spotted turtle was removed from harm’s way. A second sweep was conducted in the afternoon with Julia Fiske for 1.5 hours (3 man-hours) to account for changes to Wagner’s cutting plan for that day.</p>

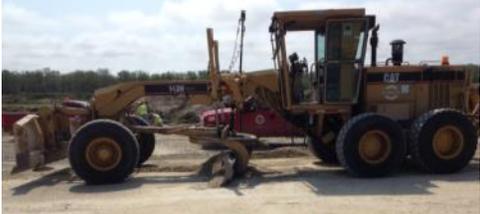
<p>Portions of the south side of Runway 5 were graded today in preparation for paving. Only a few strips remain unpaved with a first course.</p>

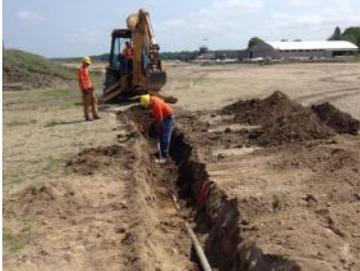
<p>Electricians were working on both the Runway 5 and 23 sides of the project today. Here they are excavating a pre-existing conduit.</p>

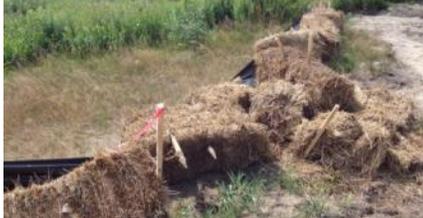
<p>A section of silt fence and hay bales was backed over by an excavator today. The fence was repaired and hay bales re-staked shortly after the incident.</p>

1. A breach occurred today in the silt fence/turtle barrier (described above). This section was repaired and is now in good condition. –COMPLETE

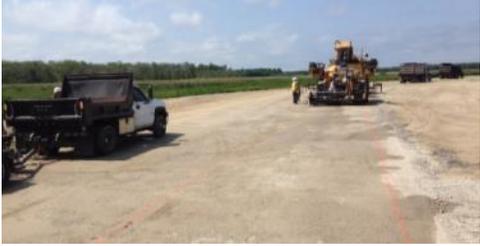
<p>Preparations were underway to pave Taxiway A on the south side of Runway 5 this morning. Course lines were drawn and contact oil spread, but the taxiway grading did not meet the specs and the asphalt and pavers were sent home. Re-grading and rolling took place in the afternoon.</p>

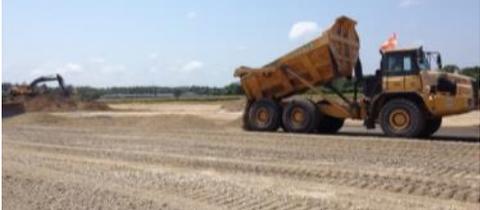
<p>P209 was distributed, graded and rolled along portions of Runway 23.</p>

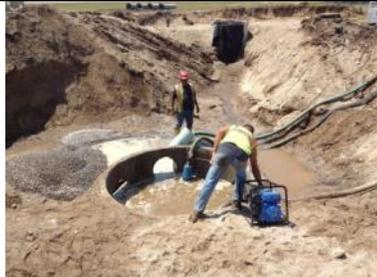
<p>ET&L battled high water tables at a large cistern on the north-west end of Runway 23. Four pumps were used to manage the water and were pumped into a nearby depression. No discharges were made into jurisdictional areas.</p>

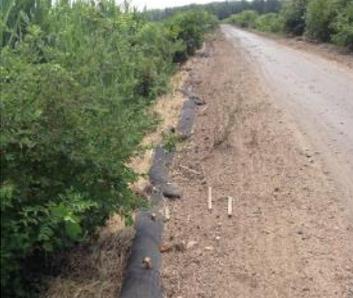
<p>The compost fiber tubes were inspected along the ILS road. The WS will continue to monitor the tubes on a regular basis now that dragging has started.</p>
