# *New Bedford High School & Adjacent Properties*

**Status of Off-Site Environmental  
Investigations - Public Meeting**

**July 12, 2006**

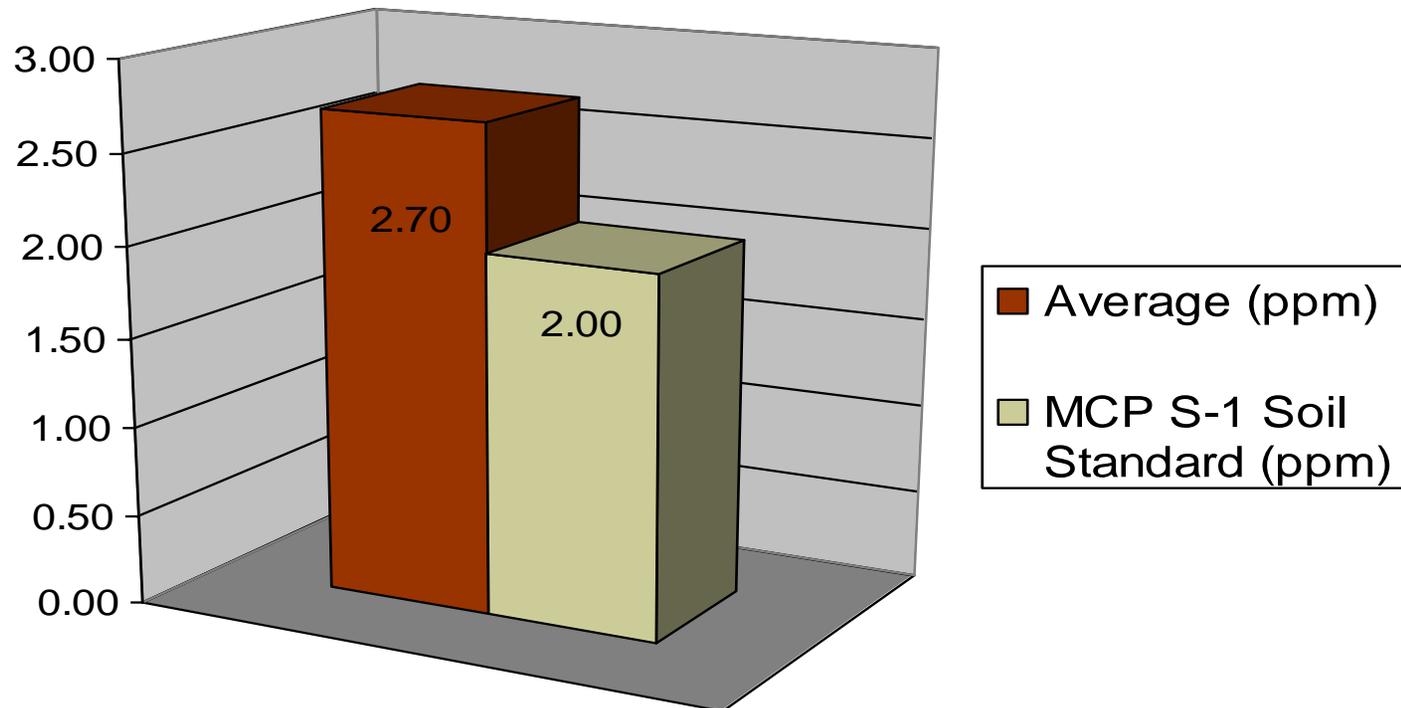
## Soil Sampling Results: PCBs

- 259 Samples Analyzed\*
- Range of Concentrations: Non-Detect to 40.0 parts per million
- Average Concentration: 2.7 parts per million
- MCP S-1 Soil Standard: 2.0 parts per million

\*A total of 69 samples exceeded the MCP S-1 Soil Standard of 2.0 parts per million

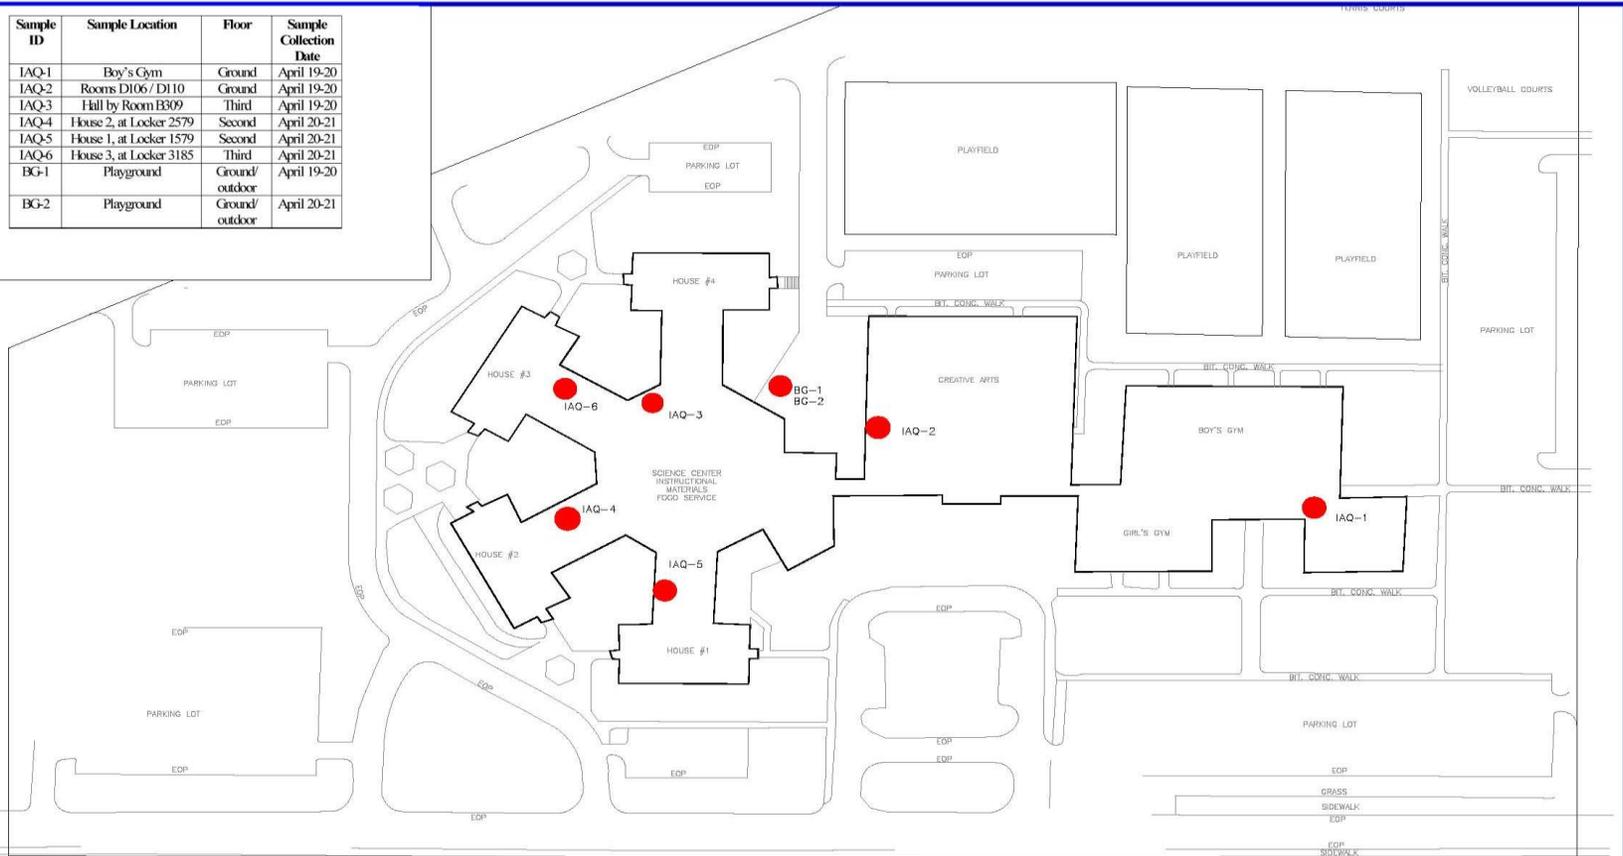
## Indoor Air Sample Location Plan

Sample ID	Sample Location	Floor	Sample Collection Date
IAQ-1	Boy's Gym	Ground	April 19-20
IAQ-2	Rooms D106 / D110	Ground	April 19-20
IAQ-3	Hall by Room B309	Third	April 19-20
IAQ-4	House 2, at Locker 2579	Second	April 20-21
IAQ-5	House 1, at Locker 1579	Second	April 20-21
IAQ-6	House 3, at Locker 3185	Third	April 20-21
BG-1	Playground	Ground/ outdoor	April 19-20
BG-2	Playground	Ground/ outdoor	April 20-21

<u>RBAC for PCBs in air</u>	<u>RBAC (<math>\mu\text{g}/\text{m}^3</math>)</u>
Action Level ( $1 \times 10^{-6}$ )	0.06
Maximum Acceptable Level ( $1 \times 10^{-5}$ )	0.3

Results from April 2006 Indoor Air Sampling:

0.0043 to 0.0519  $\mu\text{g}/\text{m}^3$

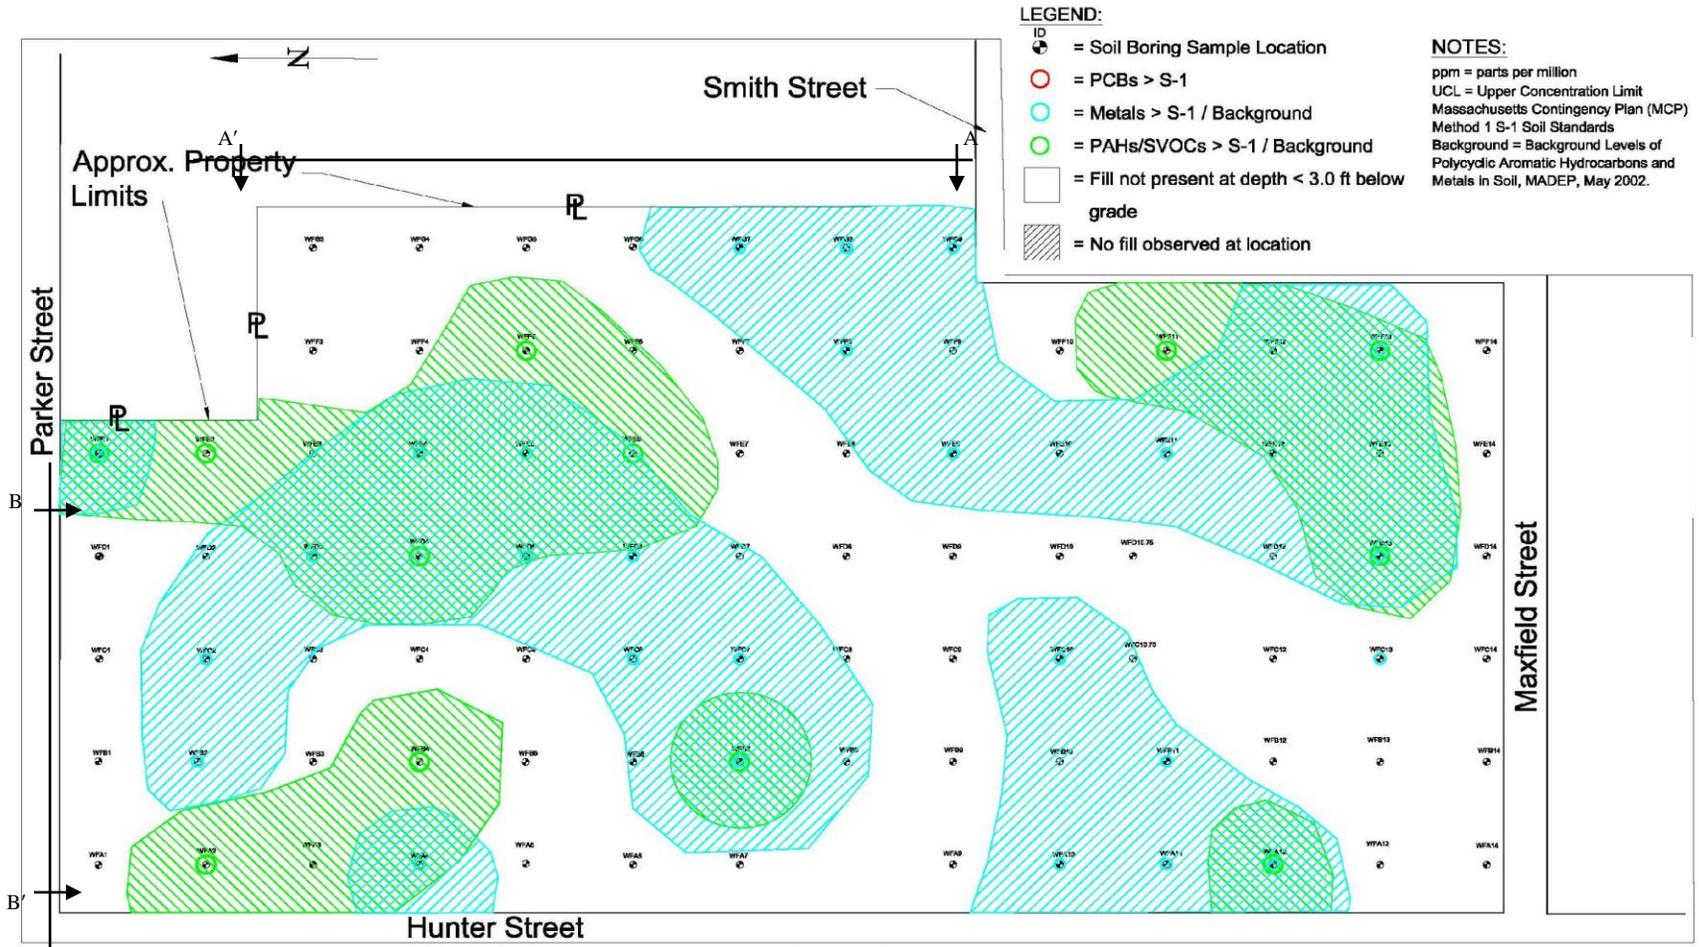
## Soil Sampling Plan

Walsh Field  
S-1 / Background Exceedances  
New Bedford, Massachusetts

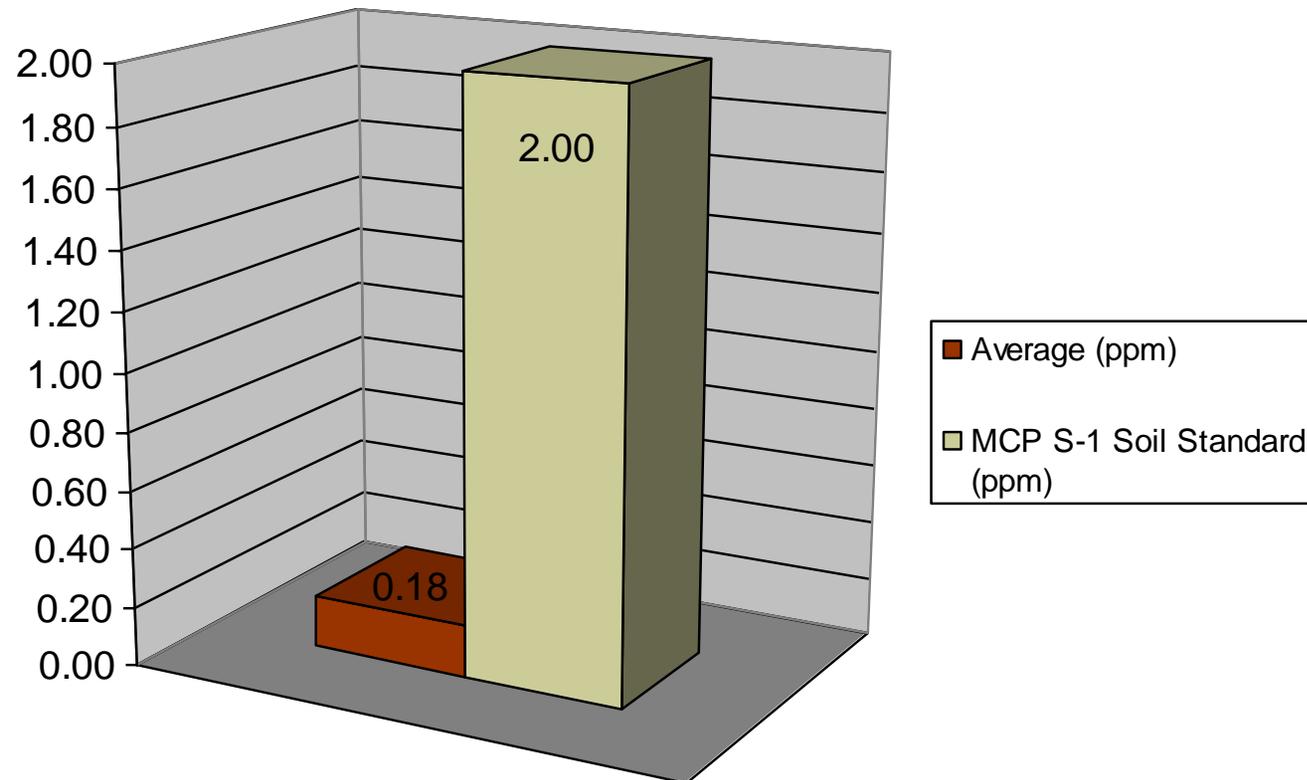
## Soil Sampling Results: PCBs

- 69 Samples Analyzed
- Range of Concentrations: Non-Detect to 0.66 parts per million
- Average Concentration: 0.18 parts per million
- MCP S-1 Soil Standard: 2.0 parts per million

\*No samples exceeded the MCP S-1 Soil Standard of 2.0 parts per million

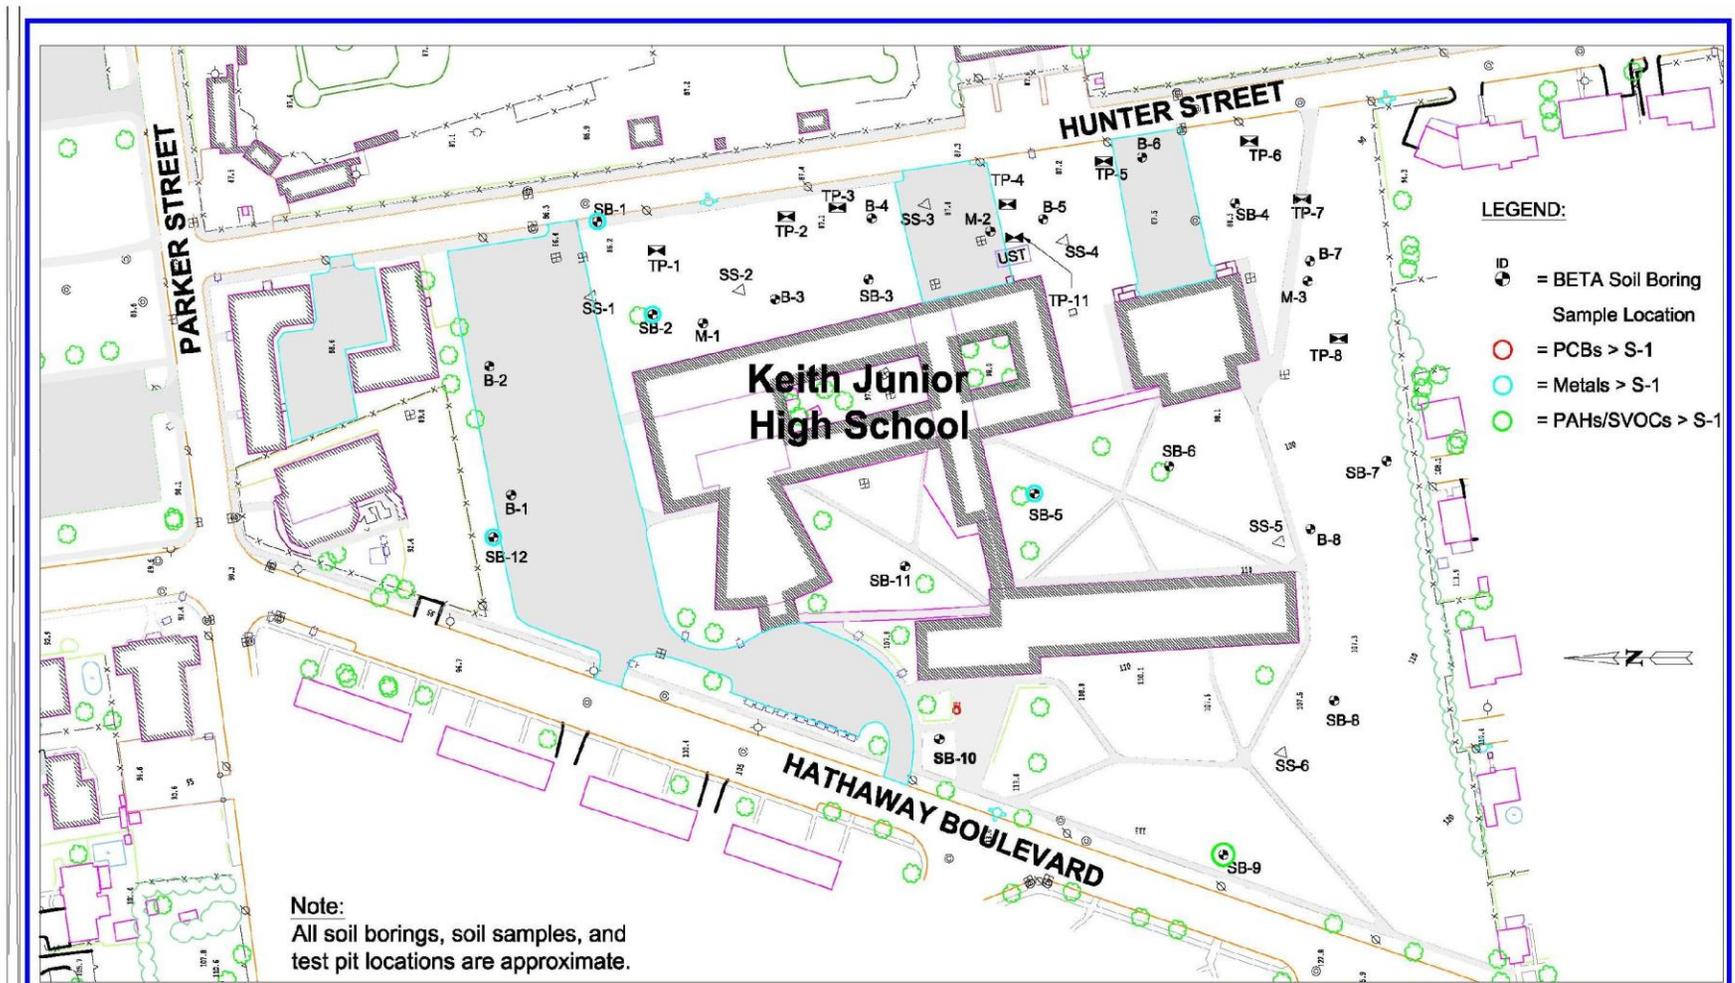
## Soil Sampling Plan

Soil Sample Locations  
S-1 Soil Exceedances  
Scale: 1" = 100'

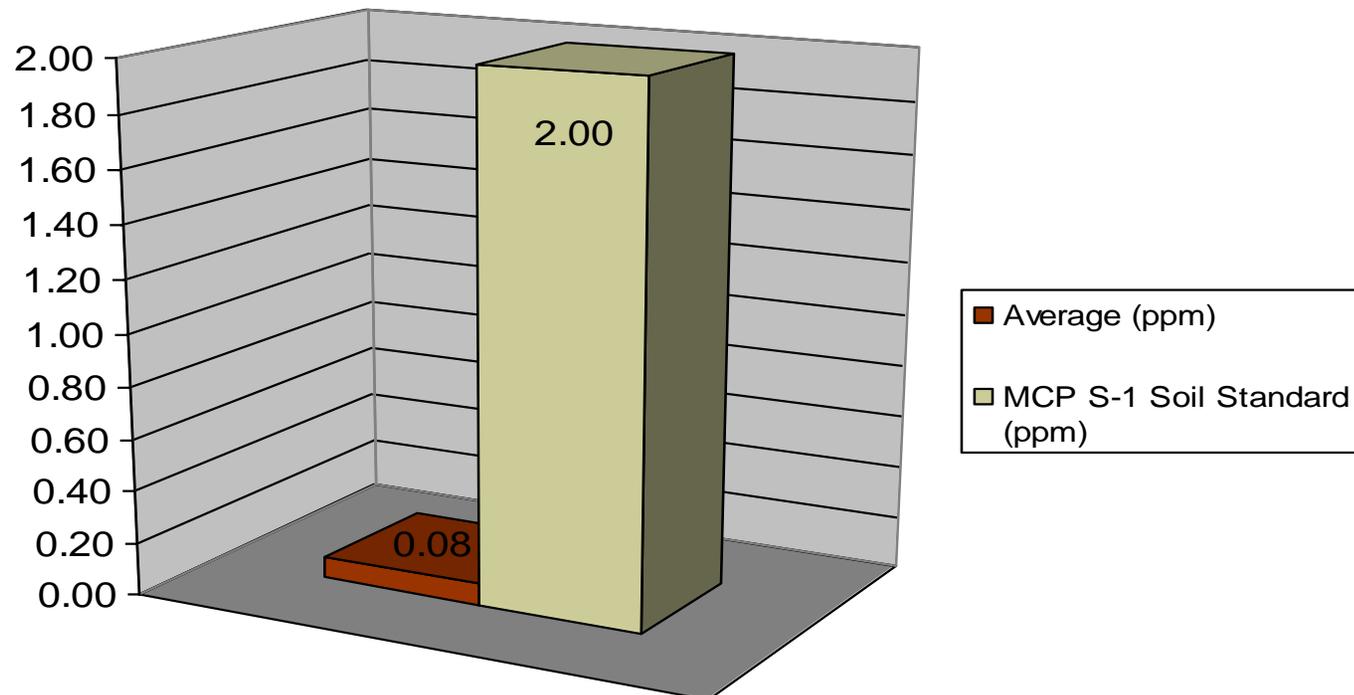
## Soil Sampling Results: PCBs

- 11 Samples Analyzed\*
- Range of Concentrations: Non-Detect to 0.9 parts per million
- Average Concentration: 0.08 parts per million
- MCP S-1 Soil Standard: 2.0 parts per million

\*No samples exceeded the MCP S-1 Soil Standard of 2.0 parts per million

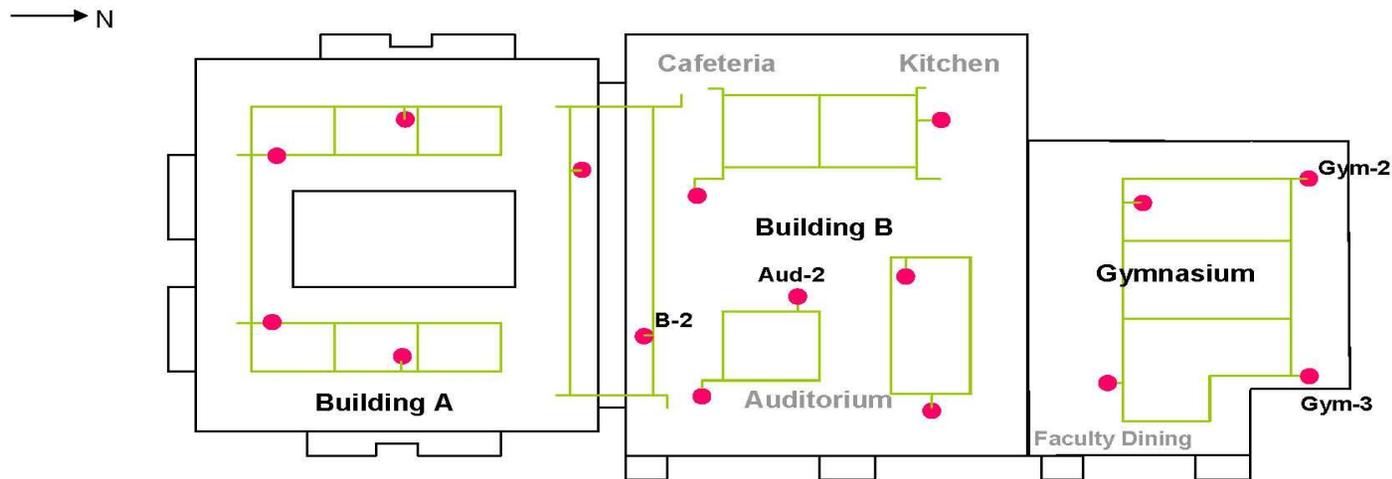
New Keith Middle School  
Foundation Vent  
Air Sampling Locations  
April 2006

● = Vent Riser

— = Pressure Venting  
and Collection System

- No PCBs or PAHs above Method Detection Levels
- Detected VOCs are largely attributed to:
  - PVC joint cements and cleaners
  - Construction vehicle exhaust
  - Measured concentrations will decrease with time
- No threat to human health, based upon current readings

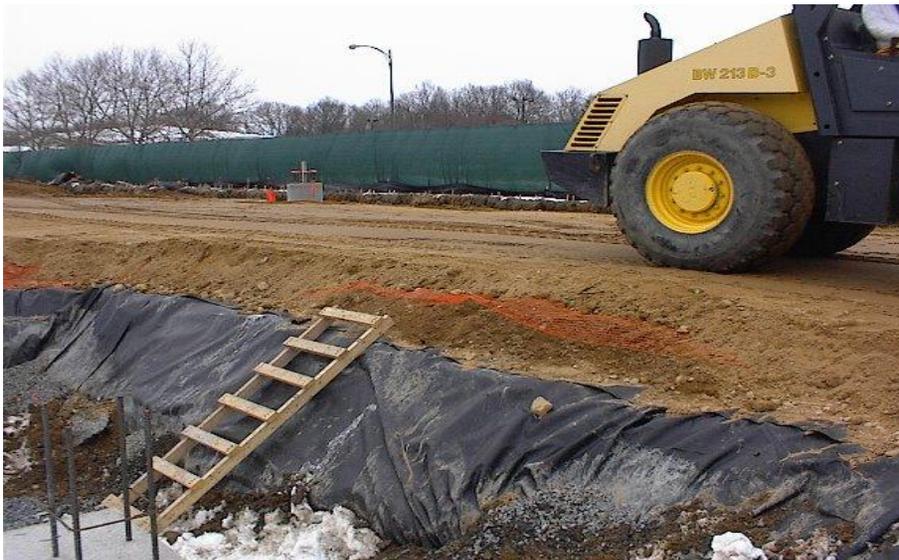
Photo showing layered backfill. Clean backfill placed above contaminated fill and geotextile fabric, followed by warning barrier, then additional clean backfill.

Backfilling in exterior areas (outside the building footprint) was completed to provide a minimum cap thickness of two feet of clean material in all paved and sidewalk areas and a minimum of three feet of clean material in all other areas (landscaping and grass areas). To accomplish this goal, contaminated soil was stripped to the appropriate pre-grading elevation and removed from the site by WES Construction. After removal of soil to the appropriate elevation, a separation layer of geotextile fabric was placed over the soil to remain. Approximately four hundred (400) spot elevations were obtained by a licensed land surveyor and submitted as an as-built drawing.

A layer of clean backfill (approximately one foot) was installed above the geotextile fabric in all locations. An orange warning barrier was then placed over the initial clean backfill to provide a visual indicator for any unauthorized excavation in the landscaped areas. Following installation of the warning barrier, clean fill was placed to an intermediate elevation by WES Construction. In areas to be paved, Agostini (Building Contractor) placed additional clean backfill and a pavement binder coarse (approximately two inches) to achieve a minimum 2-foot cap. The pre- and post-paving elevations were surveyed to make sure the final cap thickness was achieved, in accordance with EPA's conditional approval of the Risk Based Cleanup Plan.

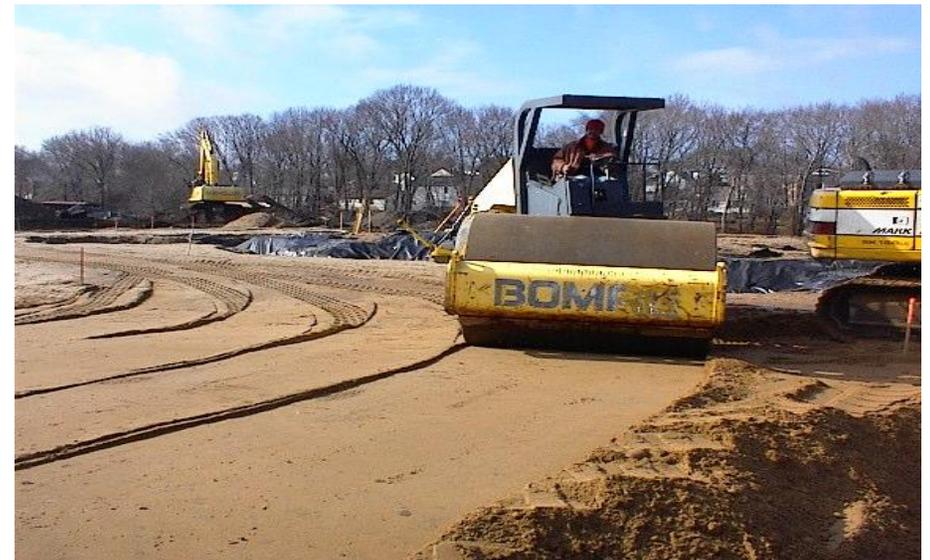
Placement and compaction of clean backfill was performed in lifts. First lift was prior to placement of warning barrier. Second lift was after placement of warning barrier.

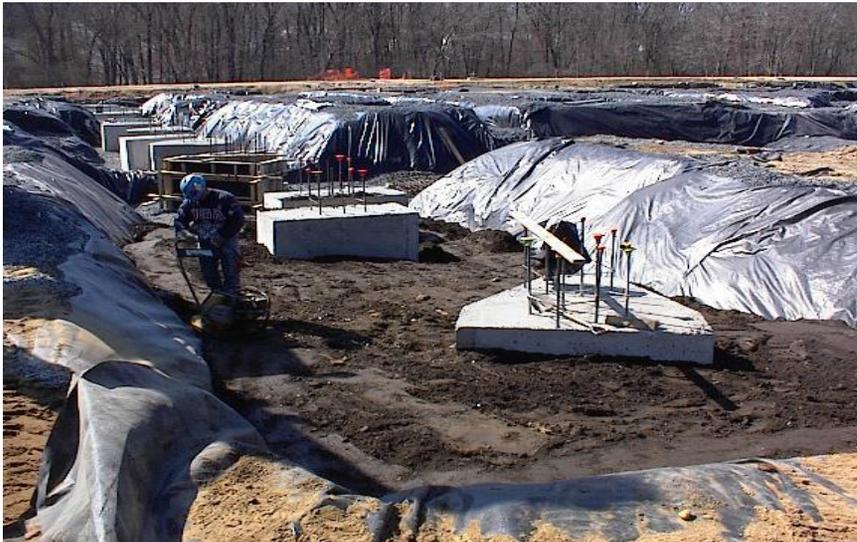
View of several "lower" pile cap excavations backfilled with contaminated fill. (April 2005)

Backfilling around pile caps and grade beams within the building footprint was performed as follows. After installation of the foundation piles was complete, contaminated soil was excavated around the piles to a depth of one foot below the base of the proposed pile caps. A separation layer of permeable geotextile fabric was placed over the soil to remain. A one-foot thick bed of gravel fill was then placed to the elevation of the base of the pile cap excavation. The concrete pile caps were then formed by concrete foundation work crews. Following curing of the pile caps, the forms were stripped and the area around the individual pile caps was backfilled with contaminated material, to an elevation six inches below the top of the pile cap (approximately 2.5-foot thick layer). A layer of separation fabric was then placed over the contaminated backfill, followed by a six-inch layer of clean granular fill.

Once backfilling was complete to the top of the pile caps, concrete grade beams were formed over the pile caps. Upon completion of the grade beams, a second layer of contaminated fill was used as backfill to an elevation of two feet below the top of the grade beams (approximately one foot). A layer of separation fabric was then placed over the contaminated backfill. An approximate one-foot layer of clean granular backfill was placed over the separation fabric, to match grade with the tops of the grade beams.

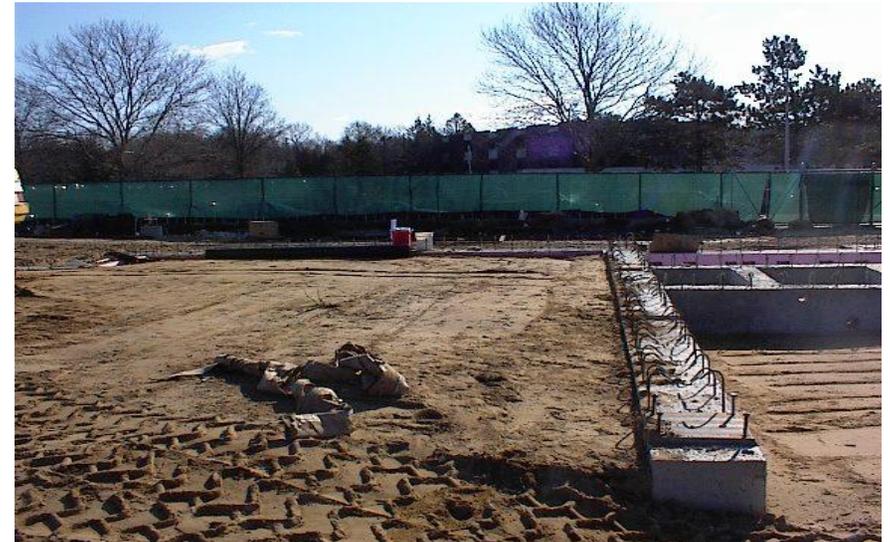
View of clean fill along interior wall. (April 2005)

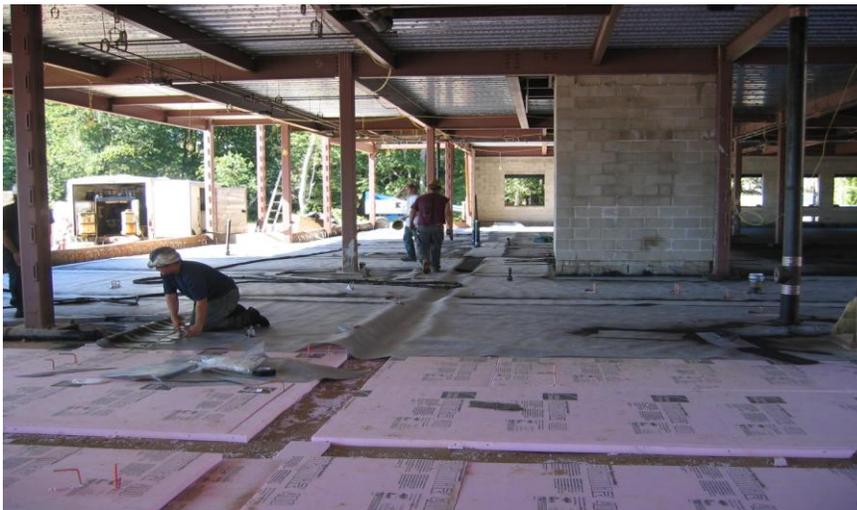
Rigid insulation board installed above clean, compacted backfill.  
The foam board was cut to allow for geovent installation.

A vapor barrier membrane was installed beneath the concrete slab on the first floor to prevent the potential migration of any toxic vapors that may accumulate under the building. The construction of the vapor barrier included placing rigid insulation board on top of clean backfill material. A 1-foot wide space was left, as appropriate, to allow for installation of the Geovent furnished by Liquid Boot. Geotextile fabric was installed over the insulation board and secured to the foam board with plastic screws spaced at approximately 12 inches. The Geovents were installed and covered with a 1-inch thick rigid insulation board to provide a smooth and level surface. The Liquid Boot vapor membrane barrier was then spray-applied to the geotextile fabric.

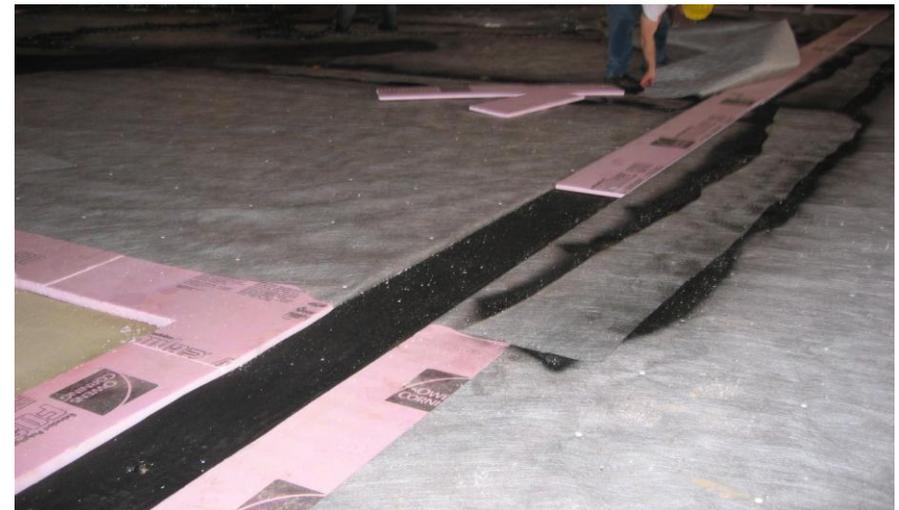
Geovents were installed between sections of insulation board to allow the ground beneath the vapor barrier to "breathe". Venting is channeled to vertical PVC pipe risers and discharged outside through the roof.

Four-inch diameter PVC piping was installed from each of the individual vent systems through the building roofs. A total of sixteen vent pipes were installed. The vent stacks were placed away from air handling units and up to approximately three feet above the roofs.
