TRC Investigation, Monitoring, and Remediation Status Report

City of New Bedford
Department of Environmental Stewardship

September 11, 2008

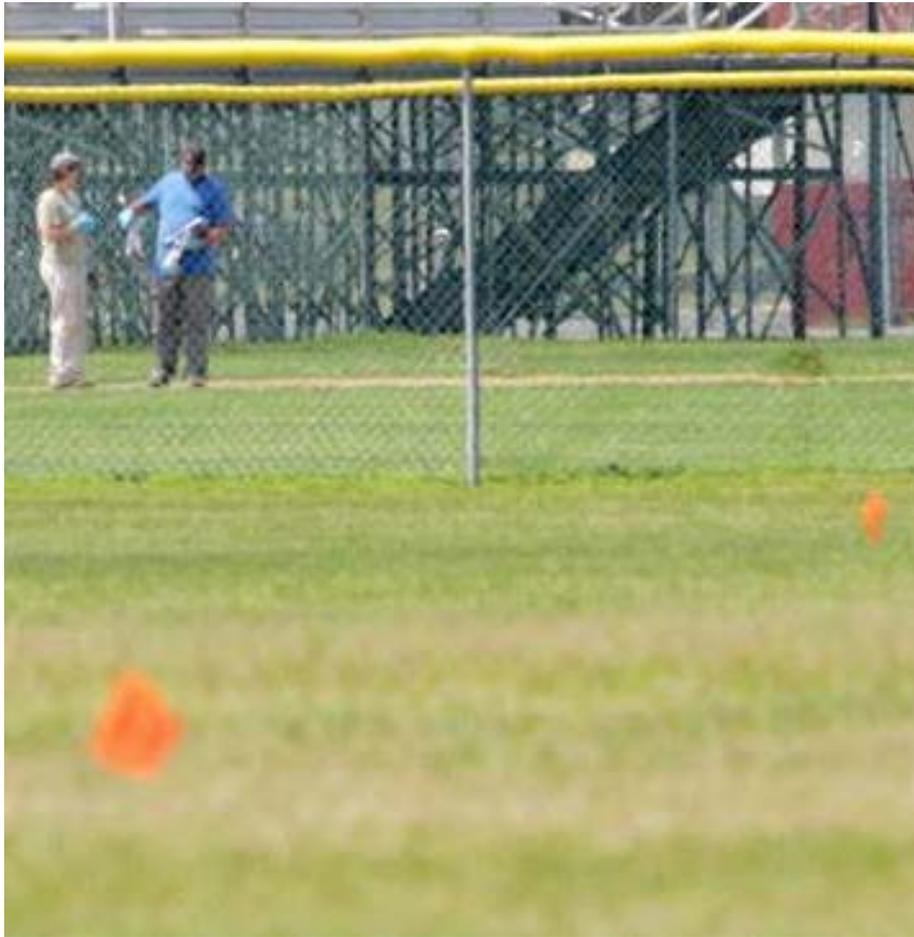
Soil Data Gaps/Delineation

- 65 soil borings
- 116 soil samples
- Analysis for PAHs, PCBs, and Metals

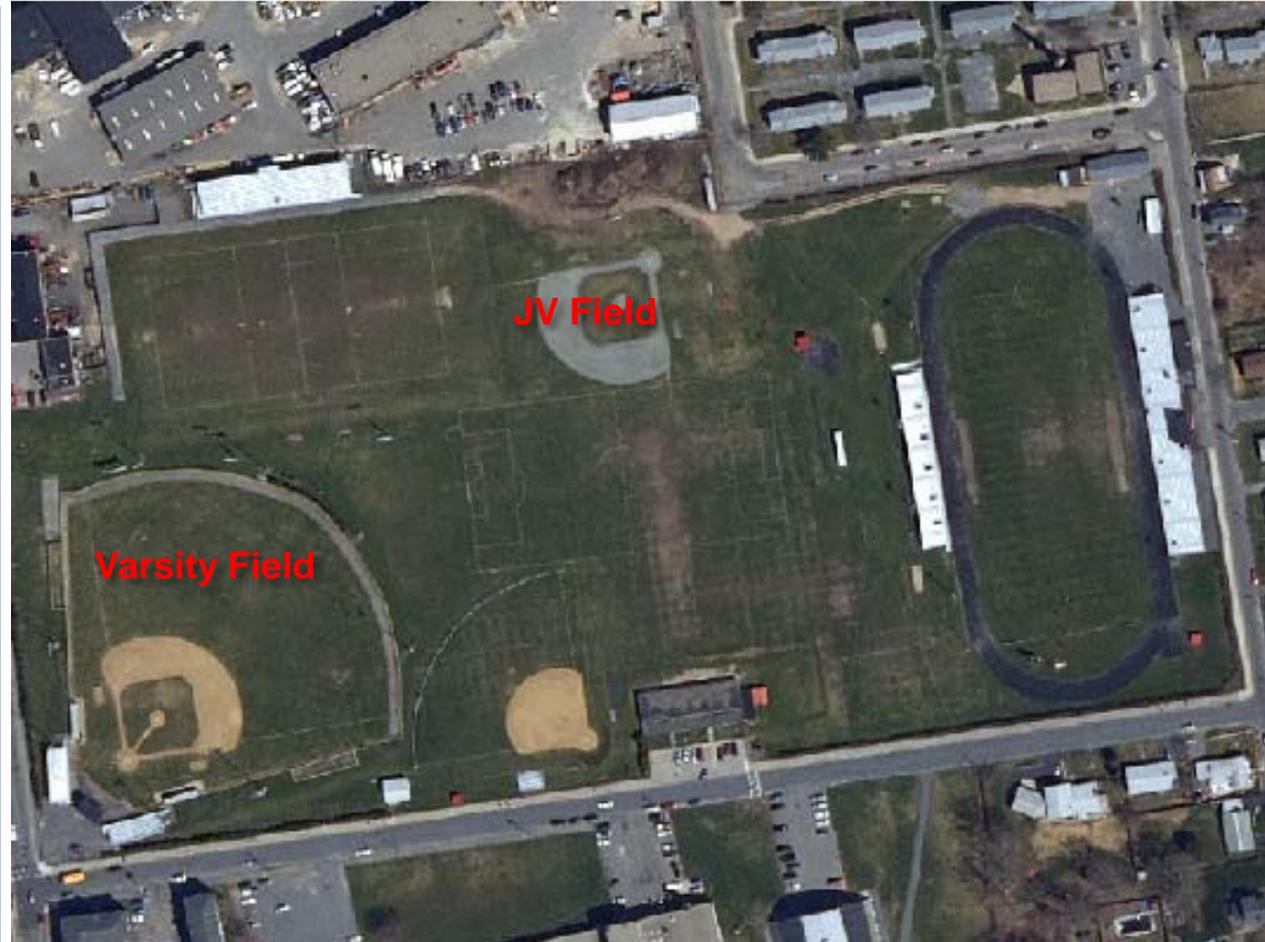
Soil Data Gaps/Delineation (continued)

- No Imminent Hazard at Jr. Varsity Field
- Calculations exceed Imminent Hazard thresholds at Varsity Field

- Varsity Field athletic field activities suspended (fenced and locked, No Trespassing signs)
- Currently evaluating expedited remedial solutions for Varsity Field

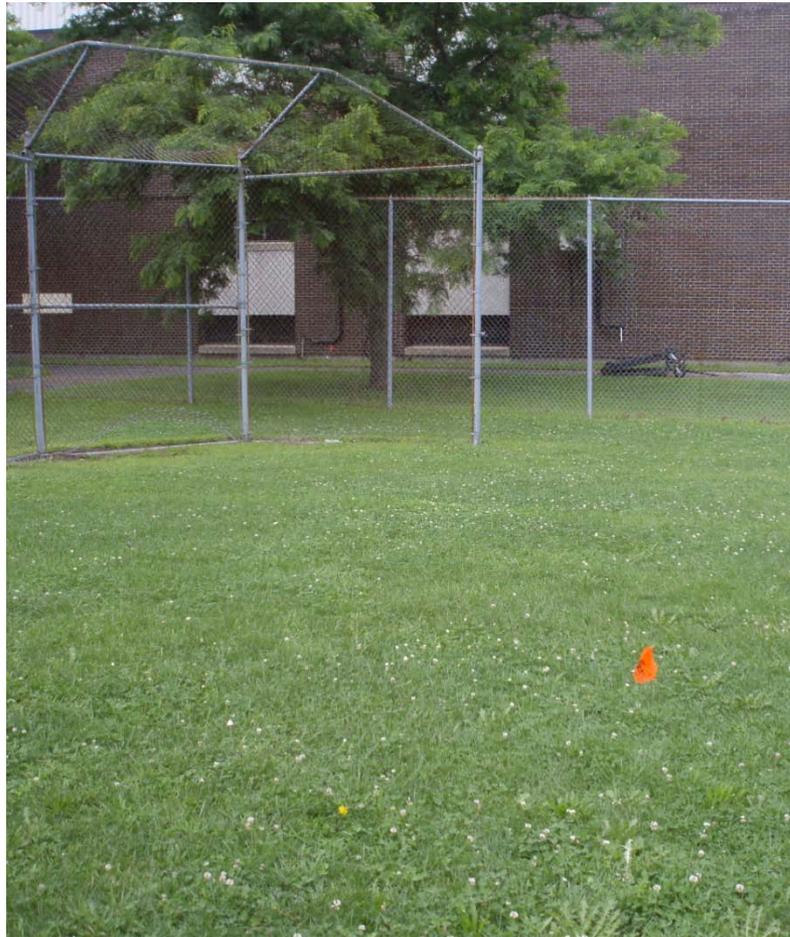
Exterior Soil and Groundwater

- Soil results generally consistent with past work by BETA
- Groundwater to be collected

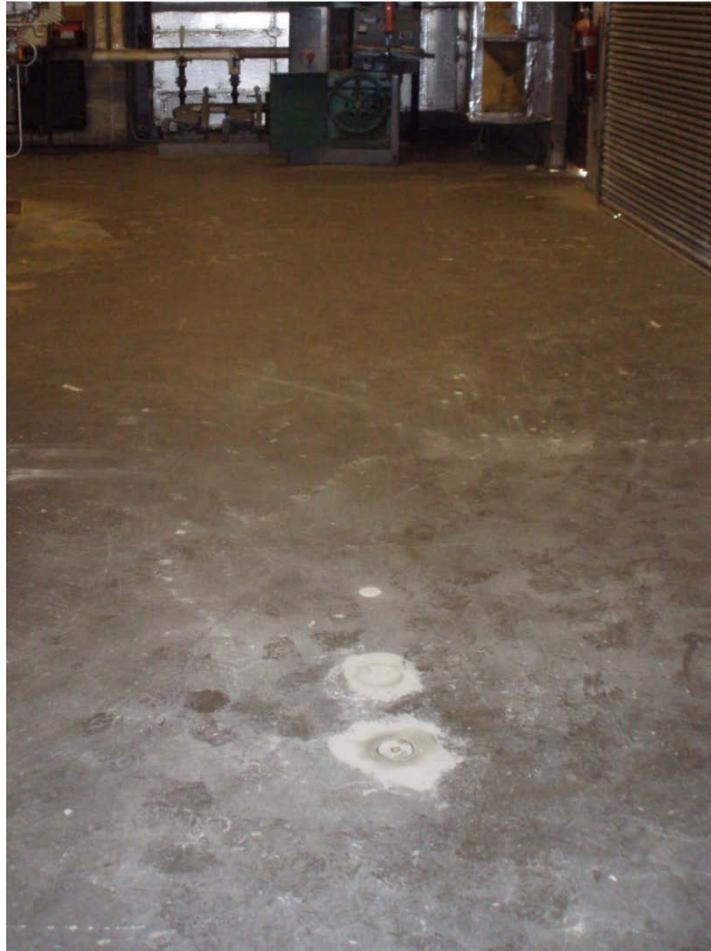
Sub-Slab Soil and Groundwater

- 8 sub-slab soil borings
- Low Concentration PCBs
- Sporadic metals above standards
- One PAH detect above standard

- 3 sub-slab wells
- Only exceed in one well due to turbidity (boiler room)
- Filtered result OK
- Exterior wells to be sampled

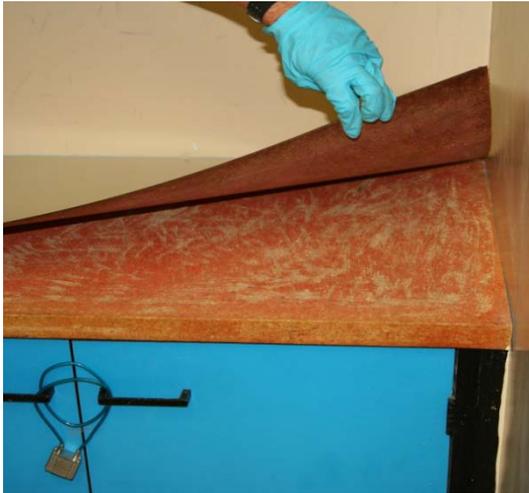
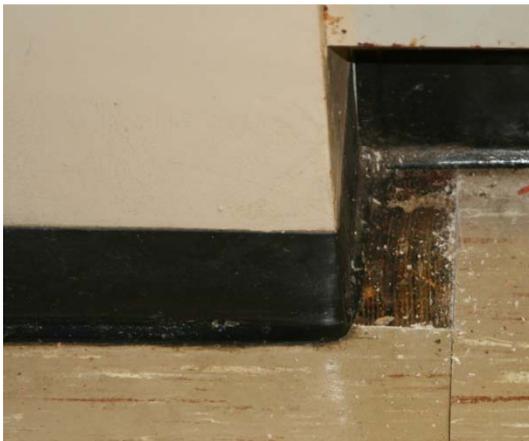
Findings

- ❑ Additional PCB-containing building materials (e.g., adhesives, gaskets)
- ❑ Numerous low-concentration building materials serve as sources of indoor air PCBs
- ❑ Higher PCB air concentrations trend with higher aggregate PCB building material concentrations

- PCBs detected in 57 out of 63 building material samples
- Concentration range: 0.16 ppm to 230 ppm (Total PCBs)

- PCBs detected in 5 out of 8 wipe samples
- Results range: 1.5 ug/100 cm² to 7.1 ug/100 cm²

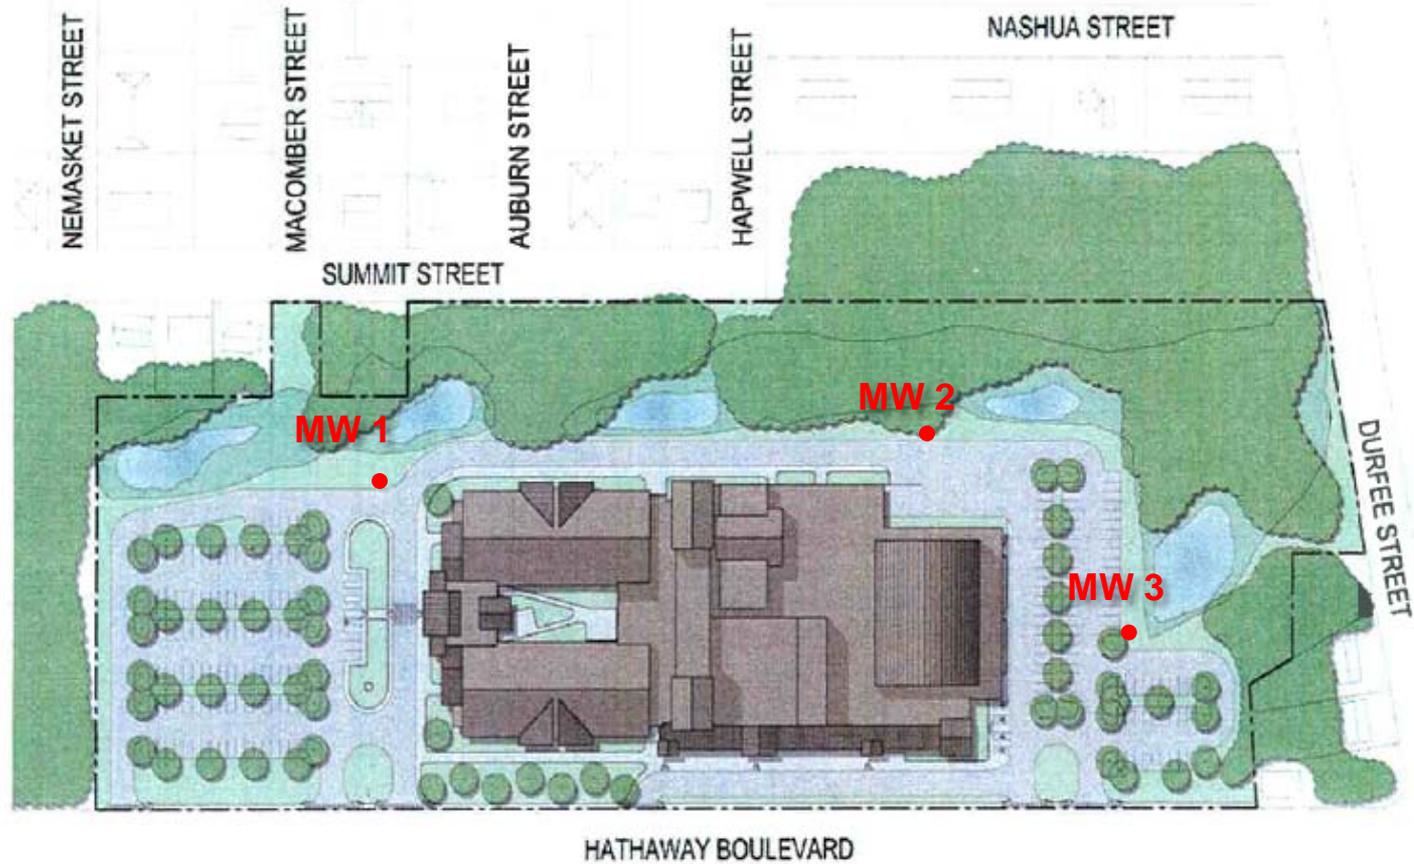
Groundwater Monitoring Well Locations

- VOCs: All Non-Detect (except MTBE, below standards)
- PCBs: All Non-Detect
- Metals: No detections above standards

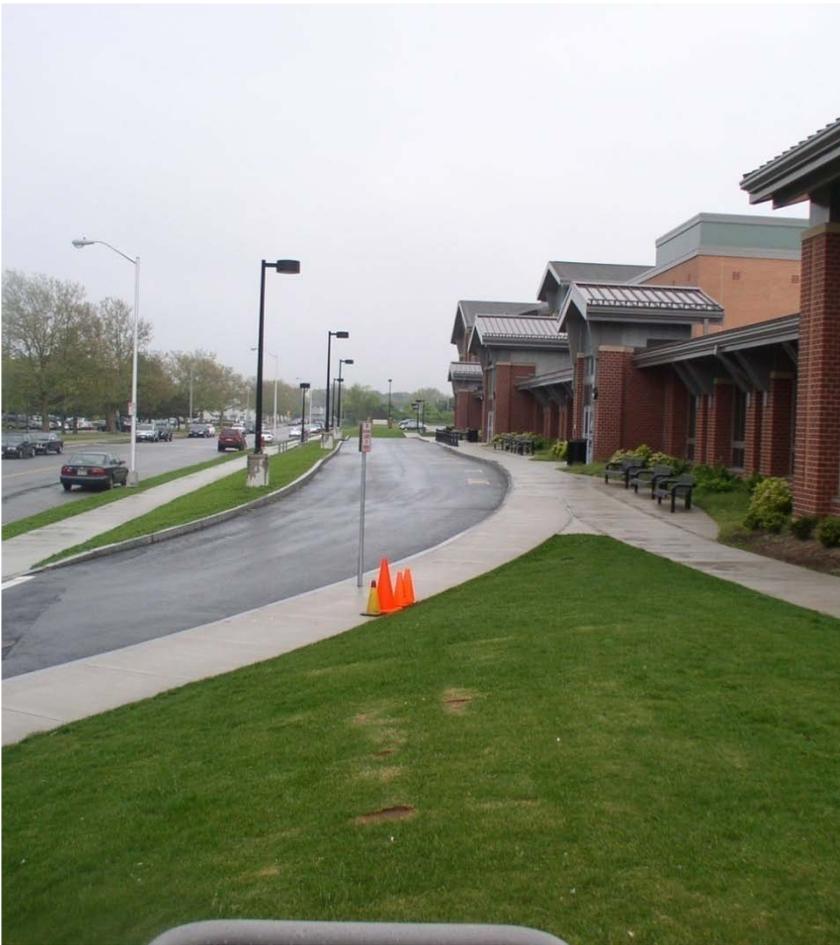
Cap Inspection - LTMMIP

- ❑ Conducted Three Times/Year
- ❑ Inspection Scope
 - Walking traverse of entire site
 - Visual observations of entire cap
 - First floor concrete slab
 - Interior courtyard
 - All asphalt and landscaped surfaces

- Concrete slab in acceptable condition
- Exterior pavement and concrete surfaces in acceptable condition
- Courtyard surfaces in acceptable condition
- Exterior landscaped areas are acceptable except as follows:
 - Sparse vegetation - southern slope
 - Area of slope failure - previously reported
 - Sloughing rip-rap - west side/storm drain
 - Minor erosion - northwest corner

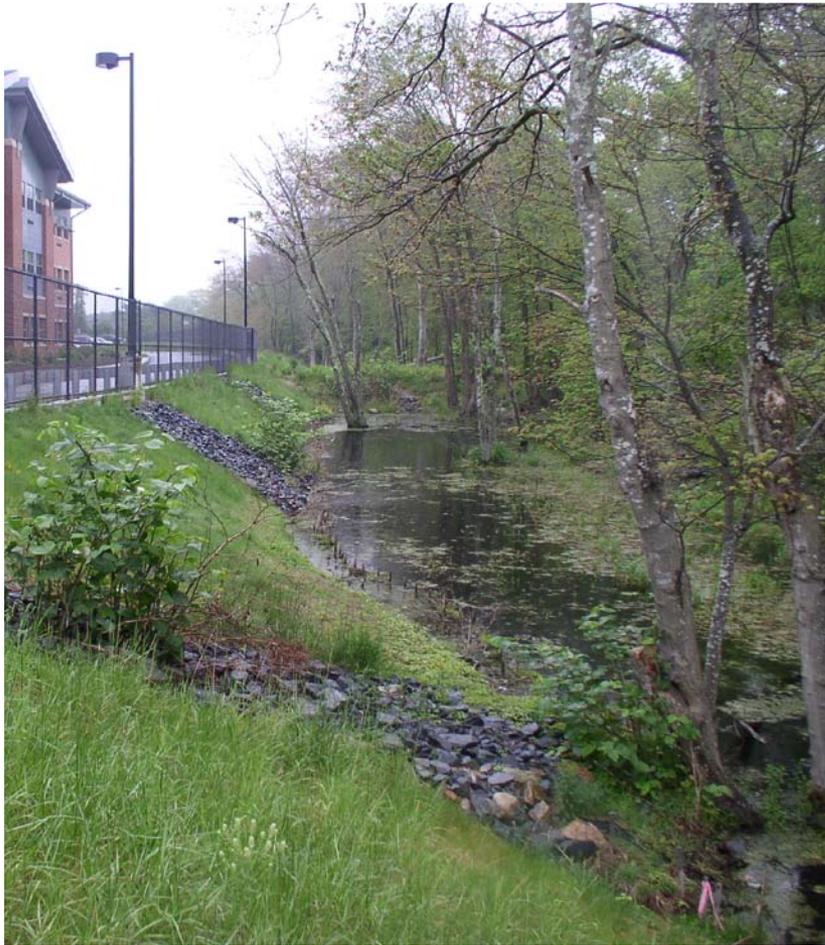
Wetland Inspection - LTMMIP

- ❑ Conducted in Spring 2008
- ❑ Inspection Scope
 - Walking traverse of entire top and toe of slope
 - Look for unacceptable conditions:
 - Excessive sedimentation
 - Conditions that could cause excessive sedimentation
 - Vegetation conditions

- Similar erosion issues as noted in cap inspection

- Temporary repair still viable with some localized soil migration around the lower hay bales

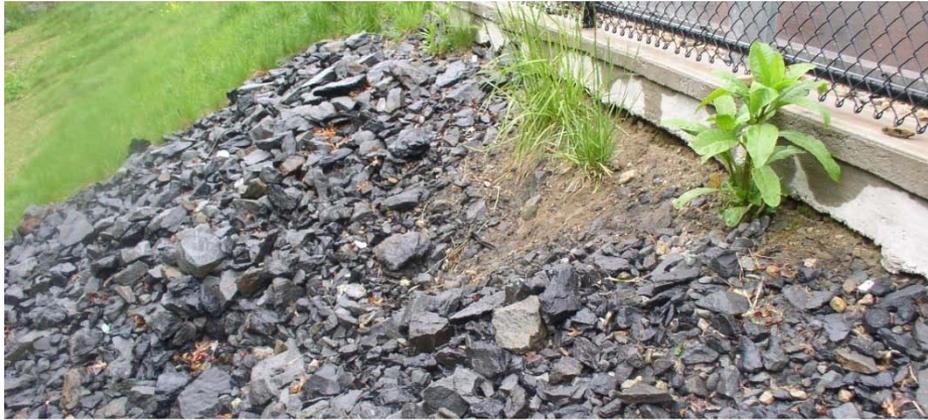
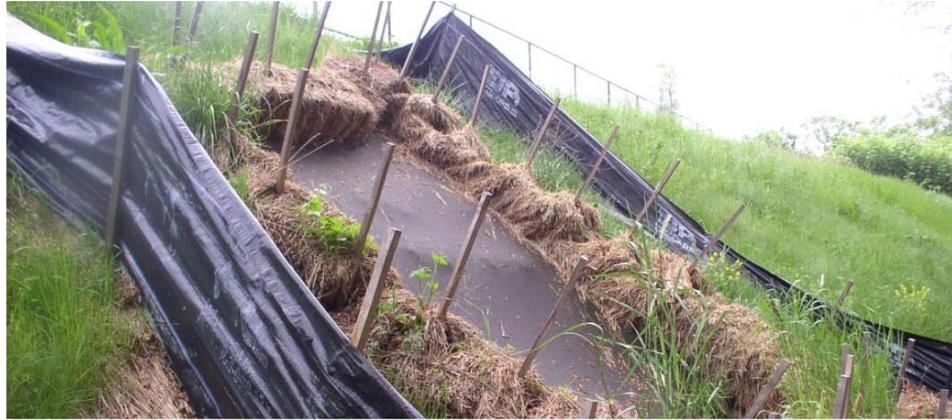
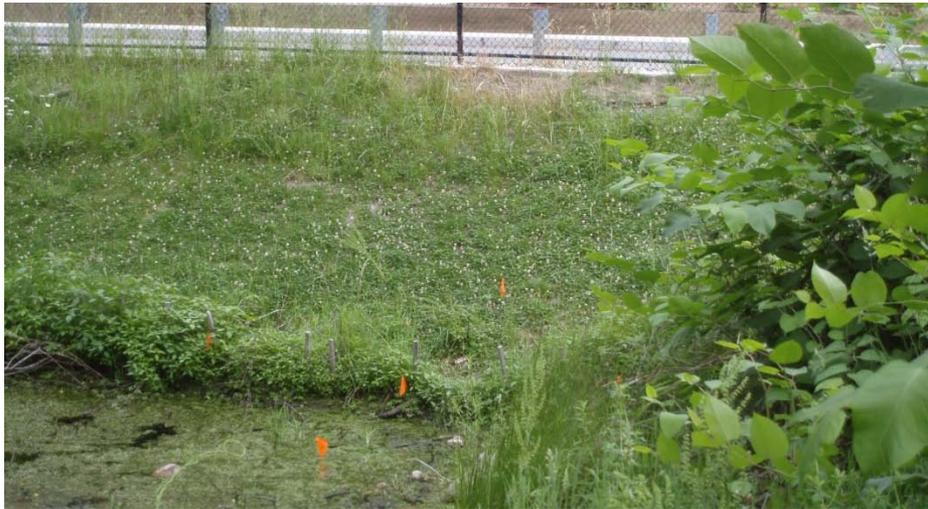
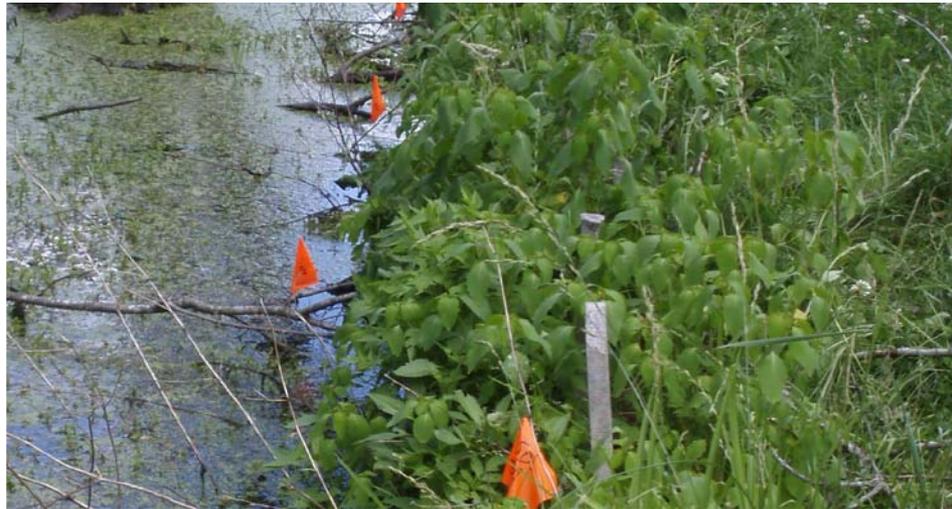
- Generally well vegetated slope
 - Exploring vegetation/animal control options

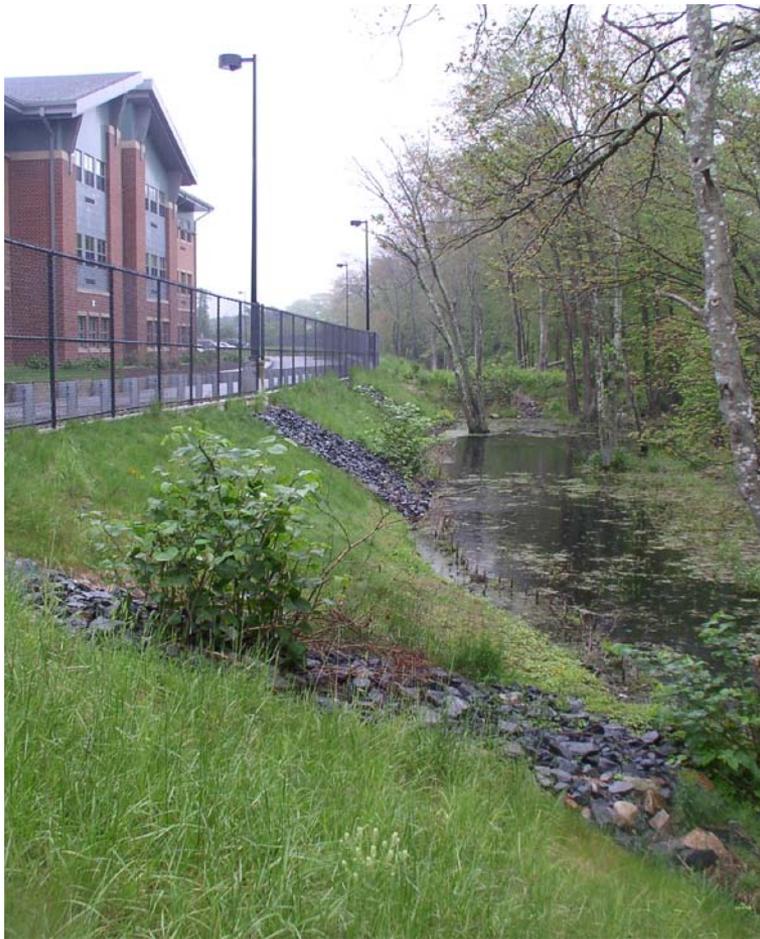
Wetland Sediment Monitoring - LTMMIP

- ❑ Long-Term Monitoring and Maintenance Implementation Plan (LTMMIP)
- ❑ Conducted in Spring 2008
- ❑ Monitoring scope
 - Four randomly collected sediment samples (base of slope)
 - Analyze samples for PCB Aroclors (Method 8082)

- Three out of four samples non-detect
- One sample detected PCBs (16.6 mg/kg)
- Triggered potential Imminent Hazard reporting and evaluation under the MCP (reported to MassDEP)
- Preliminary calculations indicate an Imminent Hazard exists (TRC's calculations slightly exceed the Imminent Hazard criteria set forth in the MCP under 310 CMR 40.0955)
- *Delineation and evaluation ongoing*

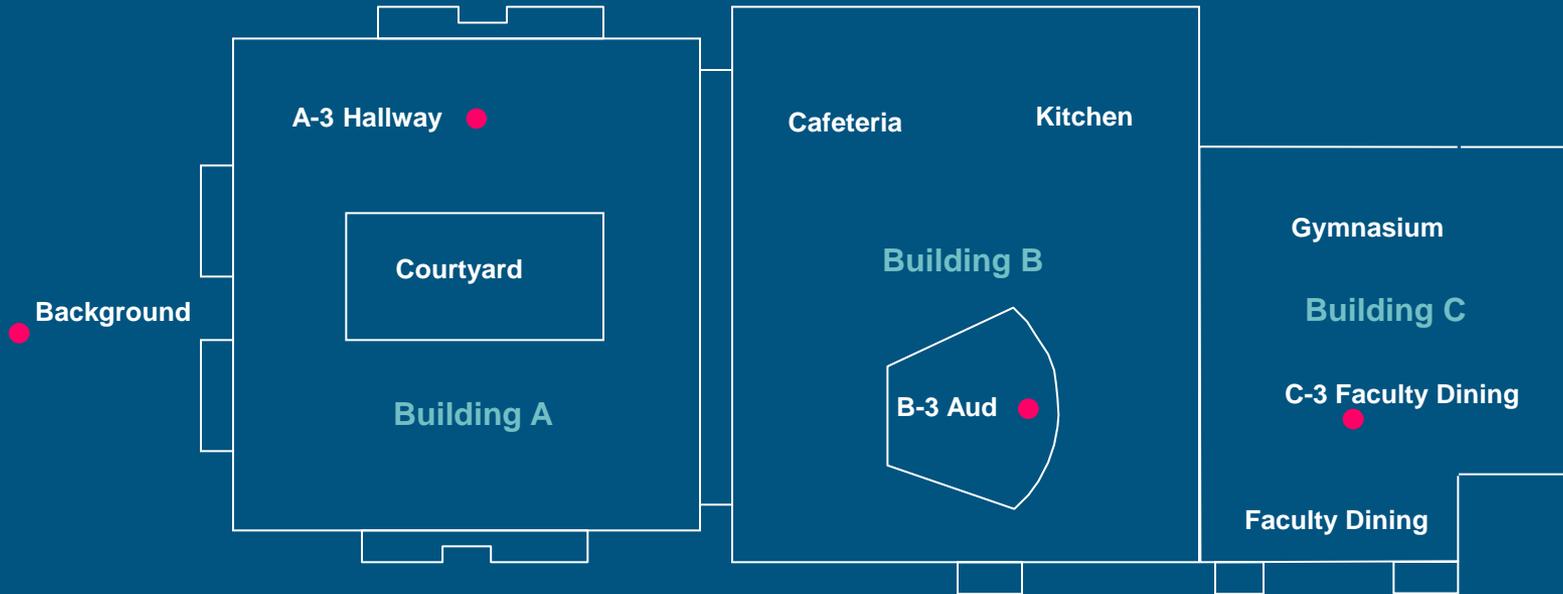
KMS Indoor Air Sampling - Locations

● = Air Sampling Location

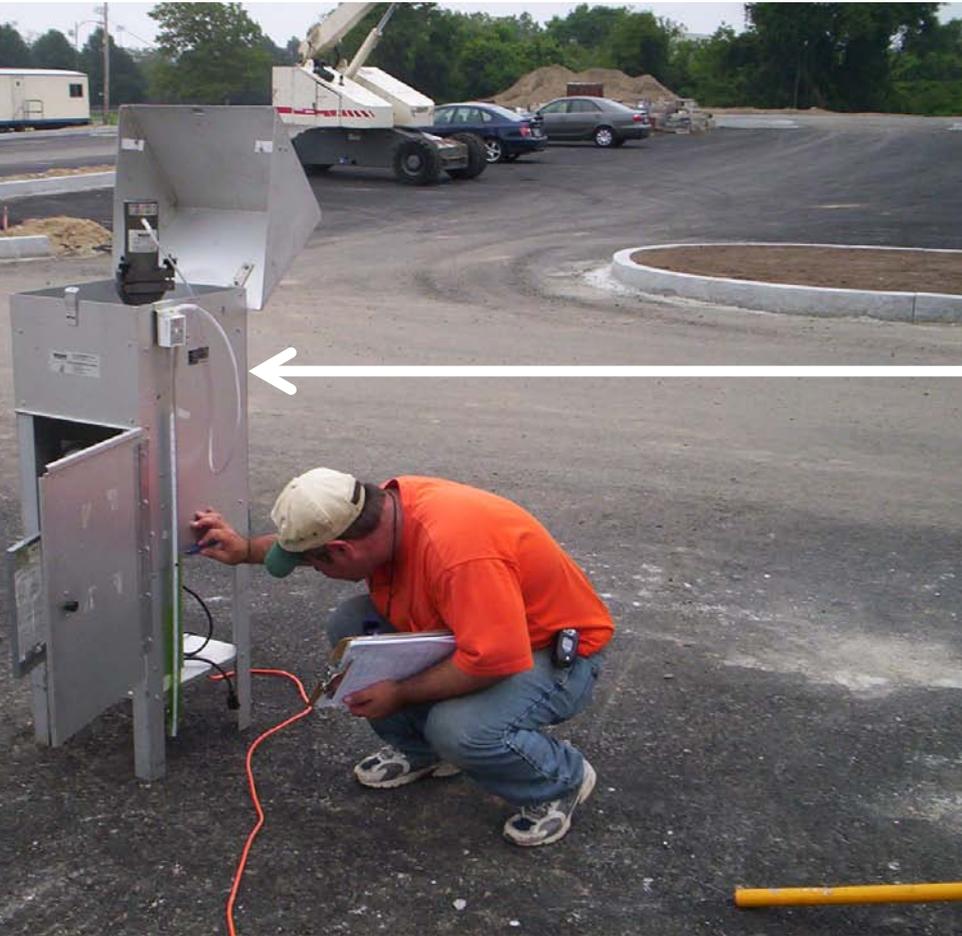
Hi-Vol
Sampling Unit

Background Sampling In Progress
