RELEASE ABATEMENT MEASURE COMPLETION REPORT

SOIL REMOVAL REMEDY IMPLEMENTED AT THE WALSH FIELD ATHLETIC COMPLEX

NEW BEDFORD, MASSACHUSETTS

Release Tracking Number 4-15685

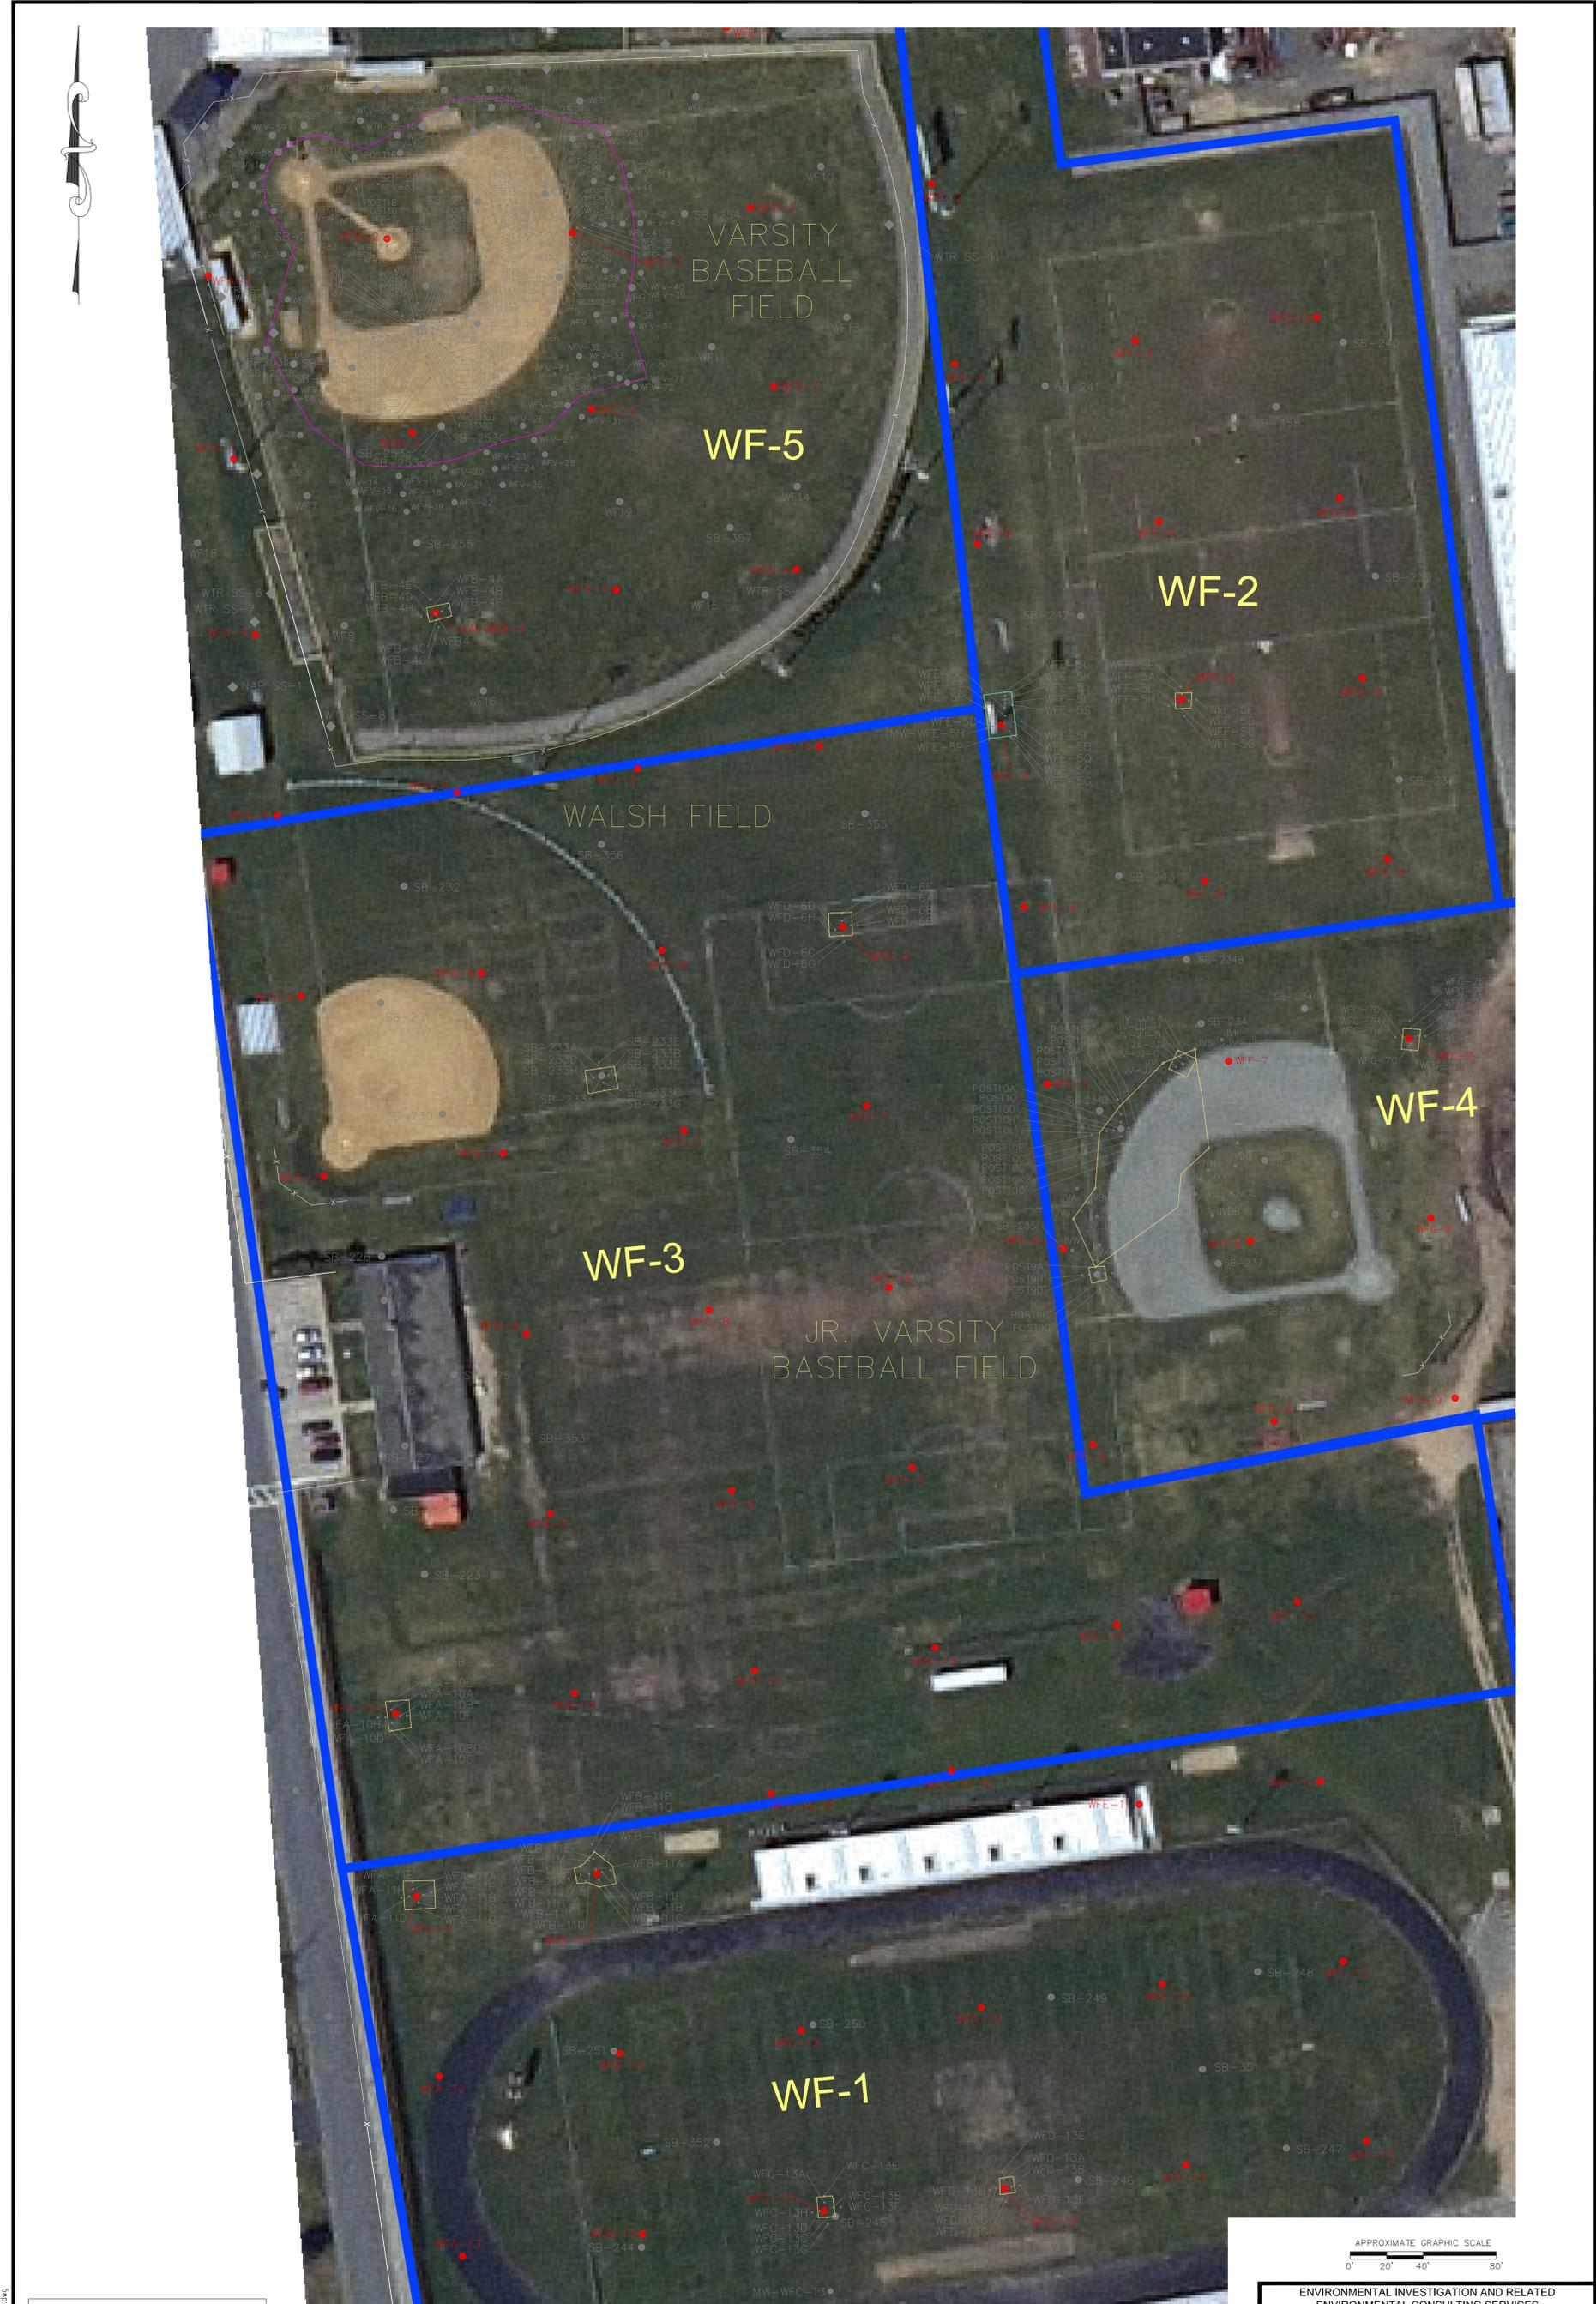
- BETA BORINGS
- TRC BORINGS
- SEPTEMBER 10 EXCAVATION
- DECEMBER 09 EXCAVATION
- PRIOR EXCAVATION
- EXPOSURE POINT AREA BOUNDARY & DESIGNATION

The exposure point area boundaries are illustrated in Figure 2.

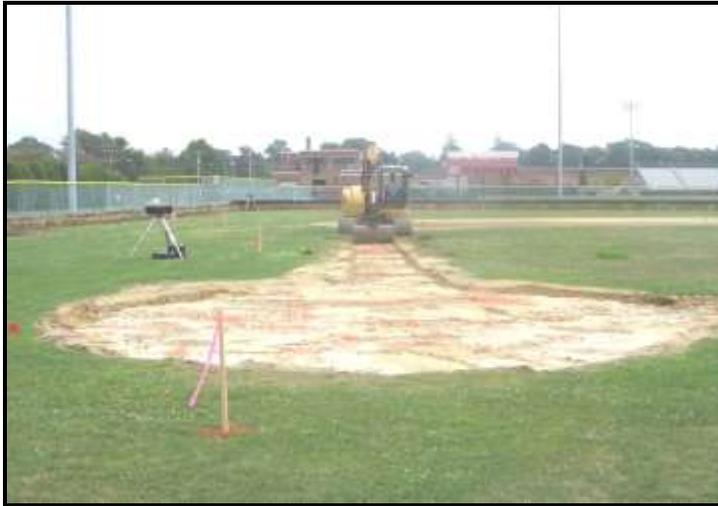
Photo 1 - Removal of base path material from Varsity Field (August 17, 2010).

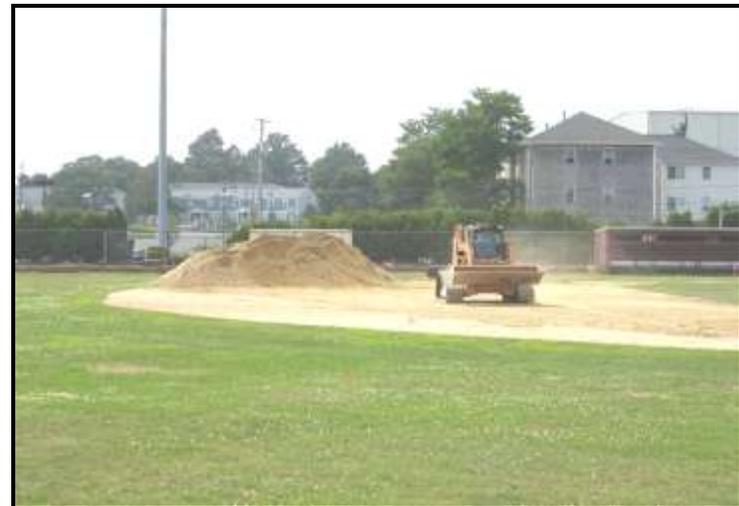
Photo 2 – Stockpiling of base path material near first base (August 17, 2010).

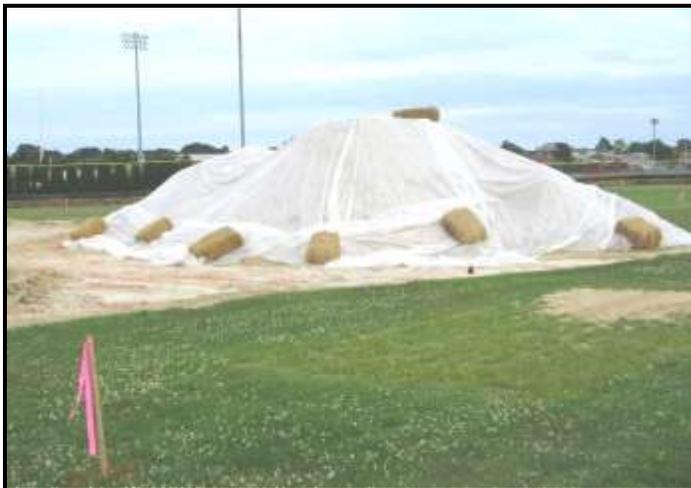
Photo 3 – Base path material stockpile covered and secured at end of day (August 18, 2010).

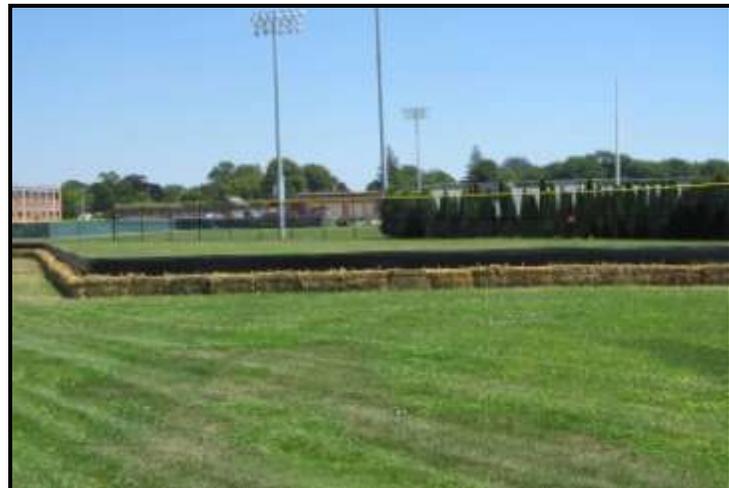
Photo 4 – Silt fence and hay bales around perimeter of Varsity Field (August 19, 2010).

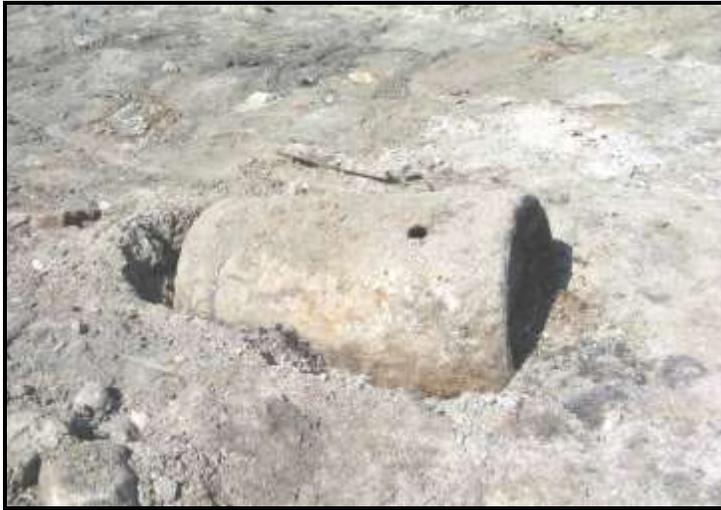
During excavation activities on August 19, 2010, TEI uncovered a small (approximately 35 to 50 gallon capacity) saddle tank near the third base portion of the excavation. The tank was found to be rusty and empty. TRC screened the soils around the edges of the tank using the MassDEP jar headspace method, as well as the void space within the tank with a PID. All PID screening results were non-detect. The tank was segregated on polyethylene sheeting (6-mil minimum) pending off-site disposal as scrap metal.

Photo 5 – Empty saddle tank uncovered in northeast portion of excavation (August 19, 2010).

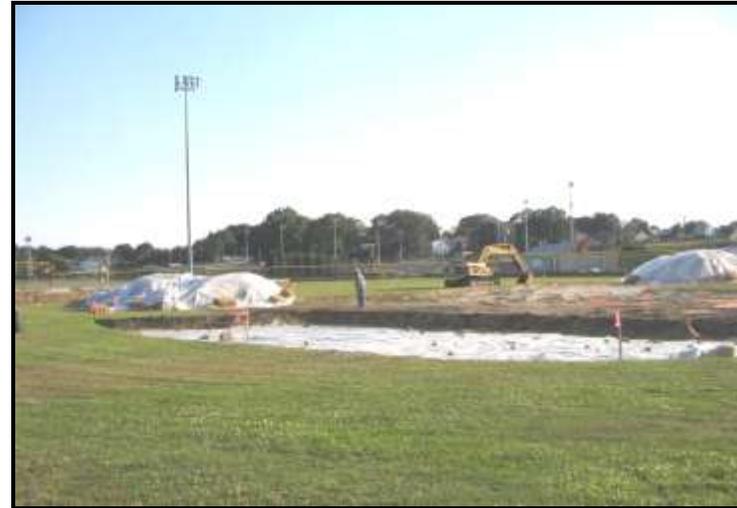
Photo 6 – View of Varsity Field excavation with polyethylene sheeting covering open hole (August 19, 2010).

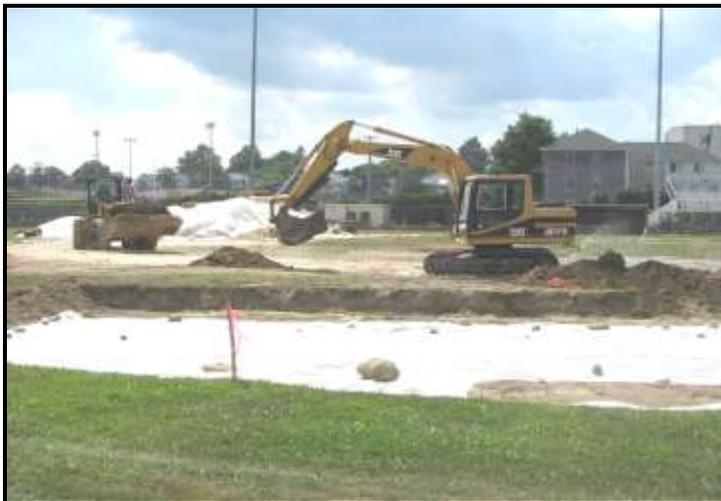
Photo 7 - Base of excavation covered with poly (August 20, 2010).

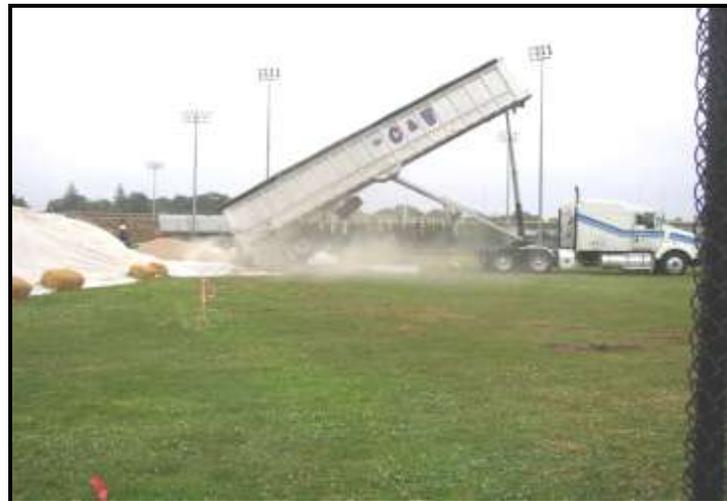
Photo 8 – Delivery of FF-100[®] stabilization treatment material (August 20, 2010).

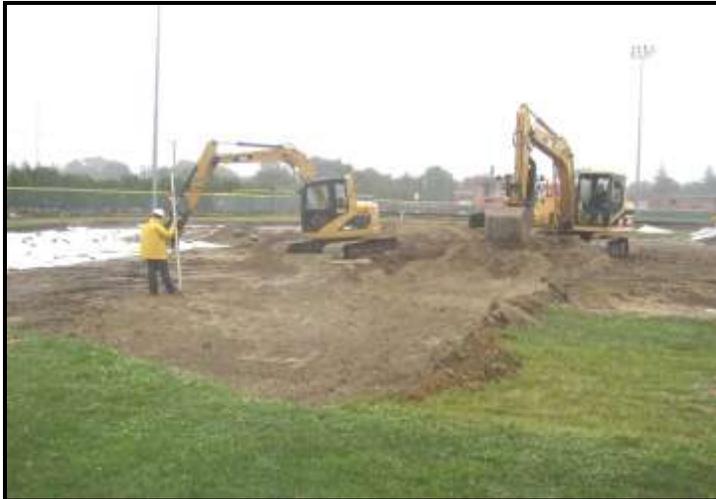
Photo 9 – View of excavation and TEI shooting grades (August 24, 2010).

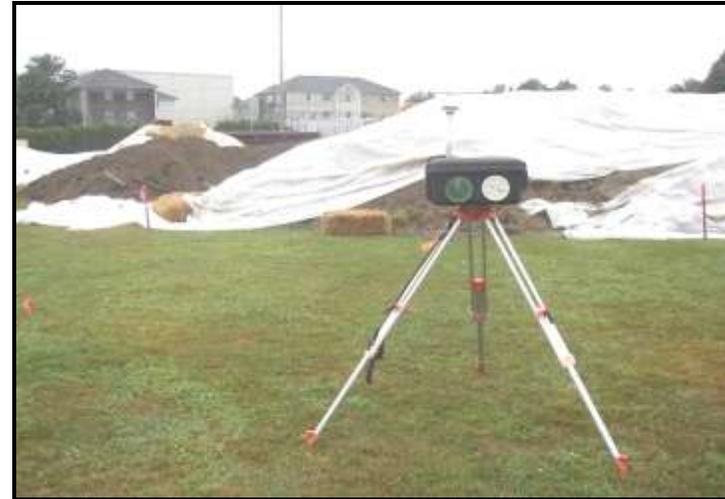
Photo 10 - Active dust monitoring with TSI DustTrak™ (August 24, 2010).

prior to the start of daily activities. The dust monitoring instruments were placed in weatherproof cases with an omni-directional probe to minimize wind interference. Depending on the daily wind conditions and RAM-related activities taking place, three to six dust monitoring units were deployed to monitor conditions upwind, downwind, adjacent to the nearest property (regardless of wind direction) and/or within the work zone. The dust monitoring units were regularly adjusted, based on changes in the localized wind direction, throughout RAM-related activities. The dust monitoring instruments were zeroed daily before use and at the end of the day. Data were logged at 60-second intervals and downloaded and reviewed daily. The TSI DustTrak™ units were periodically checked by field personnel during RAM-related activities.

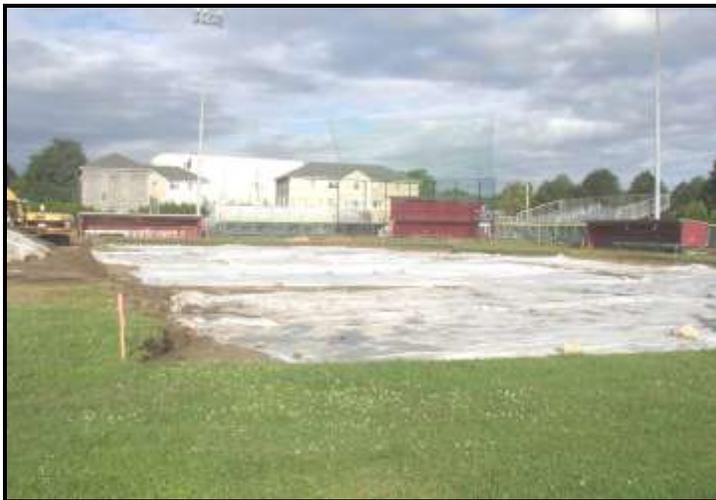
Photo 11 – Completion of first half of excavation (August 26, 2010).

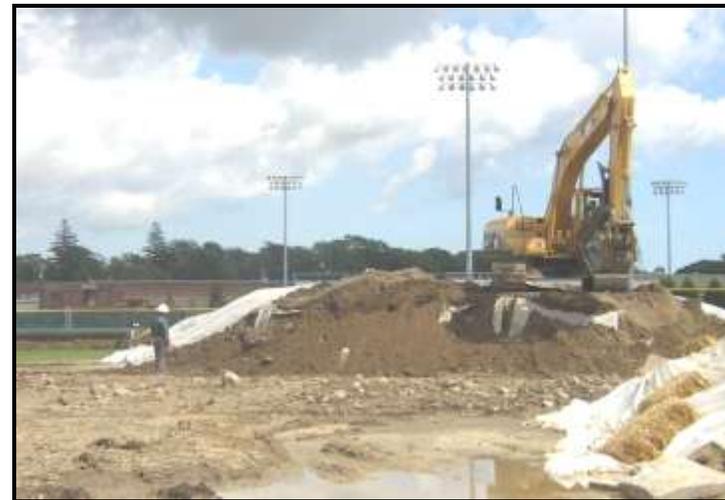
Photo 12 – Mixing of FF-100® stabilization treatment material into soil stockpile (August 26, 2010).

25, 2010 and securely covered with polyethylene sheeting to protect the material from the wind and rain (prior to use the stabilization treatment material cannot be exposed to moisture). The stabilization material was added and mixed using an excavator with a decontaminated bucket. Water sprays were applied to the soil during treatment activities for dust suppression. As noted above, the treated material was stockpiled in the staging area located in right field of the Varsity baseball diamond. The treated material was stockpiled on and secured with polyethylene sheeting (6-mil minimum). Following treatment, the material was transported to the staging area pending off-site disposal. Treatment of the first half of the excavated material was completed on August 30, 2010.

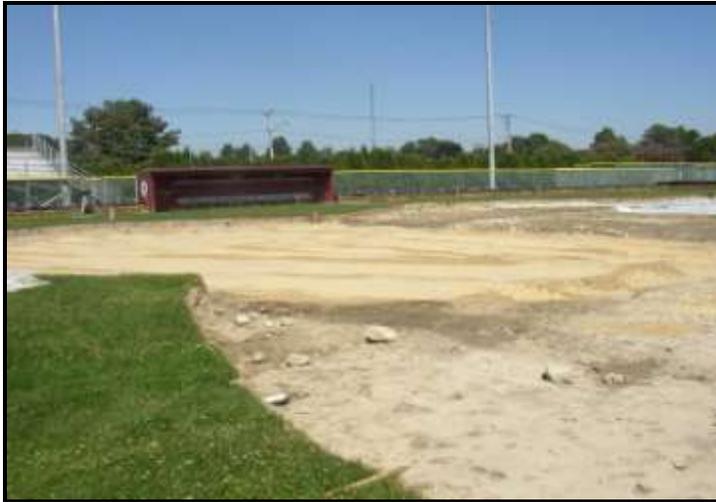
Photo 13 – Spreading of base path material in base of excavation (August 30, 2010).

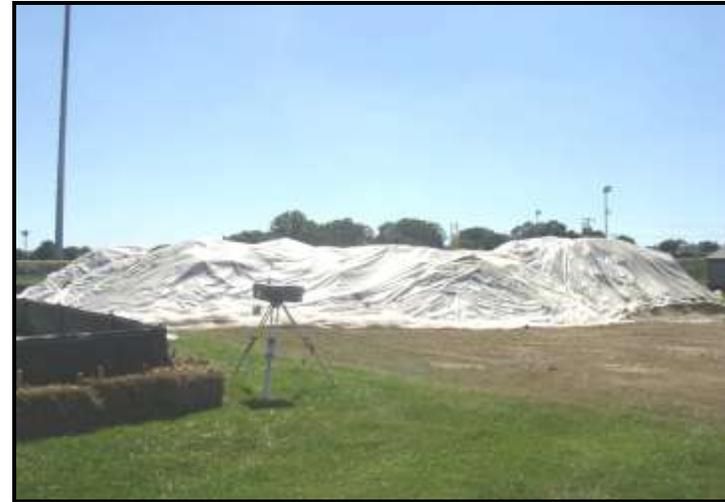
Photo 14 – View of treated stockpile (August 30, 2010).

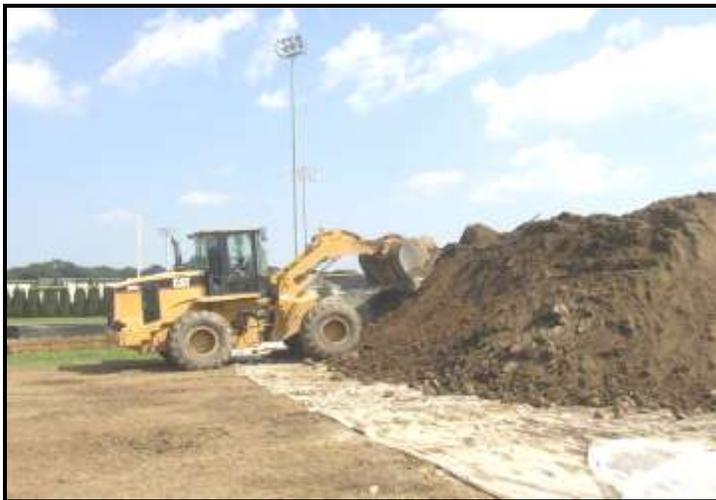
Photo 15 – Transfer of treated material from excavation stockpile to staging stockpile for off-site disposal (August 31, 2010).

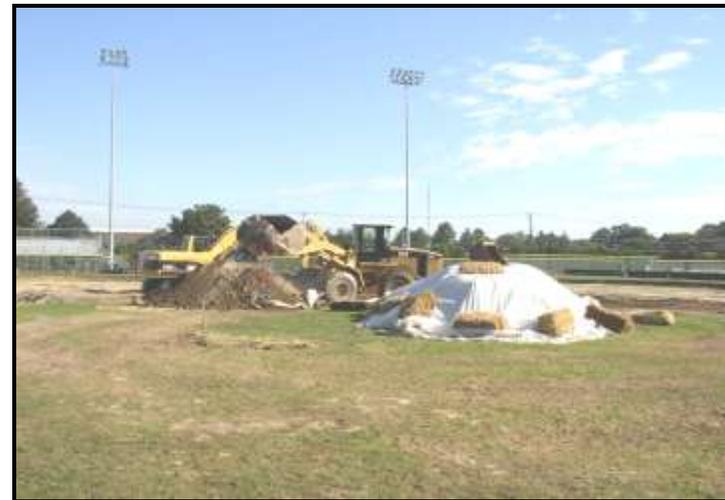
Photo 16 – FF-100[®] stabilization treatment material stockpile securely covered with polyethylene sheeting (September 7, 2010).

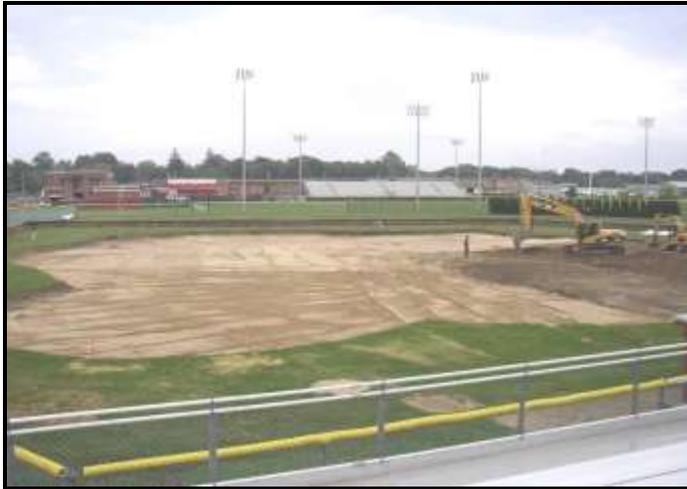
Photo 17 – View of excavation to date (September 8, 2010).

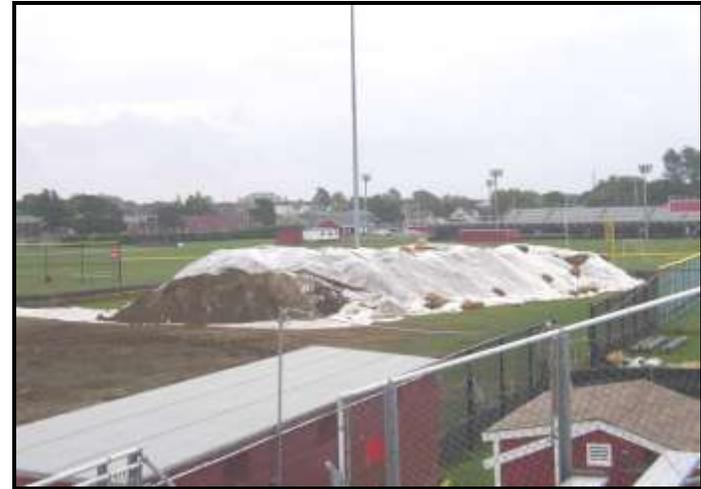
Photo 18 – View of staged treated stockpile (September 9, 2010).

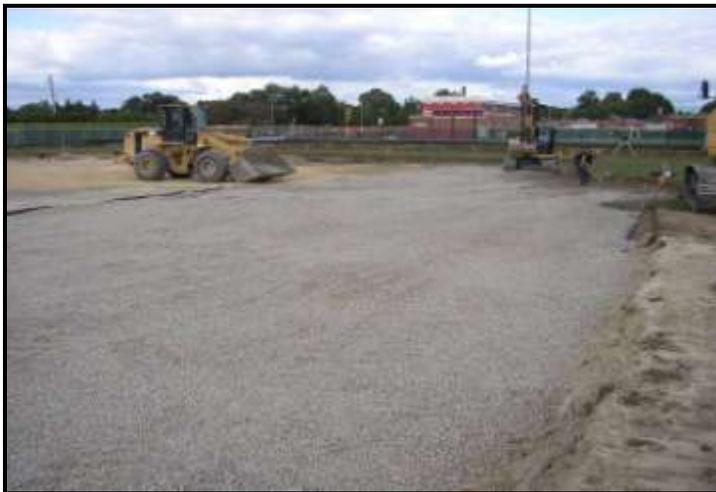
Photo 19 – TEI beginning to spread gravel over geotextile in outfield portion of excavation (September 9, 2010).

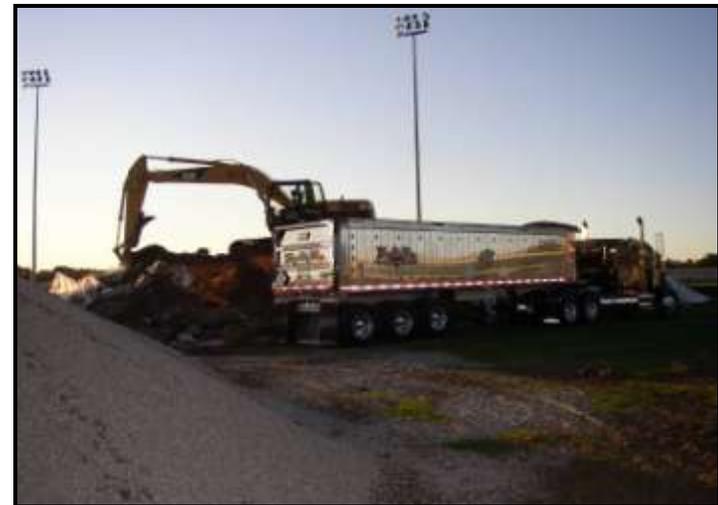
Photo 20 – Loading of stockpiled treated material for off-site disposal (September 21, 2010).

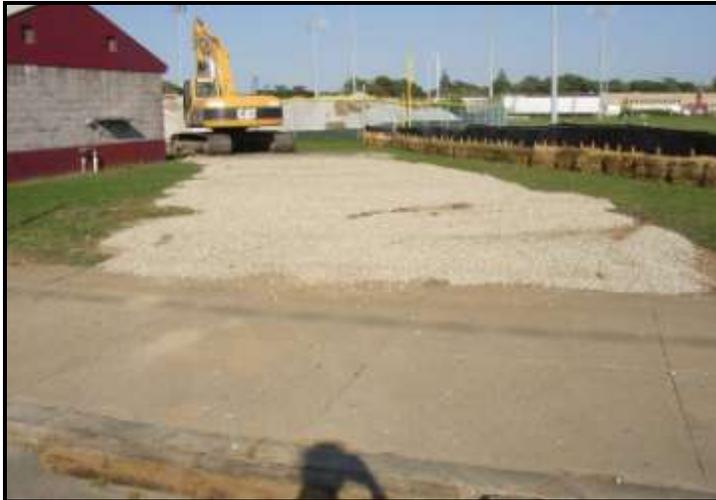
Photo 21 – Southern access road from Hunter Street adjacent leading to right field stockpile area (September 22, 2010).

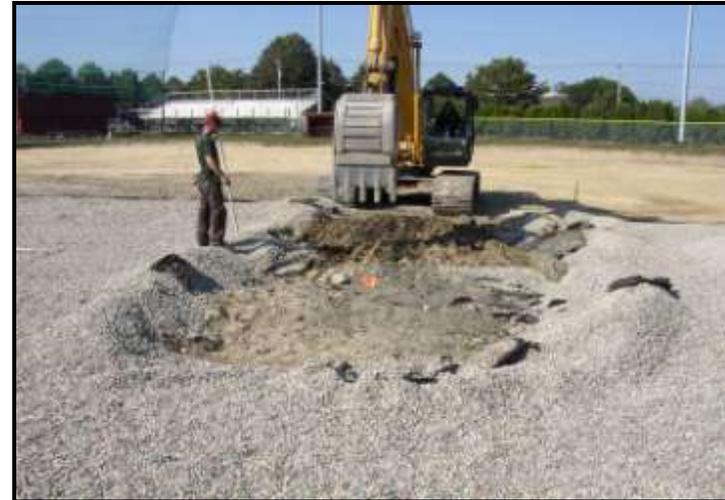
Photo 22 – Regrading of area that was not originally excavated to at least 18-inches in right field (September 22, 2010).

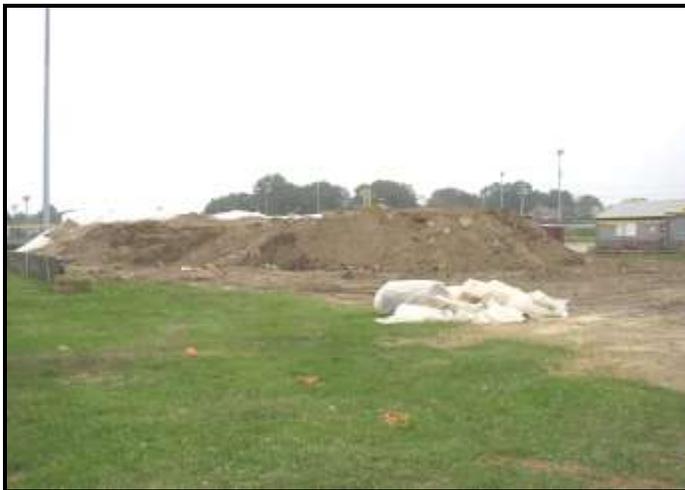
Photo 23 – View of stockpile as shipping occurs (September 24, 2010).

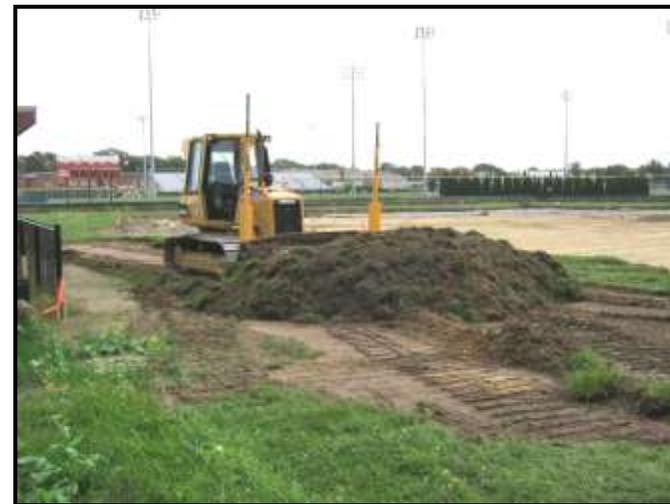
Photo 24 - Regrading for improved drainage (September 29, 2010).

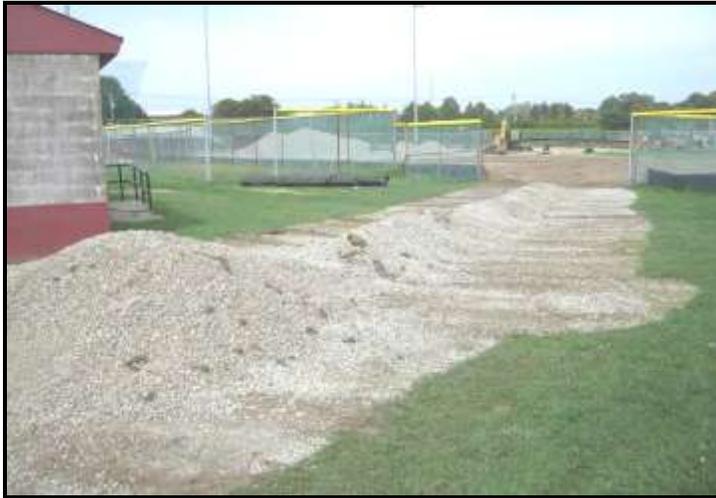
Photo 25 – Removal of southern access road to Hunter Street (September 30, 2010).

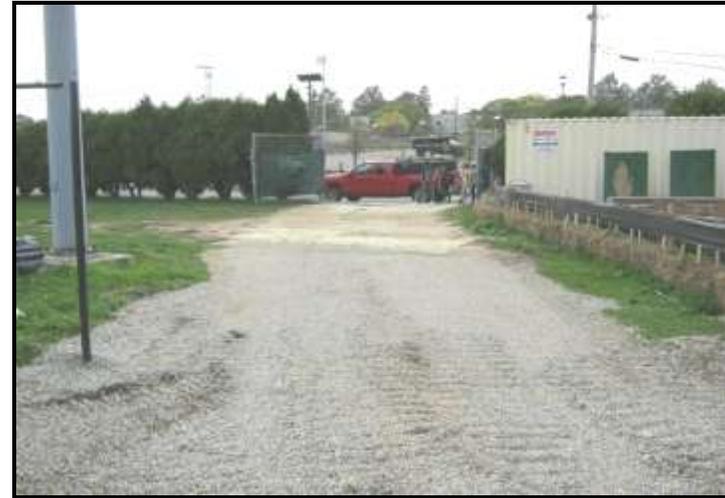
Photo 26 – Access road to existing gate on Hunter Street (September 30, 2010)

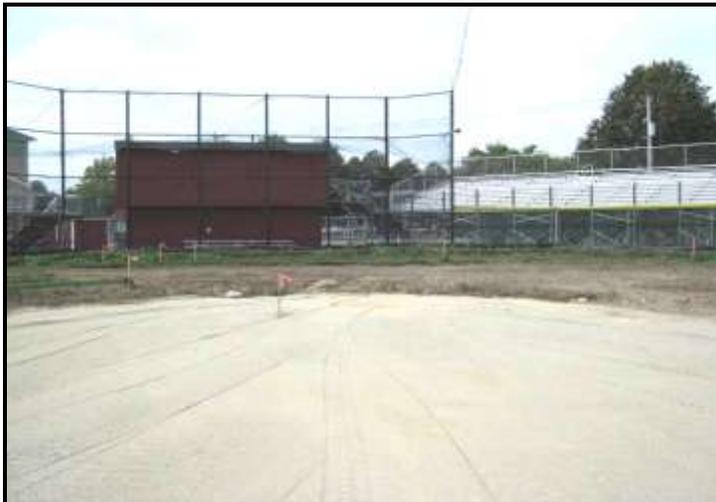
Photo 27 – Completed regrading in northeast portion of field (September 30, 2010).

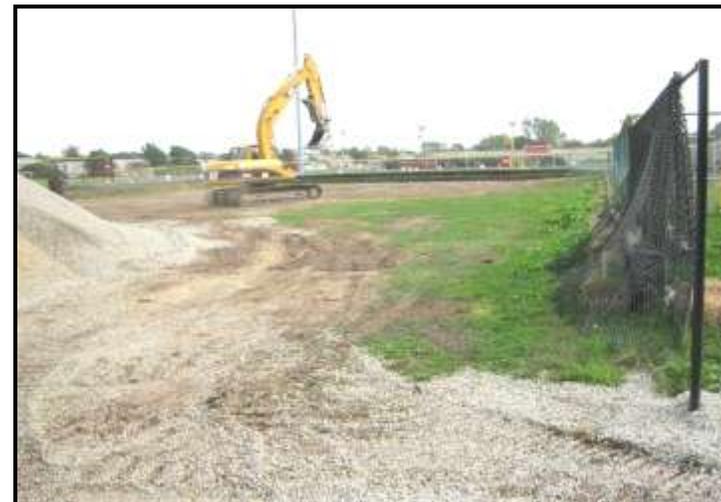
Photo 28 – Shipping of excavated soil completed (September 30, 2010).

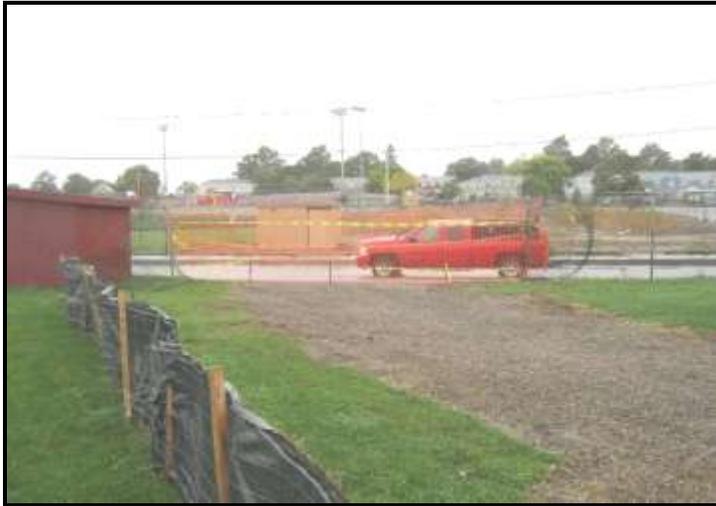
Photo 29 – Securing of Hunter Street access point pending repair of fence (October 1, 2010).

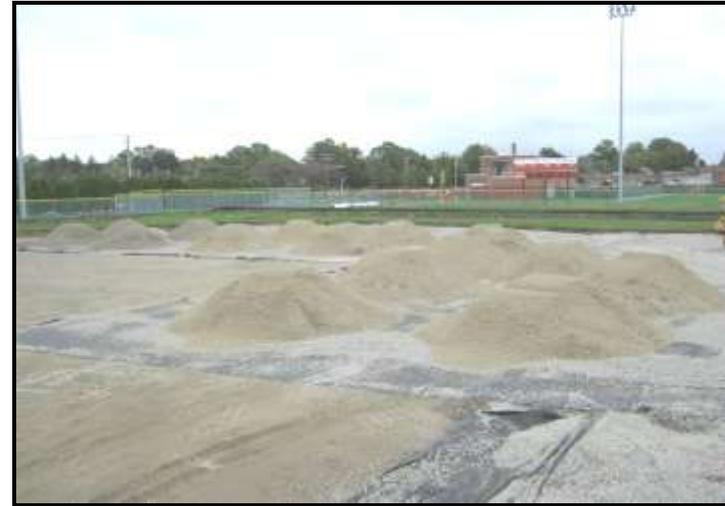
Photo 30 – Clean backfill loaded in and placed on geotextile fabric (October 4, 2010).

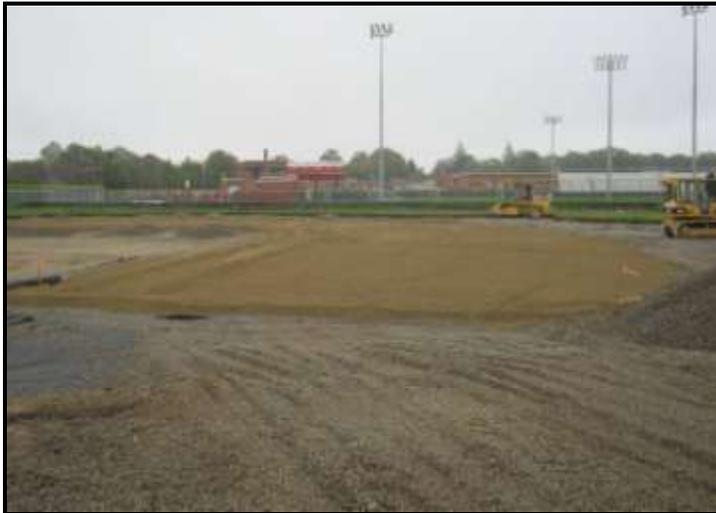
Photo 31- Outfield backfilled and graded (October 5, 2010).

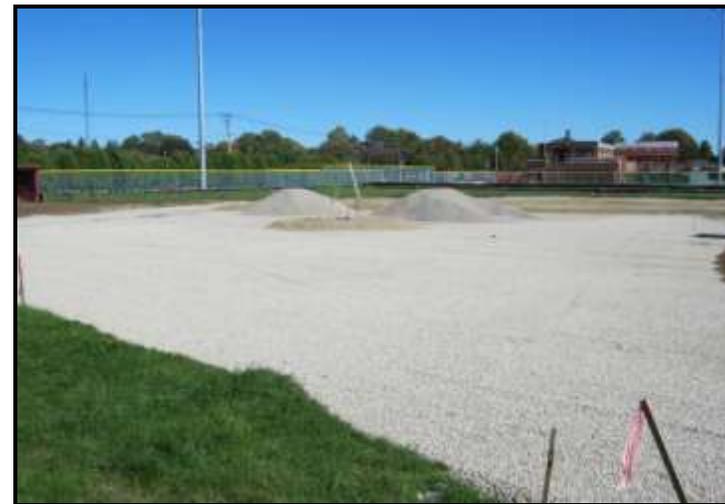
Photo 32– Gravel spread across infield (October 8, 2010).

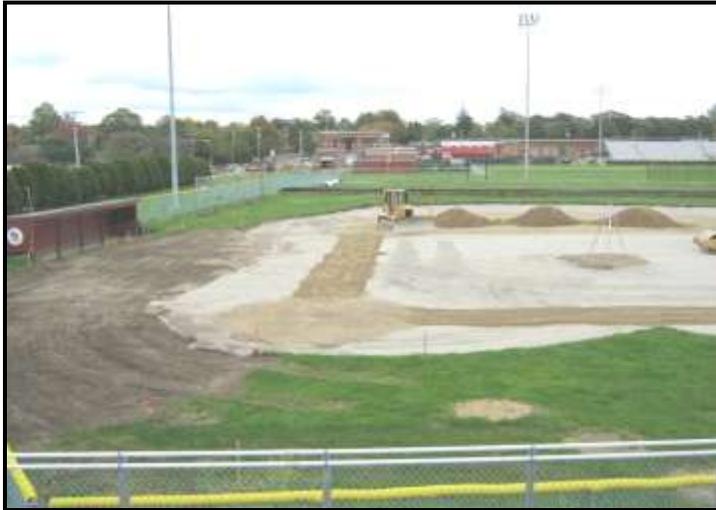
Photo 33- View of base path and grassed areas subgrade materials (October 12, 2010).

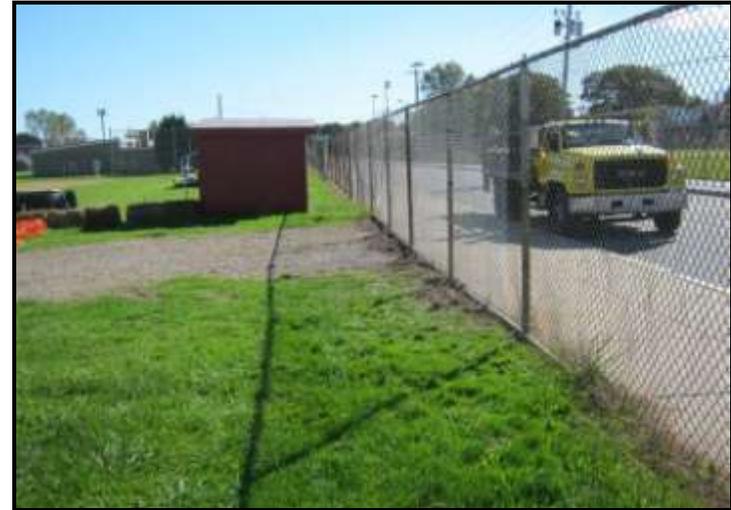
Photo 34 – Repaired fence associated with southern access road (October 13, 2010).

The temporary southern access gate to Hunter Street, used during treated soil shipment activities, was repaired on October 13, 2010 by Fence America.

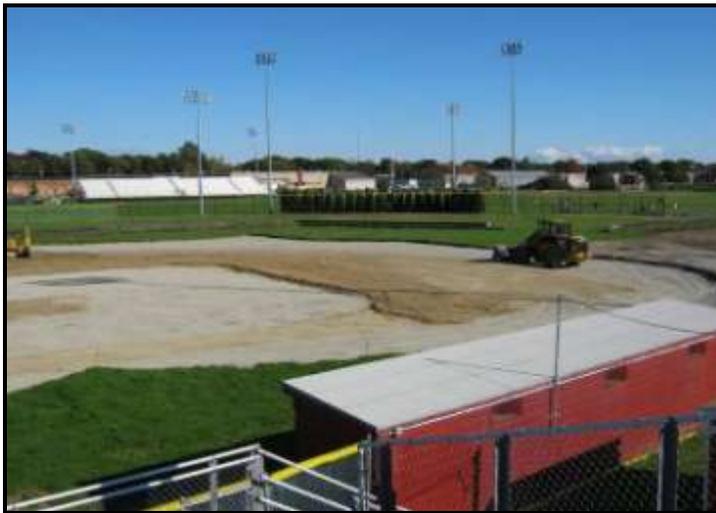
Photo 35 – Progress of grading activities (October 13, 2010).

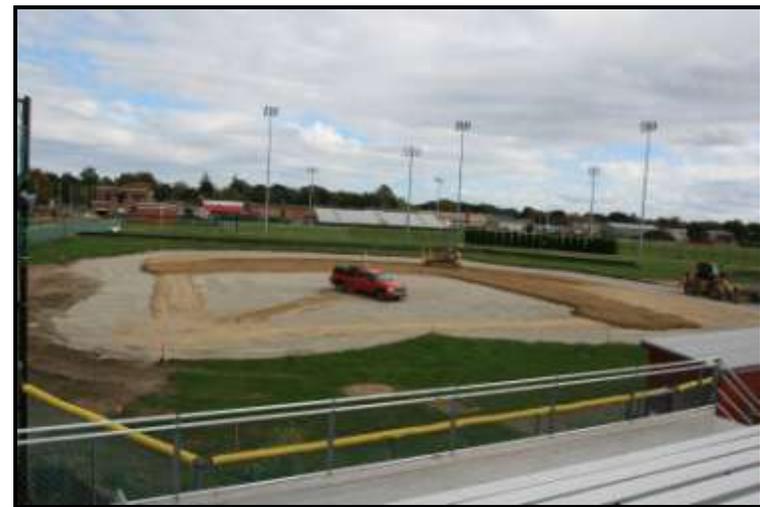
Photo 36 – Progress of grading activities (October 14, 2010).

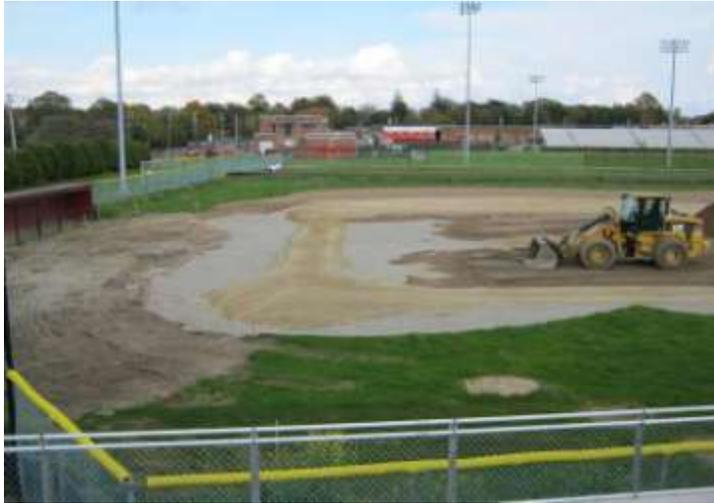
Photo 37 – Spreading loam in grassed areas (October 22, 2010).

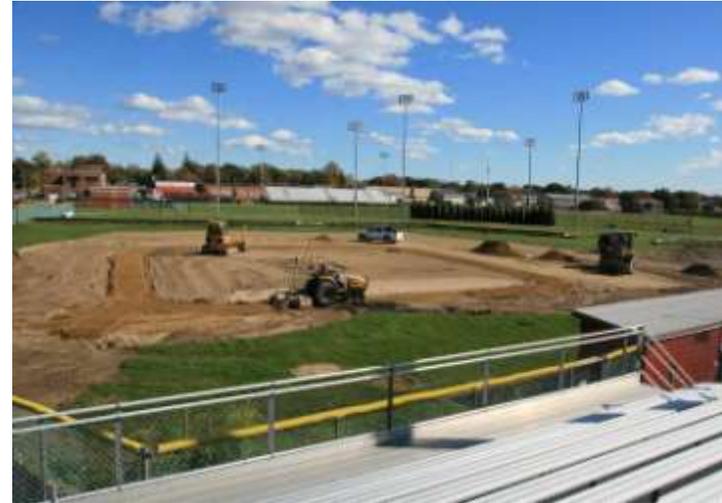
Photo 38 – Progress of grading activities (October 22, 2010).

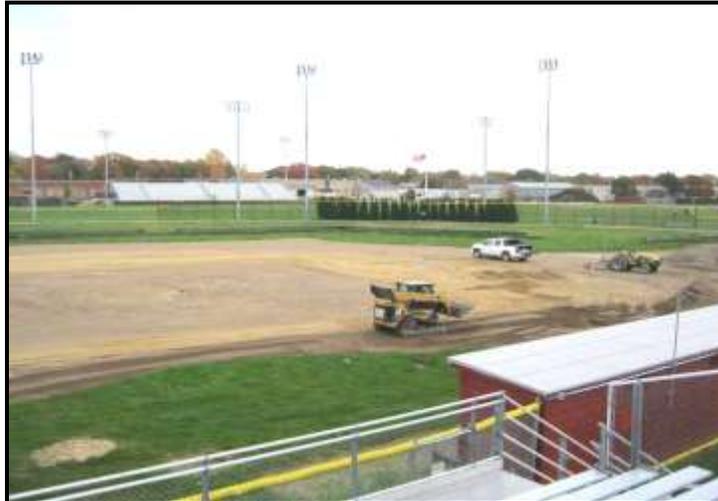
Photo 39 – Progress of grading activities (October 26, 2010).

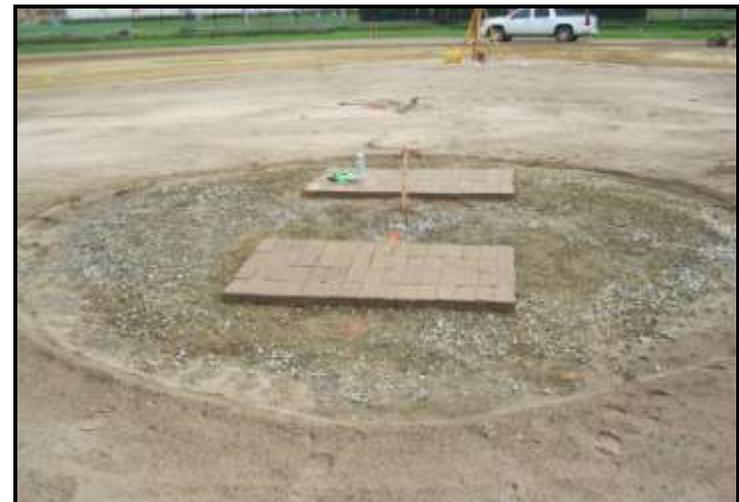
Photo 40 – Construction of pitcher's mound (October 28, 2010).

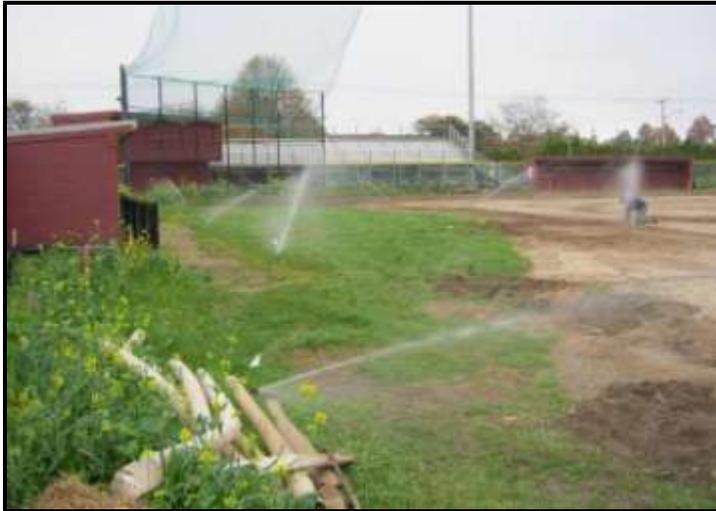
Photo 41 – Sprinkler system repaired and tested (October 28, 2010).

On October 28, 2010, Lawhorn Irrigation, Incorporated of Burlington, Massachusetts was onsite to repair those portions of the irrigation system disturbed during excavation of the Varsity baseball diamond.

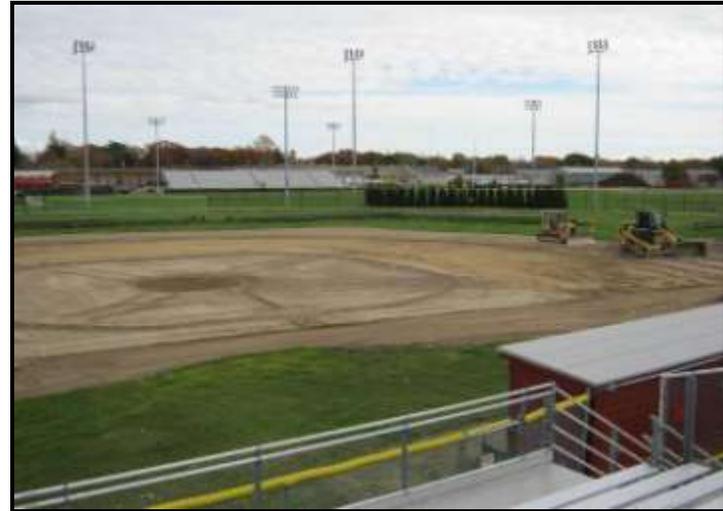
Photo 42 – Grading complete (October 29, 2010).

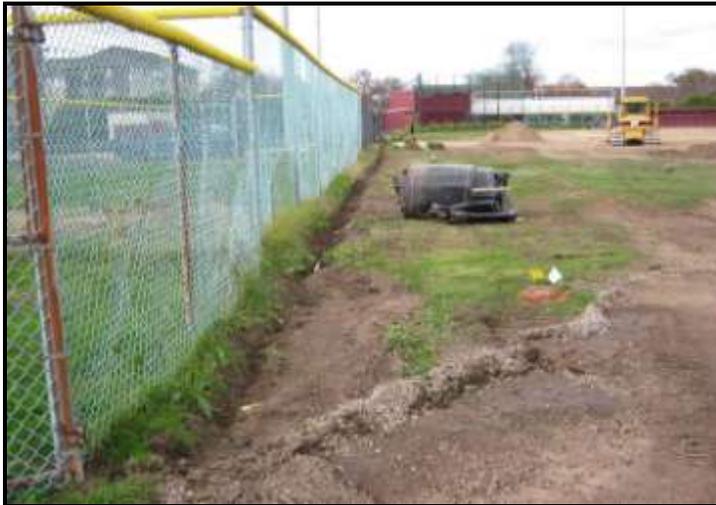
Photo 43 – Silt fence and hay bales removed (November 1, 2010).

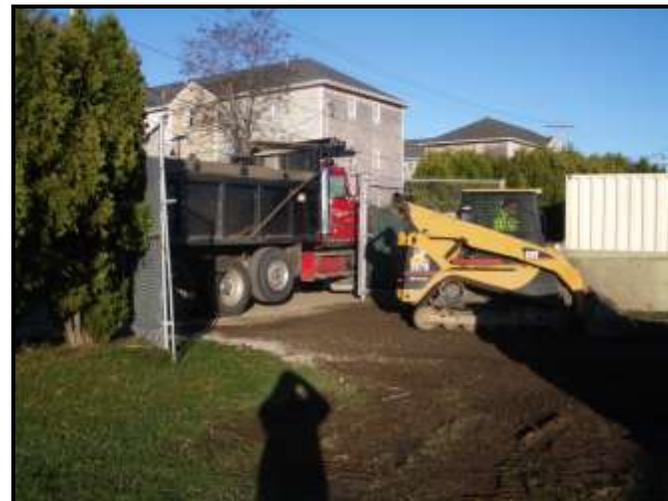
Photo 44 – Removal of Hunter Street access road (November 19, 2010).

Backfilling and restoration of the Varsity baseball diamond was completed on November 19, 2010 with the removal and regrading of the temporary access road. As previously noted, following laboratory analytical testing that material has been targeted for onsite reuse. Reseeding of the access road is scheduled for Spring 2011. Following excavation, TEI of Somerville, Massachusetts treated the stockpiled soil using Free Flow Technologies FF-100[®] stabilization material to fix metal concentrations (lead, arsenic) prior to off-site disposal. TEI used a loader to mix the material into the existing stockpiles concurrently with the excavation activities.
