Subject: LTMMIP Wetland Sediment Monitoring – Spring 2010
Keith Middle School, New Bedford, Massachusetts

<p>KEITH MIDDLE SCHOOL WETLAND NEW BEDFORD, MASSACHUSETTS</p>		<p>FIGURE 2</p>
<p>LTMMIP SEDIMENT MONITORING MAY 2010</p>		
<p>Wannancit Mills 650 Suffolk Street Lowell, MA 01854 (978) 970-5600</p>		
<p>DRAWN BY: HWB CHECKED BY: JBS</p>	<p>DATE: JUNE 2010</p>

SITE PHOTOGRAPHS
LTMMP Wetland Sediment Monitoring – May 17, 2010
Keith Middle School
New Bedford, Massachusetts

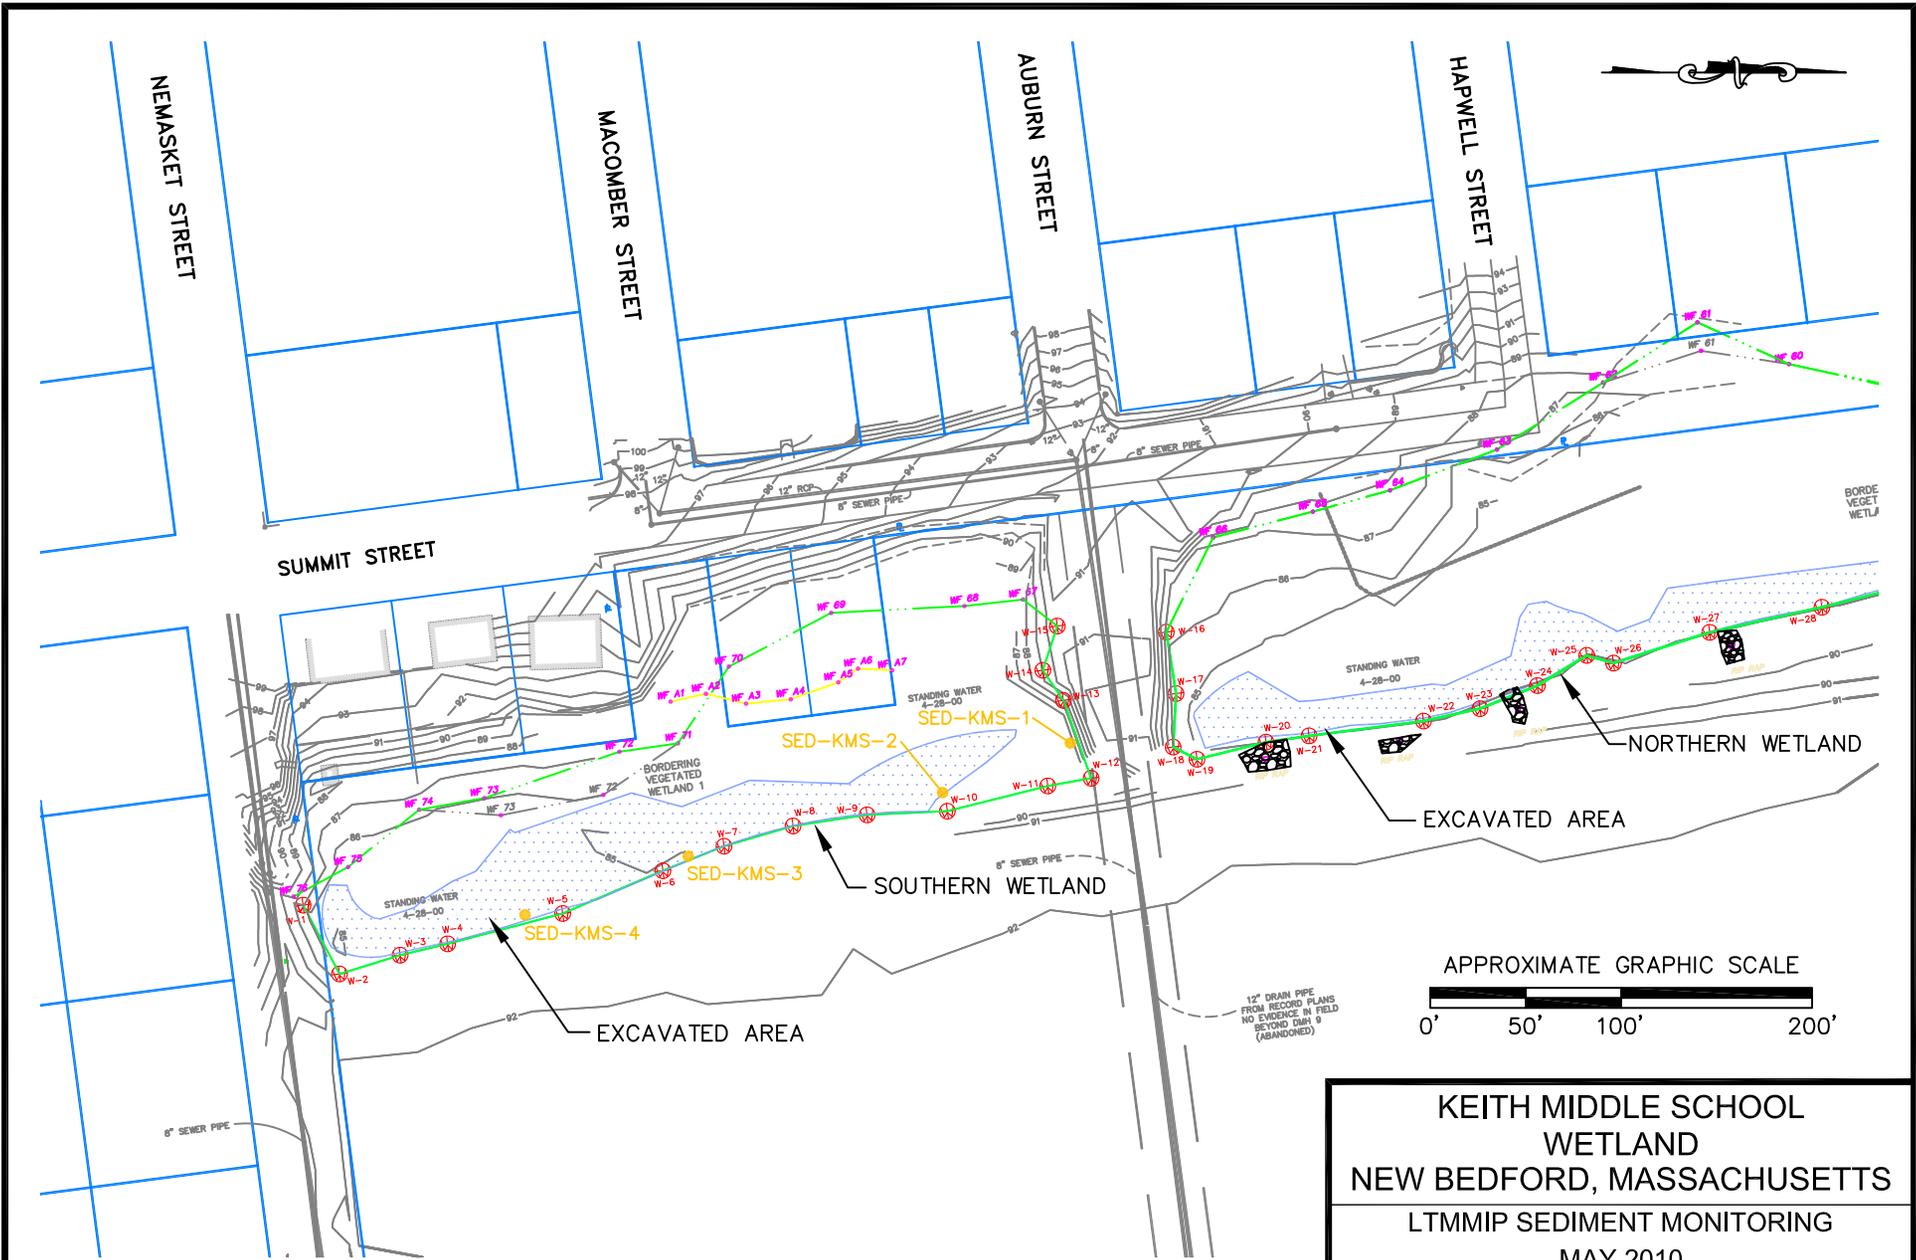
- LEGEND:
- SED-KMS-4 ● SEDIMENT SAMPLE (JUNE 2010)
 - W-11 ⊕ WETLAND BOUNDARY/FLAG
 - — — PROPERTY BOUNDARY

- SED-KMS-1 (Wetland Flag W-12)
- SED-KMS-2 (Wetland Flag W-10)
- SED-KMS-3 (Wetland Flag W-6)
- SED-KMS-4 (Biased sample from toe of slope below slope failure – collected in duplicate)

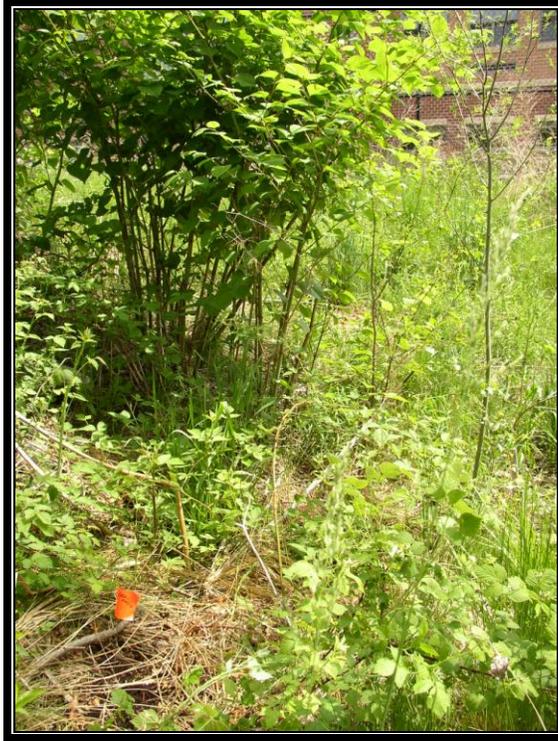
1) Sediment sample location SED-KMS-1 (view is east toward the KMS campus).

PCB Aroclors. Sediment sample SED-KMS-1 contained total PCB Aroclors at a concentration of 0.371 milligrams per kilogram (mg/kg), which is below the 1 mg/kg total PCB level previously approved for the wetland (and other site-related remedial activities) by the EPA as part of the Risk-Based Wetland Cleanup Request (BETA, 2005). Pursuant to the EPA approved LTMMIP, further assessment is not required.

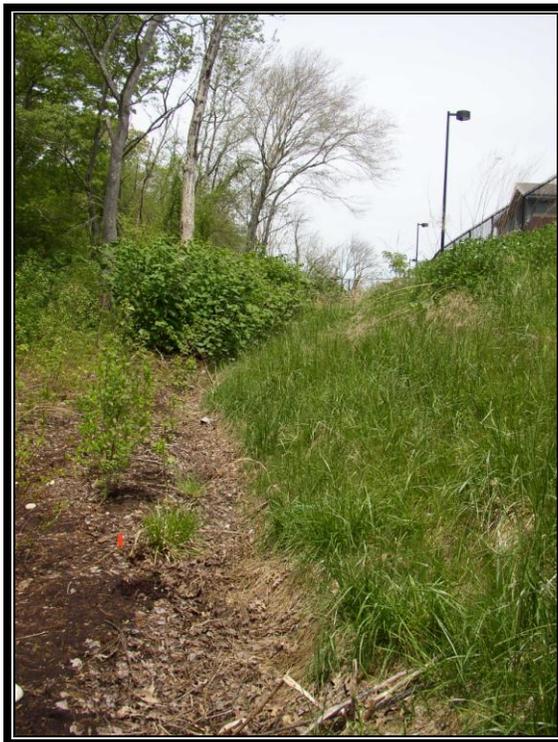
2) Sediment sample location SED-KMS-2 (view is north toward the land bridge).

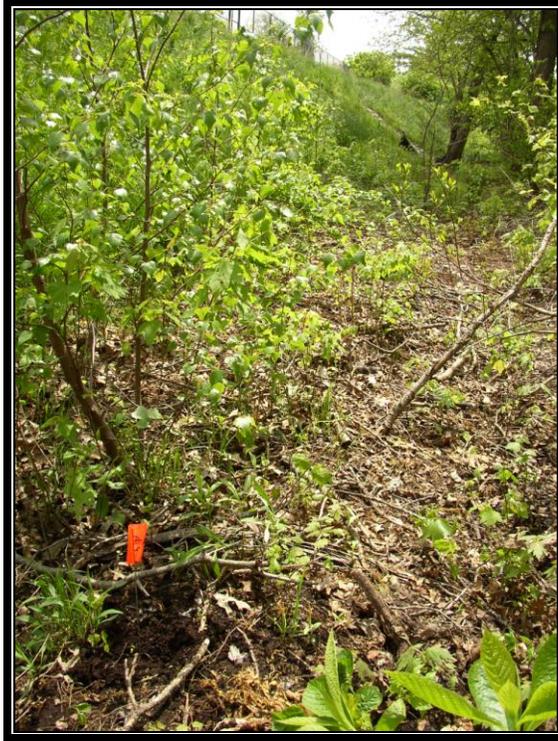
3) Sediment sample location SED-KMS-3 (facing south toward 2007 slope failure).

¹ In the spring of 2007, a slope failure occurred on the steep slope above the wetland near the southwestern corner of the Site. The area measured approximately 7 feet by 8 feet where the topsoil has slumped to the bottom of the slope. The black separation fabric that demarcates the underlying impacted fill from the clean imported fill was not exposed; however, a small (approximately 3 to 4 inch) piece of the orange warning layer was visible in the top left quadrant of the damaged area (when viewed from the wetland). TRC oversaw final repair of the failed slope on October 30, 2008. The repair consisted of lining the damaged area with an 8-ounce non-woven geotextile fabric and covering the fabric with stone (rip-rap) up to local grade to restore the protective cap thickness and allow flow of storm water through the slope in this area without pressure buildup. The rip-rap is intended to allow free drainage of water and be more resistant to the erosive force of storm water overland run off.

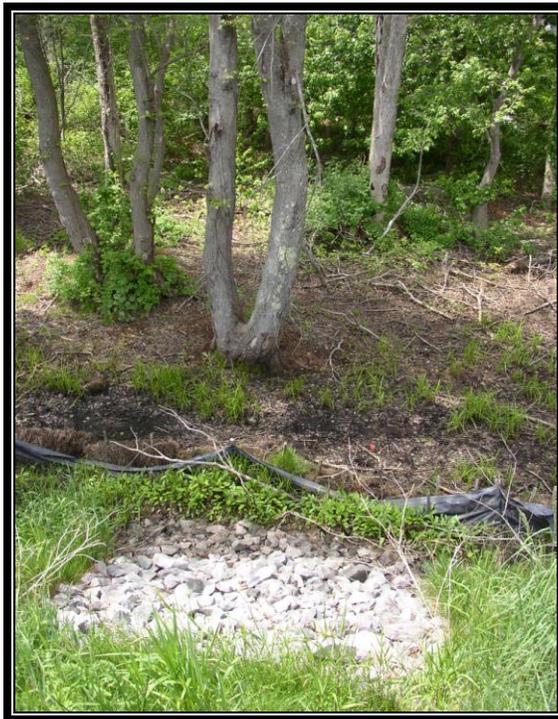
4) Sediment sample location SED-KMS-4 (viewed down the cap slope to the west).

Also with the concurrence of EPA, TRC collected one of the four sediment samples from a biased sample location at the bottom of the slope beneath the KMS Site cap slope failure along the southern portion of the wetland. The biased sample was collected to check on the potential for impacts to sediment associated with the 2007 slope failure¹. All samples were collected using hand tools and were collected from a depth of 0 to 6 inches below the top of the sediment surface. Samples were analyzed for PCB Aroclors via SW-846 Method 8082 by Northeast Analytical, Incorporated (NEA) of Schenectady, New York. The sampling locations, surveyed by Land Planning on June 1, 2001, are illustrated on Figure 2 and in the photograph log presented in Attachment 1. The samples were designated as follows (with approximate wetland flag or biased sample locations shown in parentheses):
