Re: **Building Demolition Plan**
Revere Copper Stone Building #16
New Bedford, MA

**Re: Documentation of Existing Structural Conditions
Revere Copper Stone Building #16
New Bedford, MA**

PHOTO LOG – STONE BUILDING CONDITIONS

Photo Log – Stone Building Conditions – July through December 2014

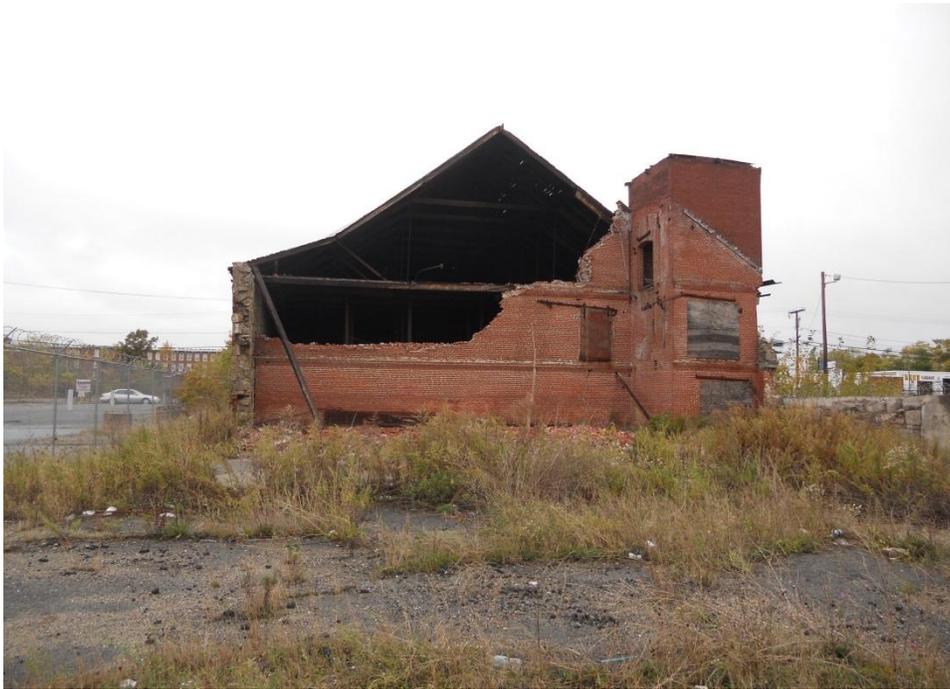
1. The partially collapsed brick wall at the eastern end is unstable, as it is unsupported at the top and exhibits severe buckling approximately one (1) foot above its base.

Photo #1 – View of Stone Building in September 2014. Note partial collapse of exterior wall

construction personnel and/or extraordinary expense, demolition of the Stone Building is necessary in accordance with the Massachusetts Building Code, IBC Section 116 and IEBC Section 115 and 117. Consequently, our recommendation is that the Stone Building be demolished as soon as possible.

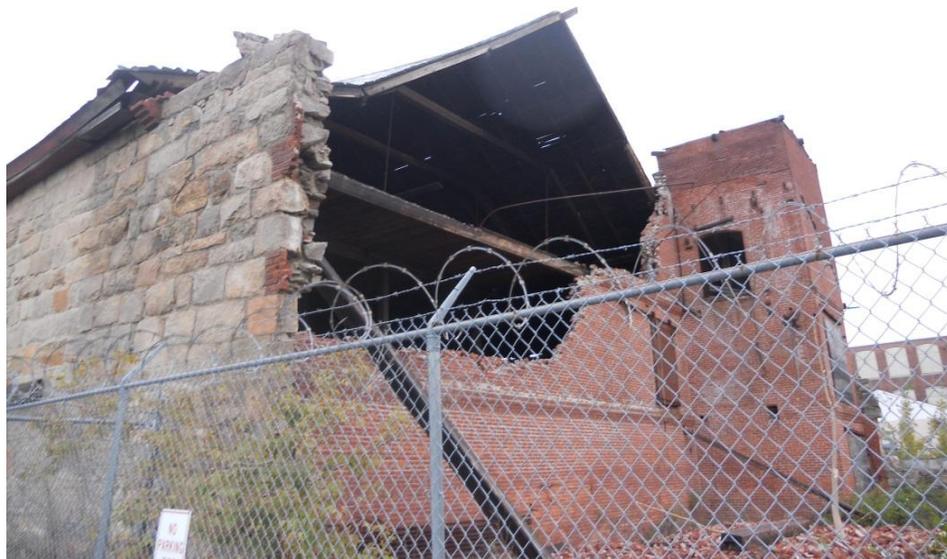
2. The eastern end of the roof is unsupported, since the aforementioned brick wall had collapsed. As a result, it is thrusting against the eastern end of the southern brick and granite wall and pushing it outwards. The brick and granite wall is also unsupported.

3. The unsupported roof structure is imparting potentially excessive loads to the next interior truss frame. Should the next truss frame fail, a progressive collapse is likely.

Photo #2 – View of eastern side of Stone Building. Note buckling of roof

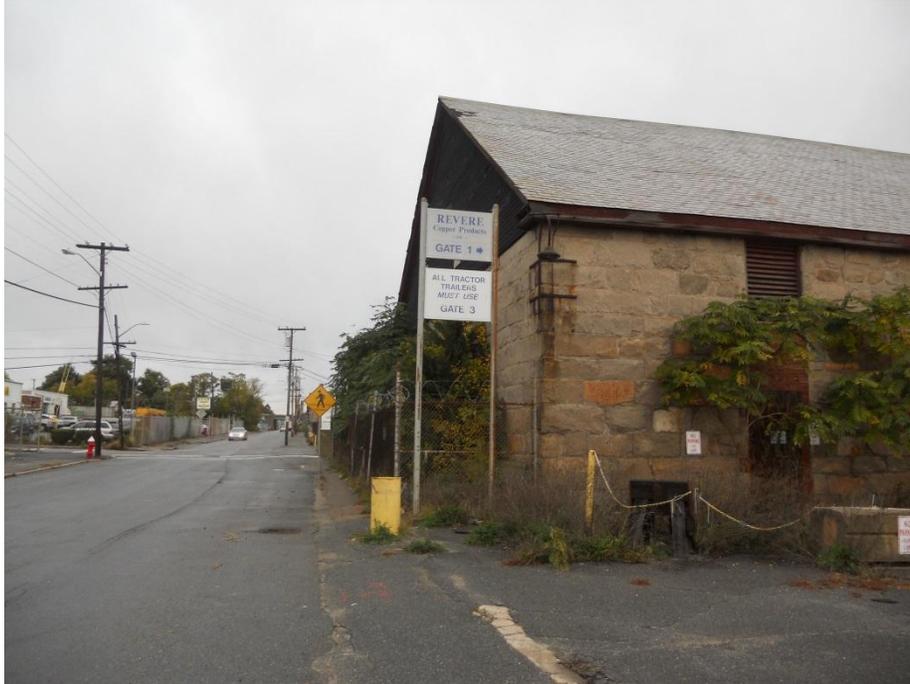
6. Due to corrosion and ongoing freeze thaw damage, many of the slate shingles are not physically attached to the building and are free to become airborne.

Photo #3 – View of western side of Stone Building. Note missing slate shingles on roof

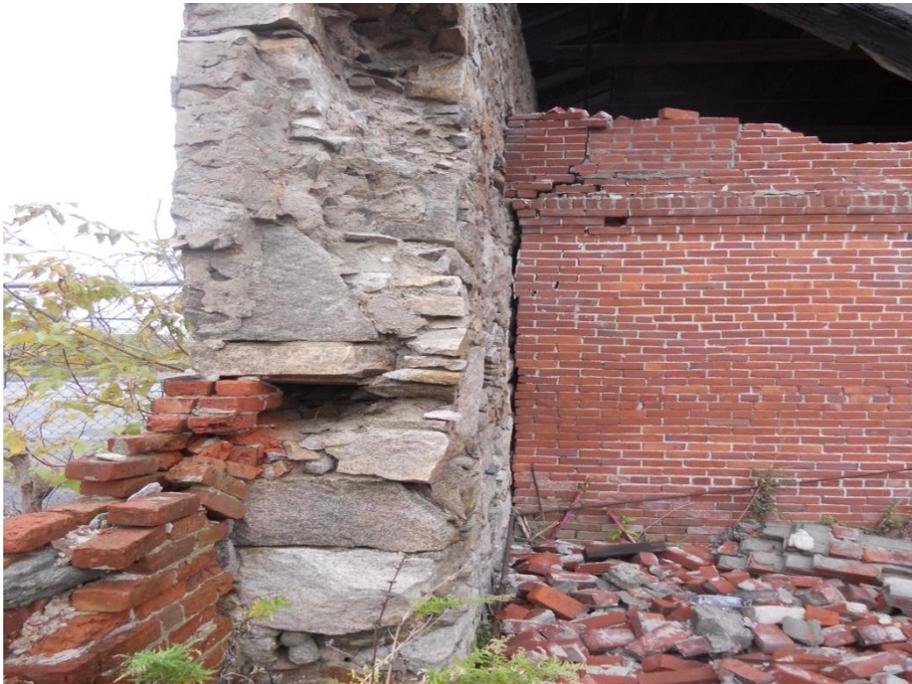
Photo #4 – View of eastern wall of Stone Building. Note gap between brick and masonry walls

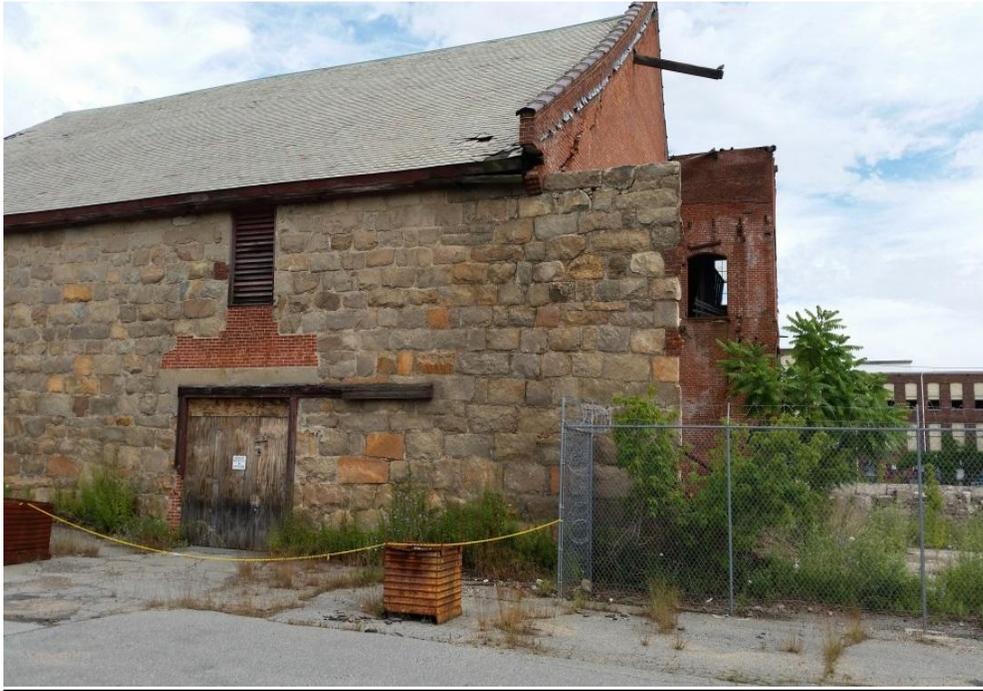
A Photo Log depicting the current condition of the Building is included as Attachment 3. As indicated on the photo log, the condition of the Building is deteriorating. Refer to Page 3 of the Photo Log for a comparison of the Building condition in July 2014 and in December 2104.

Photo #5 – Condition of Stone Building in July 2014

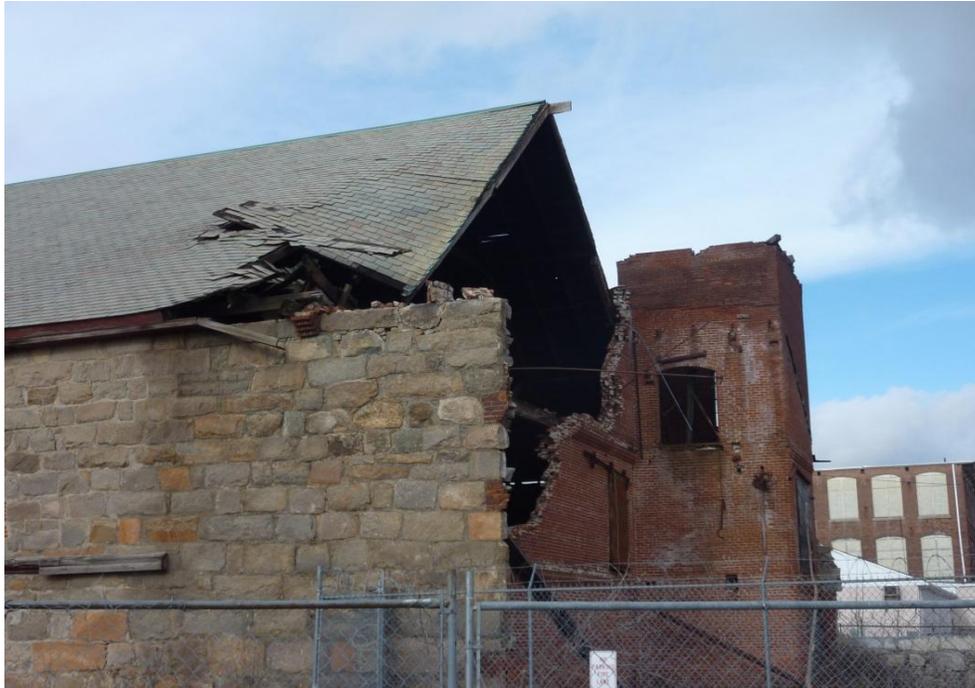
Condition of Stone Building in December 2014
