**New Bedford Regional Airport  
Runway Safety Improvements Project – Phase 4  
Reconstruct, Mark, and Groove Runway 5-23  
MassDEP File No. SE049-0635**

**ENVIRONMENTAL MONITOR INSPECTION FORM**

Date/ Time of Inspections: **5/22/14 (10am to 4pm), 5/29/14 (10am-4pm)**

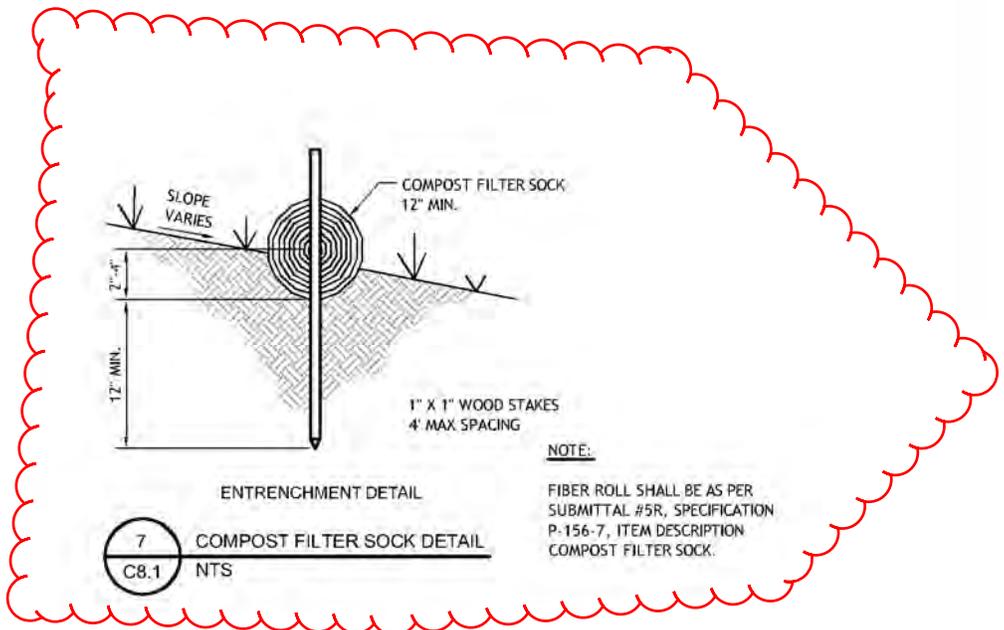
7 COMPOST FILTER SOCK DETAIL  
C8.1 NTS

NOTE:  
FIBER ROLL SHALL BE AS PER  
SUBMITTAL #5R, SPECIFICATION  
P-156-7, ITEM DESCRIPTION  
COMPOST FILTER SOCK.
