Re: Independent Observer's Monthly Report, Time Period: May 1 to May 31,
2014, New Bedford Regional Airport Safety Improvements Project
DEP File No. SE 049-0635

GZA GeoEnvironmental Inc.	REPORT NO: 41 DATE: May 1, 2014	Page 1 of 7
	PROJECT No: 15.0166235.30	
	LOCATION: New Bedford Regional Airport New Bedford, MA	
	PHOTOS: 1-10

**PROJECT: Reconstruct, Mark and Groove Runway 5-23, DEP File #SE-049-0635,
NHESP File No. 96-0737**

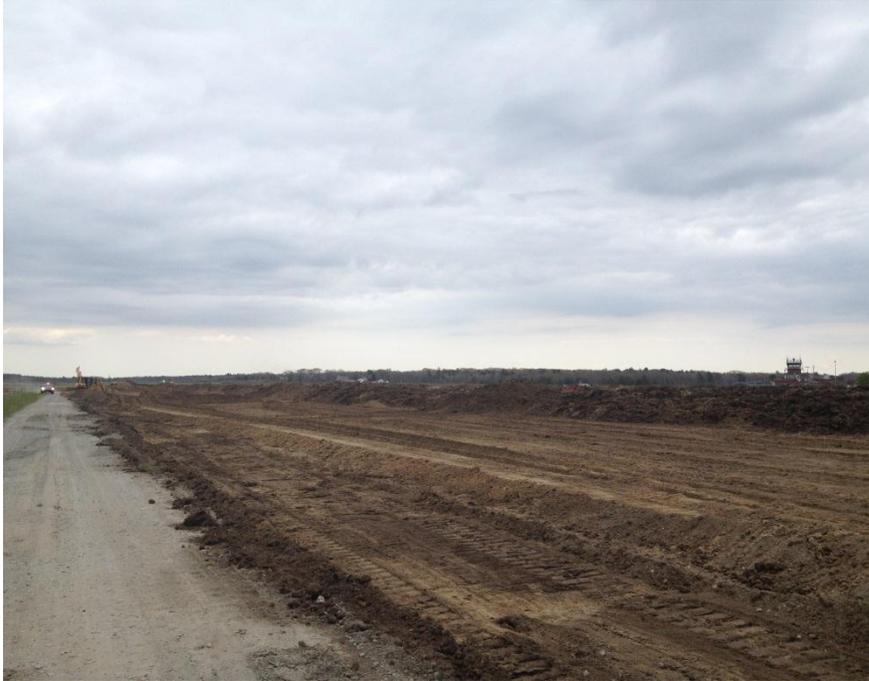
View Facing: Northeast

Photo 1: Stripping and loaming operations continue on RW 5-end.

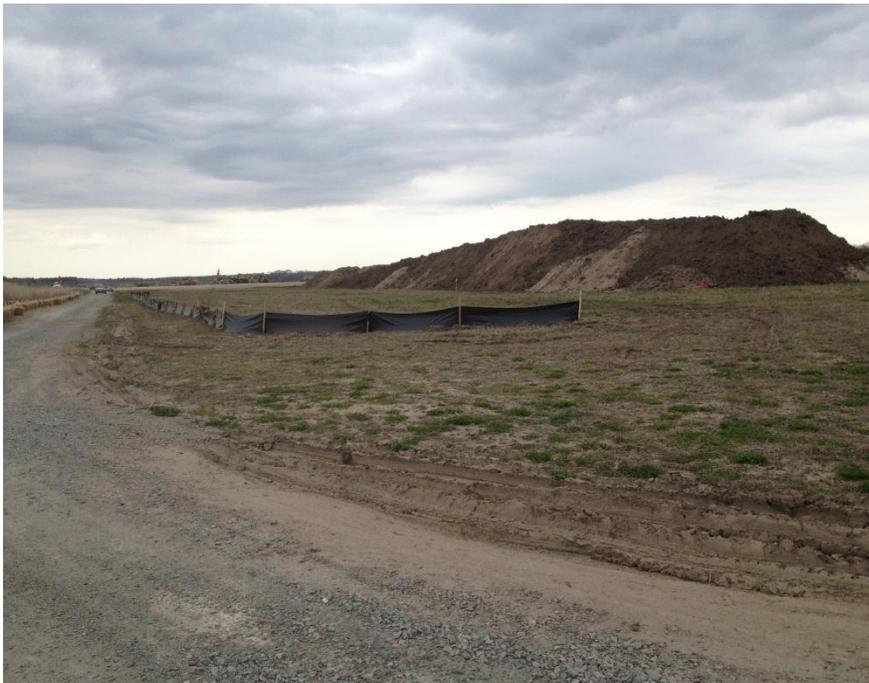
View Facing: Northeast

Photo 2: Stockpiles of loam from stripping operations in RW5-RSA are 100' off of the runway.

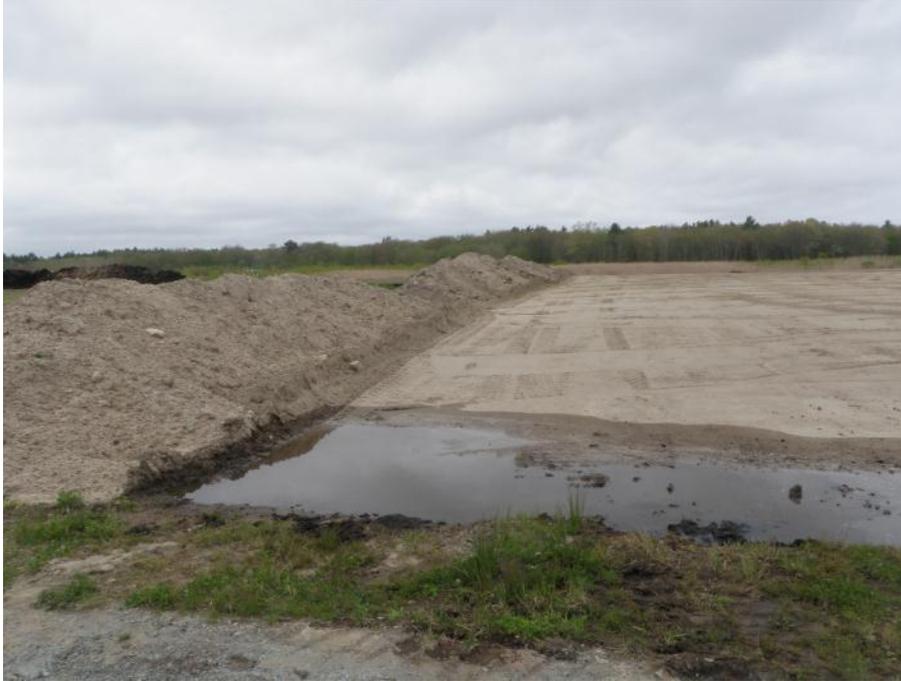
View Facing: West

Photo 1: The subgrade of the new RW 5-end is complete per the WS.

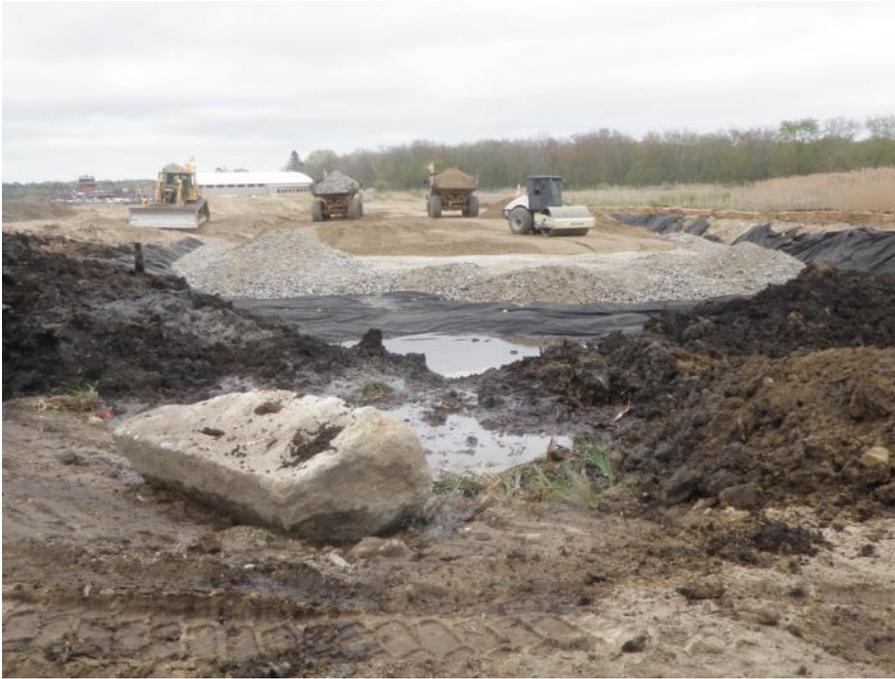
View Facing: Northeast

- Two areas of erosion were evident northeast of the temporary road; although no evidence of sedimentation was observed on the down gradient side of the road (**Photo 8**).
- The Contractor has placed geotextile fabric under a portion of the Taxiway A extension and was placing layers of graded stone on the fabric to achieve the design grade (**Photo 9**).
- The Contractor was continuing to strip topsoil from the RW23-End in preparation of the new RSA grading (**Photo 10**).

Photo 9: The Contractor has placed geotextile fabric under a portion of the Taxiway A extension and was placing layers of graded stone on the fabric to achieve the design grade.

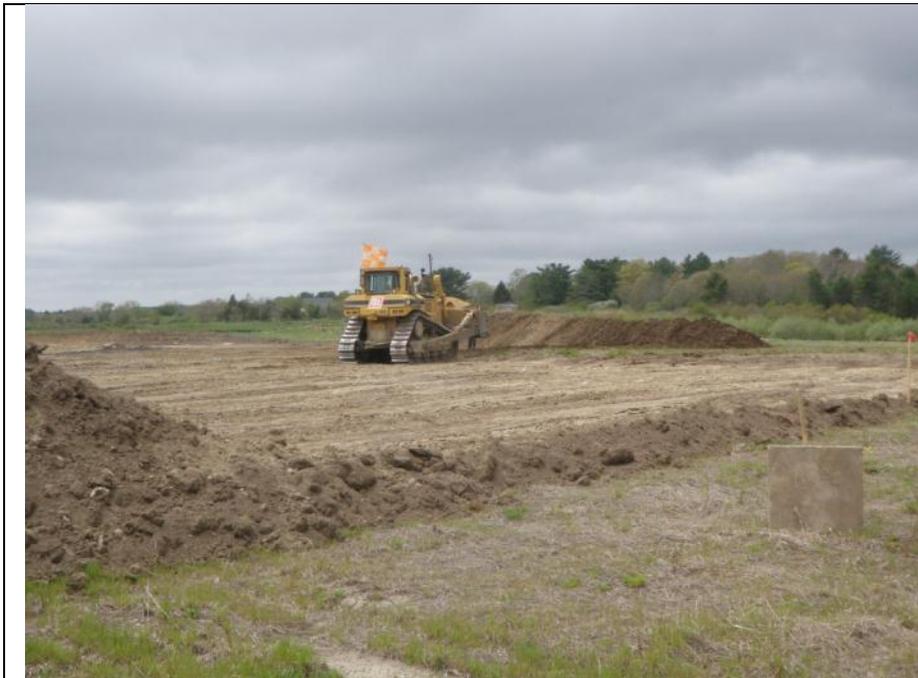
View Facing: West

Photo 10: The Contractor was continuing to strip topsoil at the RW23-End in preparation of the new RSA grading.

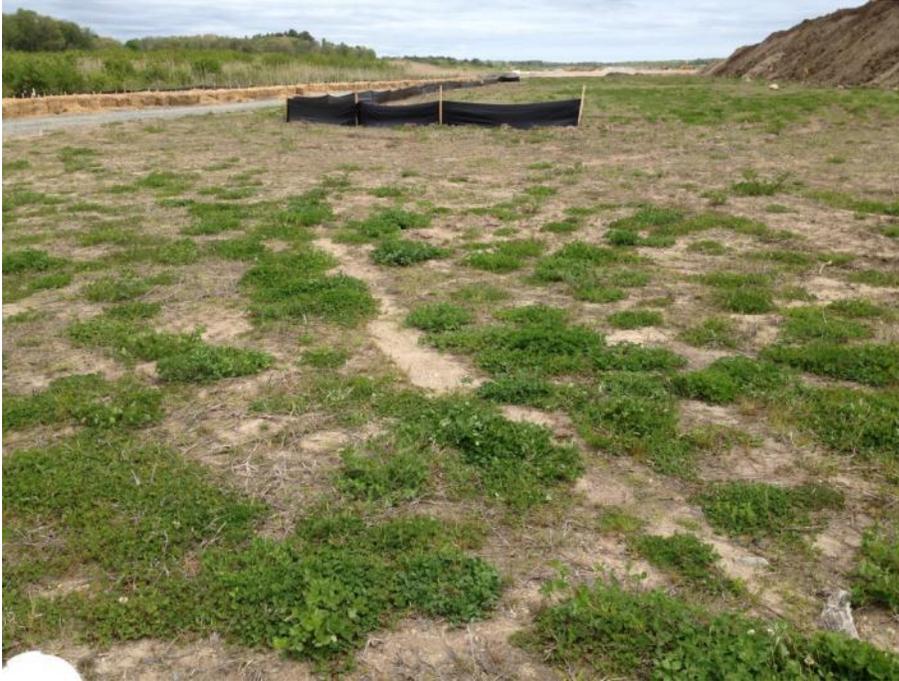
View Facing: Northeast

<u>Phase 4 Observations: May 22, 2014</u>		
<u>RW 5 RSA and Proximity</u>		
<ul style="list-style-type: none">• The IO had a field discussion with the WS and EM regarding the use of additional erosion controls that could be configured in a half-moon shape in the vicinity of the existing silt fence in the work area of the RW5-End of the runway. The location would be similar to where the contractor of a previous phase of the project placed additional straw wattles (Photo 1). The grading associated with the infiltration trench appears to have helped alleviate some of the water ponding on the haul road that runs along the West Ditch.• The stockpile of unsuitable material did not have a perimeter barrier around it at the time of the inspection.		
<u>West Ditch</u>		
<ul style="list-style-type: none">• The plants in the restoration area that were impacted by Contractor activities have been flagged with green tape for monitoring purposes. Some plant appeared to be surviving and leafing out, while other individuals appeared to be in distress (Photo 2). The EM is monitoring these individuals.• Contractors are preparing an area east of the West Ditch (Photo 3) for the installation of drainage infrastructure by staging the reinforced concrete culverts and sandbags for during construction water management near the relevant location (Photo 4a and 4b).

Photo 1: There were on-site discussions regarding a possible recommendation to place a half-moon shaped silt fence in the approximate location of straw wattles from a previous phase of the project on 5-end.

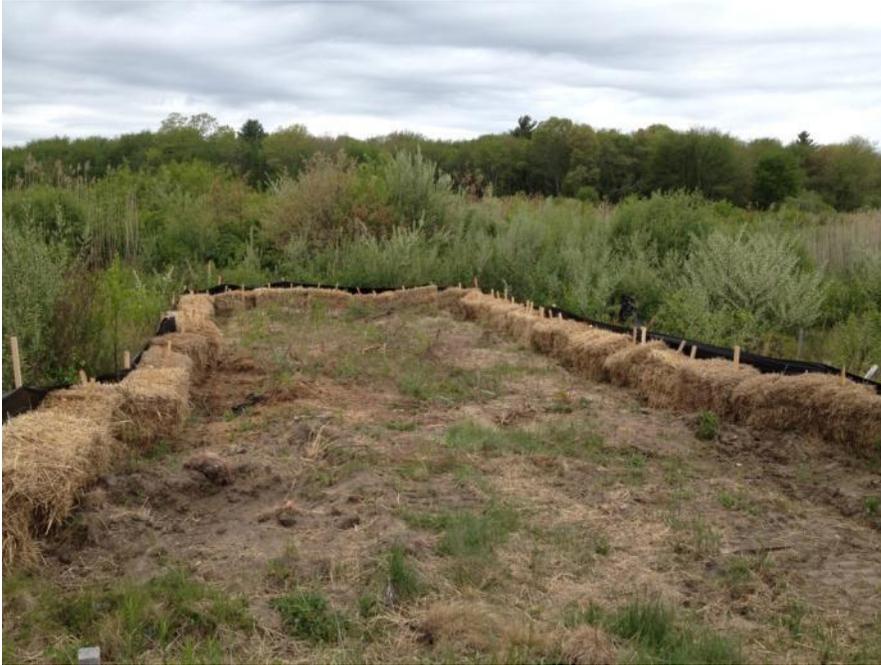
View Facing: West

Photo 3: The drainage plan for the 5-end requires the installation of a concrete headwall in this location.

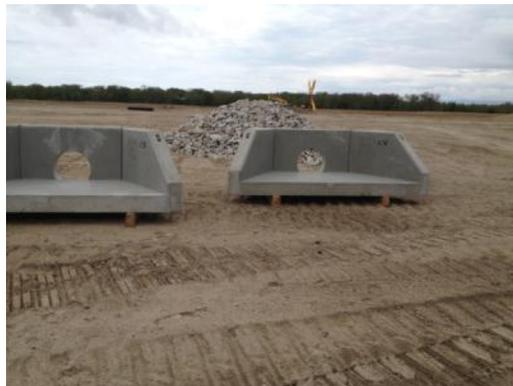
View Facing: North

Photo 4a: Concrete headwalls to be installed on the RW5-End.

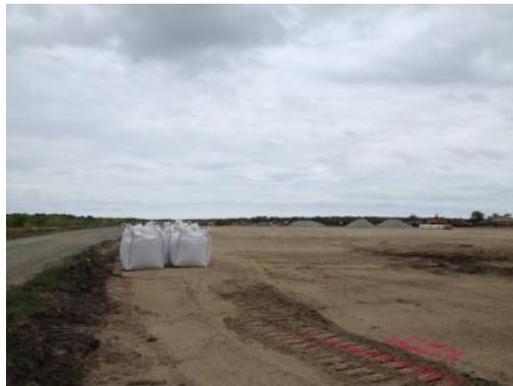
Facing: Northeast

Photo 4b: Sandbags will be employed for water management, if necessary, during work associated with installation of the drainage outflow system on the RW5-End.

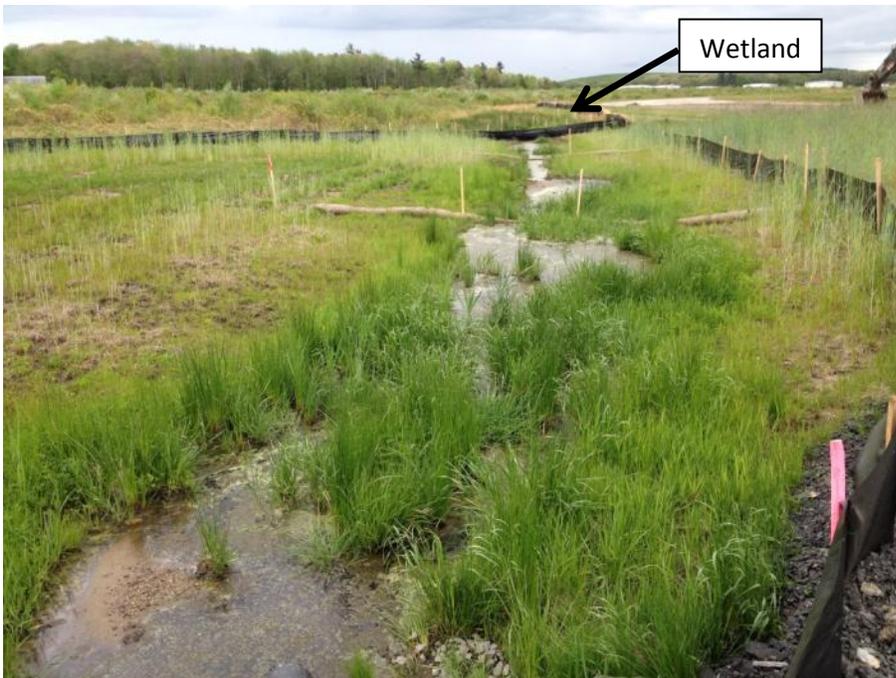
Facing: Southeast

- The WS reported that there appears to be groundwater seeping into the site on the RW 23-End and a berm was constructed to keep water from ponding on the access road and outside of the wetland; however, a machine ran over the berm and flattened the grade closest to the inlet side of the cross culverts (**Photo 7**).
- The infiltration trench continues to receive water but no evidence of sedimentation was observed in the wetland on the down-gradient side of the road (**Photo 8**).
- The water control truck applied water to the Runway 23 work area during the sit einpection.

Photo 8: A temporary infiltration trench was constructed on RW23 during a previous phase of the project and is being used for stormwater management during work on the RW23-End.

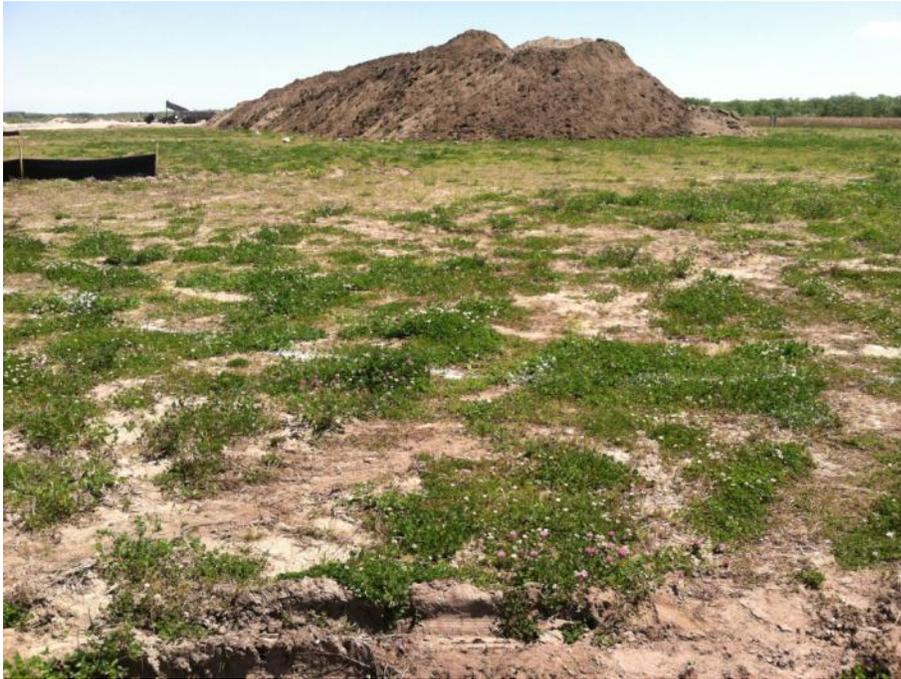
View Facing: East

- GZA had in field discussions with EM and WS representatives concerning WS proposal to install an additional 300+ feet of silt fence on the infield side of haul road at the southwest corner of the RW5-End, this area has been laid out with spray paint (**Photo 1**).
- The infiltration trench has begun to be installed along the whole of Runway 5 (**Photo 2**).
- Turtle gate locations have been laid out in various locations along the entire stretch of silt fence at the airport (**Photo 3**).

Photo 1: Area by RW5-End gravel access road where additional silt fence has been proposed to be installed by EM & WS.

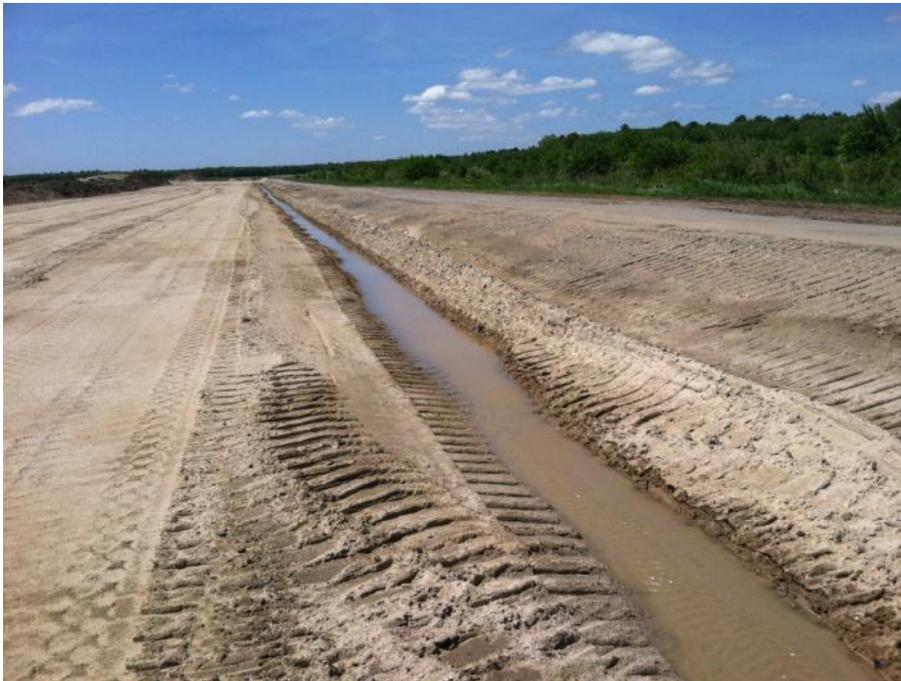
View Facing: Southwest

Photo 2: The infiltration trench is being graded along the length RW5.

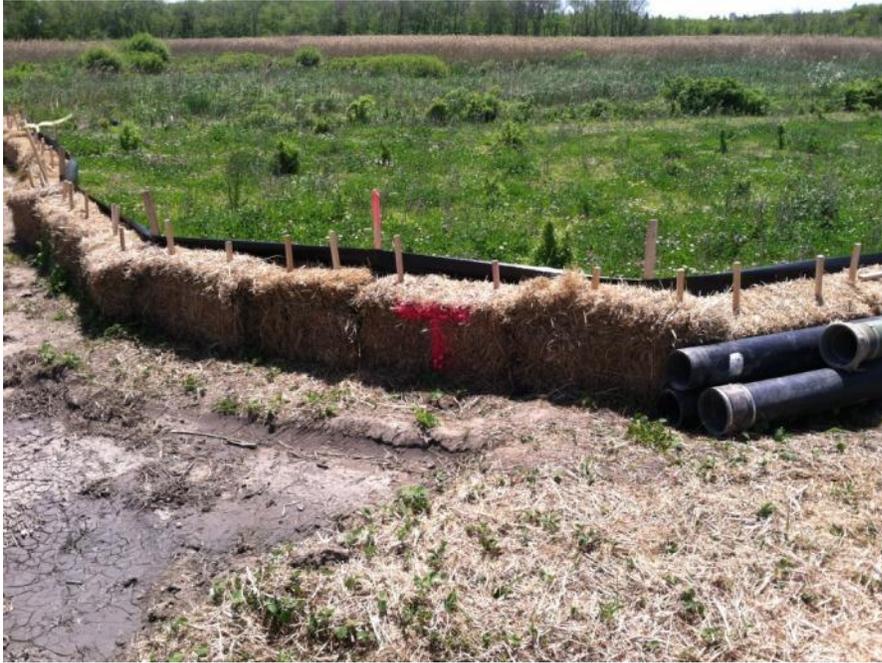
Photo 3: Turtle gate locations have been laid out in various locations along the entire stretch of silt fence at the airport.

This picture is an example at the RW5-End.

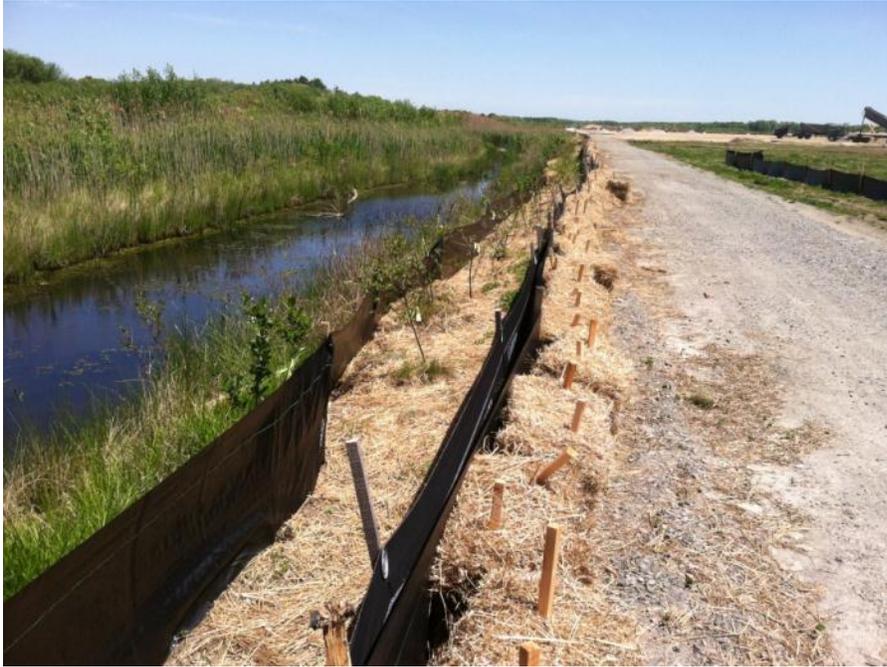
View Facing: Northeast

- The EM/WS indicated that currently 55 shrubs along the West Ditch had been damaged and two are currently dead. The EM stated that a true count will occur in August when enough time has elapsed to fully be able to gauge recovery (**Photo 4**).
- The West Ditch Restoration Area remains stable (**Photo 5**).

**Photo 5: West Ditch
Restoration Area stable.**

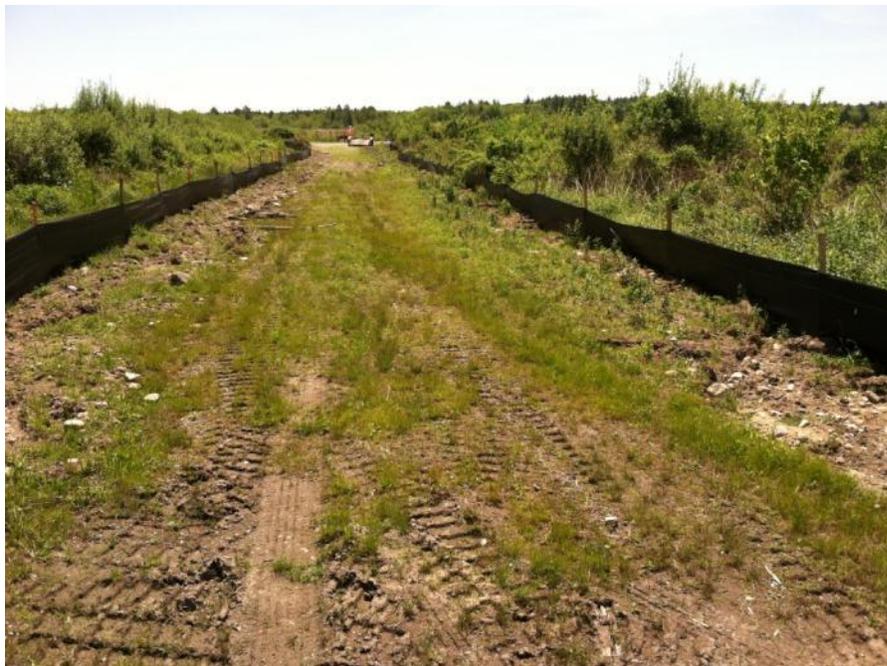
View Facing: Southwest

- Silt fencing was being installed along the ILS road and a depression was made on the ground surface in preparation for the installation of the filter socks as approved by DEP (**Photos 6 and 7**).
- The bog mat road that was part of the previous Phase of work and located northwest of the ILS road showed signs of vegetative recovery (**Photo 8**).

**Photo 6: Subcontractor
installing silt fence along
ILS road.**

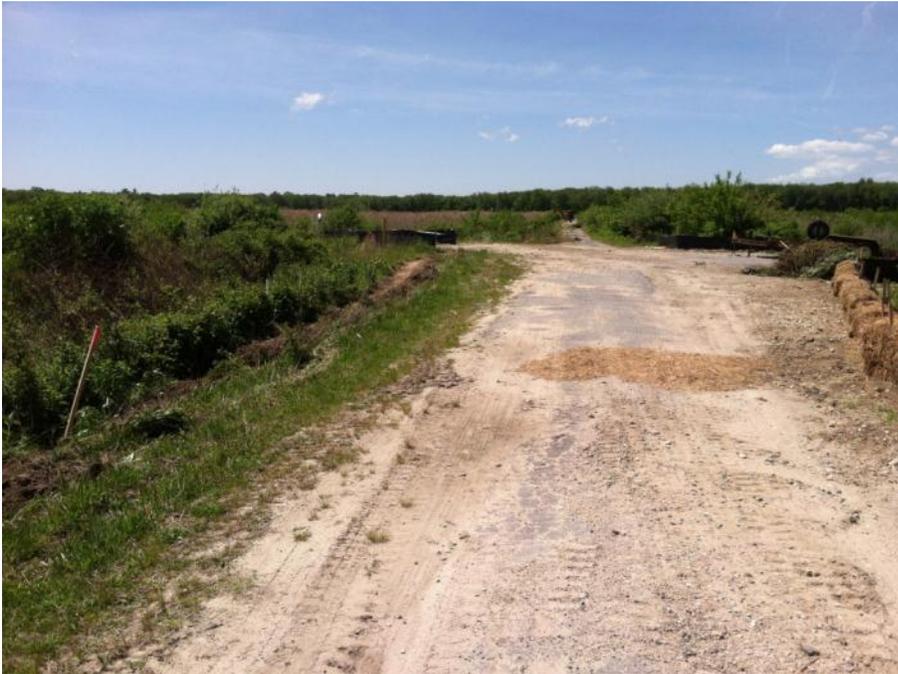
View Facing: Southwest

Photo 7: Subcontractor has cleared vegetation (on left) and installed a depression for the installation of the filter socks along ILS road.

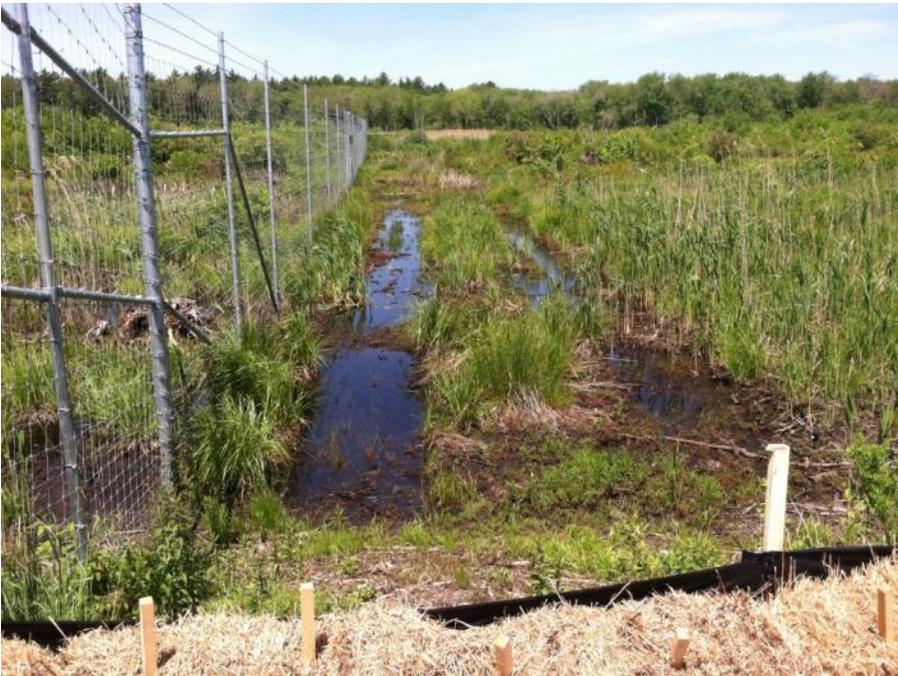
View Facing: Northeast

Photo 8: Bog mat road from previous phase still recovering, vegetation is clearly growing back, area perpendicular to wildlife fence south of the RW5-End.

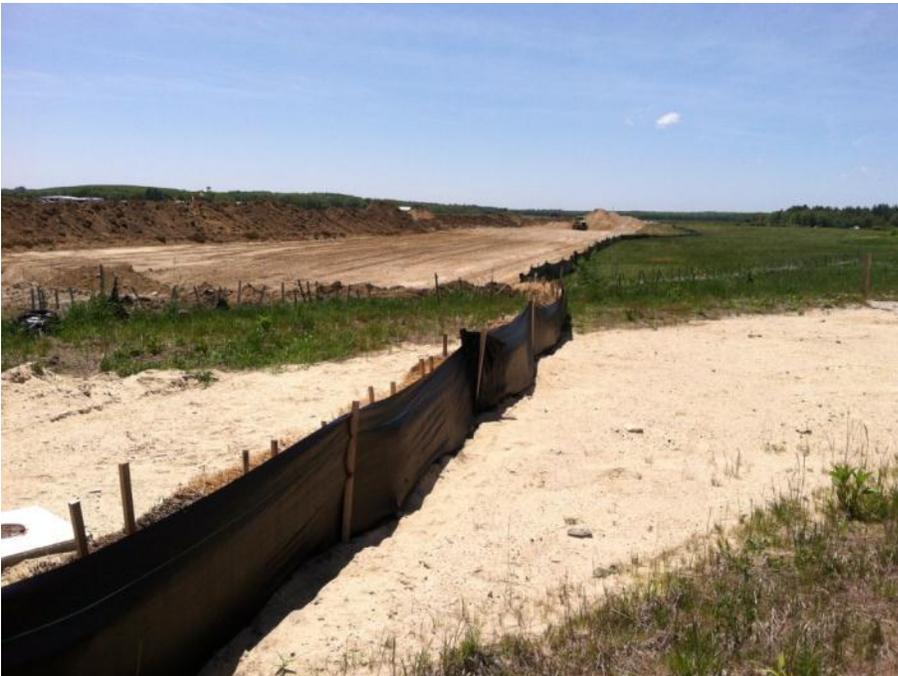
View Facing: Southeast

Photo 10: Excavation is complete to subgrade on RW23-End.

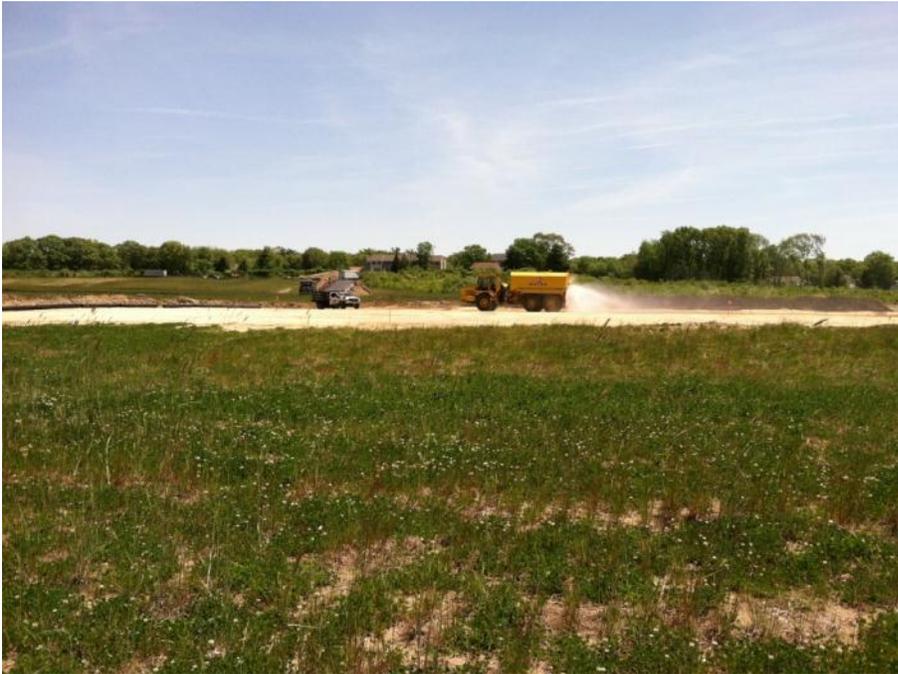
View Facing: East

Photo 11: Spraying of water for dust control by contractor is ongoing at the RW23-End.
