NB Airport Site Photos

July 5, 2014

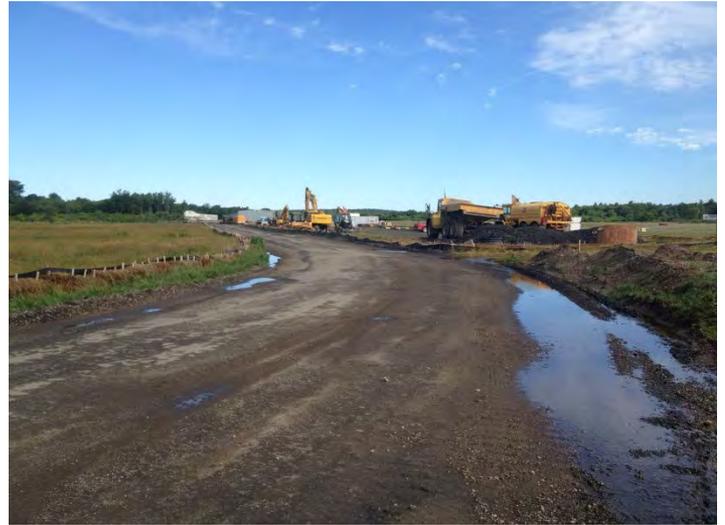
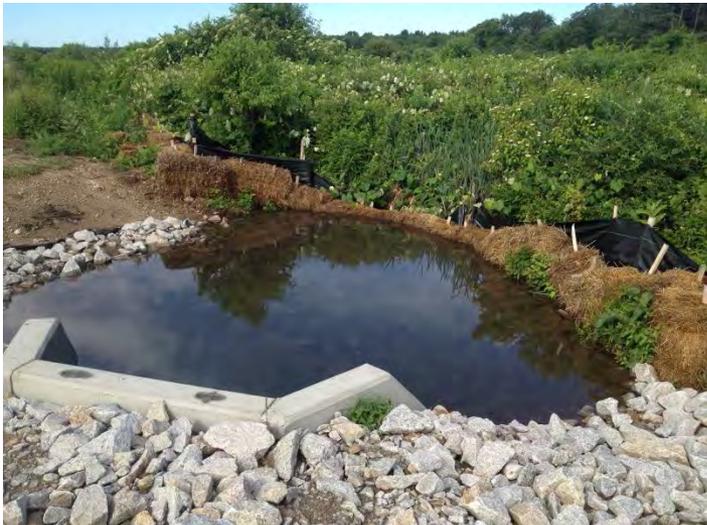
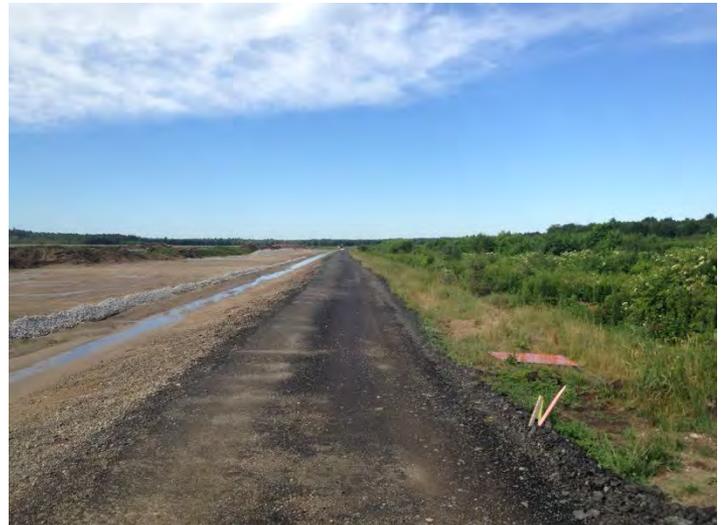
Rollers and equipment should be removed from flooded areas as soon as conditions allow. Confirm that there was no leaking of fuel or oils.

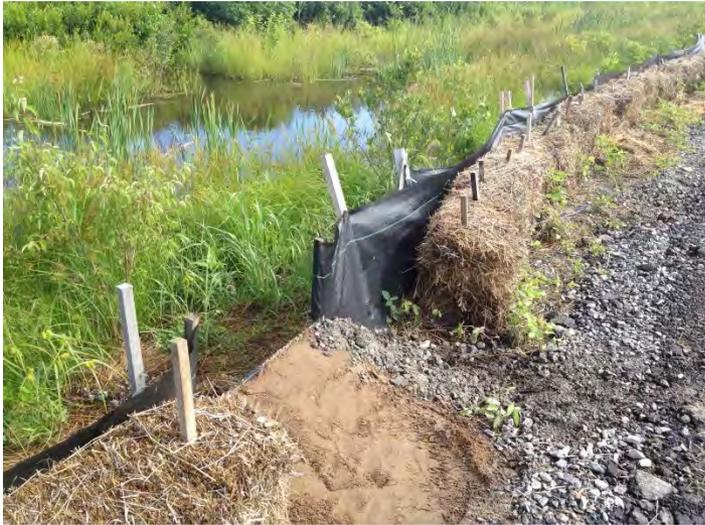
This view is where the access road turns the corner away from the West Ditch; could not access as road was under water. Please inspect and repair erosion controls as soon as conditions allow. Road may require additional stabilization measures.

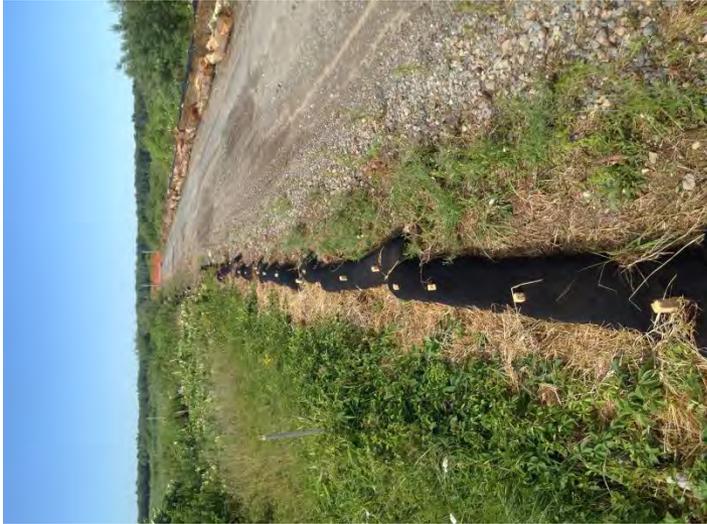
Typ. view of controls at one of the MALSR light stations that will need to be repaired before work commences in these locations.
