August 11, 2014

Subject: New Bedford Regional Airport – Phase 4
Reconstruction, Mark and Grove Runway 5-23
Re: Silt Fencing Issue – West Ditch Monitoring

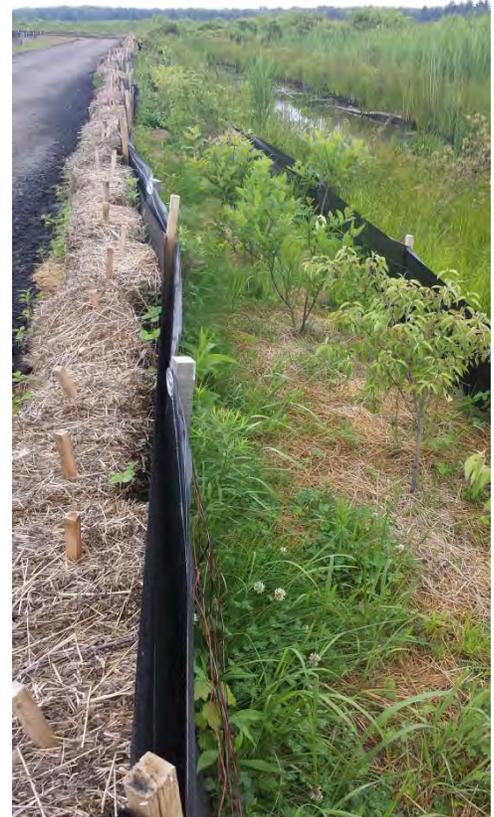
All areas are vegetated or stabilized with hay mulch. 53 of the 55 shrubs are alive.

The area is stable and no further remedial actions are recommended with the exception of replacing the 2 dead shrubs.
