NEW BEDFORD REGIONAL AIRPORT
RUNWAY 5-23 – PHASE 4

Reconstruct, Mark, and Groove

Weekly Environmental Report

WEEK 22

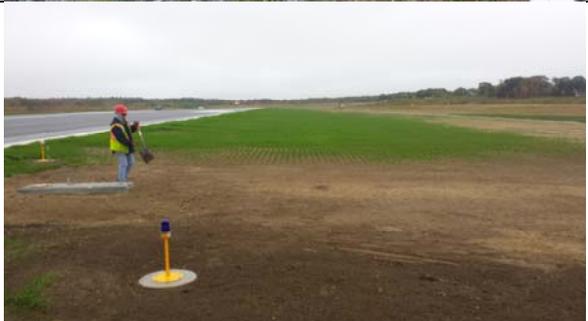
<p>ETL continues to do final touch up on loaming.</p>

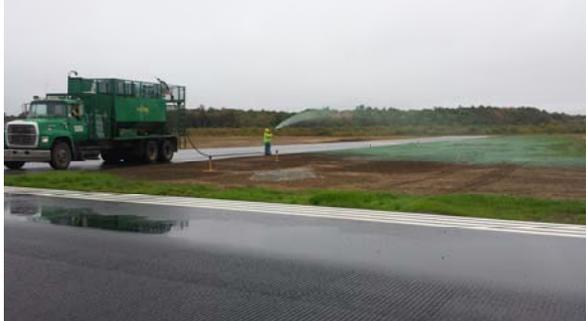
<p>MON Landscaping was on site to over-seed and reseed areas that required second applications.</p>

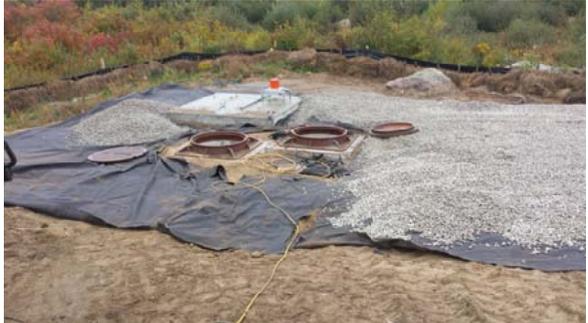
<p>The electricians continue to work on the lighting across New Plainville Road RW 23 ILS. Stone aprons were placed around the new concrete structures and man-holes.</p>

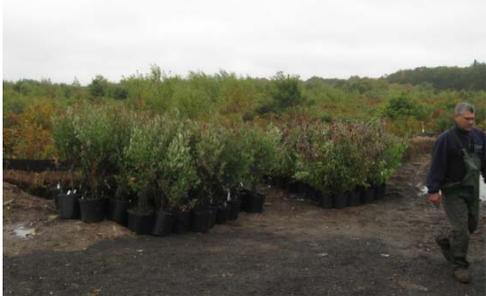
<p>Mitigation Area: The wetland shrubs were delivered this early am. The shrubs were counted one by one by the EM (Armanda) as they were unloaded from the truck. The shrubs were then separated and grouped by individual species.</p>

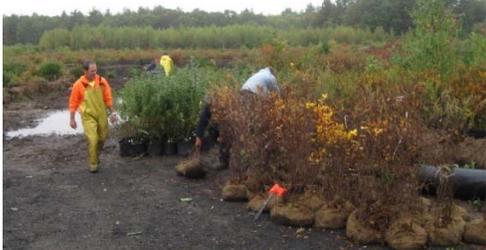
<p>Mitigation Area: A close inspection was made of each species to assess the quality of the wetland shrubs. Additional counting and recounting was completed to assure that the order had been correctly filled. The quality of the plants fulfilled expectations.</p>

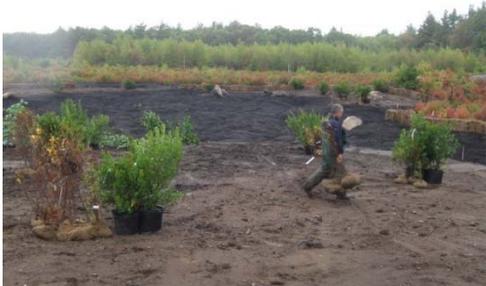
<p>Mitigation Area: MON was directed to install the wetland shrubs in groupings of approximately ten (each made up of three individual species). These groupings were placed throughout the wetland.</p>

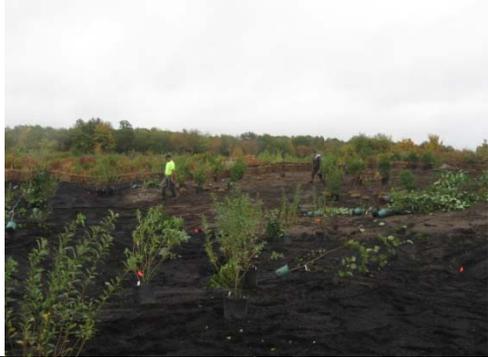
<p>Mitigation Area: In the pit and mound area, each groupings of approximately ten wetland shrubs were placed around the individual pits.</p>

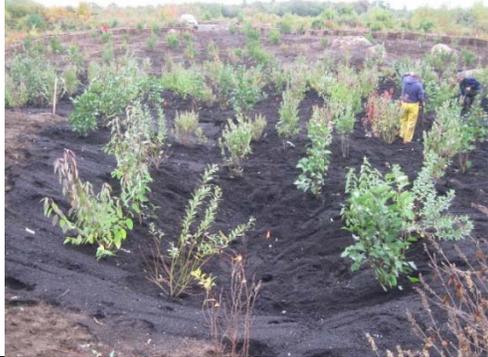
<p>Mitigation Area: JM Fiske then positioned the individual wetland shrubs on the inside edge of each pit. Careful preparation of the wetland topography and elevations at the mitigation area assured that the plants were positioned based on their individual water needs.</p>

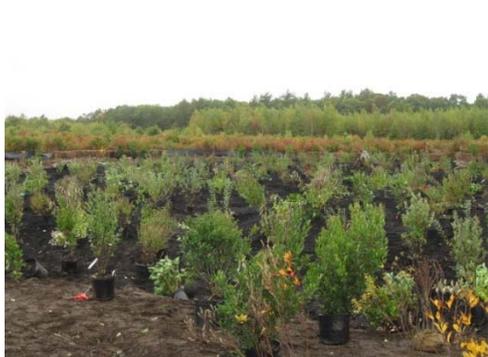
<p>Mitigation Area: JM Fiske continued to position the wetland shrubs adjusting the spacing and density at each pit area. Here the wetland shrubs have been placed, but not yet planted. The spotting of the 560 individual shrubs was completed at around 1 pm.</p>

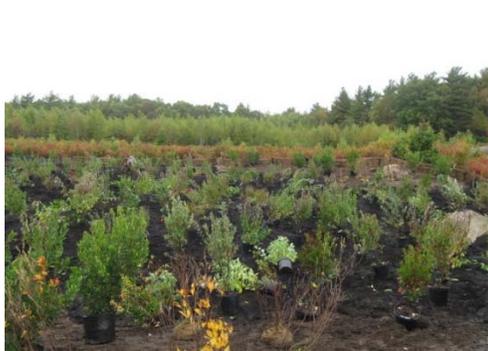
<p>Mitigation Area: Planting did not begin until all the wetland plants were spotted to assure proper spacing and densities.</p>

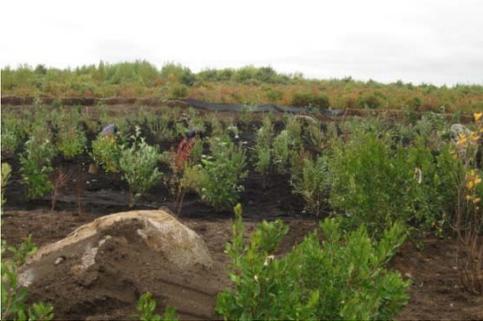
<p>Mitigation Area: Afterwards the variety of the shrubs were planted. Direct supervision was provided by JMFiske to assure proper care and planting technique.</p>

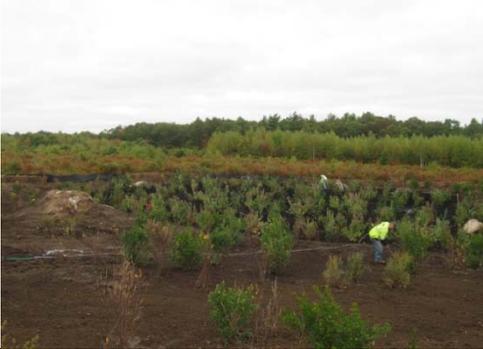
<p>Mitigation Area: The planting was finished around 3:30 - 3:45 pm. Overall results were excellent.</p>

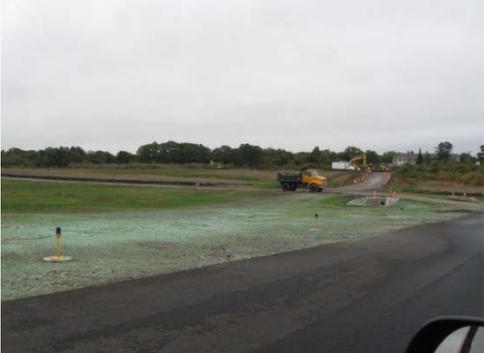
<p>RW 23; Additional areas on each side of the runways have been hydroseeded.</p>

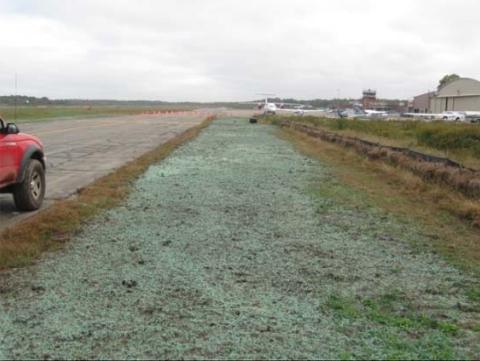
<p>Tawiway A at RW 5; Southside: Hydroseeding of newly loamed areas.</p>

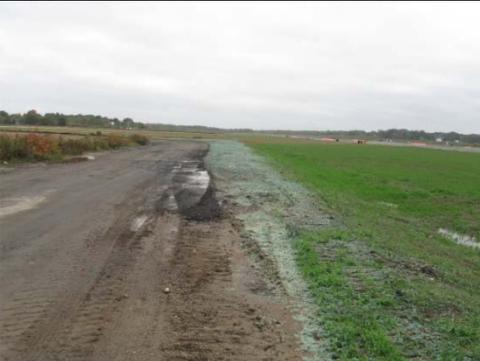
<p>RW 5; Adjacent Access Road: Hydroseeding of newly loamed areas.</p>

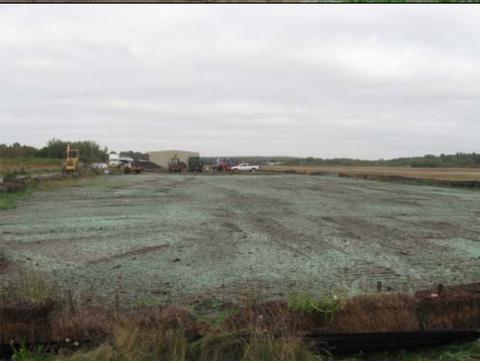
<p>RW 5; Parking and Equipment Area: This area had been re-loamed and hydroseeded.</p>

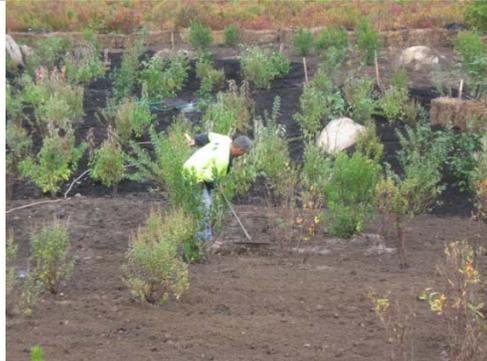
Mitigation Area: MON fine rakes the entire mitigation area to remove the footprints from yesterday's installation

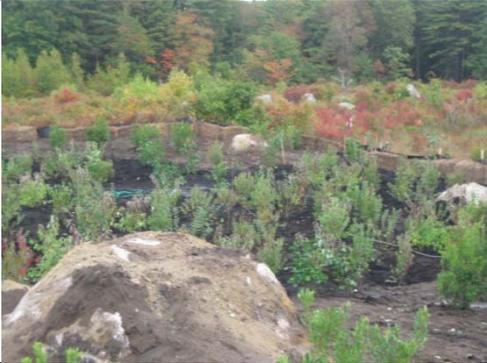
<p>Mitigation Area: Boulders supplemented or added to enhance overall habitat value. Woody debris will also be placed on the wetland surface.</p>

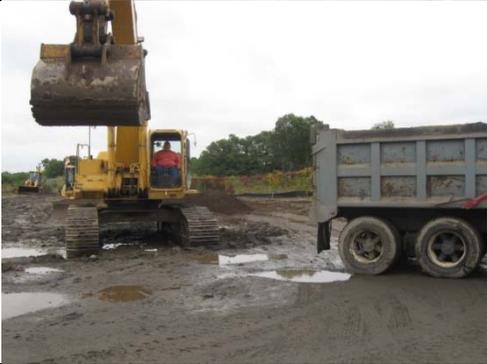
<p>RW 23 Side; Previous Parking and Equipment Area at Head of Access Road: Loam being installed.</p>
