**New Bedford Regional Airport  
Runway Safety Improvements Project – Phase 4  
Reconstruct, Mark, and Groove Runway 5-23  
MassDEP File No. SE049-0635**

**ENVIRONMENTAL MONITOR INSPECTION FORM**

Date/ Time of Inspections: **9/25/14 (morning), 10/2/14 (morning), 10/9/14 and 10/15/14.**

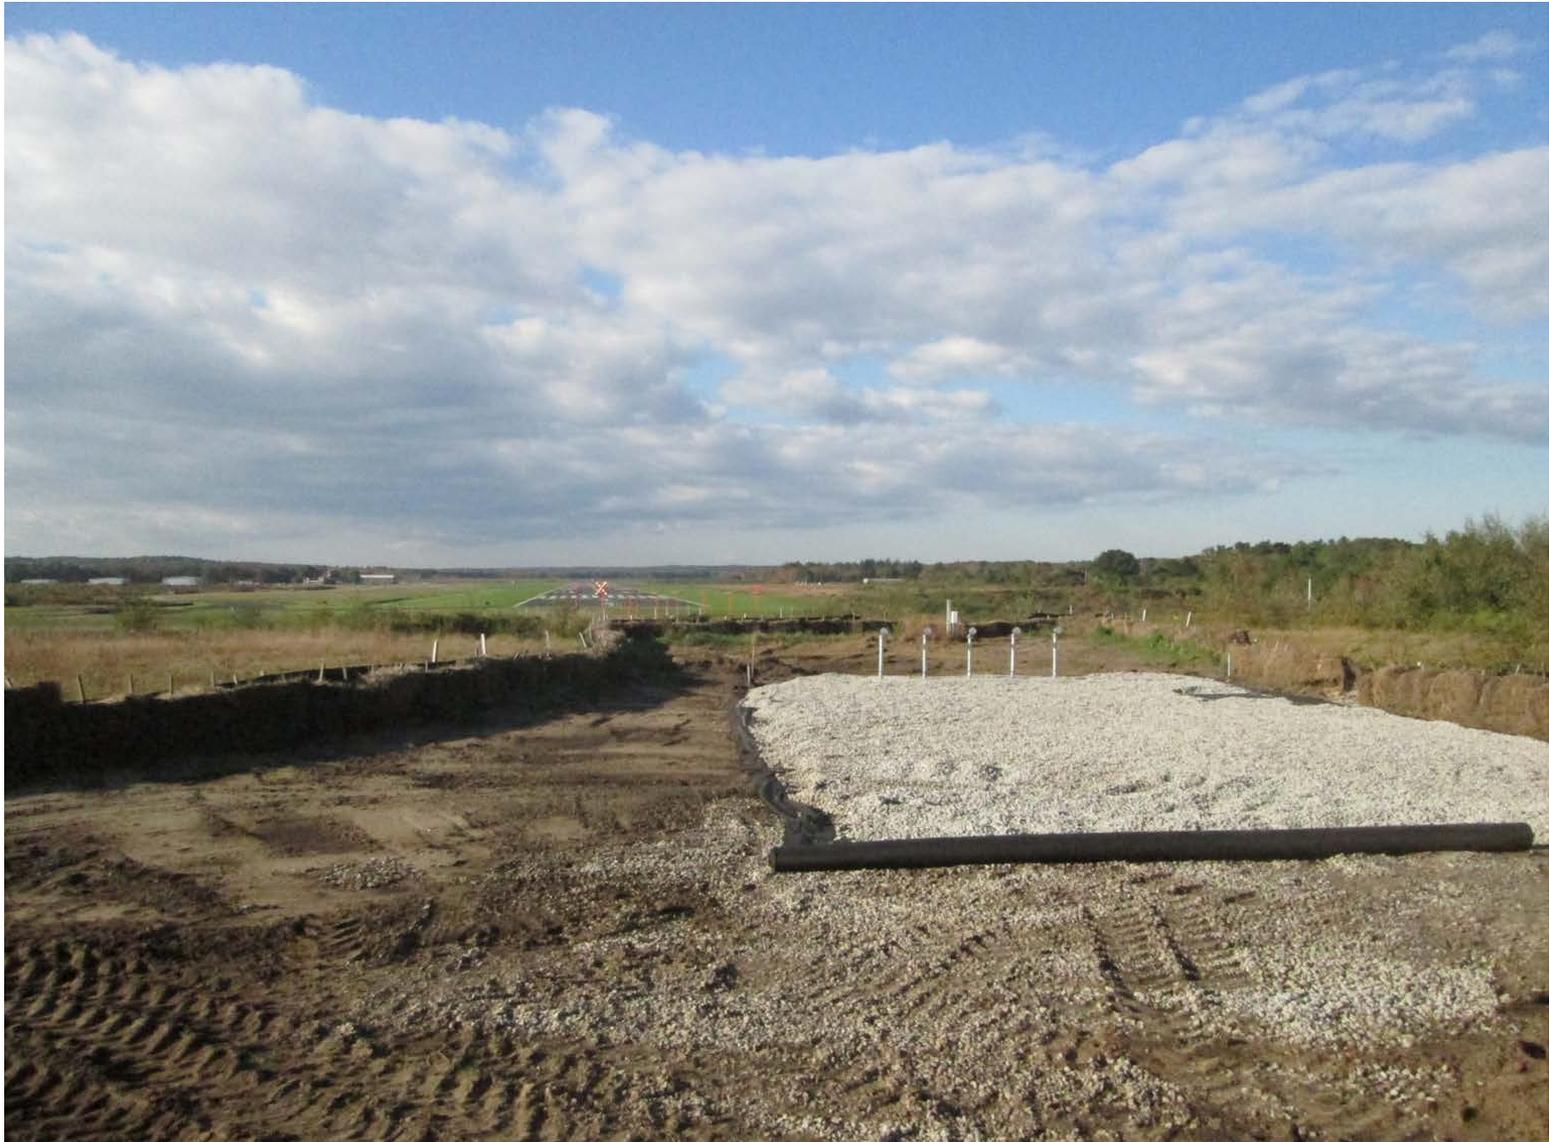
View of MALSR along 23 end. Erosion controls are in good condition.

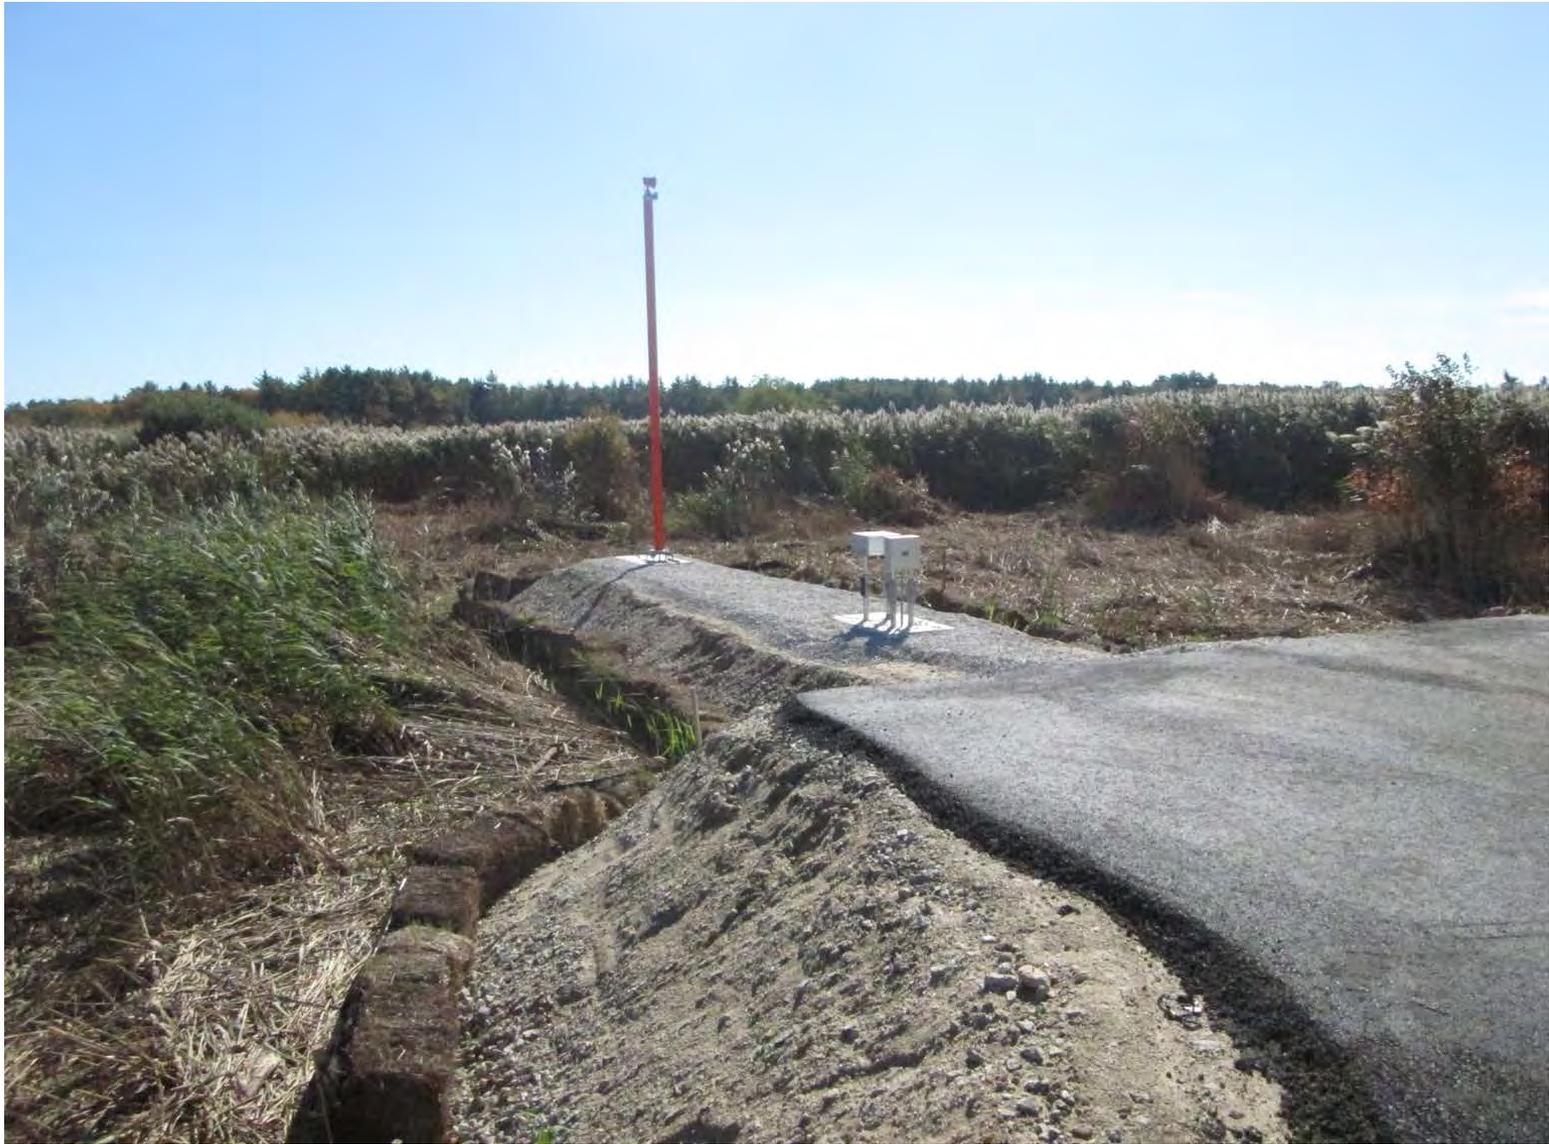
Trench goes under silt fence, silt fence was un-toed in this area. Trench continues to top of slope. No sediment was noted at this time within wetland. 10/9. This area was subsequently repaired as noted in separate WS report.
