New Bedford High School Environmental Investigation Univent Dust Issue

Wednesday – January 25, 2012

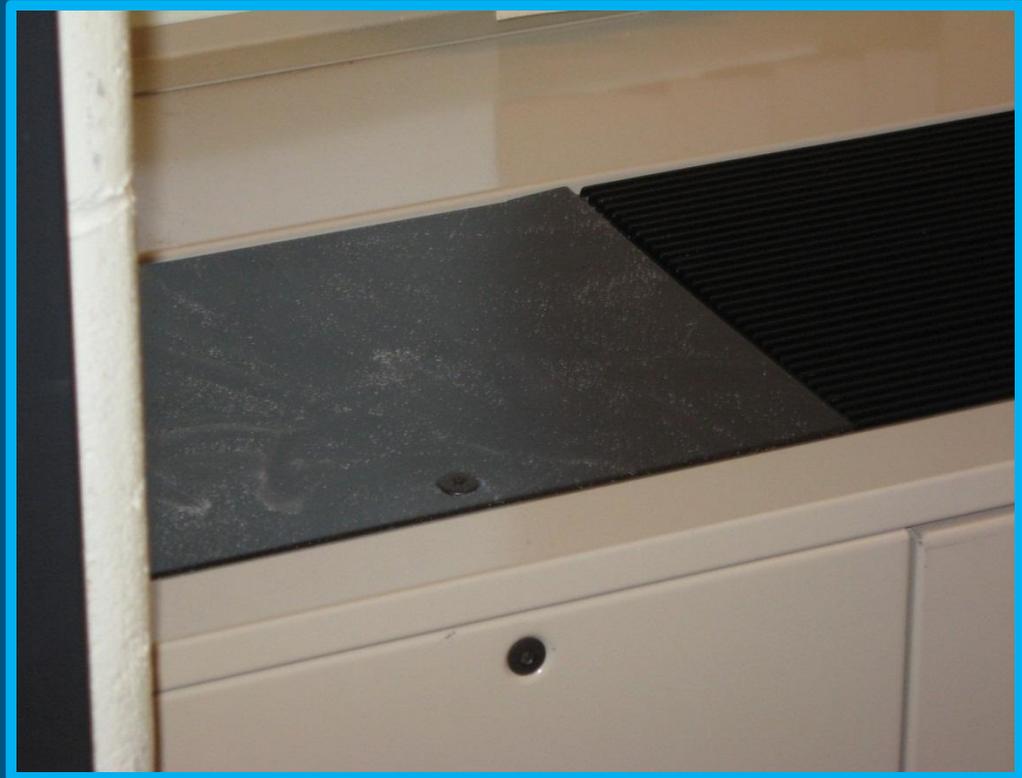
White dust

- **Observed near certain unit ventilators (univents) in some B-Block classrooms.**
- **Prevalent in third floor univents with heating & cooling capabilities.**
- **Also observed to lesser degrees in 2nd and 1st floor units.**

Concerns regarding health impacts, if any

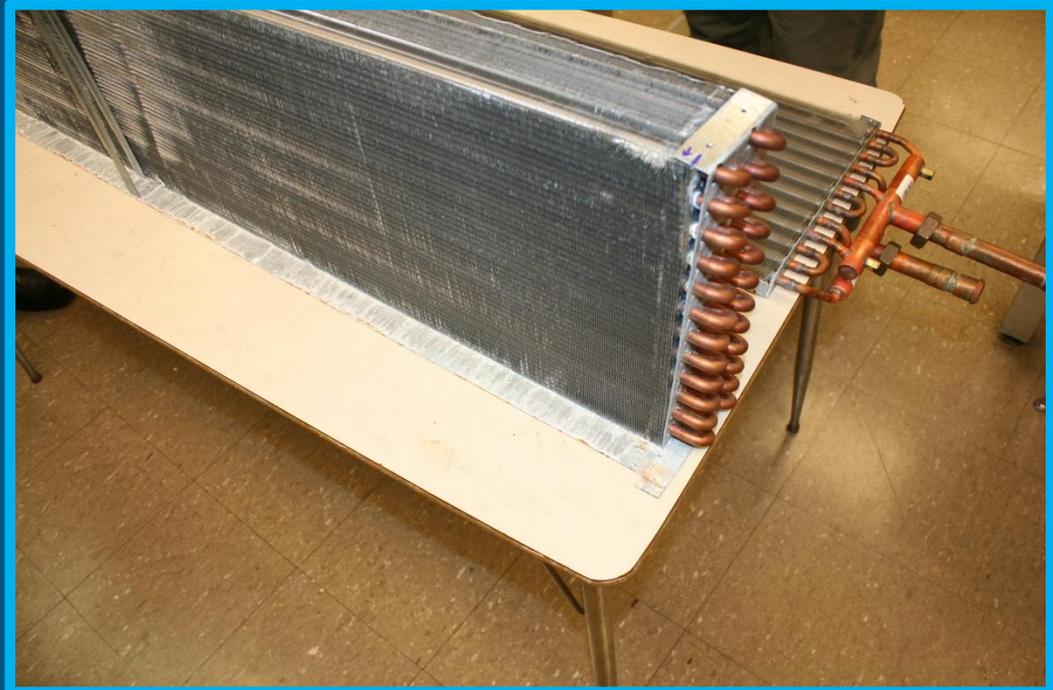
❑ Corrosion

➤ Various mechanisms

- Galvanic corrosion?
- Unique conditions at the school?
- Other?

❑ Continue investigation

❑ Work with team and manufacturer
