CLE BUILDING INSPECTION REPORT

Project: Alma Del Mar Charter School

Exterior Building Envelope Condition Survey

Report No.: ADM-01.10.24.2014
Inspection Date(s): 10.14.2014
10.15.2014
1.016.2014
Report Date: 10.24.2014

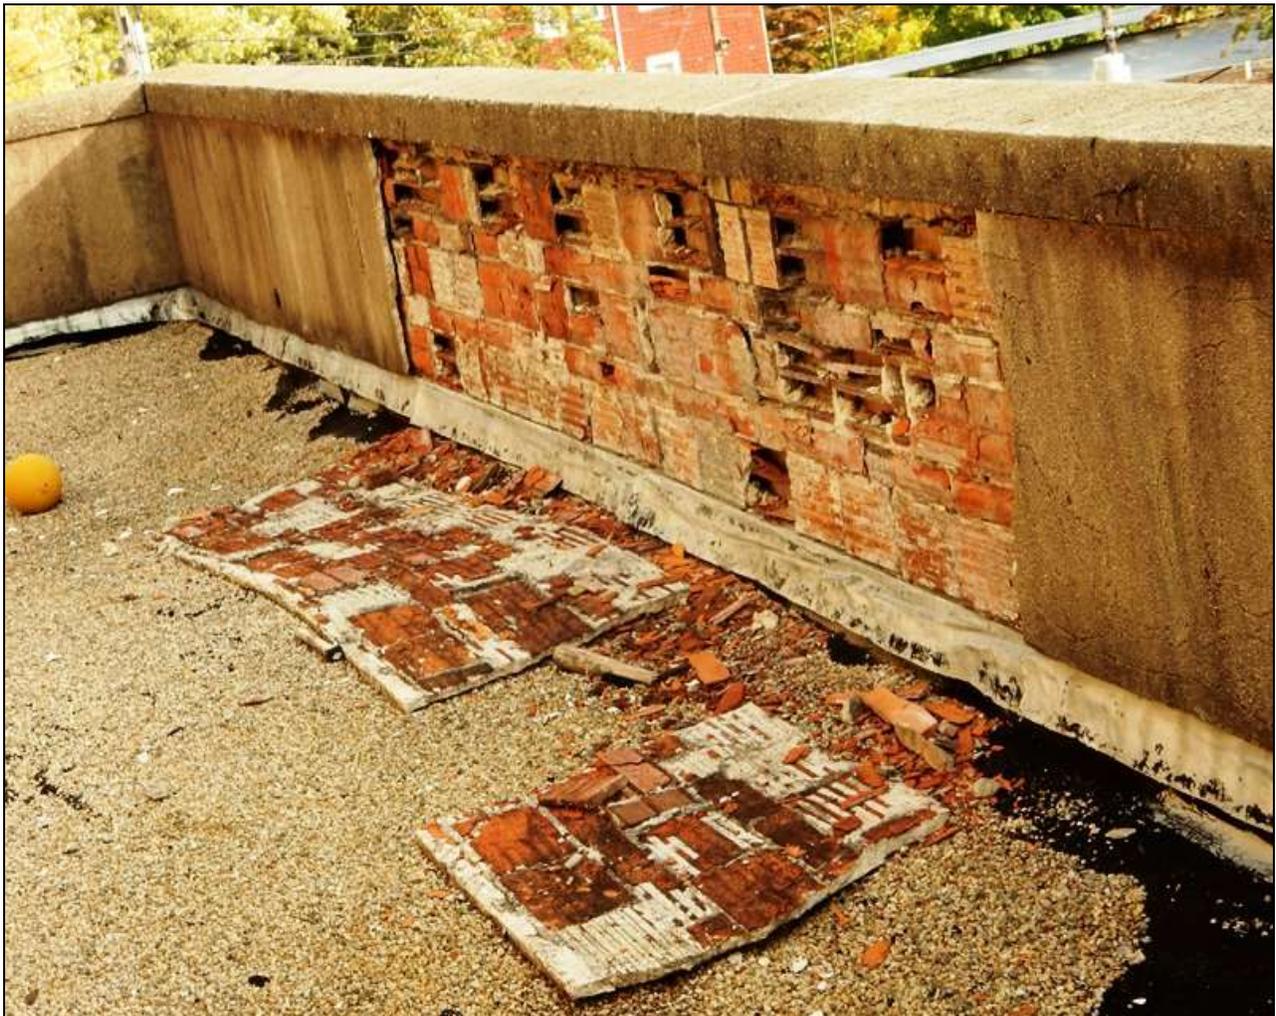
One benefit of age, and perhaps the only benefit, is that the time for differential movement due to building settling has come and gone. Differential movement still occurs though through the expansive and contractive forces associated with freeze-thaw, and delamination of bondlines through ongoing water penetration and cyclical moisture uptake. Moisture uptake can be extremely harsh on masonry systems due to mineral leaching which result in the structural degradation of the mortar system.

While the previous photo is alarming, CLE’s inspection found that there are other, less conspicuous failure patterns and conditions occurring within the vertical wall systems which repetitively manifest themselves and involve the same components and area locations.

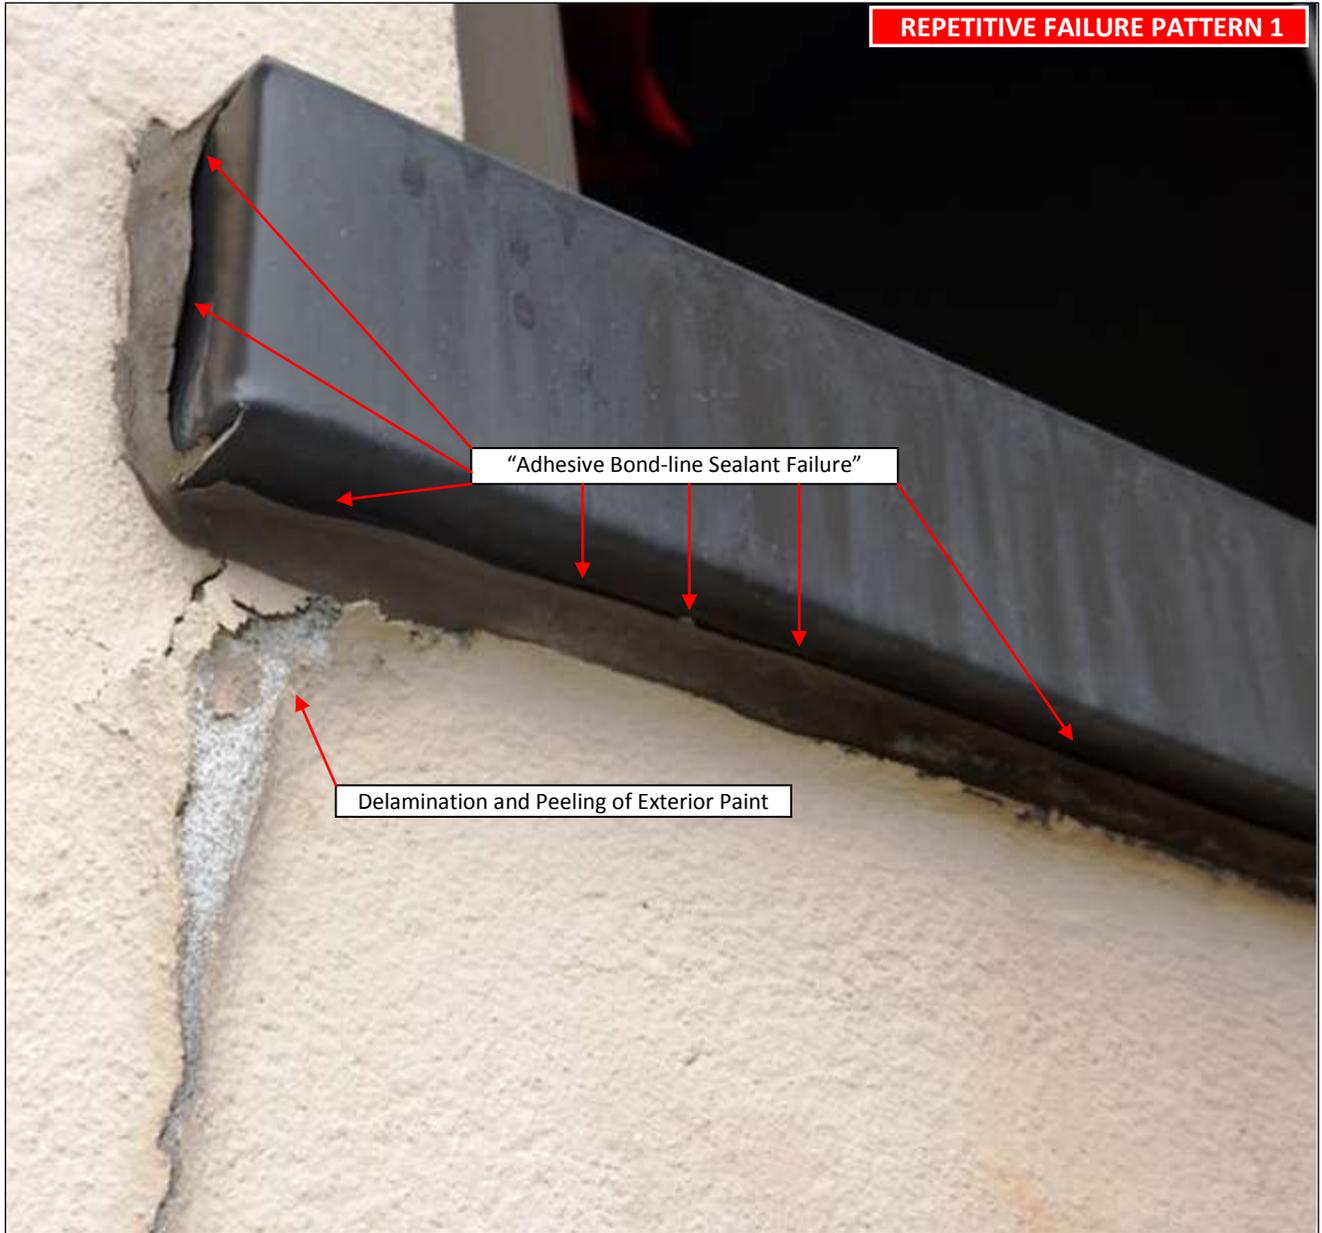
Moving outward from the punched opening into the stucco wall fields, an advanced capillary system exists that contains small, medium and large size cracks. CLE performed RILEM tube moisture uptake tests and verified that significant water penetration is occurring through the capillary systems in the wall fields. This was documented with video, and the “clips” will be made available as a media addendum to this report.

As the migration of water continues inward to sub-surface layers, ongoing damage can become invisible to the casual observer. Moisture uptake and “stucco sounding” tests however indicate that the stucco system has multiple wall areas which are delaminating and in advanced states of sub-surface bond-line failure.

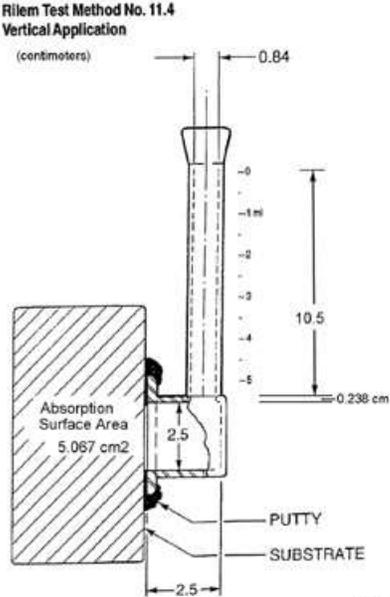
CLE conducted Rilem tube tests on multiple stucco locations which showed signs of small, medium, and large surface cracks.

Rilem testing verified that the capillary systems run deep and that they are capable of actively transporting water to inner layers of the exterior wall system. It is suspected that the capillary systems are contributing to sub-surface delamination of the stucco system, and subsequent sounding tests verify that hidden damage has occurred.

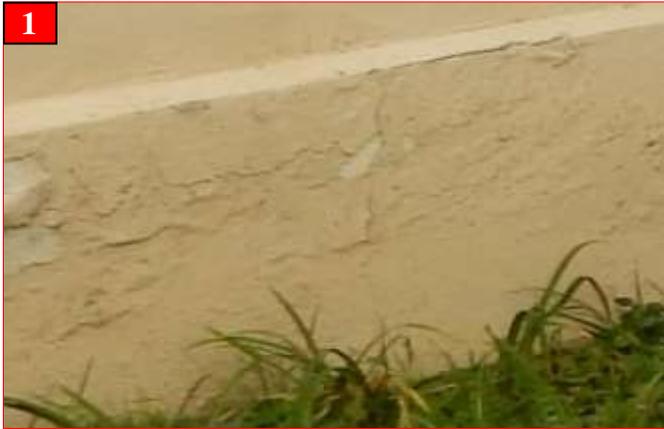
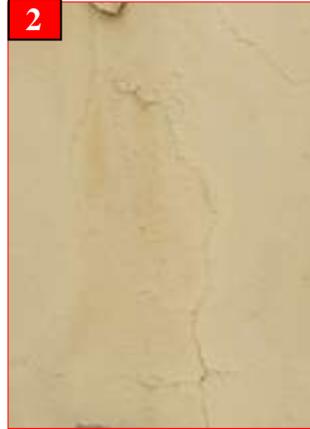
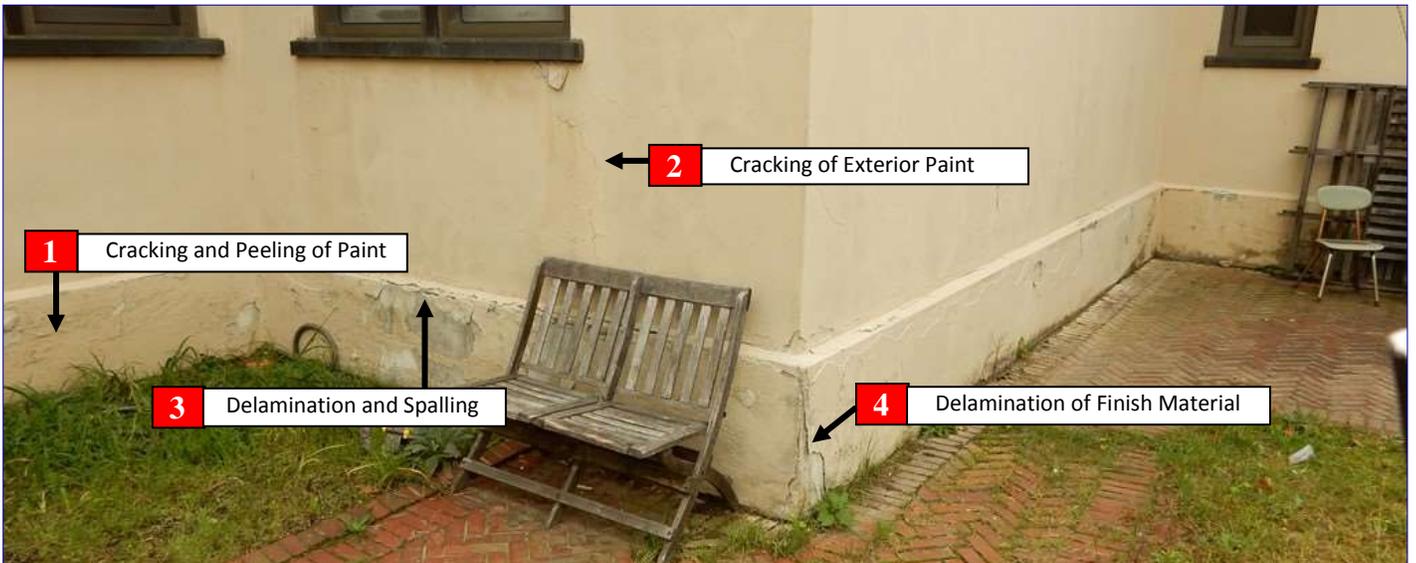
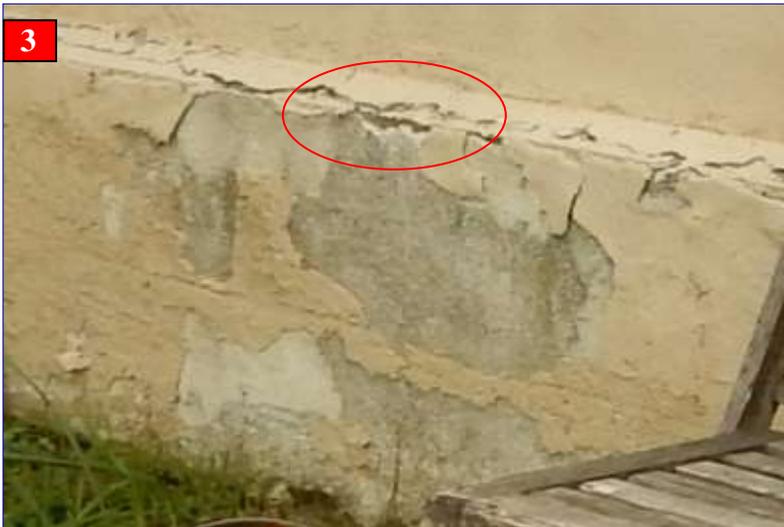
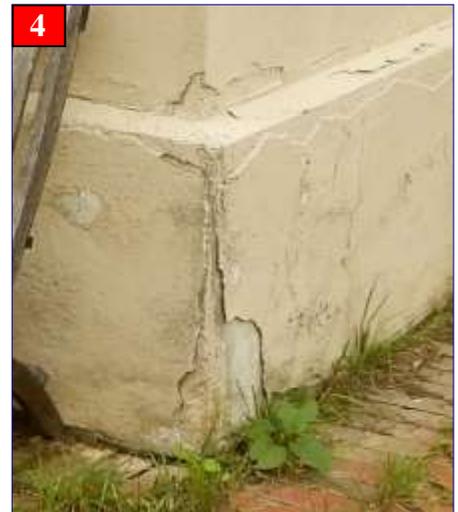
Examples of compounding surface conditions from moisture uptake and water penetration past surface layers.

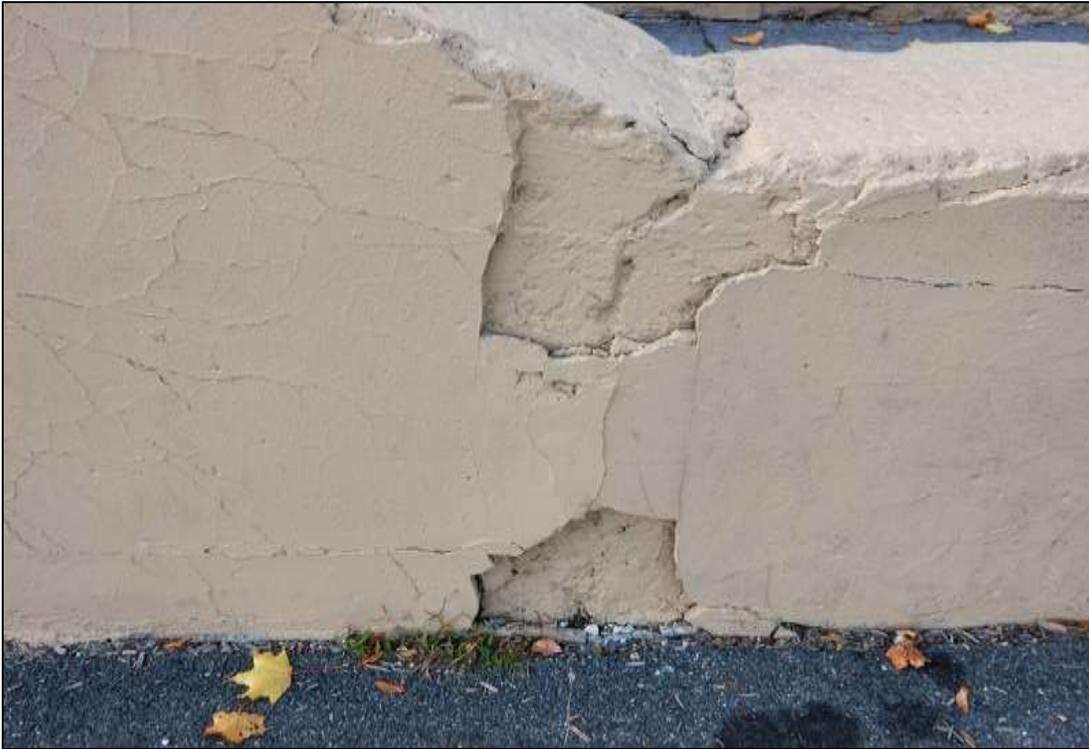
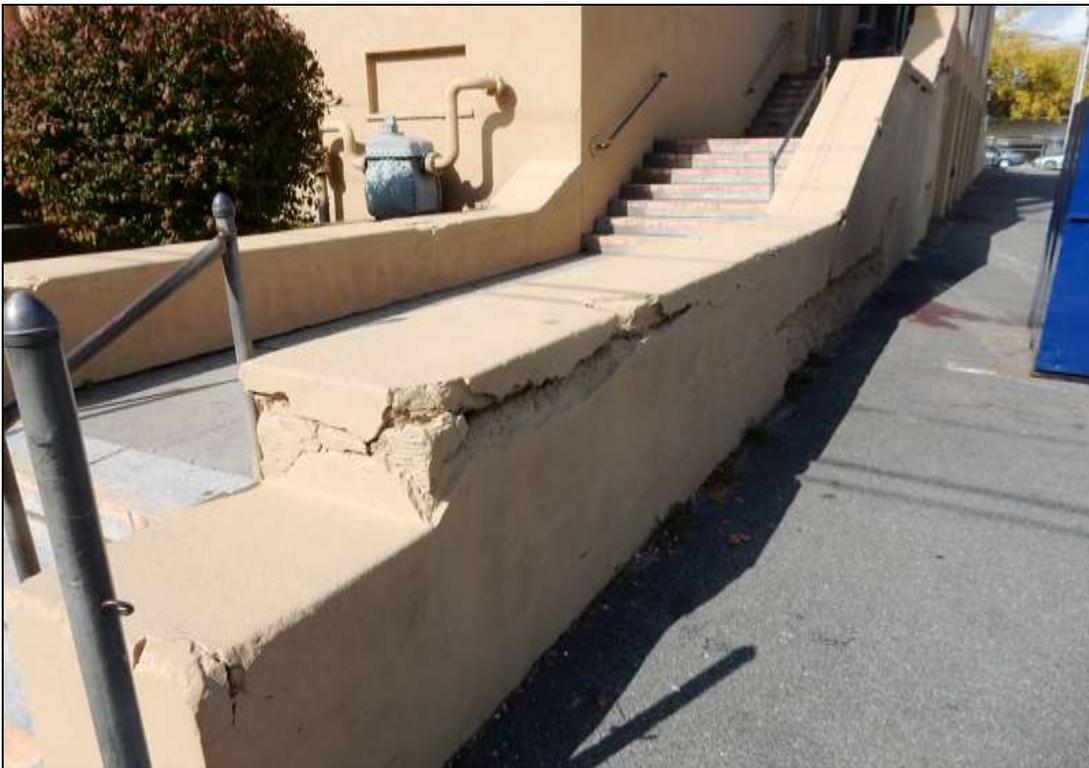
The basic water infiltration damage pattern affects the foundation walls in the same manner:

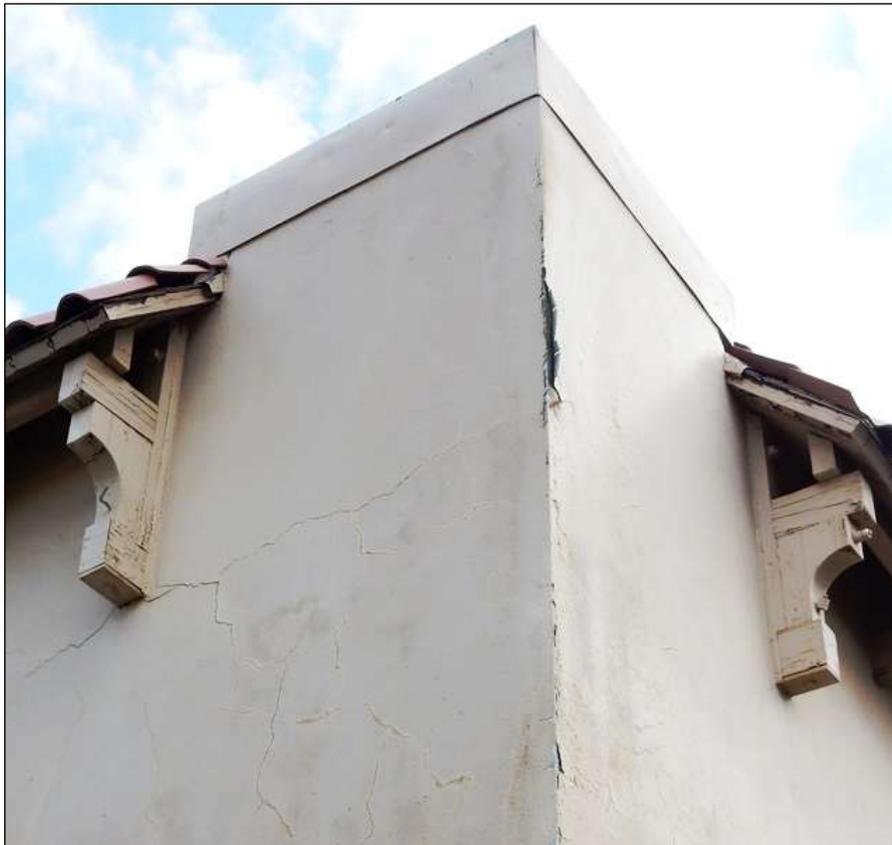
From the Top to the Bottom of surface layer protected buildings, unchecked and unmitigated water intrusion will result in substantial surface and sub-surface breakdown of finishes and components.

Alma Del Mar remains in immediate need of restorative maintenance to prevent further breakdown and degradation of the exterior envelope. The risk of stucco separation from the interior masonry wall's structural system will increase over time.

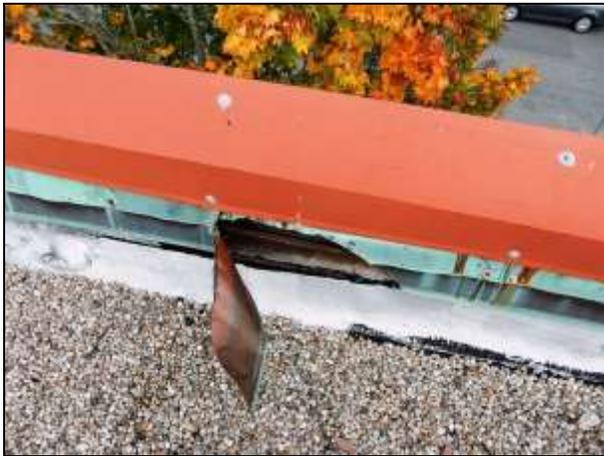
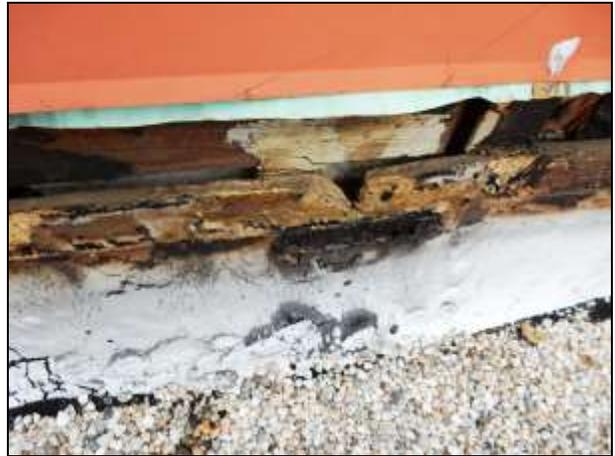
Multiple Areas of Missing and/or Damaged Interior Parapet Skin

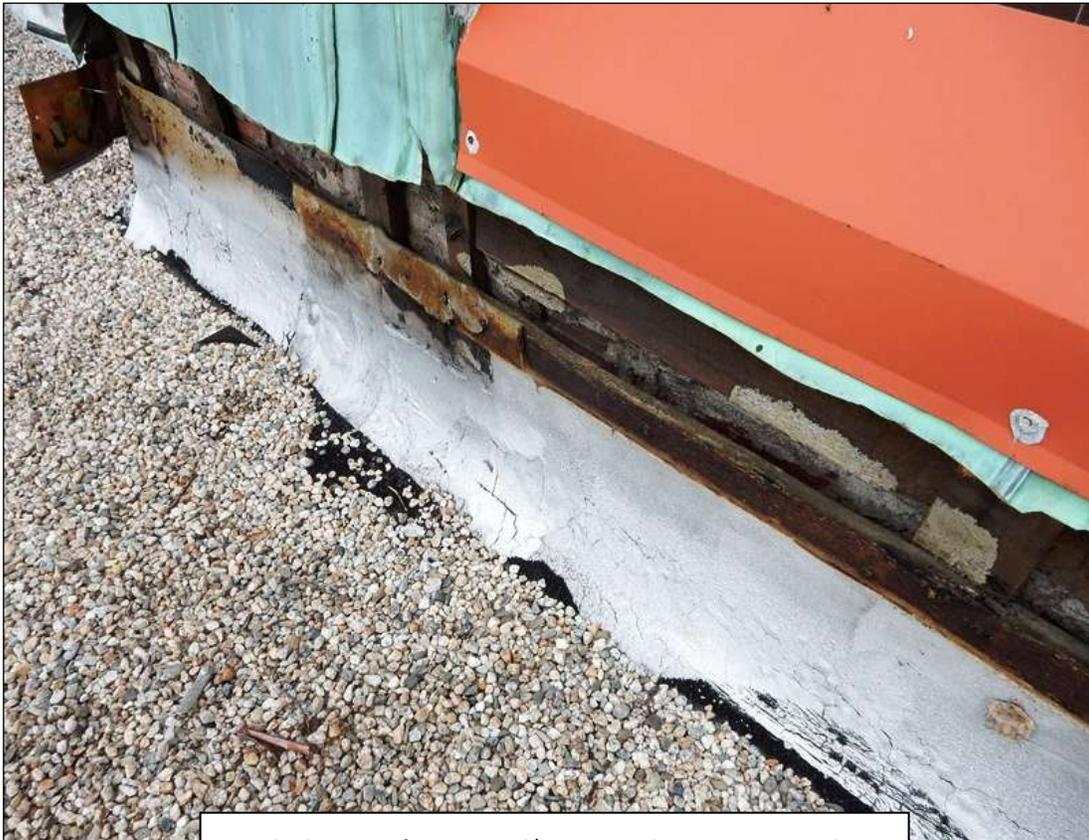
Multiple Areas of Missing and/or Damaged Interior Parapet Skin.
These Regions Create Direct Paths for Immediate Water Entry

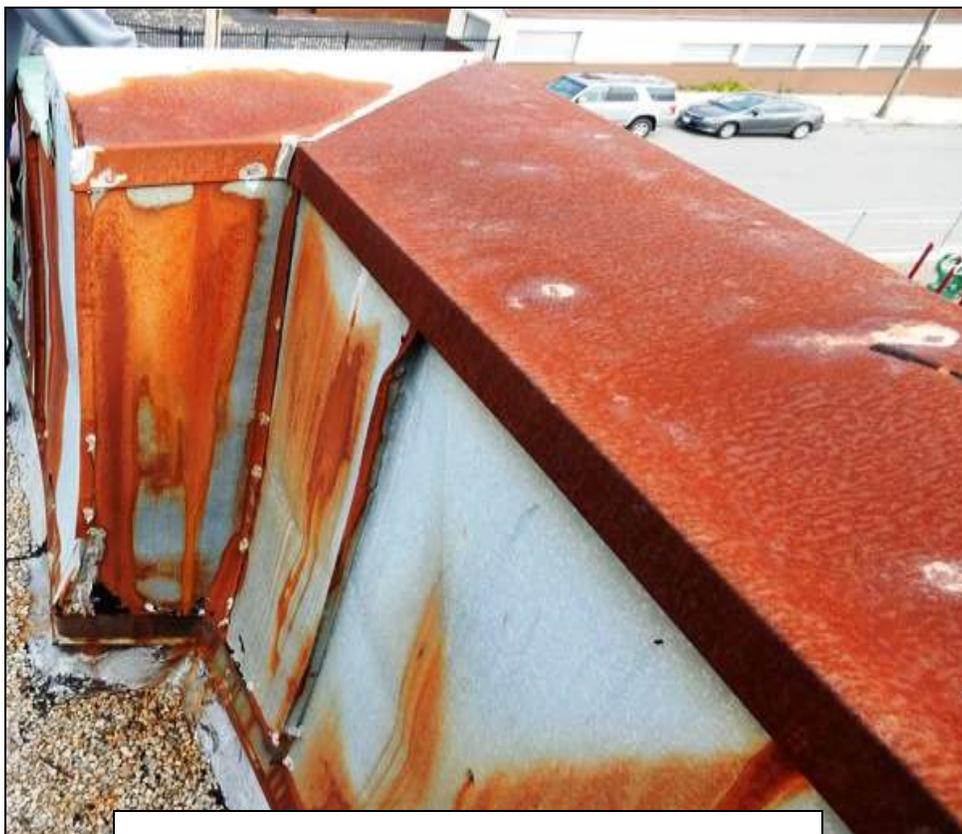
Parapet Metal System in Advanced State of Material Degradation

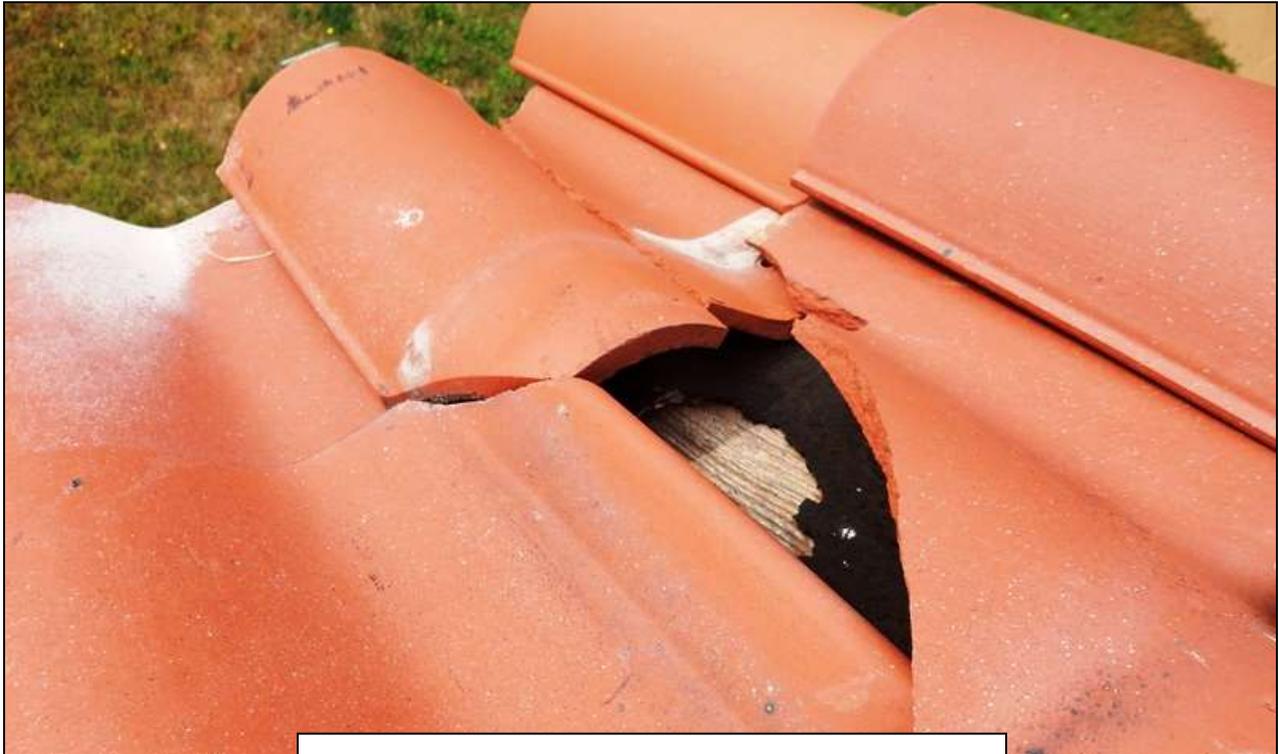
Broken Tiles and Exposed WRB Tar Paper Exist in Some Areas

There are areas where the tiles are damaged and the WRB’s tar paper is torn and the underlying plywood substrates are exposed. Some surface decay of the plywood and decking are evident.

Repairs will be needed to mend the WRB and maintain water resistivity.

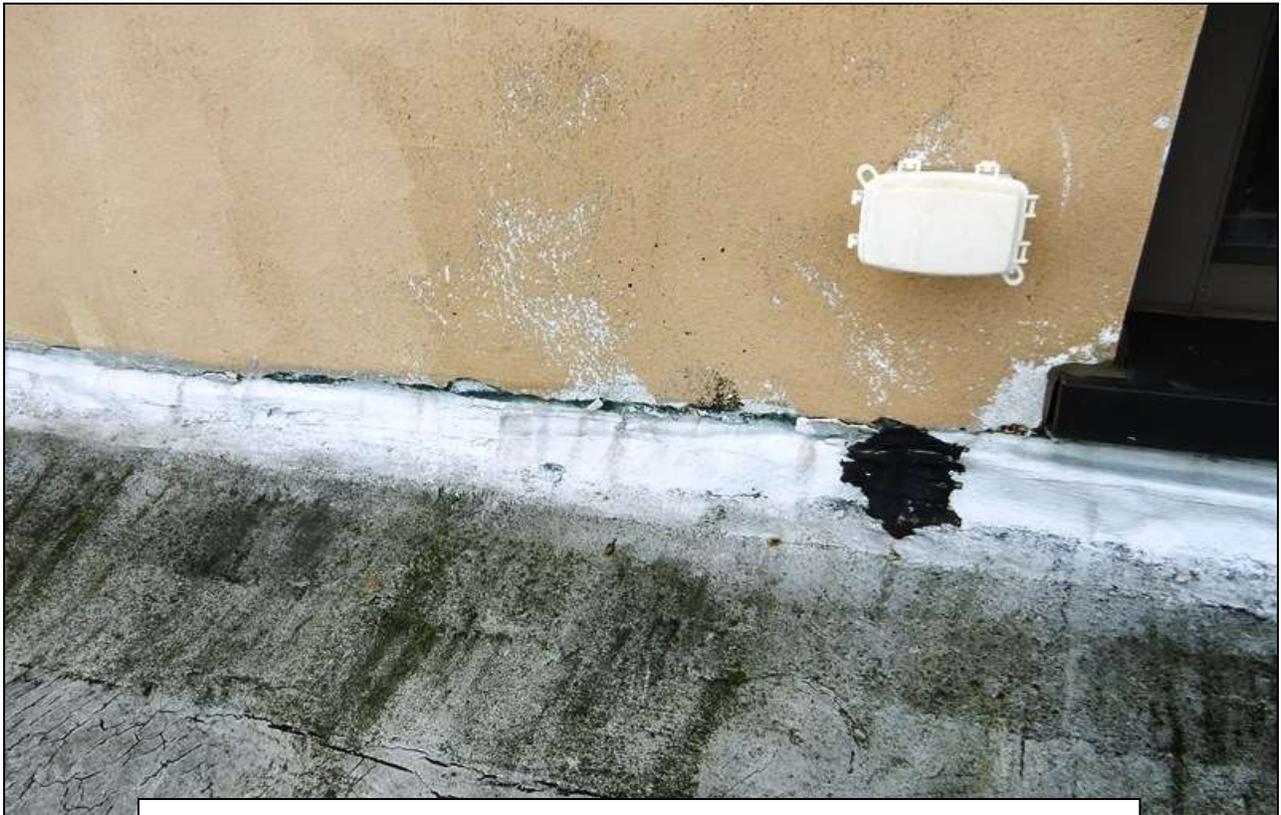
Transition Materials and Interface Areas Are Vulnerable Due to Breakdown and General Aging

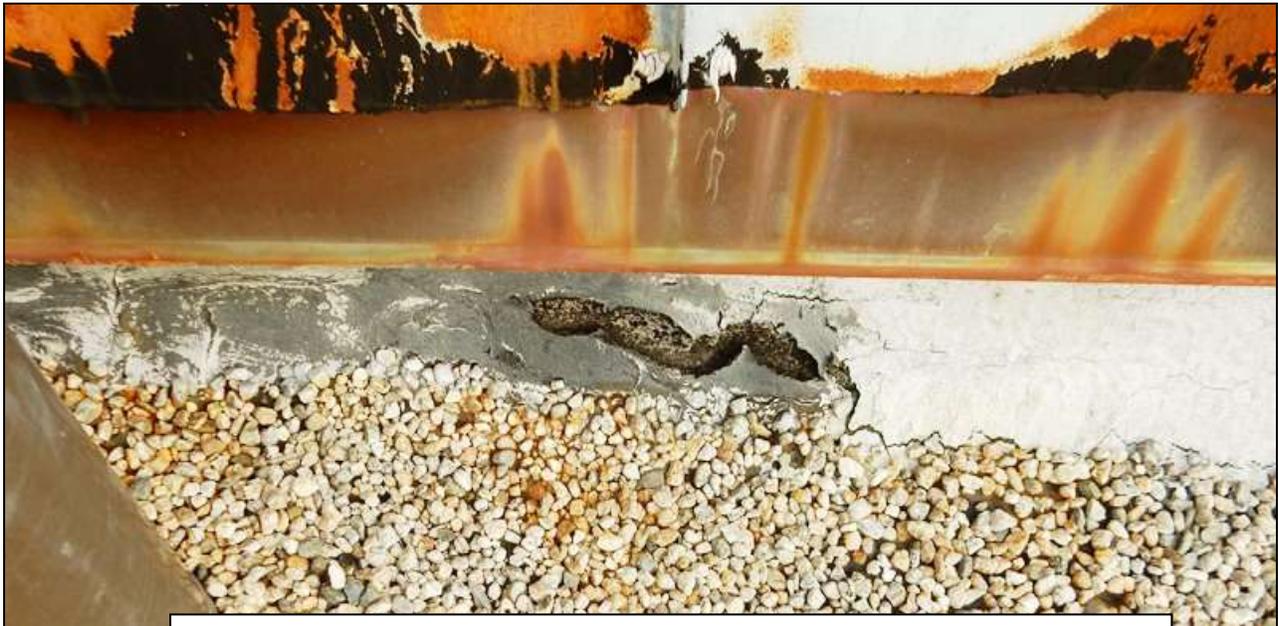
Transition Areas Are Vulnerable Due to Breakdown and May Provide Pathways for Water Entry

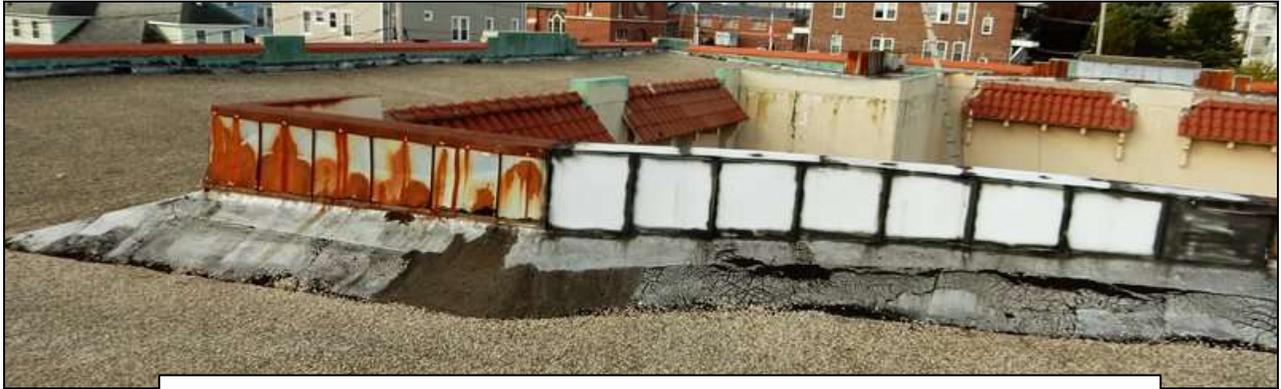
Transition Areas Are Vulnerable Due to Breakdown and May Provide Pathways for Water Entry

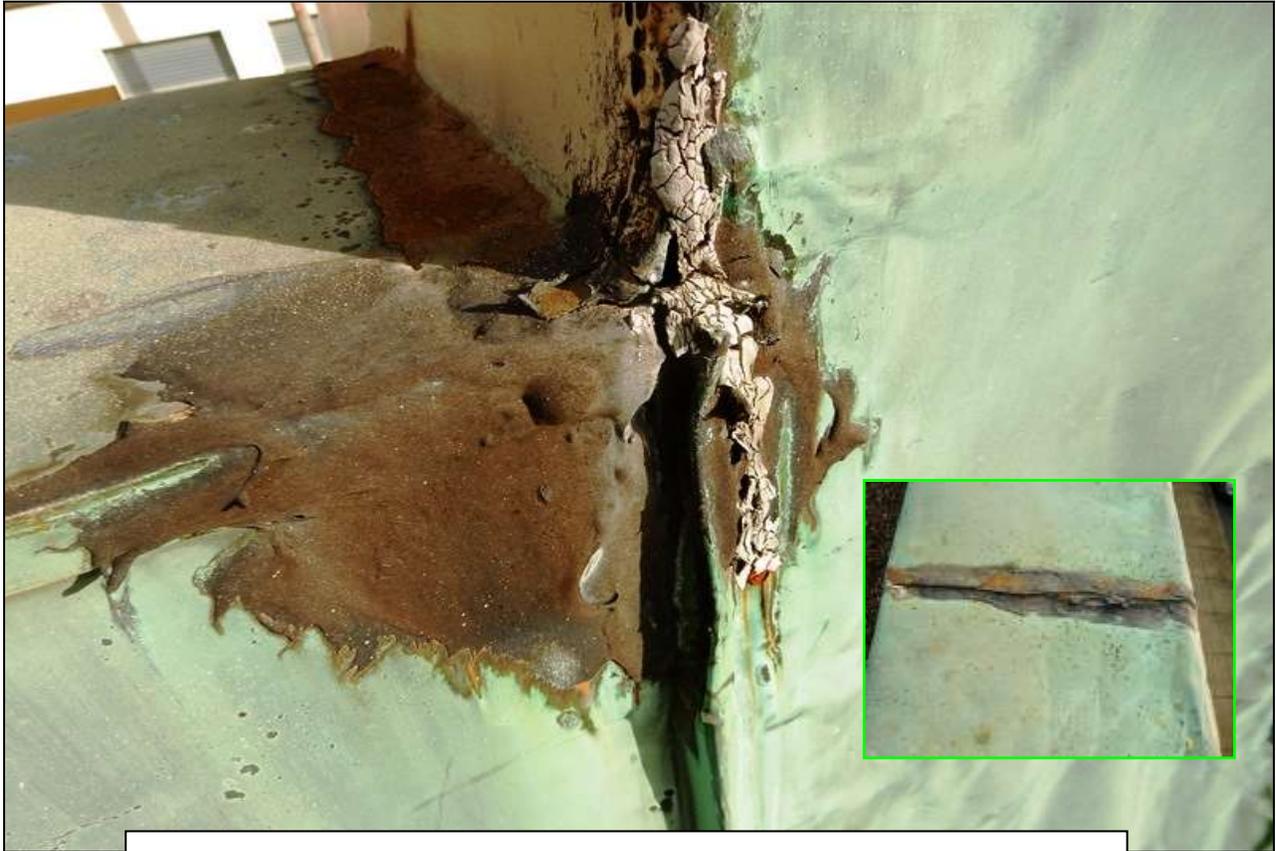
Transition Areas Are Vulnerable Due to Breakdown and May Provide Pathways for Water Entry

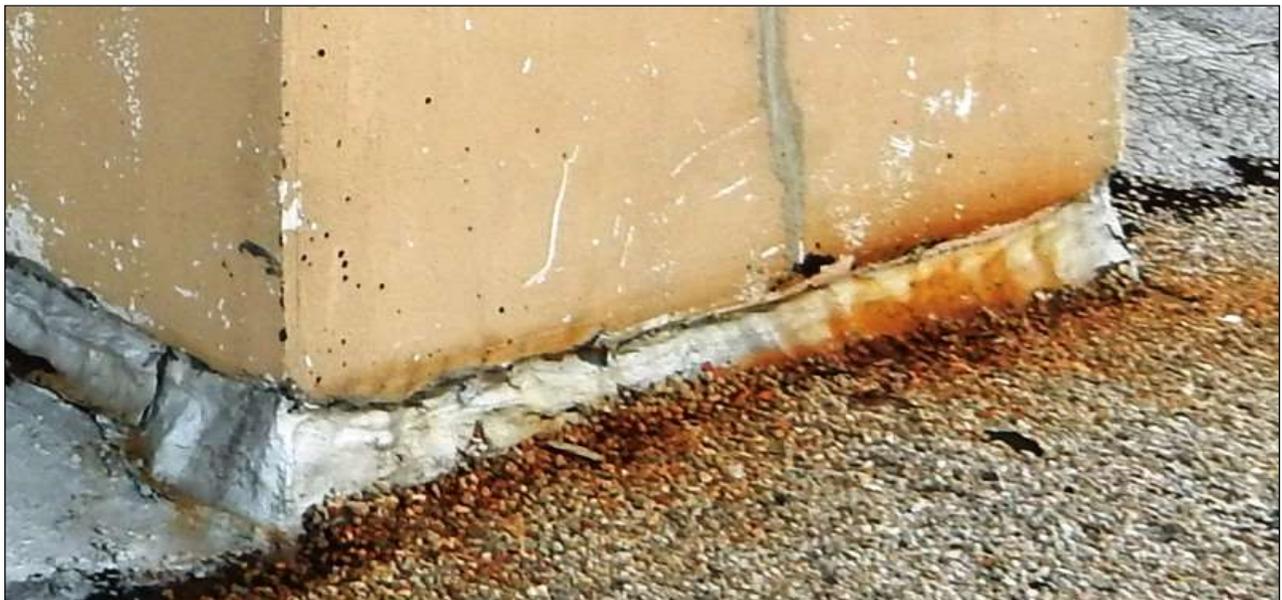
Transition Areas Are Vulnerable Due to Breakdown and May Provide Pathways for Water Entry

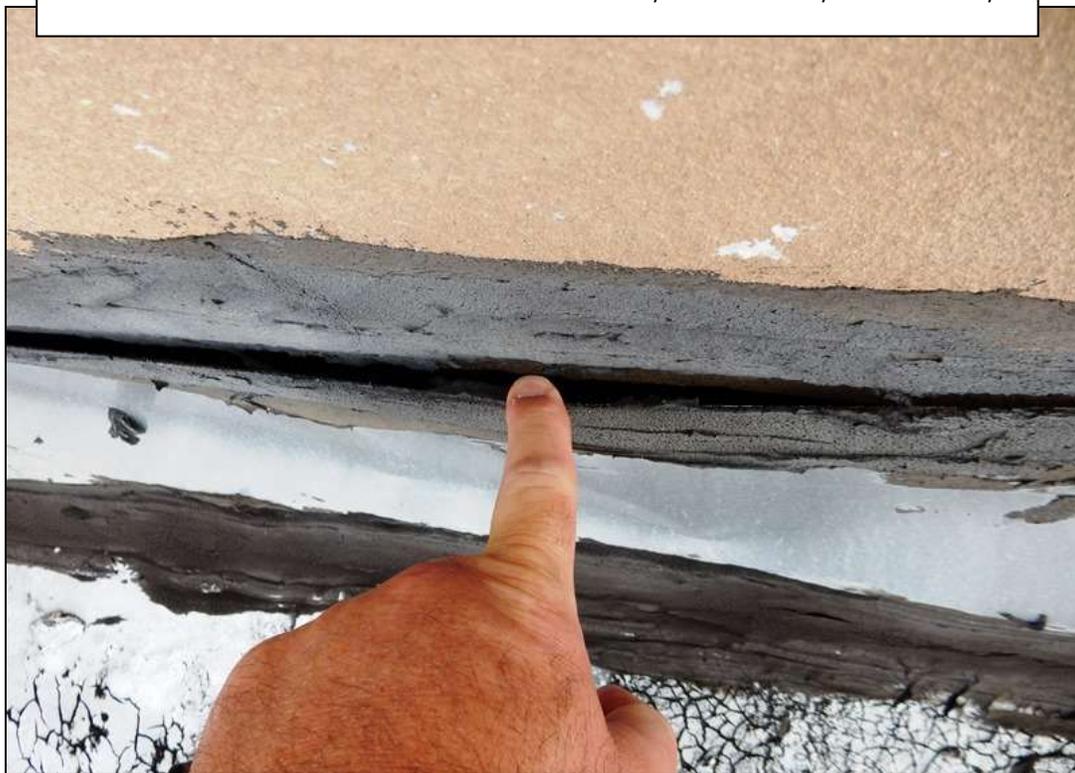
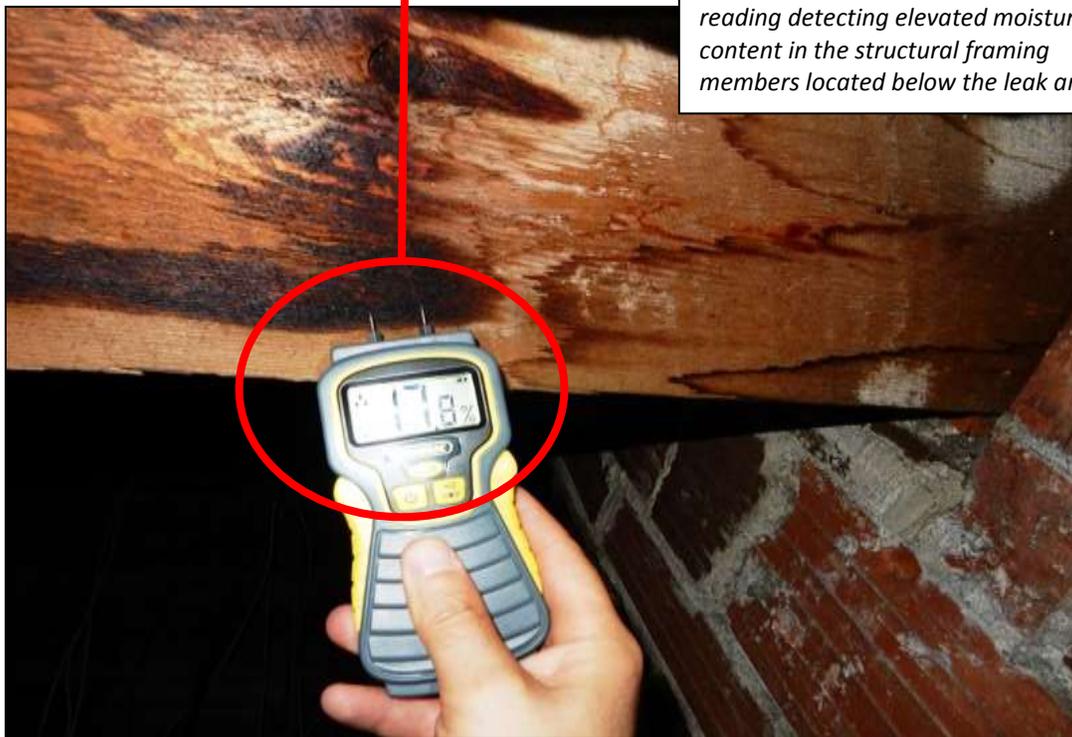
This photo shows an example of water intrusion through material and transitional interface failure. The photo below shows a moisture meter reading detecting elevated moisture content in the structural framing members located below the leak area.

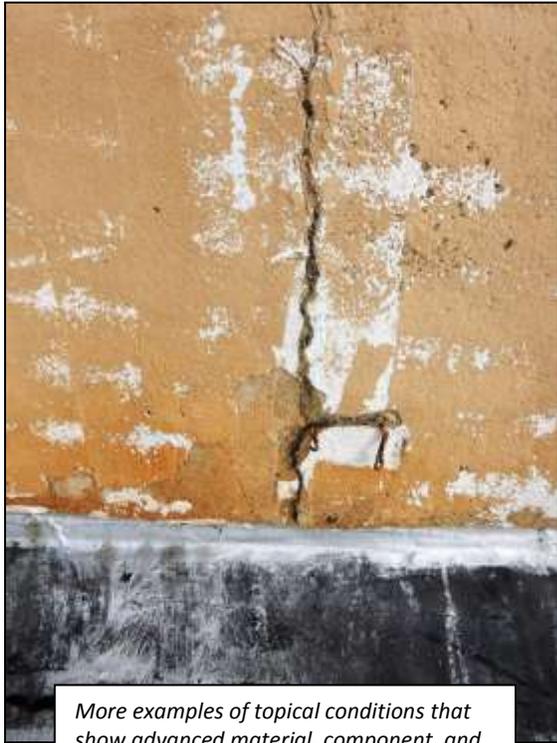
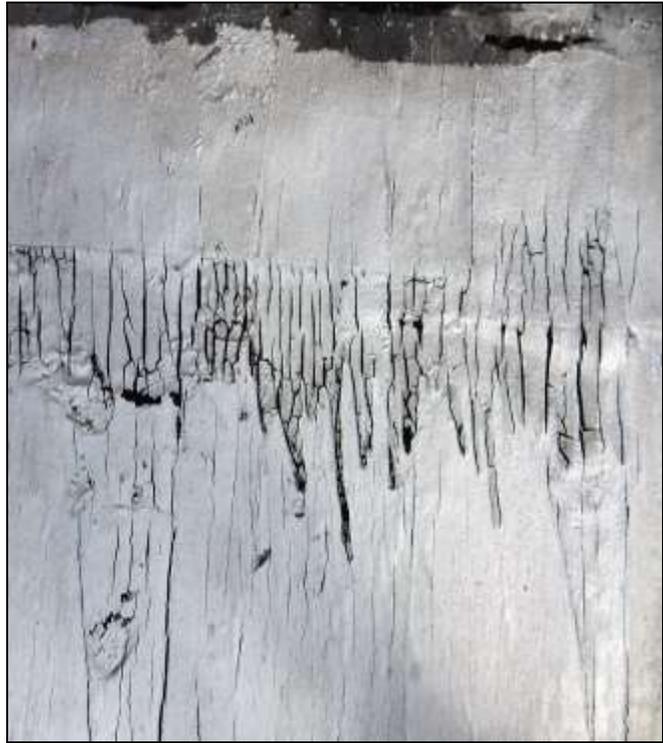
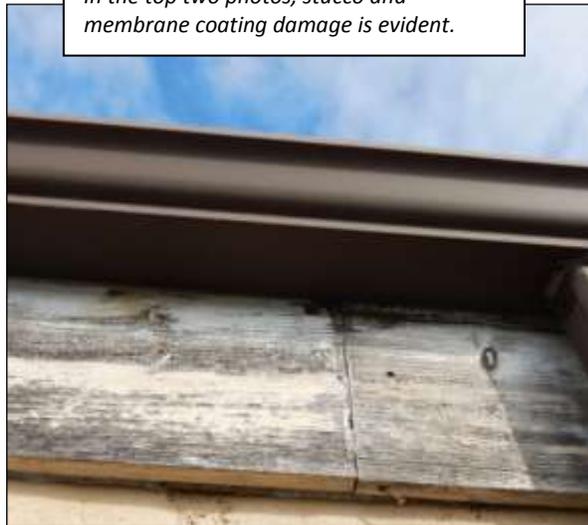
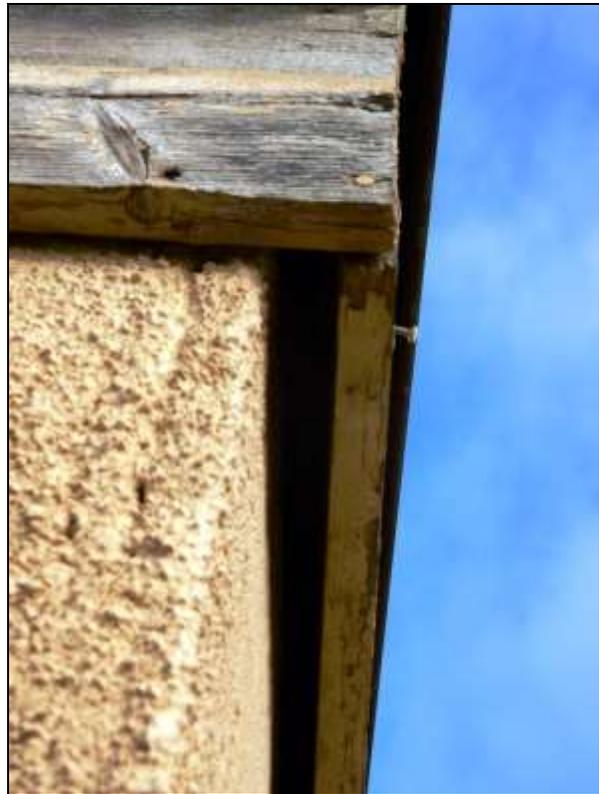
More examples of topical conditions that show advanced material, component, and system breakdown. The fascia coatings have deteriorated and the wood fibers have sustained damage. The corner joints have swollen, and water penetration behind the fascia is most likely occurring. In the top two photos, stucco and membrane coating damage is evident.

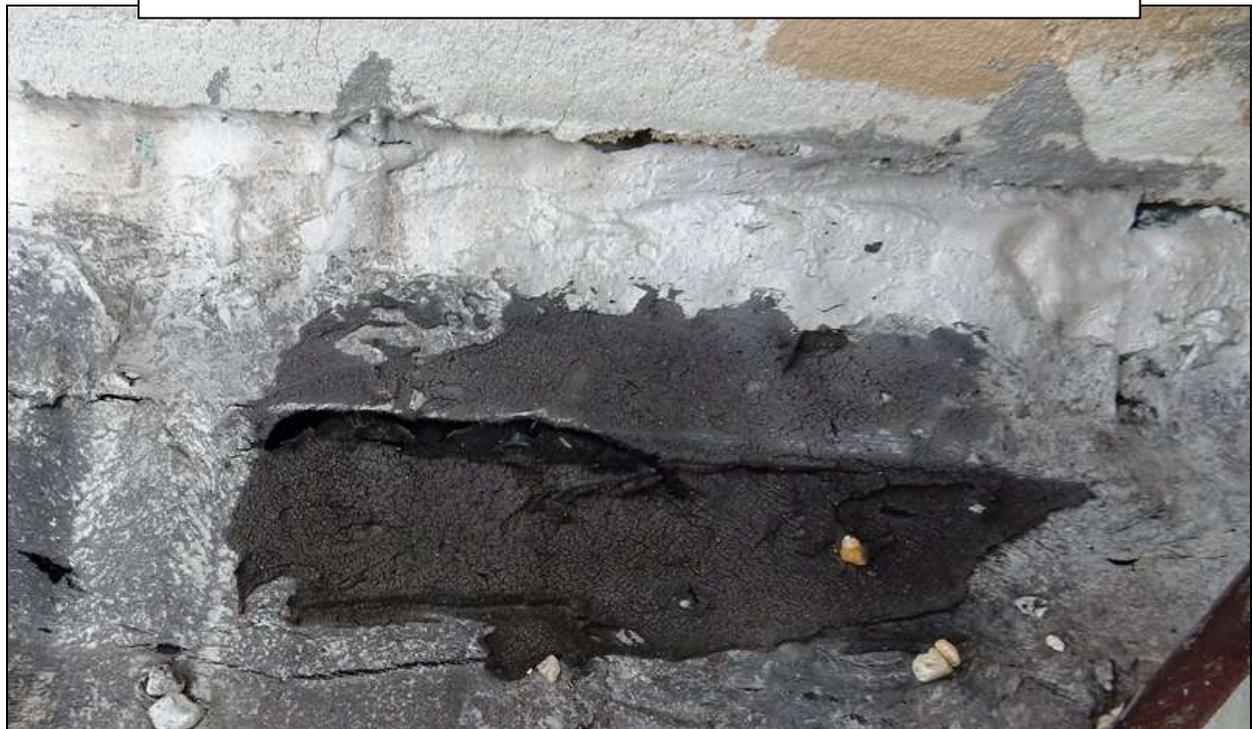
Transition Areas Are Vulnerable Due to Breakdown and May Provide Pathways for Water Entry

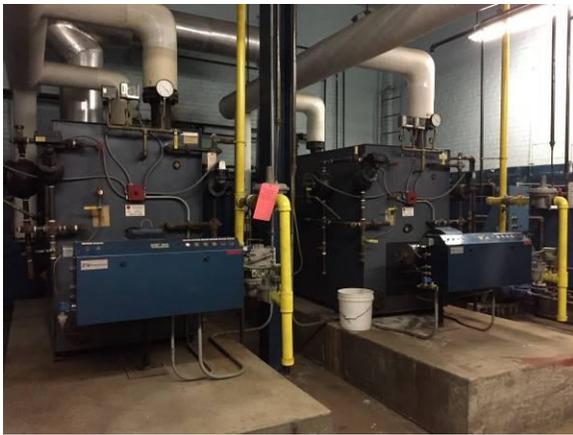
Steam Boilers, Boiler #1 (right), Boiler#2 (left)

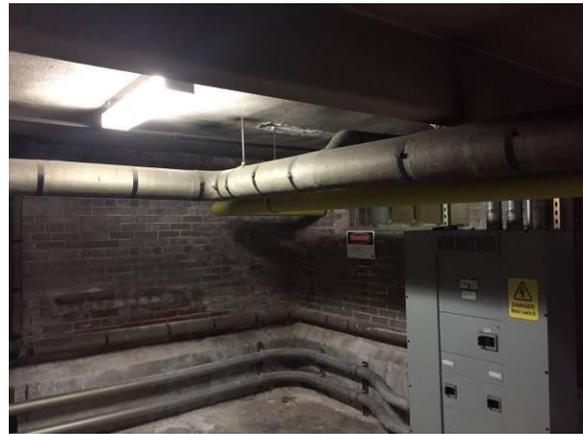
The majority of the steam and condensate piping distribution system appears to be in fair to poor condition with signs of visible corrosion and missing insulation in sections of the piping. Some of the piping insulation is believed to contain asbestos material. It is our understanding that the system's steam condensate traps are properly maintained on an annual basis.

*Condensate Piping which may contain
Asbestos insulation material*

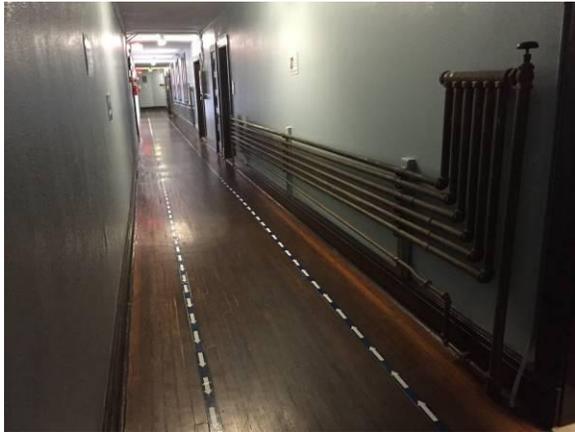
Steam is distributed from the boilers to building steam heating equipment, which consists largely of steam cast iron radiators and steam piping radiators, via a 2-pipe steel low pressure steam and condensate return piping distribution system. The majority of steam radiators appear to be originally installed equipment, and therefore have exceeded their expected useful service life. Steam control valves have been replaced on an as-needed basis throughout the years.

Steam Piping Radiator in Corridor

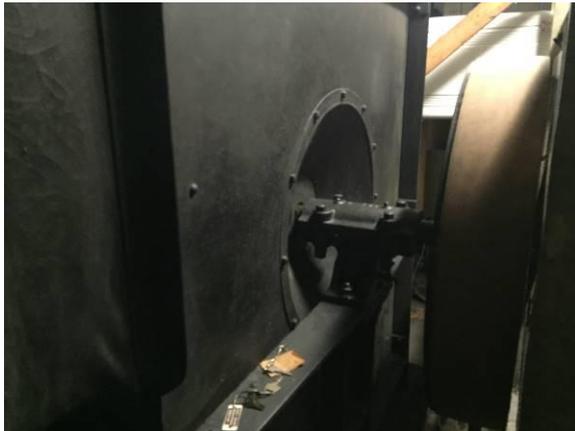
There is an abandoned-in-place air handling system that previously provided tempered ventilation air to the building. The air handling unit is located in a mechanical room adjacent to the boiler room. The air handling unit fan was manufactured by Sirocco American Blower Co. and operates on 550V electrical service. The fan is believed to be inoperable. The unit is believed to be originally installed equipment from when the building was originally constructed. The unit currently has steam heating coils and piping connected to the unit. Facility staff also indicated that it is believed that the unit previously had an evaporative cooling system connected. Ventilation ductwork is routed from the unit to floor and sidewall grilles located throughout the building.

Air Handling Unit Fan

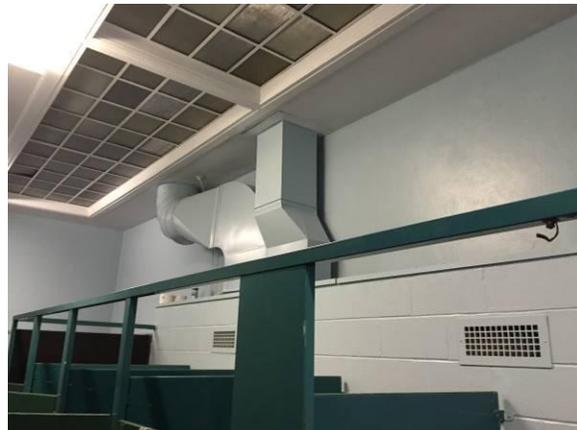
Boy's Restroom Exhaust Ductwork and Grilles

The boy's and girl's restrooms have exhaust air ductwork and grilles installed which appear to be in fair condition; however, it is our understanding that the connected exhaust air fan(s) are not operable.

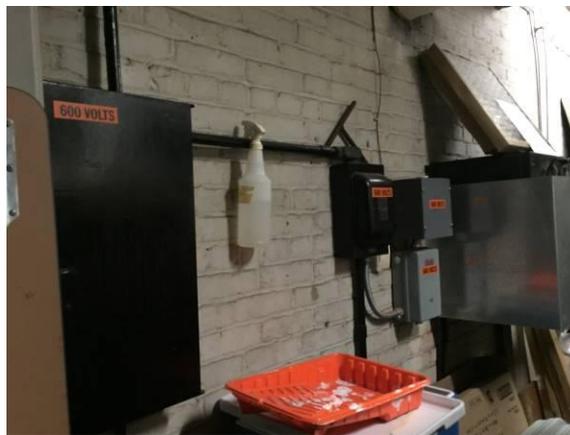
600 Volt Electrical Panel

In the old abandoned-in-place air handling unit room, there is a 600 Volt electrical panelboard and switchgear which previously served the heating and ventilation and evaporative cooling air handling unit. It is our understanding that this 600V electrical distribution system is no longer used.
