Fort Taber / Fort Rodman
New Bedford, Massachusetts

**Architectural / Structural Assessment
& Feasibility Study for Universal Accessibility**

Final Report

Bargmann Hendrie + Archetype, Inc.
Boston, Massachusetts

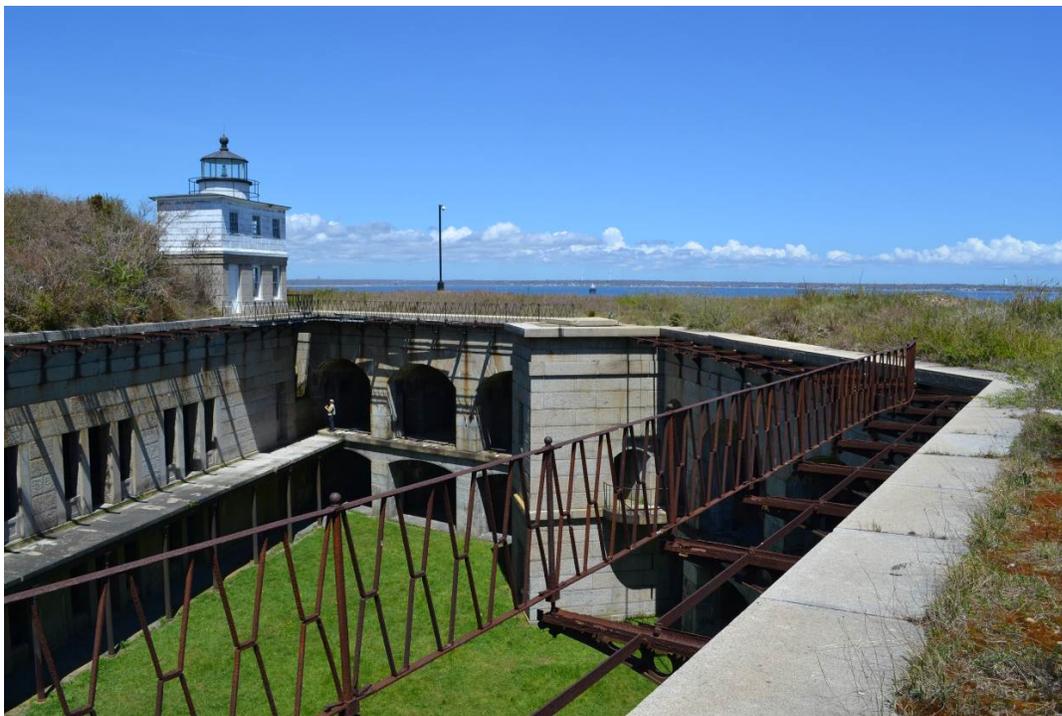
Figure 14. View of north terreplein and lighthouse.

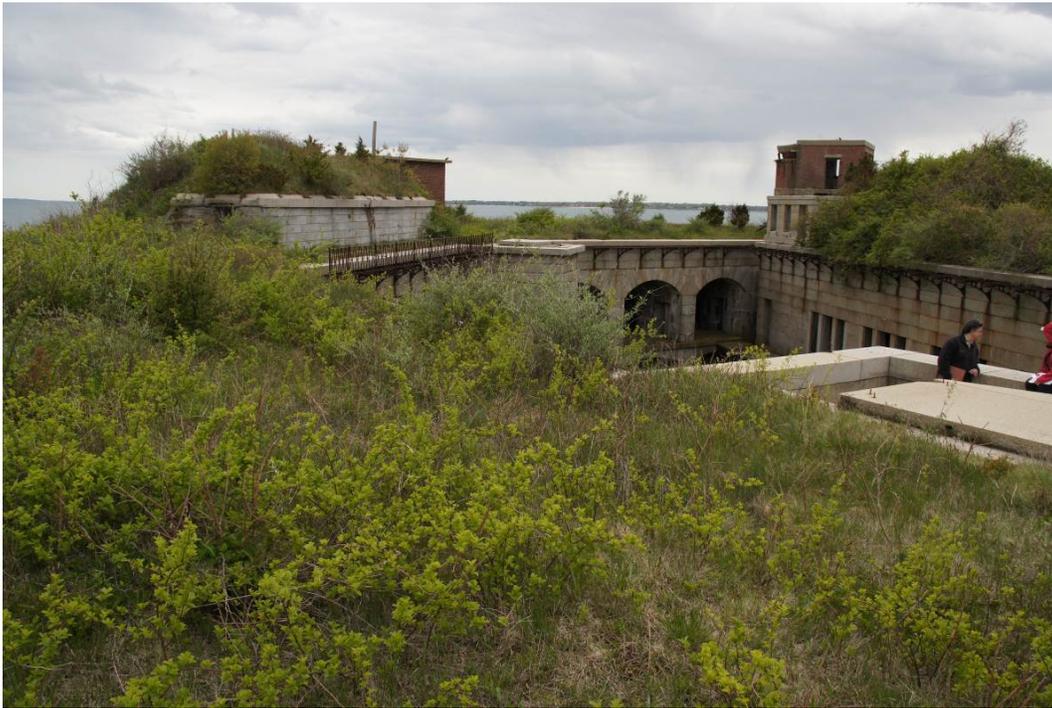
Magazines are located under earthen mounds on the terreplein; one on the northwest corner, one on the southwest corner, and one on the south. An existing section of the magazine shows that they are constructed of brick, encased in cinder concrete and covered with earth and grass (Figure 19). Accessed from the roof, a doorway leads down a short flight of stairs and around an "L" shaped hallway to reach the 15 feet long by 13 feet wide magazine. At the retaining wall around the southern magazine, the coping stones are bowed outward due to soil loads on the magazine structure. Spalled and cracked stones were found near the entrance to the magazine.

Figure 15. View of south terreplein, concrete bunker, brick head house, and magazine retaining wall.

Remove soil from the south magazine wall and re-set and/or anchor the stones to the wall below. Spalled and cracked stones should be replaced or dutchman-repaired. Repointing exposed copings, parapets, and retaining walls is recommended.

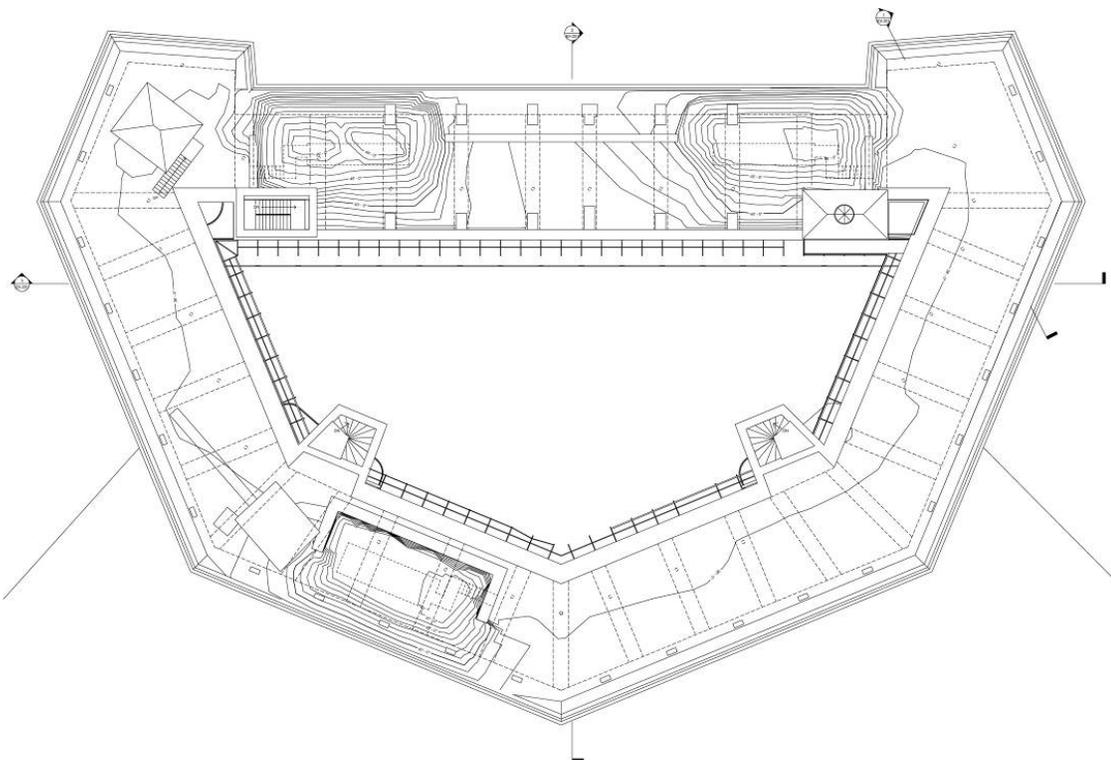
There is a system of 35 roof drains that collect rain water from the terreplein and drain it to downspouts located inside the masonry walls (See Figure 16). The earth on the terreplein is sloped toward the drains for suitable drainage down to channels below the parade grounds and possibly discharged out to sea. In recent years, this system has failed and allowed an excess of water to build up on the terreplein and pour into the vaults below.

Figure 16. Roof plan (BH+A)

Existing roof drains should be located, documented, and re-established down through the piers and walls to below-grade channels and existing drain pipes exiting the fort.

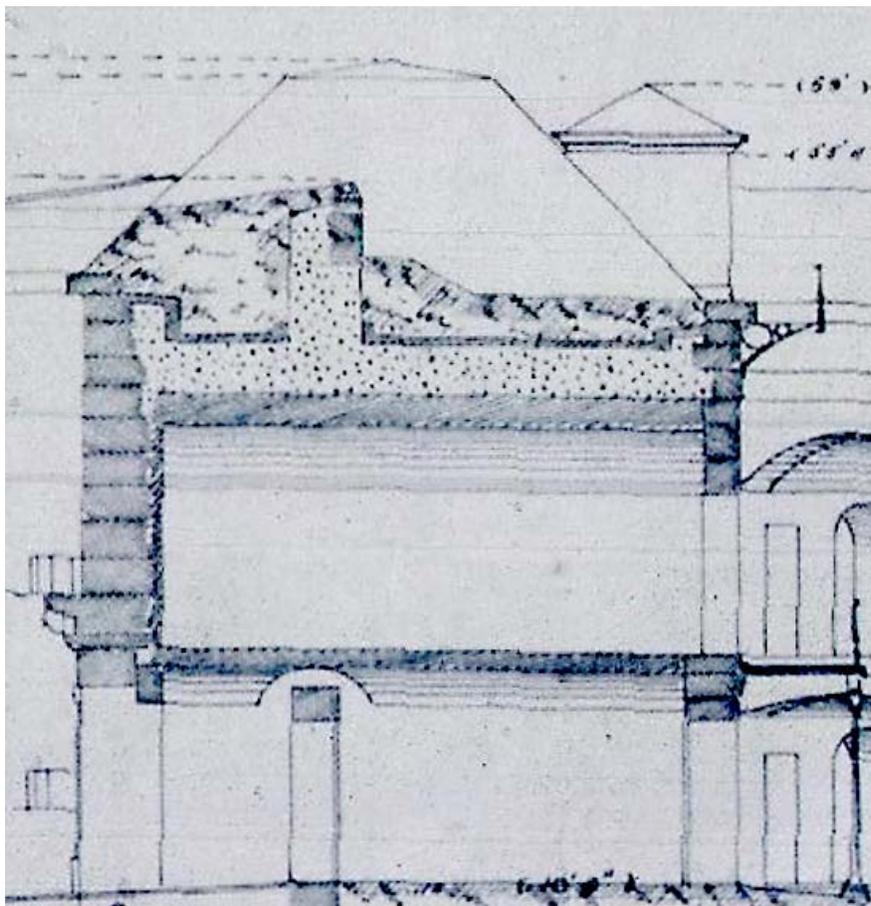
The terreplein, a once sculpted and maintained lawn and gun emplacement deck (Figure 17), is now overgrown with vegetation. Existing drawings of the fort show earth fill on top of a brick base. Between the brick layer and top of the brick ceiling vaults could be a layer of cinder concrete; indicated by a stipple pattern on the existing section (Figure 18). It is unknown if the gun emplacements were ever finished, but the existing drawings indicate that the foundations for the platforms were completed. The emplacements were designed for 10" or 8" Rodman guns, or 300lb, 200lb, or 100lb Parrott Guns. One section of the terreplein was excavated to reveal a concrete platform, a rusted pipe, and brick back-up for the stone parapet wall (Figure 20).

Figure 18. Section of fort walls from original drawings. Note layer of brick and cinder concrete below earthen terreplein.

Extensive water is seeping through the terreplein and draining down to the masonry ceiling vaults, walls, and arches below. To prevent further water deterioration, it is recommended to remove the earth fill above the casemates and barracks and stockpile suitable material for reinstallation. Introducing a waterproof membrane roofing system and flashings could prevent the water from further deteriorating the masonry below.

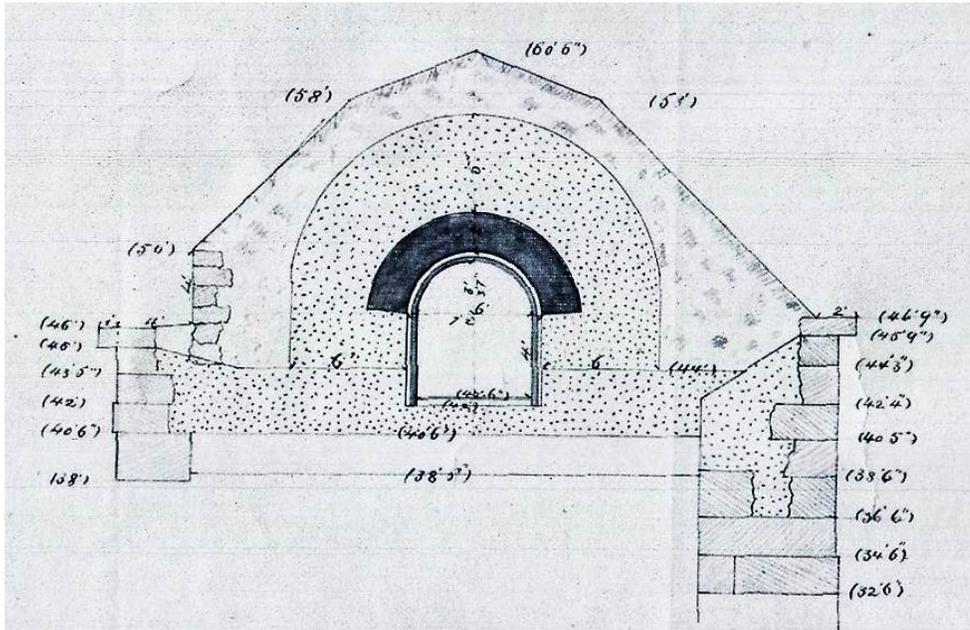
Figure 19. Section of magazine from original drawings. Note cinder concrete, retaining walls, and earthen terreplein construction.

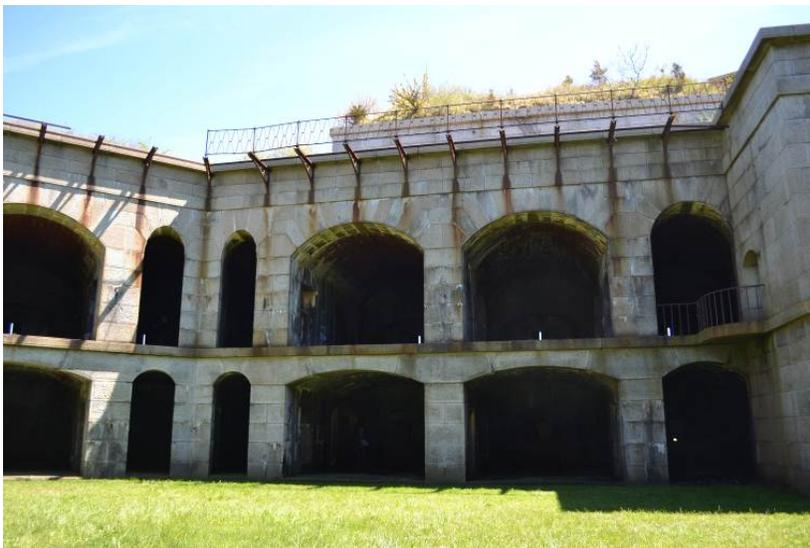
The parade elevations were constructed with more refined and smooth-cut granite blocks than the exterior. The casemate elevations are composed of granite arches and piers with two solid stair towers that jut out into the parade ground. The arches on the first tier are shallower than the arches on the second tier. The barracks elevation has door and window openings but functional doors and windows have been removed. A two story gallery on the barracks elevation has iron columns and a stone slab deck (Figure 24). Original intricate railings on the 2nd tier gallery seen in Figure 10 have been removed. In 2001, a graffiti removal project was commissioned to remove massive amounts of graffiti on the walls throughout the fort.⁸

Figure 23. Interior parade walls at casemates.

Remove inappropriate concrete patches at the brick walls and infill with brick. Dismantle or reconstruct brick furring walls at quarters for aesthetic or historical reasons. Remove vegetation from mortar joints and algae from granite. Remove graffiti and treat rust stains with a chemical cleaner. Remove efflorescence from masonry surfaces. Dismantle and reconstruct all shifted masonry at buckled walls. Pin-repair cracked granite lintels over doorways and use an epoxy injection at cracks in the granite. Epoxy-inject cracked granite stones and cut and repoint all granite and brick masonry. Removed and replace spalled brick where the masonry is to be reconstructed or repaired. Only remove the most damaged spalled brick where no other masonry repairs are needed.

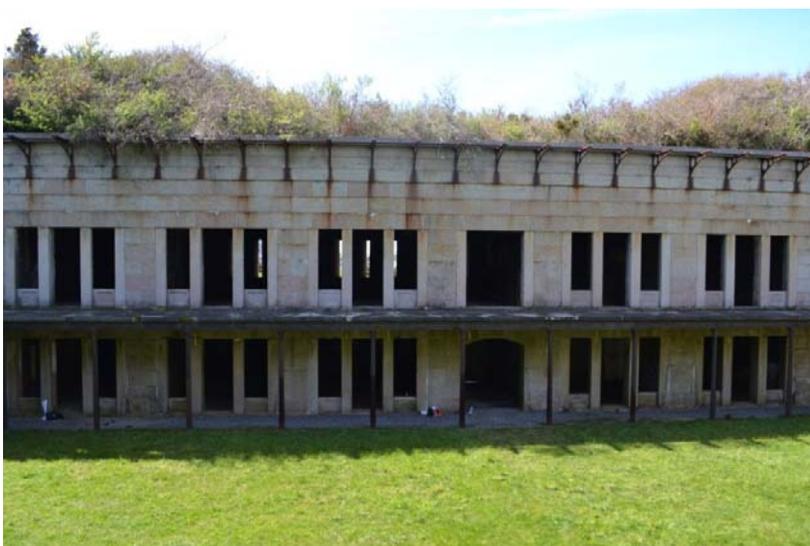
Figure 24. Interior parade walls at barracks.

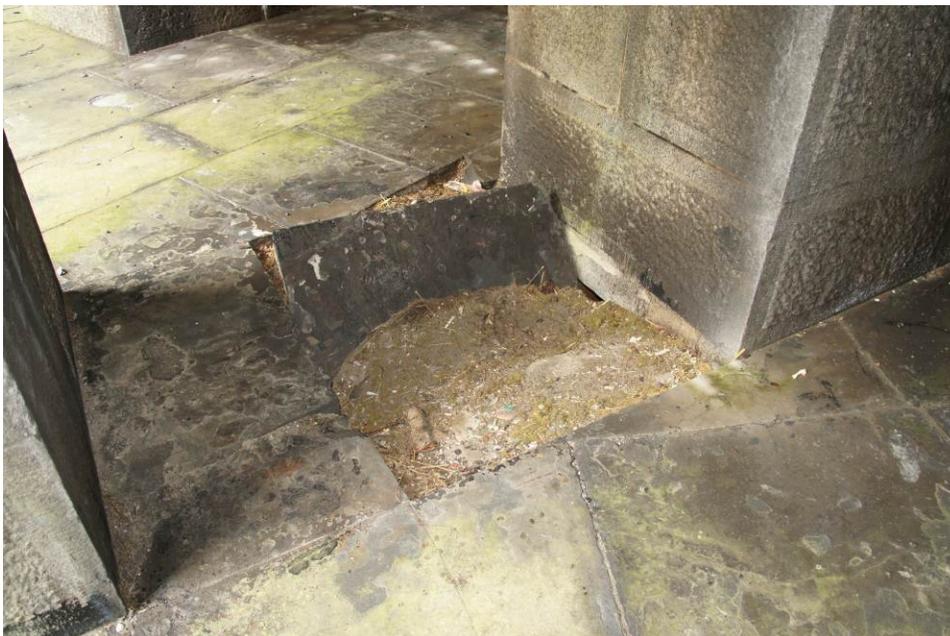
The 1st and 2nd-tier casemate floors are made of bluestone pavers set into grout. For the most part, these stones are in good condition. Some of the floor surfaces are covered in debris and it is difficult to see the condition of the stone. Some stones have collapsed over drainage channels at the 1st-tier floor (Figure 30). Some stones have shattered or disintegrated and now pose tripping hazards (Figure 31). Green algae has formed on the stones that do not get sunlight during the day.

Figure 30. Collapse of bluestone over drainage channel.

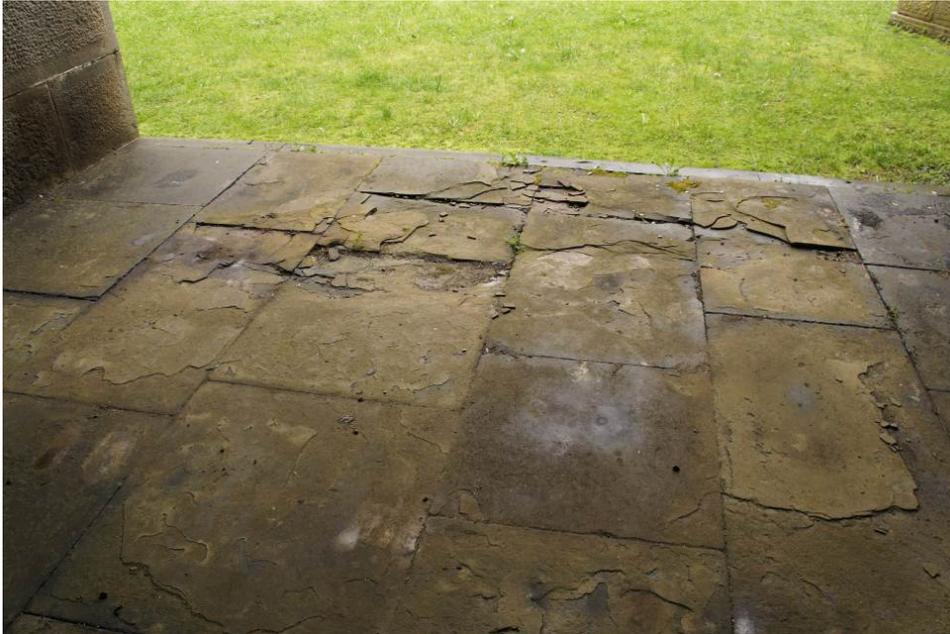
Figure 31. Shattered bluestone slabs at 1st-tier.

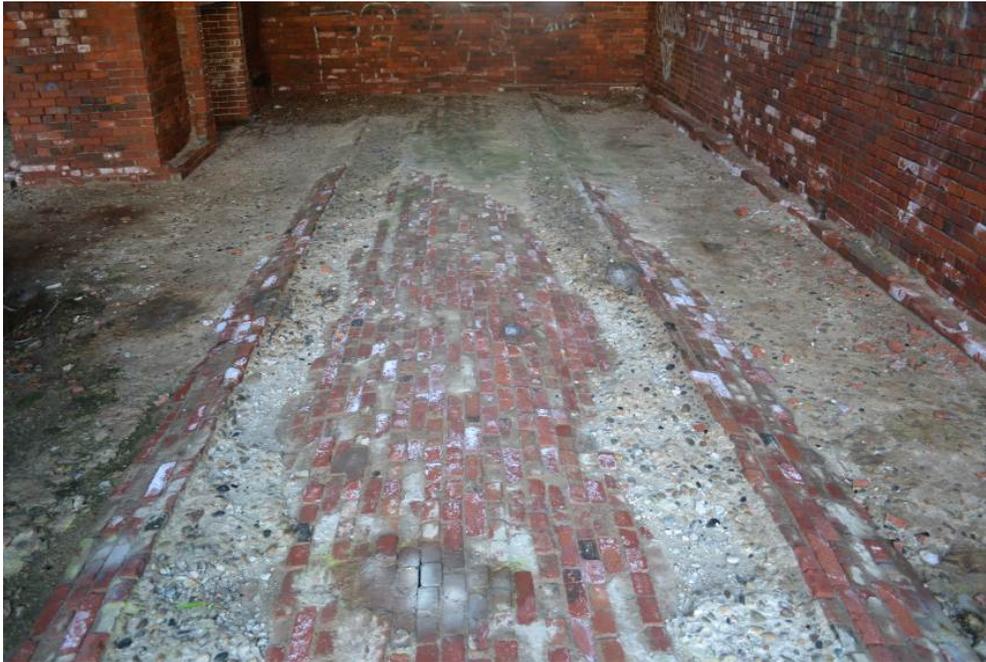
The 1st-tier barracks have compacted dirt floors that are anywhere from 4" to 9" below the stone door threshold. During later renovation into a "power plant," the southwest barracks has a poured concrete floor and four raised concrete pads. The 2nd-tier barracks floors are interesting because they expose the top of the 1st-tier barrel vault ceiling. Concrete with large stone aggregate fills in the uneven floor at the interior walls and low points of the vault (Figure 32).

Figure 32. Top of barrel vault on 2nd-tier floor of barracks.

At the 1st and 2nd-tier magazines and 1st-tier barracks with depressed or sunken floor levels, document existing conditions, remove debris and provide new compacted fill at floor. Align finish grade with existing door thresholds and walking surfaces to make accessible. At the 2nd-tier barracks, provide a wood boardwalk over a portion of the existing floor but leave a portion of the floor exposed to show the top of the brick vault and concrete construction. See Accessibility Option A for proposed area of boardwalk.

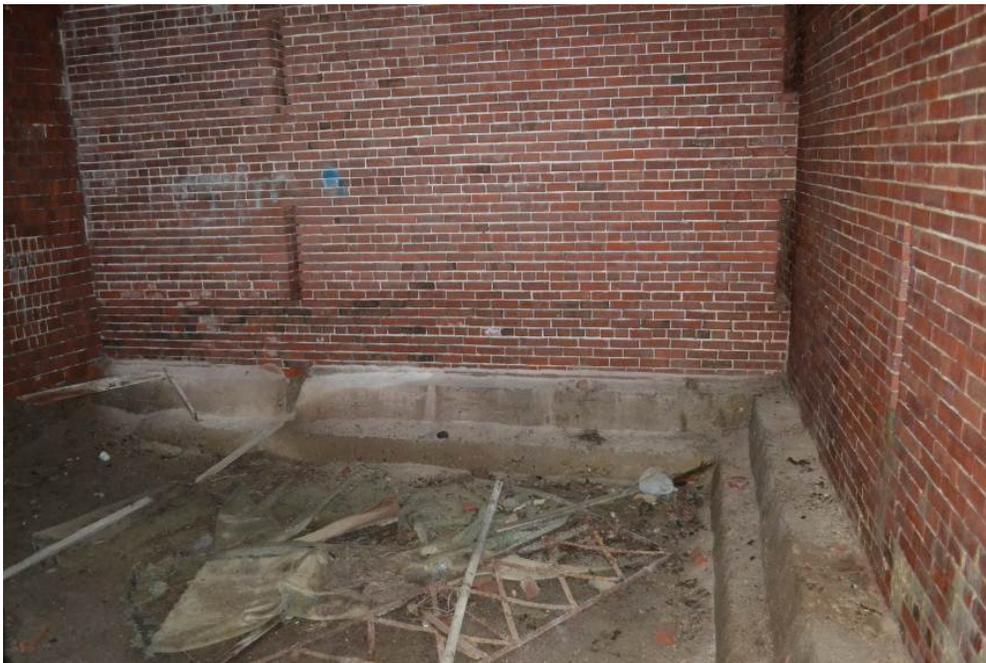
The 1st-tier magazine floors are depressed about 1'-6" and have stepped concrete around the perimeter walls (Figure 33). The 2nd-tier floors are dirt with remnants of wood framing members and wood floor boards. The boards are now deteriorated, but the southwest magazine floor is a good representation of what the floor used to look like (Figure 34).

Figure 33. Depressed floor in southwest magazine room on 1st-tier.

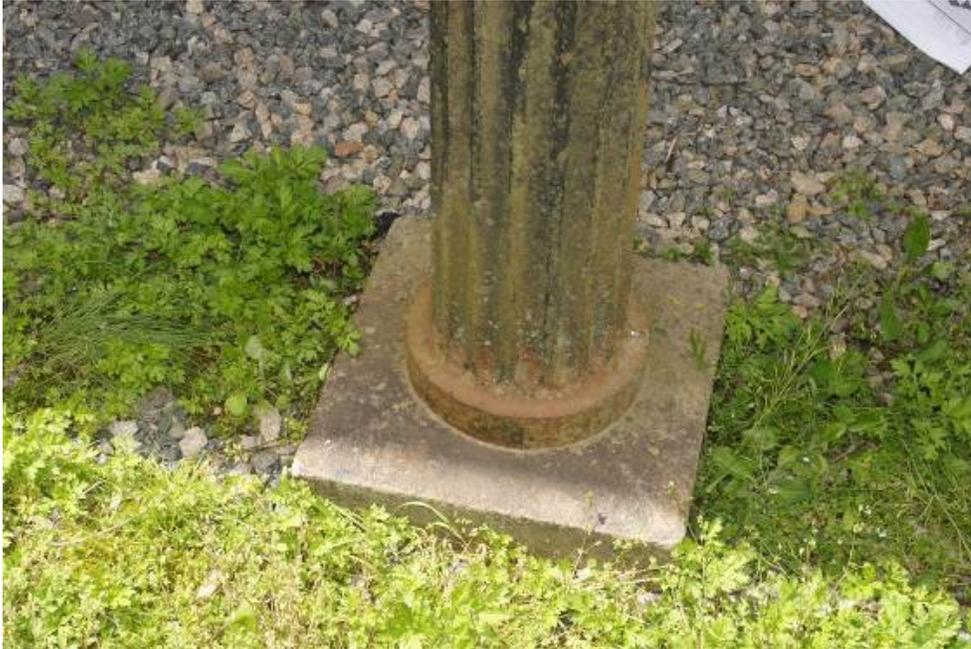
Figure 37. Column base is slightly covered with existing gravel walkway.

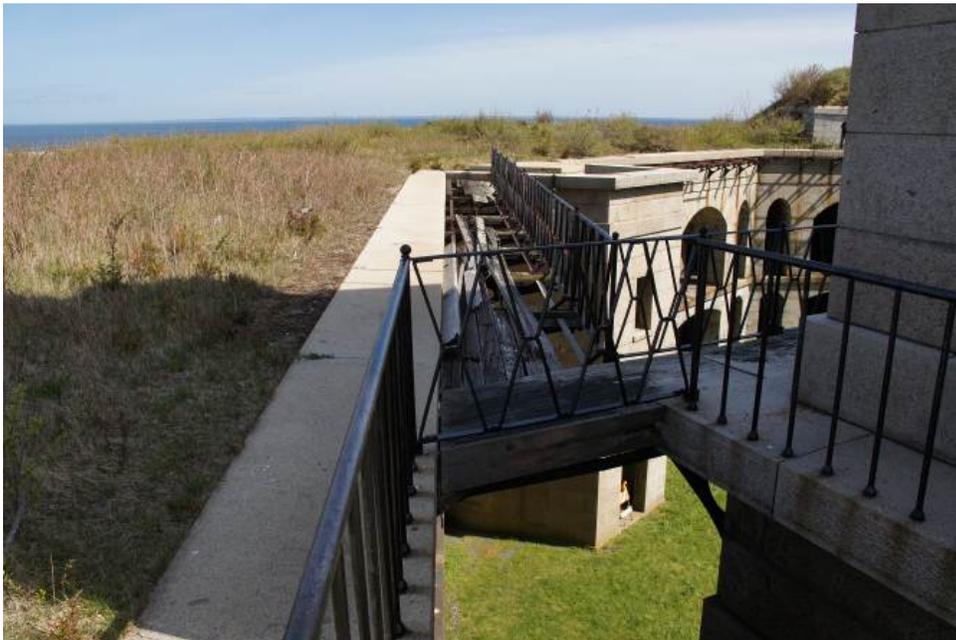
Figure 39. Existing guard rails and wood decking at lighthouse.

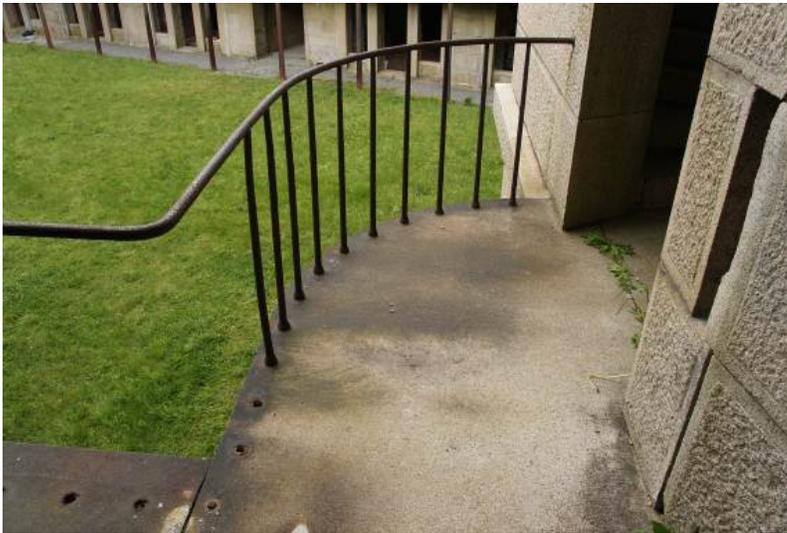
Figure 40. Existing railing assembly at circular granite stair tower.

Measure and document the existing railing assemblies currently stored on the 1st-tier. Remove rust in situ and apply a zinc-rich primer and 2-3 epoxy finish coats. Restore the cast-iron posts by casting replicas in aluminum or fiberglass and fabricating wrought-iron guardrails to match originals. Finish restored assembly of old and new components with appropriate primer and epoxy finish coats.

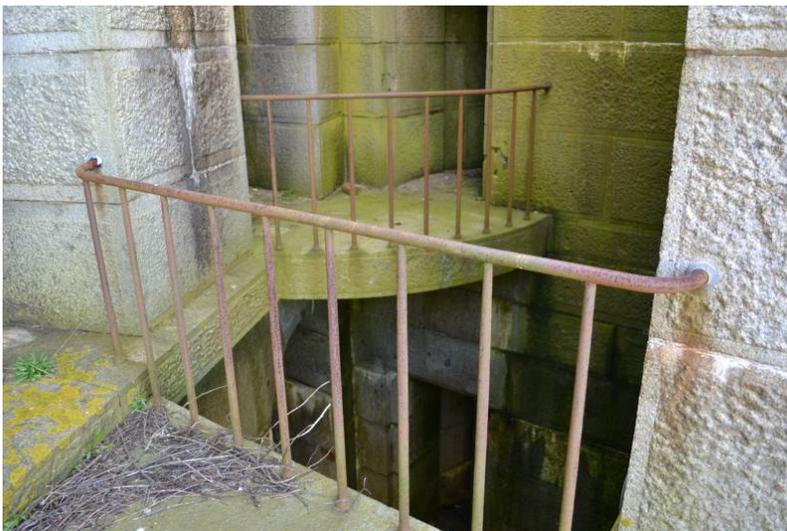
Figure 41. Existing railing assemblies at 2nd-tier gallery and magazine entrance.

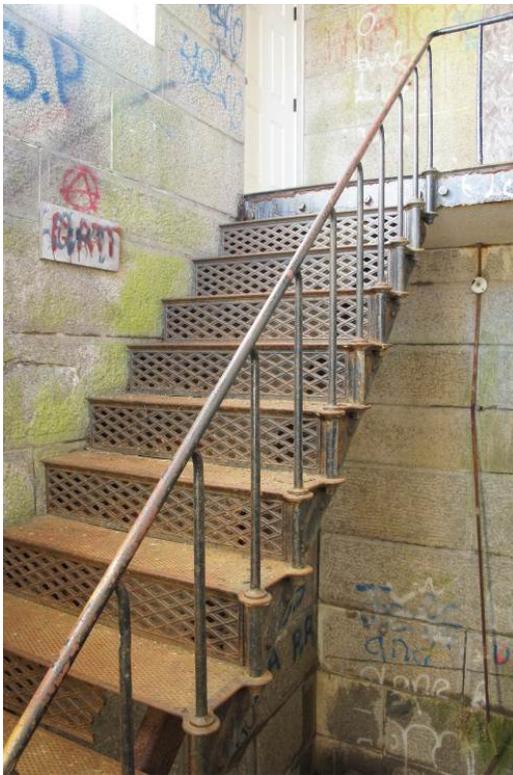
Figure 42. North stair at roof level.

Document and remove the southwest stair at the time of installation of a LU/LA elevator. Salvage the southwest stair for spare parts to restore the north stair. Remove rust in situ and apply zinc-rich primer and 2-3 epoxy finish coats throughout. Restore the north stair assemblies (stair treads/risers, stringers, balusters, handrails) by casting replica components in aluminum or fiberglass or reusing components from the southwest stair.

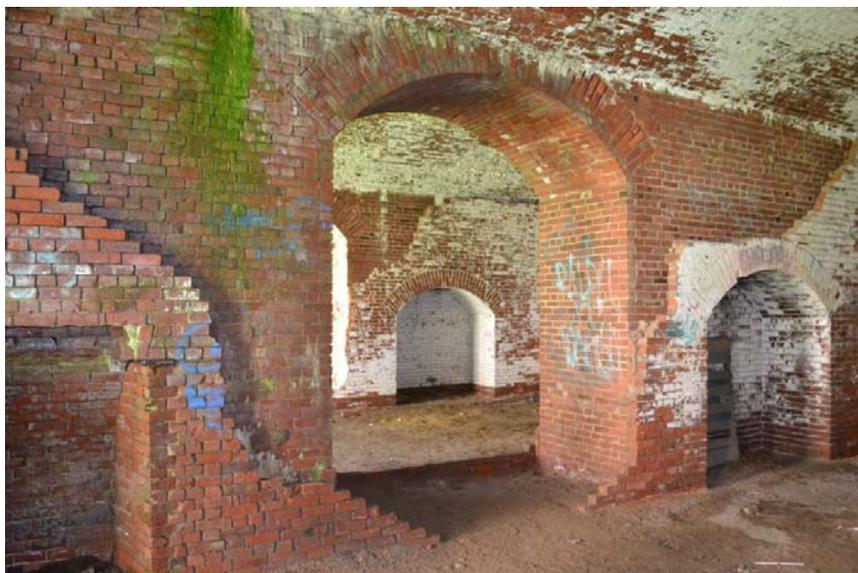
Figure 45. Interior brick masonry walls with arched openings. Furring walls have been removed in many barracks.

As an optimal scope, full restoration is recommended for one 1st-tier and one 2nd-tier barracks, including masonry veneer walls, fireplace surrounds and painted beadboard ceiling on wood furring joists. At the restored and interpreted quarters, provide an accessible floor surface, such as stonedust, lightweight concrete fill, or wood tongue-and-groove flooring on pressure-treated joists and sleepers. More research is needed to determine historical accuracy for wall, floor and ceiling surfaces.

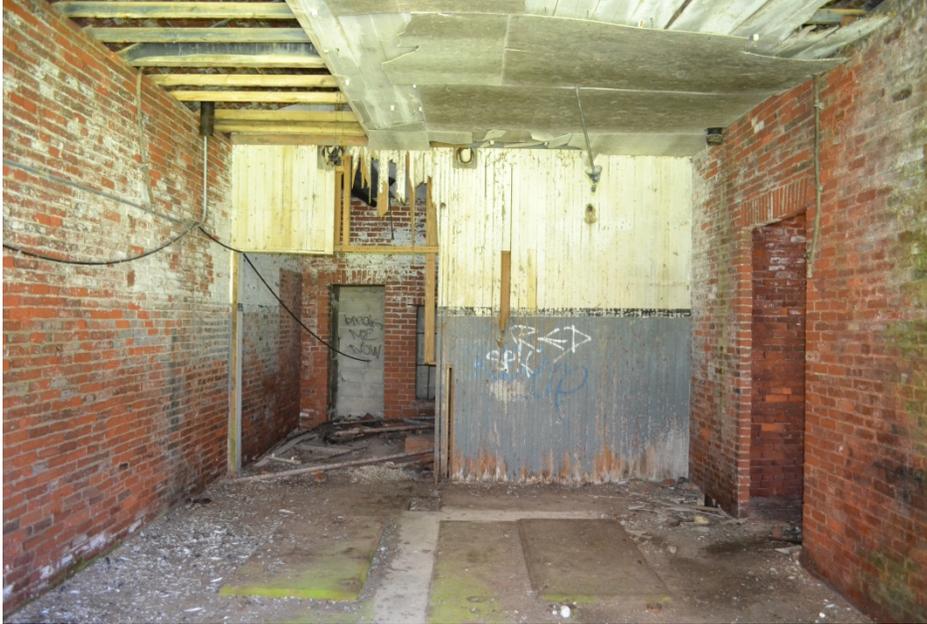
Figure 46. Southwest barracks "power plant".

At 1st-tier southwest barracks, stabilize the mostly intact wood ceiling joists and beadboard ceiling finish. Remove the modern frame partition and suspected asbestos transite ceiling panels. Provide beadboard infill at northwest barracks ceiling to match the existing. Retain concrete pads of the former "power plant."

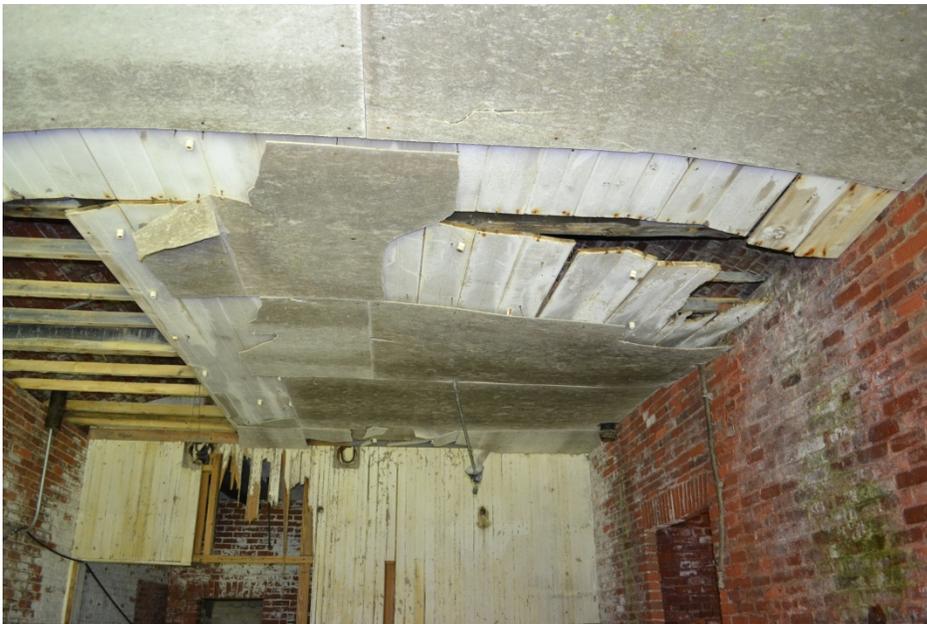
Figure 47. Transite panels on top of wood beadboard and ceiling furring joists.

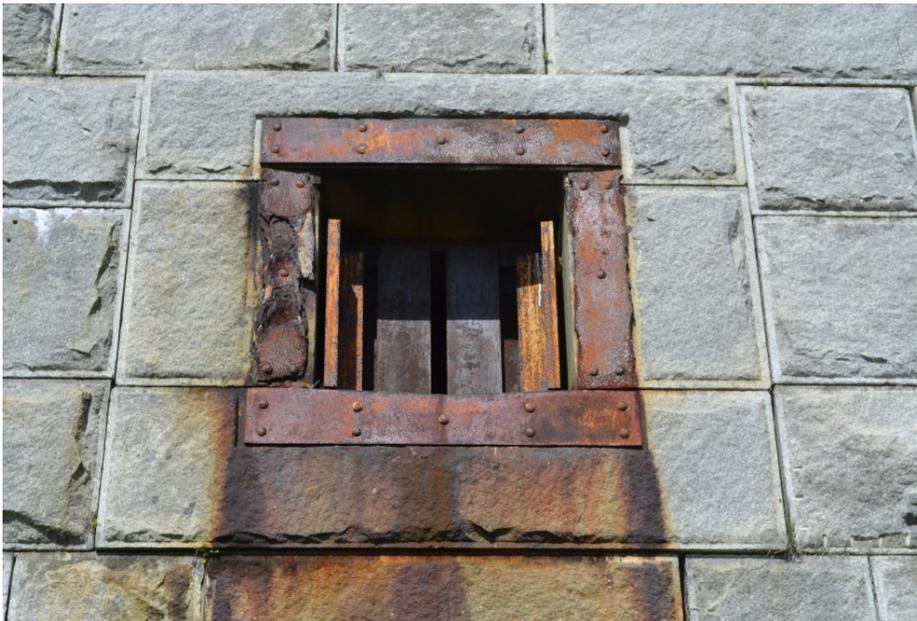
Figure 49. Rodman canon embrasures on all other elevations. Note metal barriers and extant Totten shutters in the open position.

An optimal scope would be to restore one casemate embrasure to full operation, including iron Totten Shutters and associated bronze hardware. Partner with the Military Museum and other organizations to include a Rodman Gun exhibit. See Figure 51 of Rodman gun at Fort Jefferson in Florida.

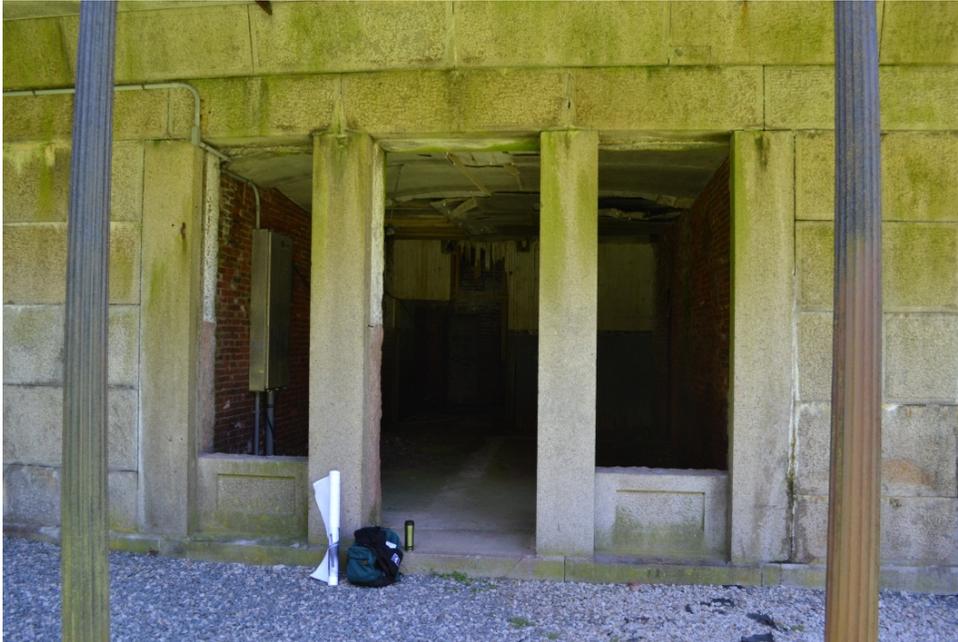
Wood doors and windows originally lined the northwest parade elevation on the 1st and 2nd tier. The double hung windows were tall and narrow and fit in the existing granite trim openings. In 1975, the City of New Bedford commissioned a project to reproduce the wood doors and windows in the celebration of the Bicentennial in 1976 (Figure 53). In the 1980's, vandals removed all of the doors and windows and stole them as salvage materials.¹⁴

Figure 52. Barracks door and window opening on the 1st-tier.

For a basic scope, art students could reinterpret the original door and windows of one barracks by painting plywood and attaching in to the masonry openings. A more costly option would be to reconstruct one operable door with transom and two window assemblies at one 1st-tier and one 2nd-tier barracks, including period-appropriate hardware.

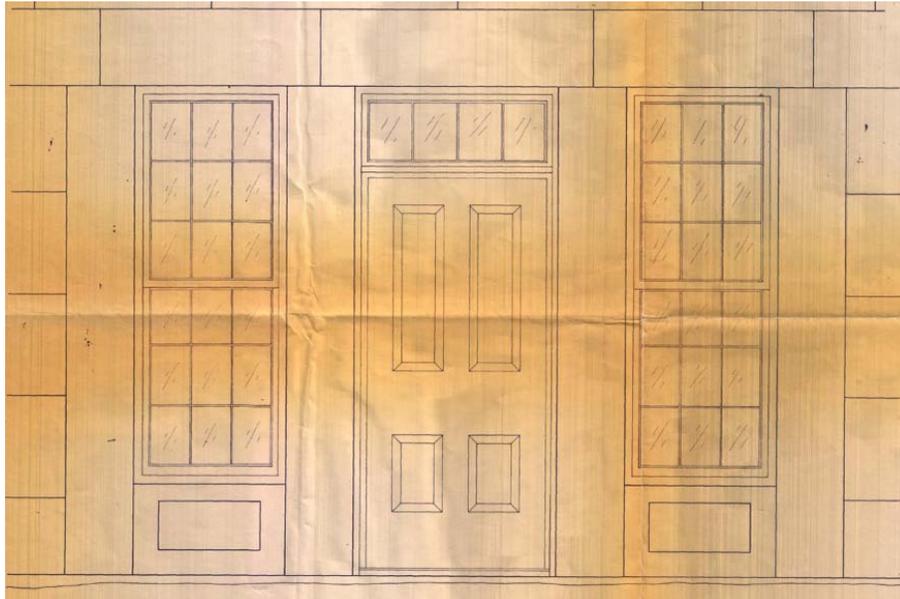
Figure 53. Drawings of door and window elevations from the New Bedford City Planning Department in January, 1975. The original door had a glass transom above it.

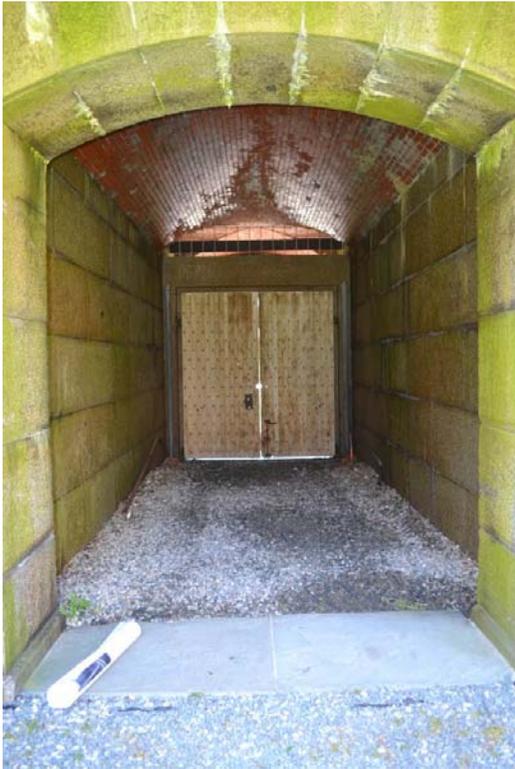
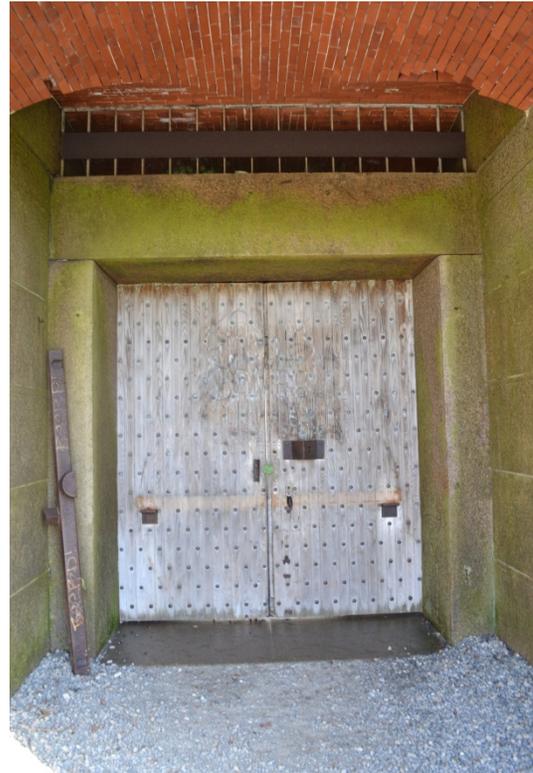
The original heavy wood doors to the entrance of the fort are still in working condition. The doors are made of small planks that have alternating bolts for reinforcement. A metal bar slides over the doors and is locked from the outside. During special events and public visitation, these doors are left in the open position so visitors do not have to close the heavy doors. The wood is weathered but in fair condition.

Figure 54. View of door and sally port from interior of fort. Figure 55. View of doors from exterior sally port.

Renew finishes on the door. Remove modern security hardware at the wood doors. Provide a new operable, welded steel gate assembly inboard of the inswinging doors that allows the original doors to remain open for after-hours views into Fort. Include integral cylinder locks and deadbolts.

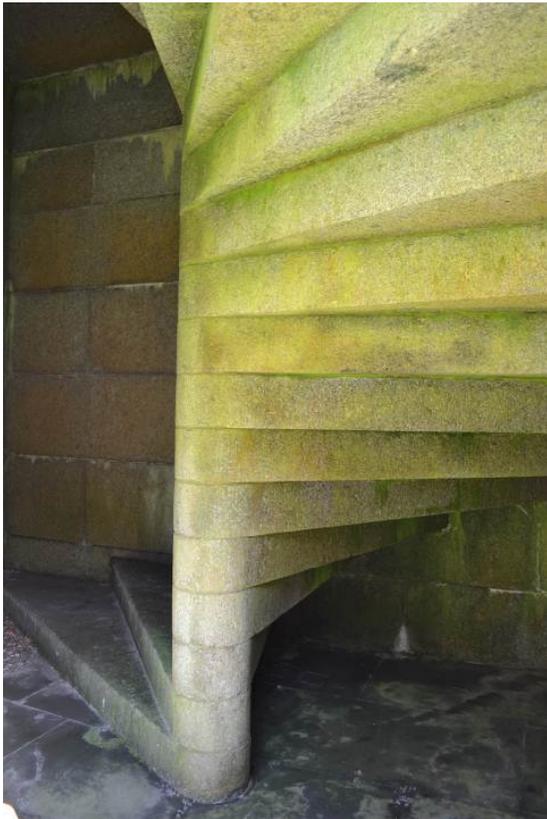
Figure 56. Base of granite spiral stair tower.

In coordination with USACE DERP-FUDS safety improvements, provide color-galvanized steel or painted, HDG steel handrails at the east spiral stair tower for three flights. Before the public use the south spiral stair tower, handrails should also be provided. Provide supplemental guardrails to meet height requirements of the current building code for the north stair tower.

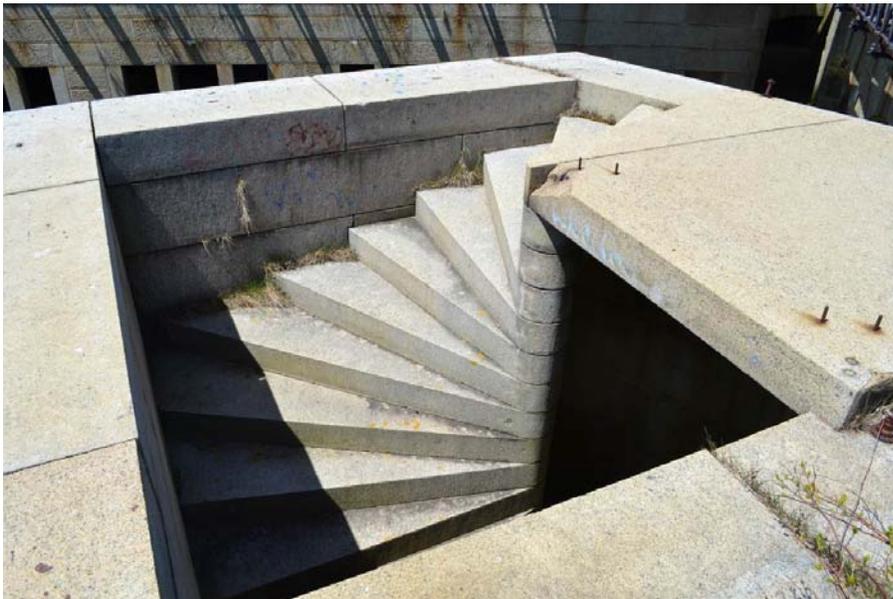
Figure 57. Top of East of granite spiral stair tower. Note historical photograph (Figure 10) with wood roof structure on top of stair tower.

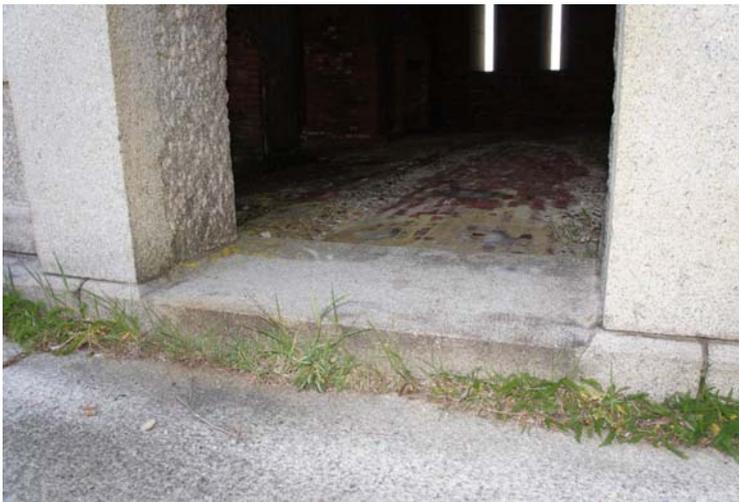
The site walkways that lead from the parking lot to the fort are accessible, but once in the sally port, the granite sett walkway ends and a gravel walkway begins. The gravel stones are too large and loose to meet the requirements of American's with Disabilities Act (ADA) and the Massachusetts Architectural Access Board (MAAB). The gravel walkway continues under the gallery to connect the north and south casemates. All of the interior spaces in the fort are not accessible because of a 3"-6" change in elevation from the parade ground to the barracks doorways and casemate entrances. The MAAB allows an elevation change of ½" maximum. The elevation change from the barracks door thresholds into the interior of the rooms differs from 3"-9" in certain areas. On the 2nd-tier stone gallery, the elevation change from the walkway to door threshold is about 3"-4" inches (Figure 58). Once in the casemate spaces, the deteriorating canon rails pose a tripping hazard as well as the spalling stone floor surfaces. The 2nd-tier barracks floor surfaces are uneven and not considered accessible surfaces.

Figure 58. High threshold of 2nd-tier barracks.

Once a wheelchair lift or LU/LA elevator is installed and the 2nd tier is accessible, a wood boardwalk can be provided on a portion of the 2nd-tier gallery that would be raised to align with the level of the door thresholds. The wood boardwalk would only be provided on a short section of the gallery and a few of the interpreted barracks and casemate rooms. Safety guardrails should be provided at edges of the boardwalk. See Accessibility Options A & B in the Appendix for plans and perspectives.

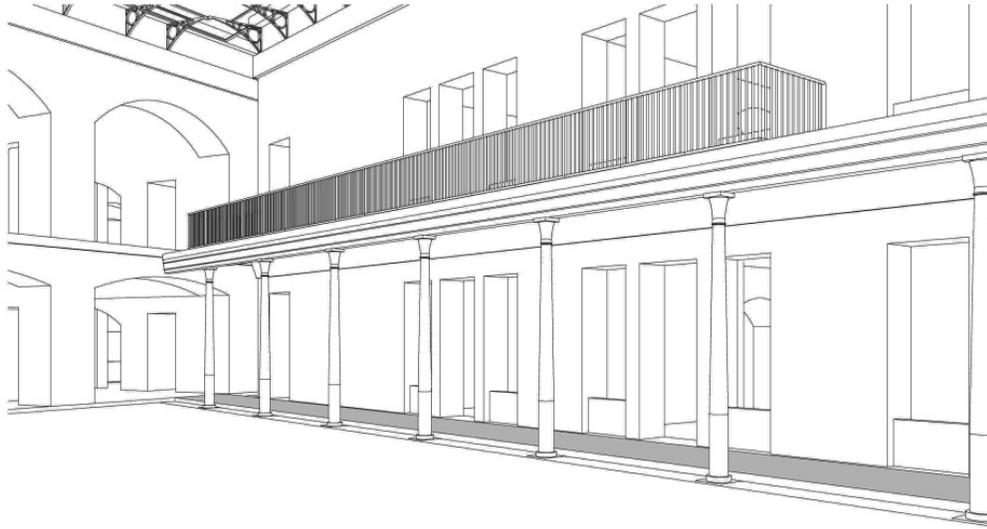
Figure 59. Proposed walkway aligns with threshold on 1st and 2nd tier to access barracks.

Remove or compact crushed stone fill at the sally port and 1st-tier gallery. Provide a stonedust path surface (4" thick) between the fort wall and cast iron columns at the parade level gallery to meet the existing stone threshold of the 1st tier barracks (Figure 59). Provide an ADA-compliant sloped walkway at the sally port to connect the exterior site walkways with the raised pathway at the interior. A slope of 1:20 or less than 5% is considered a "walkway" and does not require handrails. Fill in the 1st-tier barracks floor with dirt or stonedust fill to meet the elevation of the existing stone door threshold. Stonedust walkways can also be extended across the parade to the stair towers. See Accessibility Options A & B in the Appendix for plans and perspectives.

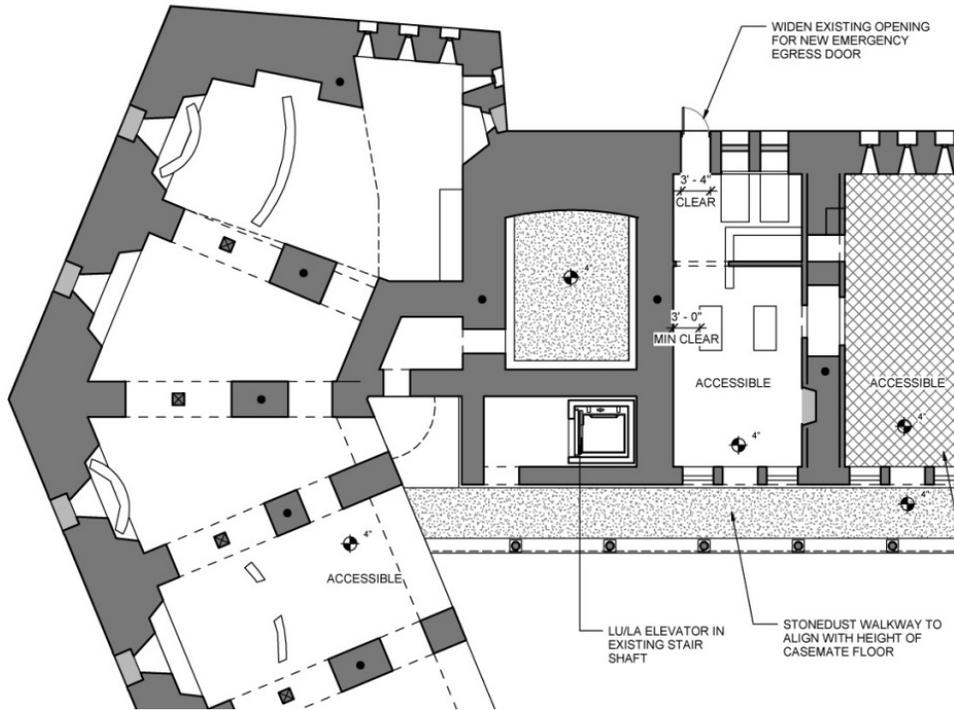
Figure 60. Accessibility Option A. Remove west metal stair for LU/LA elevator to 2nd tier.

Accessibility Option A (see Appendix) proposes to document and salvage the west metal staircase and insert a Limited Use/ Limited Application (LU/LA) elevator in the existing stone shaft (Figure 60). A LU/LA elevator is less costly and smaller than a conventional elevator, but has a height restriction. This type of elevator only travels 25 feet, therefore, could not go to the terreplein level. If terreplein access is necessary, a conventional elevator should be used. The elevator would need to be small enough to fit in the existing stair shaft. The visitors would access the new elevator through the existing doorways on the 1st and 2nd tier. The benefit of this option is that the elevator would be nearly invisible in the existing stair shaft, but would require a physical impact - the demolition of an original staircase.

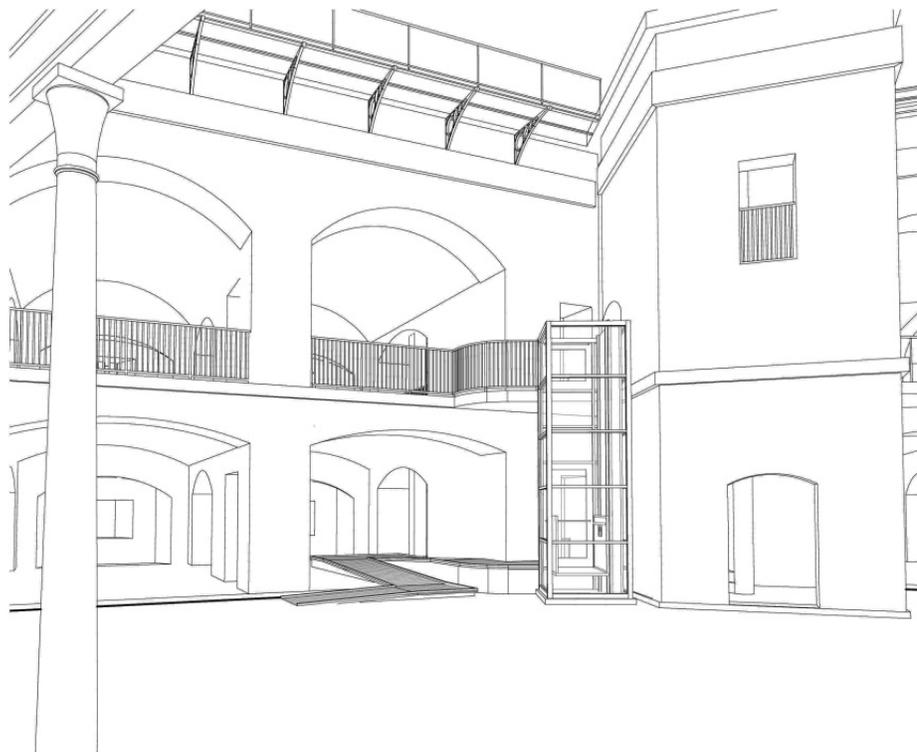
Figure 61. Accessibility Option B. Wheelchair lift with walkway.

Accessibility Option B (see Appendix) explores a low-impact, less expensive option to the LU/LA elevator. This option proposes to install a partially-enclosed vertical wheelchair lift adjacent to the east spiral stair tower (Figure 61). A ramping double-back boardwalk with 2" high wheel-guards leads to a slightly elevated wheelchair lift landing 12'-0" (elevator code) below the top landing. This boardwalk would be at a slope of 1:20 and would not require handrails. The existing 2nd-tier landing that is missing its original railings would be repurposed as the wheelchair lift platform.

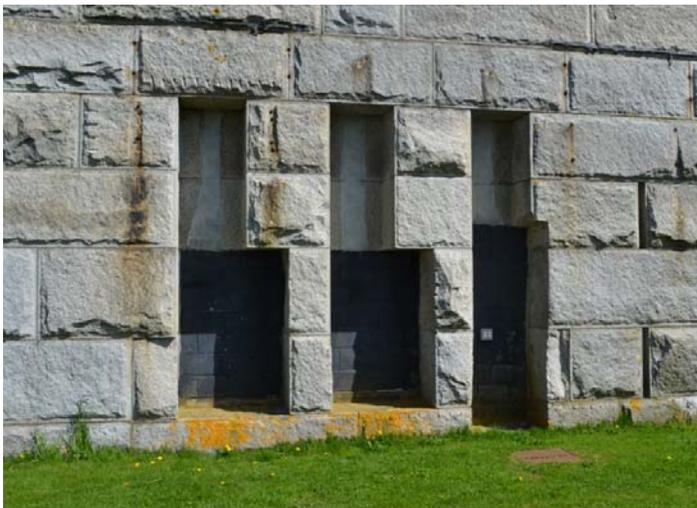
Figure 62. Possible second egress door at northwest elevation of fort.

Remove the concrete block infill at the door and windows in southwest barracks (“power plant”). Enlarge the masonry door opening as required and provide a new steel door and frame with exit hardware for the second means of egress.

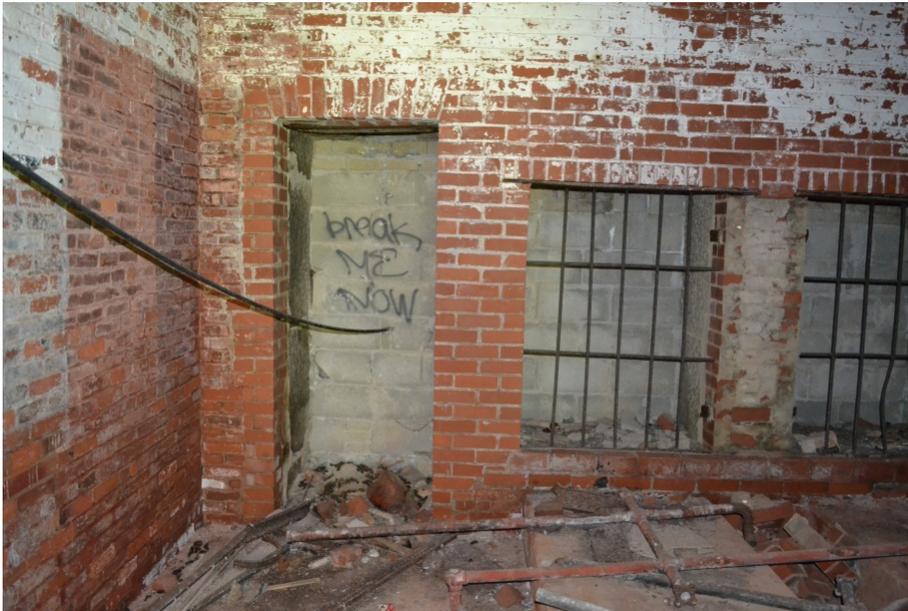
Figure 63. Interior of egress door at "power plant."
