Fort Taber / Fort Rodman
New Bedford, Massachusetts

**Architectural / Structural Assessment
& Feasibility Study for Universal Accessibility**

Final Report

Bargmann Hendrie + Archetype, Inc.
Boston, Massachusetts

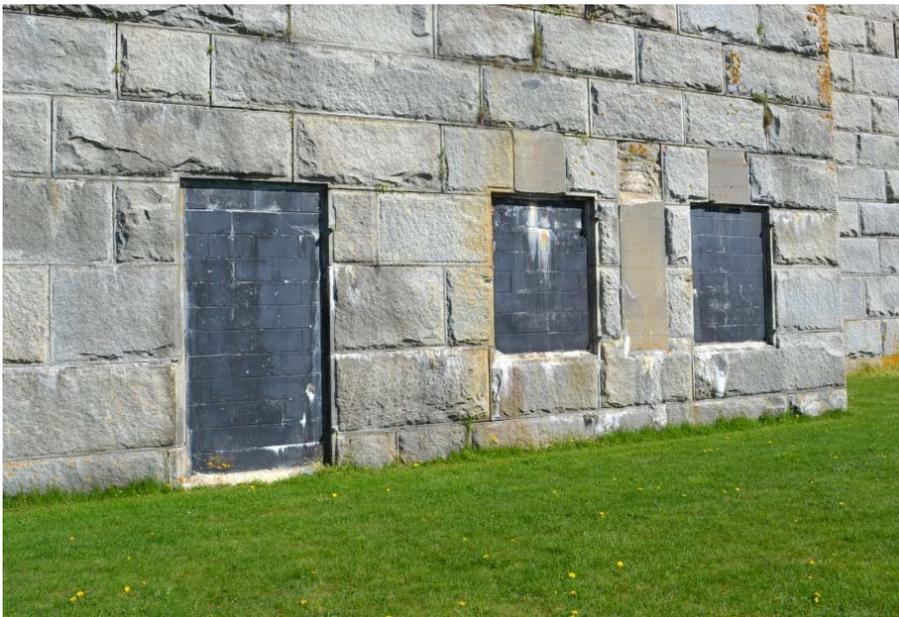
Figure 64. Door into mine control room does not access the rest of the fort.

If an opportunity for interpretation arises, the control room mine casemate could be opened for a learning experience. Remove the concrete block infill at exterior face of existing door and window openings and provide a new steel door and frame as well as welded steel gratings at window openings. Although challenging, an exit tunnel through the concrete mine casemate could be cored to provide a new egress path and connection to the interior of the fort. Interpretive waysides at the mine control room could describe the purpose for 1899 addition of the mine casemate and materials encountered.

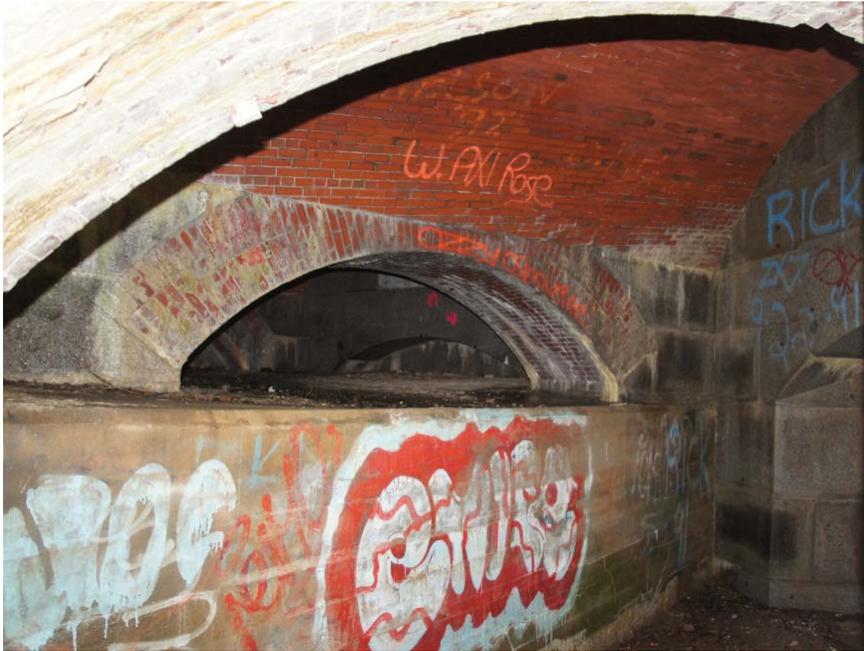
Figure 65. Thick area of concrete at 2nd tier.

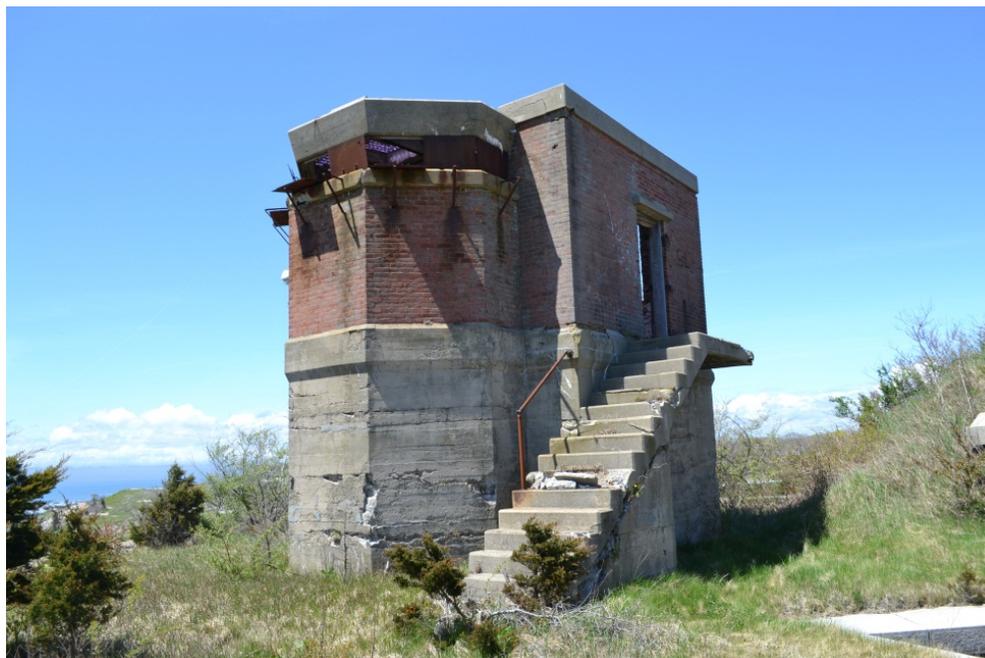
The fire control tower is in poor condition. The concrete stairs and base are spalling and exposing the rusting rebar (Figure 70). The glass at concrete roof is mostly intact, but action should be taken to stop deterioration and preserve the original glass lenses. The concrete roof beams are in poor condition because of rusting exposed rebar and large amounts of spalled concrete. The second level brick walls are in fair condition but have structural cracks and staining from rusting iron brackets. The glazed tiles on the interior are spalling and the metal window shutters are rusted (Figure 71).

Figure 69. Fire control tower for observation activity in the harbor and bay.

Provide shoring beneath the reinforced concrete stair, as required. Reset loose masonry and provide epoxy injection repairs at major cracks. The cracked brick masonry at the south elevation should be dismantled and re-set. The backup masonry should be reviewed and repaired as needed. All embedded metal to remain should be cleaned and painted. Prep and refinish exposed metalwork (e.g. railings, shutters and associated hardware). Treat exposed rebar and repair/patch concrete at access stairs. Repair the existing concrete roof structure and walls. At the roof, epoxy repair broken glass lenses and provide custom-fabricated purple glass replacements.

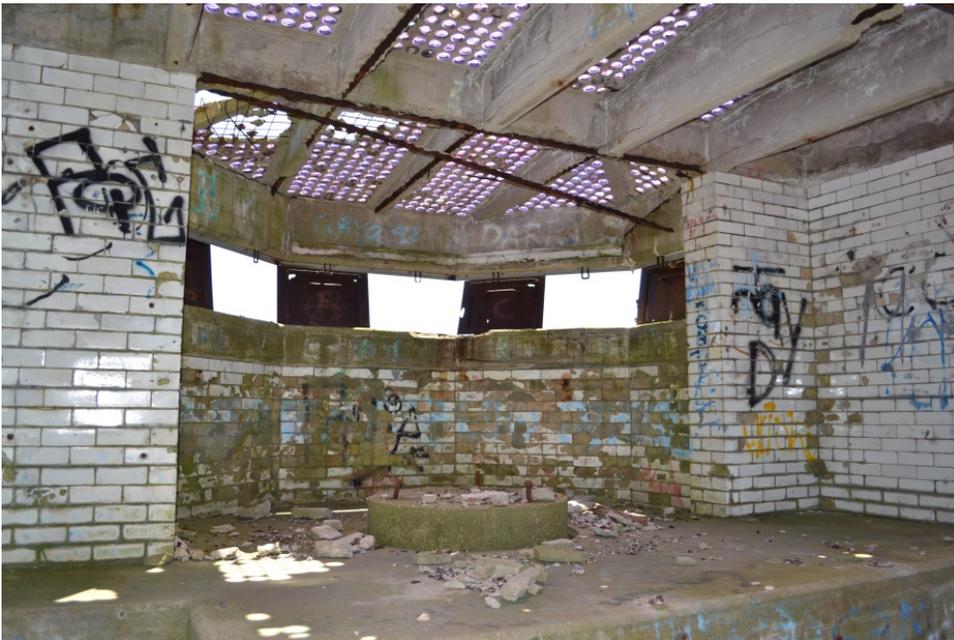
Figure 71. Interior of fire control tower.

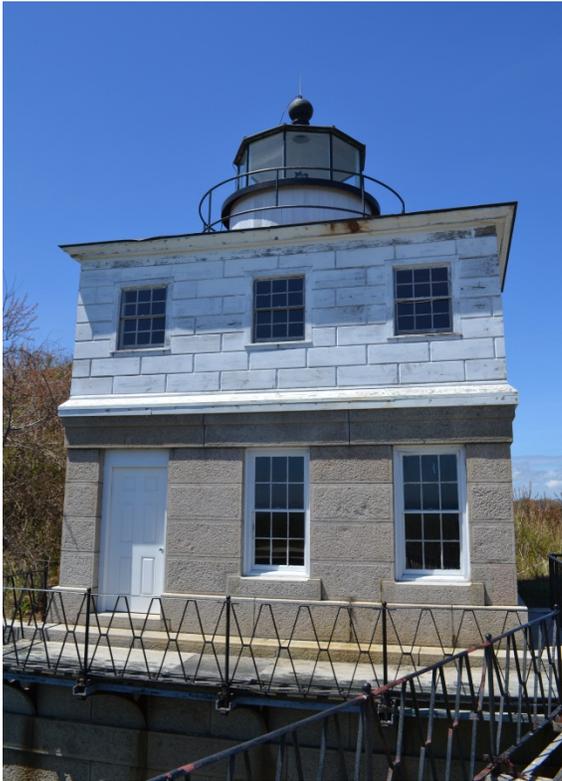
The lighthouse shack has wood siding to resemble cut stone and has small, double hung windows along the north and east sides. The paint on the wood trim, siding, windows, and fascia is peeling and wearing thin. The window glazing is deteriorating and peeling off the windows.

Figure 73. Lighthouse at north corner of terreplein.

Scrape and repaint exterior wood siding and trim. Reglaze windows as needed, prep surfaces and repaint. Remove vegetation from mortar joints and repoint mortar joints as required. Replace existing door with historically appropriate stile-and-rail door.

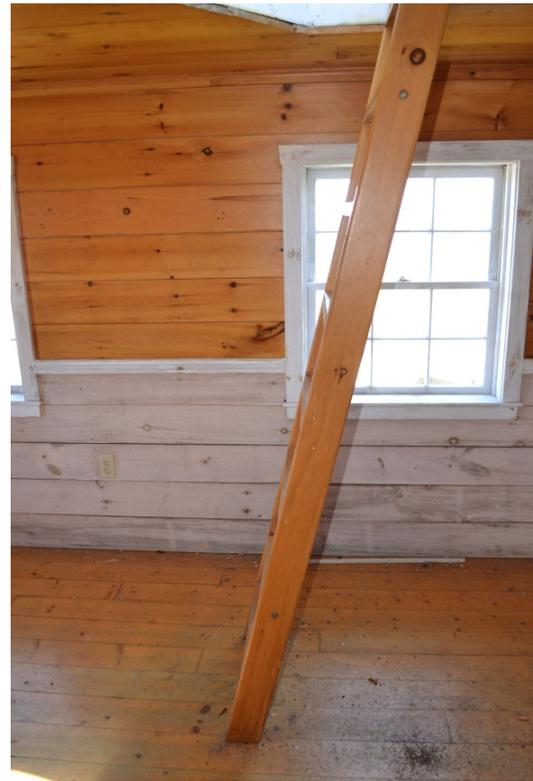
Figure 74. Steep wood ladder to access observation deck and light.

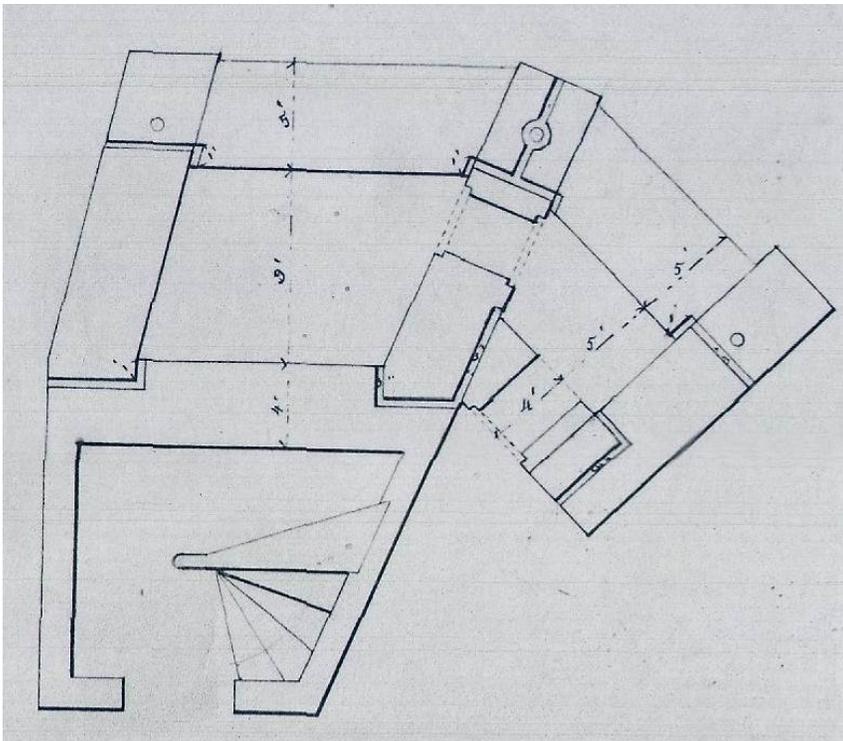
Figure 77. Original plan shows drainage downspouts and air channels in masonry walls

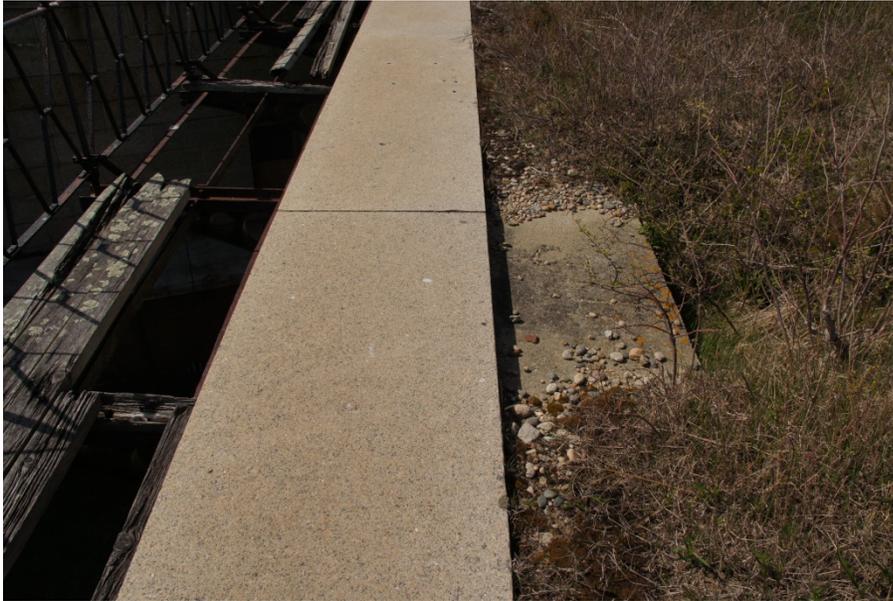
There are no plumbing systems in the fort that are recognized by the modern plumbing code. There is a system of water drains and channels in place throughout the fort to collect the water from the terreplein and bring it down to the ground and out of the fort. There are about 35 roof drains that collect rain water from the terreplein and drain it to downspouts located inside the masonry walls (Figure 77). The interior conditions of the drains are unknown. The drains run down through the 2nd and 1st-tier masonry piers and most-likely connect to a perimeter channel under the parade ground. These water channels can be seen in Figure 79 & 80.

Figure 78. Drainage channel at interior parapet at terreplein.

The roof drains should be cleaned out and viewed by a drain camera to assess their condition and the possibility of reusing them. If not in suitable condition, it may be possible to install liners using a polymer based flow able sleeve. New or existing roof drains could be re-instated to drain to the parade ground channels underground drainage system and out of the fort. In-depth review would be needed for the downspouts, underground drainage, and drainage system outside the fort walls.

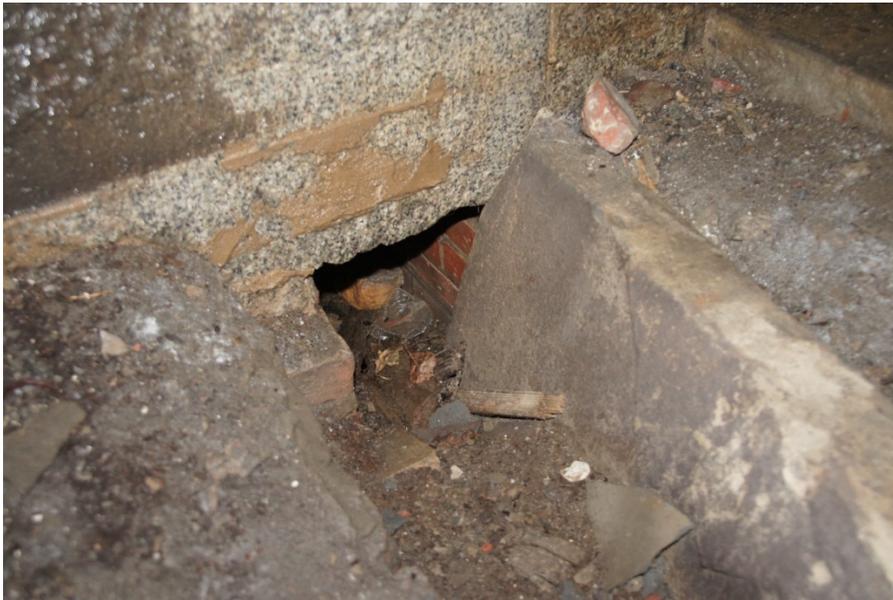
Figure 79. Collapsed drainage channel at base of 1st-tier granite pier.

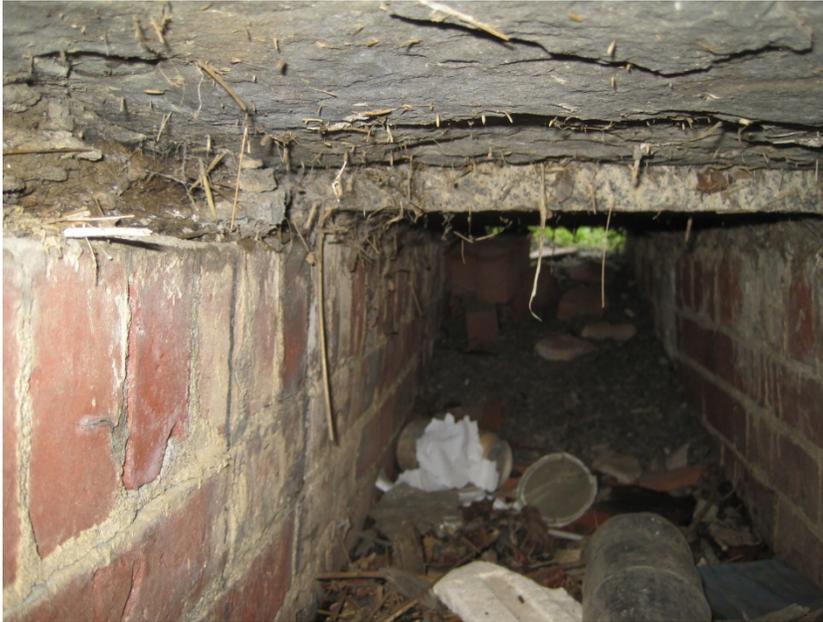
Figure 80. View of interior of drainage channel at 1st-tier.

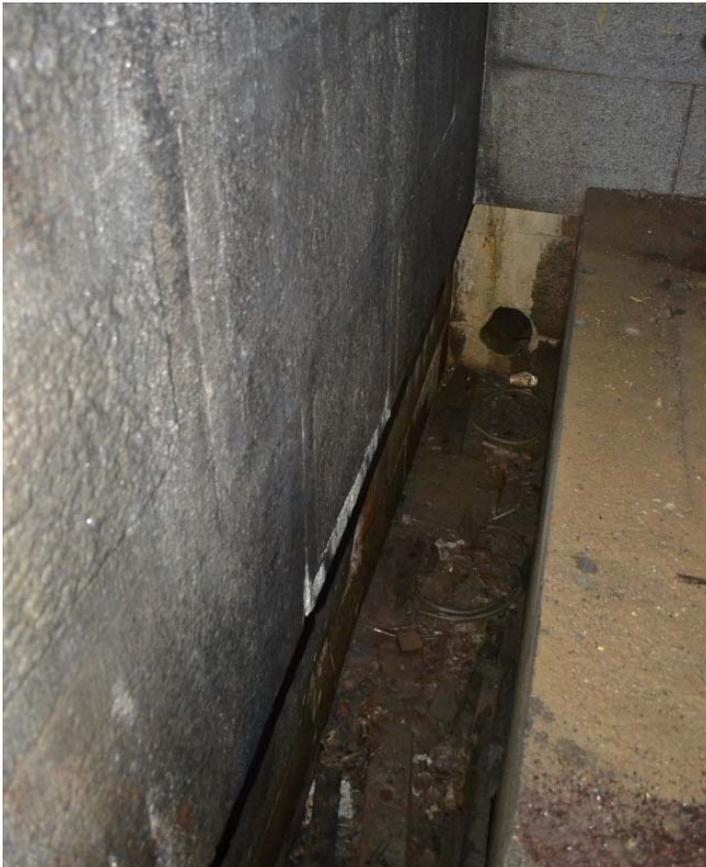
Privies on the first floor are indicated on the original drawings and a water trough was found in the southwest casemate. The privies were most-likely over the water trough and drained into a tidal cistern where the waste would wash out to sea during the changing of the tides (Figure 81 & 82).¹⁸

Figure 81. Privy trough in southwest casemate.

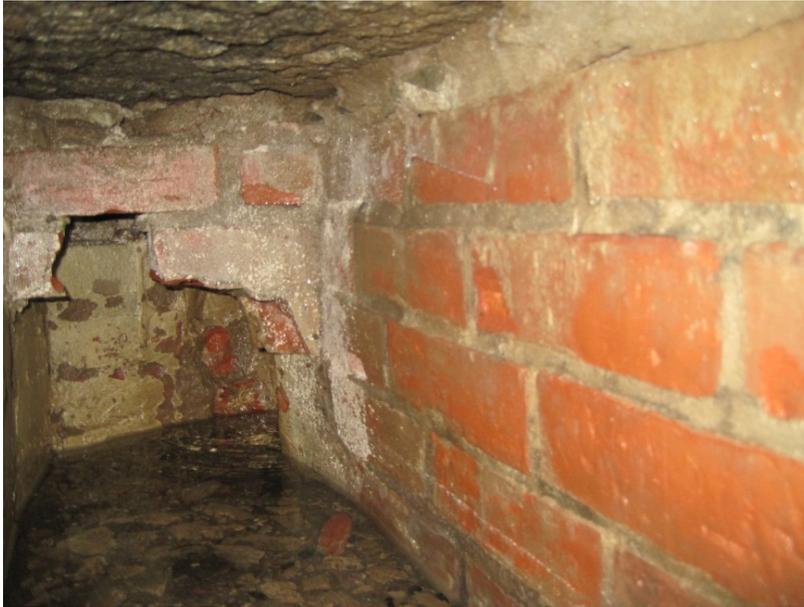
Figure 82. Privy trough still has water collecting in it.

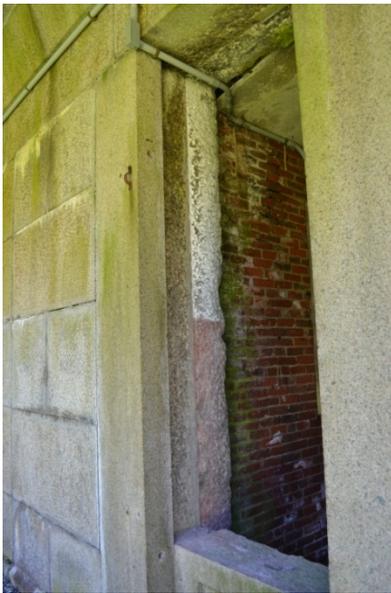
Figure 83. Conduit and electrical line exiting "power plant" barracks.

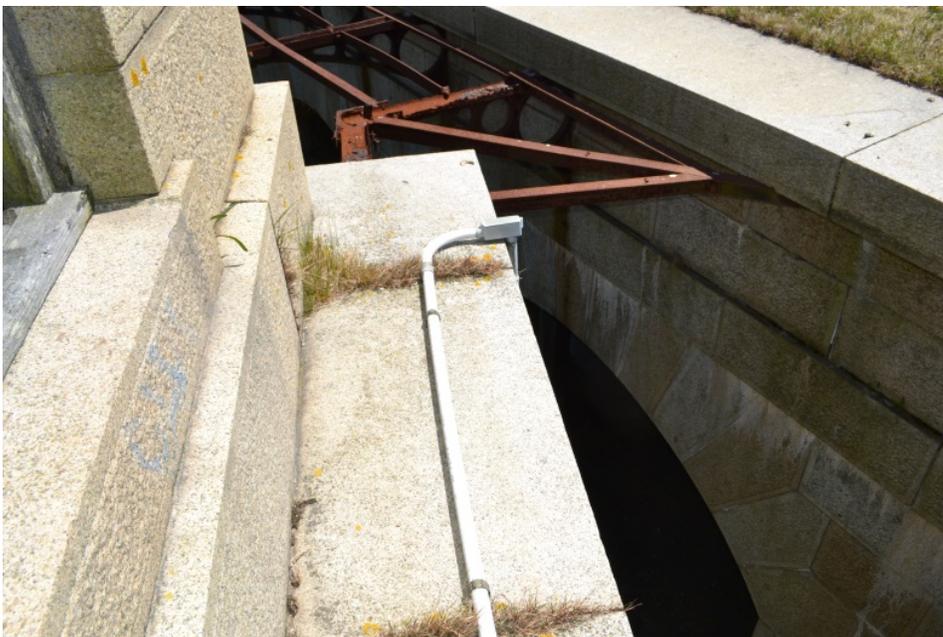
Figure 84. Conduit and electrical line at top of west stair tower.

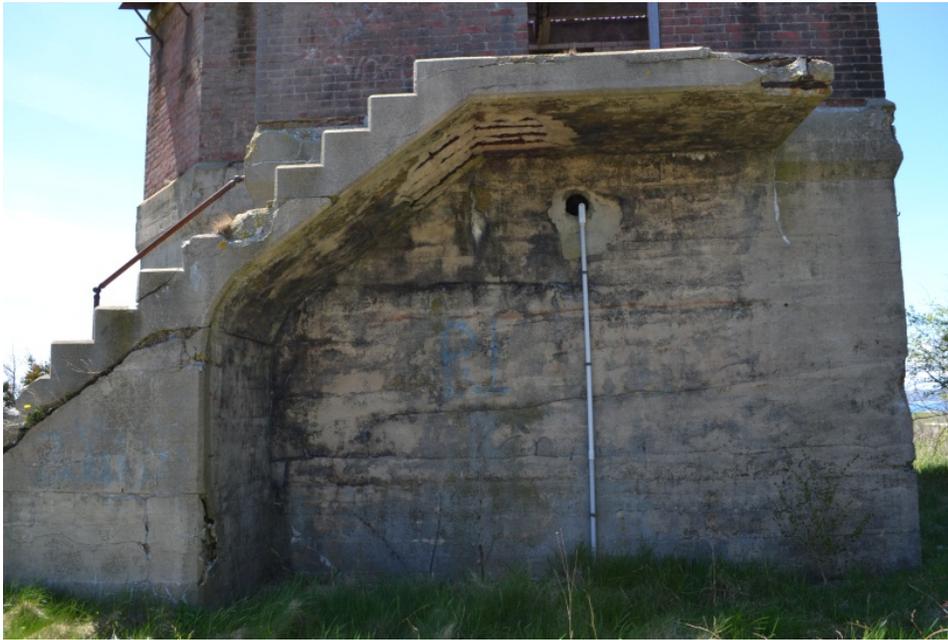
The current electrical service is found in the southwest “power plant” room. A 200 amp panel feeds the lighthouse, the fire control tower, a double duplex receptacle mounted on the front of the fort and a floodlight located on the 2nd tier over the main entry. There is no emergency power or fire alarm system in the fort. Conduit containing electrical wires run from the electrical panel, under the 1st-tier gallery roof to the southwest corner of the fort, and then up along the wall to the terreplein (Figure 83 & 84). The conduit then runs under the earthen fill on the terreplein to service the fire control tower (Figure 85).

Figure 85. Conduit and electrical line entering the fire control tower at the terreplein.

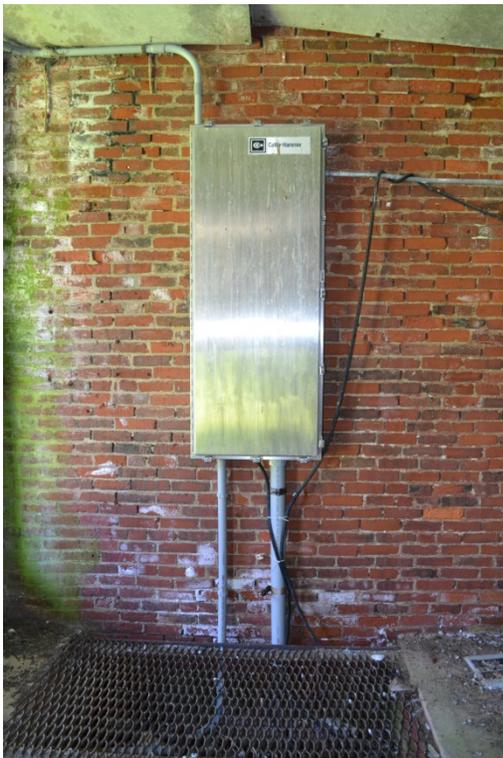
Figure 86. Existing electrical panel in "power plant" barracks.

For the installation of an elevator, the existing electrical service would need to be upgraded to 225 amps along with a new panel to house the service. The new service will require a new underground duct bank to the existing pad mount transformer approximately 100 feet away. Also, addition of a dedicated phone line to the building for elevator car communications will be required.

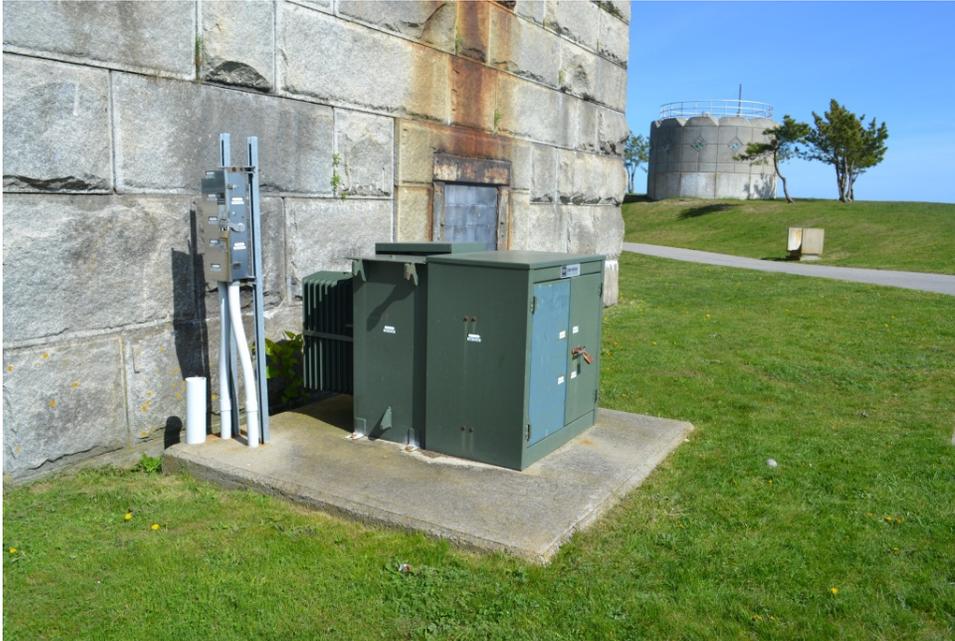
Outside the footprint of the fort, a dry transformer is located on the south side of the fort and is assumed to be dedicated to the fort. On the east side of the site, a stainless steel pedestal is a box to power up equipment for events at the park. More investigation is needed to locate underground utilities and points of connections.

Figure 87. Existing dry type transformer outside of fort at southwest wall.

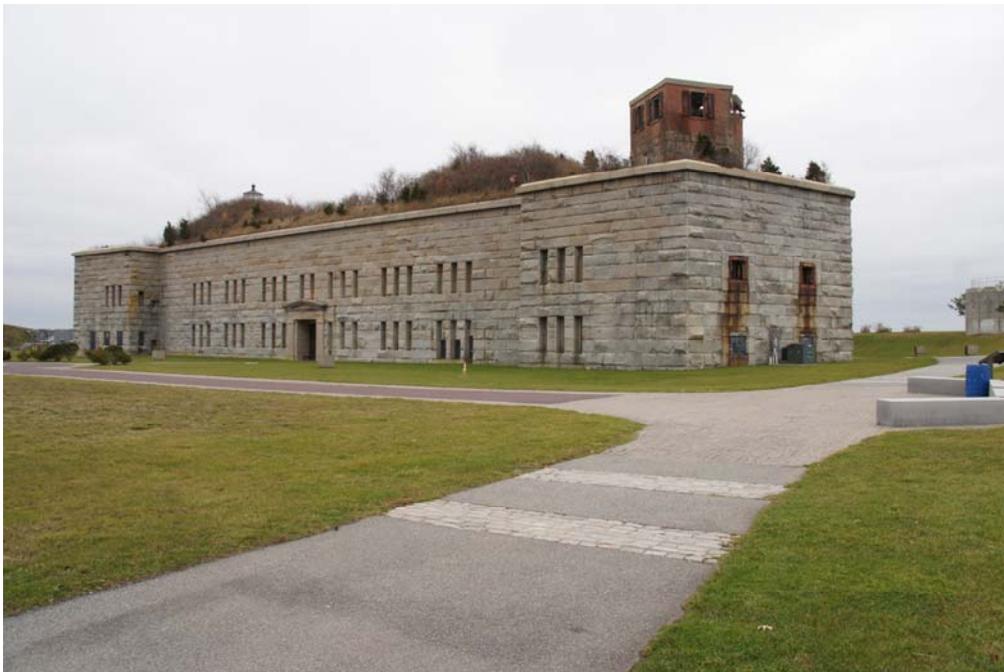
A wide, maroon-colored chip-and-seal path with granite sett edges extends from the pier to a circular plaza at the front of the fort and to a sitting area just southwest of the fort. The granite sett path continues to the front entrance of the fort on the northwest elevation. The sally port and gallery walkway on the interior of the fort is paved with loose gravel that does not meet ADA or MAAB requirements for accessible surfaces. Existing site lighting in concrete enclosures are not functional due to vandalism.

Figure 89. View of walkway and sitting area at the southwest of the fort.

The ramp and curb at the parking lot should be repaired. Some minor repair of the walkways from the parking lot to the fort is recommended. Alternate materials such as stonedust, chip-and-seal asphalt, bluestone, or granite walkways should be considered to replace the loose gravel at the sally port and gallery walkway inside the fort. Repair existing site lighting around fort.

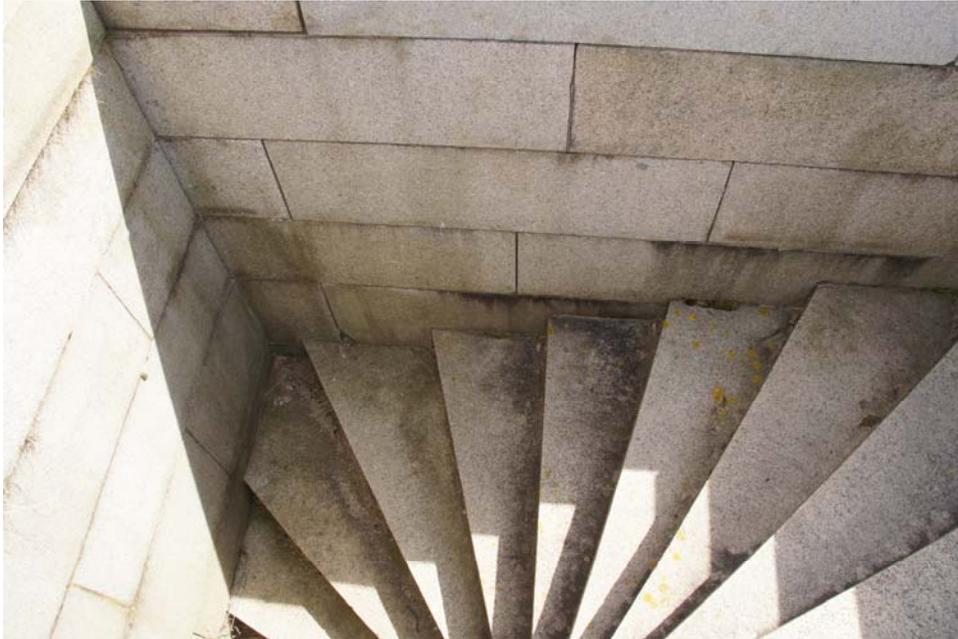
The granite mortars are mostly similar with three layers of material that have recrystallized by water percolating through them. Samples #2 and #4 were selected for thin-section analysis. The brick mortars generally contained one material and were also recrystallized due to water. Some of the brick samples were similar in character to some of the granite mortar layers. Two of the brick mortar samples were found to be modern cement mortars and were not analyzed any further. Brick mortar samples #5 and #9 were selected for thin-section analysis and Sample #9 was selected for gravimetric analysis as well.

Figure 90. Granite Mortar Sample #2 location at spiral stair vertical joint at granite

Based on the composition of the samples, either a natural cement-sand mortar with a mix of 1 part sand to 3 parts natural cement, or a lime-natural cement-sand mortar with a mix of 1 part natural cement to 1 part lime to 5 parts sand could be used. The sand should be tan in color and fine-grained to match Sample #9. The sand for the outer mortars should be finer-grained to match the outer mortars of Samples #2 and #4. Repointing mortars should also take into consideration the condition of the masonry and length of exposure to water. Recommendations for repointing mortar based on current conditions in the fort is to use a less cement-rich mortar, air entraining additives, or air-entrained lime to prolong the life of the mortar in wet outdoor environments. The mortar will most-likely require the addition of pigment to match the tan color of the existing natural cement mortar. To avoid variation of color throughout the building, great care must be taken in proportioning, mixing and installing the pigmented mortar. The use of pre-proportioned pigmented bagged mortar mix is strongly recommended.

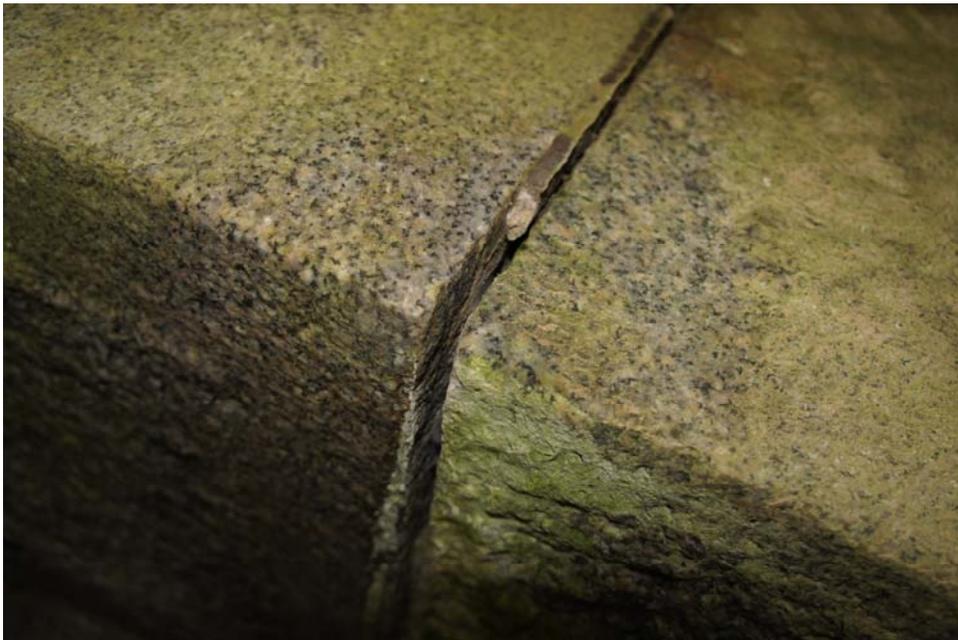
Figure 91. Granite Mortar Sample #4: 2nd Tier casemate at granite

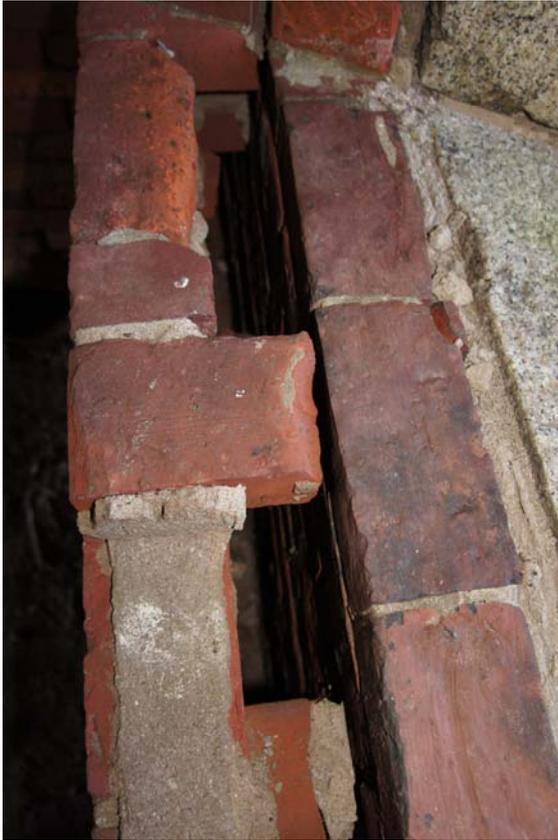
Figure 92. Brick Mortar Sample #5: 2nd Tier mortar dropped between brick veneer and brick pier

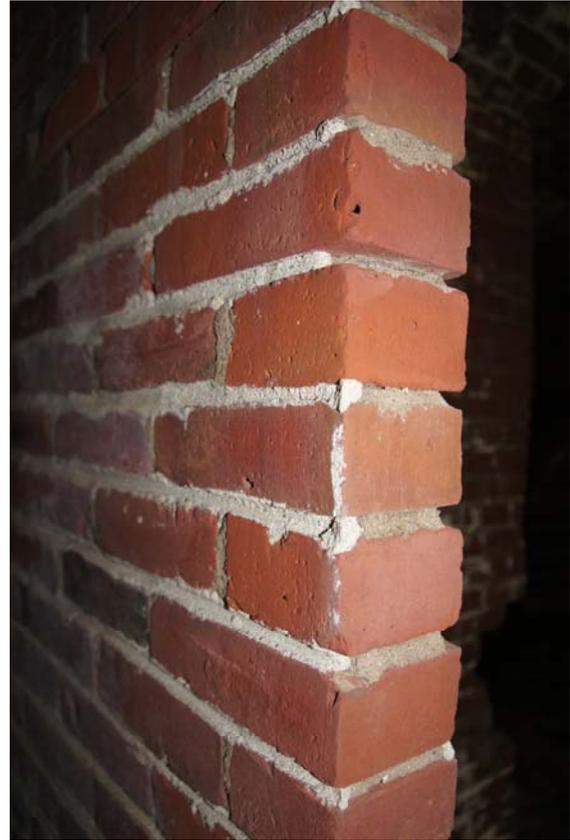
All but the modern mortars are similar in appearance, having tan to dark-tan binders with rounded nodules of tan to orange-red colors. The mortars are hard and cannot be broken by hand, except for Sample #9 that was the softest of the mortar samples. For most of the samples, two distinct layers of mortar were found at different depths in the joint. The aggregate in the outer layer is finer and more abundant than the aggregate in the inner layer. Two different conclusions can be made, but many more samples would need to be analyzed before coming to a final conclusion. The first concept is that a lime-natural cement-sand mortar was used as a setting mortar and a natural cement-sand mortar was used as a pointing mortar. The other concept is that the original joint was filled with the lime-natural cement-sand mortar and the outer layer was repointed later with a natural cement-sand mortar.

Figure 93. Brick Mortar Sample #9: 1st Tier interior brick veneer wall – bedding mortar

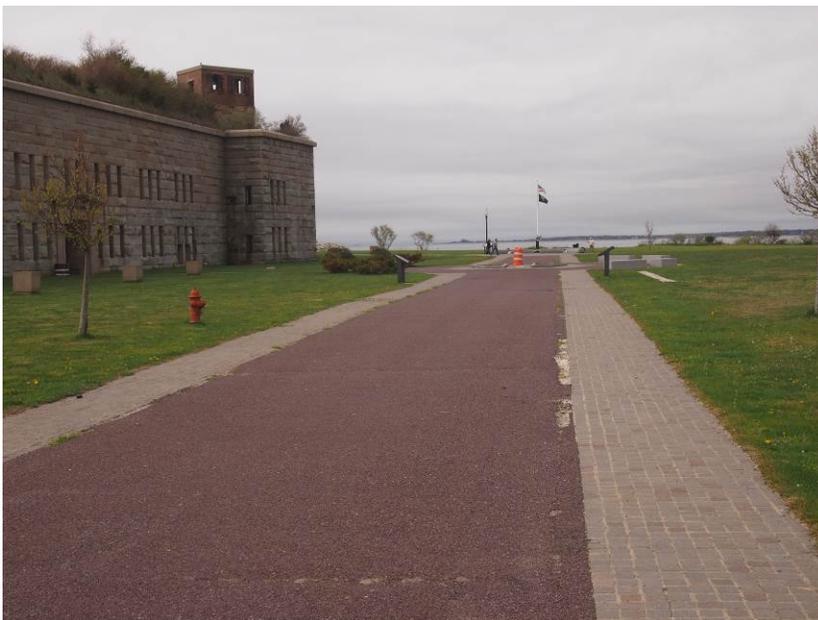
Asphalt paths traverse the park providing visitor access to the water's edge, the fort, and other park destinations. Bisecting the space between the parking lot and fort is a north-south path aligned with a pier to the north and a war memorial to the south. This maroon colored chip and seal path with granite setts edges leads visitors to a formal circular plaza in front of the fort. A granite sett path connects the circular plaza to the fort gate. The path widths and gradients are all compliant leading from the parking to the fort. Repair of the walkway chip and seal and granite setts is needed to remove potential tripping hazards.

Figure 1. Maroon colored chip and seal path from parking lot to entrance of fort.

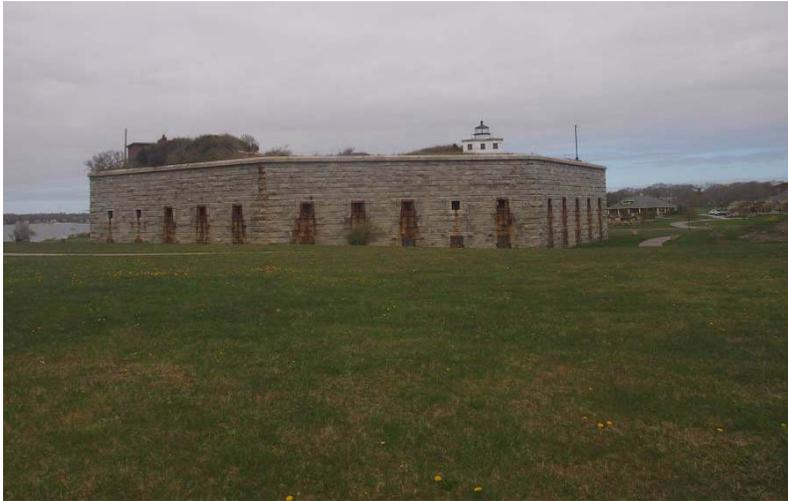
Fort Taber is the prominent architectural feature within Fort Taber Park. Dramatic water views attract park users to the many paths and earthworks for various forms of recreation. The ground plane is largely lawn with areas of ornamental planting. Architectural floodlights are located around the perimeter of the fort housed in concrete enclosures. The lights aren't functional due to vandalism.

Figure 2. View of east elevation of fort from park

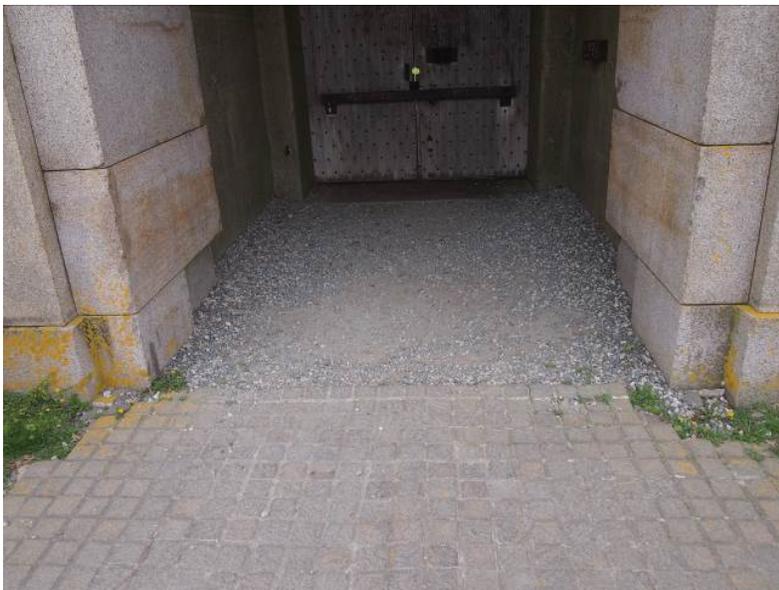
A large solid wooden two- leaf gate secures the entry to the fort and is sufficient for universal access. The gravel path surface from the granite sett walkway to the gate has too large a stone size and loose stone that does not meet the requirements for a "firm and stable" walkway per ADA or MAAB. Alternative materials should be considered i.e. stonedust, chip and seal asphalt, bluestone, or granite.

Figure 3. Granite sett and gravel walkway at entrance to fort.

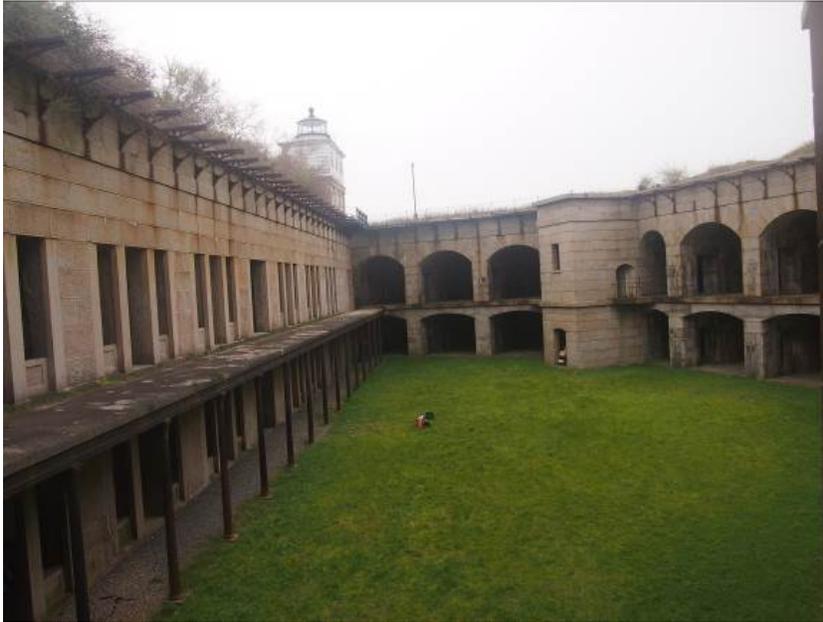
Figure 5. View of parade ground from 2nd tier.

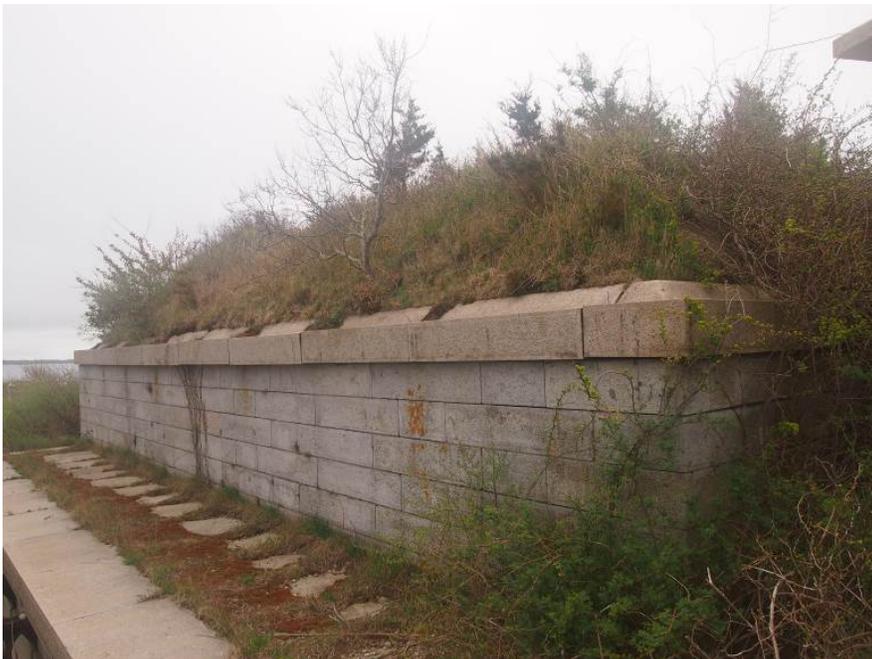
Turf, shrubs and trees all grow among the varied vegetation on the terreplein. Invasive plant species are colonizing quite aggressively as is poison ivy. Vines, root systems of plants, moss and lichen are all impacting the historic masonry. Steep slopes and the unprotected edges make maintenance of the vegetation extremely difficult. Woody vegetation should be removed from the terreplein to prevent damage to the masonry, drainage system and other elements of the fort. Annually, the vegetation should be cut back to prevent this woody growth. In flat areas, the turf could be maintained with brush mowers (if they can be lifted to this height) or hand-held weed trimmers, but on the steep slopes bucket trucks may be needed to perform this work safely.

Figure 7. Retaining wall, earth fill, and overgrown brush at magazine on terreplein.

Should the soil and vegetation be stripped to repair the fort drainage, a no-mow fescue turf mix should be established on the terreplein. This turf only needs to be mowed once annually and is tolerant of the seaside conditions. Geogrids or other devices should be included in the soil profile on the steep slopes to prevent sliding of the soil profile.

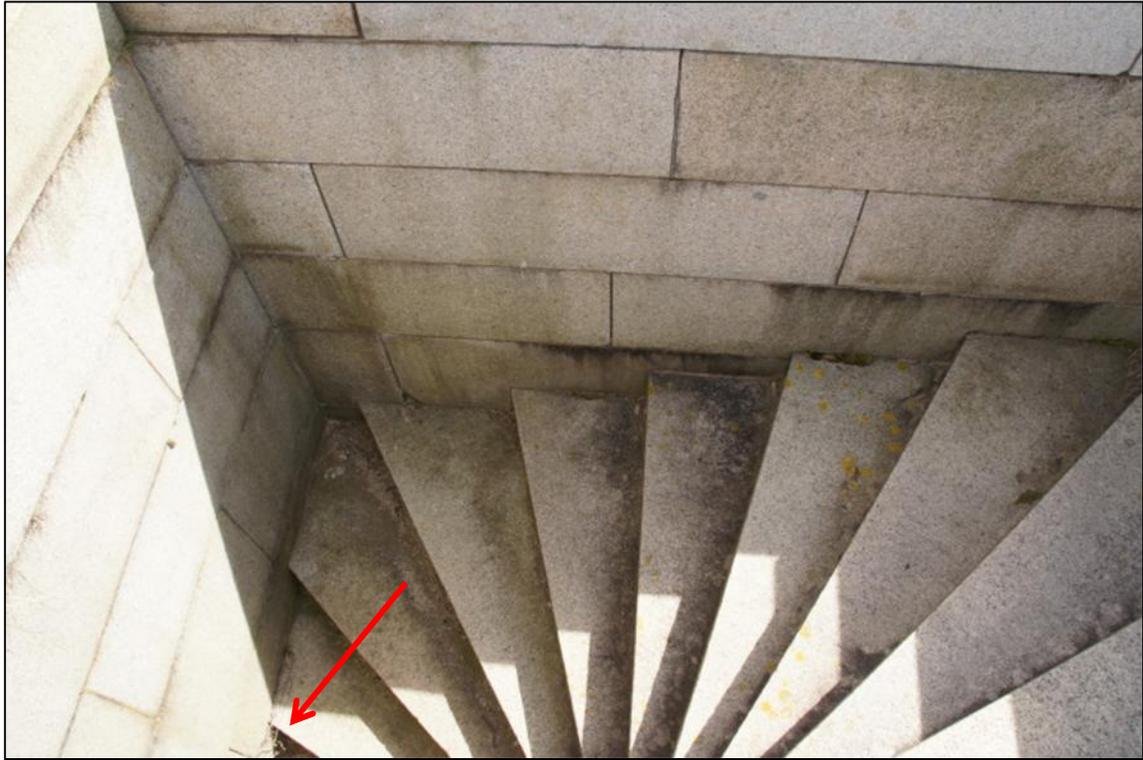
Photo 1: Overall view of the location of Sample #2 (Photo 2 taken near arrow; all sample location photos taken by BH+A).

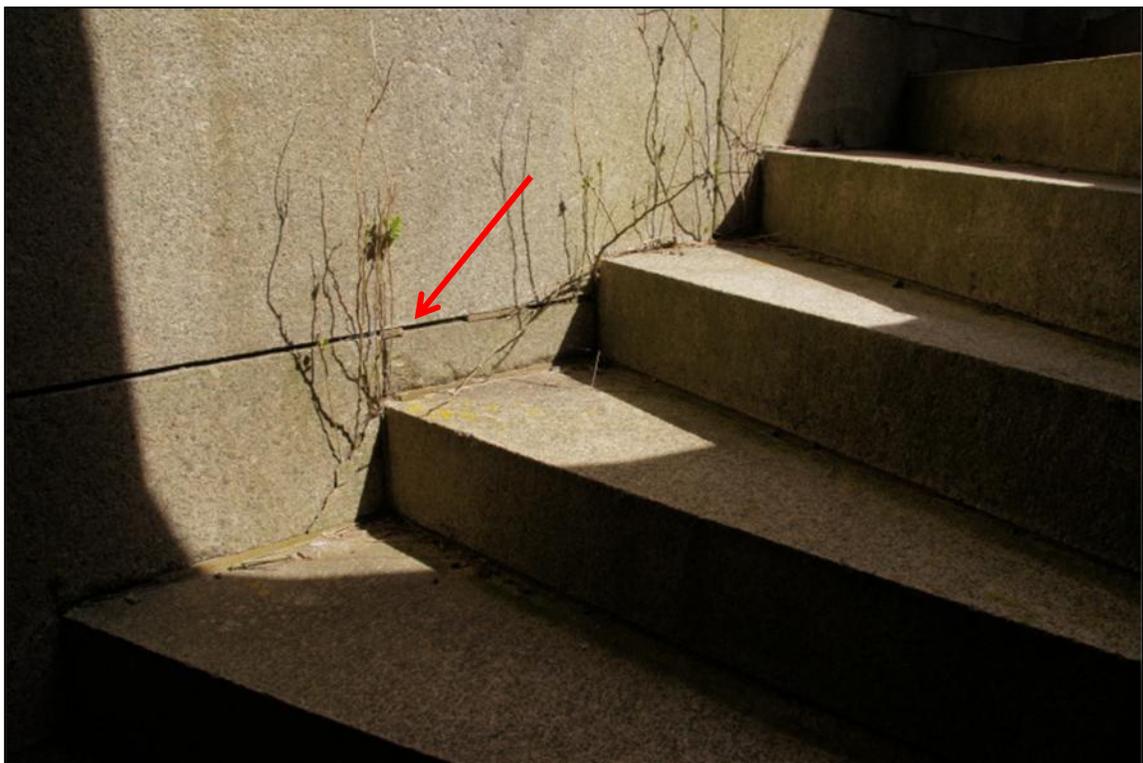
Photo 2: Detail of location of Sample #2.

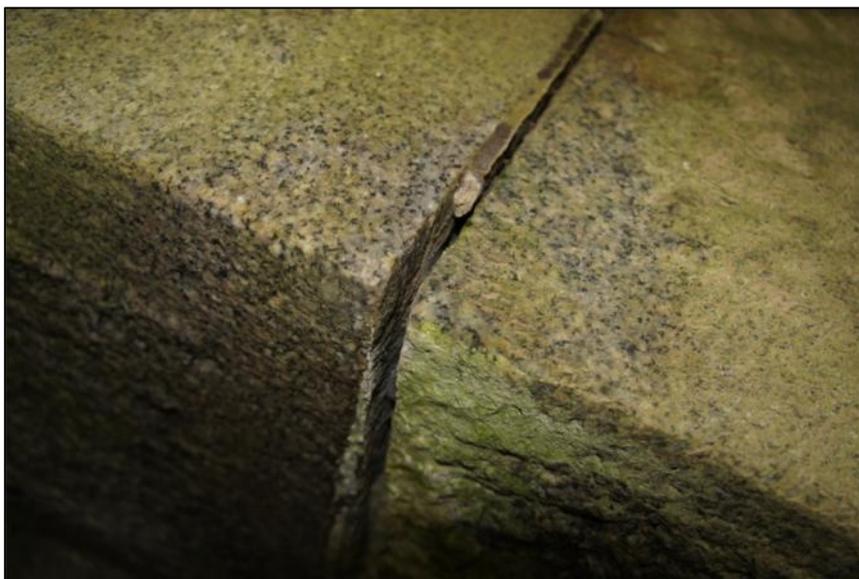
Photo 4: Detail of location of sample #4.

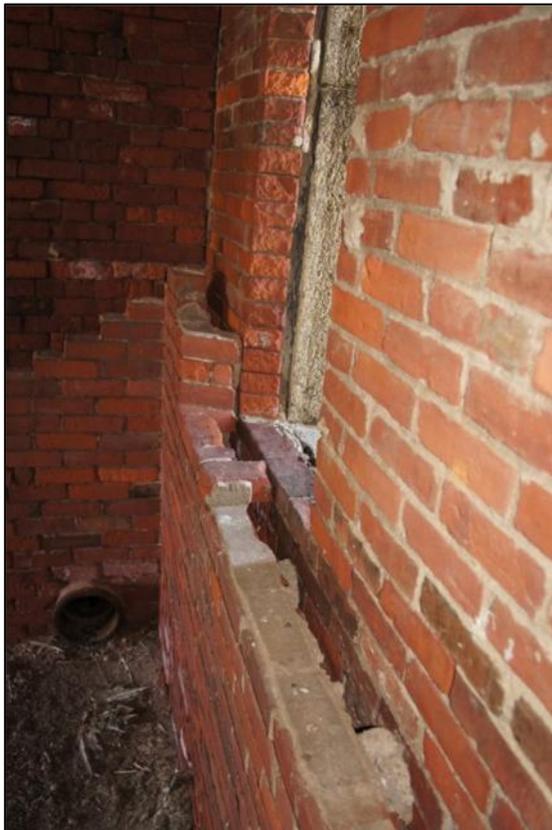
Photo 5: Overall view of the location of Sample #5.

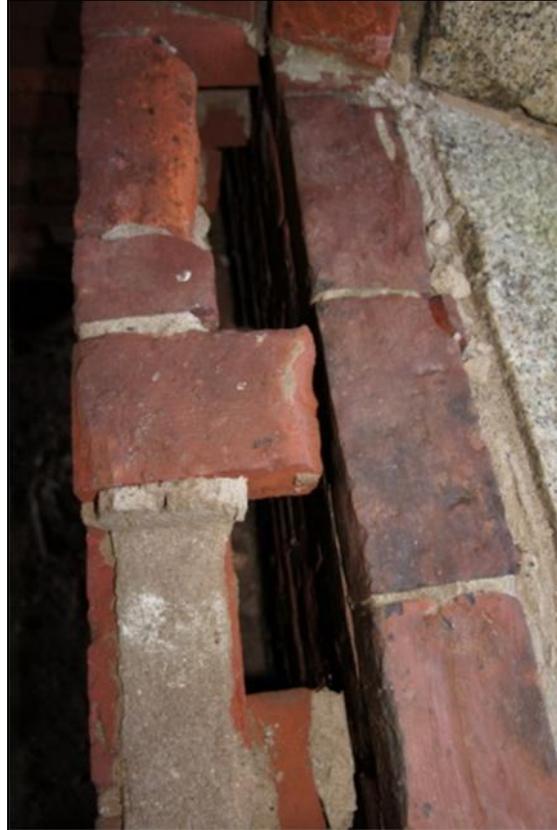
Photo 6: Detail view of the location of Sample #5.

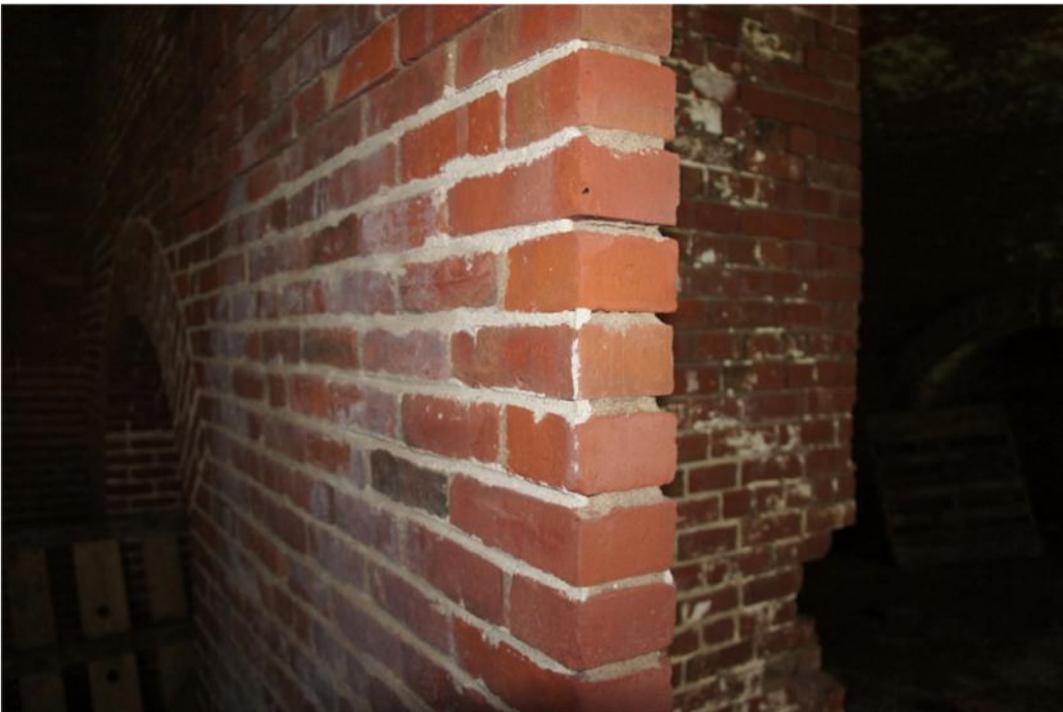
Photo 7: View of the location of Sample #9.
