Fort Taber / Fort Rodman
New Bedford, Massachusetts

**Architectural / Structural Assessment
& Feasibility Study for Universal Accessibility**

Final Report

Bargmann Hendrie + Archetype, Inc.
Boston, Massachusetts

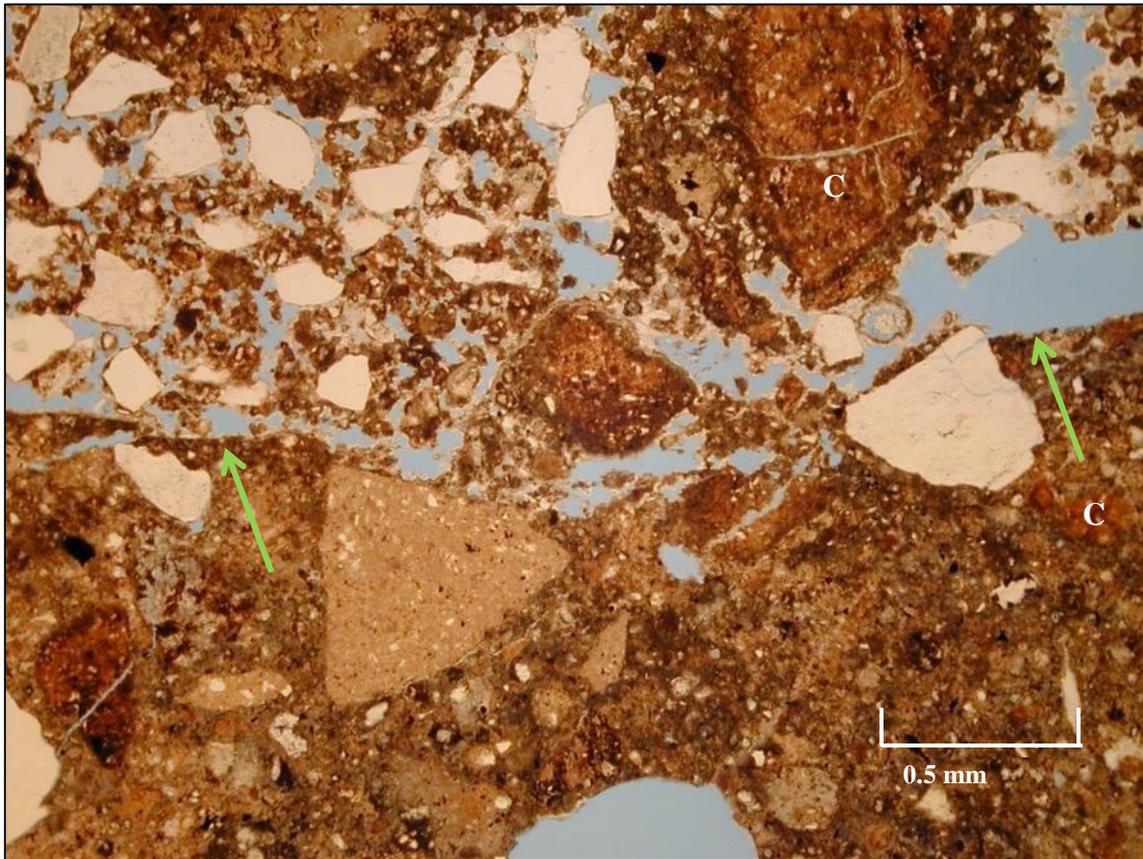
In thin section, the binder of both layers is observed to consist of micro-crystalline calcium carbonate and calcium silicates. The character is of a carbonated natural cement mortar from an incompletely calcined natural cement. (Photo 8). There are abundant nodules of this cement in various stages of calcination, hydration and carbonation; they are typically quite large (Photos 8 and 9). There are also smaller relics in the binder (Photo 10).

Photo 8: View of Sample #2 in thin-section showing the boundary between the outer (top) and inner (bottom) layers (green arrow). Uncrossed polars (ppl), 40 times magnification (40x). The difference in character with respect to voids and aggregate is clearly apparent. The light colored material in the voids of the outer layer is calcite. The dark red nodules are natural cement that is incompletely calcined and partially hydrated; the tan nodules appear to be uncalcined. Both types of nodules appear in both layers. The binder of both layers is variously carbonated.

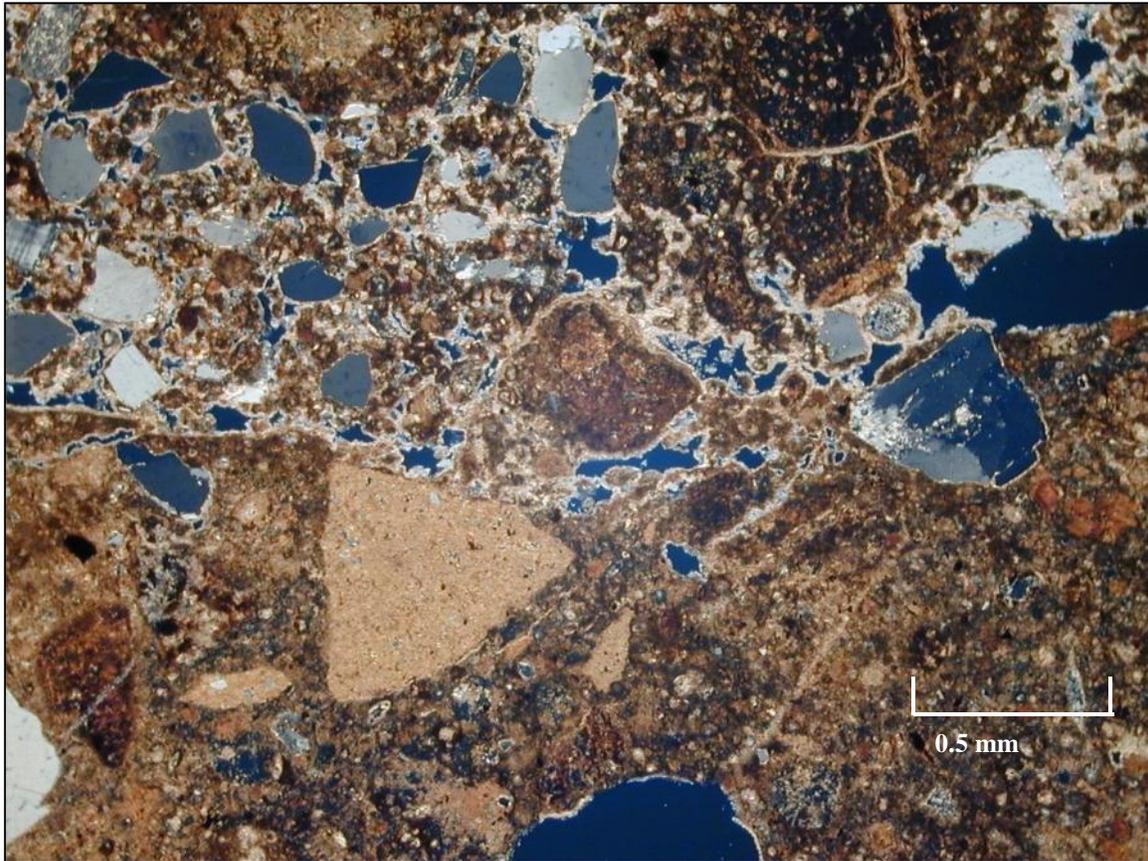
Photo 9: Same view as Photo 8, crossed polars (xpl), 100x. The white material lining the voids is calcite that is fairly coarsely crystalline; the binder of both layers is also composed largely of microcrystalline calcite and hydrated cement.

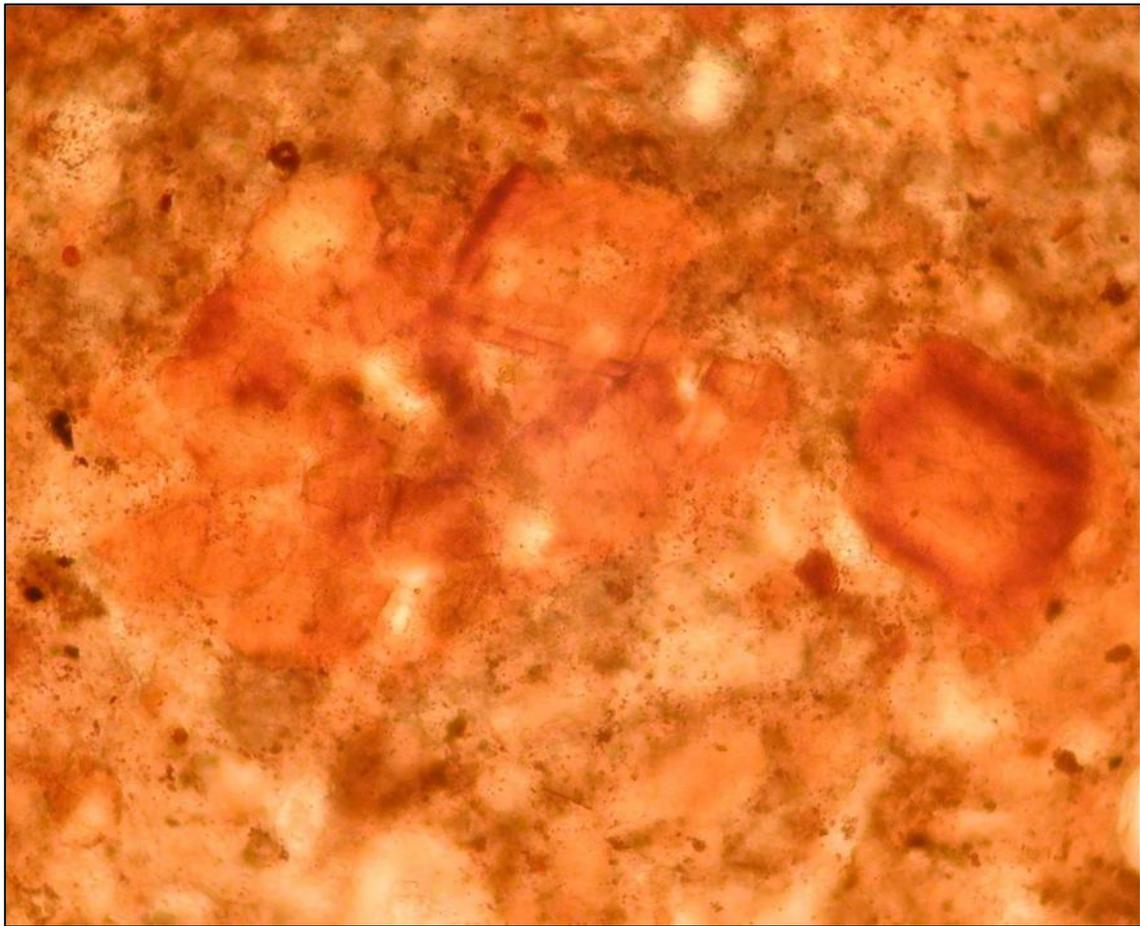
Photo 10: Detail of a relic grain from the natural cement showing the retained shape of the dolomite crystals. 400x, ppl.

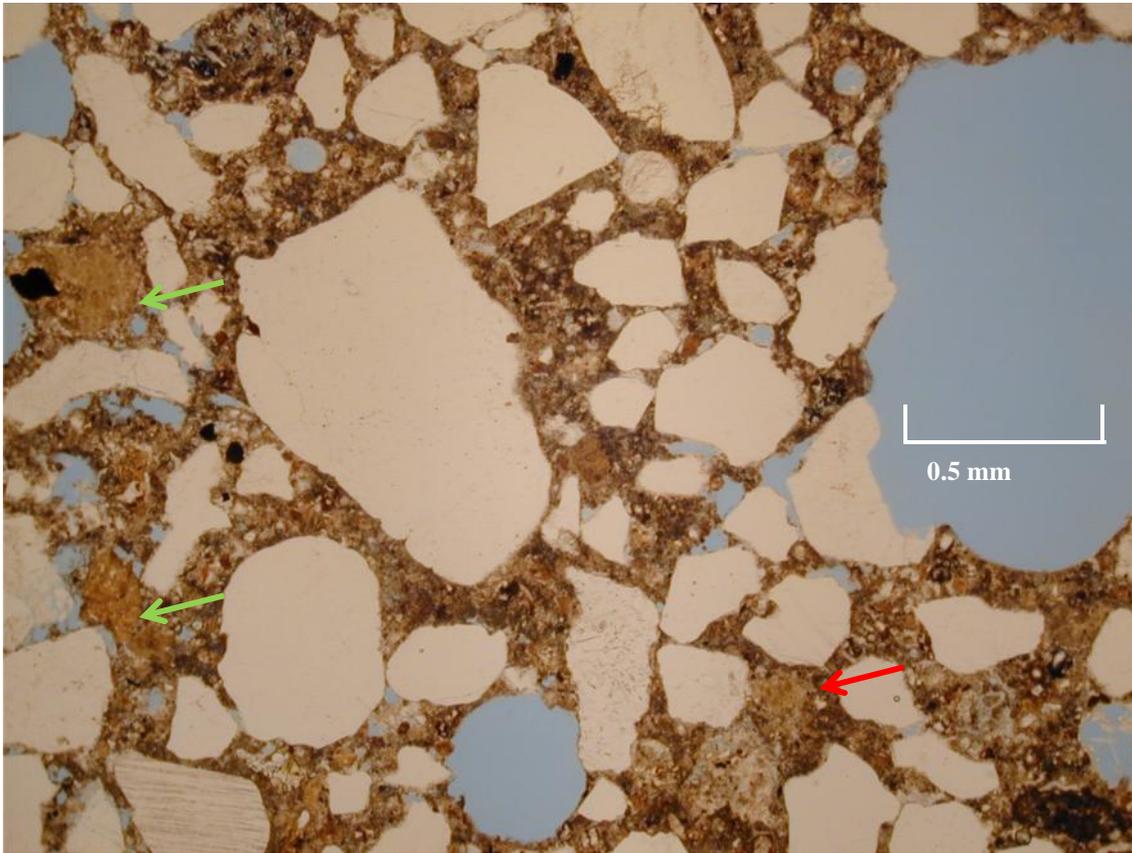
The composition of the inner layer is different from that of Sample #2 (Photo 11). Though there is evidence of natural cement, one lime nodule was also observed, and the binder is overall lighter in color than that of the inner mortar of Sample #2. There is also more aggregate; binder to aggregate ratio of the inner layer is estimated at 1 part binder to 2-2.5 parts aggregate. The aggregate of the inner mortar of this sample consists of quartz, feldspar, and also a few grains of glauconite. There are both large and small entrapped air voids; small voids are typically filled with calcite, indicating water movement through this layer as well.

Photo 11: Overall view of the inner mortar layer of Sample #4, 40x, ppl. Aggregate grains are white, void space is blue, and the binder is pale tan. There is a lime nodule at the lower right (red arrow) and natural cement relic grains at the upper and lower left (green arrows).

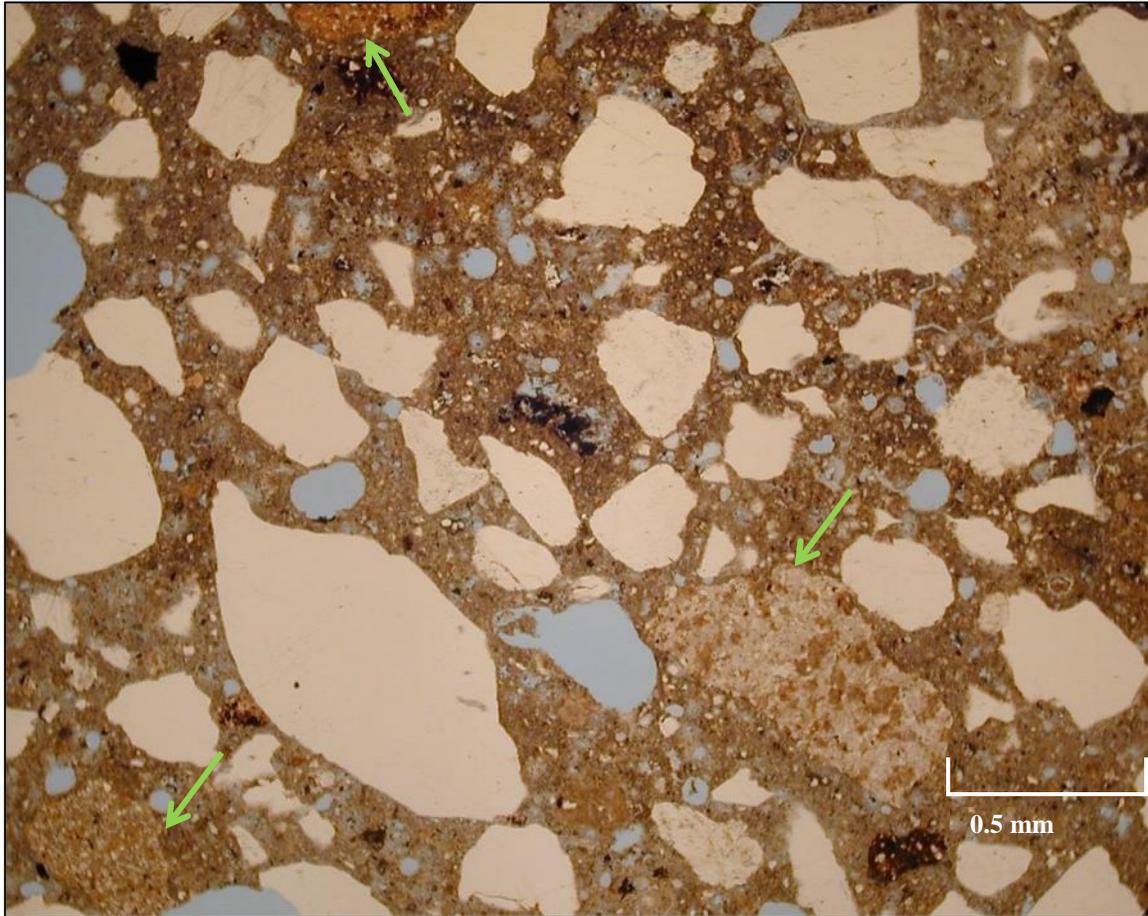
This sample is somewhat similar to the inner layer of Sample #4. The mortar is hard and cannot be broken by hand. The binder is tan in color, matte-textured and slightly granular. In-thin-section, the binder contains nodules of natural cement and relic partially hydrated grains, but does not appear to contain any lime nodules (Photo 12). The color of the binder is more similar to the inner layer of Sample #4 than Sample #2. The aggregate consists primarily of quartz with some feldspar and lithic grains. The aggregate is well graded, and the grains are subrounded to subangular, with the larger grains typically more rounded than the smaller. Void volume in both layers as estimated visually is moderate, approximately 10% of the volume of the sample. The voids are irregularly-shaped and rounded entrapped air voids of varying sizes; some are quite large. However, this sample also has a large number of smaller voids, some of which are rounded. Some of the voids are lined with calcite crystals, but overall there is less evidence of water percolation through this mortar.

Photo 12: Overall view of Sample #5, 40x, ppl. Compare with Photo 11. Examples of natural cement relics are indicated with green arrows. The relic grains are calcined and hydrated to varying degrees.

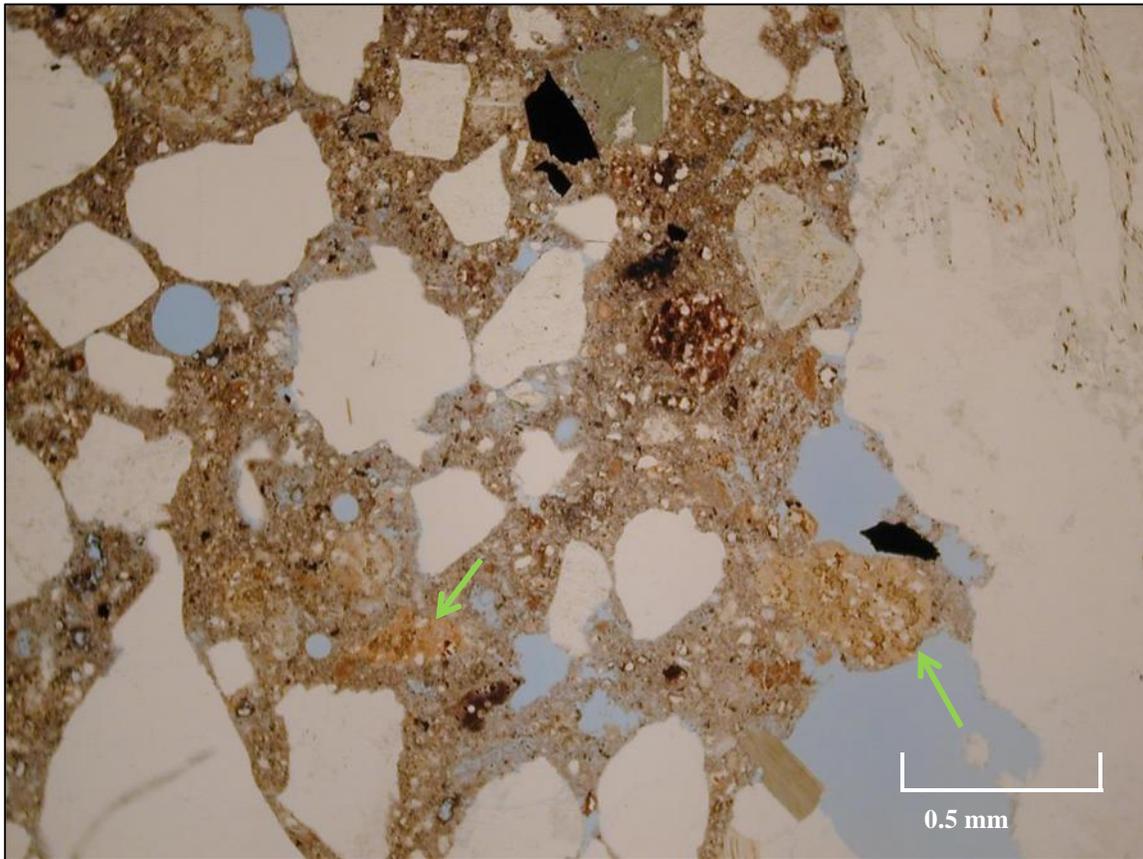
Sample #9 is somewhat similar to Sample #5, but there are some differences. The mortar is softer than Sample #5 and can be broken by hand. Dark tan in color, the binder is matte-textured and granular. Brown nodules were noted in the binder. Void volume as estimated visually is minimal, from 5-10% as large irregularly-shaped entrapped air voids. There are also smaller and more rounded voids. Many of the voids are lined with calcite crystals. In thin-section, the binder appears the same as that of Sample #5 (Photo 13) though there is some substantially larger aggregate in Sample #9. The binder is also composed of natural cement; no lime nodules were observed, but there are abundant relic natural cement grains.

Photo 13: Overall view of Sample #9 in thin-section, 40x, ppl. Compare with Photo 12; note the large aggregate grain to the right of the field of view. Examples of natural cement relics are indicated with green arrows.

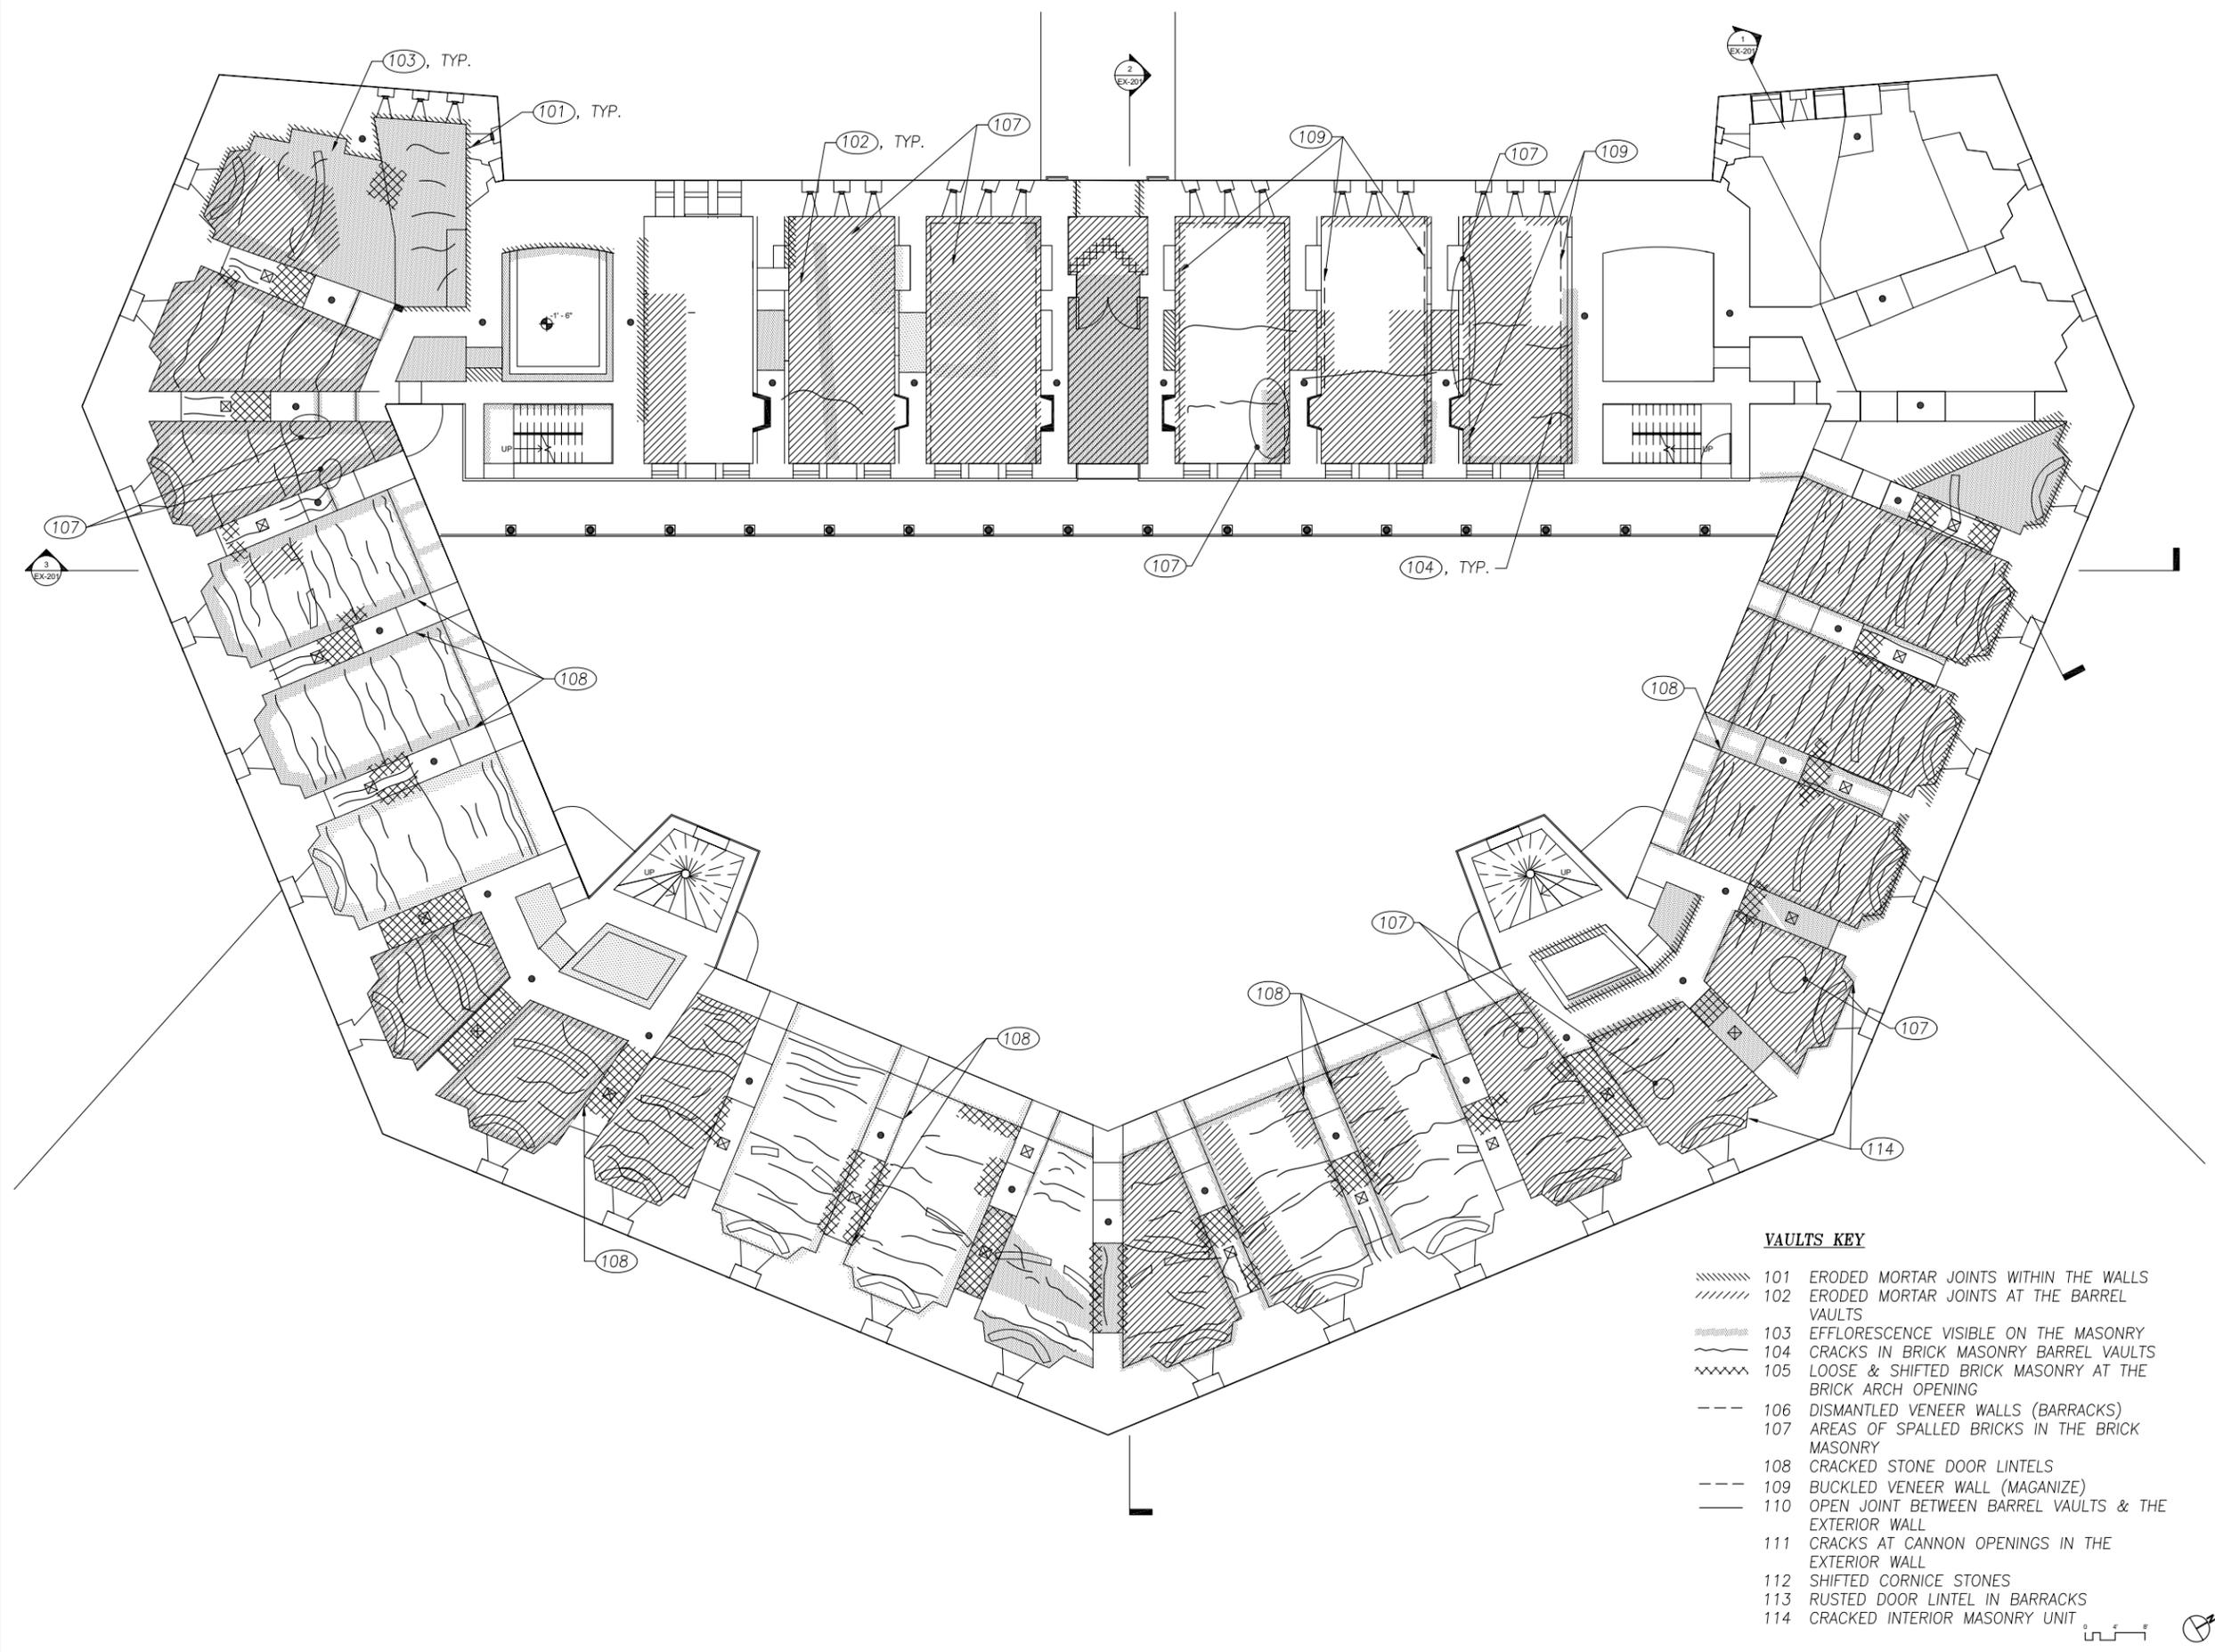
EX-101

- 101 ERODED MORTAR JOINTS WITHIN THE WALLS
- 102 ERODED MORTAR JOINTS AT THE BARREL VAULTS
- 103 EFFLORESCENCE VISIBLE ON THE MASONRY
- 104 CRACKS IN BRICK MASONRY BARREL VAULTS
- 105 LOOSE & SHIFTED BRICK MASONRY AT THE BRICK ARCH OPENING
- 106 DISMANTLED VENEER WALLS (BARRACKS)
- 107 AREAS OF SPALLED BRICKS IN THE BRICK MASONRY
- 108 CRACKED STONE DOOR LINTELS
- 109 BUCKLED VENEER WALL (MAGANIZE)
- 110 OPEN JOINT BETWEEN BARREL VAULTS & THE EXTERIOR WALL
- 111 CRACKS AT CANNON OPENINGS IN THE EXTERIOR WALL
- 112 SHIFTED CORNICE STONES
- 113 RUSTED DOOR LINTEL IN BARRACKS
- 114 CRACKED INTERIOR MASONRY UNIT

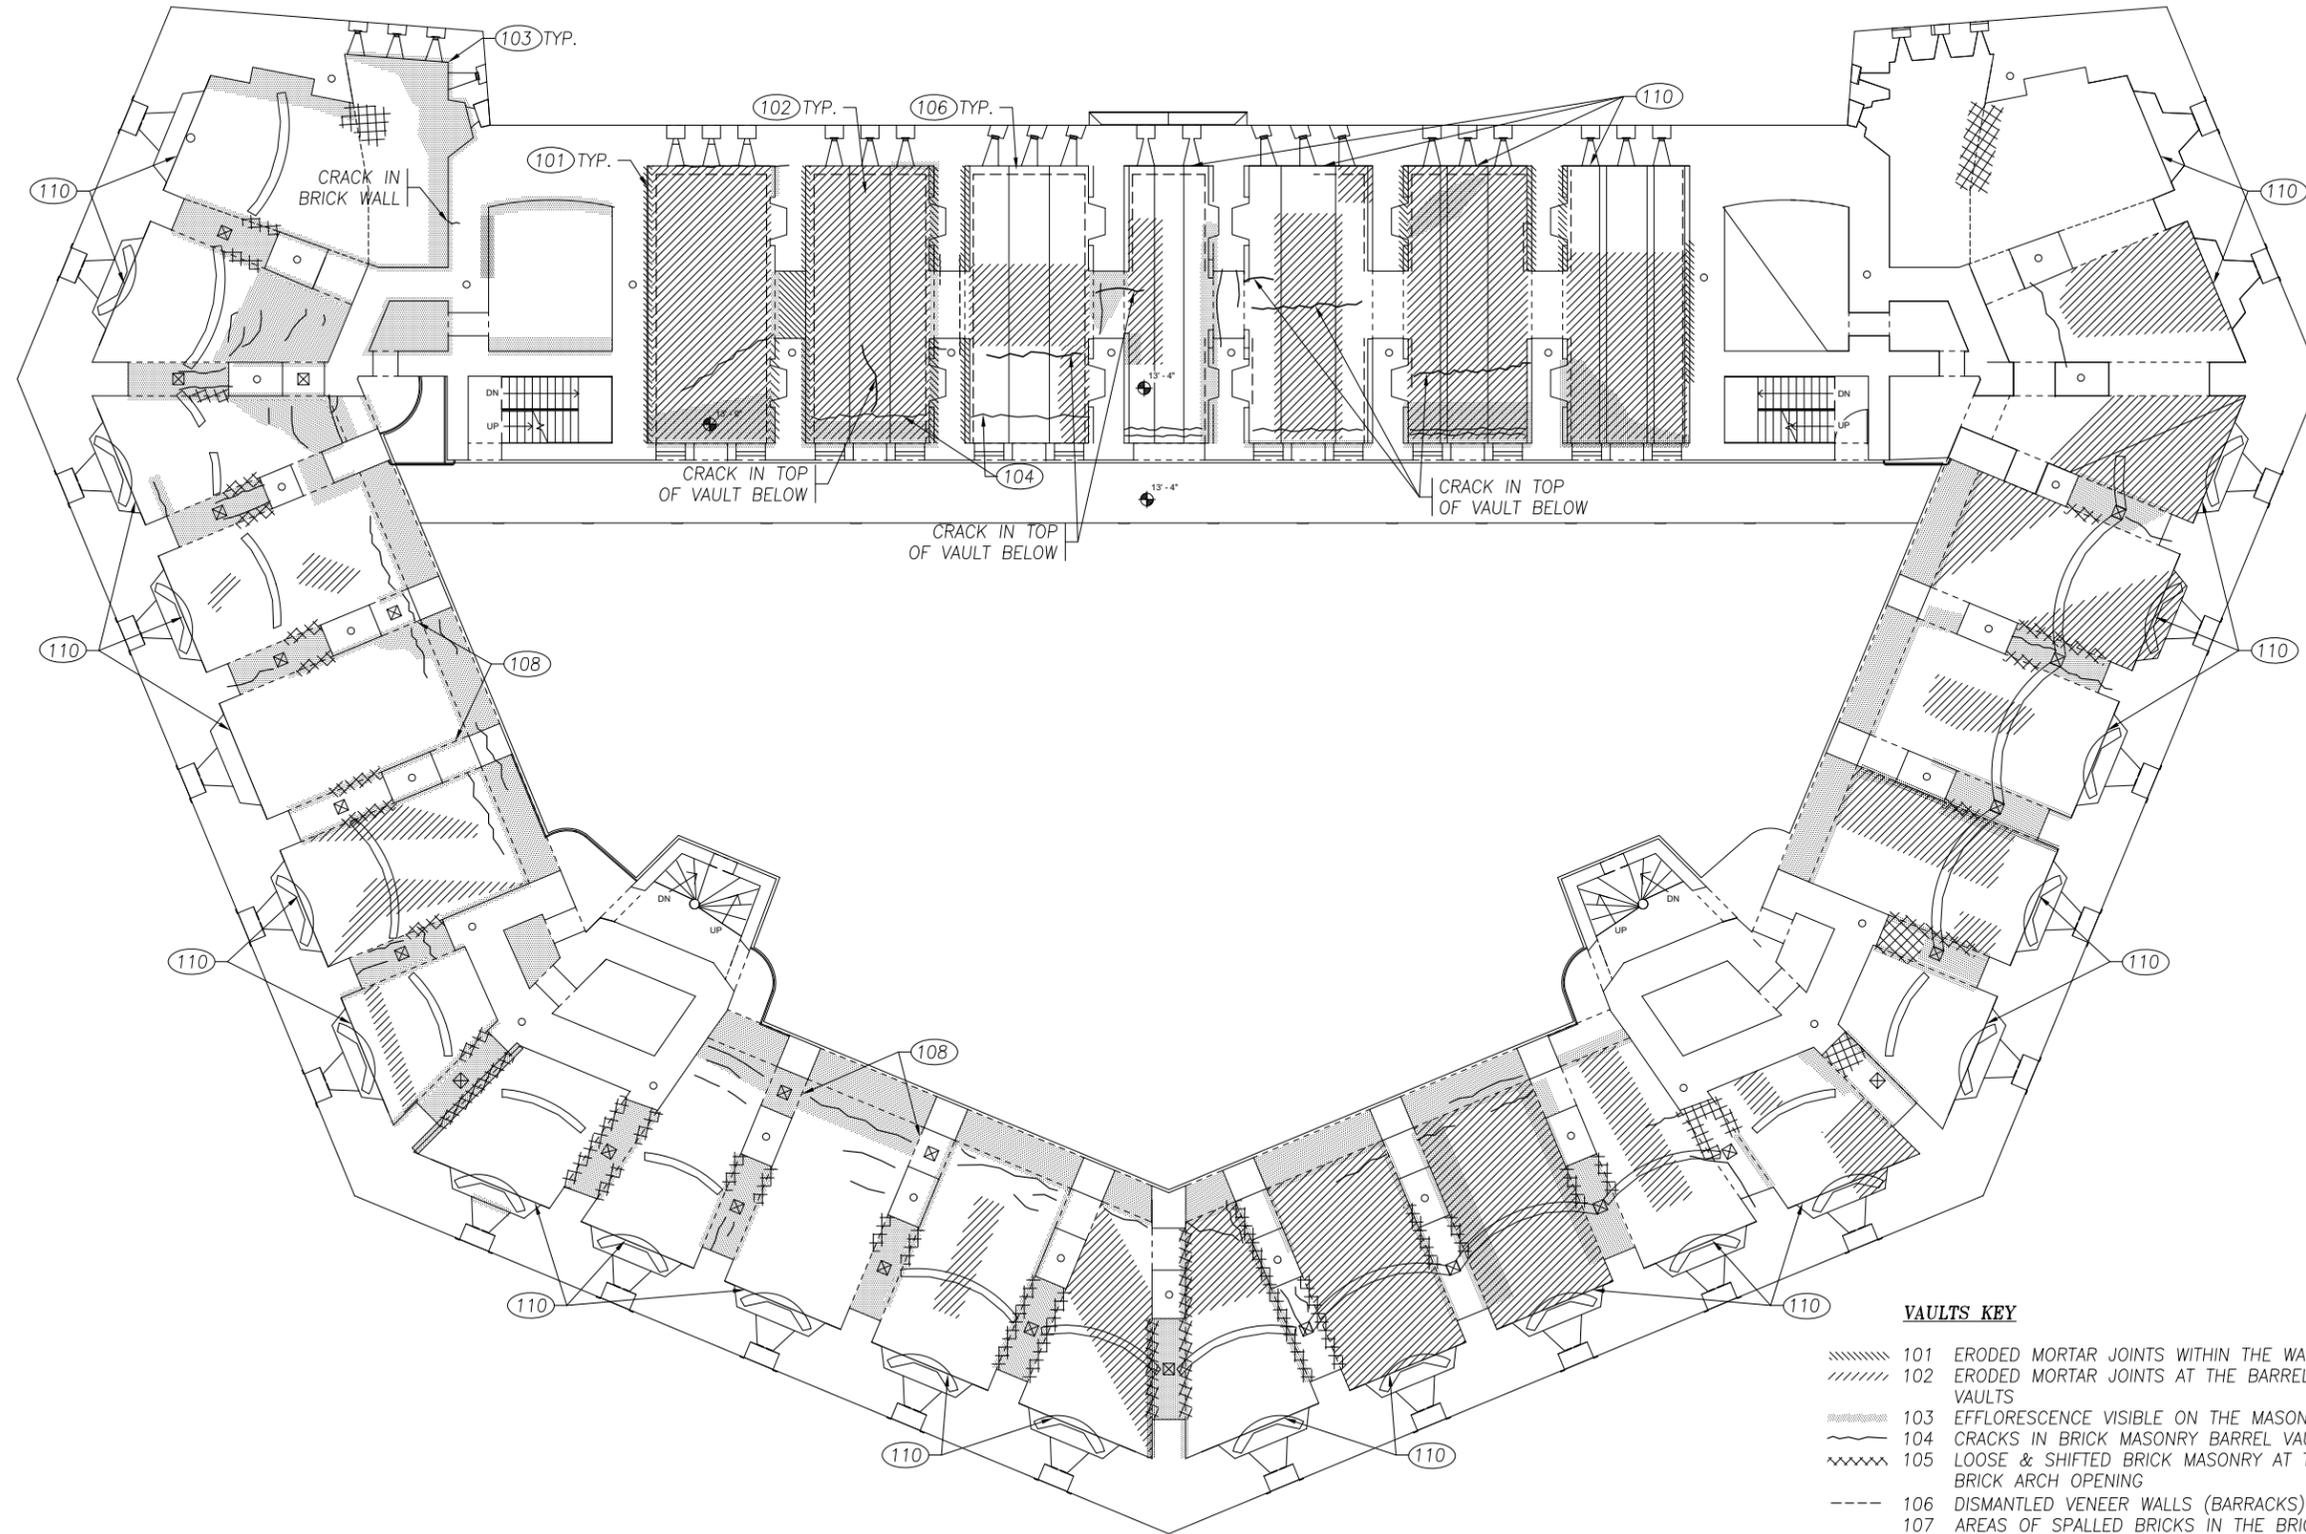
- 101 ERODED MORTAR JOINTS WITHIN THE WALLS
- 102 ERODED MORTAR JOINTS AT THE BARREL VAULTS
- 103 EFFLORESCENCE VISIBLE ON THE MASONRY
- 104 CRACKS IN BRICK MASONRY BARREL VAULTS
- 105 LOOSE & SHIFTED BRICK MASONRY AT THE BRICK ARCH OPENING
- 106 DISMANTLED VENEER WALLS (BARRACKS)
- 107 AREAS OF SPALLED BRICKS IN THE BRICK MASONRY
- 108 CRACKED STONE DOOR LINTELS
- 109 BUCKLED VENEER WALL (MAGANIZE)
- 110 OPEN JOINT BETWEEN BARREL VAULTS & THE EXTERIOR WALL
- 111 CRACKS AT CANNON OPENINGS IN THE EXTERIOR WALL
- 112 SHIFTED CORNICE STONES
- 113 RUSTED DOOR LINTEL IN BARRACKS
- 114 CRACKED INTERIOR MASONRY UNIT

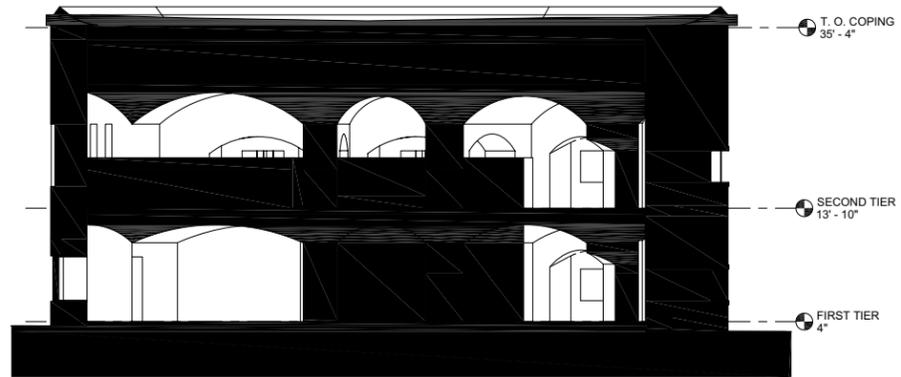
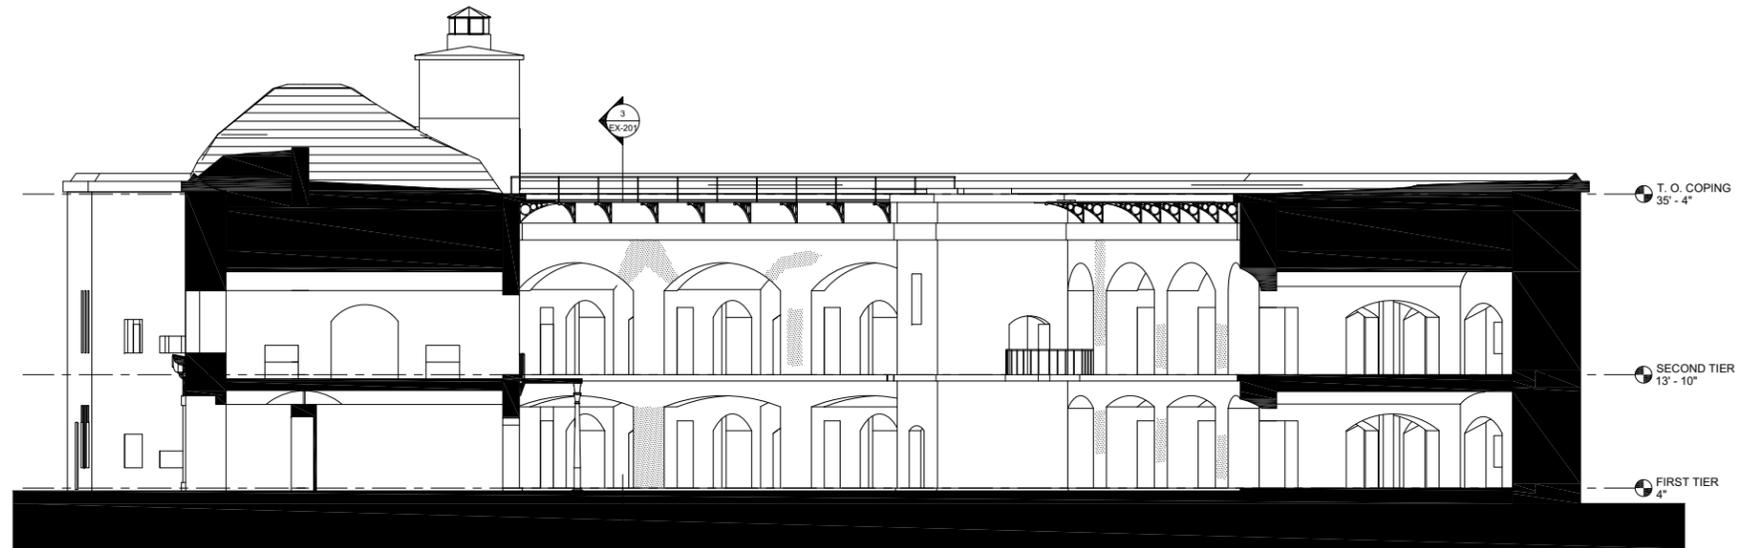
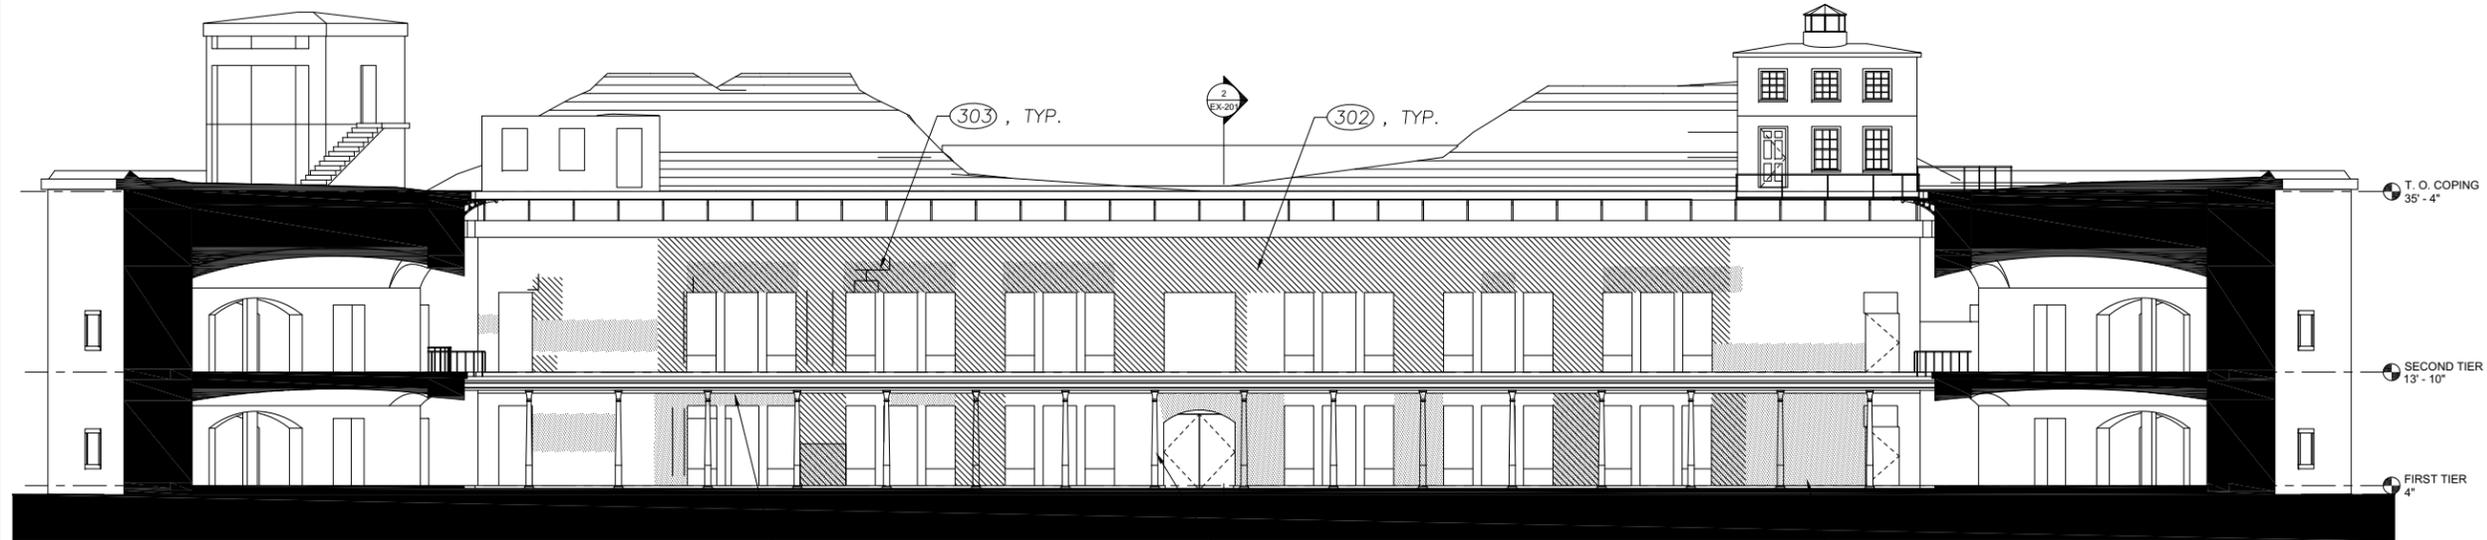
301 EFFLORESCENCE
	302 ERODED MORTAR JOINTS
	303 WIDENED MORTAR JOINTS
	305 RUSTED IRON BEAM SOFFITS
	306 DAMAGED IRON COLUMN

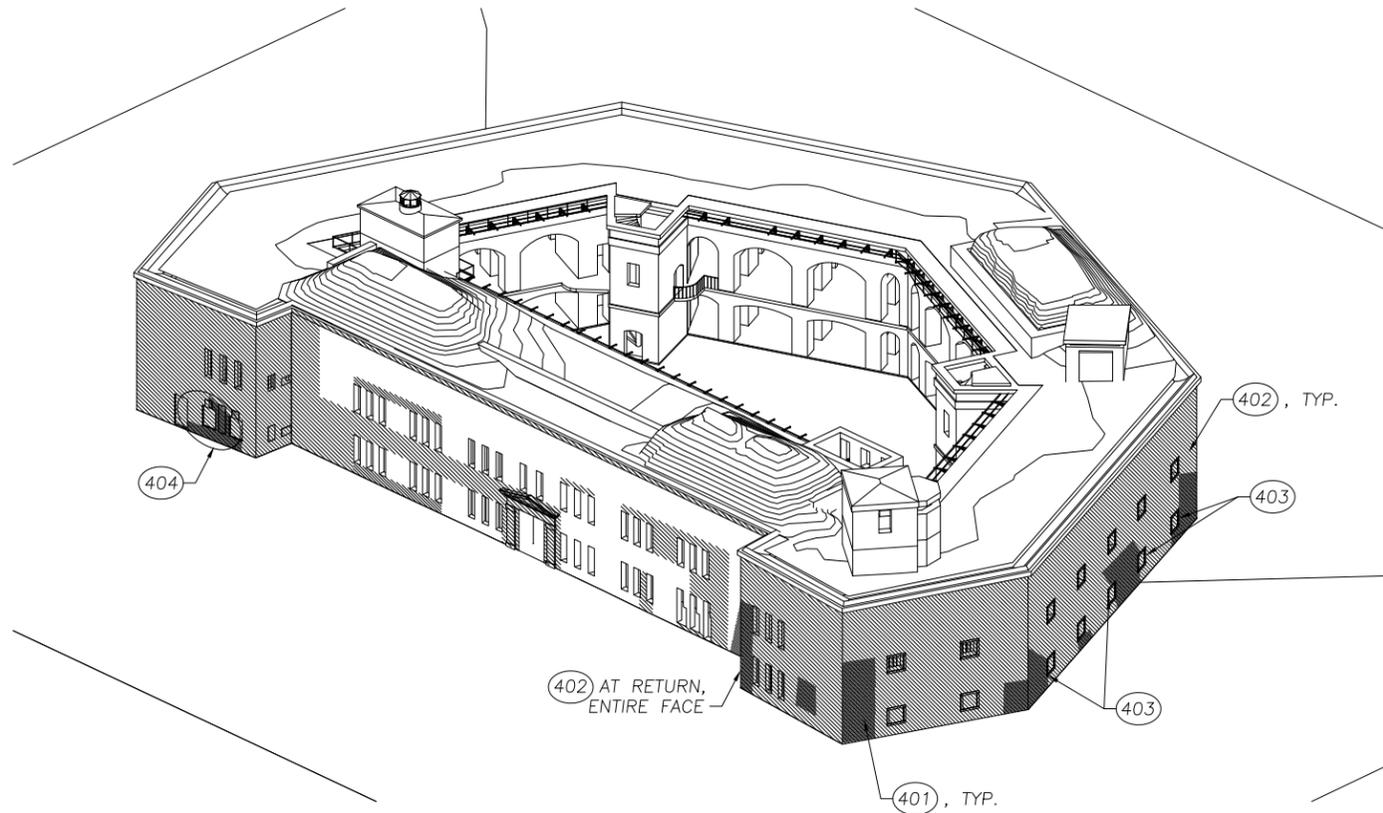
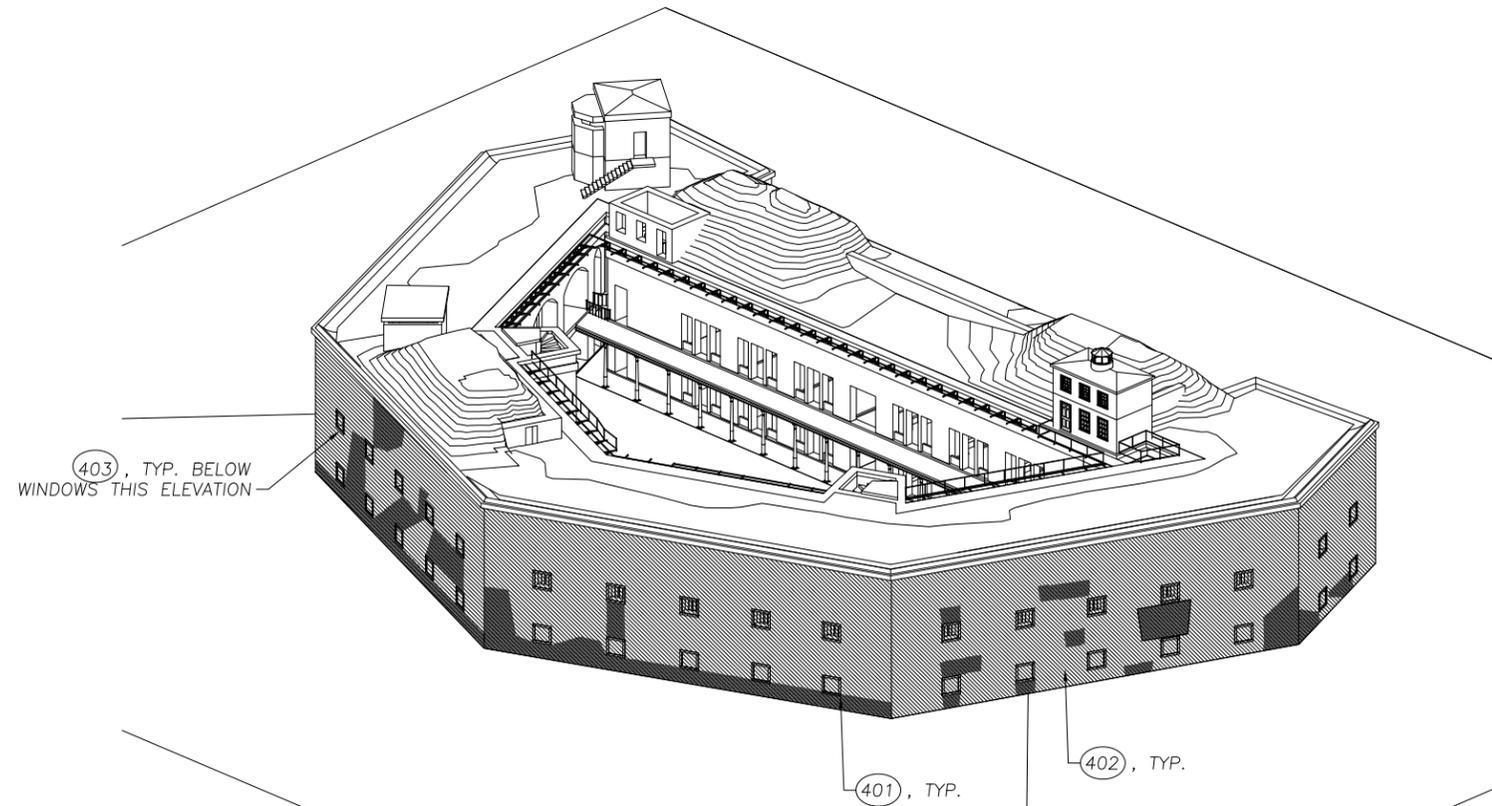
EX-202

401	EFFLORESCENCE
	402	ERODED MORTAR JOINTS
	403	CRACKED STONES & RUSTED METAL EMBEDMENTS
	404	SPALLED CONCRETE INFILL

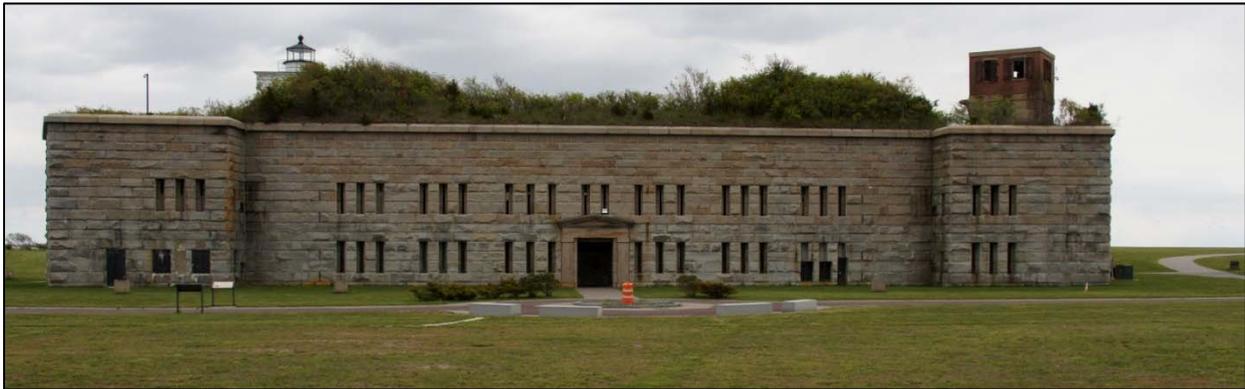
Fort Rodman today; although the ramparts are eroded and overgrown, the essential form survives.

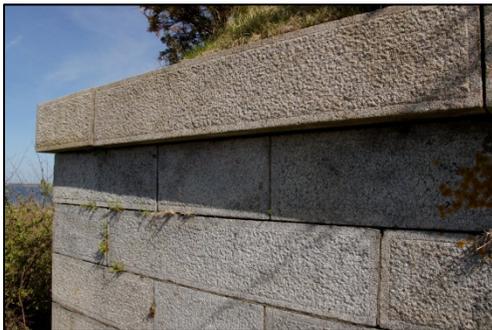
Parapet wall and coping need repointing.

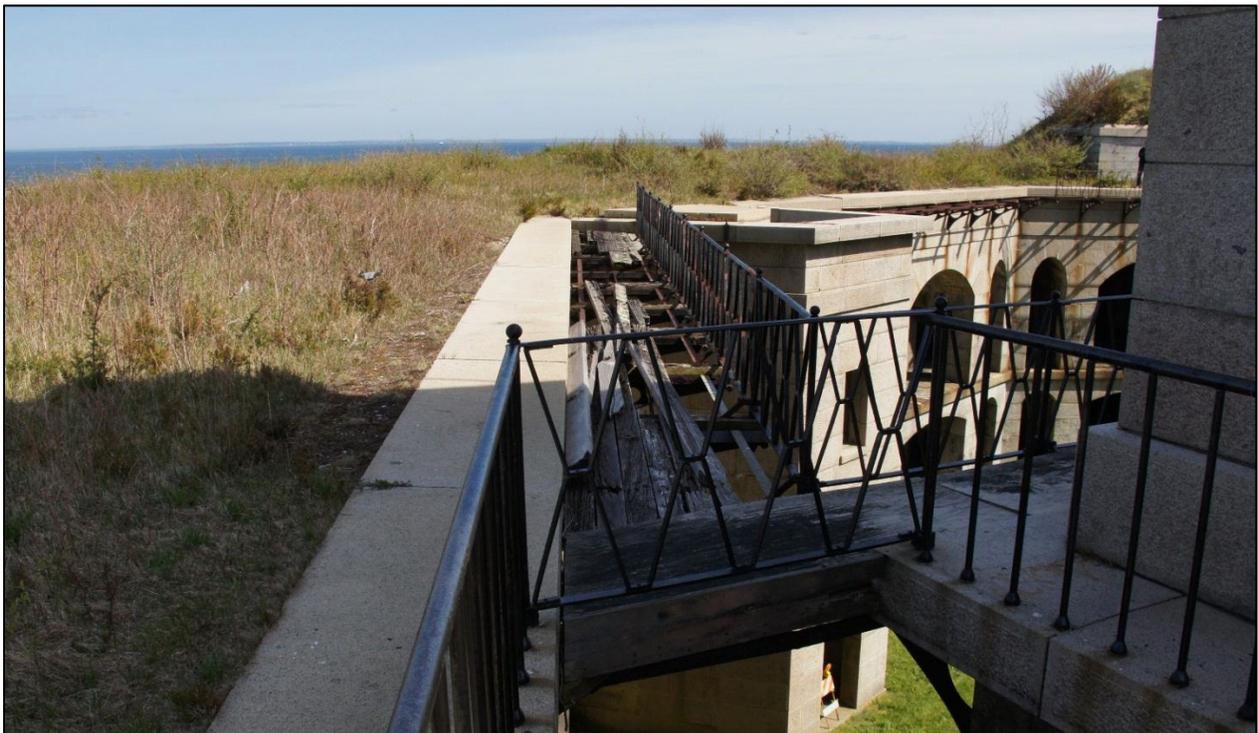
Terreplein, looking south from the lighthouse area; note the minimal change in elevation of the grassy terreplein. A new drainage membrane would need to "daylight" above the level of the repointed parade wall coping stones.

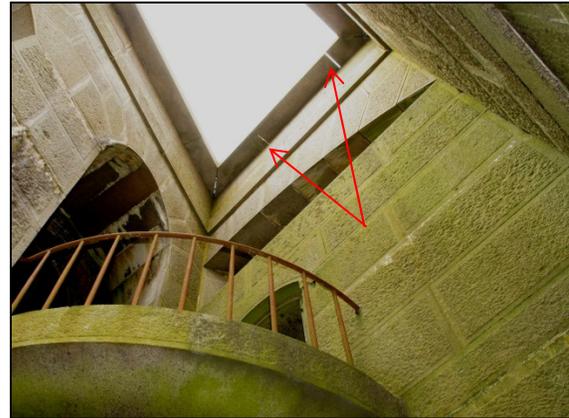
View of parade wall coping soffits from below; open vertical joints need repointing.

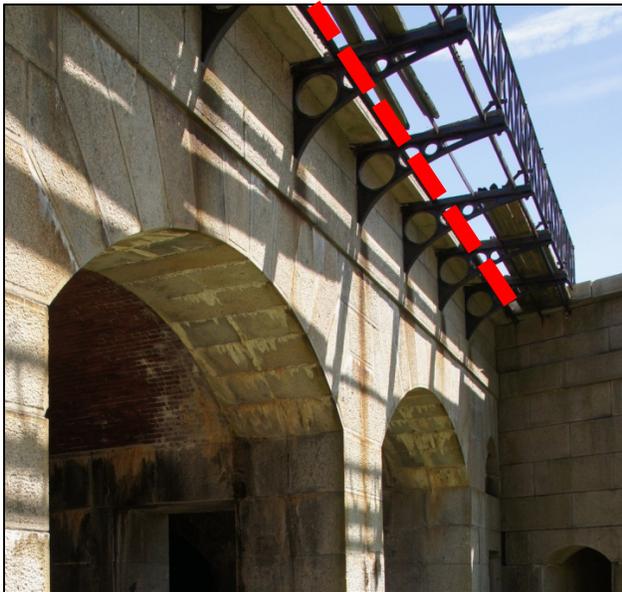
Extant iron brackets supported a wood-planked gallery. A new drainage gutter system could be installed atop the brackets and integrated with a reconstructed wood-plank gallery deck.

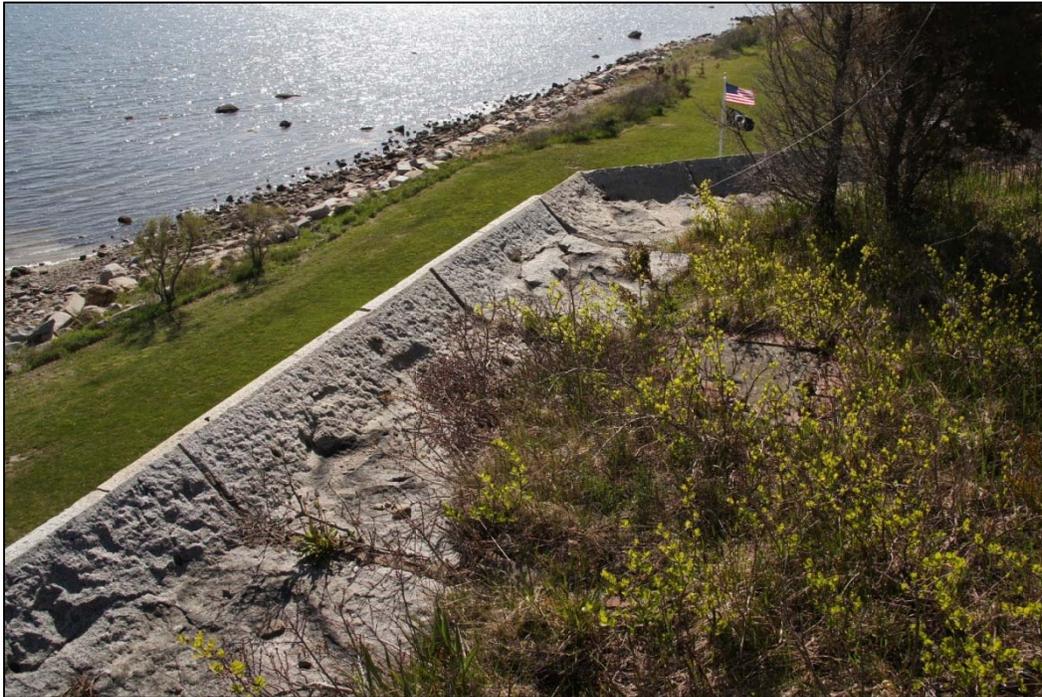
In some areas, fill atop the cordon stones has eroded away, exposed the dressed stone masonry to wind and rain.

Restoration of the original exterior slope of the terreplein is recommended.
