Fort Taber / Fort Rodman
New Bedford, Massachusetts

**Architectural / Structural Assessment
& Feasibility Study for Universal Accessibility**

Final Report

Bargmann Hendrie + Archetype, Inc.
Boston, Massachusetts

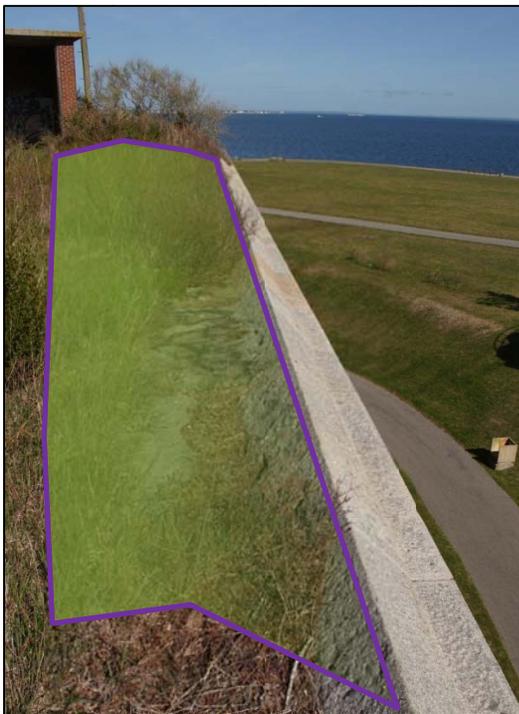
In some areas, fill atop the cordon stones has eroded away, exposed the dressed stone masonry to wind and rain.

Restoration of the original exterior slope of the terreplein is recommended.

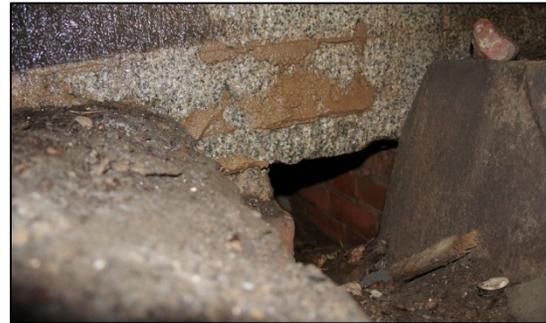
This existing underground drainage channel fed by vertical drains deep in the heart of the granite casemate piers has become undermined by flooding and/or scour.

The proposed drainage solution relies in part of carrying roof drainage down to grade via conventional gutters and rain leaders; accordingly, repair and restoration of existing underground drains is strongly recommended.

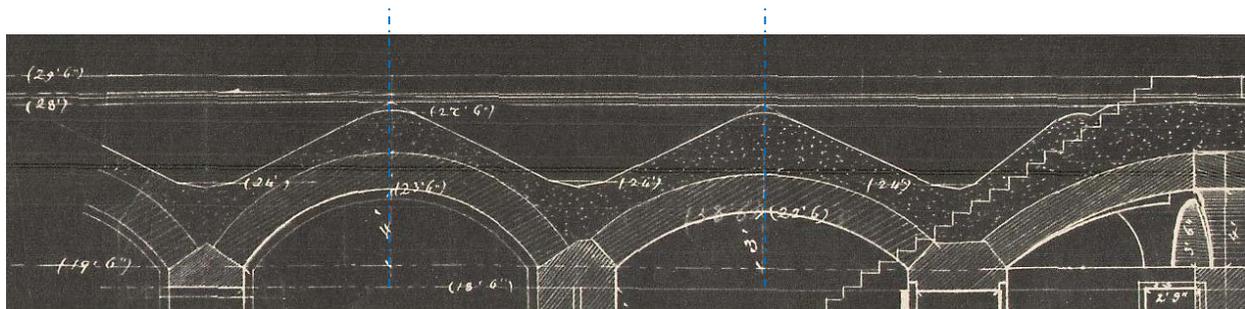
This historic "Plan of Roof Surfaces" (Drawer 25, Sheet 8) indicates subterranean pitches to internal drains; a typical drain location is circled in red on the plan.

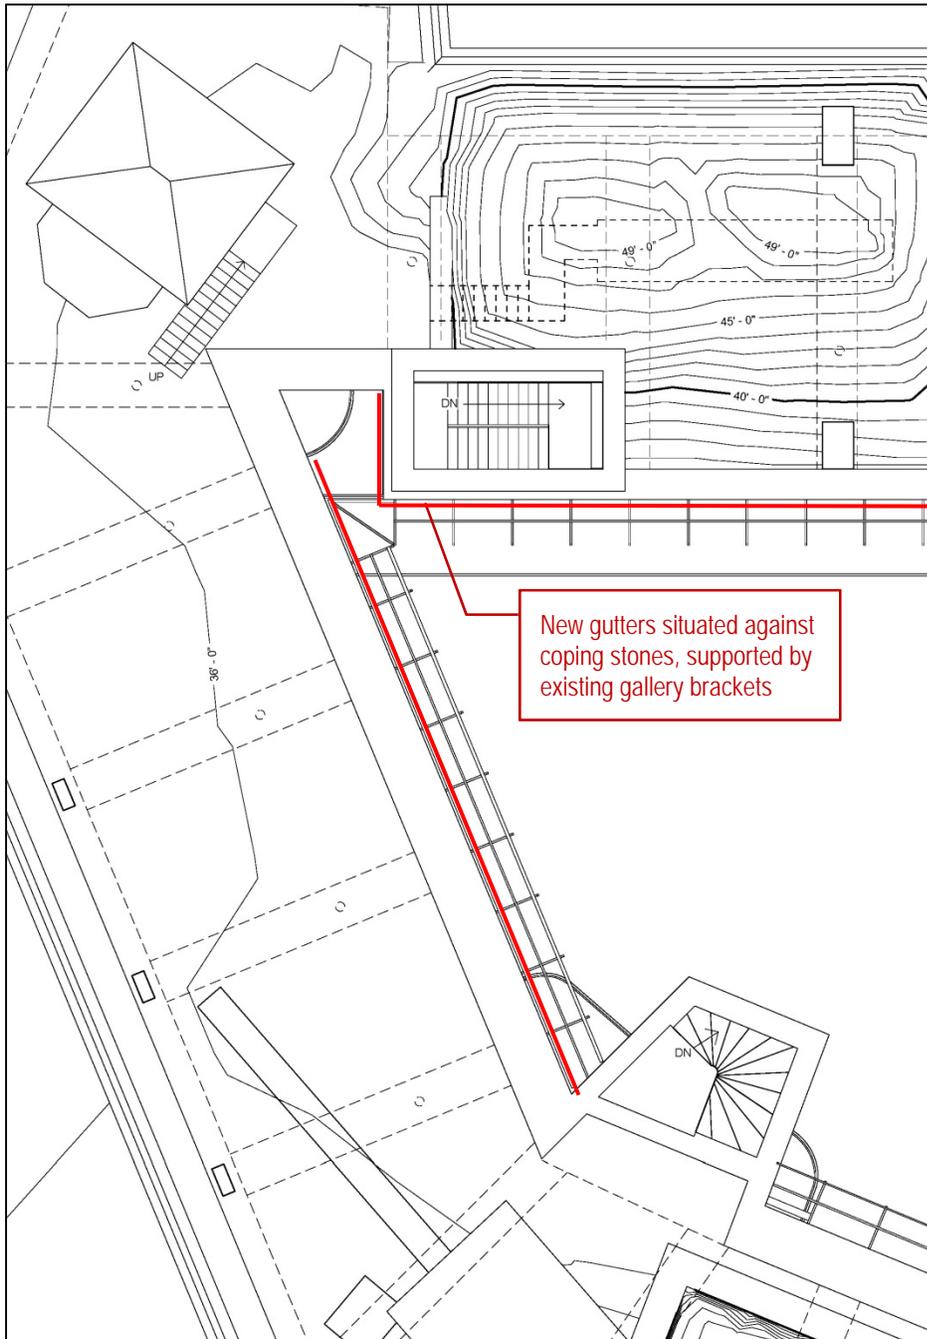
View west across parade at terreplein level; the existing iron gallery brackets could be repurposed to support (and camouflage) a new gutter system atop the interior (parade) wall.
