STAFF REPORT

NEW BEDFORD HISTORICAL COMMISSION MEETING

LOCATION: 141 William Street, First Baptist Church (Map 52, Lot 209)

Your Theatre – First Baptist Church Restoration/Renovation

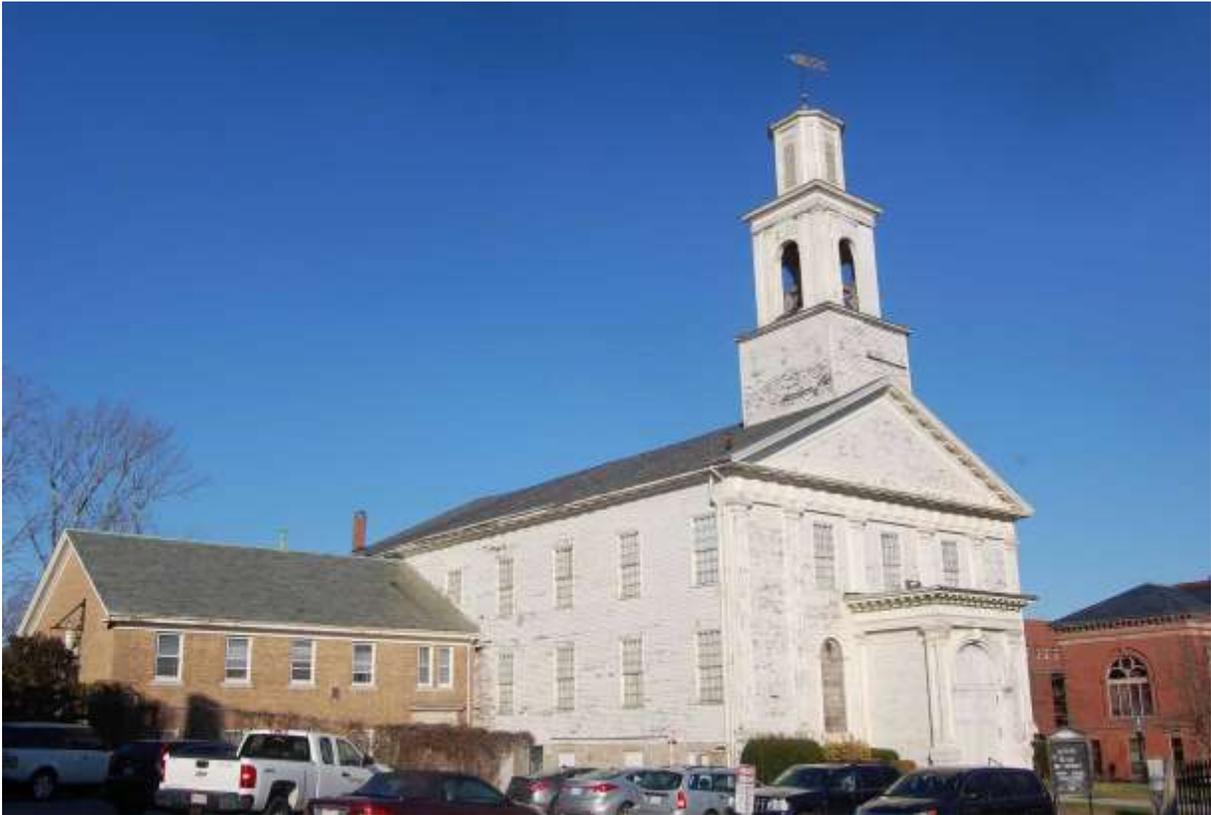
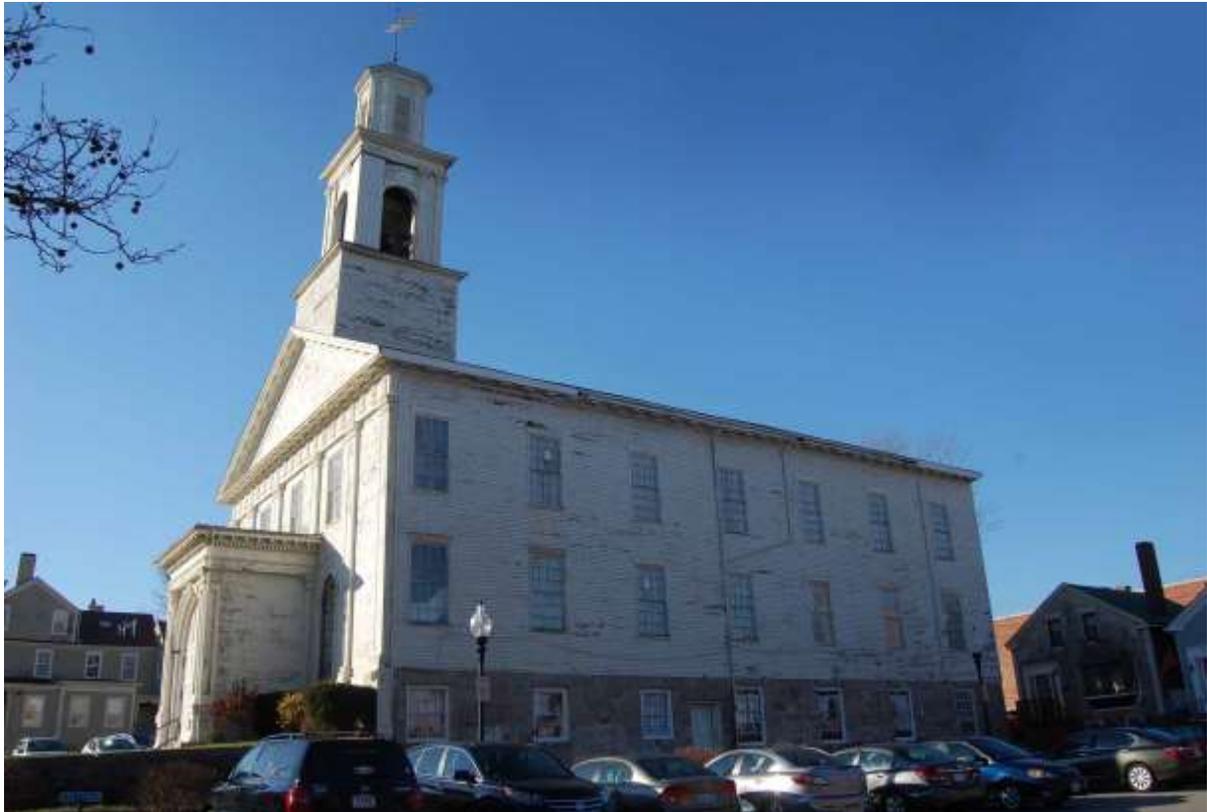
1. Overall Project Description.

Describe Existing Feature and its Condition: The original Meeting House was constructed in 1829 in the Greek Revival style with white clapboards and classical trim and built with timber frame construction. The spaces within the three-story Meeting House include a 400 person sanctuary with choir loft and balcony, baptistry, fellowship hall, kitchen and servery. Perhaps the most distinctive element of the Meeting House is the church steeple which was a prominent feature of the old New Bedford skyline and served as a navigational aid for mariners returning to the harbor. The steeple is still a visible feature of the official New Bedford city seal.

In 2006 the Massachusetts Historical Commission provided a grant to investigate the feasibility of restoring the Church as well as emergency funding to repair the roof which was actively leaking at the time. Peterman Architects, Inc., along with a team of engineers completed the study, and developed a scope of work and prepared a detailed estimate of the costs. In 2012 a portion of the wood cladding on the southeast corner of the steeple became detached and fell to the ground during a storm. The City of New Bedford paid for emergency repairs to seal the opening in the side of the steeple. During the summer of 2014 additional roofing repairs were made to complete the work started in 2006.

The scope of the rehabilitation work includes full and accurate historically correct restoration of the exterior shell including masonry, steeple repair, millwork, roof repair, clapboard repair and painting, and window and door restoration. The work also includes installation of new electrical system, new HVAC system, new accessible bathrooms and plumbing, fire protection/sprinkler system, and interior build-out of theatre space.

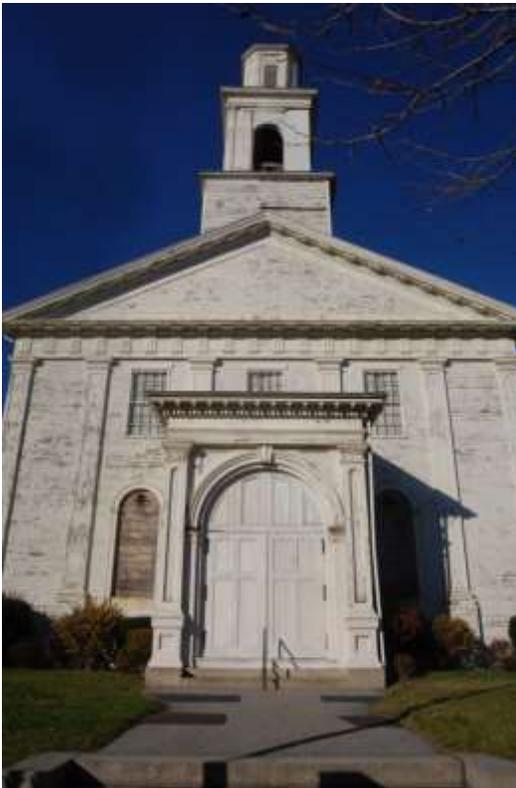
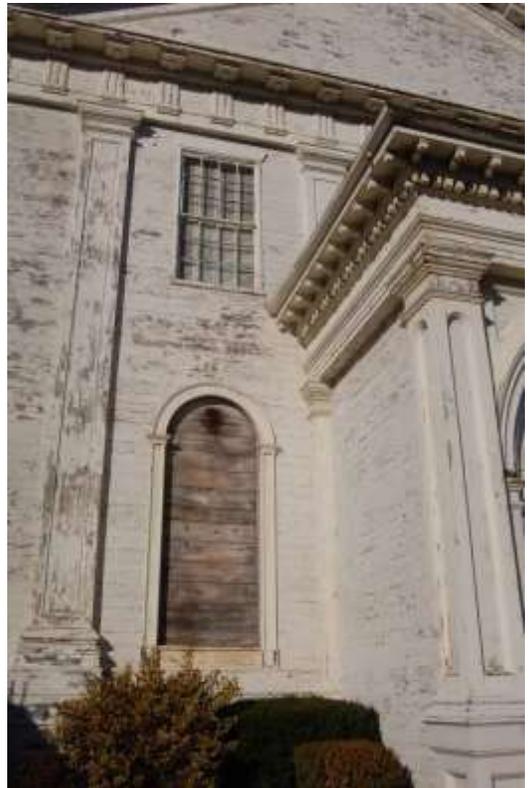
7. South Elevation, First Baptist Church.

Describe Existing Feature and its Condition: The front elevation of First Baptist Church has two arched and shuttered windows on the first floor which flank a one-story front center vestibule with round-arched double-door entrance. The second story has three twelve over twelve double hung original windows above the main entry. The main façade is articulated by pilasters, classical entablature, and full pediment. The vestibule was added in 1856.

The front façade has flush wood vertical siding. Paint failure is evident on the front elevation. The existing windows are primarily single glazed wood double hung units with sash weights that appear to be original to the structure. The windows in the older Church portion of the building are in poor condition due to loss of paint, broken/missing window panes, loss of glazing compound and broken sash cords. Window glazing is deteriorated and missing, trim is missing or badly decayed in several locations and the front entry doors are decayed along the bottom rail. Because the building has not been painted in nearly 40 years, much of the siding and trim is bare of any paint and exposed to the elements.

The existing exterior doors are painted wood stile and rail construction and they are in poor condition and not weathertight. Among the deficiencies are that the paint is peeling and gaps within the paneled doors are opening up. Door hardware does not meet accessibility requirements or egress requirements.

Describe work and impact on existing feature: All front elevation clapboard siding and trim will be prepped and painted. Broken or impaired clapboards and trim will be replaced to match existing. All shutters will be removed, and the wood frames, blades, trim and hardware will be repaired and rebuilt to original working condition. The shutters will be prepped and painted per specifications and rehung on existing hardware.

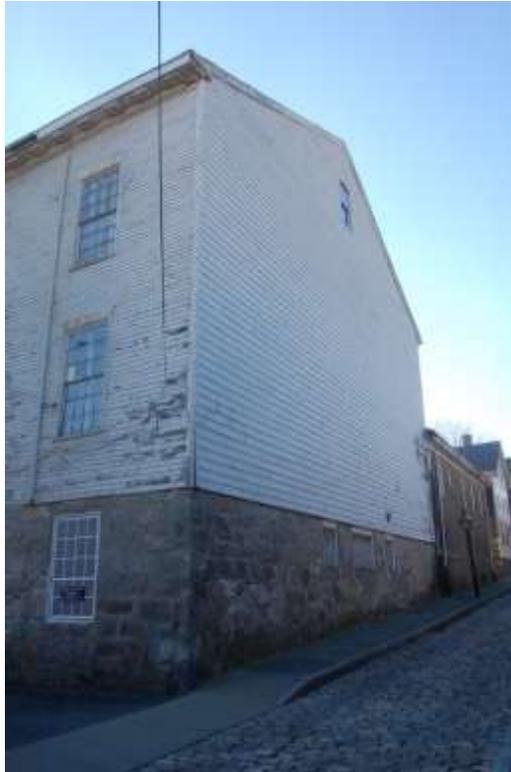
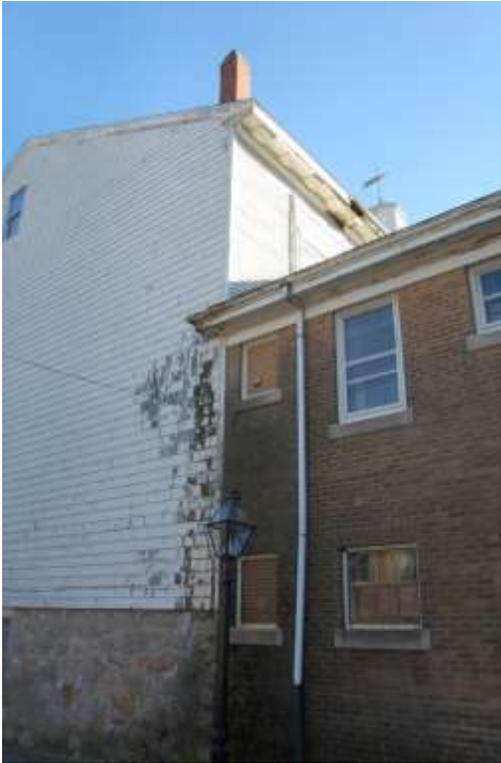
13. North Elevation, First Baptist Church.

Describe Existing Feature and its Condition: The west elevation adjoins the newer Education Wing built in 1928 which covers approximately 40% of the rear half of the façade. There are four two over two double hung windows at the basement level set in the field stone foundation, one of which is boarded up. There is also a short door at the basement level. The second and third levels have four twelve over twelve double hung original windows and two partial windows, covered by the addition. The clapboard and trim is in fair condition and the paint is severely peeling.

Describe work and impact on existing feature: The proposed work is to preserve the existing wood siding and trim and replace “in kind” only those portions that are missing or cannot be repaired with epoxy using the same materials and profiles of the existing feature. New work will be sanded, caulked and blended to smoothly blend with the existing trim. All east elevation clapboard siding and trim will be prepped and painted.
