Re: Wetland Restoration Report (MassDEP File #: SE49-466)
2301 Purchase Street, New Bedford, MA

Goddard Consulting, LLC is pleased to submit this wetland restoration report on behalf of Friends Realty, Inc. at the parcel known as 2301 Purchase Street in New Bedford, MA (Parcel IDs: 97; 6, 9). This report is in accordance to the Wetland Restoration Plan by Goddard Consulting, LLC dated May 2, 2016, and is to be an initial report documenting the work completed thus far. A post completion report as well as two seasonal monitoring reports will be forthcoming.

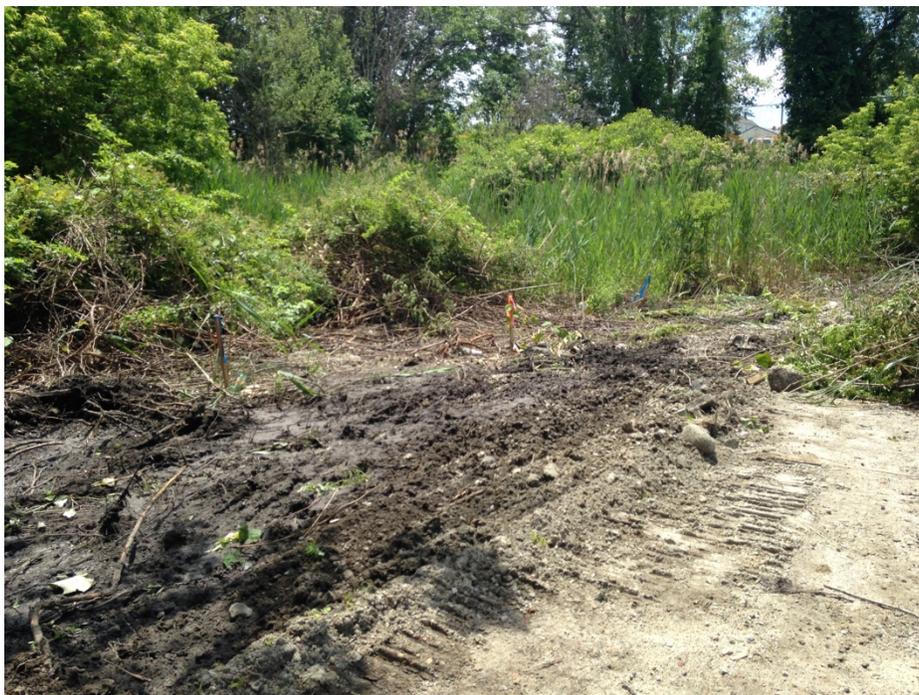
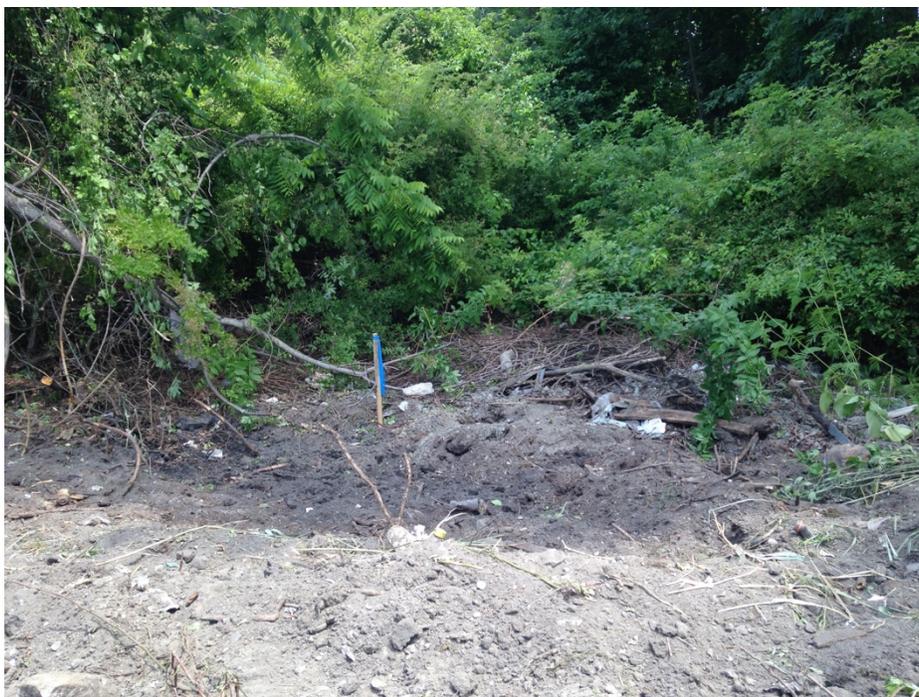
Field staking the boundaries of the wetland restoration area.

Step 1: Stake Limits of Work & Install ECB. The limits of the restoration area were staked in the field following the boundaries indicated on the plan. An Erosion Control Barrier was set in place.

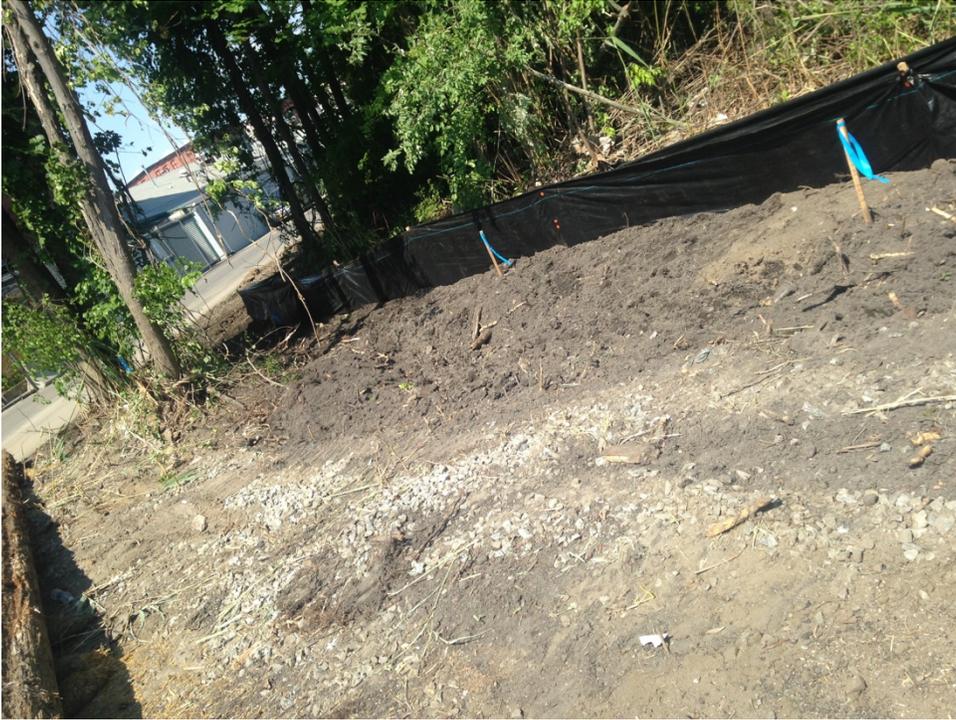
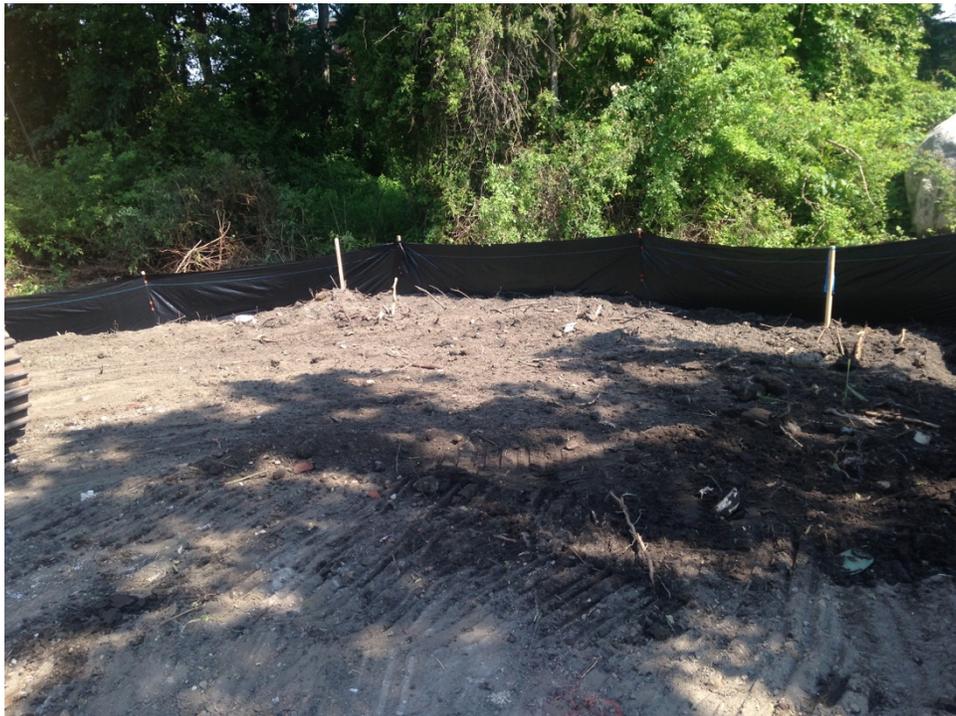
Installing the Erosion Control Barrier.

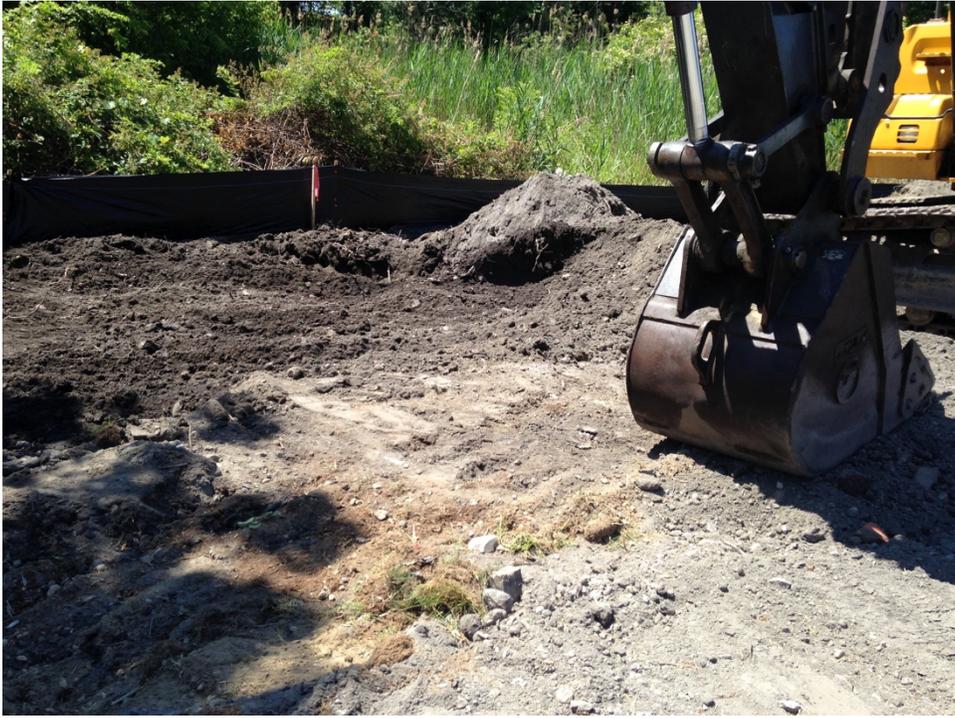
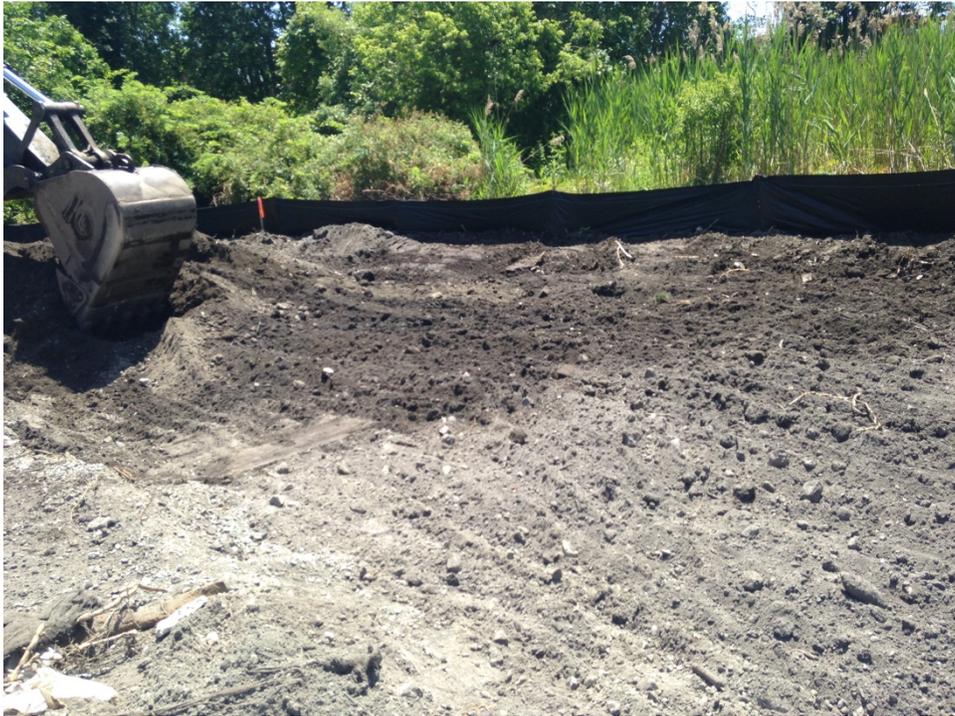
Excavating the upland soils

Step 3a: Excavation of Restoration Area. All vegetation within the restoration area was excavated, and two trees towards the southwestern corner were left in place to avoid harming them.

Step 3b: Existing upland soils and fill were removed until redoximorphic features were observed, which occurred at approximately 16 inches below grade. 6-8 inches of organic topsoil was placed on top and graded to match that of the adjacent wetland. A light layer of weed-free straw was placed on top to keep the soil moist and protect it throughout the summer.

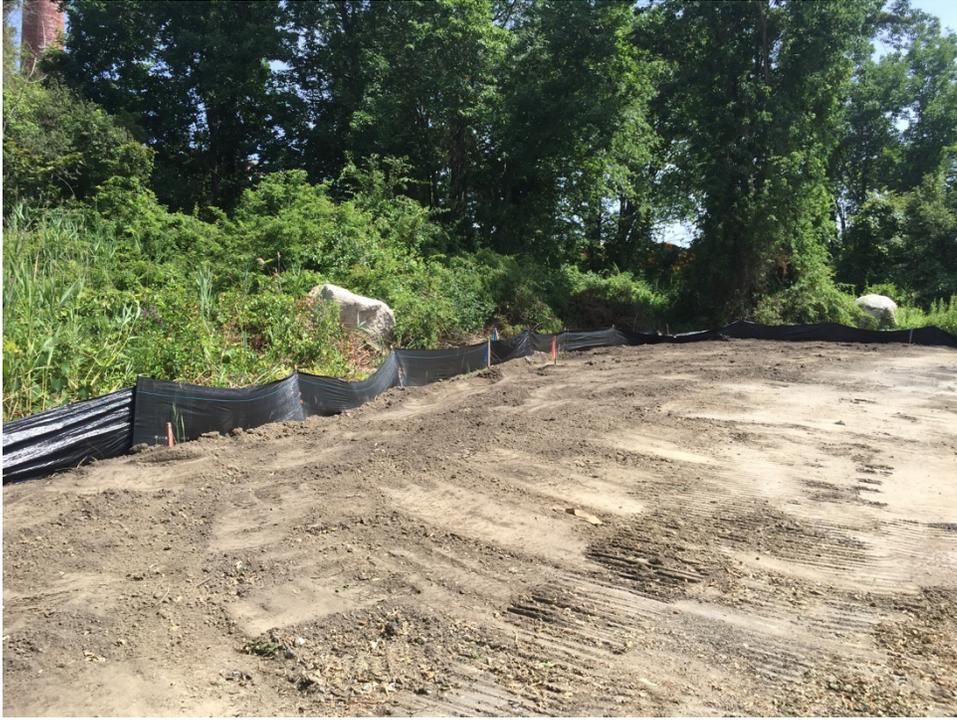
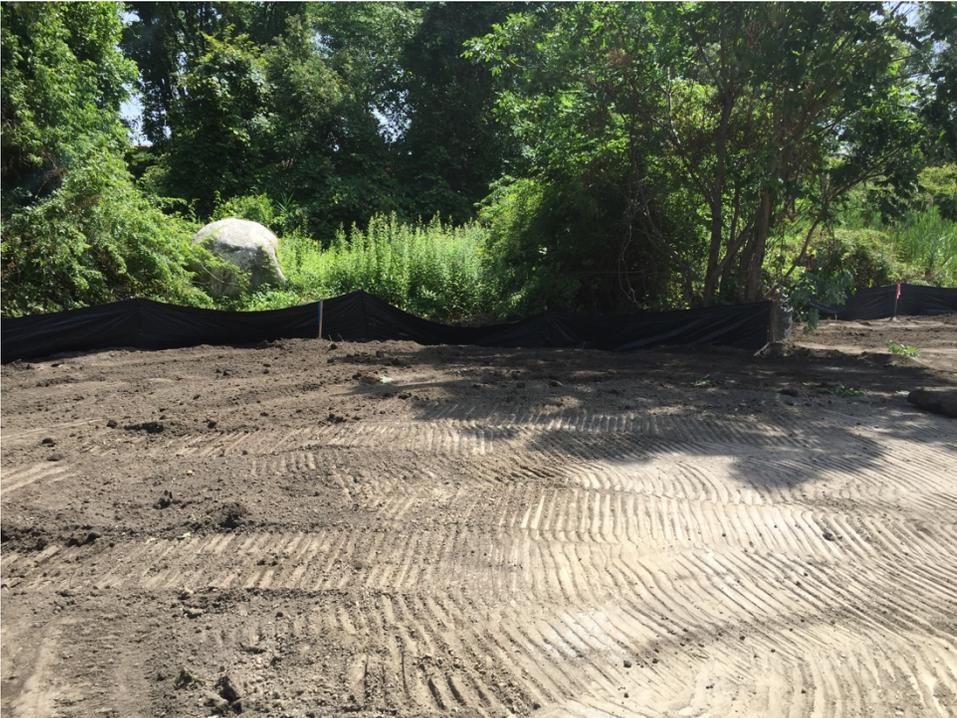
Addition of topsoil and final grading.
